Article

Structural Damage Detection Using an Unmanned Aerial Vehicle-Based 3D Model and Deep Learning on a Reinforced Concrete Arch Bridge

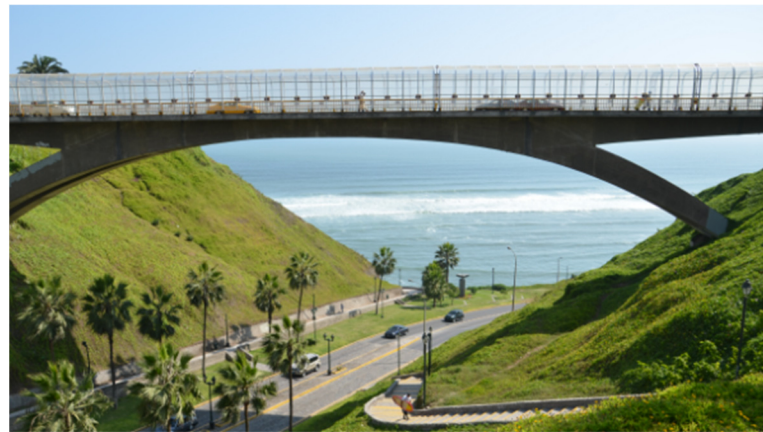
To test the proposed method, the Bridge Villena Rey (Figure 1), which is located in the Miraflores district in Lima, Peru, is taken as a case study. This bridge dates back to 1967 and passes over the “Bajada Balta” ravine. It has a two-lane road for vehicular passage and, years ago, it was bidirectional. However, due to its high traffic volume, the bridge has had traffic congestion problems and, therefore, a twin bridge was built in 2014—that is,

Figure 1. Villena Rey Bridge.

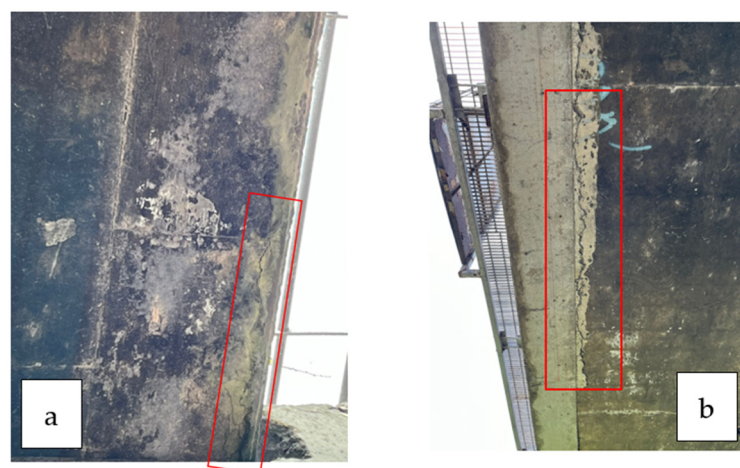
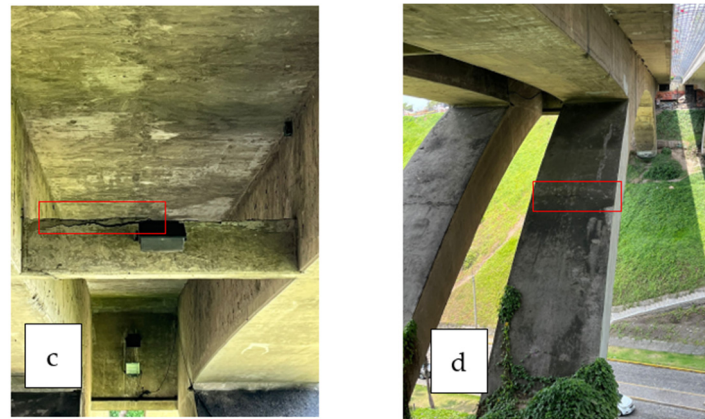
Figure 2. Structural cracks and fissures detected in a previous visual inspection. (a) Crack identified under bridge deck. (b) Crack identified under bridge deck. (c) Crack identified in cross-beam. (d) Crack identified in arch.

As part of this investigation, a visual inspection was performed on the old bridge, as would be performed in a traditional structural damage detection. In this way, it was confirmed that the bridge is damaged. The results of the inspection are detailed in Figure 2 and Table 1. When the width of the crack is greater than 0.4 mm, there is already a high level of impact, which indicates a reduction in the earthquake-resistant capacity [16]. The method proposed in this research is able to recognize damages that are at least 0.4 mm wide or even larger, due to the distance of the UAV from the structural elements, which is usually from 2 to 3 m. The UAV would not be able to capture damages narrower than 0.4 mm. Therefore, only cracks with structural significance are captured.

Table 1. Fissures and cracks reported visually in a technical inspection on the Villena Rey Bridge, visually estimated width, and its level of impact on the structure.

Damage	Ubication	Specification	Visually Estimated Slit Width (mm)	Width Classification	Level of Impact on the Structure
1	Slab	Cleft, crack	1 mm	Crack	Very high
2	Slab	Cleft, crack	2 mm	Crack	Very high
3	Beam	Cleft, crack	3 mm	Crack	Very high
4	Pier	Cleft, crack	3 mm	Crack	Very high

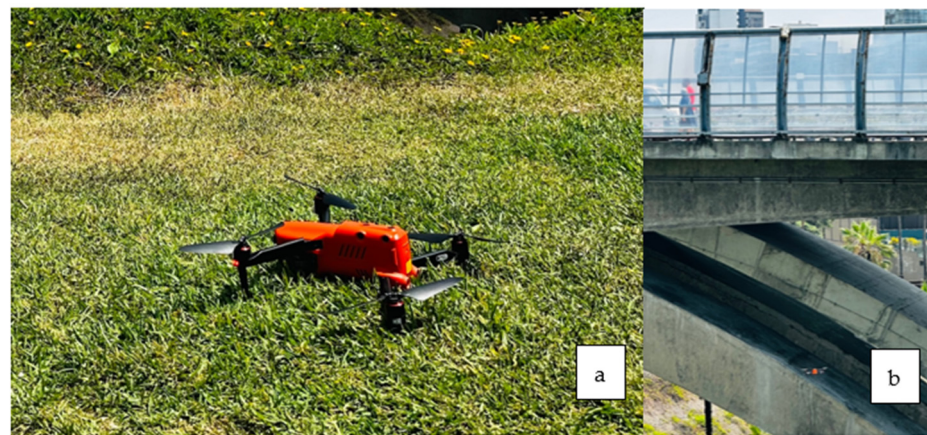
Figure 4. (a) Evo II Pro, Drone Professional Peru; (b) photogrammetry using UAV.

For the photogrammetric survey, an “EVO II Pro” drone from the Drone Professional Perú brand is used (Figure 4). Among its specifications, it stands out that it must have an adequate mass so that it is not destabilized by the force of the air (1174 g), adequate ascent and descent speeds (5 m/s and 3 m/s, respectively, in its standard mode), a long flight distance (25 km), and a safe maximum flight time (40 min). The camera should take good quality photos and produce images of various sizes (5472×3648 ; 5472×3076 ; 3840×2160). The data mentioned refer to the model and brand of the drone to be used. The approximate distances for taking photographs of the structural elements of the bridge are between 2 and 3 m. It is advisable not to bring the UAV too close to the bridge, as it may destabilize and collide due to air turbulence.

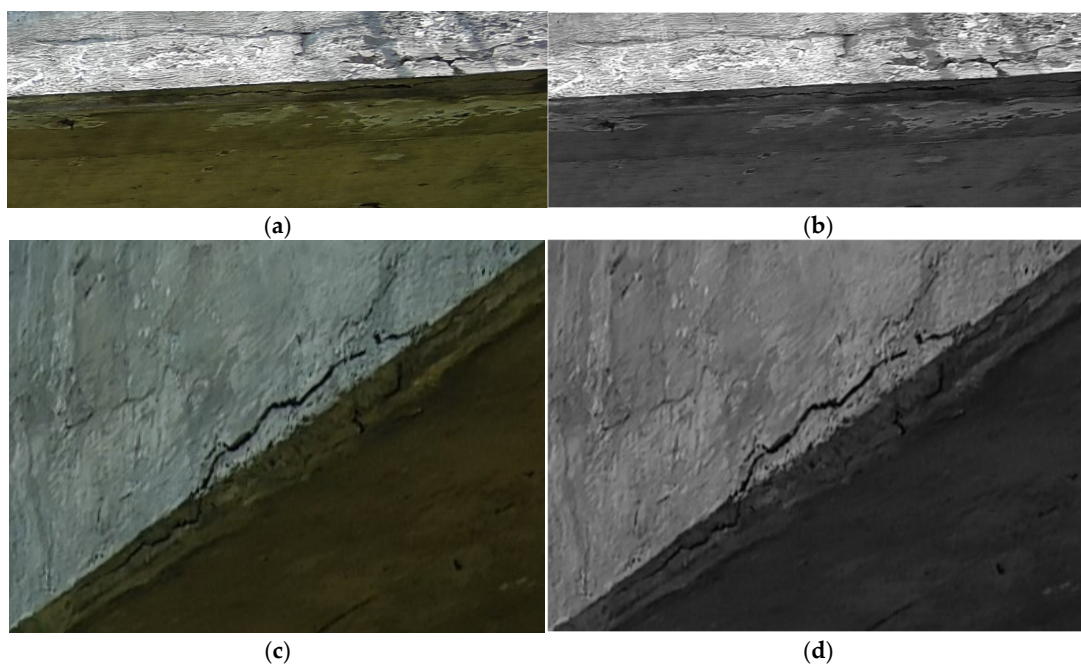
Figure 6. Images labeled “MAX_0995” and “MAX_1052” in original RGB format and grayscale. (a) Image with label “MAX_0995” RGB. (b) Image labeled “MAX_0995” in grayscale. (c) Image with “MAX_1052” RGB label. (d) Image labeled “MAX_1052” in grayscale.

An image is made up of 24-bit wide pixels distributed as follows: 8 bits for the color red, 8 bits for the color blue, and 8 bits for the color green. Therefore, in the grayscale transformation, the pixel only contains 8 bits that provide information about brightness, but not color. Mathematically, there are different methods that are used to obtain a grayscale image, and among these, we have the following: average method, luminosity method, desaturation method, and decomposition method. Among the different existing methods, the one used for algorithm functions, such as “rgb2gray” in Matlab, is the luminosity method [23]. As an example, two results of converting images to grayscale are evident in Figure 6.

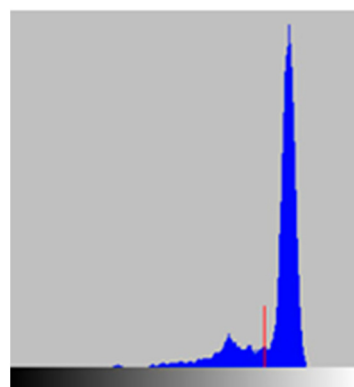
Figure 7. Histogram of an image.

In the histogram, the X axis represents the grayscale value and the Y axis represents the number of pixels for each grayscale. Likewise, the red line represents the threshold value, T , which will be responsible for dividing the image pixels between the background and the object.

Graphically, it can be visualized and interpreted in Figure 7 [26].

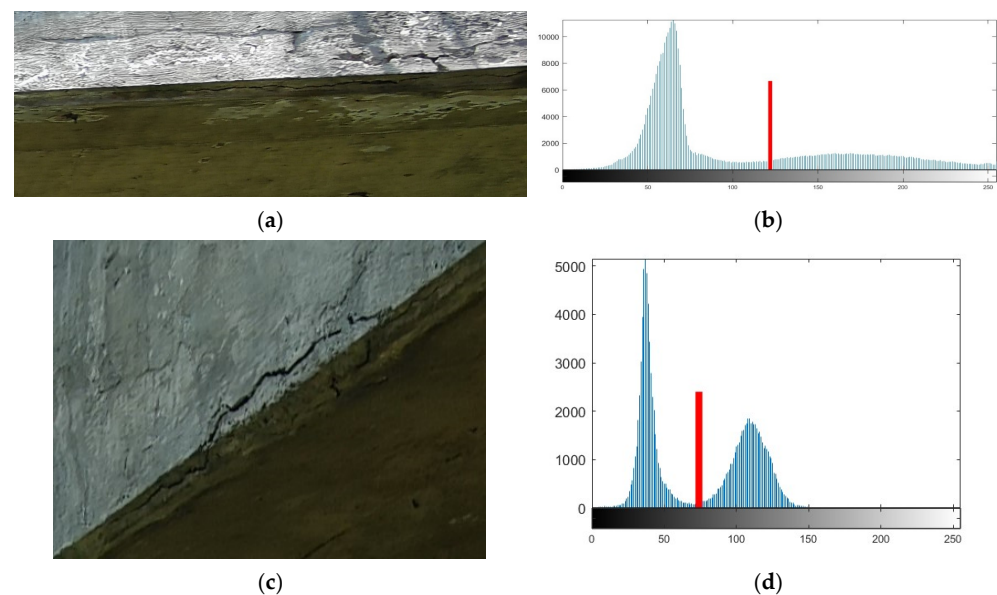
Figure 8. Images labeled “MAX_0995” and “MAX_1052”, with their histograms and average threshold. (a) Image with label “MAX_0995” RGB. (b) Image histogram “MAX_0995” (125 average scale gray and 0.48 threshold). (c) Image with “MAX_1052” RGB label. (d) Image histogram “MAX_1052” (75 average grayscale and 0.29 threshold).

In Matlab, there is the “graytresh” function that is responsible for providing the threshold value for the image by applying the method mentioned above. Figure 8 shows two histogram results and mean threshold data for two images obtained from the bridge. However, these values are referential. Depending on the code configuration, this threshold value can be set manually to match the gray tones in the image. This was performed to obtain binary images with better highlighted and visible cracks, which can be seen in Figure 9. For example, in the case of the image with label “MAX_0995” seen in Figures 8 and 9, it is reported a large number of pixels corresponding to a grayscale from 60 to 70; that is why a peak is observed in that area of the graph. The red line in the histogram represents the average grayscale of the image based on the number of pixels. That is, the pixels of the image, on average, have approximately a grayscale value of 125. With this average, the algorithm has the reference of granting a threshold value of 0.48 to the binarization process. However, as already anticipated, such a threshold may not be convenient, as it would not highlight the crack. Therefore, a threshold value of 0.1 was assigned manually because, during the image processing, it was observed that the threshold value was too high, causing distortion in the area that needed to be highlighted.

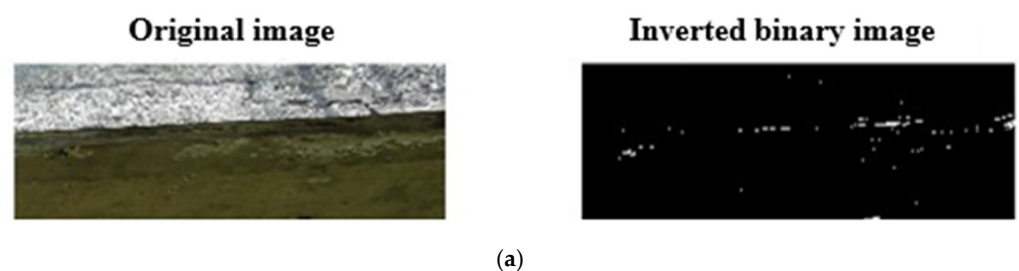
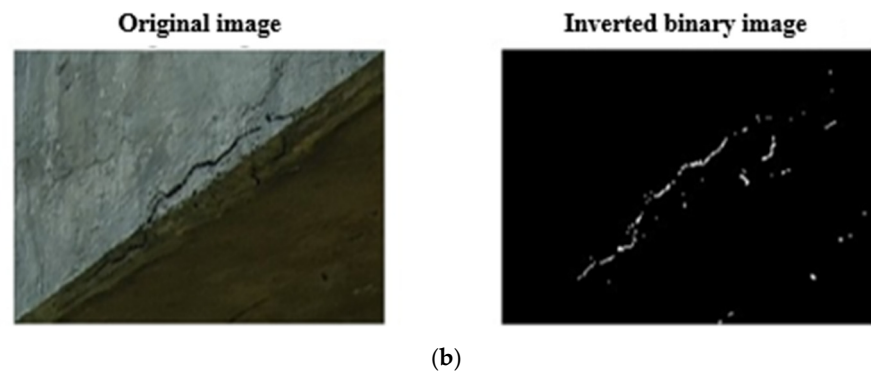
Figure 9. Binary segmentation results of images labeled “MAX_0995” and “MAX_1052” and thresholds considered. (a) Binary segmentation result of image with label “MAX_0995” with a threshold of 0.1. (b) Binary segmentation result of image with label “MAX_1057” with a threshold of 0.08.

Finally, assigning the threshold to the grayscale image is how the binary image is obtained. In Matlab, the “im2bw” function is used for this purpose. The developed algorithms can be adjusted to process folders of images that have similarity in their lighting and color characteristics, with the same threshold value. Thus, it is possible to automate the process.

After binary segmentation, the cracks, being darker than the concrete structures, turn black, while the background turns white. However, for esthetic purposes and ease of understanding, within the Matlab algorithm, it has been contemplated that the blacks and whites can be reversed. In this way, the cracks will appear white on a black background, as seen in Figure 9.

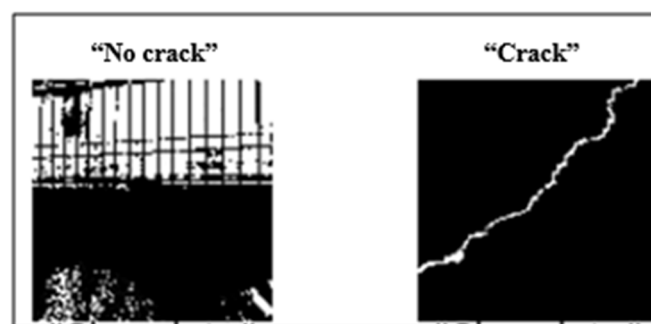
Figure 10. Example of the labels assigned to each image.

are generated that represent the image labels; in other words, it will be responsible for predicting whether the images contain a crack, as an output of the CNN. Figure 10 shows an example of the labeled images.

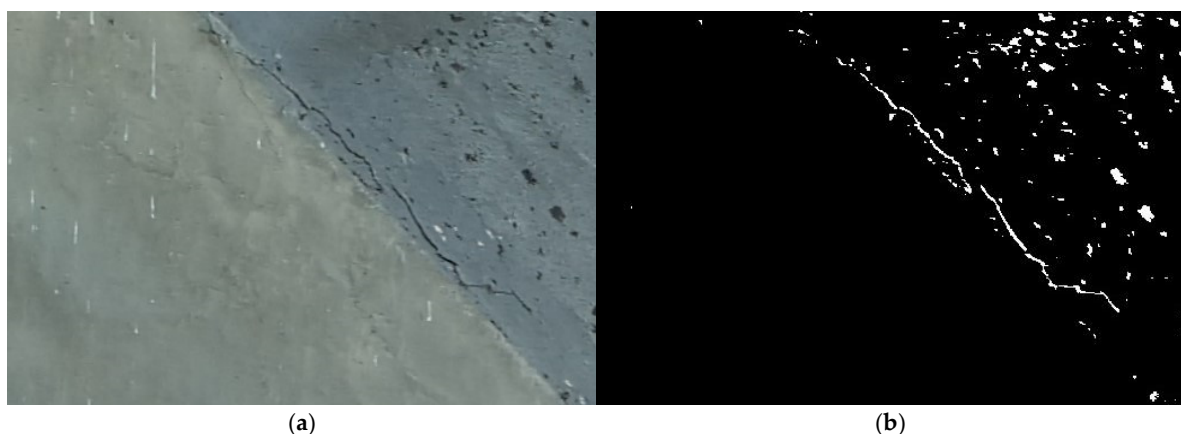
Figure 11. Image “MAX_0912” with a crack detected by CNN. (a) Image tagged “MAX_0912”. (b) Image “MAX_0912” after binary segmentation.

Table 4 shows the list of images with the presence of cracks and their location with respect to the 3D model. As an example, the case of the image labeled “MAX_0963” is taken, which is presented in color and in binary form in Figure 11. There is clearly a crack in this image. To know its location, the Agisoft Metashape Professional should be accessed; then locate in which block of the digital model the photograph is located, activate the “cameras” in the software, select the required image, and the photograph will be highlighted in the corresponding location (Figure 12).

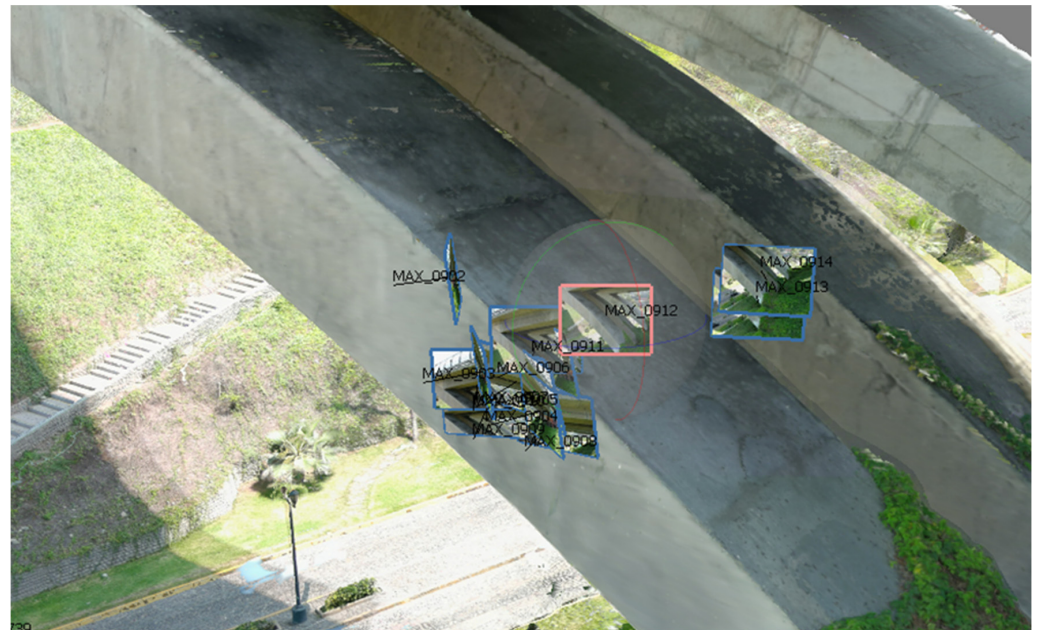
Figure 12. Image location “MAX_0912” in the digital model.

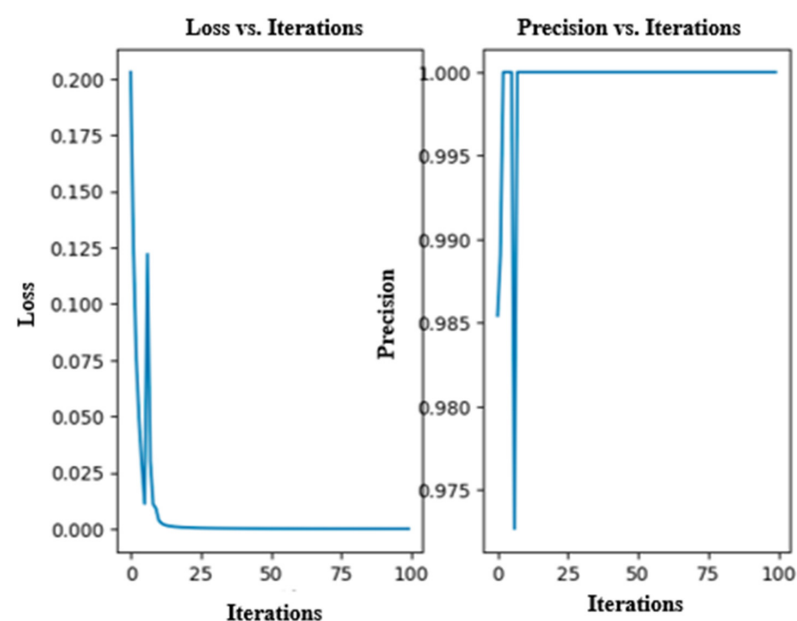
Figure 13. Loss vs. graph iterations and precision vs. iterations.

However, the accuracy achieved by the CNN was 88.4%. Graphically, the accuracy and losses are shown in Figure 13. On the one hand, it can be observed how the loss decreases as the training iterations progress. Initially, the loss decreases rapidly, indicating that the model is learning and adjusting its parameters effectively. After about 25–30 iterations, the loss stabilizes close to zero, suggesting that the model has learned the patterns in the training data well and reaches a point where more iterations do not provide significant improvements; thus, the previously mentioned range is the ideal number of epochs to train the network. On the other hand, regarding the accuracy vs. iterations graph, accuracy improves rapidly at the beginning, showing that the model is learning to predict correctly. Additionally, very high accuracy values are observed quickly; that is, the model is capable of correctly classifying almost all samples. Finally, the accuracy stabilizes rapidly and remains close to 100%, indicating that the model maintains high performance after the initial iterations.

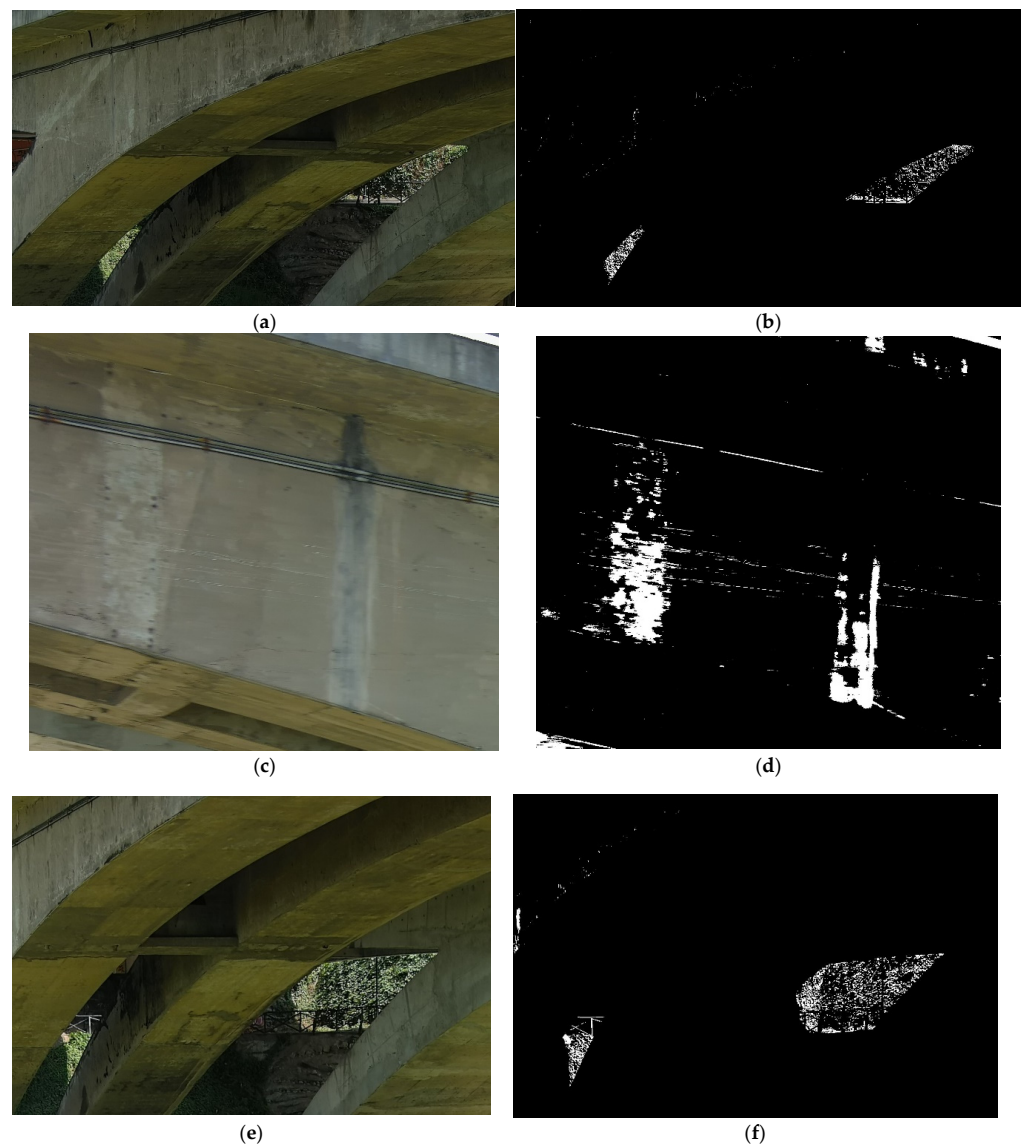
Figure 14. Images “MAX_0793”, “MAX_0807” and “MAX_0835”. (a) “MAX_0793” color version. (b) “MAX_0793” binary version. (c) “MAX_0807” color version. (d) “MAX_0807” binary version. (e) “MAX_0835” color version. (f) “MAX_0835” binary version.

Therefore, it is possible for the CNN to detect a crack in an image that, in reality, does not exist. This is the case for the images “MAX_0793”, “MAX_0807”, and “MAX_0835”, which, as seen in Table 4, do not correspond to damage. This may be due to the fact that these images, in their binary version, can become confusing for the network because of the presence of white continuities that may be interpreted as cracks. What is described can be observed in Figure 14. In the case of Figure 14d, a very clear white line is seen, but if the color version of that image is examined, that continuity is due to the pipe that runs through the bridge structure. Thus, it can also be determined that binary segmentation may emphasize and highlight continuities that are not necessarily cracks. One possible way to correct this detail is by using a database with a larger number of images for the CNN training phase. In this way, there will be more binary images with the presence of white continuities that are not cracks and the CNN, in its training, will detect this feature and will not detect them as cracks. Instead, it will improve the extraction of features from those that are cracks and will identify them more accurately. However, precision is never perfect; therefore, no matter how much training there is, the results must always be corroborated.
