# Performance Evaluation of a Sustainable Glulam Timber Rubrail and Noise Wall System Under MASH TL-3 Crash Conditions

Noise barriers are commonly used to reduce the adverse effects of traffic noise in both urban and suburban settings. While conventional systems constructed from concrete and steel provide reliable acoustic and structural performance, they raise sustainability concerns due to high embodied energy and carbon emissions. Glued-laminated (glulam) timber has emerged as a sustainable alternative, offering a reduced carbon footprint, aesthetic appeal, and effective acoustic performance. However, the crashworthiness of timber-based noise wall systems remains under investigated, particularly with respect to the safety criteria established in the 2016 edition of the American Association of State Highway and Transportation Officials (AASHTO) *Manual for Assessing Safety Hardware* (MASH). This study presents the full-scale crash testing and evaluation of glulam rubrail and noise wall systems under MASH Test Level 3 (TL-3) impact conditions. Building on a previously tested system compliant with National Cooperative Highway Research Program (NCHRP) Report 350, modifications were

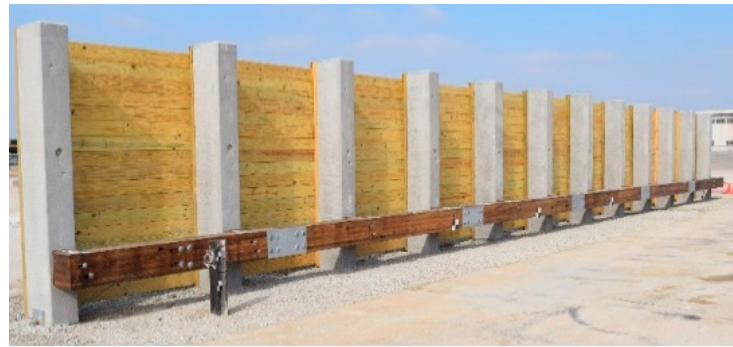
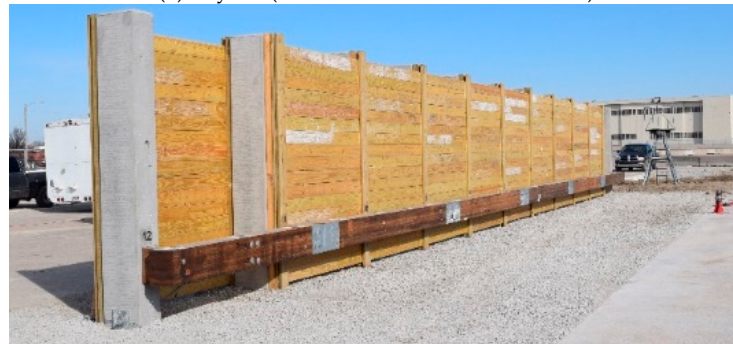
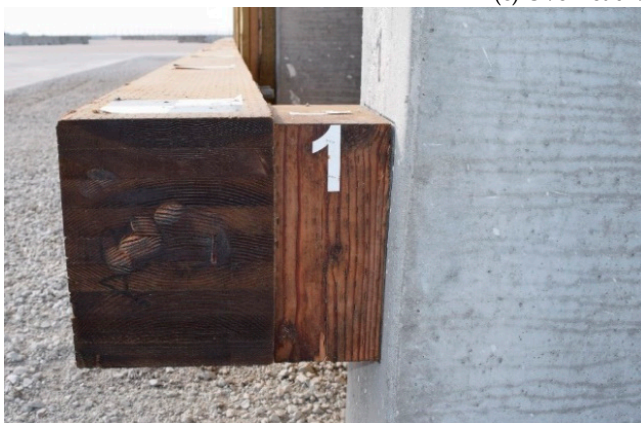
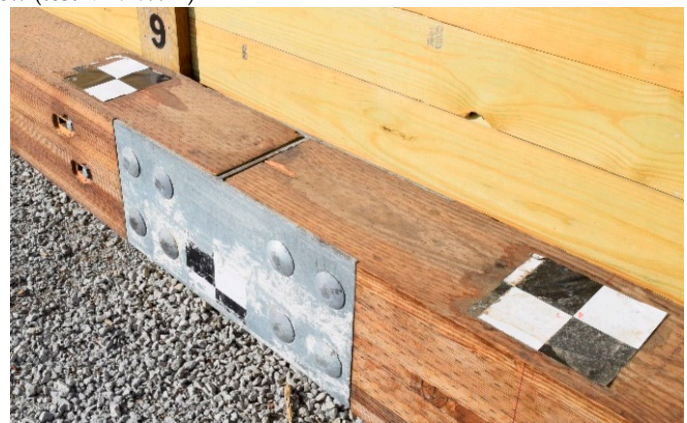
(a) Layout (tests MNNW-1 and MNNW-2)

(b) Layout (test MNNW-3)

(c) Overhead view (test MNNW-1)

(d) Rubrail, offset blocks, and rail splice (test MNNW-3)

**Figure 3.** Redesigned noise wall and glulam timber rubrail system, (a) layout used in tests MNNW-1 and MNNW-2, (b) layout used in test MNNW-3, (c) overhead view of system configuration, and (d) details of rubrail, offset blocks, and splices.

The test installation consisted of a wood plank noise wall supported by twelve vertical prestressed concrete support posts, shielded by a 27.13 m long glulam timber rubrail system. This rubrail was composed of six timber segments connected by five welded steel H-shaped splice plates, each 9.53 mm thick. Spacer blocks made of glulam timber, 229 mm wide by 152 mm deep by 343 mm long, were used to offset the rubrail from the front face of the posts. Each concrete post measured approximately 305 mm by 457 mm in cross section and 5486 mm in length. The posts were spaced 2438 mm apart from the center, with a soil embedment depth also of 2438 mm. The assembled noise wall and glulam timber rubrail system is illustrated in Figures 2 and 3.

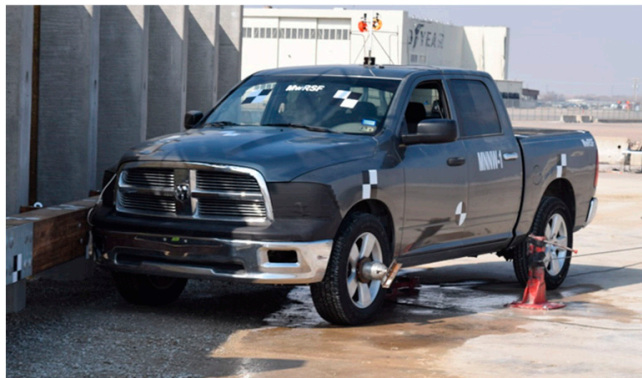
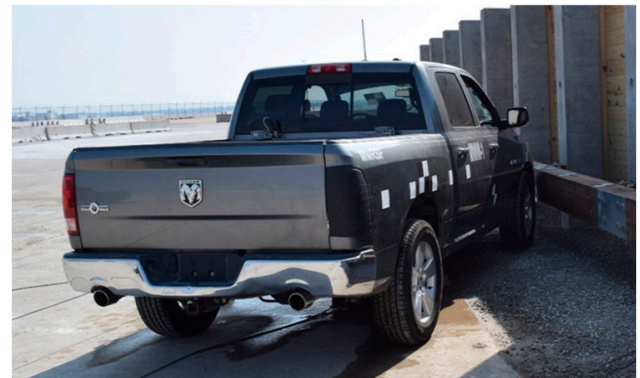
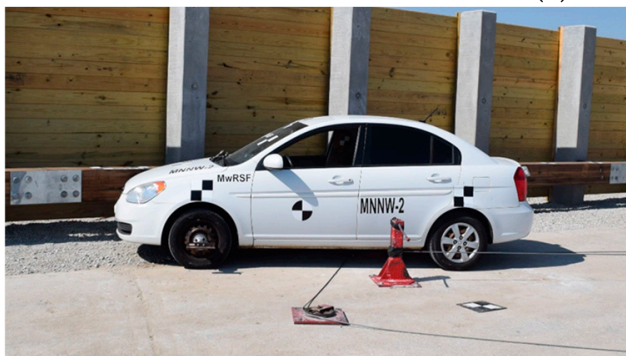
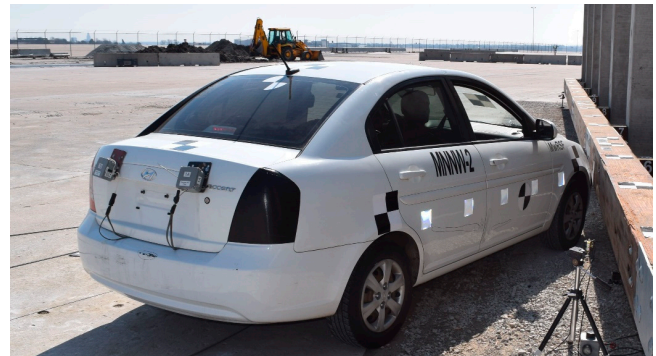
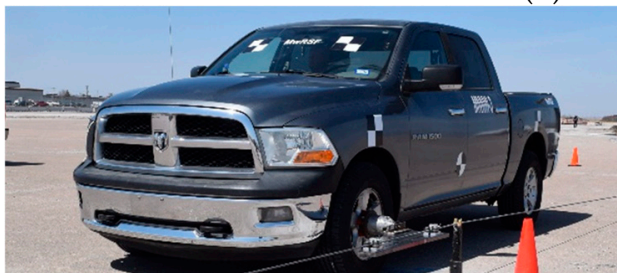
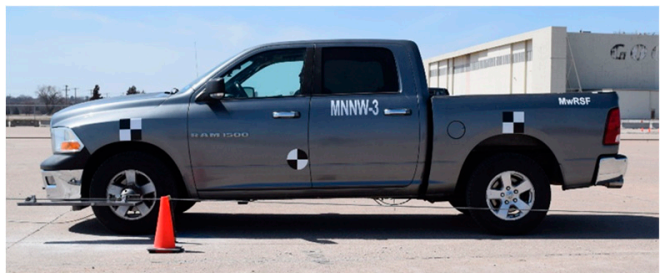
**Figure 4.** Test vehicles used in Tests MNNW-1 through to MNNW-3, including 2270P pickup trucks and a 1100C small car under MASH TL-3 conditions.

Three full-scale crash tests were conducted using vehicles representative of MASH TL-3 impact conditions. In accordance with MASH specifications, vehicle weights are reported in kilograms to represent inertial mass values used in crash testing. For test MNNW-1, a 2010 Dodge Ram 1500 Crew Cab pickup truck was utilized, with curb, inertial (ballasted and instrumented), and gross static (pre-impact) weights of 2388 kg, 2293 kg, and 2365 kg, respectively. Test MNNW-2 employed a 2010 Hyundai Accent with respective

weights of 1123 kg, 1103 kg, and 1177 kg. Test MNNW-3 again used a Dodge Ram 1500 of the same model year, with respective weights of 2388 kg, 2281 kg, and 2353 kg.

The center of gravity (c.g.) was measured using the Suspension Method [19]. This method involves suspending the vehicle in three different positions and locating the intersection of the vertical planes passing through the suspension points. For the small car in test MNNW-2, the vertical c.g. position was obtained following the procedures outlined by SAE [20]. The test vehicles are presented in Figure 4.

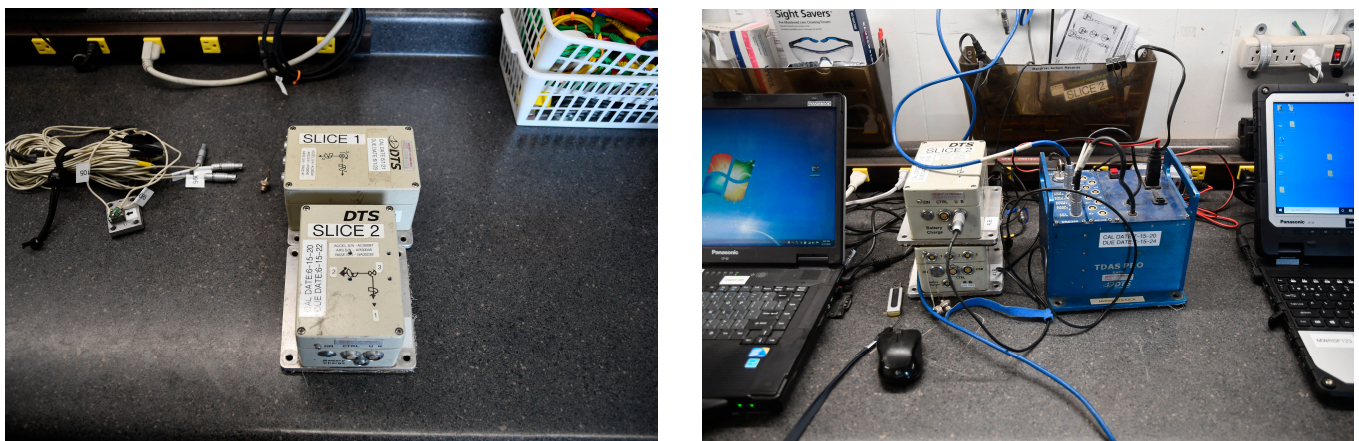
**Figure 5.** Photograph of SLICE-1 and SLICE-2 accelerometer packages.

Triaxial acceleration data were collected using SLICE-1 and SLICE-2 systems manufactured by Diversified Technical Systems, Inc. These modular data acquisition units were installed near vehicle c.g., sampled at 10,000 Hz with a range of  $\pm 500$  g, and were equipped with SAE Class 60 and Class 180 Butterworth filters in compliance with SAE J211/1 [21]. Data were stored in onboard memory and processed using SLICEWare software and custom Excel tools. Each SLICE unit also included a MICRO Triax ARS angular rate sensor, with a  $\pm 1500$  deg/sec range for roll, pitch, and yaw. These sensors captured rotational kinematics at 10,000 Hz and were used to compute Euler angles for detailed vehicle motion analysis. A representative photograph of the SLICE-1 and SLICE-2 accelerometer packages is provided in Figure 5.

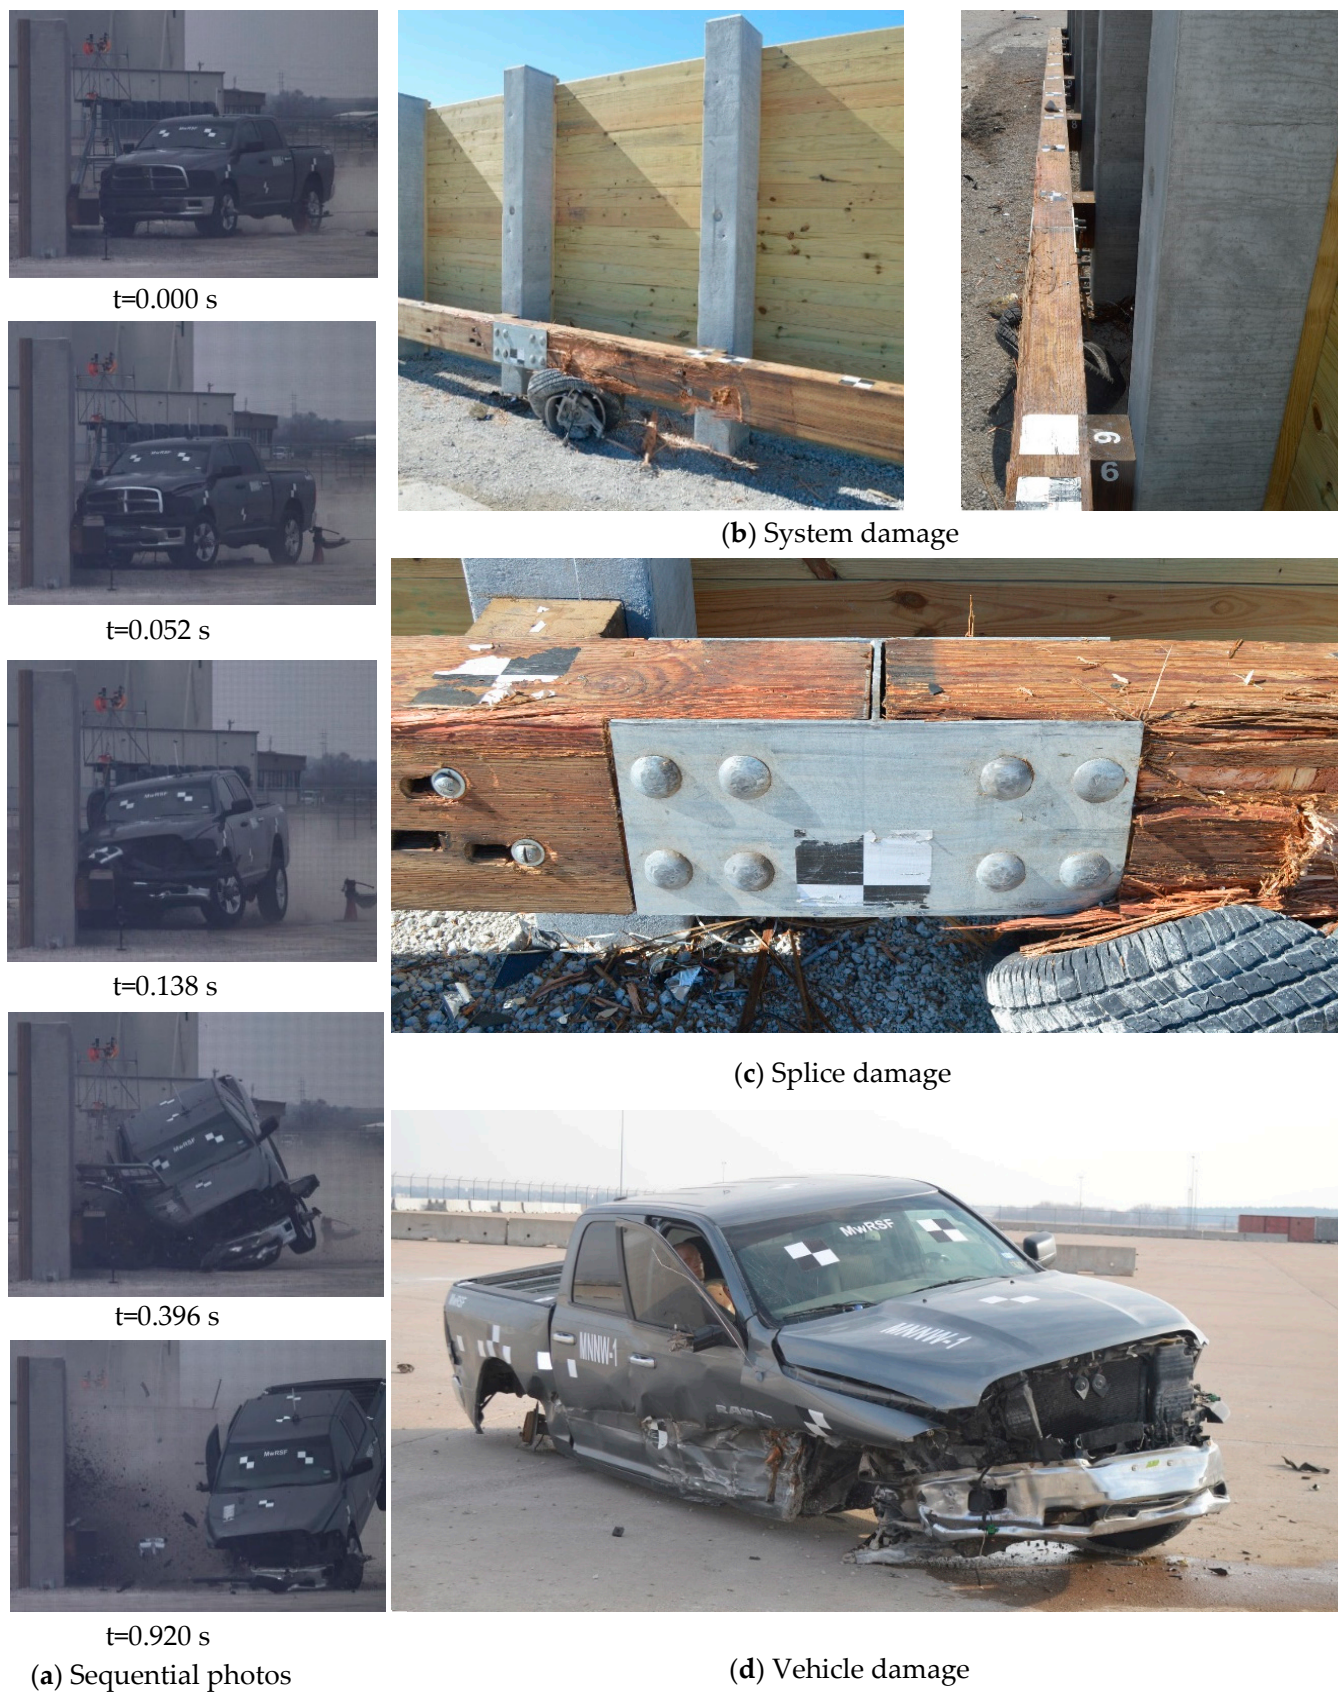
**Figure 6.** Results from test MNNW-1: (a) sequential crash test photos, (b) overall system damage, (c) splice damage, and (d) vehicle damage.

Damage to the barrier was minimal and consisted of gouging, contact marks, and localized splintering of the timber rub rail (Figure 6), particularly around posts 5, 6, and 7 where the primary impact occurred. No structural damage was observed in the concrete posts or the sound wall. The maximum lateral permanent deformation of the barrier system was measured at 22 mm at midspan between posts 6 and 7. Post displacements at rail height reached 6.35 mm. The peak dynamic lateral deflection, obtained through high-speed digital video analysis, was 96.52 mm at the top of post 7.

Vehicle damage was moderate and concentrated along the right front corner and side. All MASH 2016 occupant compartment deformation thresholds were satisfied. The highest deformation measured within the compartment was 165.1 mm, located at the right front side panel.

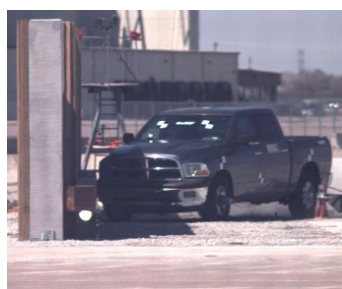
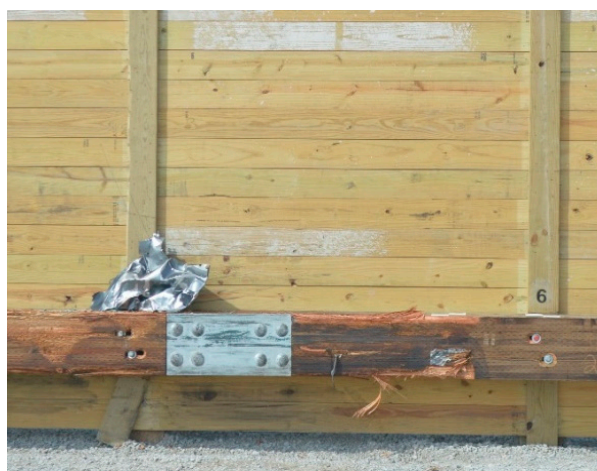
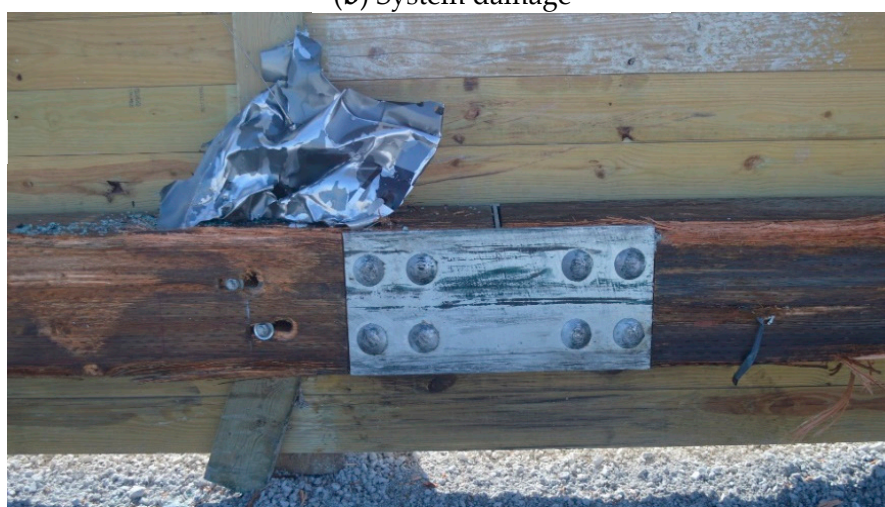
**Figure 8.** Results from test MNNW-3 results: (a) sequential crash test photos, (b) overall system damage, (c) splice damage, and (d) vehicle damage.

As illustrated in Figure 8, the barrier exhibited limited structural damage, including contact scarring, splintering of the timber rail, and visible bolt displacement. Additional marks were recorded on the front face of the noise wall and the wooden spacers. Field measurements indicated a maximum permanent lateral set of 10 mm at rail height near post 7 and midspan between posts 6 and 7. The dynamic deflection reached 177.8 mm at the top of post 7, as extracted from high-speed video footage.

The pickup truck experienced moderate deformation, predominantly on the right front corner and side. No violations of the MASH 2016 occupant compartment criteria were observed. The highest deformation, 139.7 mm, was recorded at the right front side panel.
