# Determination of Layers Responsible for Rutting Failure in a Pavement Structure

**Abstract:** Rutting is one of the most common distresses in asphalt pavements in Zambia. The problem is particularly prevalent at intersections, bus stops, railway crossings, police checkpoints, climbing lanes and other heavily loaded sections, where there is deceleration, slow moving or static loading. The most widely used methods to identify the source of rutting among flexible pavement layers are destructive methods; field trenching and coring methods. The Transverse Profile Analysis method (TPAM), which is a non-destructive method, was suggested by White et al. in 2002 as an alternative method, to avoid the expensive and destructive nature of the traditional methods. In this method, data from the transverse profile of the rutted section is used to deduce the layer of the pavement structure responsible for rutting failure. This study used the TPAM to determine the layers of pavement responsible for rutting on sections of the Chibuluma and Kitwe–Chingola Roads in Zambia. The method was first validated using the trenching method on the Kitwe–Ndola Road. Results from the TPAM showed good comparabil

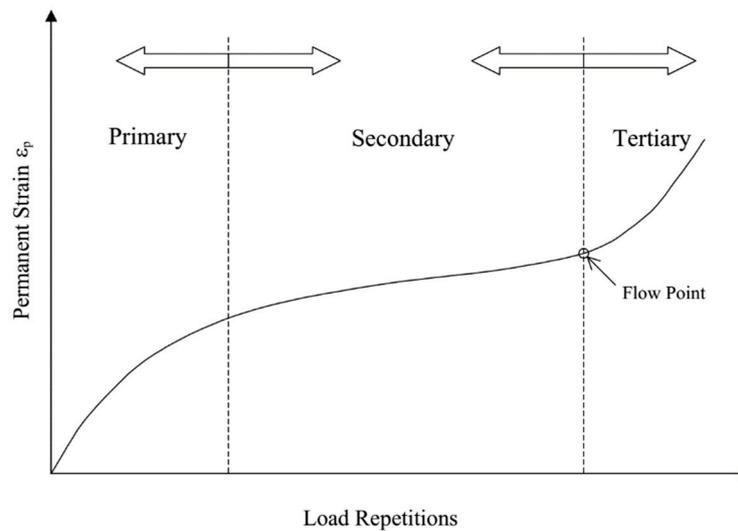
The Mechanistic-Empirical Design Guide (MEPDG) has defined three distinct stages for the permanent deformation behavior of asphalt pavements under a given set of material, load and environmental conditions. This is shown in Figure 1 [5]. The primary stage has a high initial level of rutting, with a decreasing rate of plastic deformation, predominantly associated with volumetric change. The secondary stage has a small rate of rutting, exhibiting a constant rate of change of rutting that is also associated with volumetric changes; however, shear deformations increase at an increasing rate. The tertiary stage has a high level of rutting predominantly associated with plastic (shear) deformations under no volume change conditions.

**Figure 1.** Typical repeated load permanent deformation behavior of pavement materials.

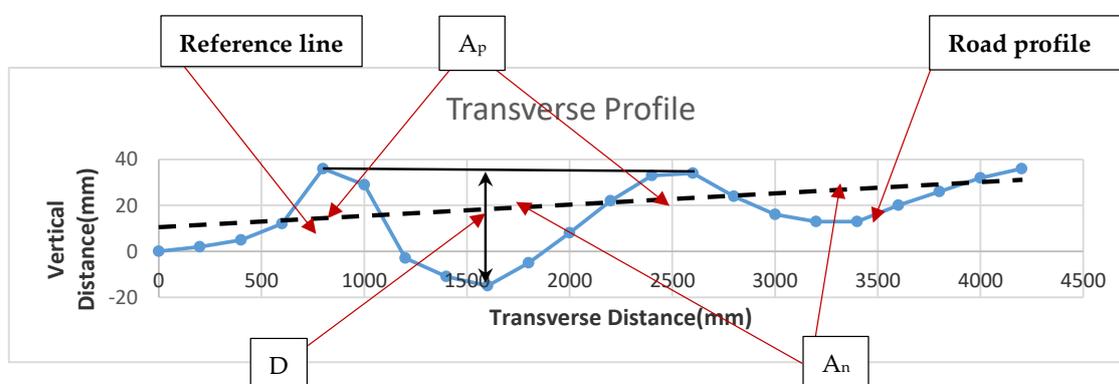
The first and last points of the profile line are joined to establish a reference line (indicated by the dotted line). The portion of the area above the line is considered as positive area ( $A_p$ ) and the portion below the line is considered as negative area ( $A_n$ ). The maximum rut depth ( $D$ ) is computed by firstly drawing a line joining the high points of the profile known as the wire line; the maximum rut depth is then equal to the line with the maximum length drawn between the profile line and the wire line in a direction perpendicular to the wire line.

**Figure 2.** Plot of transverse profile from the edge of a shoulder to the center line of a lane.  $A_p$  = area above dotted line;  $A_n$  = area below dotted line;  $D$  = maximum rut depth.

A typical transverse profile is shown in Figure 2. The method of analysis with the TPAM is explained below.

The positive and negative areas are calculated by plotting the profile to scale in AutoCAD or other software.

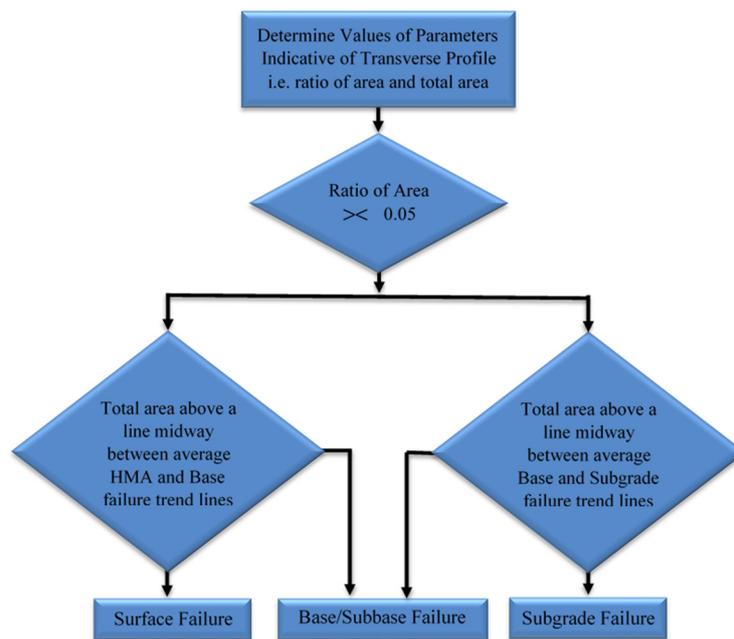
Figure 3. Illustration of the procedure for failed layer prediction [15].

The method of analysis is summarized in the flow chart shown in Figure 3.

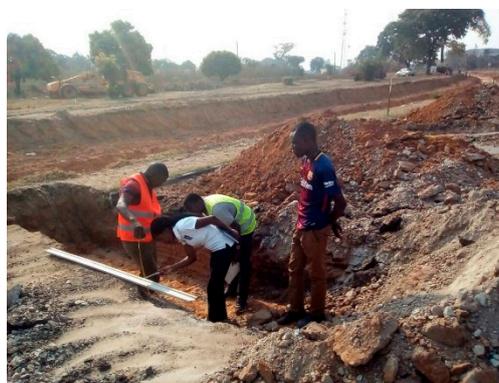
Figure 4. Trench measurements of Pit 1 (Kitwe-Ndola).

Figures 4–7 show the straight edge and gauge measurements and trench measurements on the Kitwe-Ndola Road.

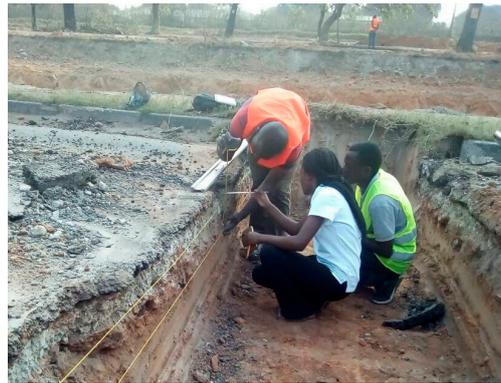
**Figure 5.** Trench measurements of Pit 2 (Kitwe-Ndola).

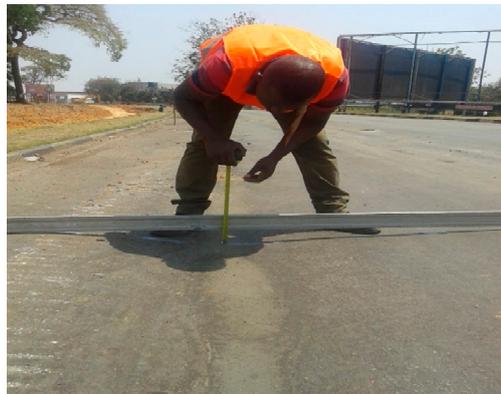
The pavement transverse profile was analyzed by measuring rut depths on a heavily rutted section of the road. This was done using the straight edge and gauge method. Four measurements were taken every 15 m on the rutted section. Profile measurements were taken at intervals of 200 mm from the shoulder edge to the center line of a lane. Four trenches were excavated at each point where a profile analysis was conducted. The excavation was done from the edge of the shoulder to the center line of a lane. The thickness of the asphalt and underlying layers were measured at intervals of 200 mm equal to the spacing used for rut depth measurements.

**Figure 6.** Profile measurements on Kitwe-Ndola Road.

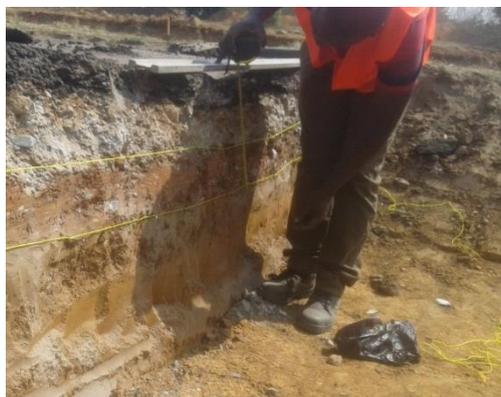
**Figure 7.** Trench measurements of Pit 3 (Kitwe-Ndola).

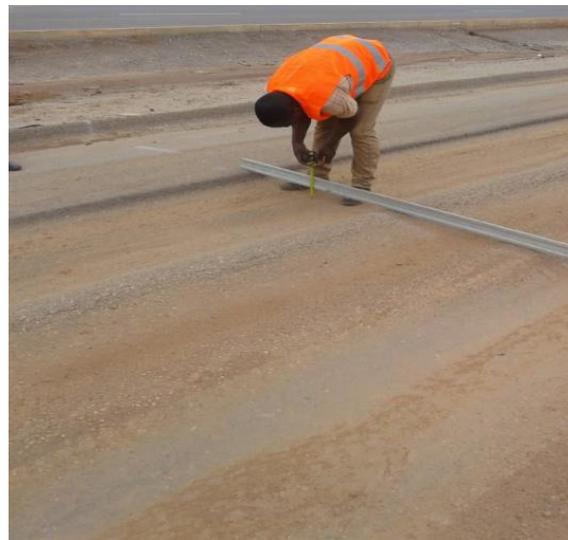
Figure 8. Profile measurements (Chibuluma).

The two roads were chosen due to the high levels of traffic and the high degree of rutting on the selected sections (see Figures 8 and 9). Chibuluma Road is used by heavy traffic to bypass the central business district of Kitwe, while Kitwe-Chingola Road is a key route connecting the two towns and goes further to the Kasumbalesa border and the mining region of the northwestern province. The two roads are interconnected somewhat, in that the heavy traffic that passes through Chibuluma Road eventually uses Kitwe-Chingola Road to connect to the Kasumbalesa border or the northwestern

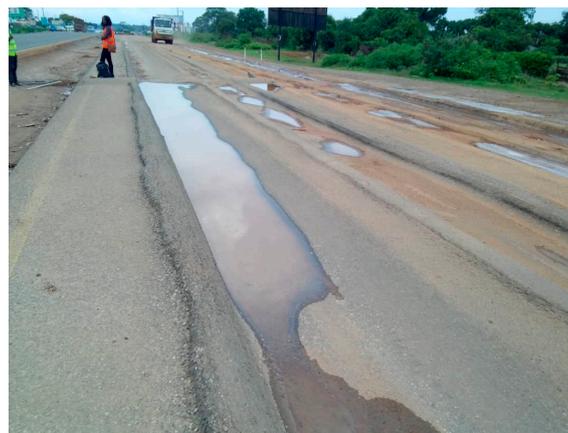
Figure 9. Extent of rutting (Kitwe-Chingola).

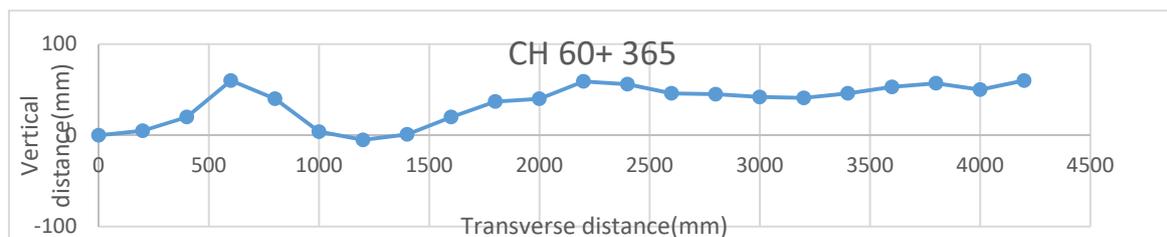
Figure 10. Transverse profile of 60 + 365 km.

From the profiles it is evident that the rutting at 60 + 365 km and 60 + 427 km resulted from within the asphalt surfacing. This is evidenced by the shoving and upheaval of the asphalt, which is clearly visible in Figures 10 and 12. It can also be seen from Figures 11 and 13 that the profile of the top of the asphalt surfacing is different from that of the top of the base, subbase and subgrade.

The TPAM was undertaken to verify these observations. Distortion parameters were determined and calculated as outlined in Section 2. For example, for profile Chainage (CH) 60 + 365;

Both criteria were met, indicating that the failure occurred in the asphalt surfacing.

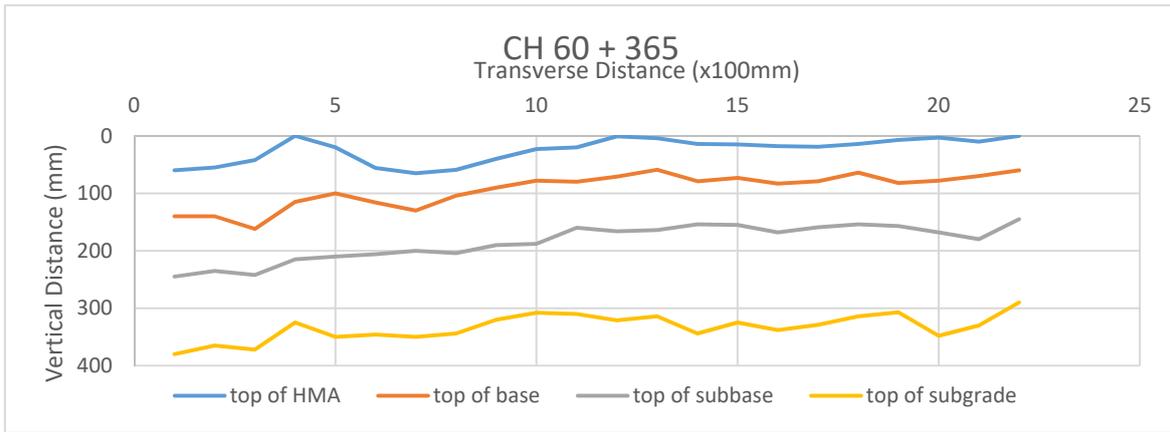
Figure 11. Profile of trench measurements of 60 + 365 km.

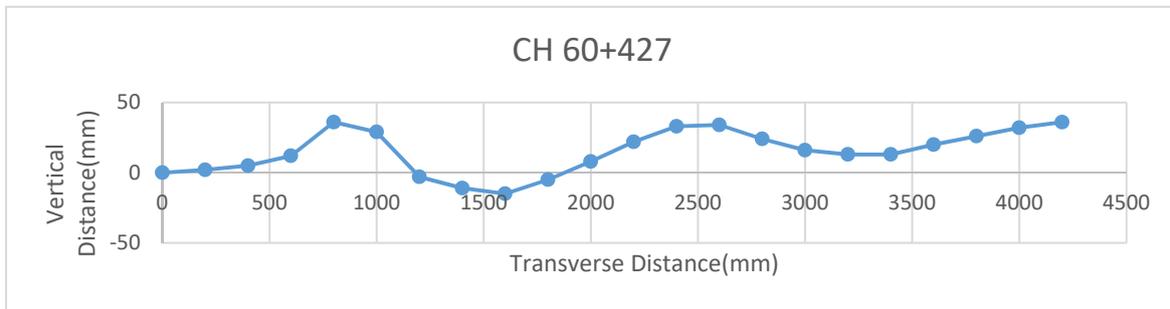
Figure 12. Transverse profile of 60 + 427 km.

The procedure was repeated for all the profiles on the road (Table 2). It was established that at 60 + 365 km and 60 + 427 km the rutting was in the asphalt while at 60 + 437 km and 60 + 487 km the rutting emanated from the underlying base/subbase. This is consistent with the observed profile shape.

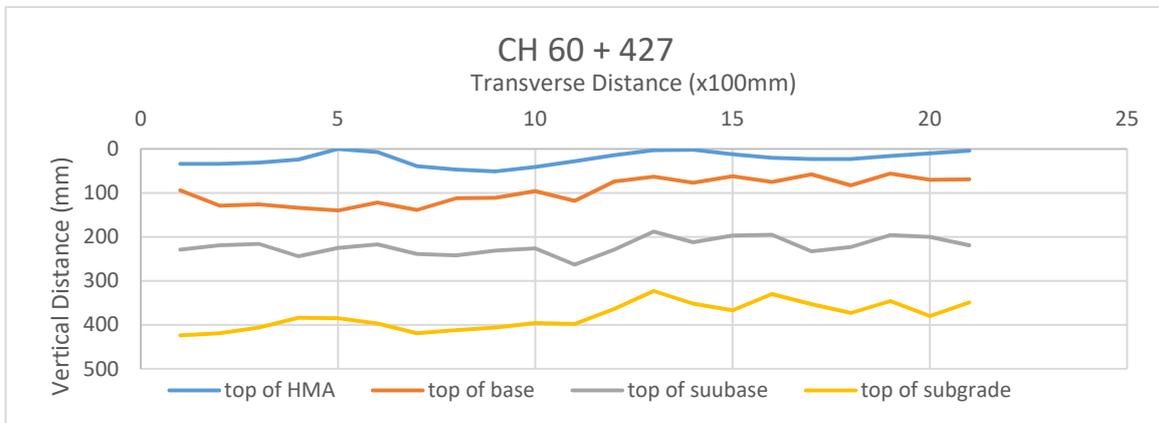
Figure 13. Profile of trench measurements of 60 + 427 km.

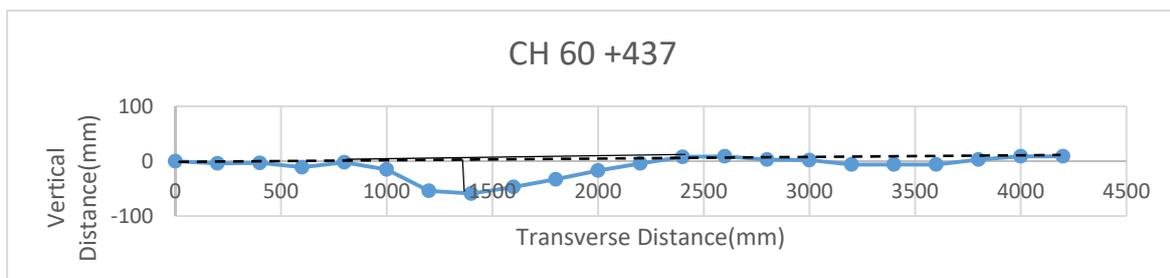
Figure 14. Transverse profile of 60 + 437 km.

The profiles at 60 + 437 km and 60 + 487 km, on the other hand, show that the underlying layers are responsible for the rutting failure. The asphalt profile is almost equivalent to the underlying layers and there is little to no shoving and/or upheaval of the asphalt.

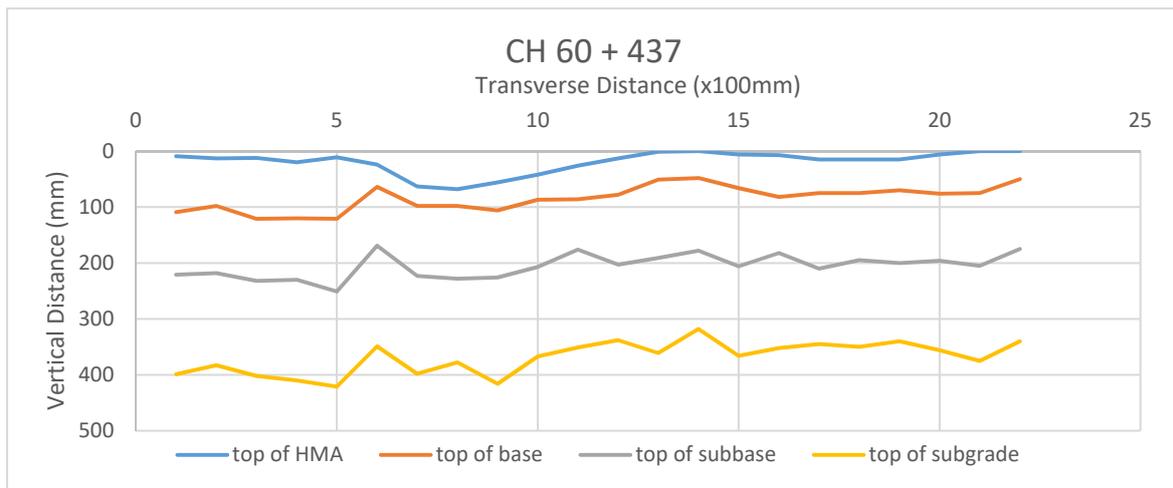
Figure 15. Profile of trench measurements of 60 + 437 km.

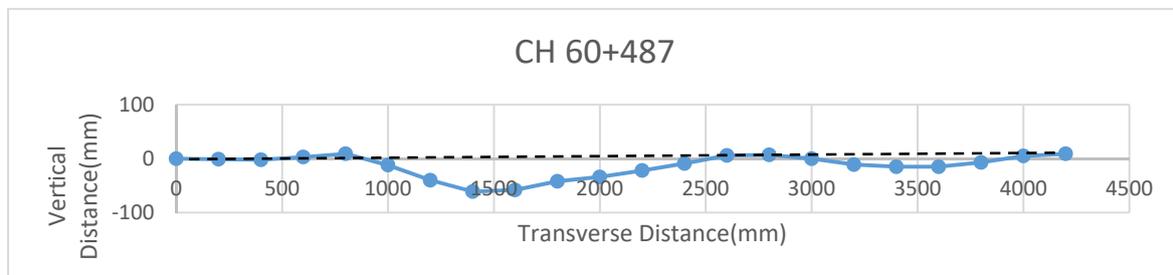
Figure 16. Transverse profile of 60 + 487 km.

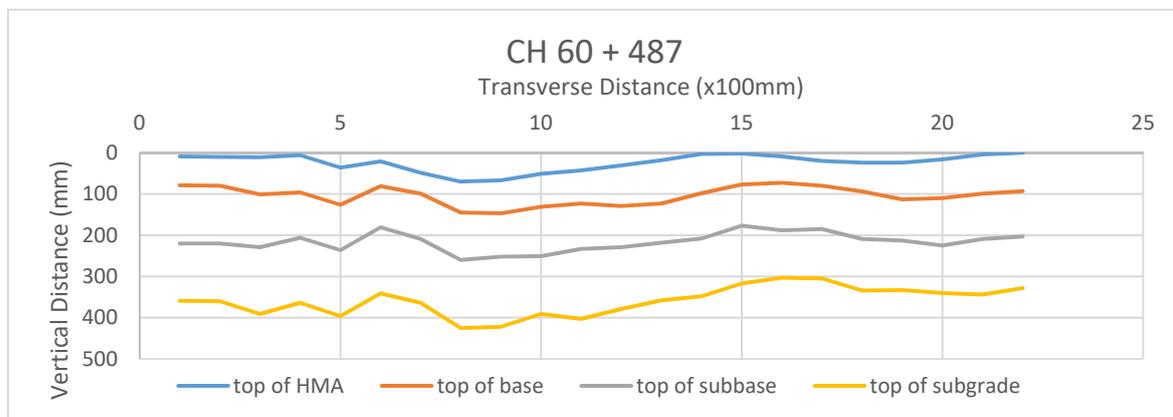
Figure 17. Profile of trench measurements of 60 + 487 km.
