Article

Strength Enhancement of Interlocking Hollow Brick Masonry Walls with Low-Cost Mortar and Wire Mesh

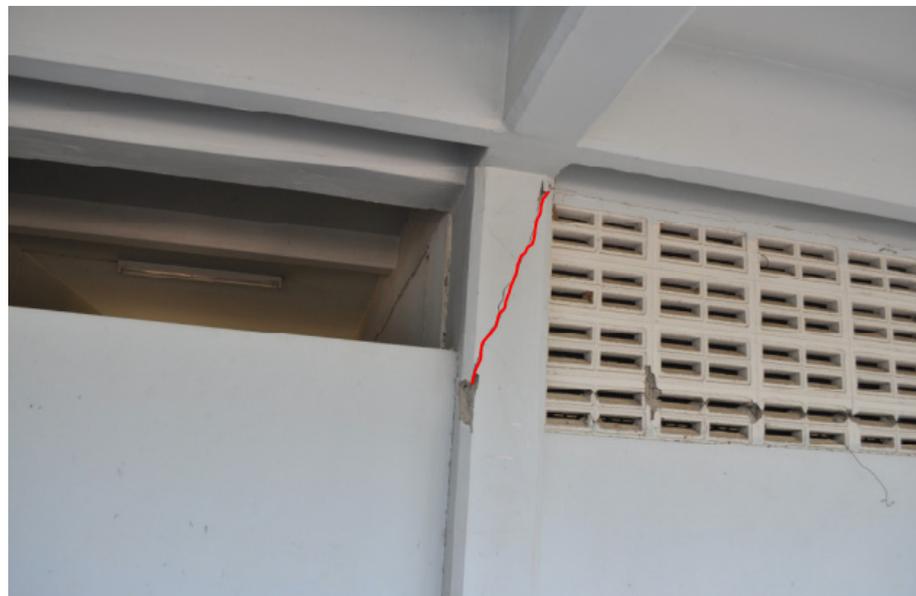
Figure 1. Damage of a building with small columns in Chiang-Saen District [7].

to buildings may result in the highest number of casualties compared to partial damage [1,2]. An appropriate selection of material and proper design is vital to safeguard the infrastructure against all types of natural disasters, especially earthquakes. Brick and/or block masonry structures (both un-reinforced and reinforced) are commonly constructed throughout the world because of the wide availability of the construction materials and comparatively low construction cost. In some countries, concrete blocks of different shapes are frequently used for construction. In Asian and Southeast Asian regions, clay brick masonry construction is very common. Different waste materials such as ceramics, fly ash, and slags have been frequently used in the past to produce bricks [3–5]. However, there are few drawbacks of masonry construction such as weak joints, brittle nature, and insufficient lateral stability, especially in the case of un-reinforced masonry construction. As a result, widespread destruction to the masonry structures and buildings was observed in past earthquakes. For example, an earthquake of 6.3 magnitude occurred in Christchurch, New Zealand, in 2011, which caused massive destruction. Although this earthquake was moderate, it caused devastating damage to the masonry structures and buildings because of the high shaking of building levels in the city centre. In the damaged buildings, those that were unreinforced masonry structures suffered the highest damage among other buildings in that earthquake [6]. Although Thailand is located in a low-seismic region in Southeast Asian and is far away from the sources that may cause high intensity earthquakes, in the past, few devastating earthquakes have been recorded in the northern provinces of Thailand such as Chiang Mai and Chiang Rai. In 2004, a 9.1 magnitude earthquake was recorded near the Island of Sumatra, Indonesia. This earthquake resulted in a devastating tsunami that killed almost 225,000 people in several countries such as Sri Lanka, Maldives, and Thailand. After the earthquake, the water level was observed up to 19.6 m at Ban Thung Dap and 15.8 m at Ban Nam Kim, Thailand. Damage to the infrastructure was mainly observed in two districts, i.e., Chiang-rai and Chiang-saen, as shown in Figure 1 [7].

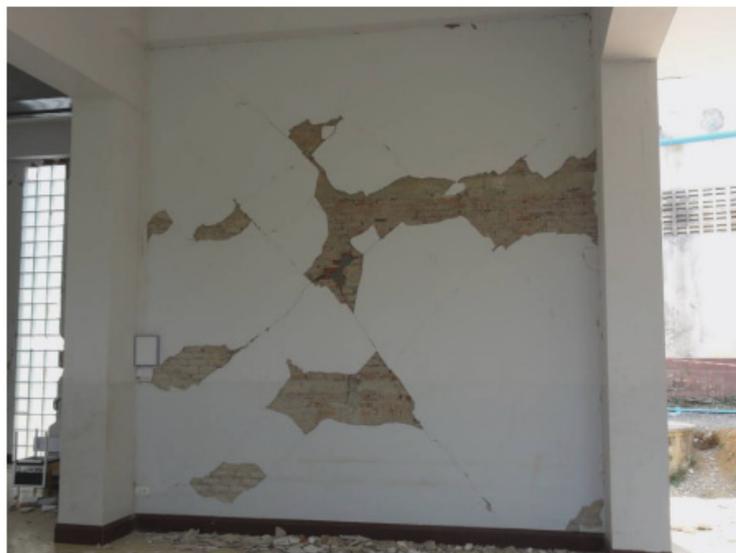
Figure 2. Diagonal cracks in a masonry wall [7].

existing earthquakes have shown severe damage to masonry construction as shown in Figures 2 and 3.

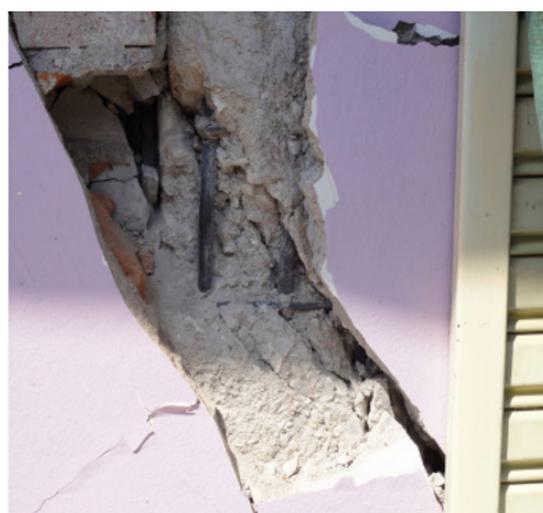
Figure 3. Damage due to load transfer from masonry walls [7].

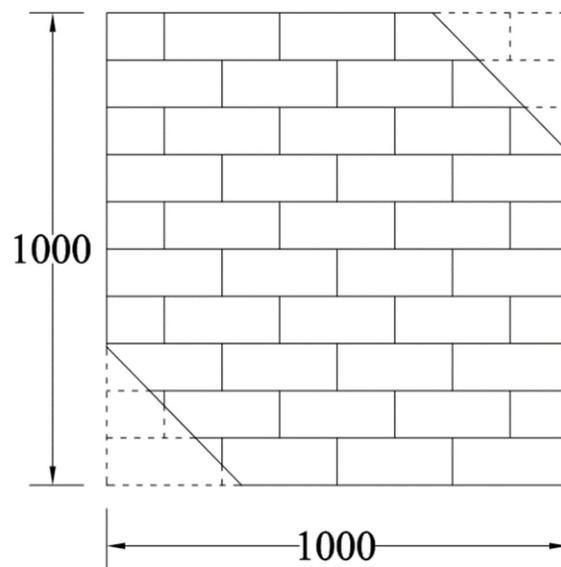
Figure 4. Dimensional details of wall specimens (units: mm).

The size of CCIHBM walls was selected in such a way to accommodate the capacity and size of reaction frame in the laboratory. The length of CCIHBM walls 1000 mm and height were also kept equal to the length, as shown in Figure 4, and the thickness of the walls was equal to the thickness of cement clay interlocking bricks, i.e., 125 mm. Locally available CCIH bricks were used. A typical sample of cement clay interlocking brick is shown in Figure 5. The type of bond was considered as the running bond for the construction of the CCIHBM walls (Figure 6), and circular holes were filled with the cement mortar. This type of construction is very common in Thailand.

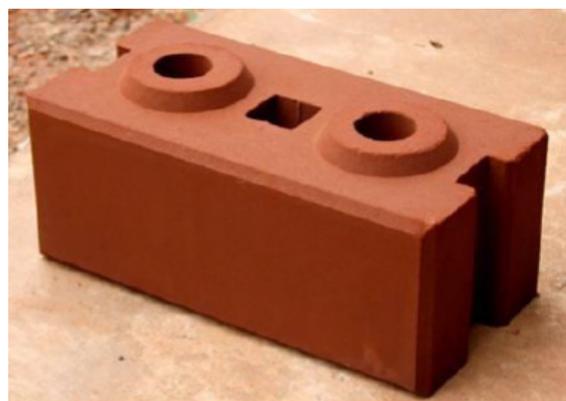
Figure 5. CCIH brick.

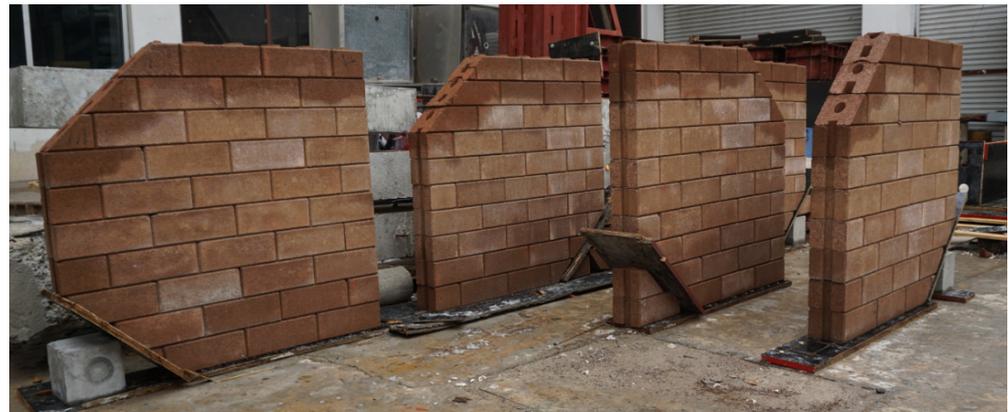
Figure 6. Typical construction of CCIHBM walls.

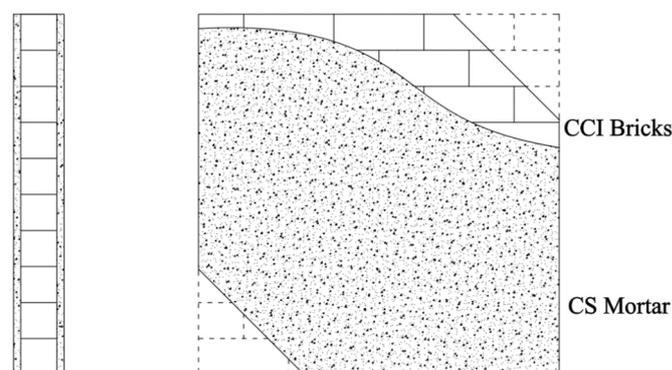
Figure 7. The application of CEMENT mortar on CCI bricks.

The strength enhancement of CCIHBM walls was performed by using cement mortar with and without wire mesh to alter the structural behaviour of CCIHBM walls. The cement mortar was prepared using ordinary Portland cement of Type 1 and Type 2 (PC1 and PC2) and sand. The CEMENT mortar was mixed by using a ratio of 1:2 (cement:sand) to achieve CEMENT mortar of maximum compressive strength. The CEMENT mortar was applied to the CCIHBM walls by using a simple hand layup technique. The application of CEMENT mortar on CCIHBM wall is shown in Figure 7. In CCIHBM wall specimens W-PC1-10-1W and W-PC1-10-3W steel wire mesh (Figure 8) were also fixed to the bricks prior to the application of the CEMENT mortar. The installation of the wire mesh on the CCIHBM wall is shown in Figure 9, and a typical CEMENT mortar strengthened CCIHBM wall is shown in Figure 10.

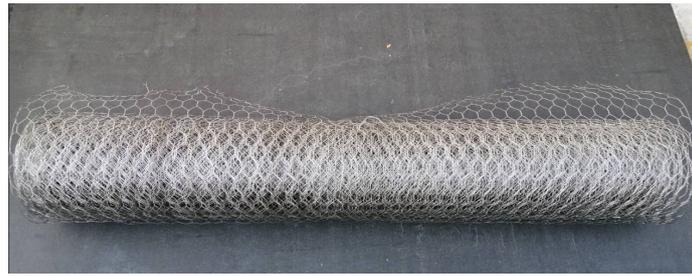
Figure 8. Typical view of wire mesh.

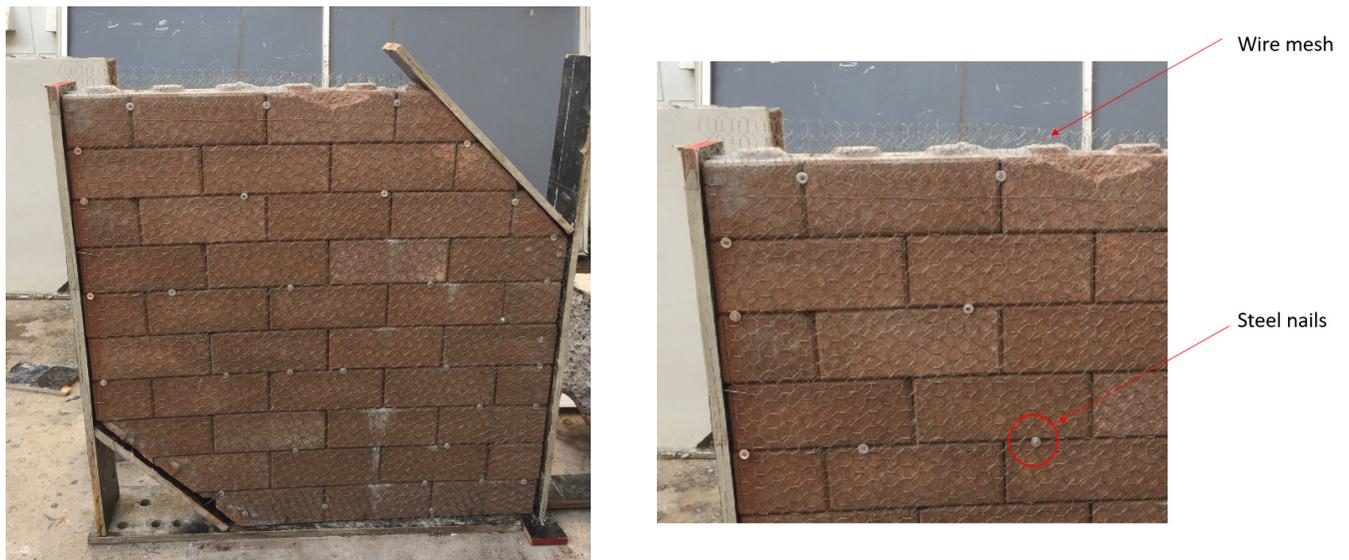
Figure 9. The attachment of wire mesh to the CCIH bricks.

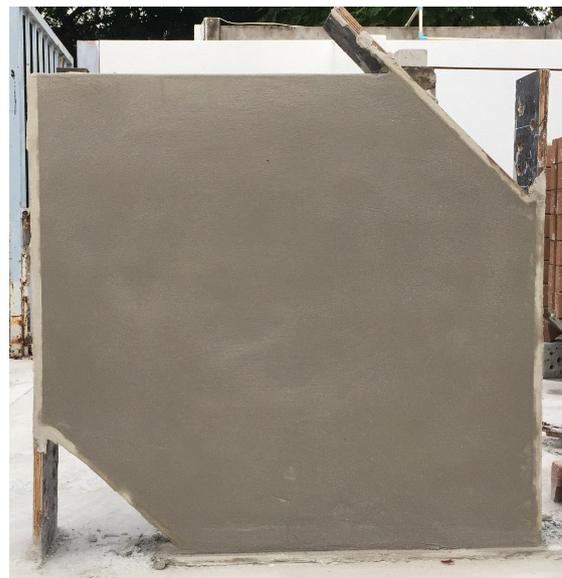
Figure 10. CCIH brick masonry wall with CEMENT mortar.

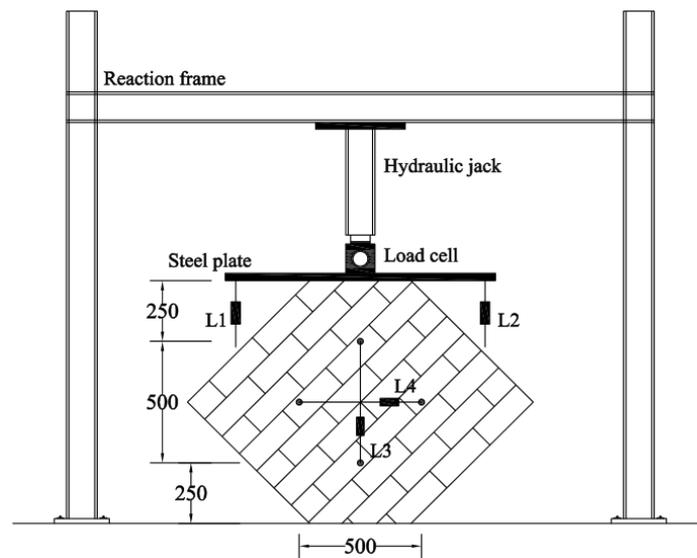
Figure 11. Loading setup and instrumentation details (units in mm).

The CCIHBM walls were tested in diagonal compression. A rigid steel reaction frame was used to apply the load at the top of the CCIHBM walls. The maximum capacity of reaction frame was 2000 kN. The load was applied using a hydraulic jack as shown in

Figure 11. A pre-calibrated load cell of capacity 1000 kN was placed under the piston of the hydraulic jack to record the load. A steel plate 20 mm in thickness was placed at the top of the CCIHBM wall to safeguard the uniform application of the load. A total of four linear variable differential transducers (LVDT) were installed at different locations to measure the deformation of the CCIHBM walls under the applied load. The details of loading setup and installation of LVDTs are shown in Figures 11 and 12. Additionally, during the test, the appearance and propagation of the cracks was carefully marked and captured by using digital cameras.

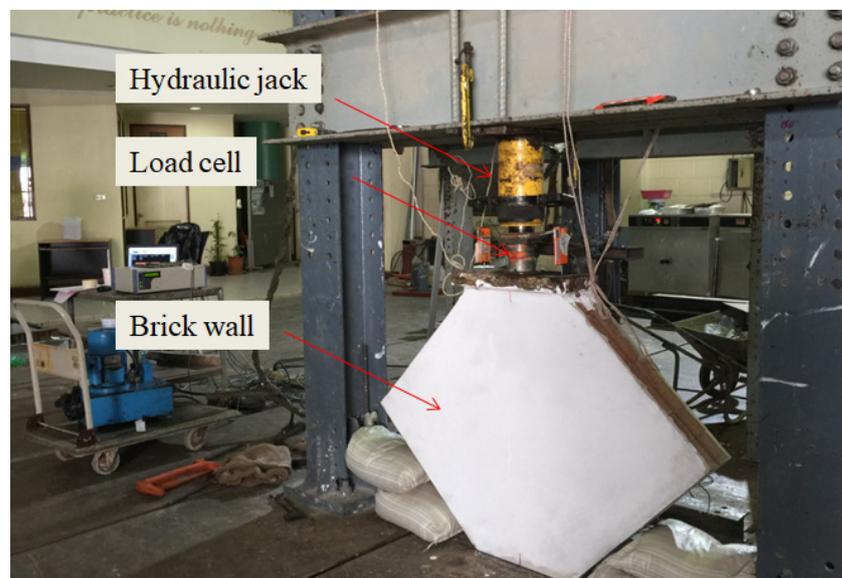
Figure 12. Loading setup.

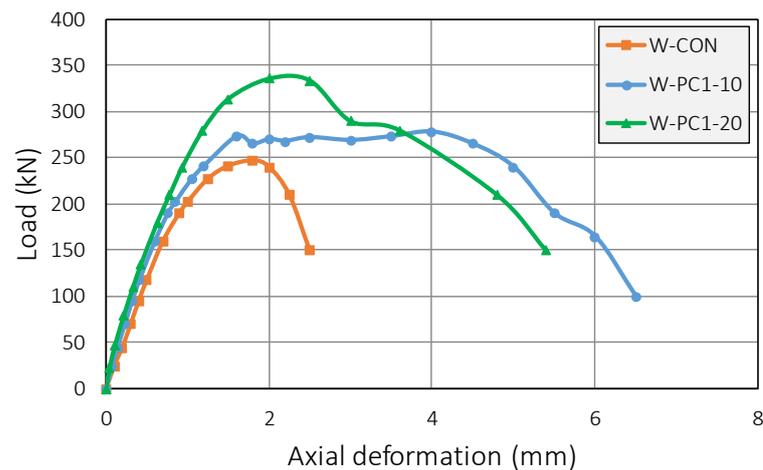
Figure 13. Experimental responses (Control and PC1 walls).

in Table 2. The experimental results in terms of diagonal load versus deformation are shown in Figures 13–16. From Figures 13–16, it can be noted that the strength and ductility of cement mortar and wire-mesh-strengthened walls were found to be higher than the reference CCIHBM wall. A linear response (load versus deflection) was noticed for the control wall specimen, i.e., W-CON. The crushing of the CCIH bricks was observed at the ultimate load following a sudden drop in the load. The initial stiffness of cement mortar and wire mesh strengthened walls were also found to be higher than the reference wall as shown in Table 2.

On the other hand, a gradual drop in the load carrying capacity was observed after the peak strength in CEMENT-mortar-strengthened CCIHBM walls such as W-PC1-10, W-PC1-20, and W-PC2-20. The use of wire mesh is found to be very effective to alter the diagonal load versus deformation responses of CCIHBM walls. In all cement-mortar-strengthened walls, W-PC1-10, W-PC1-20, and W-PC2-20 (without wire mesh), the load-versus-deformation responses were mainly linear up to the first peak, except the wall specimen W-PC1-10. However, in the case of CCIHBM walls W-PC1-10-1W and W-PC1-10-3W (strengthened using cement mortar and wire mesh), the axial-load-versus-axial-deformation responses were tri-linear. In the tri-linear responses, the first part is identical to the load-versus-deformation response of the unstrengthened wall, i.e., W-CON. The second part represents the transition curve, and the third part is once again linear. However, the stiffness of the third part is much lower than that of the first part. This tri-linear behavior is an indication that the use of wire mesh is very suitable to provide the external confinement to the CCIHBM walls.

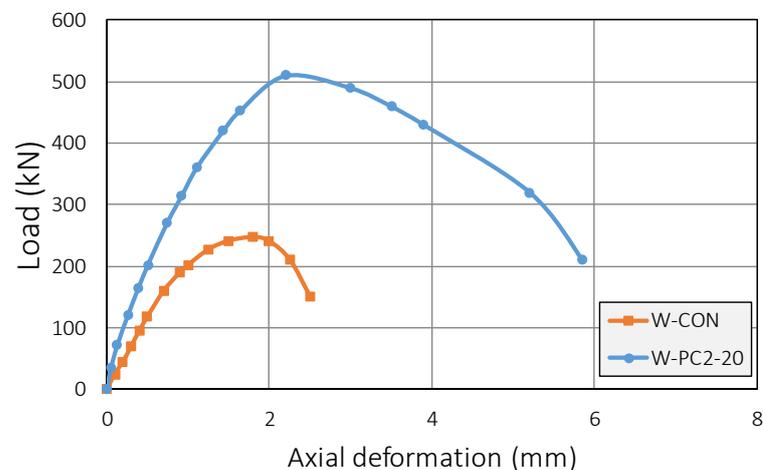
Figure 14. Experimental responses (Control and PC2 walls without wire mesh).

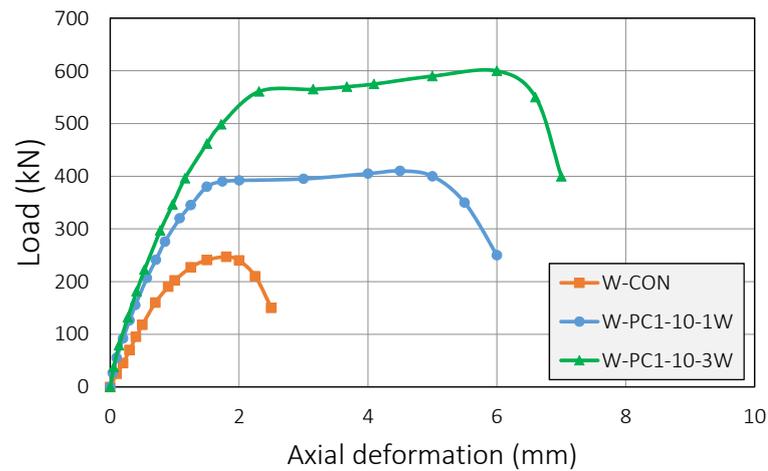
Figure 15. Experimental responses (Control and PC1 walls with wire mesh).

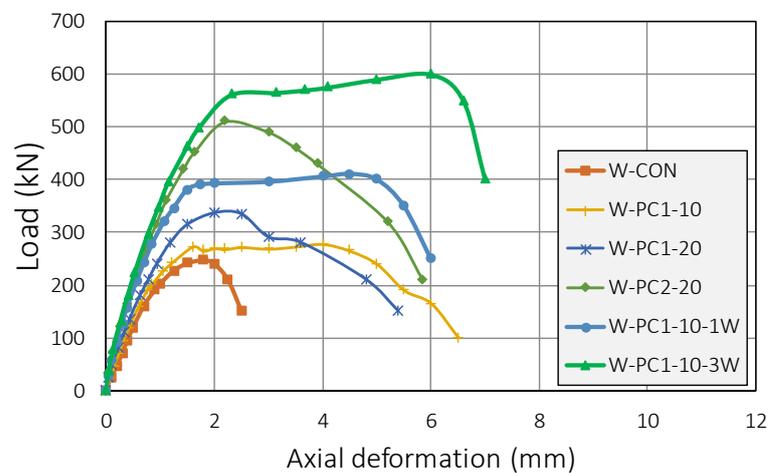
Figure 16. Experimental responses of all CCIHBM walls.

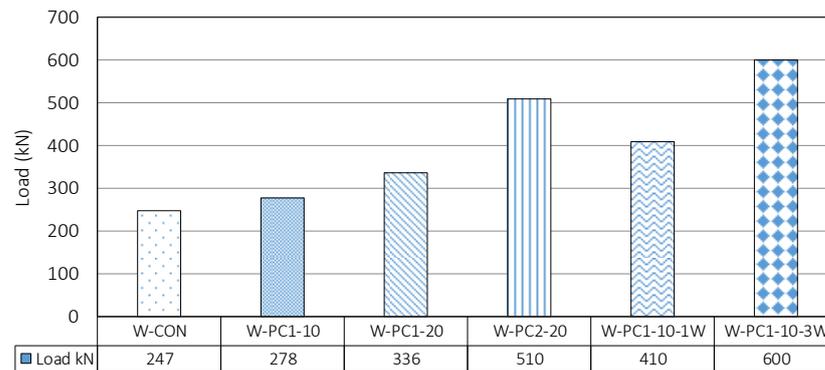
Figure 17. Load of CCIHBM walls.

The load behaviors of the CCIHBM walls are shown Figure 17. The control CCIHBM wall, i.e., W-CON, failed at an ultimate load of 247 kN. The ultimate load-carrying capacity of the CEMENT mortar (Portland cement Type 1)-strengthened walls W-PC1-10 and W-PC1-20 was enhanced by 13% and 36% compared to the control wall, i.e., W-CON. The ultimate load carrying capacity of cement (Portland cement Type 2) was recorded higher than the walls W-PC1-10 and W-PC1-20. This phenomenon could be related to the higher

compressive strength of the Portland cement of Type 2 as compared to the compressive strength of Portland cement Type 1. The ultimate load of wall W-PC2-20 was recorded to be 106% higher than the control wall (W-CON). Further, it was found that the use of wire mesh is also very effective to delay the cracking of the CCIHBM walls and to further enhance the ultimate load-carrying capacity of CCIHBM walls. In the case of CCIHBM walls W-PC1-10-1W and W-PC1-10-3W (strengthened with cement mortar and wire mesh), the ultimate load-carrying capacity was increased by 66% and 143%, respectively, as compared to the control wall, i.e., W-CON.

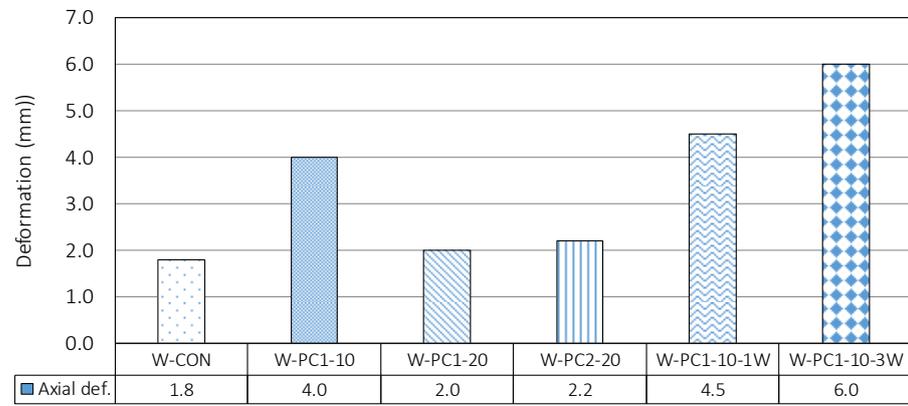
Figure 18. Deformation of CCIHBM walls.

The experimental results in terms of ultimate deformation again peak diagonal load are graphically shown in Figure 18. It can be seen that the use of cement mortar with and without wire mesh is very effective to enhance the ultimate deformation or ductility of the CCIHBM walls. The control wall, i.e., W-CON, failed at an ultimate axial deformation of 1.80 mm. The ultimate axial deformation of cement (Portland cement Type 1)-mortar strengthened walls W-PC1-10 and W-PC1-20 was enhanced by 122% and 11%, respectively, compared to the control wall. The ultimate axial deformation of cement (Portland cement Type 2) was recorded as higher than the walls W-PC1-10 and W-PC1-20. This phenomenon could be related to the higher compressive strength of the Portland cement Type 2 as compared to the compressive strength of Portland cement Type 1. The ultimate axial deformation of wall W-PC2-20 was recorded as 22% higher than the control wall. Further, it was found that the use of wire mesh is also very effective to further enhance the ultimate axial deformation of CCI walls. In the case of CCIHBM walls strengthened with cement mortar and wire mesh, i.e., W-PC1-10-1W and W-PC1-10-3W, the ultimate axial deformation was increased by 150% and 233% compared to the control wall, i.e., W-CON.

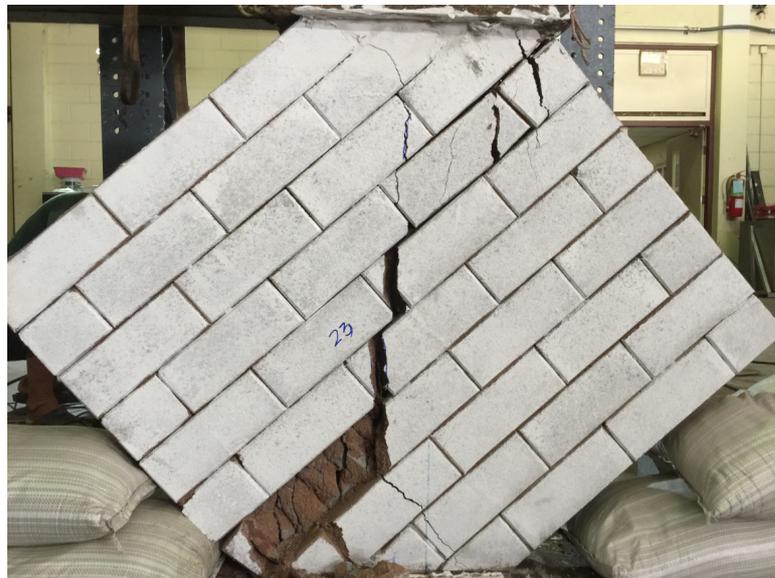
Figure 19. Ultimate failure mode of wall (W-CON).

The failures of CCIHBM walls are shown in Figures 19–22. In the case of the control wall, i.e., W-CON, the ultimate failure was mainly due to the splitting of the bricks at the middle of the CCIHBM wall, as shown in Figure 19. Prior to the ultimate failure of the control wall, slight splitting and cracking of cement clay interlocking bricks was observed at the bottom of CCIHBM wall. At that moment, severe crushing of the bricks was also observed at the bottom edge of CCIHBM walls. The ultimate failure modes of cement-mortar-strengthened walls (without wire mesh) were approximately similar to that of the control wall; however, compression crushing of the bricks was not observed due to the presence of cement mortar. In these walls, the peeling of cement mortar was observed at the bottom of the CCIHBM wall, as shown in Figure 20. In contrast to the walls strengthened with cement mortar without wire mesh, the ultimate failure modes of CCIHBM walls (strengthened using cement mortar with wire mesh) were less explosive and more ductile as shown in Figure 21. In these walls, fracture of wire mesh and peeling of cement mortar

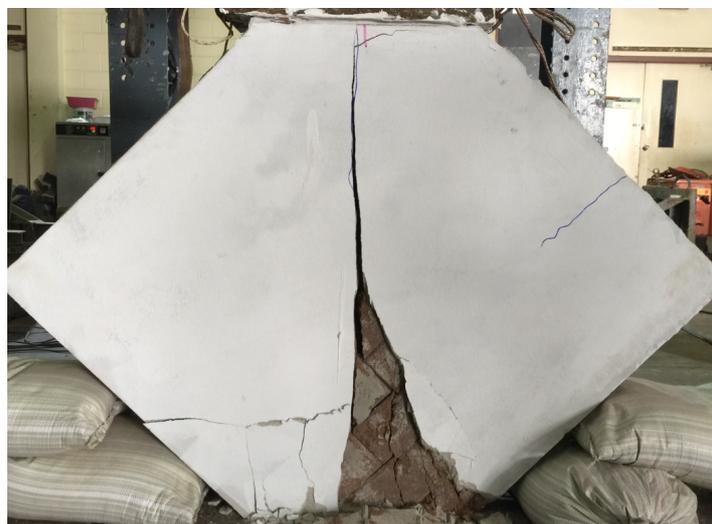
Figure 20. Failure of wall (W-PC1-10).

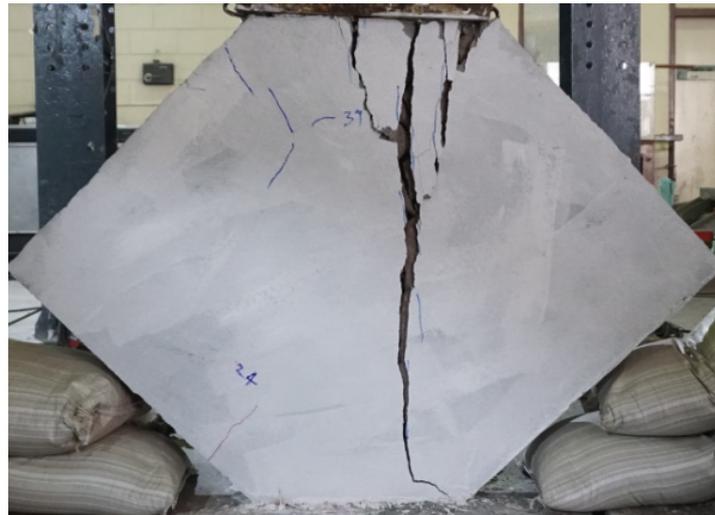
Figure 21. Failure of wall (W-PC2-20).

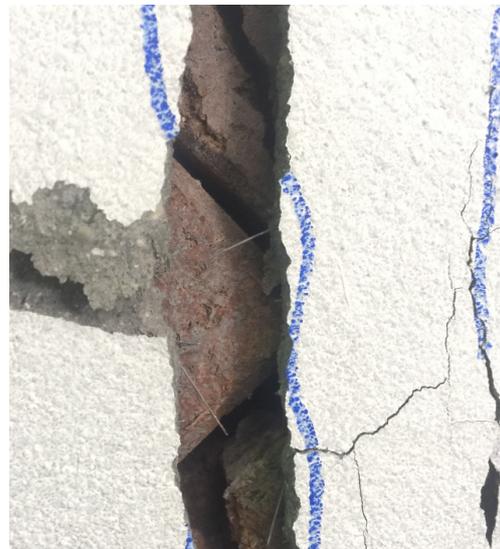
Figure 22. Fracture of wire mesh.

were observed at the middle of the CCIHBM walls as shown in Figure 22. The ultimate failure modes of CCI-IBM walls are inconsistent with the previous studies [29,37].
