Article

Durability of Gerber Saddles in RC Bridges: Analyses and Applications (Musmeci Bridge, Italy)

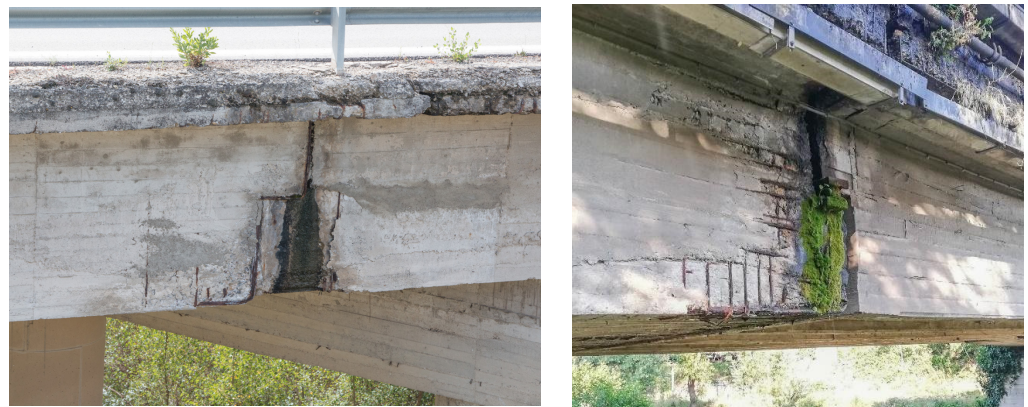
Figure 1. Examples of deteriorated Gerber saddles in RC road bridges.

technical standard. This applies especially for older 2nd and 3rd category bridges, even more if they are placed in industrial areas subjected to expansion and development after the construction of bridges. These bridges were sometimes conceived according to a cantilever scheme needing the presence of Gerber saddles, which were originally thought for railway bridges, where there is no water accumulation on the deck. Road bridges should expel the deck water through side drains, while expansion joints across the Gerber saddles should be waterproof to avoid water seepage. Actually, lack of maintenance to drains and joint degradation systematically allow water seepage through them, inducing deterioration of the underlying structural elements, which is even heavier when the water contains de-icing salts (Figure 1).

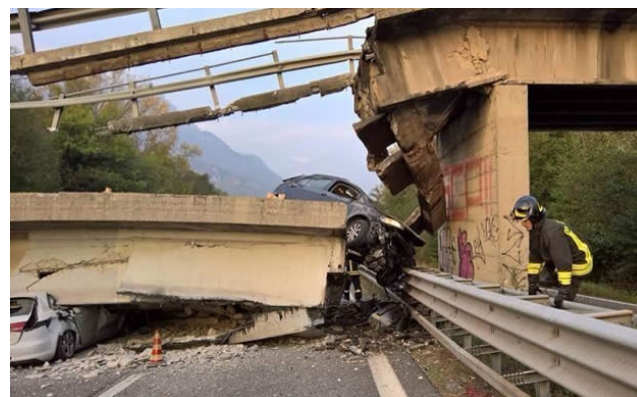
Figure 2. The Annone Brianza overpass collapse.

Exemplary of the joint effect of increased loads (with respect to design ones) and material degradation is the collapse of the Annone Brianza (Lecco, Italy) overpass in October 2016, which caused one fatality and three injuries [21]. The structure was designed as a 2nd category bridge according to the code Circolare 14 Febbraio 1962 n. 384 [22]. The collapse started in one of the Gerber saddles due to passage of an exceptional 1080 kN heavy convoy [21]. The external saddle's collapse transferred the load to the others, which progressively collapsed too (Figure 2). Therefore, even local damage to a single Gerber saddle can cause severe consequences to the whole bridge structure.

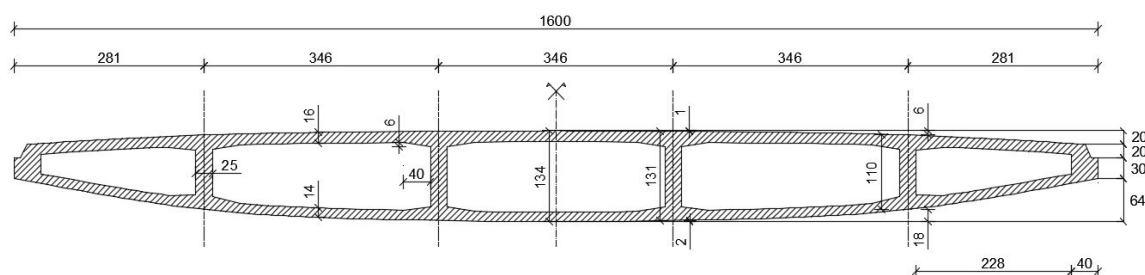
Figure 4. RC box deck cross-section of the Musmeci bridge.

compression [37]. The vault is 0.30 m thick and forms four equal spans 69.20 m long and is provided with thicker ribs at joints with the deck. The RC box deck is 16 m wide and supported by the vault every 17.30 m for total length of 300 m (Figure 4). Moreover, the deck is interrupted by simply supported sections (10.38 m long) connected by Gerber saddles corresponding to the expansion joints (see Figure 5).

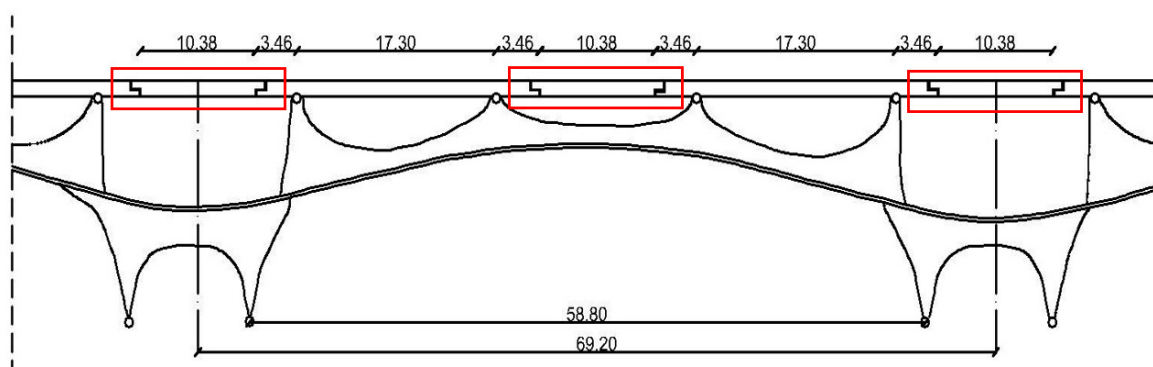
Figure 5. Scheme of a single bridge span and indication of simply supported sections (original sketch by Sergio Musmeci).

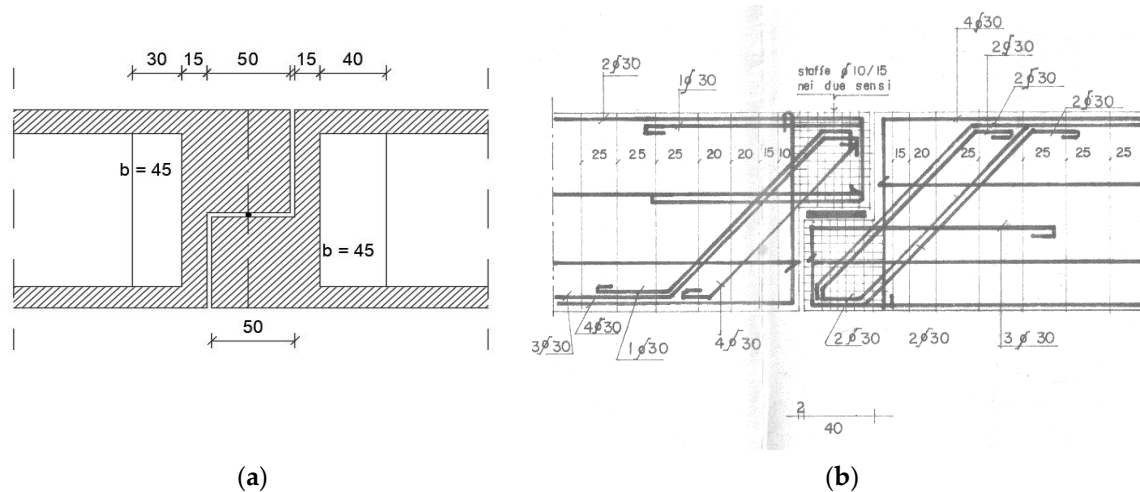
Figure 6. (a) Geometry and (b) structural details of Gerber saddles from the original design drawings by Sergio Musmeci (dimensions in cm).

Structural details of Gerber saddles are shown in Figure 6. Diagonal and horizontal 30 mm diameter reinforcement bars are present along with 10 mm diameter stirrups with variable spacing. Further, the corbels are provided with 10 mm diameter confining hoops spaced 50 mm and placed in the two orthogonal directions with 20 mm cover. Horizontal rebars typically have 50 mm cover, while diagonal ones have 50 mm minimum cover near the corbel junction. More detailed schemes of reinforcement bars are shown in the following.

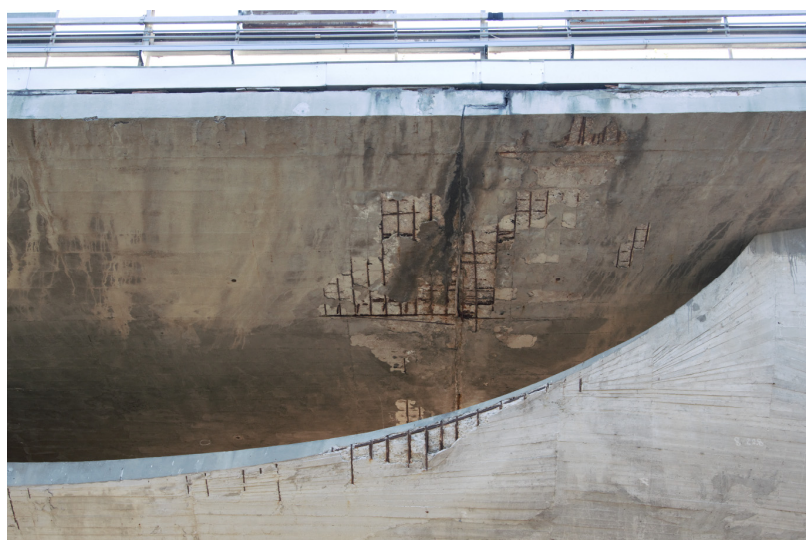
Figure 7. Deterioration of Gerber saddles and underlying vault.

Today, the bridge is affected by a significant deterioration level especially near the Gerber saddles, where expansion joints are placed. The lack of maintenance on the water drainage system causes continuous seepage across the joints and Gerber saddles, causing evident corrosion which induces cracking and spalling, also to the underlying vault sections (Figure 7). The necessary restoring interventions are planned to be carried out in the next few years by the Municipality of Potenza. However, technical difficulties related to the bridge shape and structural scheme are amplified by the fact that the structure has now become a symbol known throughout Italy and abroad, being a modern artwork officially recognized by the Italian Ministry of Cultural Heritage and Activities and Tourism. Due to these reasons, the bridge cannot sustain traditional intervention techniques used for ordinary bridges, but advanced and low-impact techniques are needed for the preservation of its historic value. In summary, the Musmeci Bridge is an artwork supporting high traffic loads, and rehabilitation measures must respect the bridge aesthetic and spirit given by its designer, Sergio Musmeci.

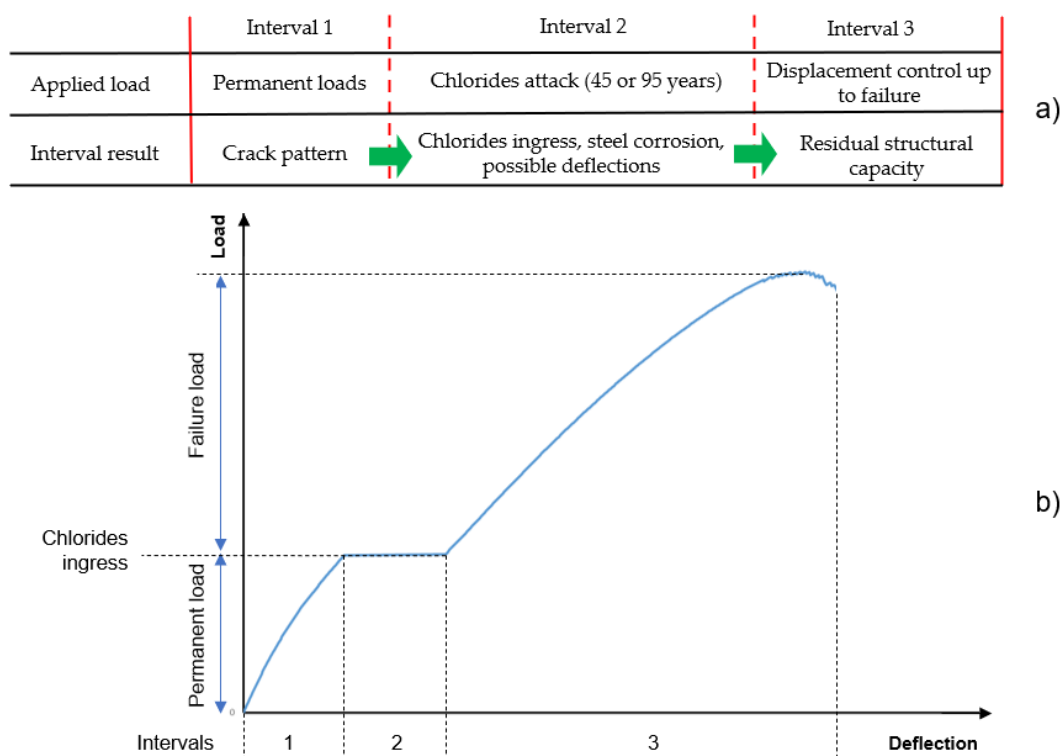
Figure 9. (a) Sequence of intervals in mechano-chemical analyses, (b) typical load-deflection curve in mechano-chemical analyses.

As reported in Figure 9a, the results of interval 1 are used in interval 2 to perform the chloride ingress analysis, accounting for cracks generated by permanent loads. Chloride ingress analyses at interval 2 are able to account for chloride diffusion into the concrete volume, detecting the initiation and progress of reinforcing steel corrosion. Specifically, based on the 1D chloride diffusion model reported in Equations (1)–(5), chloride content in the concrete volume is computed as a function of time, monthly. When the chloride content near the rebars exceeds the critical one, corrosion starts with the consequent reduction in rebars' cross sectional area. After each corrosion step (one month), based on the new structural configuration (the model is updated with the new values of steel rebars' area), a new static equilibrium iteration is computed to determine possible variations of the displacements, stresses and crack pattern, which, in turn, may influence subsequent corrosion steps. The latter reflects on the static equilibrium condition because a reduction in steel area may increase deflection under a constant permanent load. Finally, in interval 3, accounting for the new crack pattern and steel corrosion, the structure is led to collapse, increasing the vertical displacement applied to the corbel. Therefore, interval 3 makes it

possible to evaluate the structural capacity after a given corrosion period. It is worth noting that the deflection amplitude under constant load in interval 2 is often very small compared to those due to permanent and failure loads. Indeed, the representation of Figure 9b is only as an example.

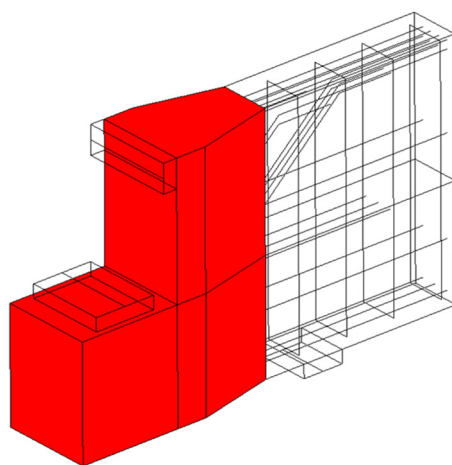
Figure 10. Surfaces exposed to chloride attack.

In order to model the corrosion attack, red surfaces shown in Figure 10 were exposed to chlorides based on parameters summarised in Tables 3 and 4. These surfaces were selected considering the water seepage from the platform containing chlorides due to de-icing salts.

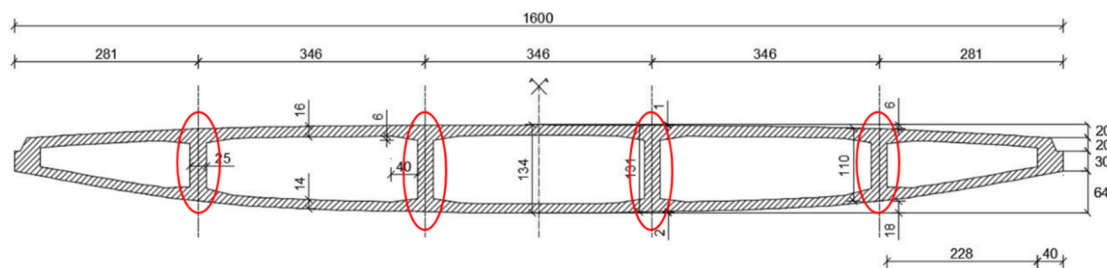
Figure 11. The four effective Gerber saddles (dimensions in cm).

The crack pattern due to self-weight of the simply supported bridge span (interval 1) is considered in the chloride analysis. It is worth remembering that the effective Gerber saddles, according to the original design by Musmeci, are four, namely those highlighted in Figure 11. The most external ones cannot be considered effective due to their reduced depth. A single Gerber saddle’s reaction due to permanent gravity loads (self-weight of structural and non-structural deck components related to the single simply supported span: deck box section, road pavement, guard rails) is equal to $R_P = 270$ kN.

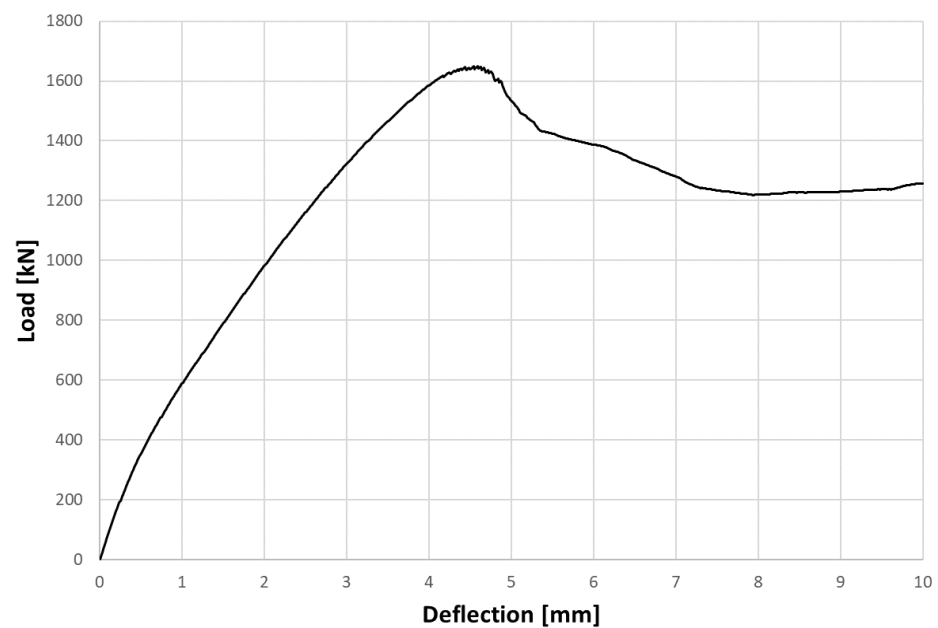
Figure 12. Load-deflection curve of the saddle.

The saddle’s qualitative response is shown in Figure 12 with reference to analysis “ t_0 ”, in the absence of permanent loads and corrosion. As expected, the behaviour of such a type of element does not show a significant ductility, and collapse modalities are similar to those observed in other experimental research [21]. The peak load is equal to 1648 kN achieved at a deflection value of 4.6 mm (Figure 12). Then, a load drop leads the saddle capacity to about 1200 kN, at a deflection of about 8 mm, with a loss of 25%, meaning that the structural element is practically collapsed.

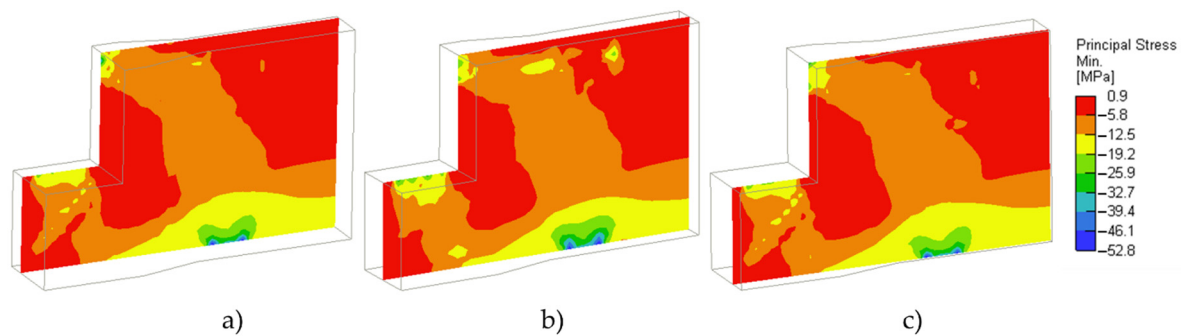
Figure 13. Principal stress distribution in concrete at peak load (analysis "t0") for side (a,c) and centre (b) cutting planes.

Analysis of principal stresses at peak load shows the saddle’s pronounced three-dimensional behaviour due to the variable width of the connection between corbel and girder. The latter is proved by the fact that an evident compression strut formed inside the corbel is subjected to higher stresses upon a section plane cutting the corbel at the centre (Figure 13b), while stress values decrease in section planes near to the sides, as shown in Figure 13a,c. This 3D effect cannot be considered when assessing this type of element with plane-stress approaches such as those based on strut-and-tie methods [44], highlighting the importance of 3D simulations.

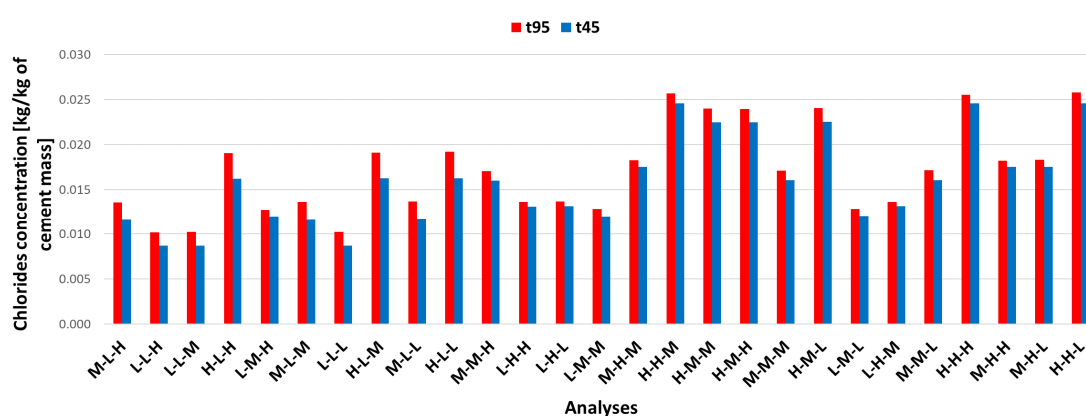
Figure 15. Chloride concentration at reinforcement depth as a function of chloride parameter combination and corrosion period (t45 = 45 years, t95 = 95 years).

Different combinations of the three parameters also affect the amount of chloride presence inside concrete at a reference depth of 2 cm from the external surface. Figure 15 shows the amount of the detected chlorides according to the different analyses at 45 and at 95 years. As can be seen, analyses at 95 years, being subjected to longer chloride exposure, exhibit higher concentrations than analyses at 45 years, thus increasing the amount of reinforcement corrosion.

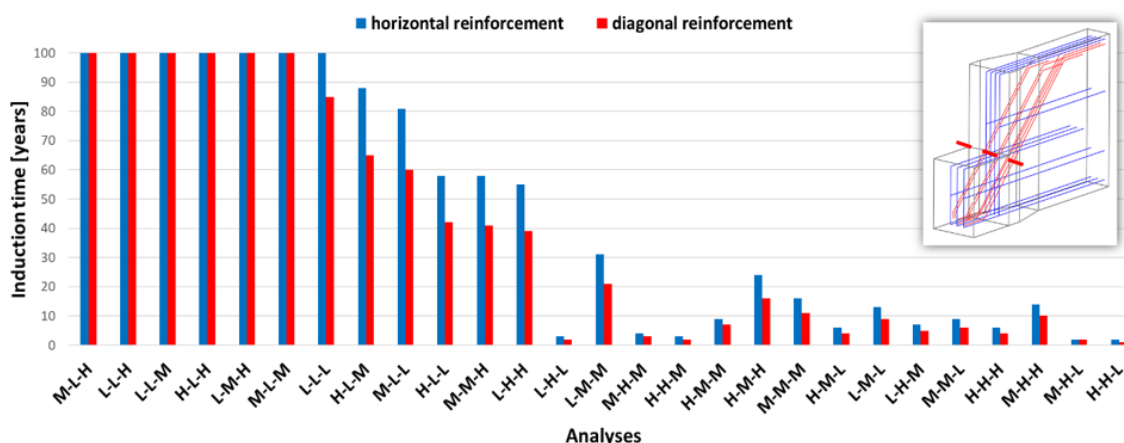
Figure 16. Induction time as a function of the chloride parameter combination.

Further monitored data are the number of years necessary to exceed critical chloride concentration, C_{crit} , to start corrosion, namely the induction time, referred to diagonal and horizontal reinforcement. Figure 16 shows that for some combinations of durability parameters, even after 95 years of corrosion, no reinforcement corrosion is triggered. For these analyses, an initiation period of 100 years (i.e., >95 years) was indicated. On the contrary, other analyses exhibit a very low induction time due to high chloride attack and low values of the critical threshold.

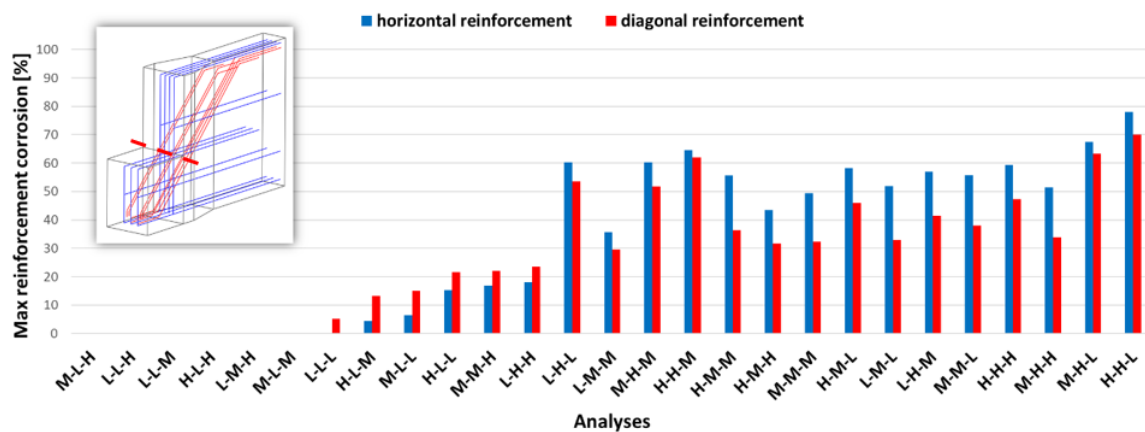
Figure 17. Reinforcement corrosion as a function of chloride parameter combination for case t95.

Figure 17 shows the maximum values of diagonal and horizontal reinforcement corrosion for t95 (t45 are negligible), confirming that the higher ones are obtained from the same analyses causing high values of chloride concentration and low values of induction time. Combinations with induction time larger than the corrosion period yield an absence of reinforcement corrosion. Further, horizontal reinforcement is subjected to higher corrosion, although it has a longer induction time. In fact, most of the horizontal rebars are parallel to the concrete surface from which chlorides enter. Diagonal rebars have a minimum distance from the concrete surface smaller than horizontal ones (corner between corbel horizontal surface and the vertical one, i.e., the red dashed line in schemes of Figures 16 and 17) and for this reason, their induction time is smaller. The remaining part of them is rather far from the concrete surface, and therefore, corrosion propagation is slower.

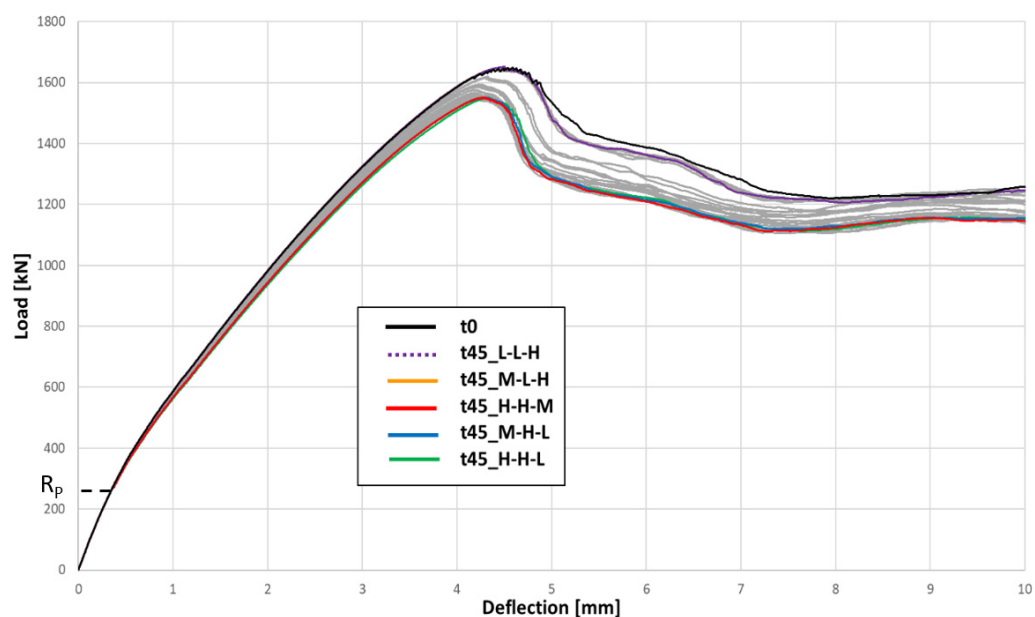
Figure 18. Envelope of load-deflection curves of chloride-induced corrosion analyses at 45 years.

Figures 18 and 19 show the envelope of load-displacement curves of t45 and t95 analyses, respectively, while Figure 20 shows peak load values for the different analyses. In both cases, the load-deflection curve for case t0 is reported to evaluate the loss of strength and behaviour differences due to corrosion. In these graphs, the coloured curves are related to the most (t45_H-H-M, M-H-L, and H-H-L) and the least (L-L-H and M-L-H) severe chloride parameter combinations. It is worth noting that the corrosion effects of these latter do not provide enough corrosion to cause a reduction in the load-bearing capacity of the saddle, even for a corrosion period of 95 years. Other intermediate load-deflection curves are shown in grey.

Especially for t95 analyses, a significant stiffness reduction is observed in load-deflection curves. In fact, for load values higher than the permanent one ($R_P = 270$ kN) corresponding to interval 3, the curves are less steep and, for the most severe chloride parameter combinations, they achieve the peak load for a deflection of about 6 mm instead of 4.5 mm. Moreover, in these cases, the post-peak behaviour is different, showing a faster strength degradation.

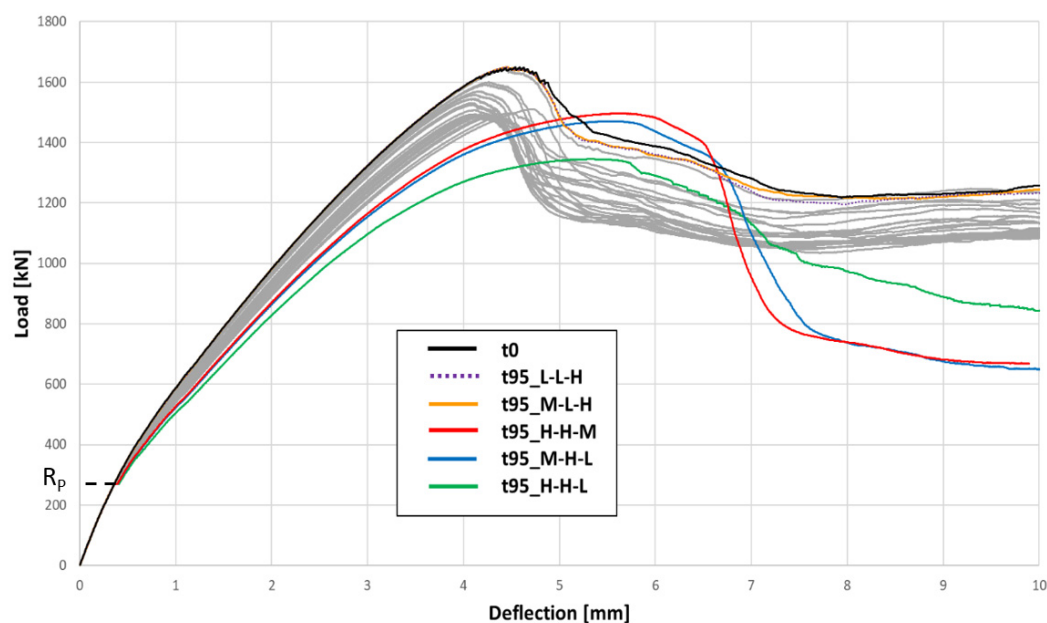
Figure 19. Envelope of load-deflection curves of chloride-induced corrosion analyses at 95 years.

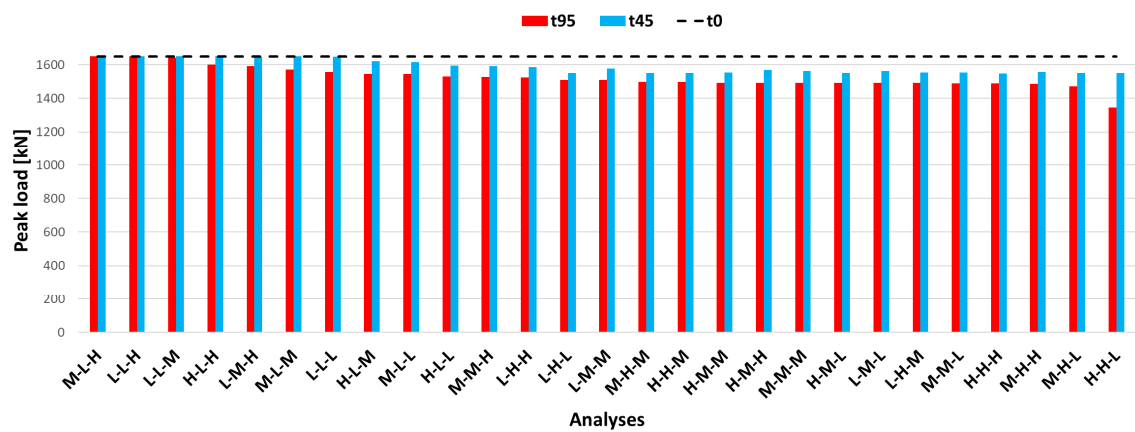
Figure 20. Load-carrying capacity of the saddle as a function of chloride parameter combination.

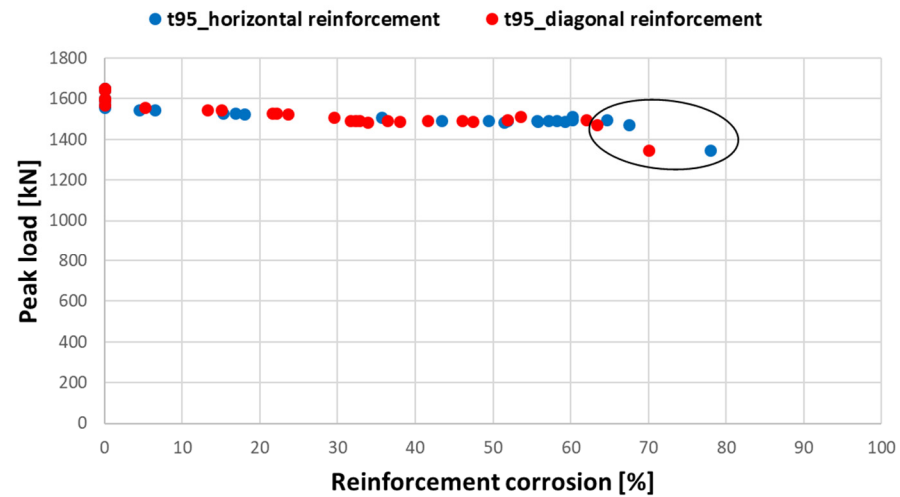
Figure 21. Correlation between peak load and reinforcement corrosion (t95).

for both t45 and t95 cases. Figure 21 shows this correlation for horizontal and diagonal reinforcement at t95. When corrosion is under 60%, it has a low influence on the peak load value. Once this threshold is overcome, strength significantly reduces. For case t45 (see Figure 22), corrosion is not enough to trigger the same effect as for t95. Figure 23 shows that the influence of corrosion of vertical stirrups (reported only for the t95 case) is negligible since for 100% corrosion there is also a large variability of the peak load, which depends on the horizontal and diagonal steel rebars. This means that the saddle's structural behaviour is mainly governed by phenomena specifically referred to concrete crushing effects in specific locations of the saddle.

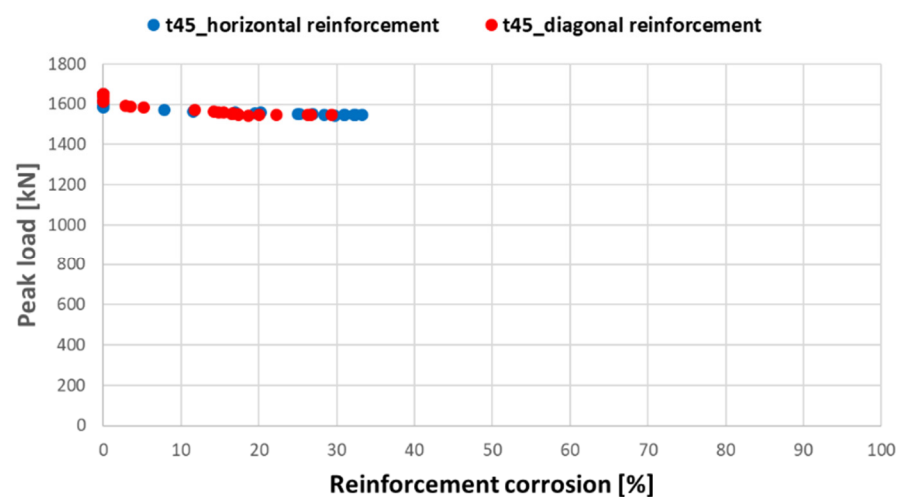
Figure 22. Correlation between peak load and reinforcement corrosion (t45).

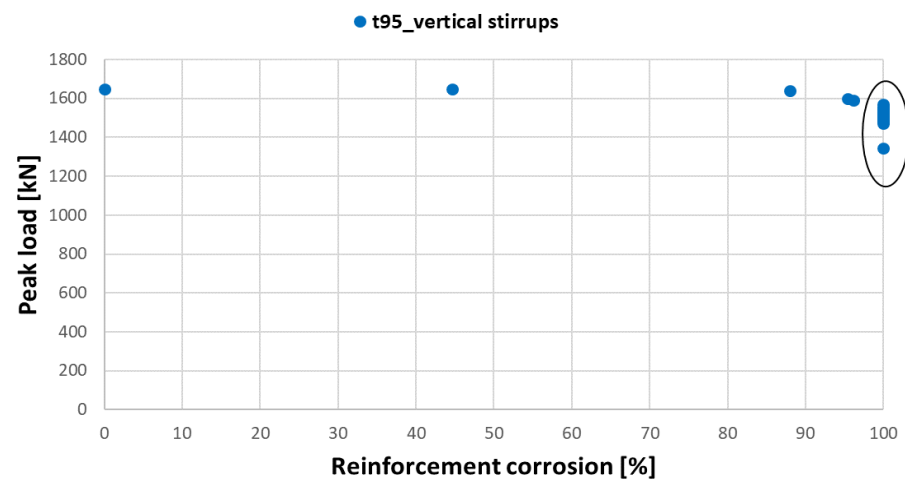
Figure 23. Correlation between peak load and vertical stirrups corrosion (t95).

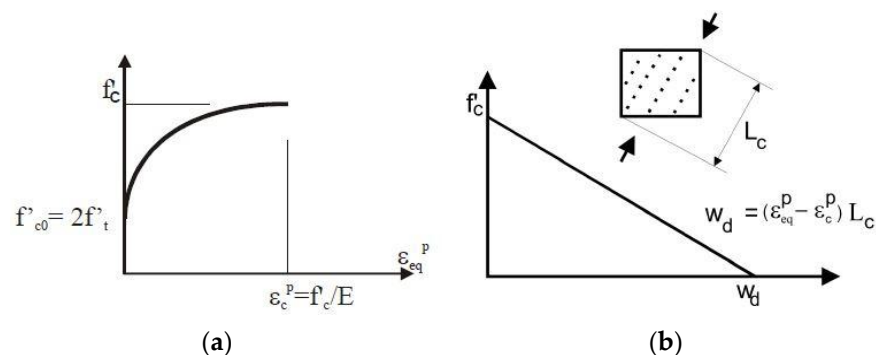
Figure 24. (a) Compressive hardening and (b) softening concrete constitutive law [23].

In order to show the above-mentioned concrete crushing effects, it is necessary to select a proper monitoring parameter, capable of describing the concrete strength degradation under compression. The equivalent plastic strain E_{ps} , computed as the minimum value (compression is assumed to be negative), is selected among the different concrete strain components. The softening of concrete in compression can be identified by the condition $E_{ps} > \varepsilon_{cp}$, where ε_{cp} is the plastic strain at peak stress (Figure 24a). When plastic strain exceeds ε_{cp} , the softening branch of the concrete constitutive law starts according to a linear behaviour governed by displacements, ending at the critical compressive displacement w_d (Figure 24b).

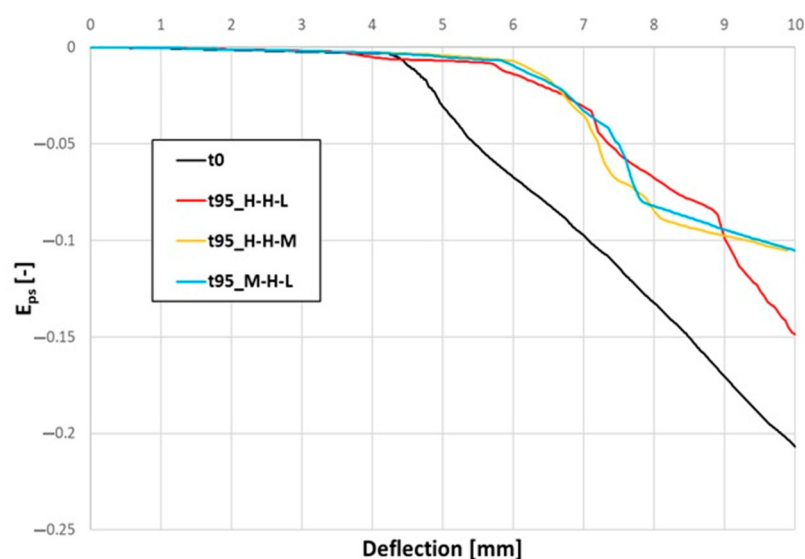
Figure 25. Minimum equivalent plastic strain-deflection curves.

Keeping this in mind, the graphs of Figure 25 show variations in the minimum equivalent plastic strain of concrete, E_{ps} , as functions of the applied deflection (and load) for case t0 (absence of corrosion) and for the most severe chloride parameter combinations (t95_H-H-L). Figure 26a,b shows the region of the saddle where this value is detected, i.e., the most damaged concrete zone under compression.

As reported in Figure 25, in the absence of corrosion (t0), E_{ps} rapidly increases when deflection reaches a value of 4 mm, meaning that concrete is increasing its plastic deformation and then crushing phenomena occur. On the contrary, in the presence of huge corrosion (t95_H-H-L, H-H-M and M-H-L, which provide diagonal and horizontal corrosion above 60%), absolute values of E_{ps} begin to increase at higher displacement values (i.e., about 6 mm). Further, the location where the maximum crushing effects are reached significantly differs from case t0 (Figure 26a) to case t95_H-H-L (Figure 26b). In fact, corrosion modifies the internal equilibrium of the saddle, moving the crushing zone from the junction between the girder and corbel (frame in Figure 26a) to the corbel strut (frame in Figure 26b).
