# Enhanced Flexible Pavement Performance Using Treated Compared to Untreated Aggregate Bases: A Comparative Case Study in the Southern United States

Mena I. Souliman \*, Hemant GC and Zabi Mohammed

Department of Civil Engineering and Construction Management, The University of Texas at Tyler, 3900 University Blvd, Tyler, TX 75799, USA; hgc@patriots.uttyler.edu (H.G.); zmohammed@patriots.uttyler.edu (Z.M.)

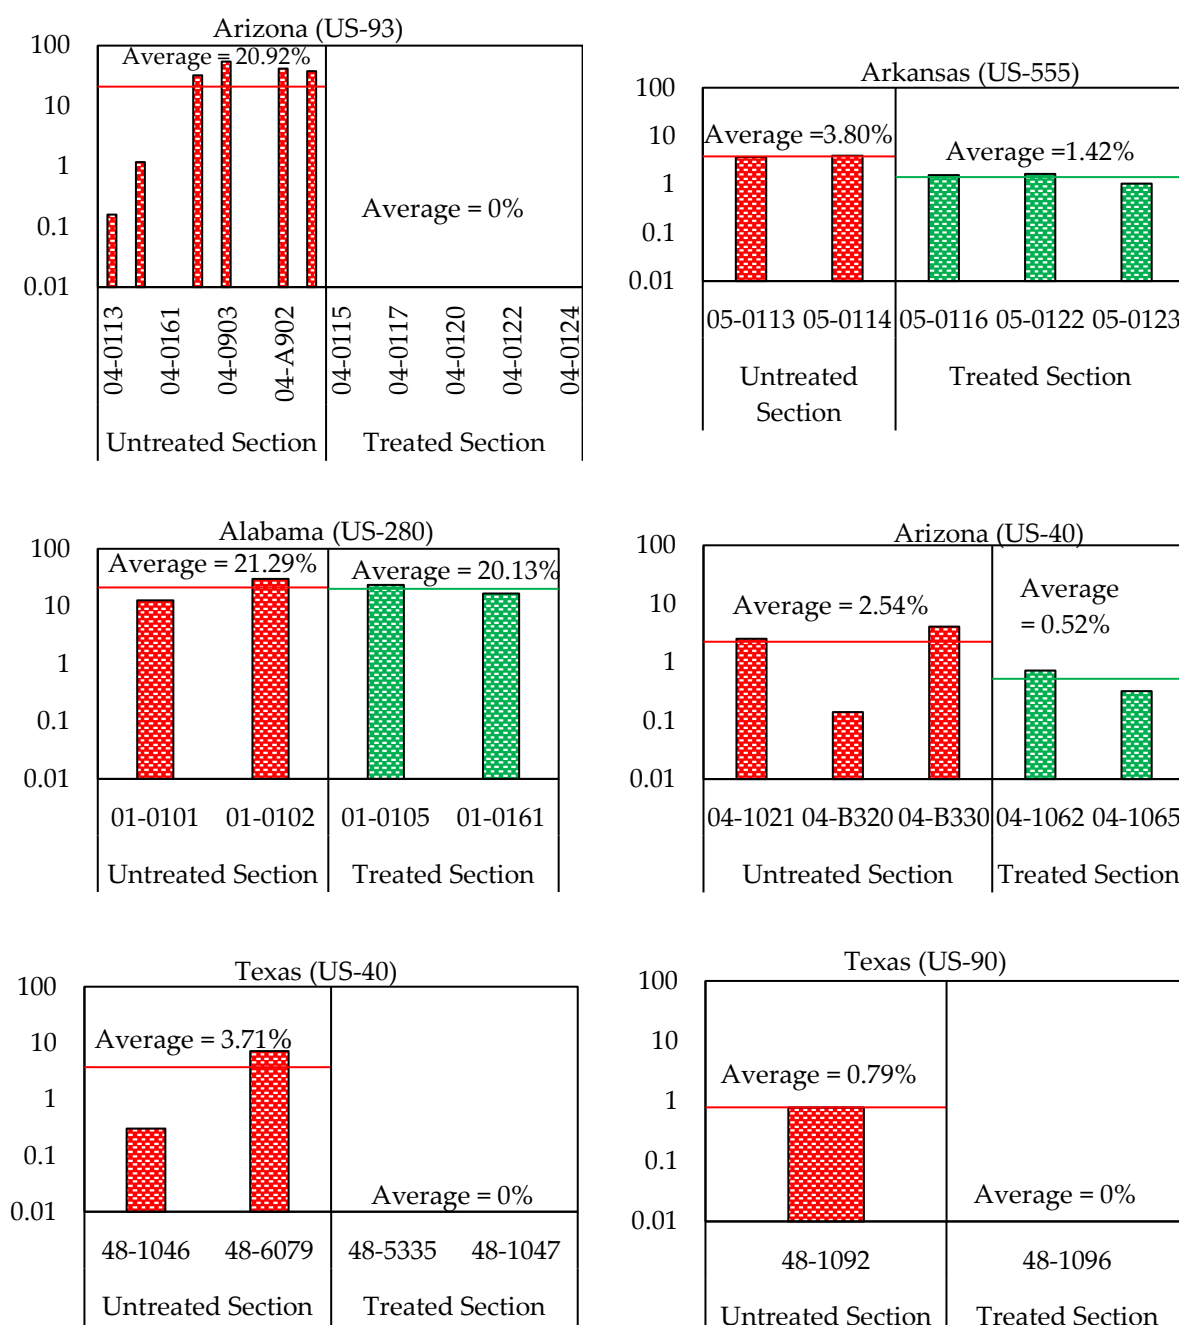
**Figure 2.** Average Fatigue Cracking Comparison between Treated and Untreated Sections in the Considered 4 Different States.

Figure 2 indicates the mean fatigues of acted and unacted parts in the four different states having footway parts on the similar highroad and subjected to the similar horizon of

traffic & State of weather. For all States, the acted parts do excellent than the unacted parts. The mean slackness of acted parts for all four States were less than the untreated sections. The high achievement of the acted part has been noticed in Arizona state of US-93 highway which had 0% fatigue fracturing for an acted part and 20.92% mean fatigue cracking for the unacted parts. From Figure 3 we can observe that the united mean fatigue cracking of the treated sections is five times better than the untreated sections. The average fatigue cracking of the unacted part is 12.91% while, the mean fatigue fracturing of the unacted part is 2.40%. To sum up, the bases assist in the fine achievement of the footways in terms of fatigue.

- In terms of fatigue cracking, base treatment (irrespective of the treatment agent) was observed to be quite effective for all of four considered States. The average value of fatigue cracking for the untreated sections was higher than that of the treated sections in all four States. The combined average fatigue cracking of the untreated sections was five times higher than the treated sections.

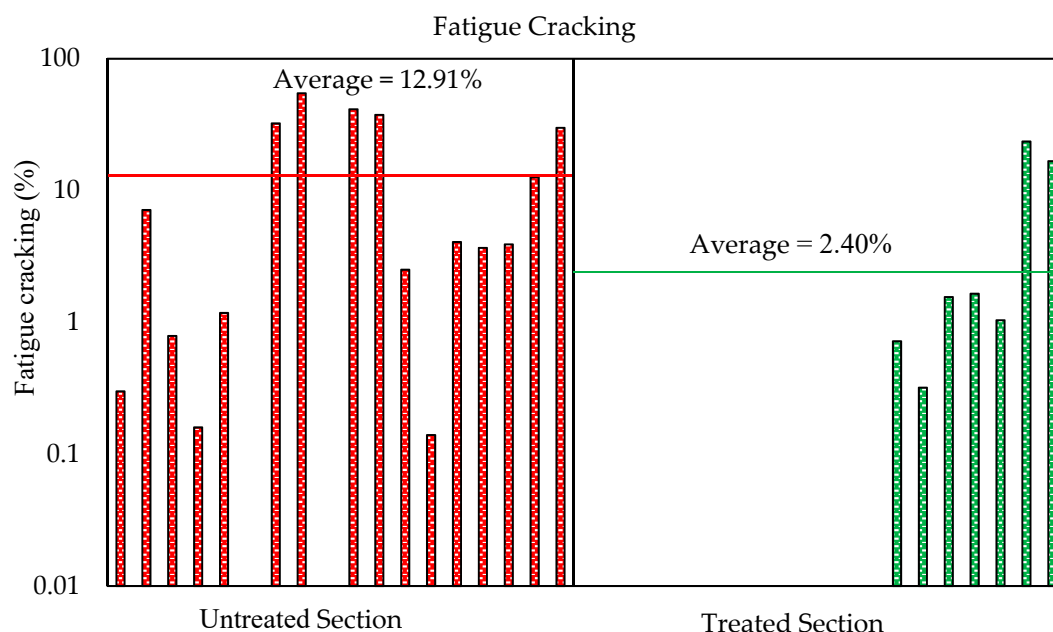
**Figure 3.** Combined Average Fatigue Cracking of Treated and Untreated Sections.

- The overall combined average demonstrated that the treated sections had better field performance in terms of all the considered three distresses. This paper focused on the base treatment, however, the instability base caused cracking is not considered and will be considered in future studies.

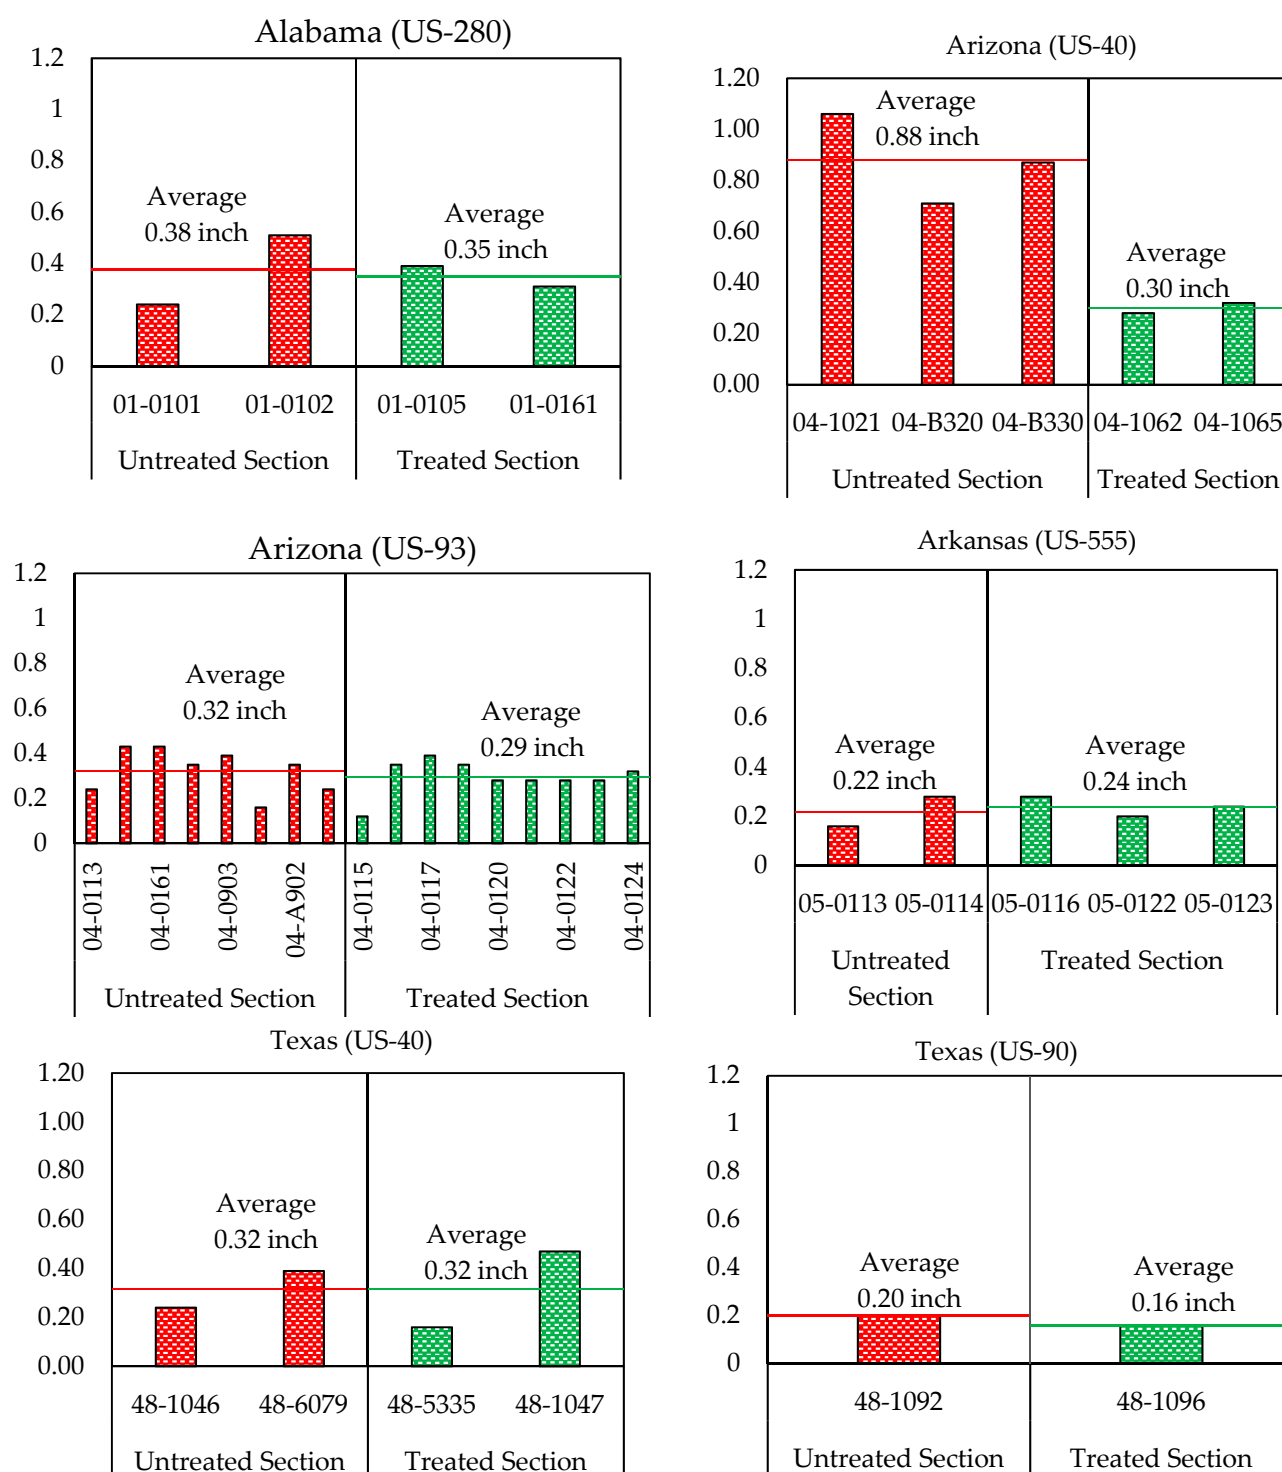
Figure 4 indicates the mean face rutting of the treated and the untreated flexible pavement parts in all of the four States. The practical action of the acted sections in terms of rutting seems to be better in most of the cases except for the state of Texas (US-40) and the state of Arkansas (US-555) highway. For the state of Texas (US-40) highway, both parts of treated and untreated have the same mean rutting of 0.32 inch and for the state of Arkansas (US-555) highway, the mean rutting of the treated or acted section is 0.02 inch higher than that of the untreated or unacted section. In all of the other cases, the treated section has done well with a mean rutting inferior than the acted parts. In the state of Arizona US-40 highway, it has been noticed the best result of the treatment. Here, the mean rutting of the unacted part is 0.88 inch, and the mean rutting section is 0.30 inches.

**Figure 4.** Average Pavement Surface Rutting Comparison between the Treated and the Untreated Sections in the Four Different States.

In the case of Arkansas (US-555) highway, Section 05-116 has a high amount of rutting than the other two sections. The number of stabilizers used in this section was found to be 2.9% HMA. The optimum amount of HMA stabilizers from the overall study was observed to 4 to 5%. Higher or lower than 4 to 5% of stabilizers resulted in a lower performance of the sections. For Texas (US-40) the section with high rutting used a 3% lime stabilizer. The section with the best performance had a lime stabilizer of 5%. The sections under comparison were on the interstate, with the sections handling a high amount of traffic

every day, a high percent of stabilizers resulted in a better performance. In addition, the average amount of traffic handled by treated sections were more than the untreated section for this highway. An in depth study can be conducted with a greater number of sections for the optimum amount of lime stabilizers for the various functional classes of the highway. The cumulative average rutting of the treated and untreated parts from all four States is shown in Figure 5. The average rutting of the treated portion is 0.11 inches smaller than that of the untreated sections, as can be seen. This demonstrates that the treated parts are also less rutted.

- The treated sections performed better in most of the cases, with an average surface rutting for the treated sections being lower in four out of the six considered highways within the four States. For sections on the state of Texas (US-40) highway, the average rutting of the treated and the untreated sections were both equal. The optimum number of stabilizers for this highway was observed to be 5%. The treated section with high rutting had a lime percent of 3%. This resulted in a lower average performance of the treated section. For sections on the state of Arkansas (US-555) highway, the average rutting of the treated sections was 0.02 inches higher than that of the untreated sections. The section with the high rutting had a HMA stabilizer percent of 2.9%. The optimum HMA stabilizer for the Arkansas highway was observed to be 4 to 5%. The combined average surface rutting showed a better performance for the treated sections, with the average rutting of the treated sections 0.11 inches lower than of the untreated sections.

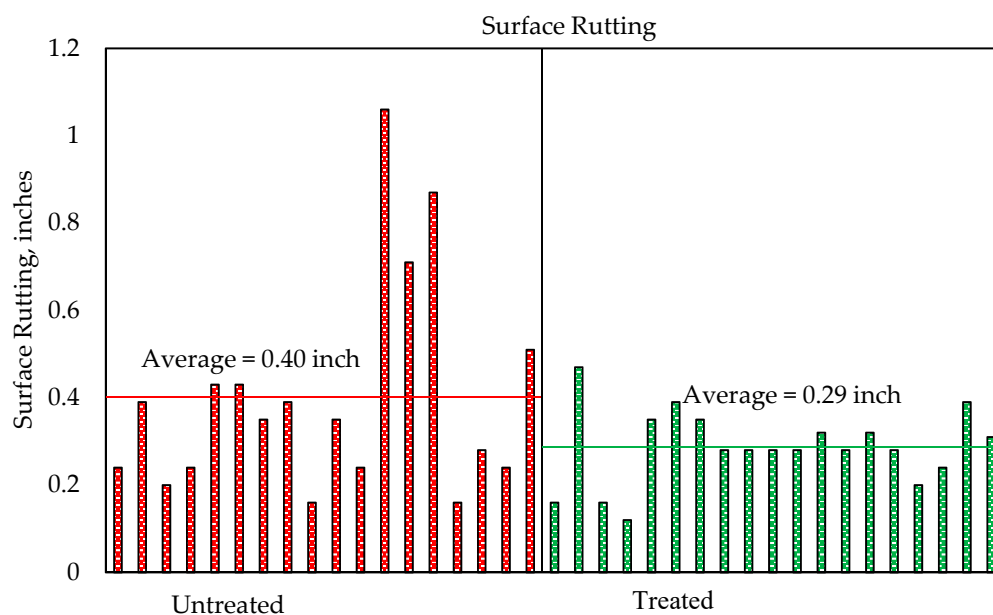
**Figure 5.** Combined Average Surface Rutting of Treated and Untreated sections.

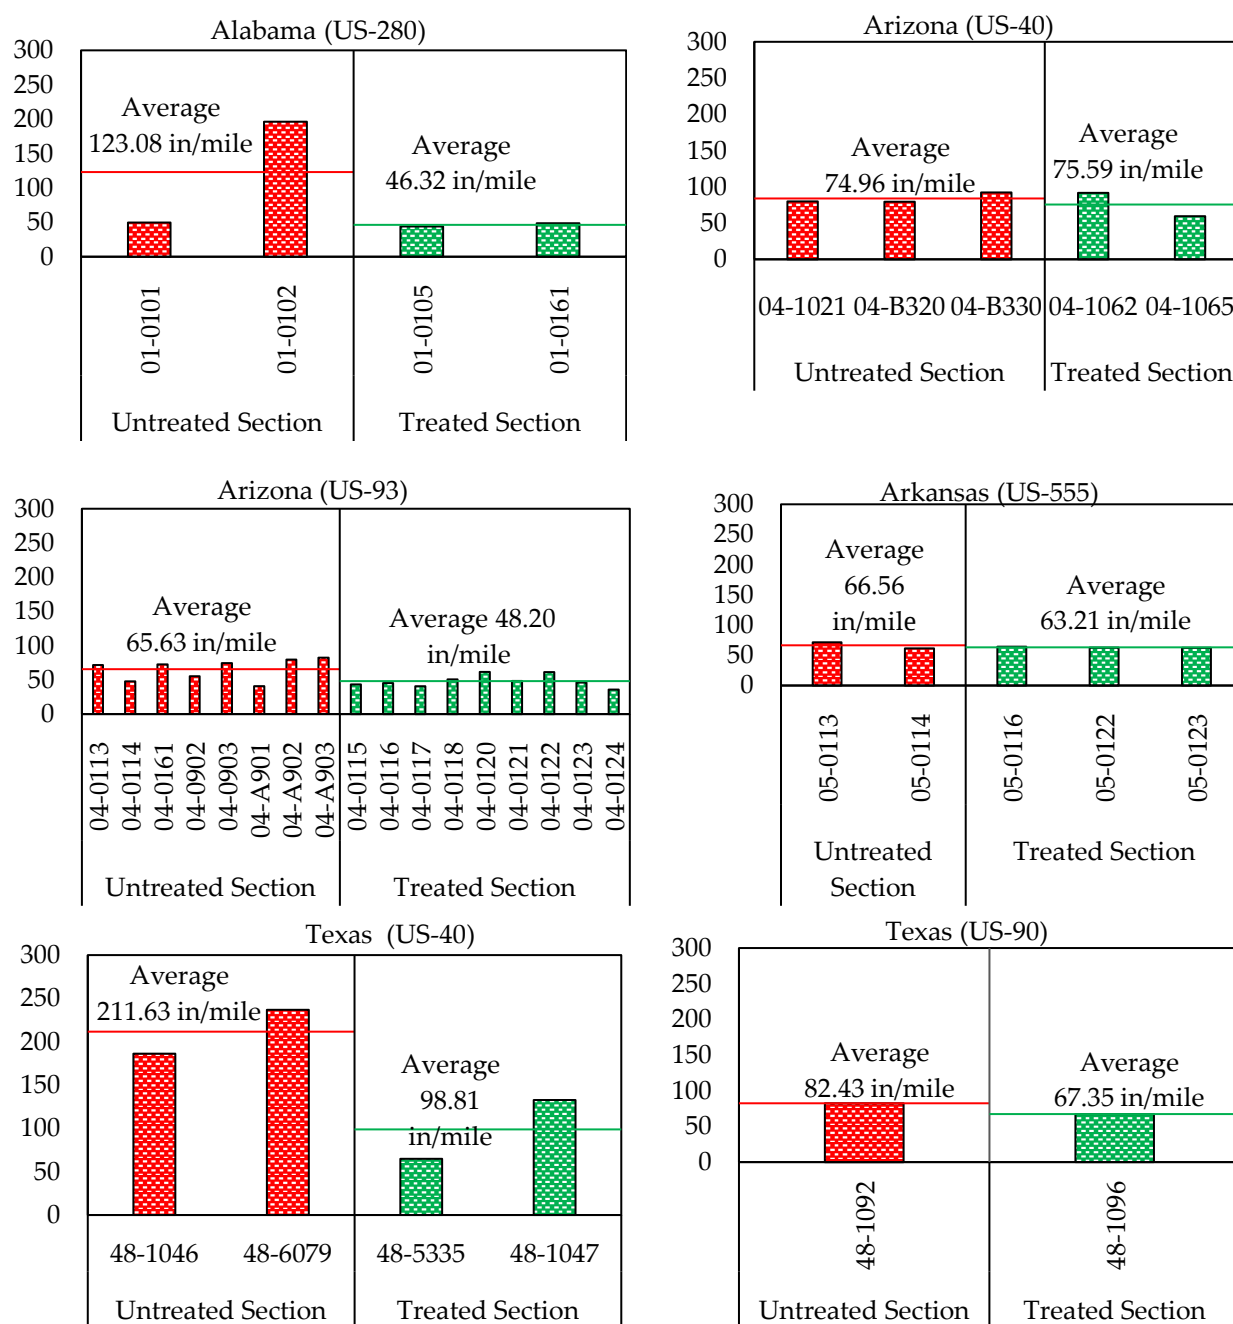
As shown in Figure 6, the average IRI of the treated sections is lower than the untreated sections in all of the four considered States. The base treatment had helped in the better performance of the pavement sections. The high performance of the sections had been observed in the state of Alabama (US-280) highway, with the treated section having an average IRI of 46.32 in/mile and the untreated sections having an average IRI of 123.08 in/mile. Figure 7 shows the combined average IRI of the treated and the untreated sections from all of the four States. The average IRI of the treated and the untreated sections are 59.59 in/mile and 92.32 in/mile, respectively. It can be concluded that the pavement sections with the treated bases are better in terms of IRI.

**Figure 6.** Average IRI Comparison between the Treated and the Untreated Sections in the Four Considered Different States.

The roughness of the road surface has long been regarded as a significant indicator of its efficiency. Safety, ride comfort, and vehicle wear is all directly influenced by the roughness. It also raises the dynamic loading exerted on the pavement by cars, hastening the degradation of the pavement system [14]. Mean roughness, measured in terms of the international roughness index (IRI), of the treated and untreated sections in the four selected various States, with both the untreated and treated sections on a similar highway and subjected to the similar traffic level and conditions of climate is shown in Figure 6 (*y*-axis is IRI in inches/mile).

- In terms of IRI, the average value of the treated sections was lower for all of the States. The average IRI value of the treated sections was almost 1.1 to 1.7 times less than that of the untreated sections. The combined average showed a high difference in IRI between the treated and the untreated sections. The average rutting of the treated sections is almost 1.7 times lower than the untreated sections.

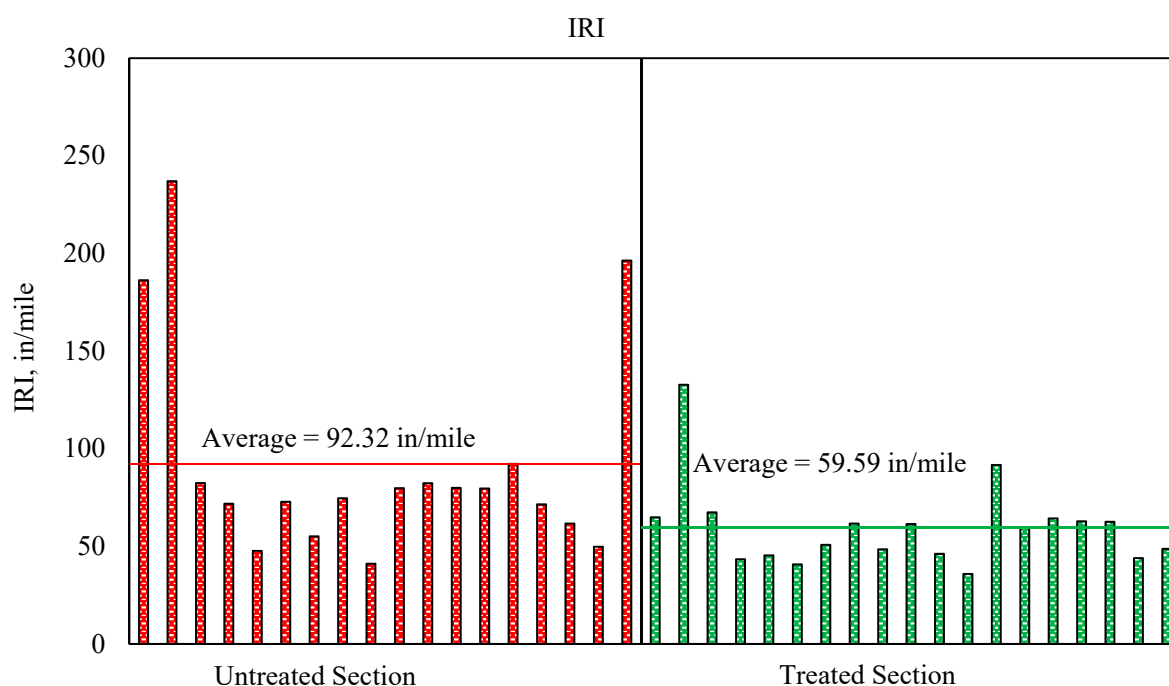
**Figure 7.** Combined Average IRI of Treated and Untreated sections.
