Hydraulic Safety Evaluation and Dynamic Investigations of Baghetto Bridge in Italy

Abstract: The present study deals with the structural safety evaluation of a 50-year-old river bridge, called Baghetto Bridge, located in north Italy on the Adda River. Generally speaking, hydraulic processes are the main cause of bridge failure. Scour and hydrodynamic loads have been largely studied by the hydraulic engineering community; however, in practice, integration with structural analysis is often missing. The aim of this research is to provide a multidisciplinary procedure based on hydraulic and dynamic investigations devoted to the structural verification and monitoring of river bridges with traditional mechanical bearings. The deck–river interaction is addressed, studying the influence of debris accumulation on the bridge and performing structural verification of the bearing supports. The actions exerted on the bridge deck by the river current were estimated following the recommendations of the Italian code and making some further assumptions. In addition, dynamic investigations and FE modelling were performed. The results show (1) a relatively fast procedure that can be applied by pract

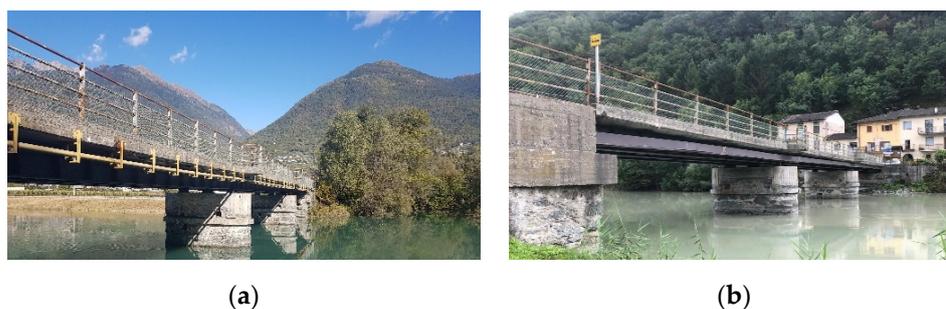
Figure 1. The Baghetto Bridge: view from (a) upstream and (b) downstream.

The Baghetto Bridge (Figure 1) is a three-span, steel–concrete composite bridge built in 1966 over the Adda River. It carries the route SP23 between the municipalities of Chiuro and Castello dell’Acqua, about 10 km from the city of Sondrio, in the north part of Lombardy, Italy. The structure—along with other bridges [18,19]—has been investigated as part of joint research between the Lombardy Region and Politecnico di Milano aimed at defining guidelines for monitoring key infrastructure.

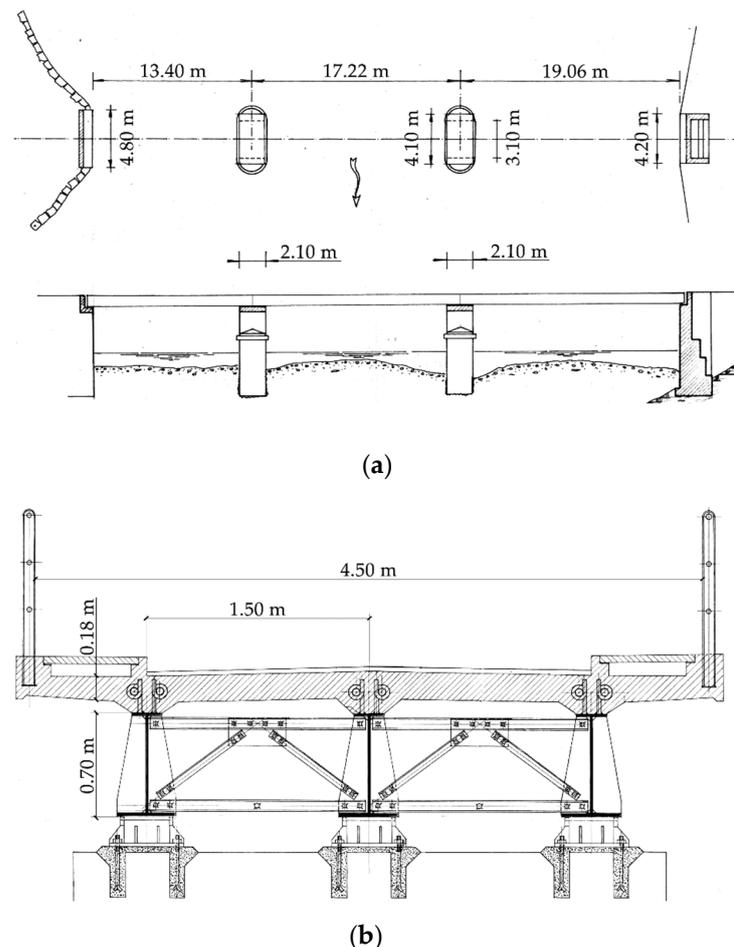
The structure is approximately 50 m long and is composed of three simply supported girders. The steel–concrete composite girders have different lengths, 19.06 m, 17.22 m, and 13.40 m, and have a free span (i.e., the distances between the supports) equal to 18.76 m, 16.62 m, and 13.10 m, respectively. The carriageway is 4.5 m wide, providing an alternating one-lane. The piers and one abutment are in roughly cut stone masonry with concrete strengthening in the upper part, while the other abutment is reinforced concrete. Regarding the geometry, piers and abutments have a height—starting from the foundation level—of about 7 m. The piers have an approximately rectangular section (2.30 m × 5.50 m) with rounded edges. The longitudinal and plan views of the bridge are shown in Figure 2a.

Figure 2. Original blueprints of Baghetto Bridge: (a) plan and longitudinal section; (b) detail of the steel–concrete composite deck.

The metallic part of the cross-section consists of three identical steel I-girders spaced at 1.5 m and connected by intermediate cross-bracings (double-channel sections) and diagonals (angular sections). The upper part of the cross-section consists of a reinforced concrete slab with a height of 0.18 m. The detailed dimensions of the cross-section are shown in Figure 2b. According to [20], the connection between the concrete slab and the steel beam are obtained by welded stud connectors (Figure 2b). Regarding the layout of the metallic bearing supports, they restrain transverse and longitudinal displacement on one side of each span while allowing longitudinal translation on the opposite side (flat-sided roller-bearing typology); their detailed description will be given in Section 4.

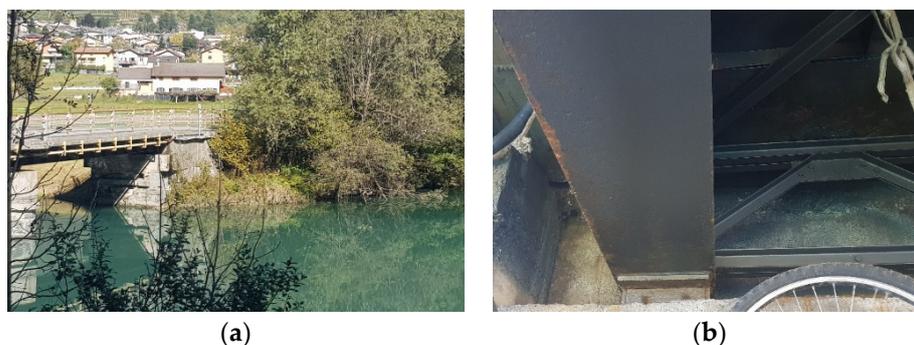
Presently, the structure exhibits a fairly good state of preservation, with only a few signs of rust expansion (Figure 3) causing deformation of some diagonal members of the girder.

Figure 3. (a) View of the right embankment to access the bridge; (b) detail of rust signals.

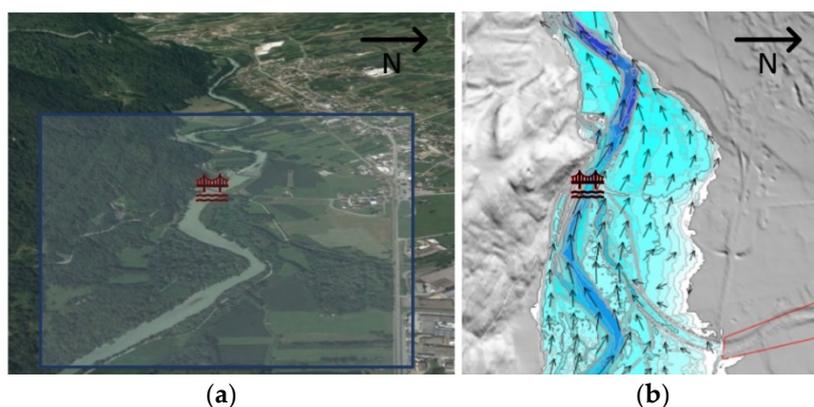
Figure 4 shows the flow field in the area around the bridge during a 200-year event (the event referenced in the Italian code). The Adda River runs with a subcritical current and very variable speed depending on the topographic conditions (up to 3.7 m/s). On the left, the flow is bounded by the steep valley side, while it can freely expand on the right side, which is not protected by levees or embankments, to occupy part of the agricultural and natural floodplain with water depths up to 2.0 m and low speeds (<1.0 m/s). Therefore, the right access road to the bridge that crosses the floodplain perpendicularly is submerged. This embankment is covered in stone masonry, so it appears to be minimally vulnerable to direct erosion by the flow, at least in a first-level evaluation. A further threat for the right embankment (and abutment) may come from lateral shift of the riverbed (action (iii)): however, by observing historical aerial and satellite images going back to 1954, no evident signs of bank erosion—which would induce lateral migration of the river—were noted; lateral erosion may be, therefore, considered to be low probability.

Figure 4. (a) View from upstream of Adda River crossed by the bridge. The blue rectangle highlights the 2D model domain of figure (b). The arrows indicate the direction and intensity of the current velocity, up to 3.7 m/s for the event $T = 200$ years. Note the expansion of the river in the right floodplain.

The main result from the simulation is that the bridge is hit by the current at the level of the deck with a water depth equal to 5.90 m (with respect to the lowest point of the riverbed at the bridge) and a depth-averaged flow velocity equal to 2.63 m/s. Therefore,

the bridge does not meet the standard set out in Italian code, which states that the distance between the water surface and the deck must not be less than 1 m.

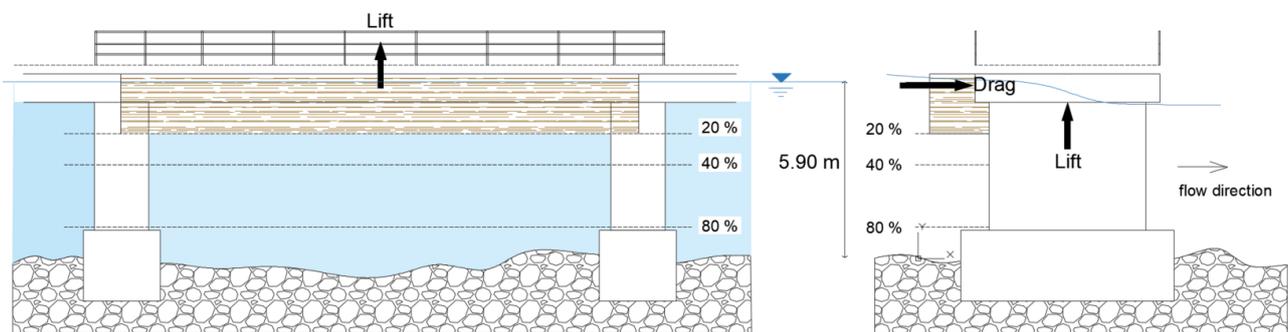
Figure 5. Front and lateral views of partial occlusions (20, 40, and 80%) of one span caused by debris accumulation. Black arrows represent the drag and lift forces acting on the deck.

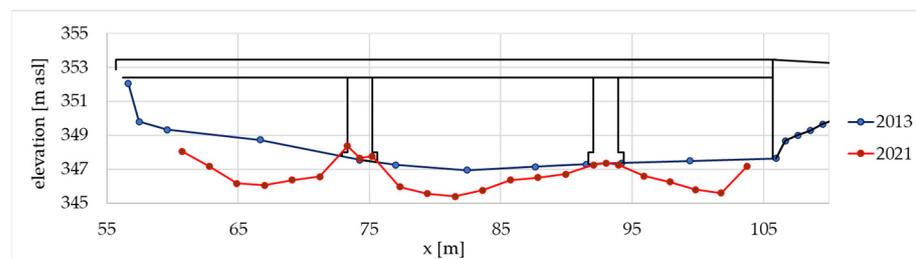
The riverbed elevation at the bridge section was measured in 2021 to detect altimetric variations with respect to the 2013 configuration. From Figure 6, a general degradation of about 1.5 m can be noted, apart from the area around the pier foundations. These measurements led to the hypothesis of the presence of a rip-rap to protect the foundations against scour.

Figure 6. Riverbed elevation comparison between 2013 and 2021 at the bridge cross-section.

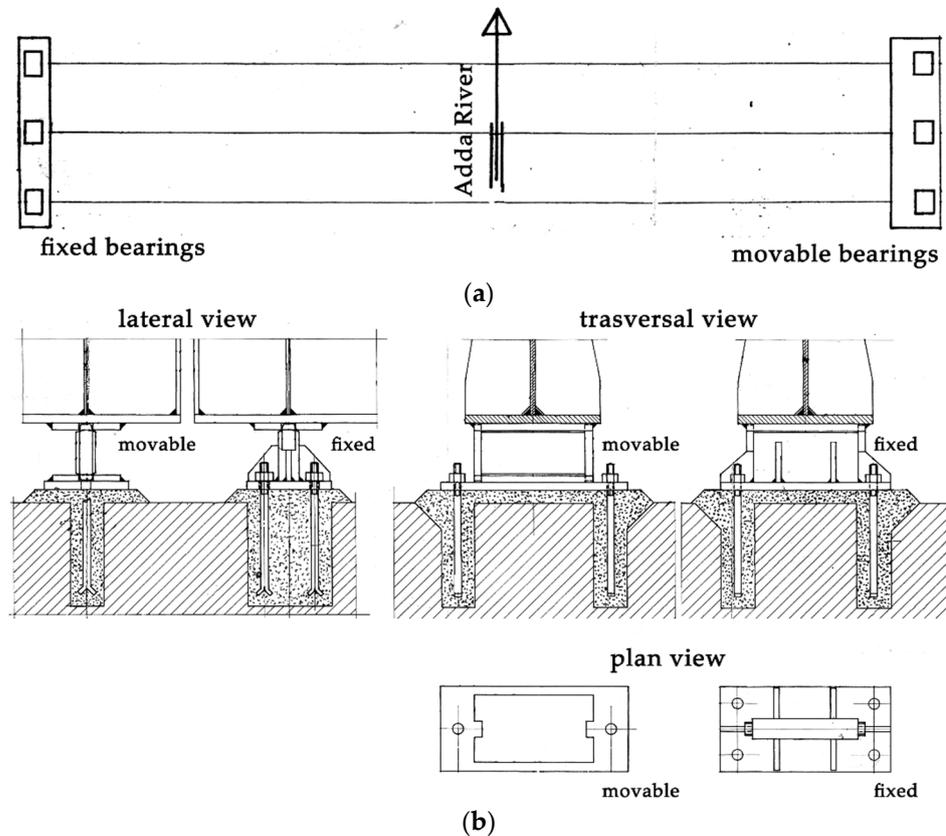
Regarding the characteristics of the bridge’s metallic support devices, each girder span is supported on a knuckle pin bearing at one side, restraining transverse and longitudinal displacement, and a single sliding roller bearing at the other side, releasing the longitudinal translation from the opposite side. Each span has a total of three fixed supports and three roller supports. The supports are identified as flat-sided bearings according to EN 1337-4:2004 classification [27]. Each support device is composed by assembling two horizontal plates: the first one is connected to the lower intrados of the metal beam and the second one is fixed to the pier; both horizontal elements are connected by a vertical plate, as shown in Figure 7.

The lower plates are anchored to the pier by anchor bolts $\phi 27$ ($A_b = 470 \text{ mm}^2$). As shown in Figure 7a, there are two anchor bolts for each roller-bearing support and four for each fixed support. The transfer of shear force between each horizontal plate and vertical plate occurs through a contact area of about $40 \times 20 \text{ mm}^2$ (Figure 7b). Regarding material properties, the original calculation report [28] refers to Aq42 UNI 815 steel for the steel plates and Aq50 for the bolted girder connections. Referring to Verderame et al. [29], the yield strength is assumed equal to $f_y = 235 \text{ MPa}$ (steel plates) and 265 MPa (bolts), while the ultimate stress is $f_u = 412 \text{ MPa}$ (steel plates) and 490 MPa (bolts). Because of lack of detailed indications, the anchor bolt elements were assumed to be of the same material as the bolts

Figure 7. Bridge support devices: (a) kinematics of the bearings, with knuckle pin bearing (left) and sliding roller bearing (right); (b) lateral, front, and plan view of the bearings.

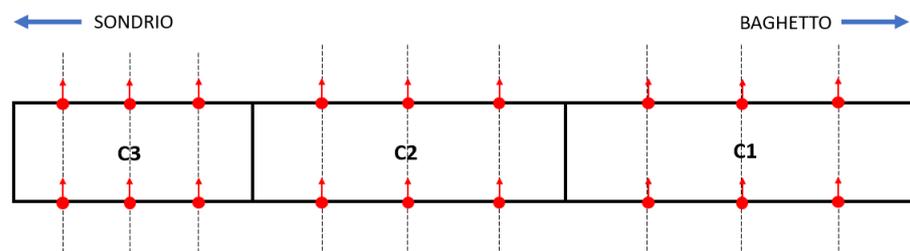
In order to evaluate the dynamic characteristics of the bridge in operational conditions, a first ambient vibration test (AVT) was performed on 20 July 2020. During the test, the vertical and transverse structural dynamic response was measured: three cross-sections for each span were instrumented for a total of eighteen measuring positions, as schematically depicted in Figure 8. As shown in this figure, the sensors were placed on the external curb of the bridge, in order to protect them from cars traffic.

Figure 8. Measurement set up adopted during the experimental field tests on the Baghetto Bridge. The spans are numbered in ascending order from Baghetto to Sondrio.

Instrumentation consisted of 24-bit resolution DAQs and high-sensitivity (10 V/g) piezo-electric accelerometers and servo accelerometers. The sensing devices featured a measurement range of 0.5 g pk and a frequency range (± 3 dB) from 0.05 to 4000 Hz. The

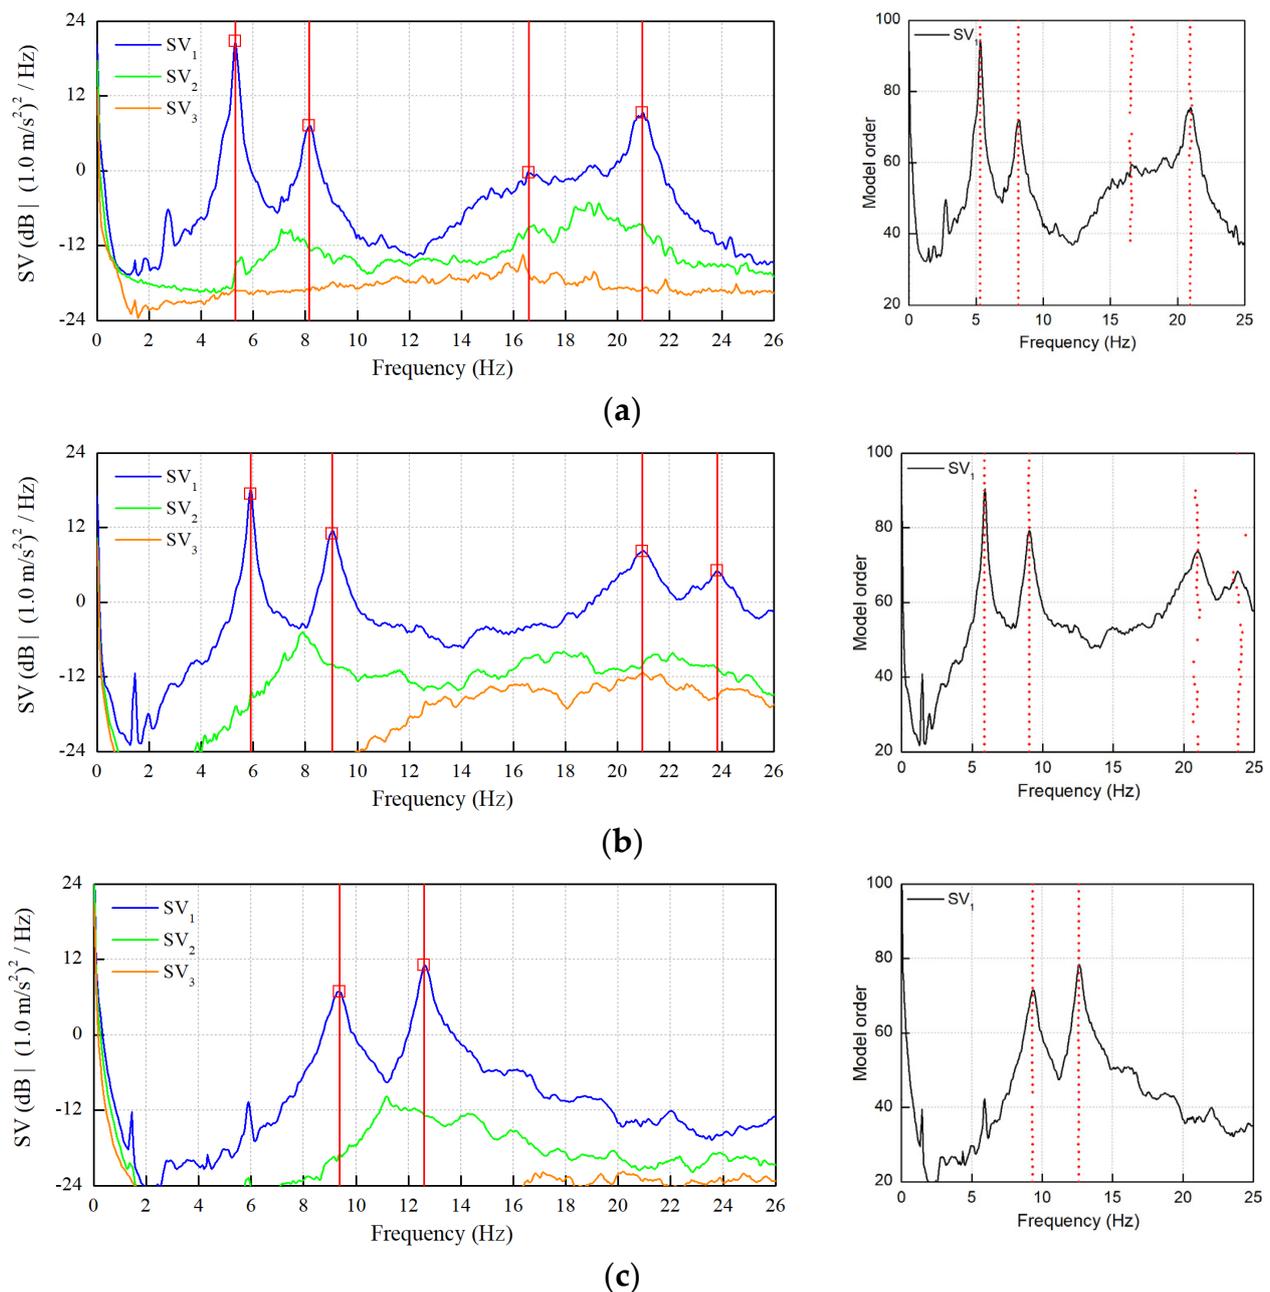
Since analysis of the horizontal signals did not highlight any significant component in the lateral direction, only the vertical dynamic characteristics are herein discussed. Figure 9 shows on the left side the results of data processing in terms of the largest singular value (SV) lines for each span in the range of 0–26 Hz, while on the right side the outcomes of the SSI algorithm are illustrated. Four vibration modes were identified by the local maxima of the first SV line for the longest spans, S1 and S2 (Figure 9a,b), whereas two vibration modes were identified for the shortest span, S3 (Figure 9c).

Figure 9. Identification of natural frequencies with FDD and SSI techniques: (a) Span S1, (b) Span S2, and (c) Span S3.

Modal identification was carried out by two well-known approaches: frequency domain decomposition (FDD) [33]—available in Artemis software—and covariance-driven stochastic subspace identification (SSI Cov) [34]—developed in previous research [35].

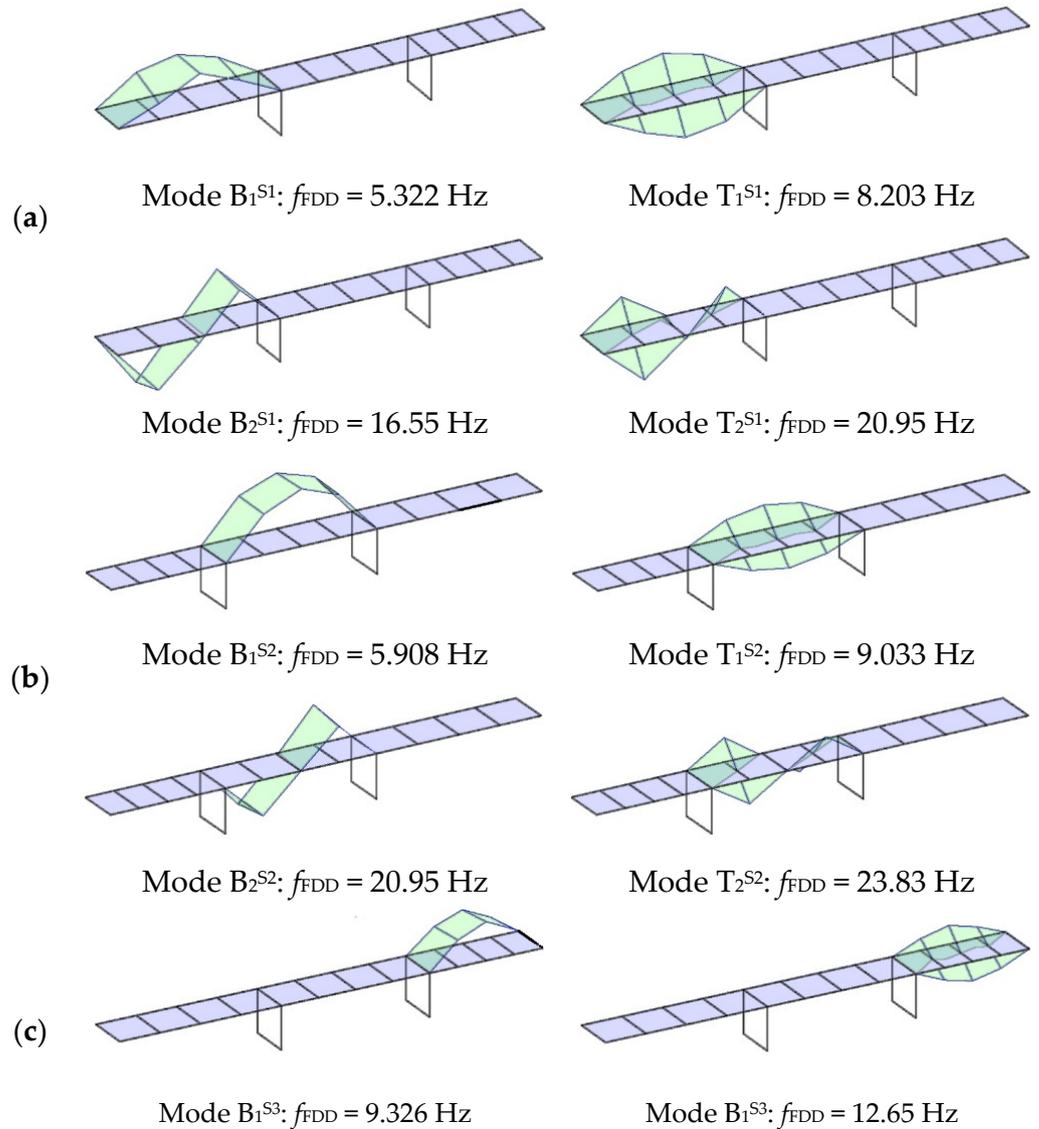
The corresponding mode shapes are reported in Figure 10: the mode shapes follow the expected sequence of bending (B) and torsion (T) modes of first and second order.

Figure 10. Vibration modes identified from the first AVT: (a) Span S1, (b) Span S2, and (c) Span S3.

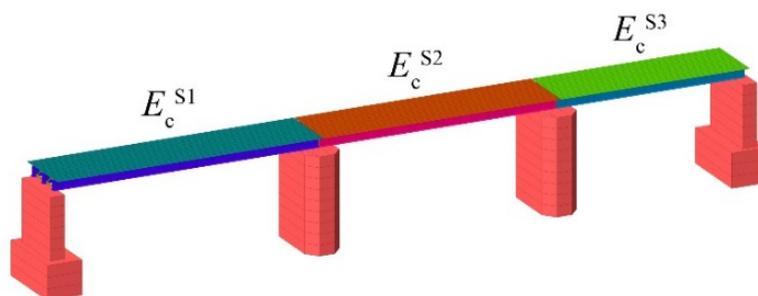
The 3D numerical model of the bridge was carried out with MIDAS software and is shown in Figure 11 and it is carried out with MIDAS software. The three main girders, the bracings elements, and the struts were simulated as beam elements with cross-sections taken from the original drawings. Ideal hinges are assumed as connections between bracings and main girders. The concrete slab is modeled through four-noded rectangular shell elements and is connected to the steel beams with rigid links allowing vertical rotation. It is worth noting that the modelling strategy is consistent with other known examples (see [36,37]).

Figure 11. FE model of Baghetto Bridge with the updated parameters indicated.

In order to obtain a regular distribution of mass, a consistent description of geometrical features, and to avoid frequency sensitivity to mesh size, a relatively large number of elements were used. In total, the numerical model consisted of 816 elements, 6441 nodes, and an average mesh size of 0.7 m, as shown in Figure 11.

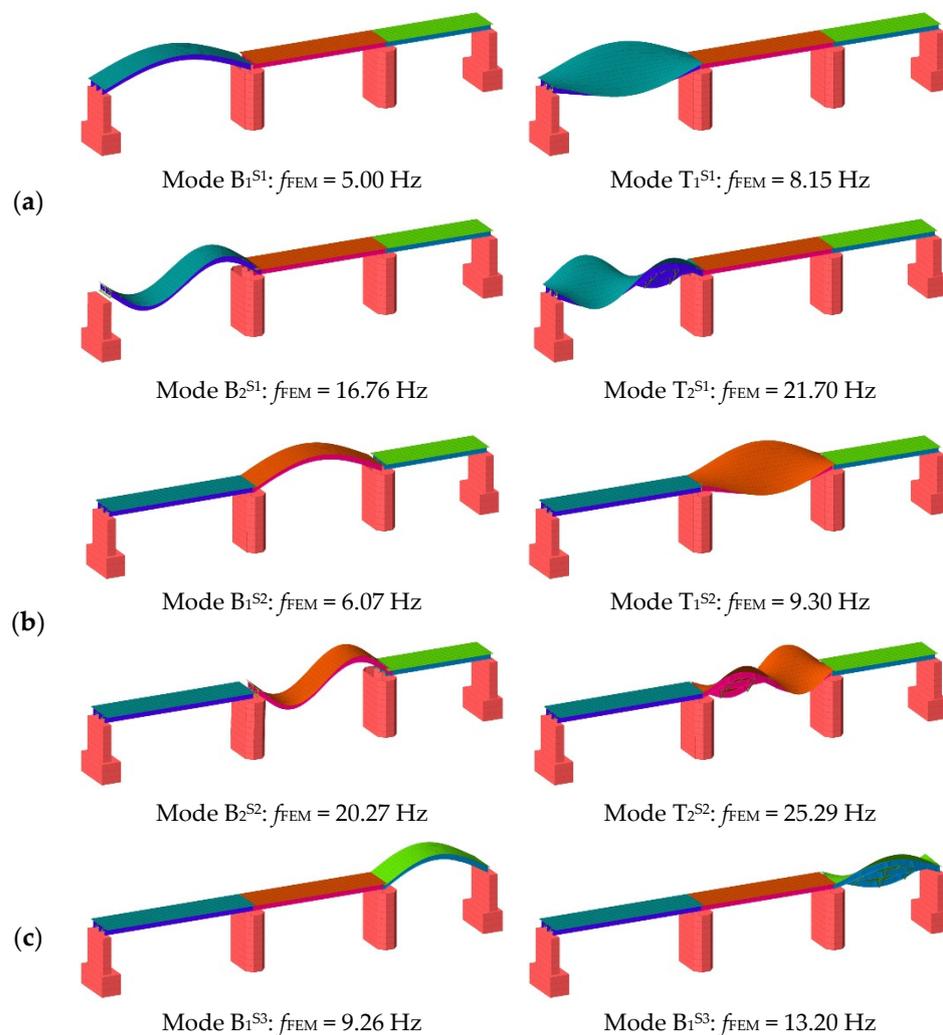
for the other two spans (S2 and S3), the minimum was obtained with E_c equal to 31 GPa. As shown in Table 3 and Figure 12, correlation with experimental natural frequencies increased, providing preliminary validation of the numerical model with discrete accuracy.

Figure 12. Vibration modes of the updated model: (a) Span S1, (b) Span S2, and (c) Span S3.

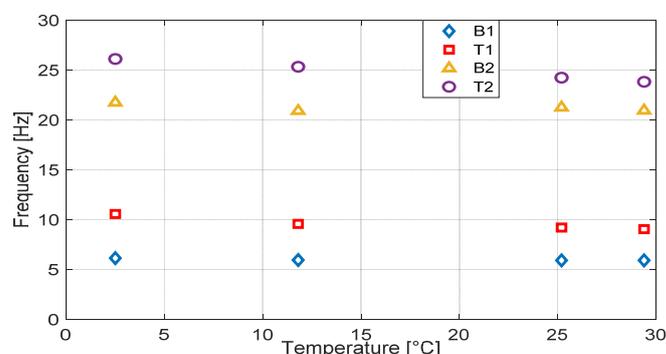
The evaluation of temperature effects on natural frequencies is crucial when dealing with repeated dynamic testing or continuous dynamic monitoring (see [16,17]). As shown in Figure 13, which refers to span S2, changes can be observed for the first two torsional and bending mode frequencies (collected in Table 4). In fact, as temperature increases, the natural frequencies of the central bridge span tend to decrease: changes in frequency up to 15% were observed due to the effects of temperature. The freeze–thaw process [38], which is particularly severe for wet concrete bridges when the temperature approaches the freezing point, explains why the highest frequency values were observed at the coldest temperature: close to 0 °C. Water droplets seep into concrete slab pores, and when the temperature gets close to the freezing point, they tend to expand, causing global stiffening of the structure, thus increasing the structure’s natural frequencies. On the other hand, as the temperature increases, the natural frequencies decrease due to softening as a result of temperature changes to the bridge [39]. The experimental tests presented represent the first step in defining frequency–temperature correlation; in subsequent years, the relationship between modal parameters and environmental parameters will be detailed through exploitation of new data.

Figure 13. Span S2: evolution of frequency–temperature correlation among different tests.

- The AVT were repeated in different seasons, showing remarkable dependence of bridge natural frequencies on temperature. In fact, frequency changes of up to 14.8% for the first torsional mode of the central span were observed with a temperature difference of 27 °C. In particular, the highest frequency values were observed when the temperature was close to the freezing point due to the freeze–thaw effect, while with increasing temperature a decreasing trend of frequencies was observed for the whole ensemble of modes.
