# Protection of Immovable Cultural Heritage: The Urban Structure of Vlasotince, Southern Serbia

Recognizing these gaps, the Institute for Cultural Heritage Preservation Niš launched in 2023 the project “Assessment of the Condition of Immovable Cultural Heritage in the Municipalities of Vlasotince and Babušnica and Preparation of the Conservation Study for the Old Čaršija of Vlasotince”, supported by the Ministry of Culture of the Republic of Serbia.

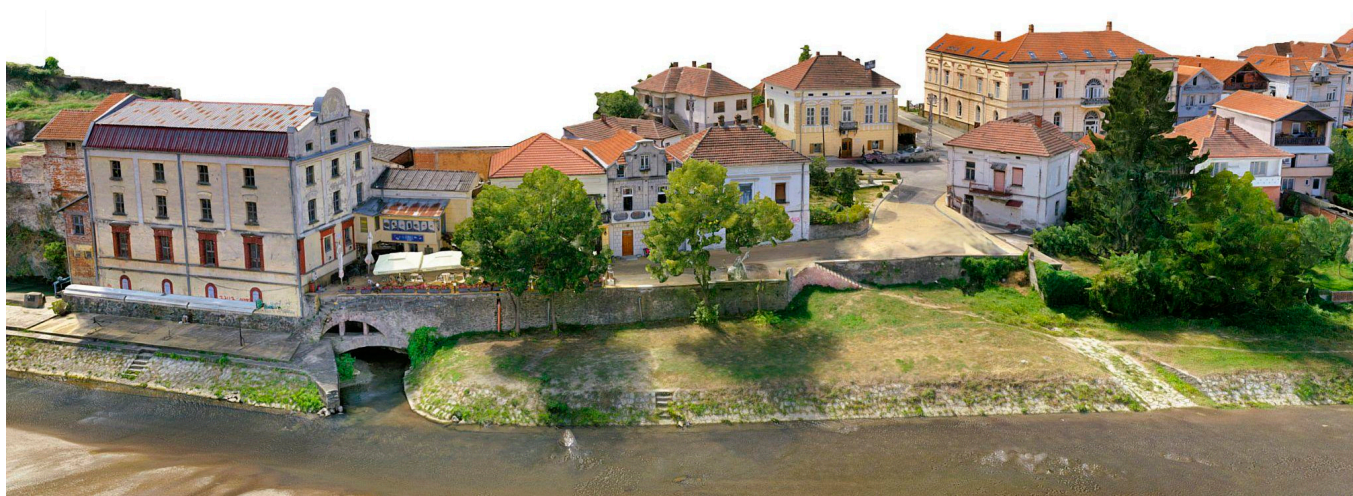
Over the centuries, Vlasotince developed as a town with a strong commercial, craft, and architectural identity, with each historical period—the Ottoman era, the post-liberation period, the interwar years, and the postwar period—clearly reflected in the city's structure. This stratification is evident in the layout of the old bazaar (čaršija), house typologies, urban lines, and numerous buildings that bear the marks of different eras. Along the main street are rows of craft workshops and shops with narrow facades and typically deep plots, as well as multi-story bourgeois houses of architectural and artistic value, showcasing skilled craftsmanship. The partially preserved old trading bazaar (čaršija) in the town center represents the urban and living core of the settlement, densely built and retaining inherited specificities (Figure 3).

**Figure 3.** A part of the historic ambient ensemble in Vlasotince (documentation of ICHP Niš).

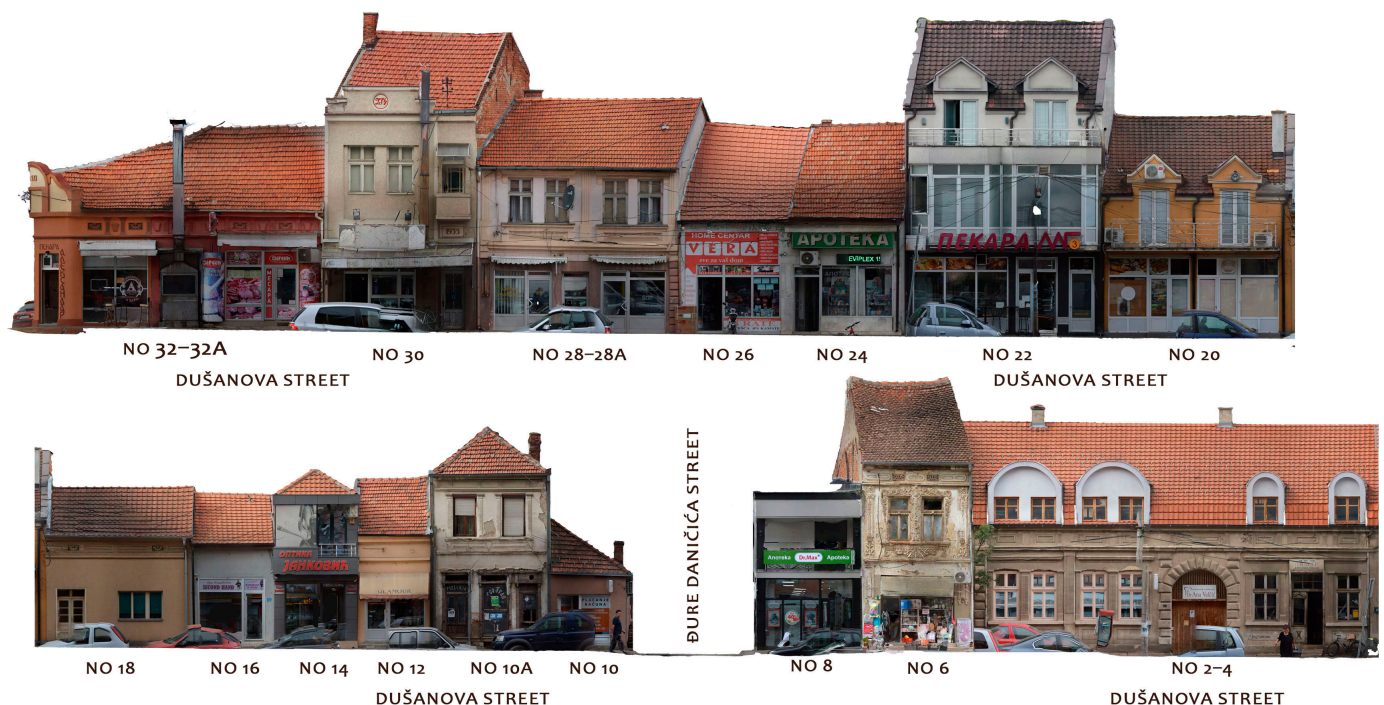
Of the total number of buildings in this row (Figure A1, Table A1), 50% are buildings of value or of special value (categories I and II). Buildings without visible value and those incompatible with the surrounding environment (categories IV and V) make up the remaining 50% of the building stock in this part of the Old Bazaar. A degradation level A was observed in 19% of the examined buildings. The same share was recorded for degradation levels C and I. Degradation level B is present in 37% of the buildings, level D in 6%, level E in 44%, and level F in 12%. The most common interventions are those on roof planes (G), identified in as many as 56% of the buildings. The most severe degradation level (J) is present in 12% of the buildings.

**Figure A1.** Orthophoto view of the street-front facades on the even-numbered side of Dušanova Street (documentation of ICHP Niš edited by authors).

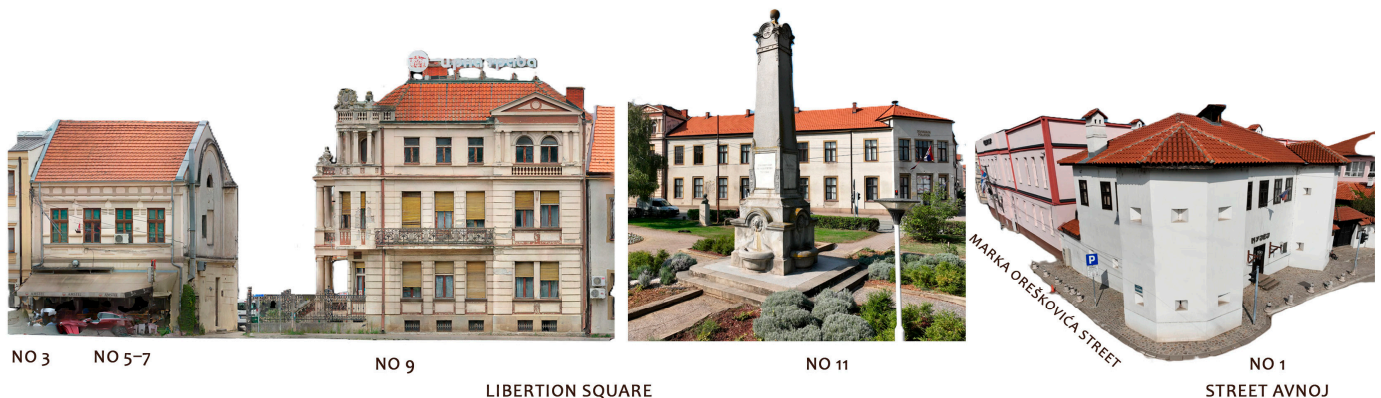
The row at Liberation Square is considerably smaller in scale, comprising only five buildings (Figure A2, Table A2). Of these, 60% are buildings of exceptional value (Category I), while 40% are those that complement the ambient setting by their appearance (Category III). Among the buildings of value (Category I), 67% exhibit only minimal types of degradation (Grade A), whereas the remaining 33% show more pronounced forms of degradation (Grades F and G).

**Figure A2.** Odd-numbered side of the frontage on Liberation Square (documentation of ICHP Niš edited by authors).**Table A2.** Liberation Square—Heritage Value Assessment and Building Degradation.

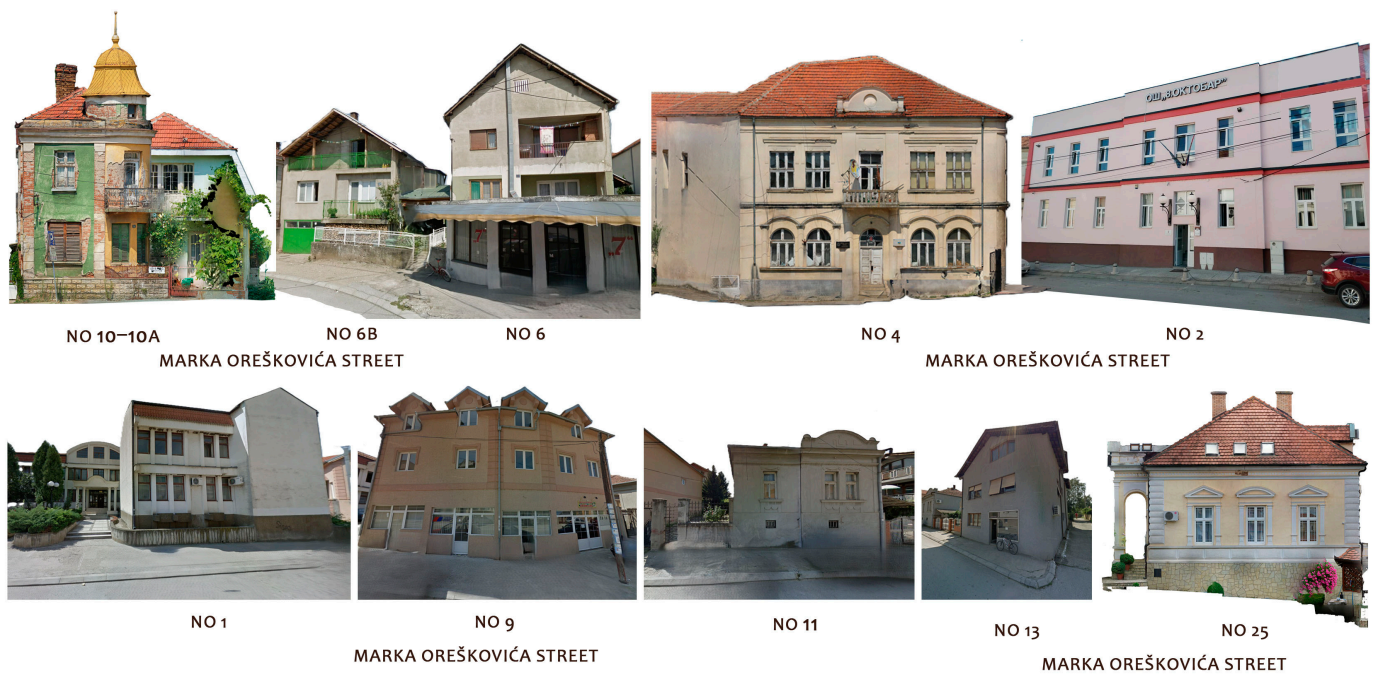
The row on Marka Oreškovića Street is characterized by numerous contradictions (Figure A3, Table A3). As much as 44% of the buildings are classified as Category I, of

exceptional value. On the other hand, the remaining 56% consist of buildings without visible value or those completely out of context with the environment (Categories IV and V). Minor degradations of Grade A are present in 22% of the observed buildings, while 11% exhibit Grade C and G degradations. As expected, buildings that are out of context have the most significant degrading effect on the row, with the proportion of this type (Grade J) reaching 56%.

**Figure A3.** Even- and odd-numbered sides of the frontage in Marka Oreškovića Street (documentation of ICHP Niš edited by authors).

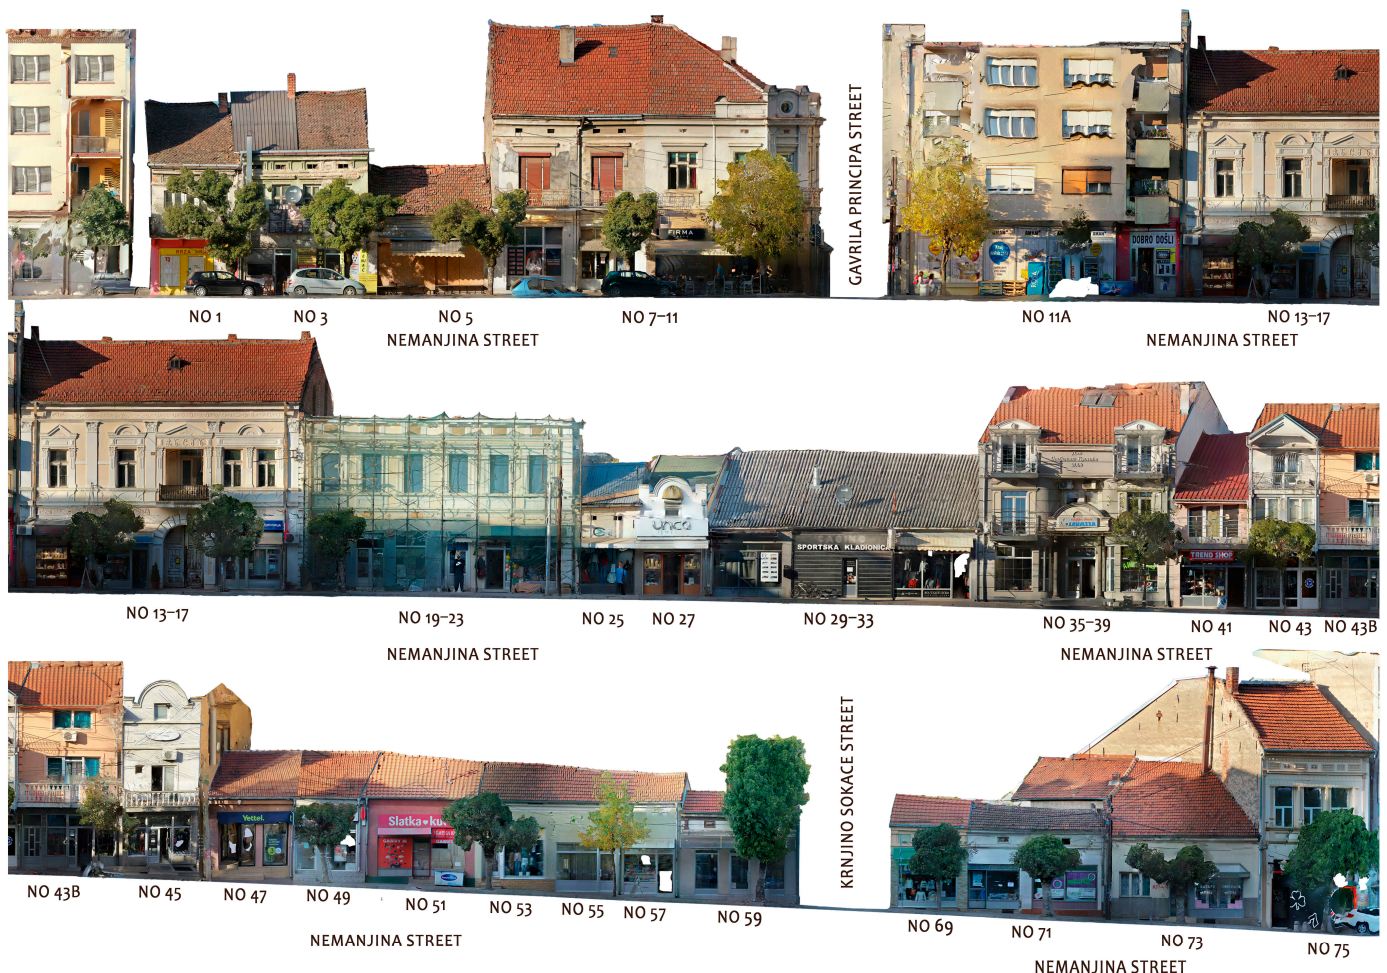
buildings in this row. All buildings in this category (J) are newly constructed and entirely out of context with the surroundings.

**Figure A4.** Orthophoto of the frontage on the odd-numbered side of Nemanjina Street (documentation of ICHP Niš edited by authors).

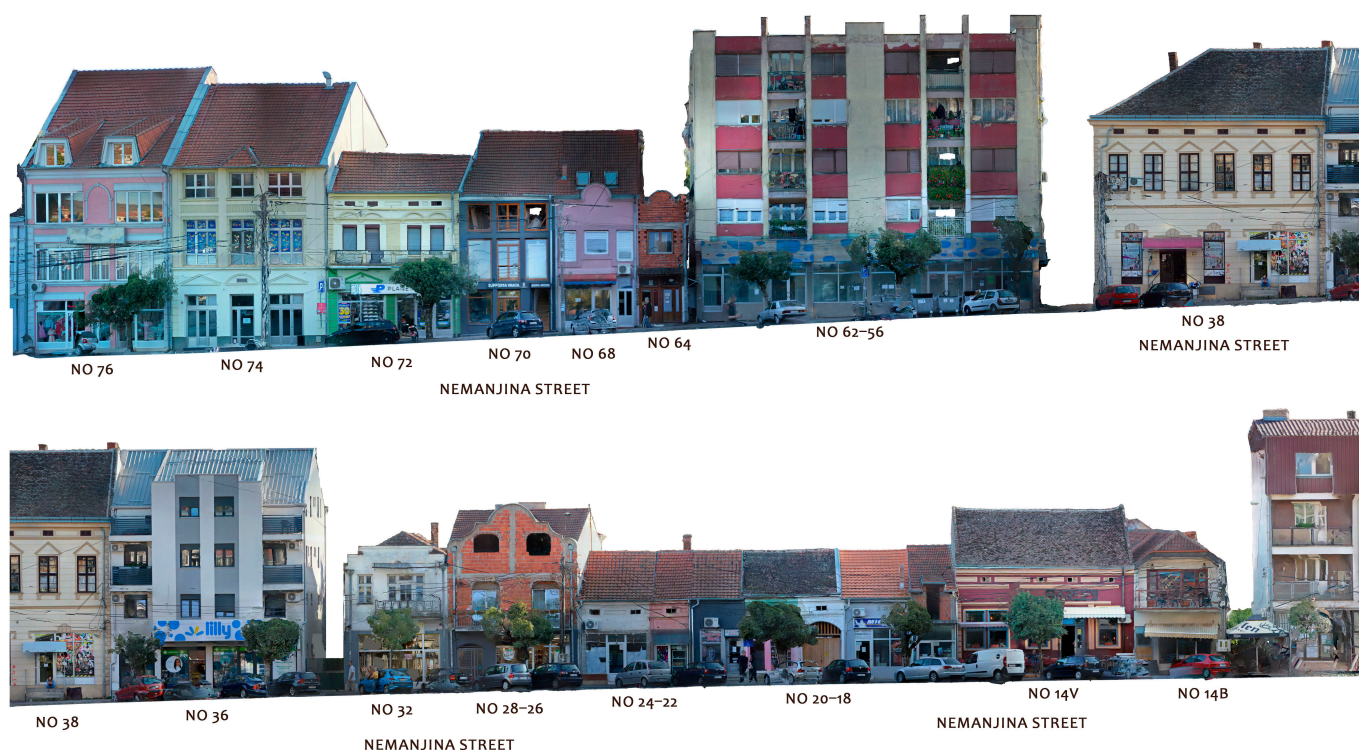
The row on the even-numbered side of Nemanjina Street (Figure A5, Table A5) consists of 31% Category I buildings and 8% each of Categories II and III. Buildings that are incompatible with the ambient character (Category V) make up the largest share, accounting for as much as 53% of the building stock in this part of the Old Bazaar. Eight percent of the buildings exhibit degradation type A, and the same share is recorded for type J. Degradation type B is observed on 15% of the analyzed buildings, while type C appears on 31% of the buildings in this row. The most prevalent forms of degradation are types F and I, with total shares of 46% (F) and 54% (I), respectively, which is expected given the high percentage of buildings incompatible with the ambient character on this side of Nemanjina Street. Interventions on roof surfaces (G) are recorded on 23% of the buildings.

**Figure A5.** Orthophoto of the frontage on the even-numbered side of Nemanjina Street (documentation of ICHP Niš edited by authors).

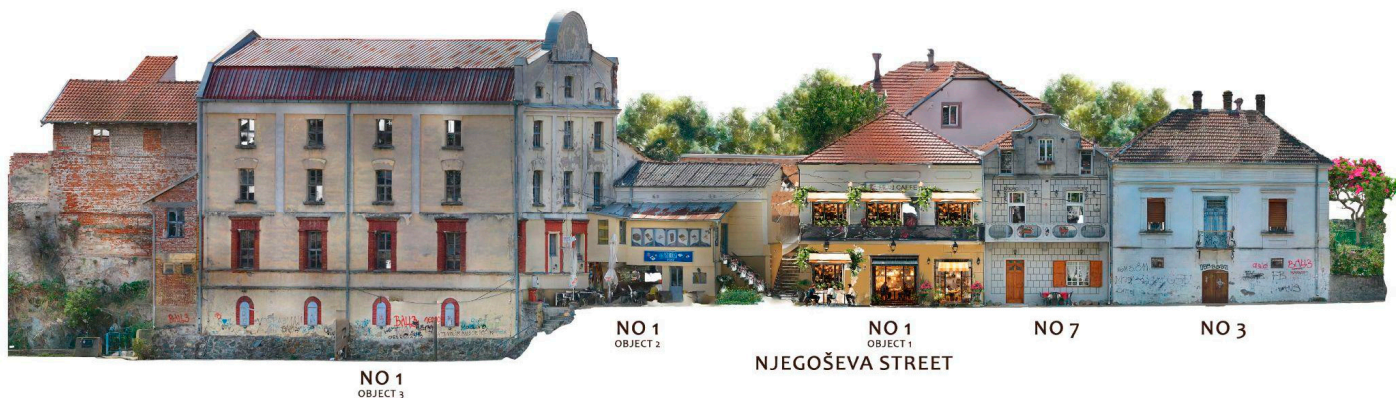
The row on Njegoševa Street (Figure A7, Table A7) represents the core and most significant part of the entire unit. It comprises 60% of buildings classified as Category I with exceptional values, 20% of buildings that complement the ambient setting (Category III), and the remaining 20% are buildings without visible value (Category IV). Grade A degradation was observed in 40% of the surveyed buildings, while Grade C occurred in 20%. Grade G degradation is present in 60% of the buildings, and Grades H, I, and F each occur in 10%.

**Figure A7.** Orthophoto of the frontage in Njegoševa Street (documentation of ICHP Niš edited by authors).**Table A7.** Njegoševa Street—Heritage Value Assessment and Building Degradation.
