## Article

# Pollution Reduction in Throughflow from Vegetated and Non-Vegetated, Foam-Based Surfaces and Green Roofs

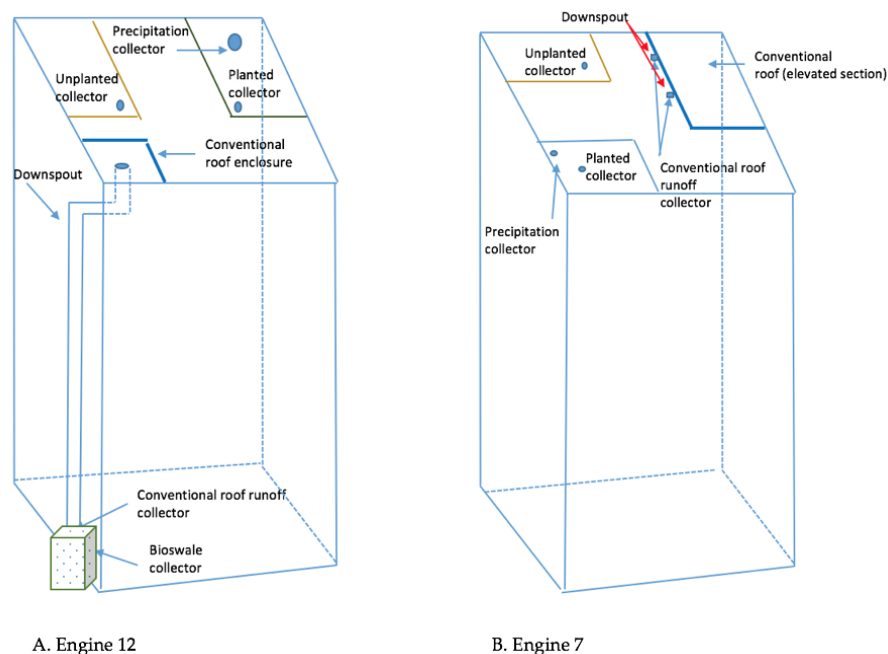
**Figure 2.** Schematic of green surface plus points of collection from D.C. Fire and Emergency Medical Services (DC FEMS) Engines 12 (A) and 7 (B). The planted and unplanted collectors are under the Aqualok™ foam panels in the respective areas outlined as rectangles in the figure. The figure is not to scale and only represents the positions of the various green surfaces and collection points.

For this project there were two study sites that received Aqualok™ roofs/surfaces. Both were D.C. Fire and Emergency Medical Services (DC FEMS) locations (Figure 1). Engine 12 (DC FEMS) is located at 2225 5th Street NE, Washington, D.C. in the Petworth neighborhood. This site was sampled between 2012 and 2015. This site contained approximately 631 m<sup>2</sup> of roof over two stories and a 139 m<sup>2</sup> garage roof. On the main portion of the building, 325 m<sup>2</sup> of Aqualok™ panels were installed. Of that portion, 111 m<sup>2</sup> were planted and 214 m<sup>2</sup> were unplanted Aqualok™ panels. This system also used a bioswale Aqualok™ panel to treat the conventional roof runoff at one drainpipe anchored to the exterior of Engine 12. Twenty-three m<sup>2</sup> of tar and gravel conventional roof drained into 0.37 m<sup>2</sup> of bioswale panel. Engine 12 had water collected from 5 points (planted, unplanted, bioswale, runoff from conventional roof (“downspout”), and direct precipitation) (Figure 2).

Engine 7 (DC FEMS) is located at 1101 Half Street SW, Washington, D.C. near Nationals Stadium. Monitoring spanned two years, 2013–2015. This site contains approximately 3251 m<sup>2</sup> of roof over a two-story building. Of this, approximately 1923 m<sup>2</sup> contained Aqualok™ roof material, in which 576 m<sup>2</sup> was planted and 1347 m<sup>2</sup> was unplanted. Engine 7 had water collected from 4 points (planted Aqualok™, unplanted Aqualok™, conventional runoff, and precipitation). Conventional roof runoff at Engine 7 was collected from a tar and gravel roof similar to that at Engine 12, but was larger (>300 m<sup>2</sup>). Engine 7 did not have a bioswale (Figure 2).

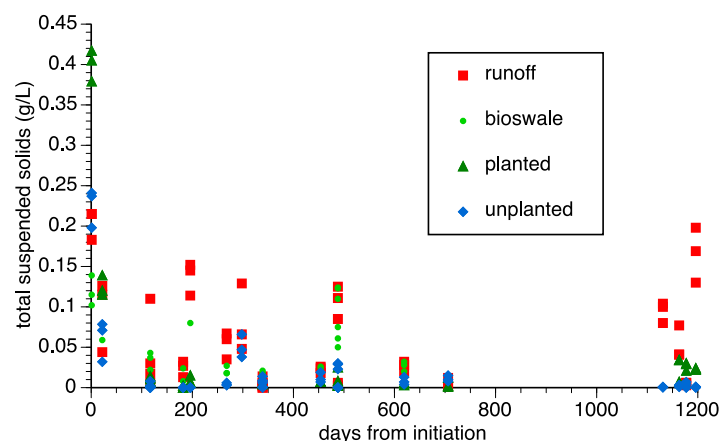
**Figure 3.** Engine 12 total suspended solids (TSS) from three Aqualok™ treatments vs runoff from the conventional roof. High-throughflow TSS after installation of the Aqualok™ treatments diminished by the 117th day while runoff remained high. Even after >1000 days, the Aqualok™ treatments reduced TSS substantially relative to untreated runoff.

Contrasting the various Aqualok™ treatments to runoff at Engine 12 (which had the longest continuous record) suggests that the various Aqualok™ treatments may have been consistently lower in TSS than runoff (Figure 3). Detecting statistically significant differences among the treatments was difficult, even if means were greatly different, because of the variance over the study. The TSS for the unplanted Aqualok™ were as low as the direct precipitation for both Engines (Tables 3 and 4).

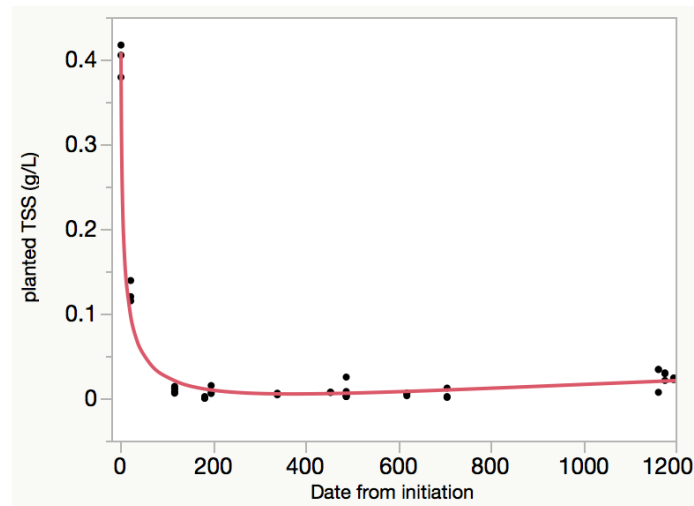
**Figure 4.** DC FRMS Engine 12 planted Aqualok™, total suspended solids (TSS) versus time. Total suspended solids (TSS) show high concentrations post-roof installation, but taper off and remain low for the duration of the study. Equation of best fit is a second-order logarithmic. Planted TSS (g/L) =  $0.4062088 - 0.1355718 \times \text{Log}(\text{Date from initiation}) + 0.0114551 \times \text{Log}(\text{Date from initiation})^2$ .  $R = 0.99$ .

Engine 12 had the longest continuous period of monitoring (3 years, 3 months). During that time, concentrations of TSS and NO<sub>3</sub> in throughflow changed significantly. Between summer 2012 (July and August) and spring 2014 (April), the NO<sub>3</sub> and TSS concentrations in throughflow from the planted Aqualok™ decreased by 94% and 80%, respectively. Subsequently, however, nitrate concentrations increased during the summer months in 2014 and again in 2015. TSS also was slightly higher at the end of the study than it was in spring 2014 (Figure 4). For the unplanted Aqualok™, the decrease in TSS between 2012 (summer) and 2014 (spring) was approximately 95% (Figure 5). Nitrate, ammonium and phosphate did not show a significant decreasing trend in the unplanted Aqualok™ (Figure 6). The bioswale Aqualok™ at Engine 12 improved the TSS retention by approximately 50% over the first 18 months of the study, however, values rose again during the second year. The last three measurements on day 1131, which are high, occurred after more than a year without data (due to funding delays) and were directly after a maintenance visit (Figure 7). If those values are excluded from the analysis, then a second-order logarithmic equation shows significant decreases in TSS over time. NO<sub>3</sub> in bioswale Aqualok™ throughflow decreased approximately 40% over the initial 18 months as well, however, concentrations increased later in the study. There were no clear trends with time for ammonium, TP or TOC for the bioswale Aqualok™ treatment.

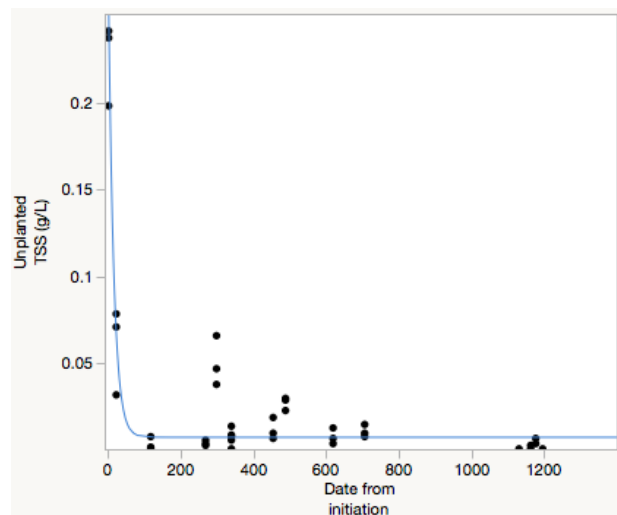
**Figure 5.** DC FRMS Engine 12 unplanted Aqualok™ total suspended solids (TSS). Total suspended solids (TSS) show high concentrations post-roof installation, but taper off and remain low for the duration of the study. Unplanted TSS (g/L) =  $0.2232581 - 0.0706367 \times \text{Log}(\text{Date from initiation}) + 0.005712 \times \text{Log}(\text{Date from initiation})^2$ .  $R = 0.95$ .

The trend of decreasing TSS post-installation continued for the unplanted Aqualok™ for the entire study. This was expected since they were less disturbed than the planted panels. The unplanted Aqualok™ probably acts as a filter for any water that flows through them. It is reasonable to expect that the effectiveness of the unplanted Aqualok™ will decrease over time, however, that did not happen over the 3.25 years of this study. The unplanted Aqualok™ showed a dramatic decrease in TSS, as was observed in the planted Aqualok™ (Figures 4 and 5). However, the TSS measurements around 1200 days are lower than those from the planted Aqualok™.

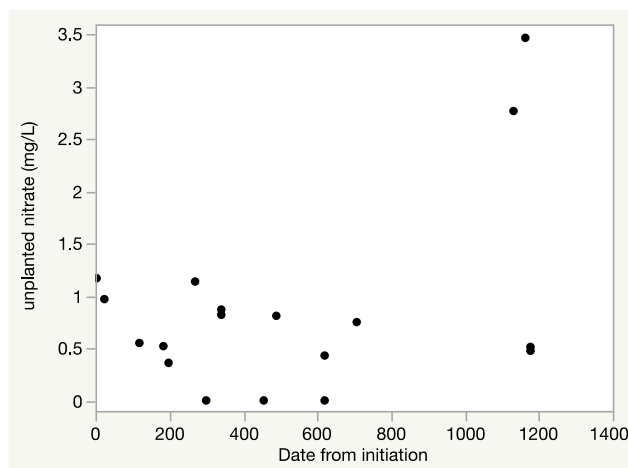
**Figure 6.** DC FRMS Engine 12 unplanted Aqualok™ NO<sub>3</sub> (mg/L) over time. July 2012 to October 2015.

NO<sub>3</sub>, NH<sub>4</sub> and TP did not show a significant decreasing trend in the unplanted Aqualok™. However, this is largely because the concentration of these pollutants was initially low in the unplanted Aqualok™ (relative to the planted Aqualok™), and a decreasing trend would not be expected necessarily. There were, however, periods of high nitrate in unplanted Aqualok™ throughflow, even two years after installation (July and August 2015, for example, between 1100 and 1200 days from initiation). The source of the elevated nitrate is unknown.

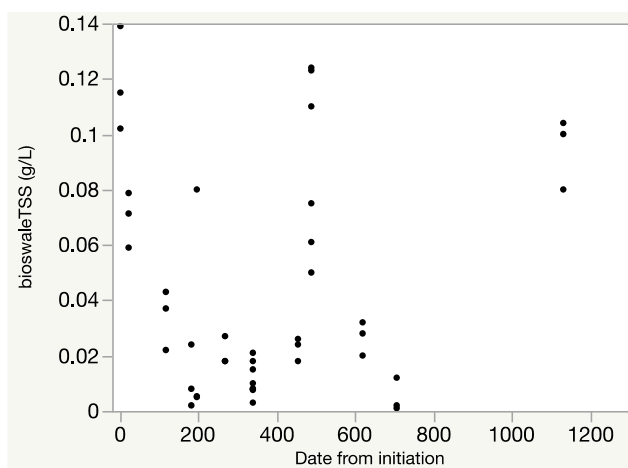
**Figure 7.** DC FRMS Engine 12 bioswale Aqualok™ total suspended solids (TSS) over time. July 2012 to October 2015.

The increase in NO<sub>3</sub> observed in the bioswale of Aqualok™ after day 620 may have been a result of mulching after a decorative cobble surface was removed. The volume of rainwater that filtered through the bioswale Aqualok™ was far larger than the intercepted rain on the roof panels (23 m<sup>2</sup> of conventional roof runoff drained into 0.37 m<sup>2</sup> of bioswale panel). The lower performance of the bioswale Aqualok™ relative to the roof Aqualok™ could be related to volume of untreated roof runoff that entered it.

$\text{NO}_3$  from the Engine 12 bioswale Aqualok™ consistently approached 50% that of the unplanted Aqualok™. Although it had a concentration peak post-installation in July 2012, followed by a decrease through January 2013, concentration increased following that period. The elevated concentrations observed towards the end of the study mirror those seen in the unplanted Aqualok™. Fertilizers were not added to the area, and only routine maintenance was conducted. It is possible that the maintenance, which included trimming and mulching, disturbed the installation and contributed to the increased  $\text{NO}_3$ . This hypothesis is supported by the increase in TSS that is observed in those same samples. If the last three measurements of TSS (day 1131) are removed from the data set, a second-order log regression approximates TSS retention over time.
