Water Leak Detection by Thermographic Image Analysis, In Laboratory Tests [†]

Abstract: One of the most undesirable failures is water loss due to leaks in the supplying system; there are mainly two types of water losses: the visible and the non-visible. Within the non-visible we have those that are detectable by acoustic methods and those that are not. Here we decide to study new techniques for leak detection, since non-visible leaks are more difficult to find (detect). This is the aim of this paper. In a previous stage we have been studying the possibility of obtaining thermographic images to develop visualization techniques on pipes as an option for leak detection. Analyzing this possibility, with previous studies we have established conditions for taking images for later analysis, which has confirmed the benefits of the use of thermography as a tool. Here we present a case study where images were taken in a controlled atmosphere in a laboratory, using a physical model that contained a buried pipe with a simulated loss of water. During the entire duration of the test, images were taken at a certain interval of time and afterwards the images were analyzed. The results show the be

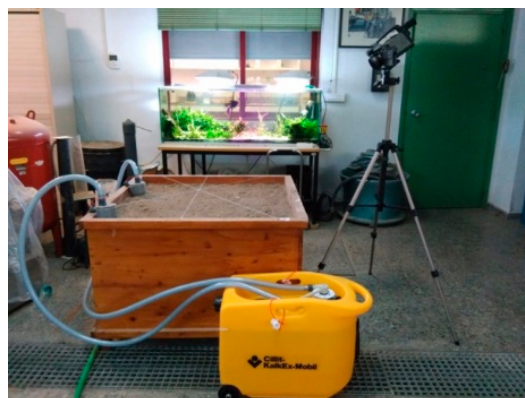
The physical model as show in Figure 1, is a simple box, with dimensions $100 \times 100 \times 70$ cm, filled with earth material similar to the filler, that let us imitate the working conditions of a pipe in a WDS. Two conditions were simulated: (1) a gravity condition and (2) a pressure condition with a closed re-circulating water circuit, both first working without leak and after with leak. Notice that the second condition was the most representative for the aim of this paper. For this reason, just the results for the second experiment are shown.

Figure 1. The laboratory model working with the Thermographic camera.
