# Thermal Infrared and Visual Inspection of Photovoltaic Installations by UAV Photogrammetry—Application Case: Morocco

**Keywords:** photovoltaic installation; UAV; defects; visual inspection; thermal infrared inspection; automatic detection

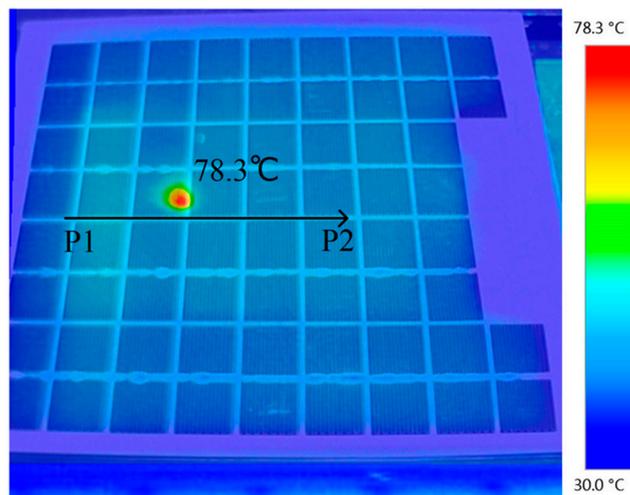
Mismatches, along with defective bypass diodes, may evolve hotspots (Figure 1) that may cause browning, burn marks or in severe cases, lead to fire [8–10].

**Figure 1.** Observed hotspot on a thermal image of a PV module [11].

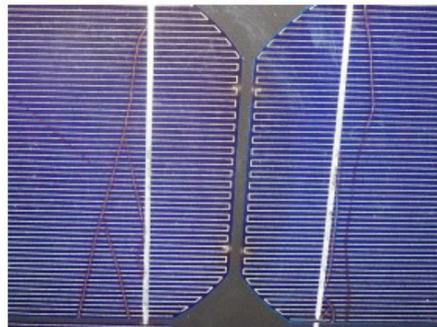
Cracks (Figure 2) are one of the most frequent defects affecting PV modules. They can have different lengths and orientations and may appear at different stages of modules' lifetime: during manufacturing due to soldering, stringing process, and handling, after finishing the production due to packaging, transport, and reloading, and lately in the field, as a result of mechanical loads due to wind, snow, and hail [8–12].

**Figure 2.** Cracks in PV cells [8].

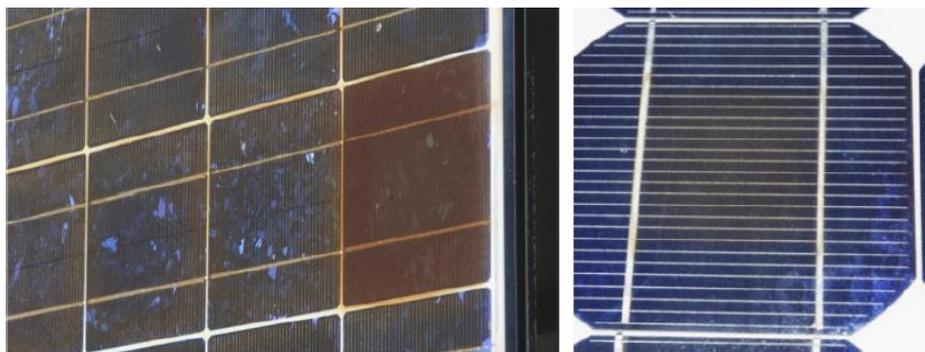
Discolorations (Figure 3) may result from internal factors, such as the use of bad quality polymers in cells assembly, or external ones, such as hot temperatures and humidity. Discolored areas reduce the quantity of sunlight penetrating cells, and thus, may result in yield losses [13].

**Figure 3.** Discolored (brown) PV cells [8].

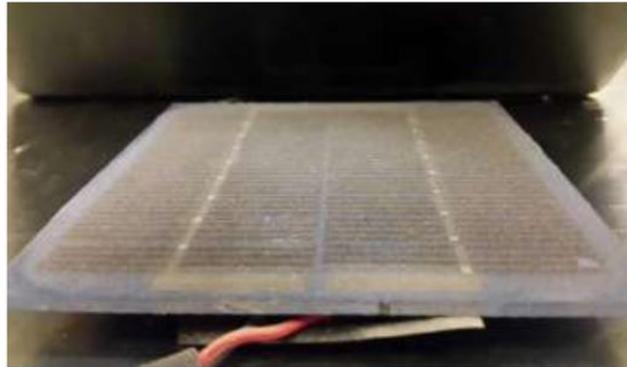
Soiling refers to the accumulation of dirt on the surface of PV modules (Figure 4). This may result from various causes such as dust, pollution, bird droppings, etc. [14]. Literature shows annual PV yield losses due to accumulated sediments ranging from 1–7% in regions, such as Spain, to more than 10% in dry zones, such as Cyprus and Kuwait [15]. However, accurate losses prediction remains difficult due to the existence of multiple correlated parameters to be put into consideration such as environmental and weather conditions, tilt angle of the PV modules, the type of soiling agent, and also the texture of cells' front glass [16,17].

**Figure 4.** Soiled PV Cell [18].

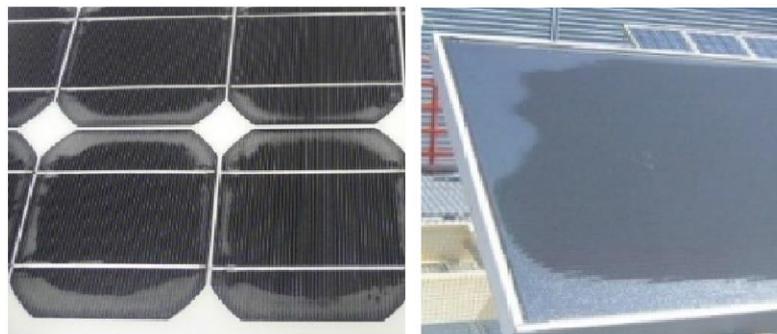
**Figure 5.** PV delaminations [8].

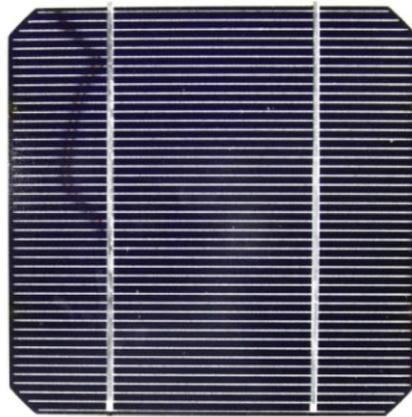
Snail trails are a grey/black discoloration effect of silver grid lines on crystalline silicon cell surface (Figure 6). It occurs at micro cracks and/or along cell edges [20]. Snail trails can be easily identified by eyesight. They typically occur three months to one year after the installation of the PV modules and spread depending on environmental conditions [8]. Experimental tests demonstrated a decrease of more than 20% of electrical PV output on modules affected by snail trails [21].

**Figure 6.** Phenomenon of snail trails in a PV cell [8].

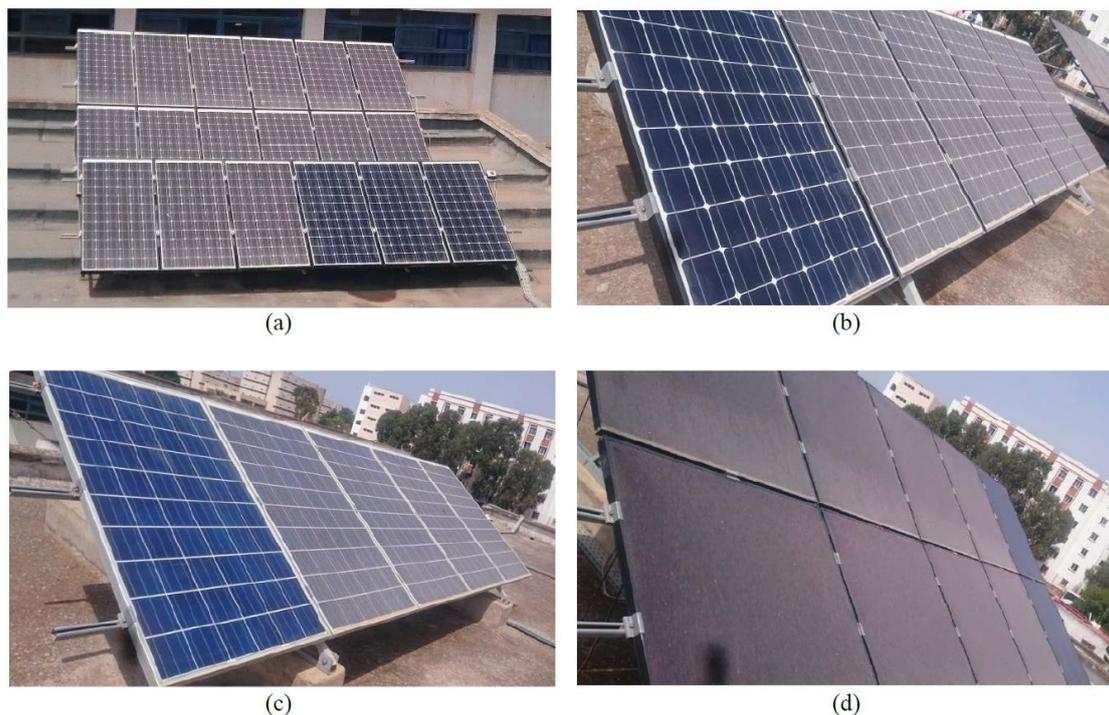
For our field experiment, two photovoltaic installations were inspected within the campus of Rabat National Mining School (Figures 7 and 8). The first one comprises 18 monocrystalline modules (Figure 7). The second one (Figure 8) comprises a string of six monocrystalline modules, another one of five polycrystalline modules, and a third of 10 amorphous modules. For comparison purposes, some modules have been washed before the flights in every installation.

**Figure 8.** Inspected installations on Rabat National Mining School. (a): Installation 1 (Three monocrystalline strings), (b): Installation 2 (Monocrystalline string), (c): Installation 2 (Polycrystalline string), (d): Installation 2 (Amorphous string).

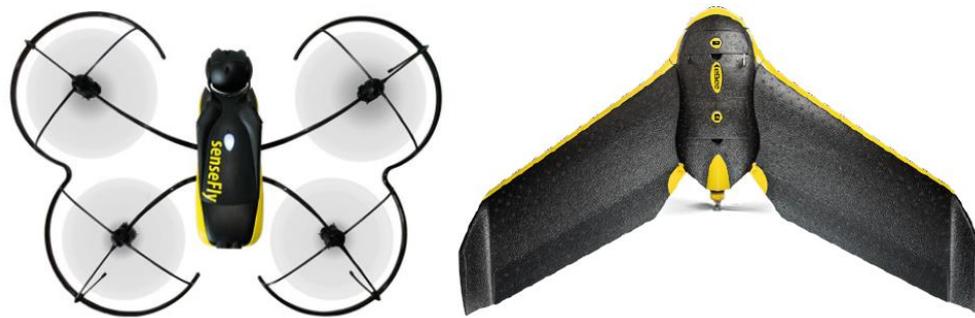
Visual and infrared images were captured using a quadcopter drone type Albris, manufactured by SenseFly (Figure 9). The Albris weights 1.8Kg, this includes the battery, the payload, and shrouding. It is equipped with four electric brushless motors providing a flight autonomy up to 22 min. Visual and

Figure 9. The Albris (left) and the eBee (right) (SenseFly, 2018).

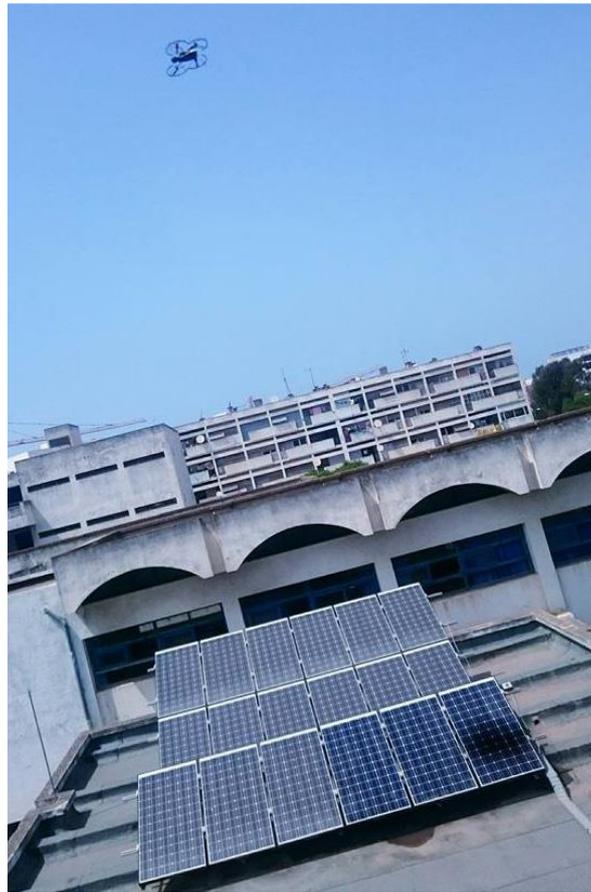
Our inspection mission (Figure 10) took place on 14 June 2017, between 12:00 and 15:00, under steady-state maximum power production conditions, an ambient temperature of 27 °C, irradiance

values between  $550 \text{ W/m}^2$  and  $780 \text{ W/m}^2$ , and a wind speed below  $5 \text{ m/s}$ . Ambient measurements were provided by a meteorological station located in the inspected site performing continuous tracking.

**Figure 10.** A photo from the mission.

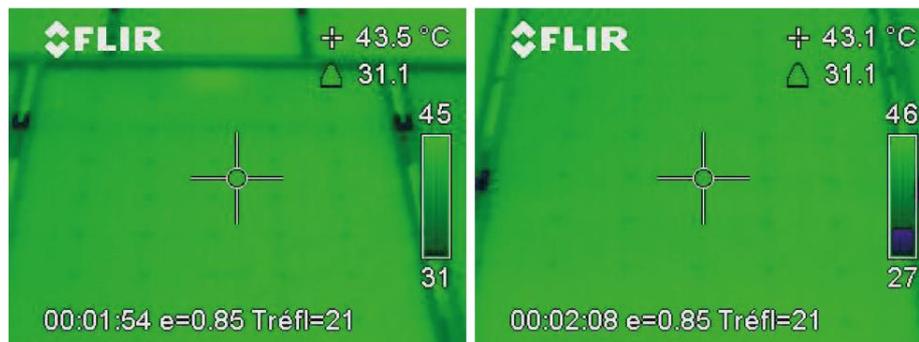
In the end of the mission, captures for thermal validation were taken by the FLIR E2 imager for both installations (Figure 12). Real time mode captures were also taken by the Albris for the first installation for comparison purposes. Five Ground control points were lately observed in two static sessions, each of approximately 40 min.

**Figure 12.** Thermal images captured by the FLIR E2.

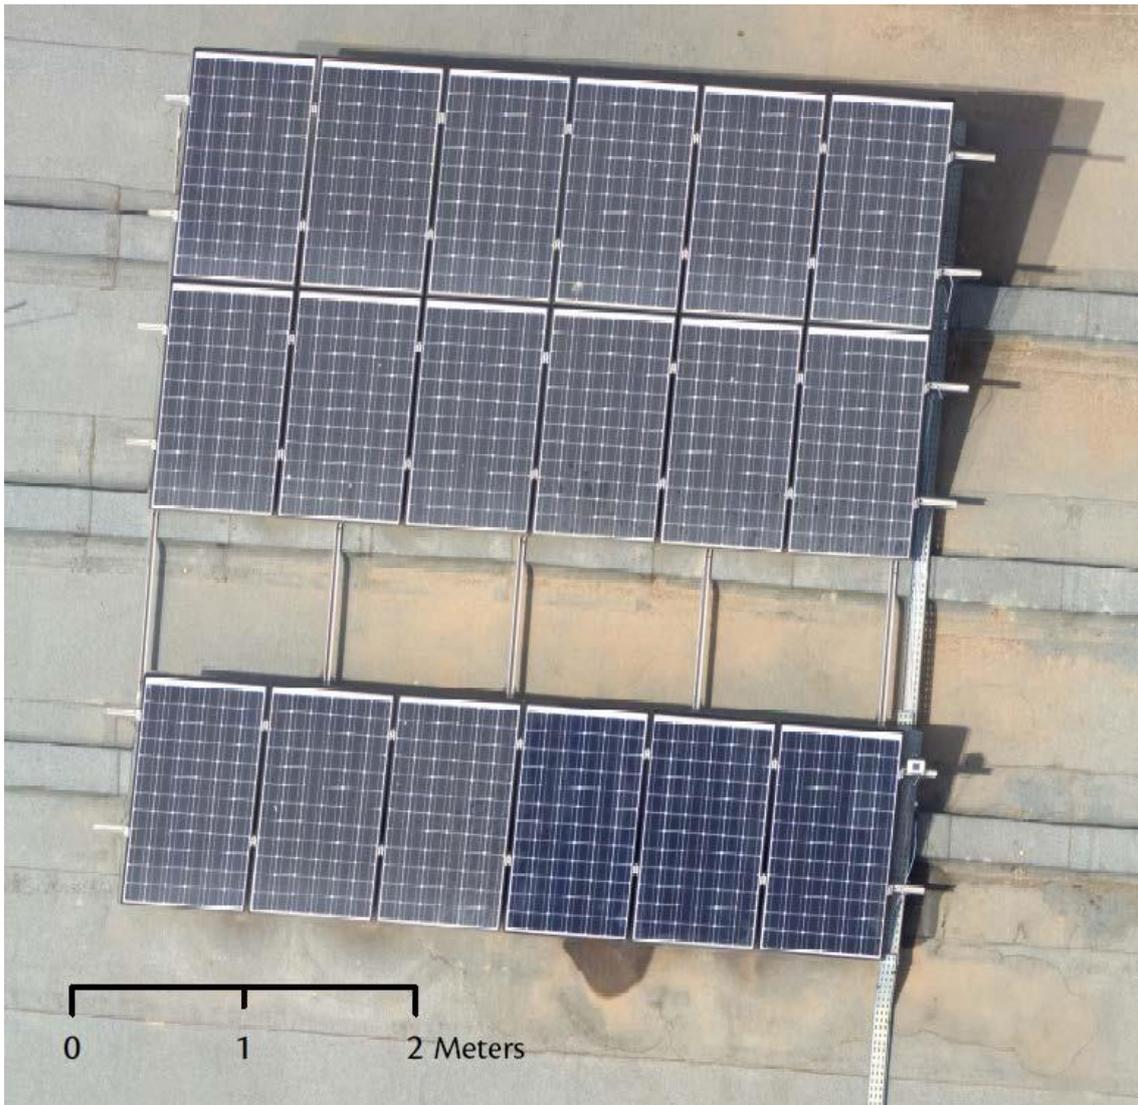
**Figure 13.** Visual orthomosaic of installation N°1.

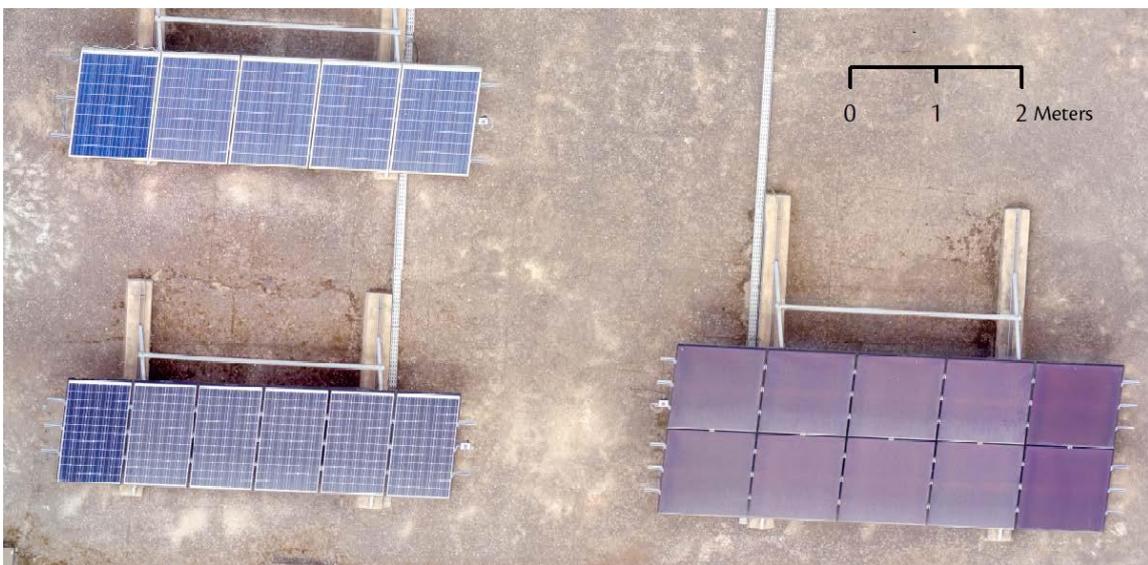
**Figure 14.** Visual orthomosaic of installation N°2.

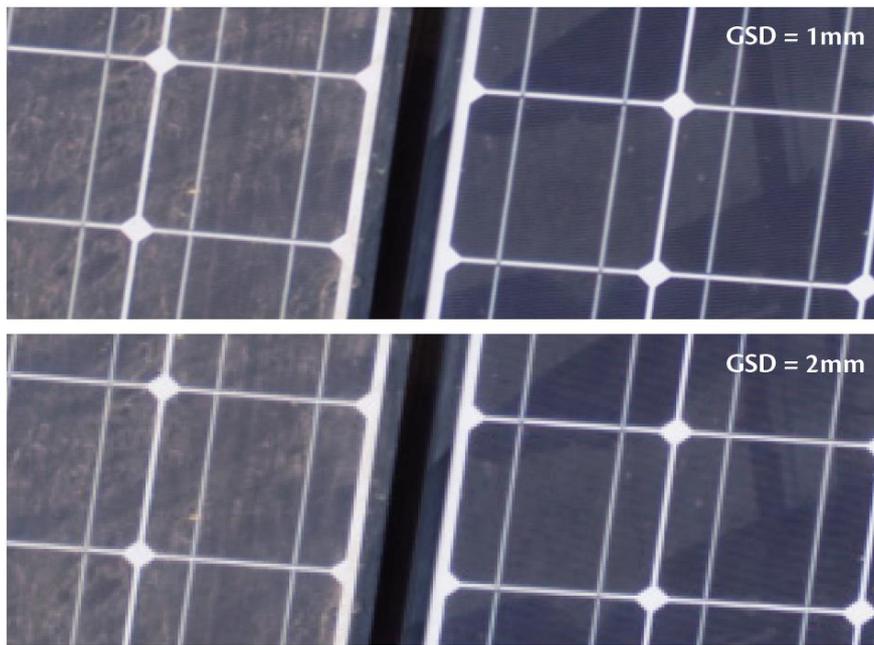
- Soiling was clearly distinguishable on all generated orthomosaics. Even after washing, the smooth left layer remained visible (Figure 15).
- Cracks were found on four cells in the first installation. At a 1 mm GSD, they are clearly visible whereas at a 2 mm GSD, additional effort is required from the examiner in order to detect them (Figure 16).
- Smears of different sizes and forms were also found in almost all modules. Big ones are easy to detect on all orthomosaics whereas small ones require an additional effort to detect them on 2 mm GSD orthomosaics (Figure 17).

Figure 15. Appearance of soiling at the two experimented flight altitudes.

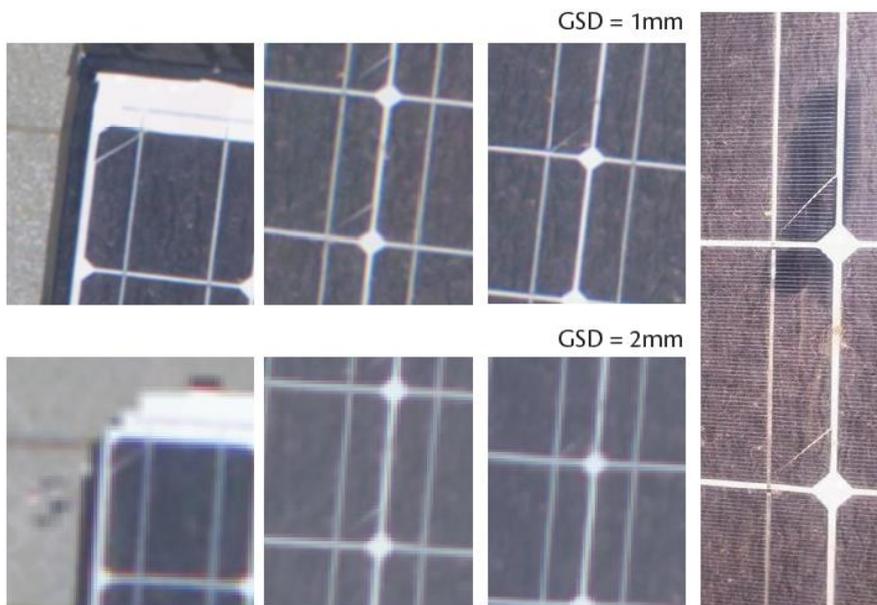
Figure 16. Appearance of cracks at the two experimented flight altitudes.

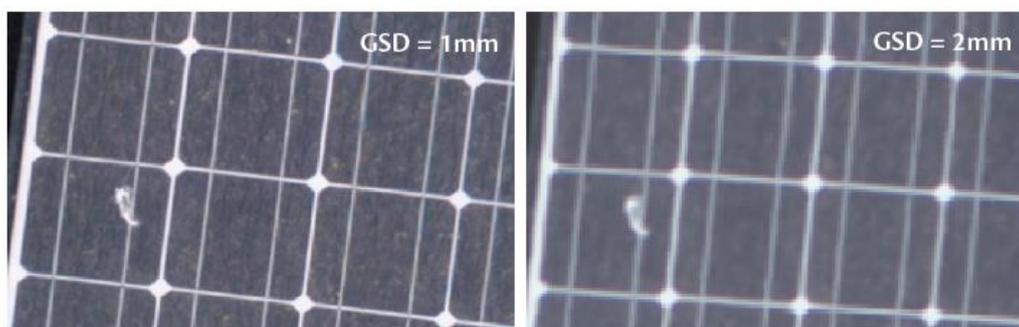
Figure 17. Appearance of smears at the two experimented flight heights.

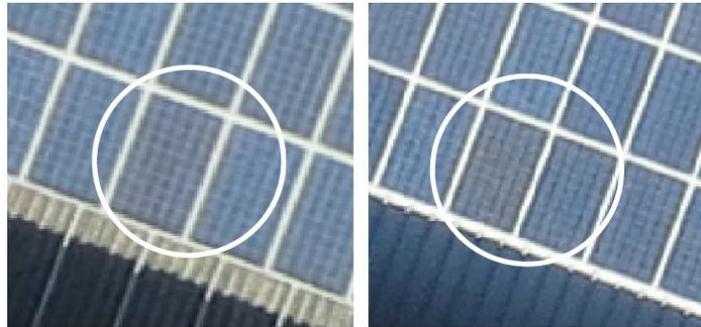
Validation of detected defects was performed manually by eyesight on the field. On the other side, in the RGB orthomosaic we generated from Ecublens data, no defect has been detected, except slight soiling in some zones. Strings surface appears quasi homogeneous. Except irradiated zones by the sun, cells contours are distinguishable, but defects detection on a sub-cellular scale was impossible due to insufficient GSD (Figure 18).

**Figure 18.** Slightly soiled modules observed in Ecublens RGB orthomosaic.

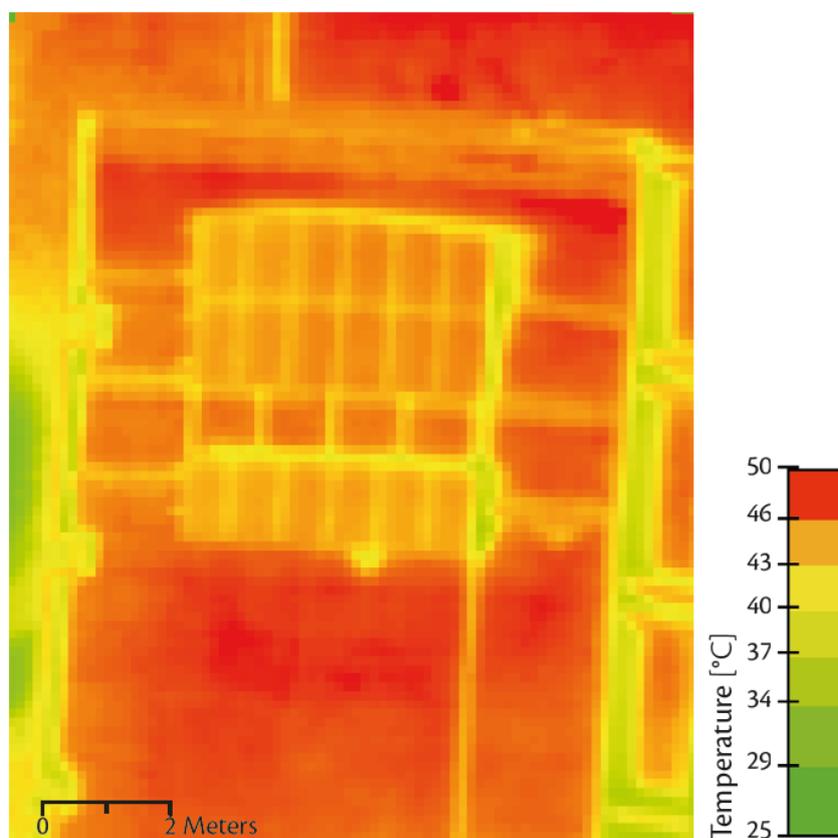
**Figure 19.** Thermal orthomosaic of installation N°2.

The GSD of the thermal orthomosaic was 13.4 cm. At this scale, modules' edges were distinguishable but cells were not so. No defect has been detected. This was lately validated by the thermal imager which didn't show any abnormal profile temperature on all modules surfaces, and also by the yield tracking station that did not save any abnormal output losses. However, there were some thermal imager captures showing point shaped spots corresponding to bird droppings (Figure 20).

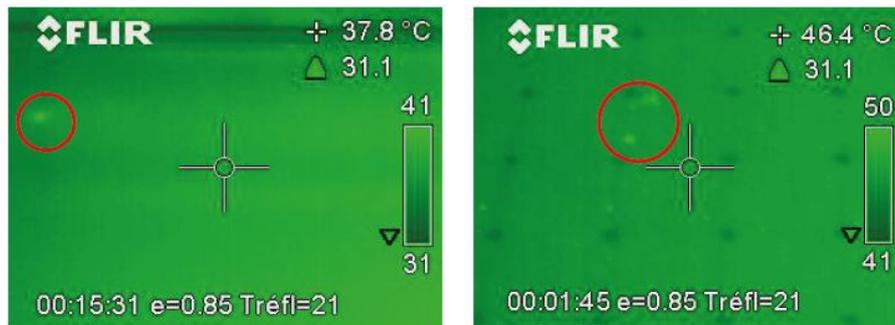
Figure 20. Spots on thermal images due to bird droppings.

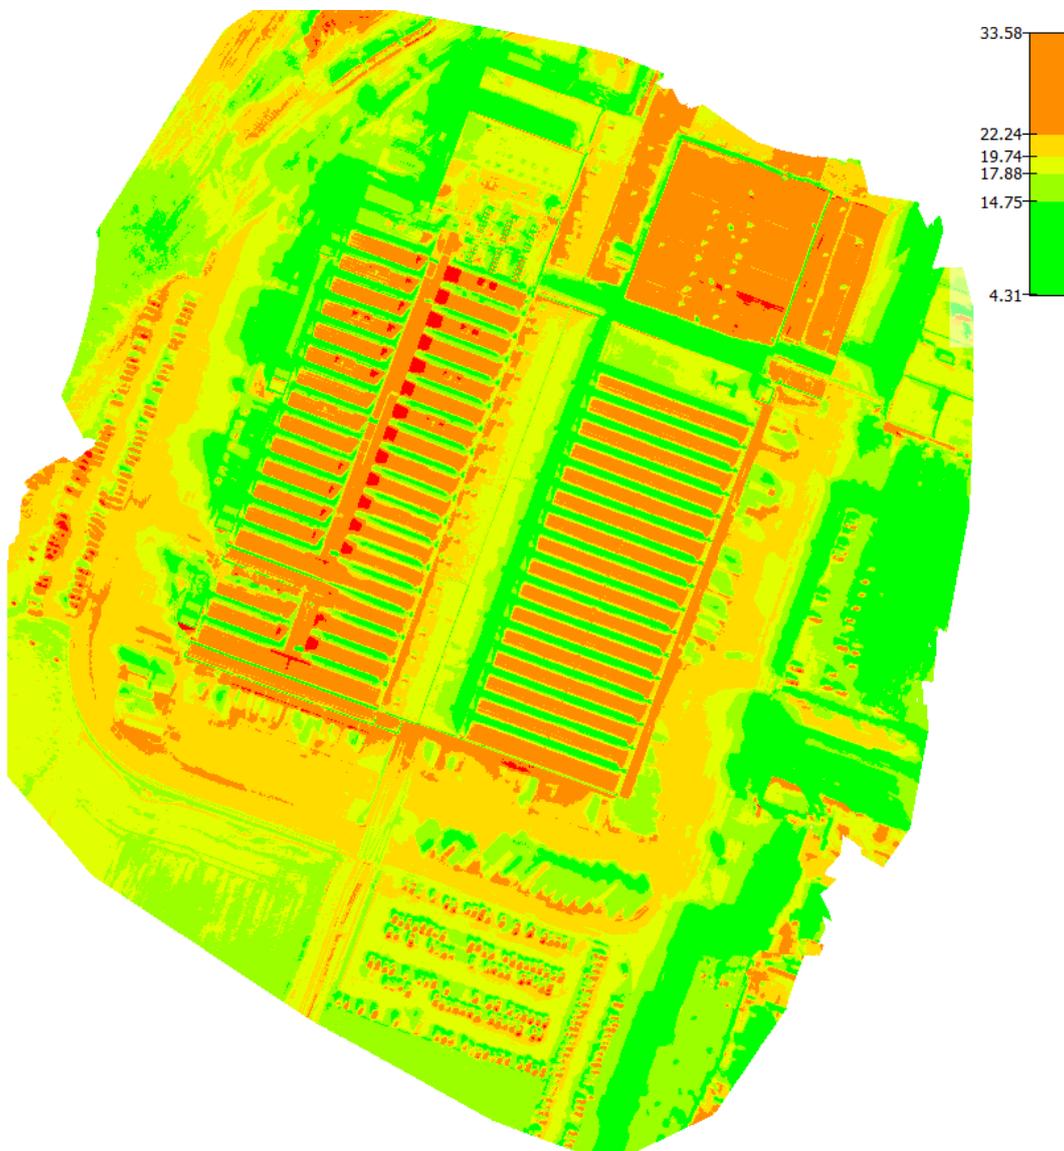
For hotspots automatic extraction, we applied our proposed methodology on Ecublens thermal dataset owing to their better quality and resolution (Figure 21). Results of the methodology, step by step, are presented below (Figures 22–24). Validation of extracted hotspots was lately done referring to SenseFly team inspection’s report which revealed exactly the same hotspots we have extracted.

**Figure 21.** Generated thermal orthomosaic from Ecublens dataset (temperature values are in °C).

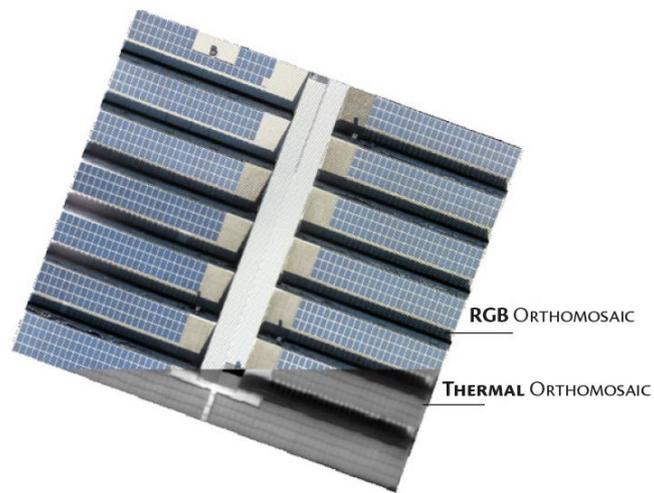
Figure 22. Superposition of RGB and thermal orthomosaics.

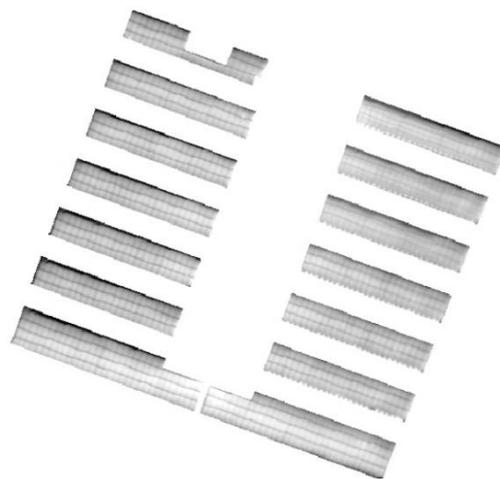
Figure 23. Extracted modules on thermal orthomosaic.

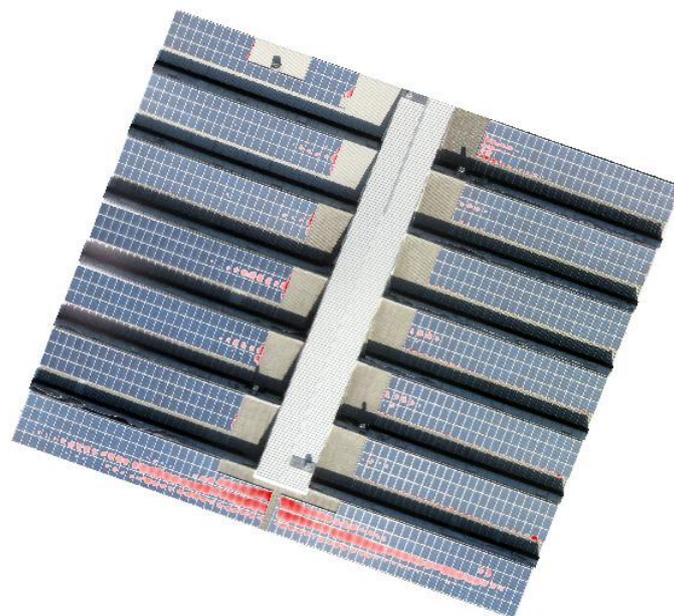
Figure 24. Extracted hotspots and their location within the installation.
