Article

Using UAV to Capture and Record Torrent Bed and Banks, Flood Debris, and Riparian Areas

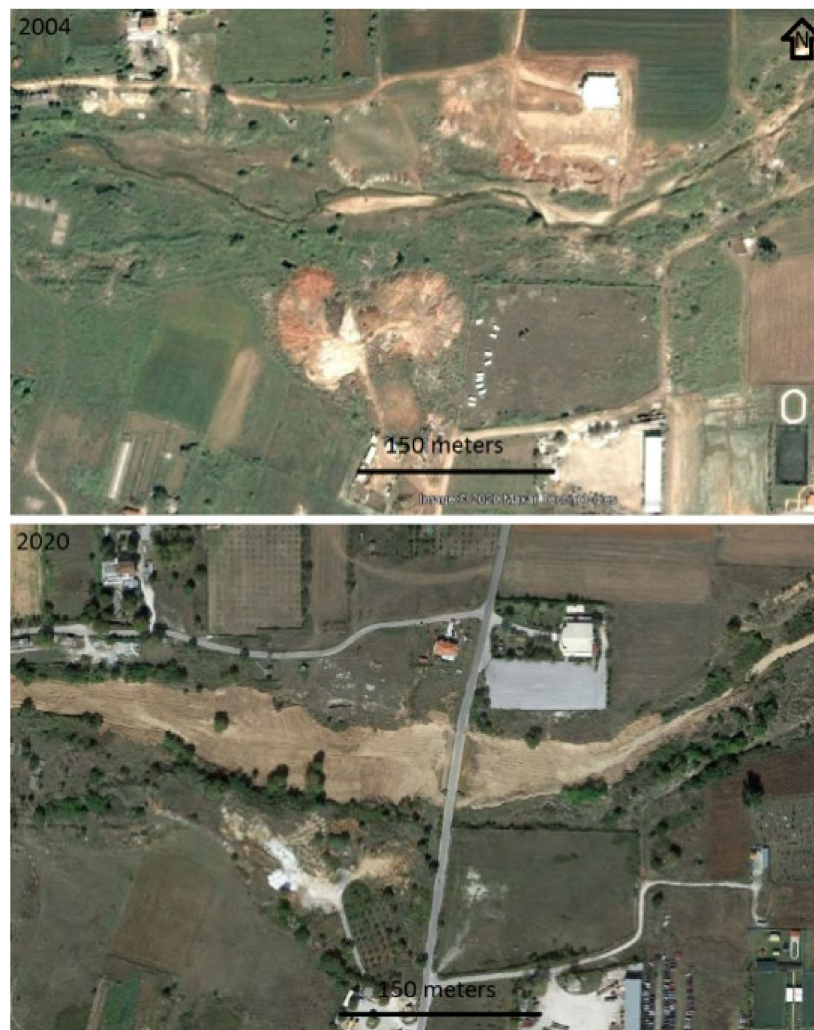
Figure 3. Google images illustrating the alteration of Kallifytos torrent due to the increase of urban infrastructure and intervention in the torrent and entire area. The images are from 2004 (top photo) and 2020 (bottom photo) (Source: Google Earth).

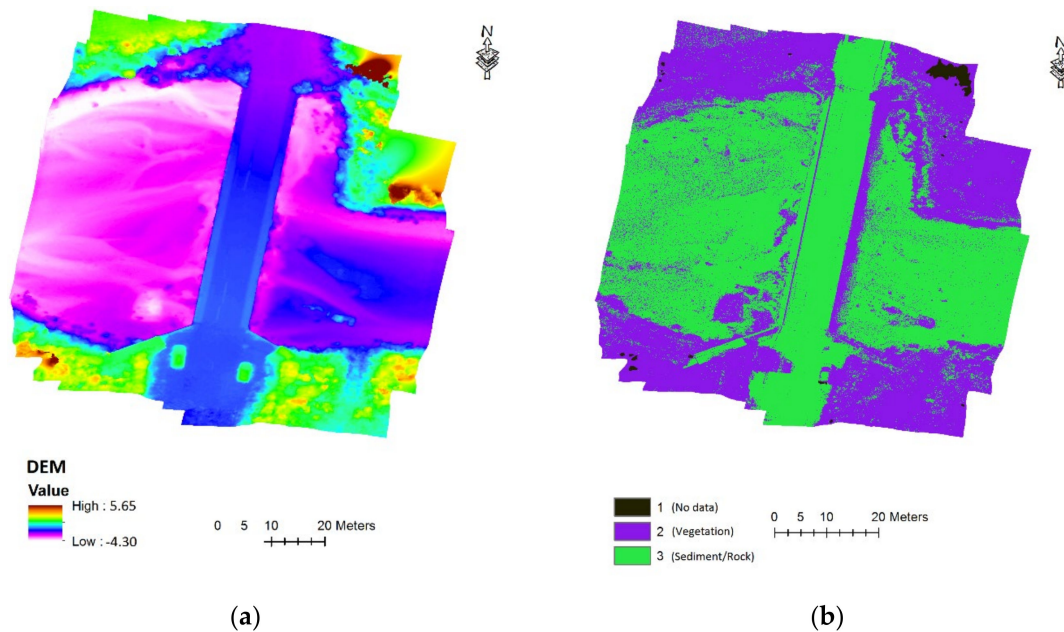
Figure 7. (a) The digital elevation model (DEM) of the study area developed based on the flight of 7 August 2020, the legend illustrates the elevation; (b) The elevation distributed in three categories in order to showcase the vegetated areas: (1) no data (black), (2) vegetation (purple), and (3) sediment/rock (green).

The DEM was also produced based on the orthomosaic for the August flight (7 August 2020). The DEM (Figure 7a) has its zero level at the bridge top and this is the reason why minus values (-) are also present in the image that represent the torrent bed. The flow paths are visible due to the height variance. Three main flow paths that start from the right part under the bridge culverts and continue at the left section mainly at the top of the image. This is a result of the debris and sediment deposition at the central part of the bridge at the right section which forces the main body of water to the right bank (top of the image). Furthermore, we were able to produce a map (Figure 7b) that categorizes the different illustrations mainly based on the vegetation and creates the following categories: (1) no data (black), (2) vegetation (purple), and (3) sediment/rock (green). This map highlights the vegetation

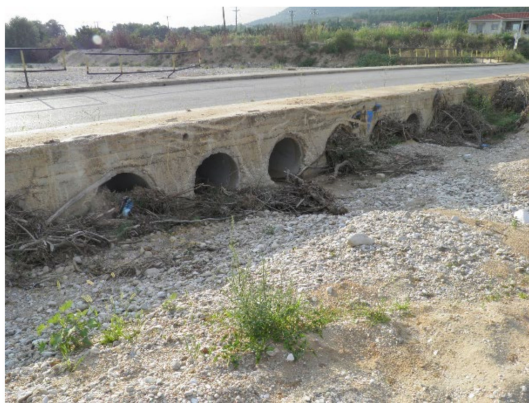
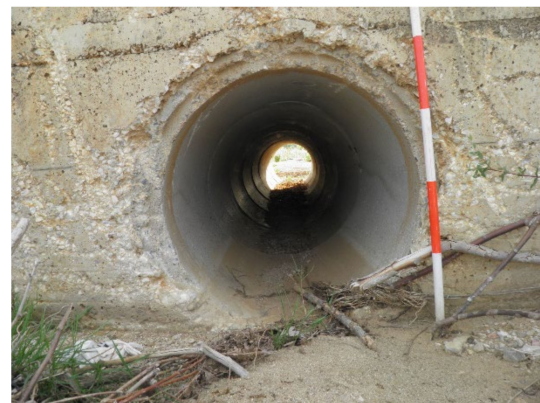
Figure 8. (a) The debris (tree brunches and other material) are depicted in the right section of the bridge; (b) A rare clean culvert under the bridge.

in front of the bridge culverts adjusted at the right section of the bridge. The riparian vegetation consists mainly by low vegetation and trees: *Morus ssp.*, *Ailanthus altissima*, *Avena sativa*, *Melissa officinalis*, *Populus nigra*, *Salix alba*, *Onopordum acanthium*, and *Arctium ssp.* among others. The dead vegetation material represents the debris that act as barrier and have a negative impact, enhancing the potential and creating floods (Figure 8). Debris material are mainly tree brunches but also large rocks. Their dimensions can be measured by the recorded airborne images or by normal field monitoring (Figure 9). A granulometric analysis was also performed on the orthomosaics via ArcGIS. The airborne measurements were verified by using past field measurements. Specifically, field measurements, by using a tape measure, were collected along five cross sections downstream from the bridge. For the bed material, the pebbles and cobbles were measured in the two dimensions (largest and smallest). The majority of the material ranged from 1 to 20 cm (84.5%) and 1 to 10 cm (85.1%), concerning length and width, respectively. The results between field and airborne measurements were very similar in their dimensions in both cases which ranged from 1–67 cm. This highlights that UAV images can be utilized as an innovative, quick, and easy-to-use method to perform granulometry on these types of torrents.

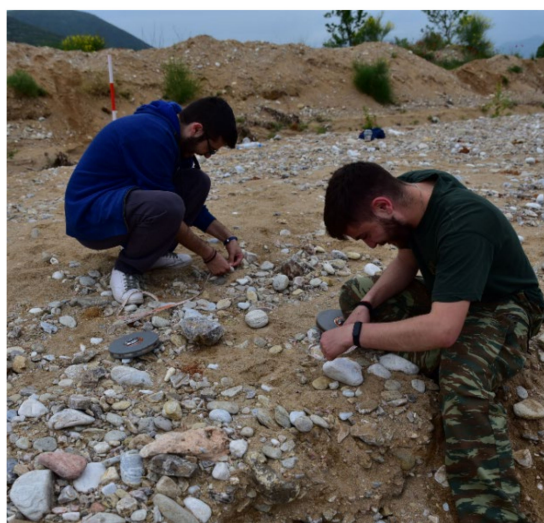
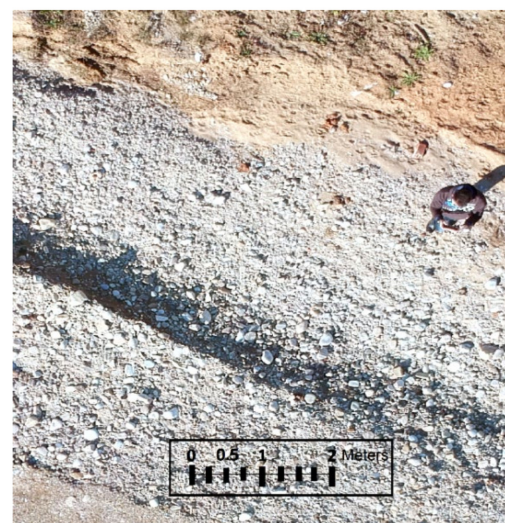
Figure 9. The bed material transported by the water flow during the torrential phenomena (a) performing granulometric field measurements; (b) The bed material captured by the drone flight.

Granulometry via UAVs photogrammetry is a promising alternative in comparison to field gravel dimensions measurements by using a type measure and sampling gravels in squared sections located in floodplains [87,88]. In addition, UAV-based products can be better than other remote sensing approaches for grain size quantification because of the great accuracy and resolution of the images [89]. Although, granules are three-dimensional objects for which at least three parameters (length, width, and height) are required for a complete description [90], still the orthomosaics could not provide the height data, so only the two dimensions (length and width) were enough to compare the field data with the airborne results. The dimensions can be measured very quickly via this methodology and can cover a greater area in contrast to field-based measurements that are more time-consuming. Furthermore, the orthomosaics were able to identify the vegetation debris that blocked the culverts under the Irish bridge. This was done by the produced DEM of the area and the further segregation of the vegetation cover from the sediment/rock material. The DEM can be helpful in many ways and different approaches in regard to environmental sciences [91–93]. For the needs of this study, the importance lies in determining the torrent flow paths and the locations where the debris created barriers. This would help water managers make proper management plans to stop these materials from reaching the central part of the bridge, as it was recorded by the drone flights.

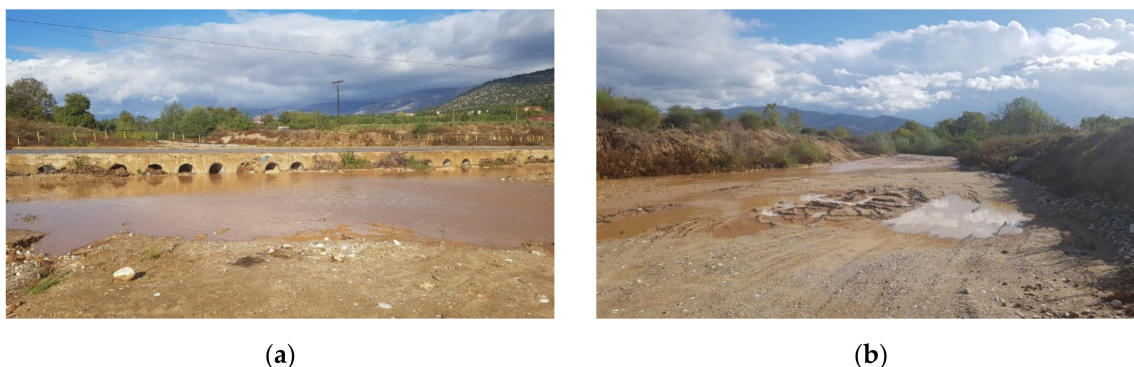
Figure 11. (a) Showing the flood phenomena at the right section of the bridge/torrent; (b) Upstream from the bridge the truck tracks are clearly evident. Images captured 13 October 2020.

In addition, orthomosaics showcased the changes on the torrent bed because of human intervention. The removal of bed material and debris by excavators and trucks is a common practice in Greece to “clean” the torrent bed from this additional material that is carried and deposited by flash flood events. This “cleaning” method has many negative effects in the fluvial environment due to human alteration of the torrent bed, the changes in the geomorphology or even the hydraulic conditions, the degradation of the riparian vegetation, the destruction of habitats environment, and the fatality of micro-invertebrates or other animals that exist in the torrent bed during these works. Furthermore, the specific case study showcases that only the bed material removal was achieved, while the debris remain and continued to block the culverts (the most serious problem) of the Irish bridge, resulting to the repeated same flood phenomena (Figure 11). The solutions to such problems should include more environmentally friendly methods such as ecosystem-based approaches and nature-based solutions to reduce flows and sediment transport capacity [94]. Unfortunately, in most urban cases, the riparian areas are completely cemented and the natural riparian vegetation is devoid, which does not provide a long-term sustainable solution [27].
