# Structural Response of Thin-Web Beams to Various Web Opening Retrofit Techniques

Oday A. Salih , Kaythar A. Ibrahim , Mohammed H. Shukur, Suhaib Y. K. Al-Darzi and Sofyan Y. Ahmed

Civil Engineering Department, College of Engineering, University of Mosul, Mosul 41001, Iraq;  
kaythar6871@uomosul.edu.iq (K.A.I.); m.h.alkafaf@uomosul.edu.iq (M.H.S.);  
sofyan1975@uomosul.edu.iq (S.Y.A.)

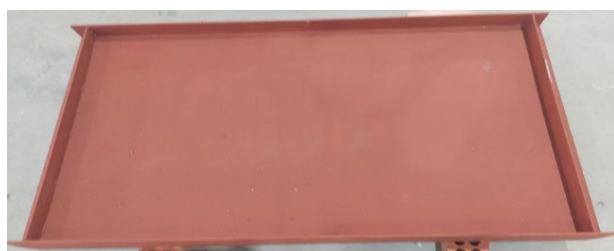
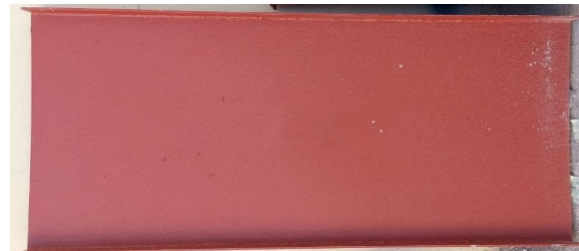
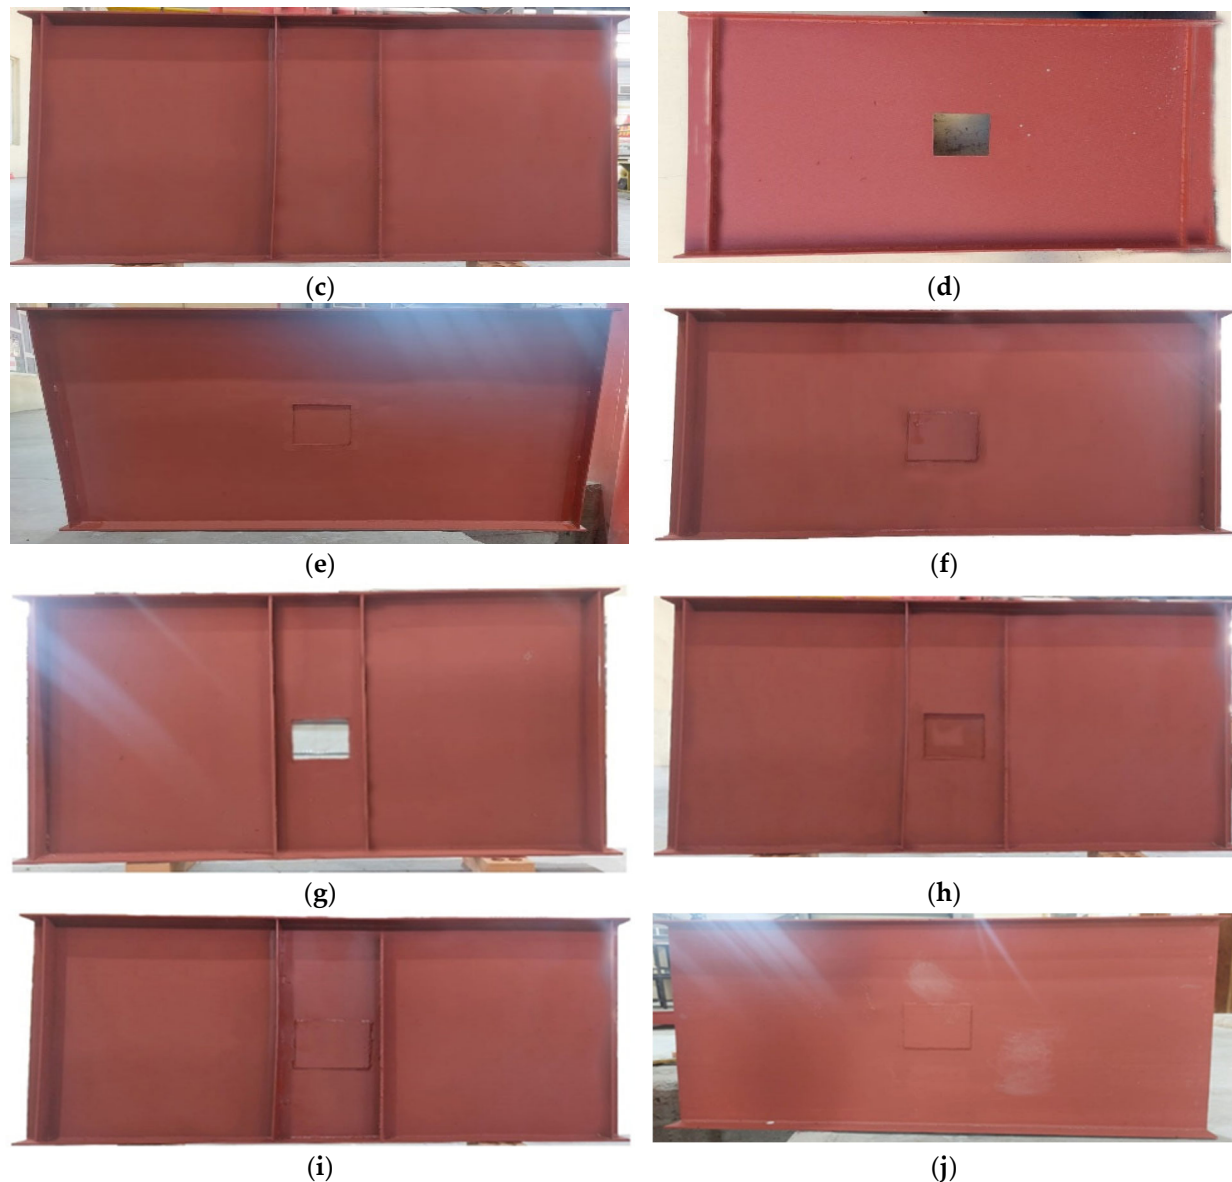
**Figure 4.** Images of specimen configurations. (a) BC beam control (no opening). (b) BC\_NS beam control with no stiffeners at ends. (c) BC\_TS beam control strengthening by two stiffeners at mid-span. (d) BO beam with opening of  $180 \times 180$  mm at mid-span. (e) BO\_OP beam with opening of  $180 \times 180$  mm at mid-span retrofitted by one side patch plate. (f) BO\_TP beam with opening of  $180 \times 180$  mm at mid-span retrofitted by two side patch plates. (g) BO\_TS beam with opening of  $180 \times 180$  mm at mid-span retrofitted by two stiffeners. (h) BO\_TS\_OP beam with opening of  $180 \times 180$  mm at mid-span retrofitted by two stiffeners and one patch plate. (i) BO\_TS\_TP beam with opening of  $180 \times 180$  mm at mid-span retrofitted by two stiffeners and two patch plates. (j) BO\_NS\_TP beam with opening of  $180 \times 180$  mm at mid-span with no stiffeners at ends retrofitted by two side patch plates.

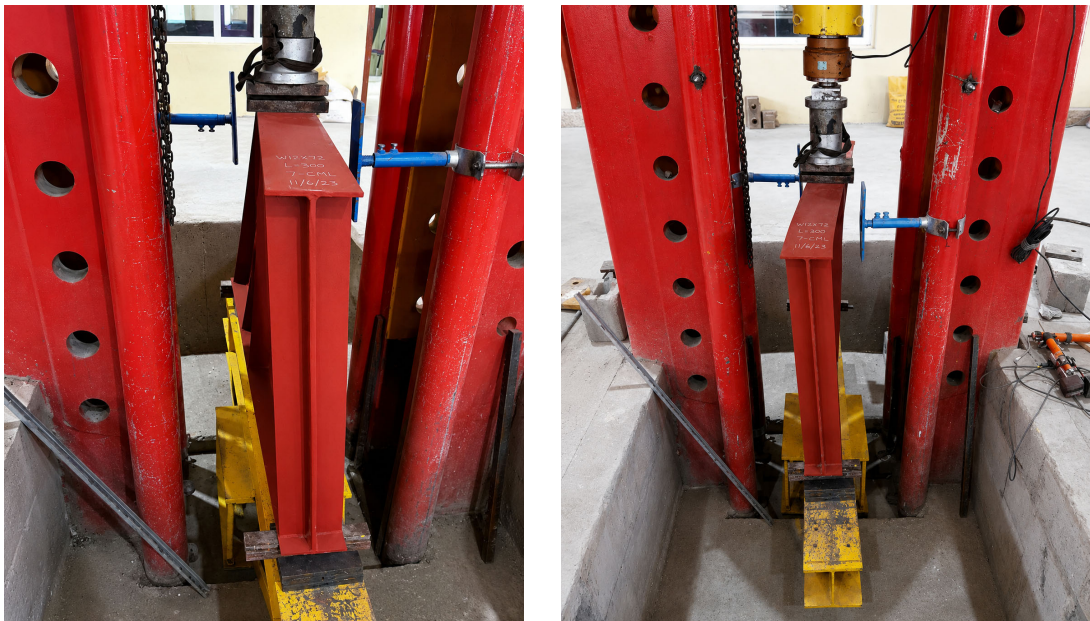
Figure 6. Specimen distortion during testing.

The bearing and local yielding effects were minimized by using end stiffeners and a loading plate at the point of application. No local flange crippling, web bearing failure, or weld fracture was observed during testing. The dominant failure mode was global instability, accompanied by web buckling and lateral deformation, confirming that slender-web behavior governed the specimens' response.
