Enhancing Fire Safety: Real-Scale Experimental Analysis of External Thermal Insulation Composite System Façades' Behavior in Fire

Keywords: exterior fire; ETICS façades; building façades; fire barriers; experimental measurements; heat release rate

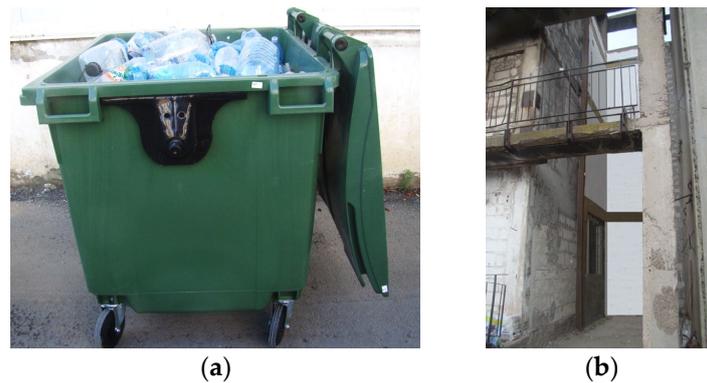
The source of the fire was represented by two containers of household waste, each with a capacity of 1100 L and a mass of 45.5 kg (see Figure 1). These containers were made of high-density plastic material with a higher calorific value of 46.97 MJ/kg, as determined using a calorimetric bomb in the laboratory for fire reaction. The dimensions of each container are as follows: length (L) = 1370 mm, width (l) = 1070 mm, and height (h) = 1344 mm. The containers were each filled with 10.7 Kg of PET bottles that have a higher calorific value of 23.90 MJ/kg.

Figure 1. (a) Fire source; (b) placement zone.

The dumpsters had their lids open intentionally to analyze an unfavorable yet plausible scenario. In this way, air could enter, aiding combustion. There are numerous real-world cases where a larger volume of waste is deposited inside the dumpsters than the containers can accommodate, and the lid remains partially open or even fully open, allowing natural ventilation of air into the dumpster in the event of a fire.

One of the containers was placed on top of a 600 kg tare industrial scale with an accuracy of $\pm 0.5\%$, that had been insulated against fire using ceramic mineral wool. Measuring the real-time mass loss of the container allowed us to determine the time evolution of the heat release rate (HRR) parameter.

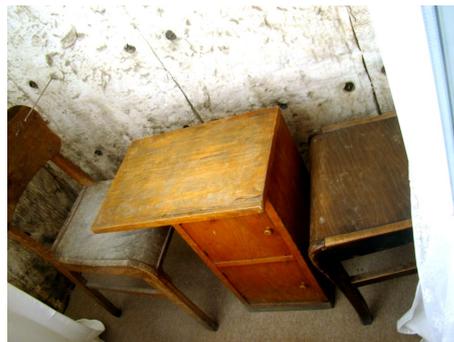
Inside the test room, the following were installed: an 8 mm thick HDF laminated parquet was put over the entire floor area, with a carpet placed on top of it. The room also contained a wooden desk, two wooden chairs, and curtains with drapes near the window, to make the fire scenario as realistic as possible (see Figure 2).

Figure 2. Experimental setup—object placement inside the room.

To assess the fire load in the considered room, the weights of the room's furnishings were measured as follows: each chair, 4 kg; the desk, 12 kg; and totaling 20 kg of hardwood. On the floor, there was an 8 mm thick laminate parquet covering an area of 2 square meters, with a layer of expanded polyethylene with a thickness of 3 mm beneath the parquet (covering 2 square meters). Additionally, there were two polyester curtains (5.6 square meters in total at 50 g/square meter) and two opaque polyester drapes (8.4 square meters in total at 300 g/square meter) at the window.

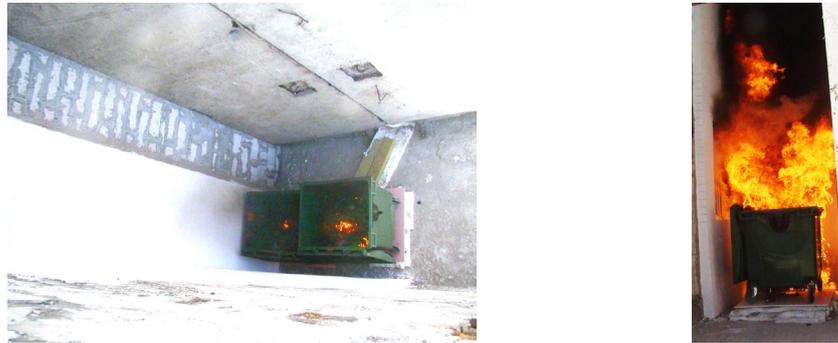
After the initiation of the sources, for about 5 min, the PET in the containers that had the caps tightened, suffered mechanical explosions. After this period, the fire manifested itself for approximately 2–3 min with reduced intensity inside the containers, maintaining the burning of the melted plastic mass—Figure 5. After the 8th minute, the fire began to develop rapidly and encompassed the entire mass of the containers, so that in the 8:30th minute a generalized fire (similar with a flash-over) of the two containers was reached.

Figure 5. Initial phase followed by the flash-over in minute 8:30.

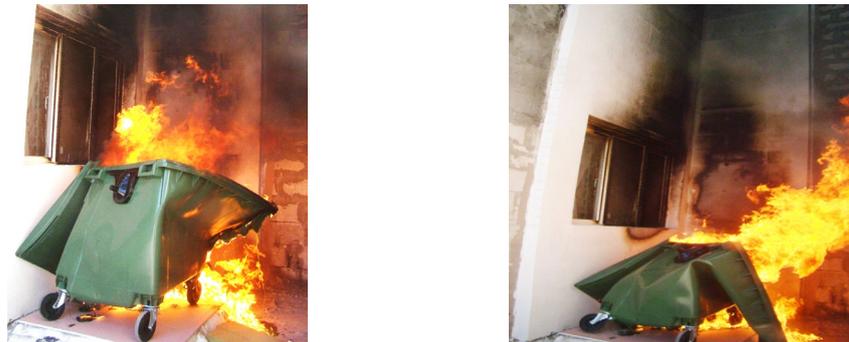
Within 1 min after the flash-over, the containers' cover gave way under the influence of the fire and began to deform and melt. Because of this, the containers lost their balance and overturned in the direction opposite the camera, as depicted in Figure 6.

Figure 6. Containers start melting after 9:30 min.

By the 9:30 min mark, the fire had not spread inside the room or on the ETICS system. Approximately one minute later (min 10:30), the fire began to affect the PVC profile around the room's window. At 11:30 min from the start of the fire, the burning of the window frame became extensive, leading to the windows breaking. This, in turn, allowed the fire to start spreading inside the room, as depicted in Figure 7.

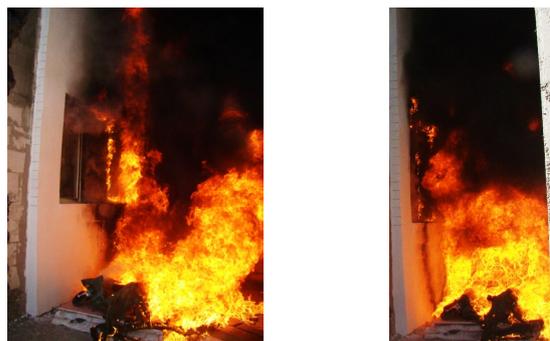
Figure 7. Fire penetration inside the room, after 14 min.

At 14 min, the fire began to spread inside the room, and by 16 min, the fire entered the regression phase. By 21 min, the fire inside the room had been extinguished, and the fire outside entered the phase of strong regression, as shown in Figure 8. It is worth noting that the ETICS system sporadically ignited on the 1st floor, above the basaltic mineral wool barrier, but the fire did not spread higher.

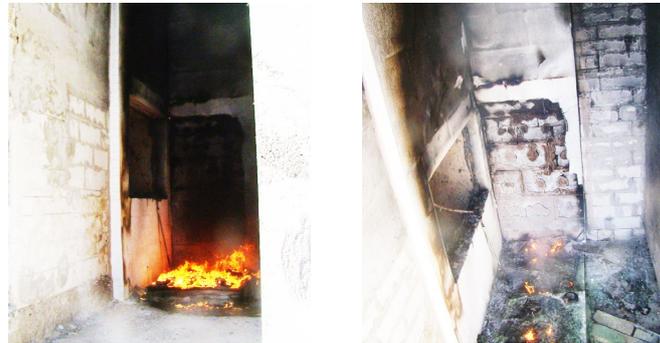
Figure 8. Fire regression phase, after 16 min.

At min 37, the fire generated from the outside of the building was still burning and continued to burn at a reduced intensity until after the 60th minute from the ignition of the fire, when it was completely extinguished.
