Heritage Preservation Policy of Civil Servants Joint Stock Fund for Historical Buildings in Athens: The Deligiorgi Residence Case

2. The Deligiorgi Residence on the Corner of Pindarou, Academias and 1 Kanari Str

3. Restoration, Renovation, Repair, and Arrangement Study of the Deligiorgi Residence

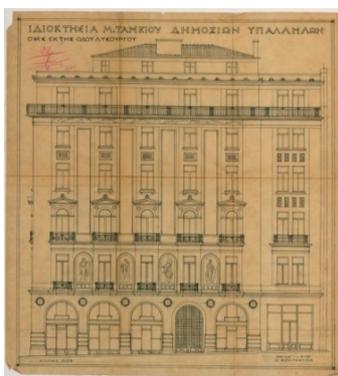
Figure 1. Architectural design of V. Kouremenos on Lykourgou and Athinas Str. (11 of May 1927). Source: Modern Greek Architecture Archives (M.G.A.A.) of the Benaki Museum.

- (1) In 1926, a three-story newly-built building was purchased, located at the corner of 12 Lykourgou Str. and 56 Athinas Str., which was reconstructed in 1929 by the addition of three more floors and one recess (Figure 1). The study and supervision of the project was commissioned by architect Vasileio Kouremenos (1875–1957). In 2005, a project for the building's restoration, renovation,

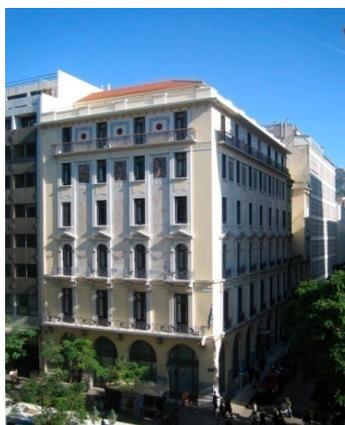
Figure 2. The Civil Servants Joint Stock Fund (C.S.J.S.F.) building, after the restoration (22 November 2007). Source: C.S.J.S.F. Photographic Archive.

repair, and arrangement was accomplished in order to achieve its integration into modern city life (Figure 2) [1].

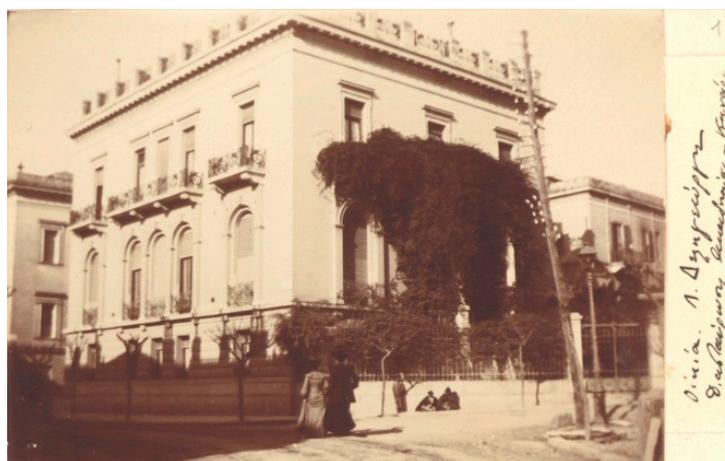
Figure 8. The Deligiorgi Residence (1900), E.L.I.A–M.I.E.T. Photographic Archive.

The Deligiorgi Residence is an example of mature Athenian neoclassicism trends of the 1880–1890s, with renaissance elements built by the well-known German architect Ernst Ziller. It is a significant example of a wealthy bourgeoisie private house with neoclassical features on the exterior and very rich painting and sculptural decoration in the interior. The building was designated by the Ministry of Culture as a monument “... which has to be under the State's protection because it is the home of the former Prime Minister of Greece Ep. Deligiorgi and now belongs to the C.S.J.S.F., it is the work of the great architect Ziller and present significant interesting from architectural point of view...”. Furthermore, it was designated by Urban's Decree as a listed building (Figure 8) [4,10,11].

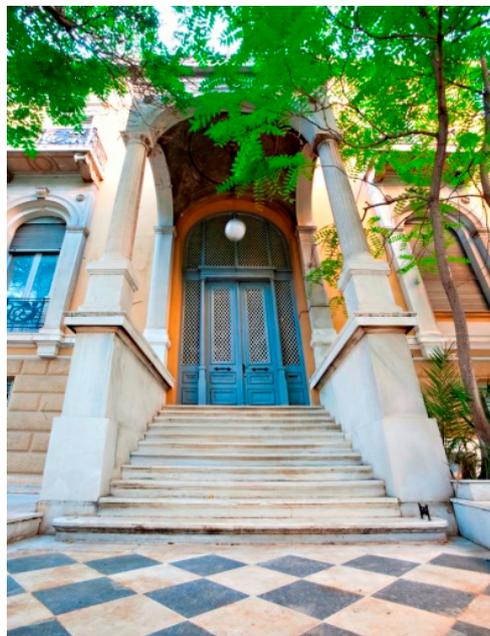
Figure 9. The portico of the entrance (2009). C.S.J.S.F. Photographic Archive.

On the face of Akademias Str., the central balcony on the floor, which has four beads and elaborate railing, is emphasized [15]. In the main view of the entrance to Kanari Str., a feature that focuses on the central axis, is the portico, which is supported by two marble columns, houses the marble staircase of the entrance, protrudes the main volume of the building, and supports the central large balcony of the 2nd floor (Figure 9). The rails of the building balconies, the roof, and the pseudo-balconies on the 1st floor are cast iron, of domestic production, with forms of mythical creatures (female feathered torso, lower limbs, and reptile tail) (Figure 10). The garden extends to the side of Kanari Str., where the entrance of the building is formed on two levels with marble paving [15].

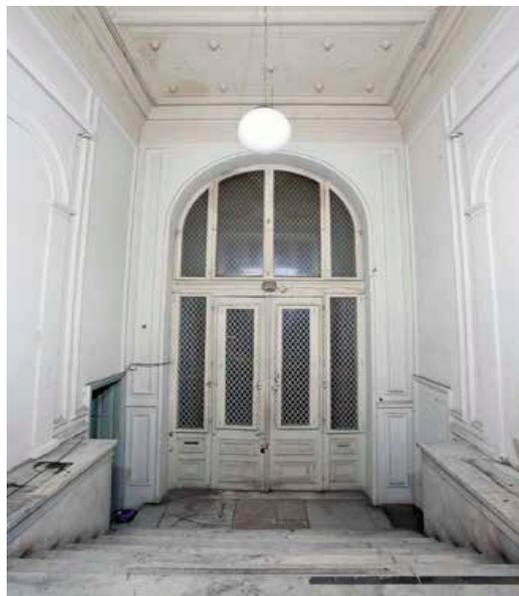
Figure 13. The entrance with the small front and the marble stairs (1999).

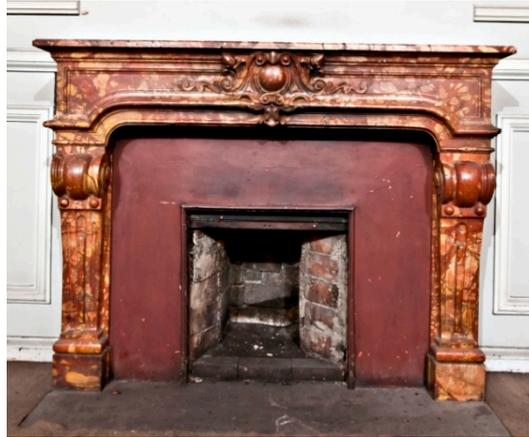
Figure 19. Ornamented fireplace in the reception area of the 1st floor (2009). C.S.J.S.F. Photographic Archive.

doors are made of paneling with wooden decoration and rectangular patterns. The knobs are cast with elaborate decorations, in all reception areas and office spaces on the 1st floor there are ornamented fireplaces covered with white or red marble (Figure 19). Three of these rooms have a bronze round stamp, marked Jules Cantini Marseilles, which apparently states the name and the city of origin of the factory that manufactured them. It is probably the workshop of the great French marble sculptor and art collector Jules Cantini (1826–1916) (Figure 20), who was born in Marseilles and participated in the construction of many public and religious buildings in the city. Works of art from his collection, as well as his studies, including studying fireplaces are exhibited at the city's Cantini Museum of Marseilles [4,16,17].

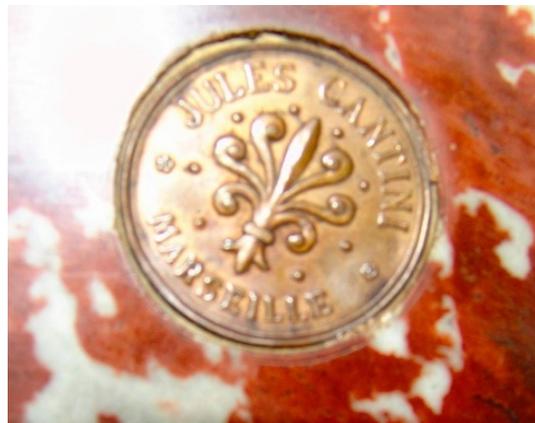
Figure 20. Bronze round stamp, marked Jules Cantini Marseilles.

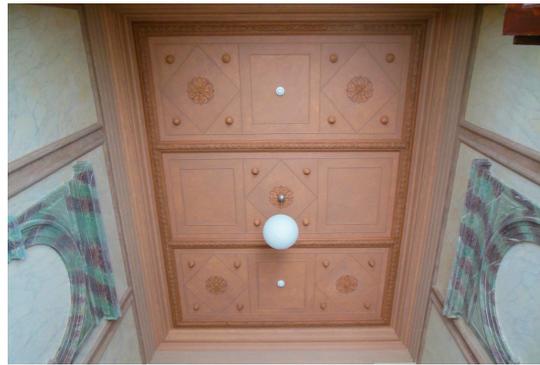
Figure 21. Decoration of the central entrance.

The interior decoration of the building, painted and sculptural, consists of three categories; the wall-painting, the frescoes, and the relief-plaster decorations [14]. In the gypsum decoration of the central entrance, the main corridor, and main areas of the 1st floor, it was determined by exploratory cuts that the hollow decorative friezes and the reliefs of the roofs are adorned with gold leaf, while the background is imitated wood. There is an elaborate ornate decoration, and the walls are both imitation of marble, or repeating plant and geometric decorations (Figure 21). The ceiling on the 2nd floor are painted in bands of different dimensions, with strips of repetitive wavy decoration and flowers, which form helical repeating shapes or are richly decorated with plant motifs. The colors are distinguished by the tones of sienna, umber, green, ciel, red, gray, and white (Figure 22).

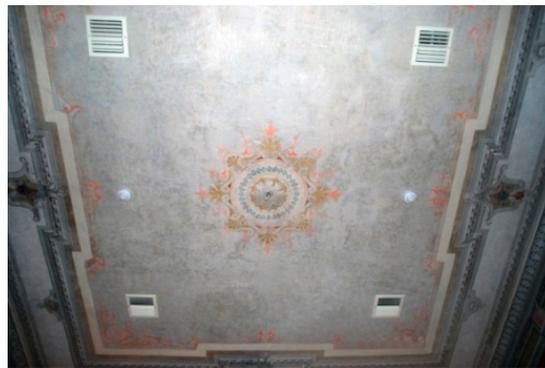
Figure 22. Ceiling on the 2nd floor.

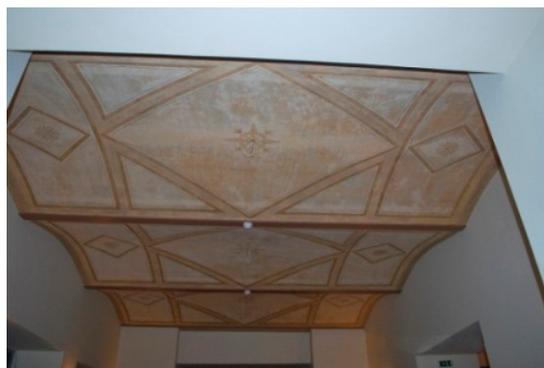
Figure 23. Ceiling on the 2nd floor.

The painted and embossed decorations were fully revealed during the restoration, renovation, repairing, and laying-out of the building that began in September 2009. In central areas of the basement after exploratory incisions, it was found that the ceilings were divided into three arches with identical decoration; rosettes, enclosed by strips forming geometric shapes (e.g., diamond and triangles) (Figure 23) [4,18,19].

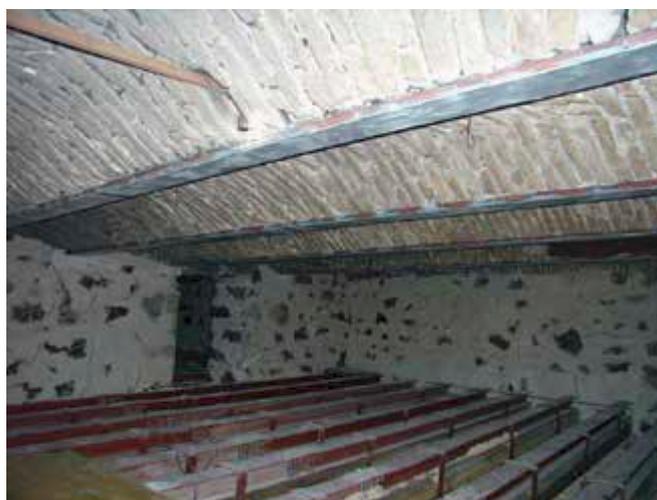
The load-bearing structure is stone with up to one meter (~1 m) thickness. On the basement and 2nd floor roofs, the lowered domes system (KAPPEN) is used, a technical solution widely used by Ziller, with its first application at the Schliemann Mansion (1879) (Figure 24). It consists of brick blocks that are supported by parallel tiles (T) of about ninety centimeters. The 1st floor roof is of wooden construction, with wooden beams, an intermediate false floor painted with plaster, a layer of insulation made of ceramic trimmings, soil support frames on the beams, and a nailed floor. In the auxiliary areas

(1st and 2nd levels flooring), where the final floor consists of marble slabs, the construction is with double tau (T) bridged with stone slabs [15].

Figure 24. The lowered domes system of the roof of the 2nd floor.

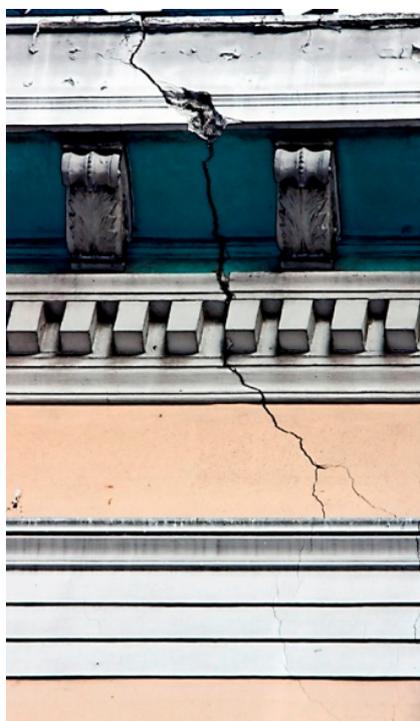
Significant alternations of the static operation were caused by the occasional interventions in the ground floor masonry, with demolition of parts of the masonry and coatings, as well as due to natural causes such as earthquakes and the 1996 fire that occurred at the 2nd floor, where the Film Archive was located (Figures 25–27).

Figure 25. Naturally caused changes by earthquakes.

3.1. Strengthening the Building Structure

- Through understanding of the existing structural system concerning geometry materials, and definition of their strength and quality through inspection and non catastrophic methods (masonry, foundation of masonry grout, mortar, steel beams, wooden beams).
- Calculation with finite element analysis of the building’s model to find out the strength of the existing structural system in terms of stresses.

- Definition of the strategy which was needed to follow, in order to reinforce the existing building against future loading actions such as earthquake, fire, and differential settlements as well as cooperation of different materials which were needed for the reinforcement of existing ones. Of note, the above strategy of reinforcement had to take into account the limitations of almost zero changes to the existing geometry and materials in order to preserve the initial form of the monument.

- Calculation with finite element analysis of the building's model with reinforcements of the existing structural system which resulted to the following:

1. Excavation to the ground floor and construction of new L-shape stripe reinforced concrete footings in all the separate openings.
 2. Use of shotcrete at the core of the building and throughout its height.

3. Use of special grout mixture for the reinforcement of masonry walls.
 4. Use of fiber mortar applied on steel galvanized mesh for the finishing of masonry walls.

5. Reinforcement of wooden floor beams with vertical galvanized steel plates on their two vertical sides, throughout their length.
 6. Reinforcement of the bottom flanges of the existing steel beams by welding steel inox plates [4,15].

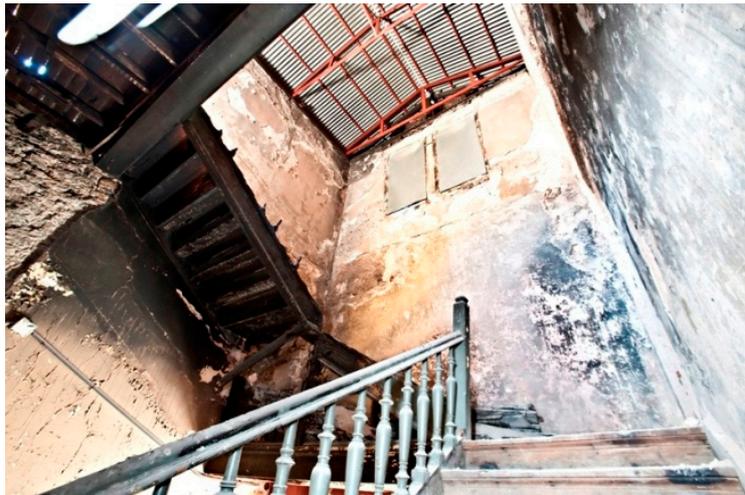
Figure 26. Damages due to the 1996 fire.

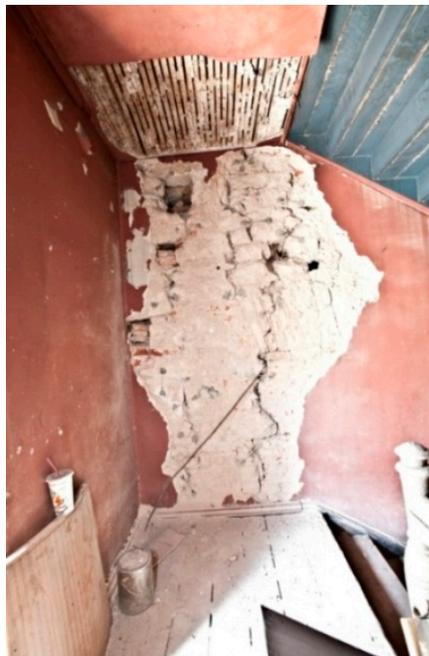
Figure 27. Longitudinal cracks in the central stairway area.

The building was intersected by longitudinal cracks in the masonry walls due to seismic stresses, with a wider range in the central stairway area where the external wall to Pindarou Str. had been detached (Figure 27). The poor conservation status concerned floors, ceilings, walls, cabins, and an auxiliary stairway. The most significant damage was caused by the natural aging of the building's materials, the lack of maintenance, and the presence of moisture. Aging phenomena were recorded in all wooden frames and floors, in addition to local cracks in the marble of balconies, entrance floors, and decorative elements of facades.

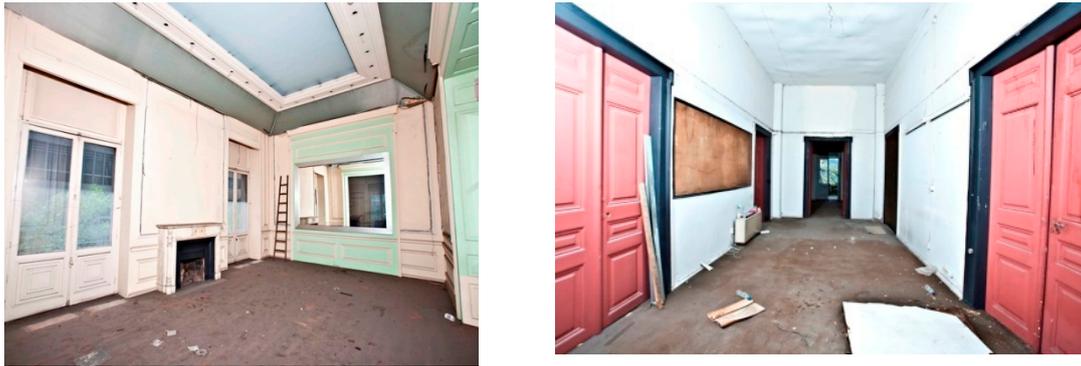
The problems encountered in the wall paintings and frescoes of the buildings come mainly from: (a) moisture, which created cracking, detachment of parts, and discoloration; (b) earthquakes that caused cracks; (c) several layers of coloring and placements of plaster decorative elements which covered the painting layers (Figures 28 and 29); and (d) the 1996 fire, which completely destroyed the painting decoration in some areas (Figure 30) [15].

Figure 28. Covering the painting layers in the lounge area around the reception room on the 1st floor (left) and at the central area on the 2nd floor (right).

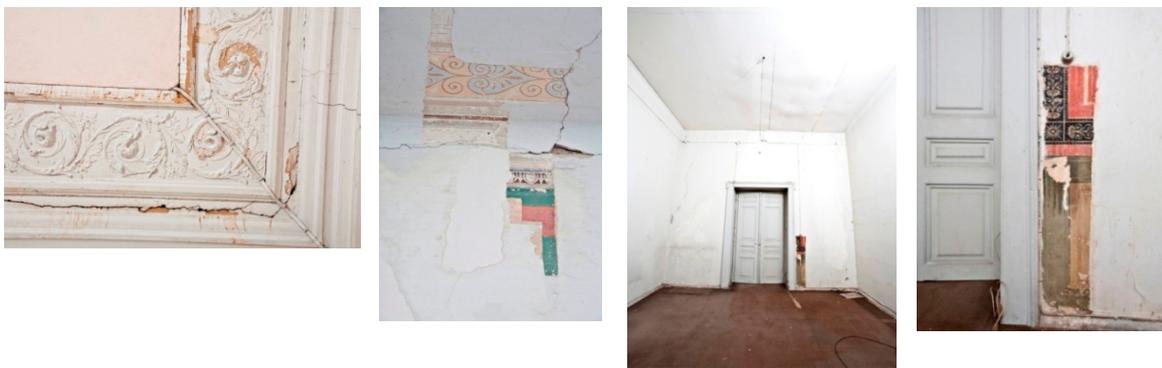
Figure 29. Covering of painting layers on ceilings and walls of the 1st and 2nd floor.

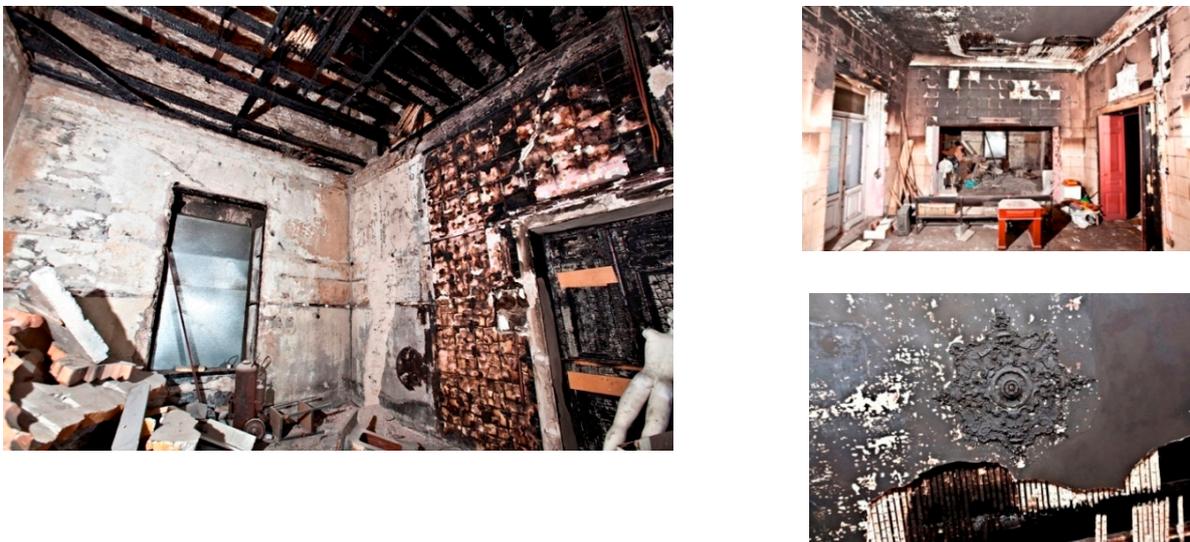
Figure 30. Damages due to the 1996 fire on the 2nd floor.

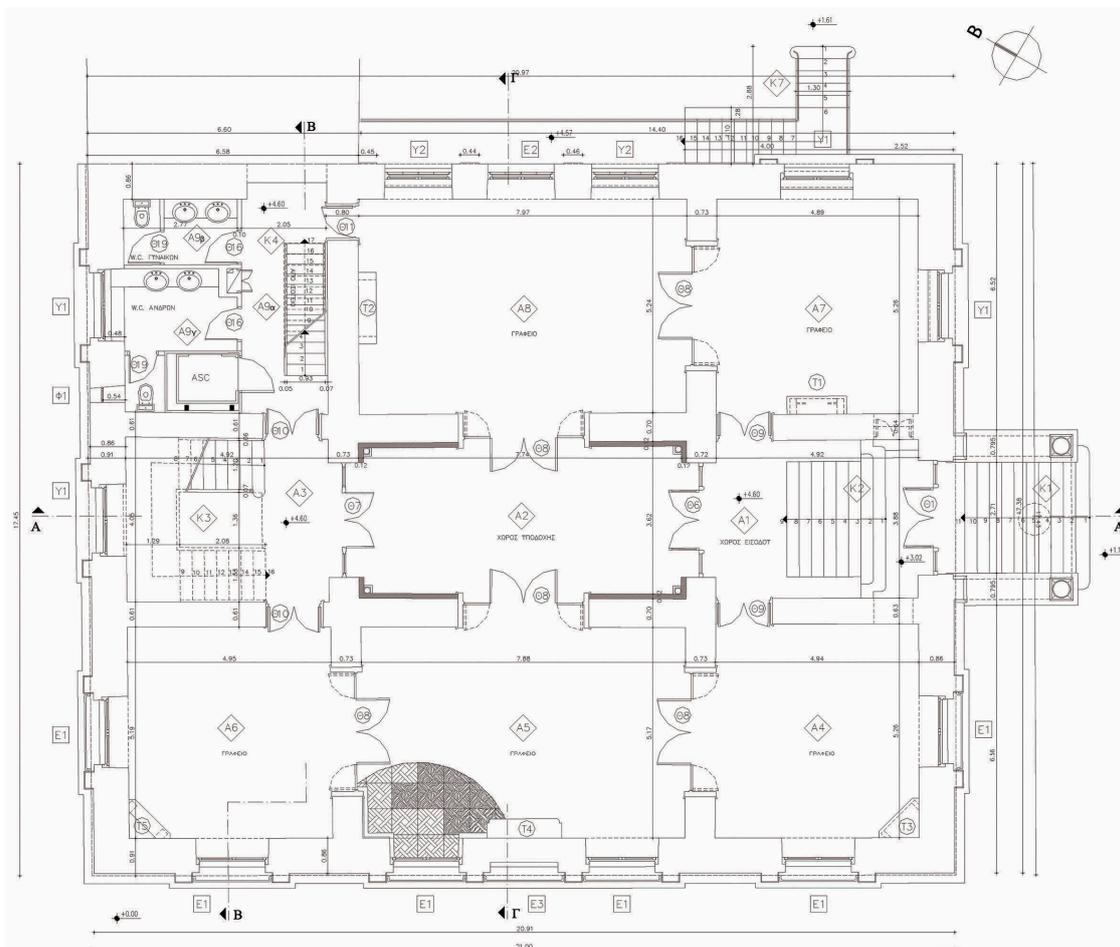
Figure 33. Plan of the 1st floor (1999). Proposal. C.S.J.S.F. Archive.

The three-story building can be operated in two different ways: (a) the operation of all three floors in a single complex, and (b) the operation of the two upper floors as a single set and the basement as an independent unit (Figures 33 and 34). In order to achieve this, the secondary staircase was reconstructed and a lift was placed in the area of auxiliary spaces, on the ground floor of which a new entrance and concierge space was created (Figure 35). The remaining existing entrances on the ground floor are maintained to serve its most likely use, as commercial or cultural activity [4,15].

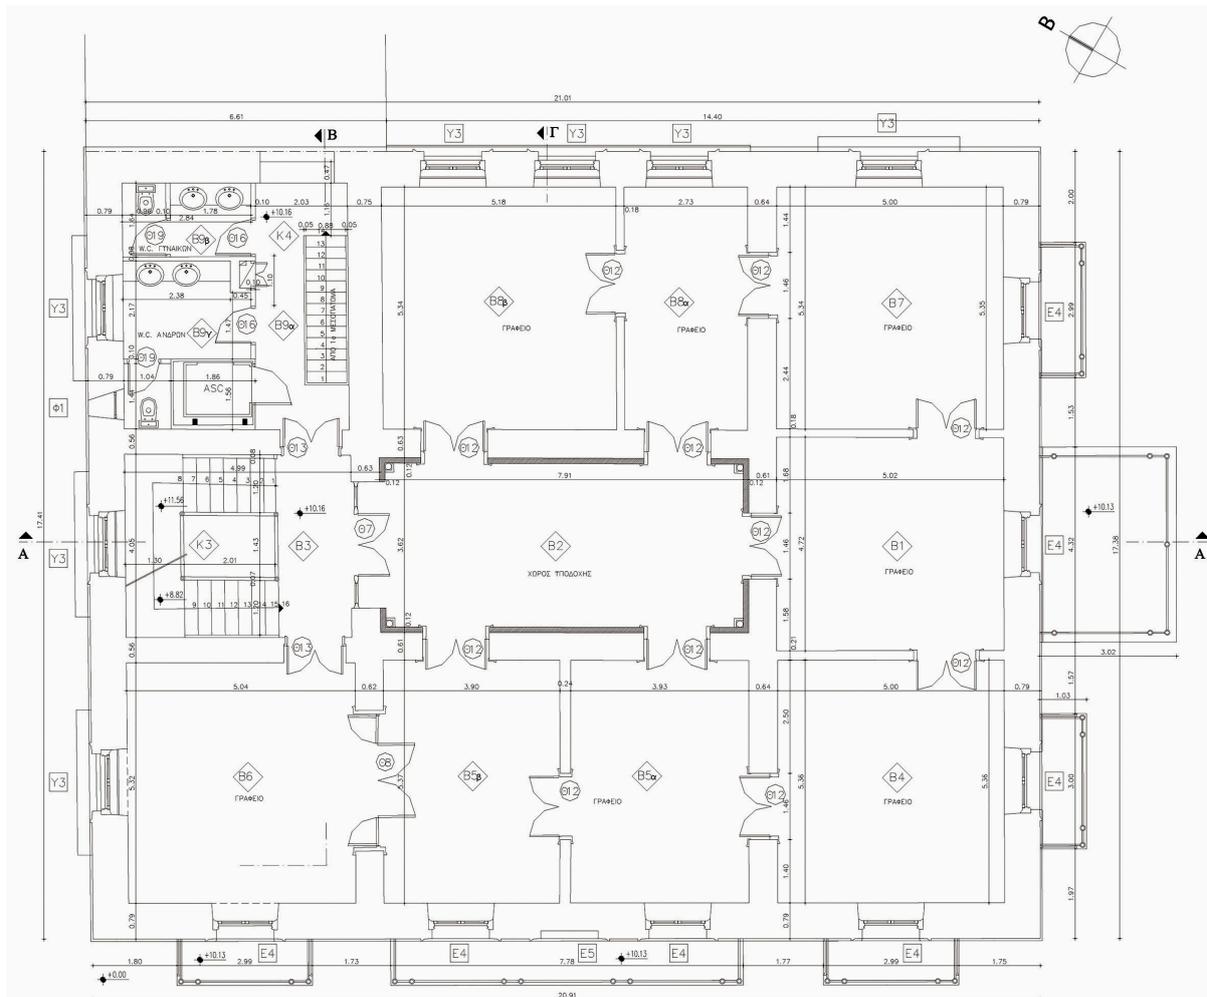
Figure 34. Plan of the 2nd floor (1999). Proposal. C.S.J.S.F. Archive.

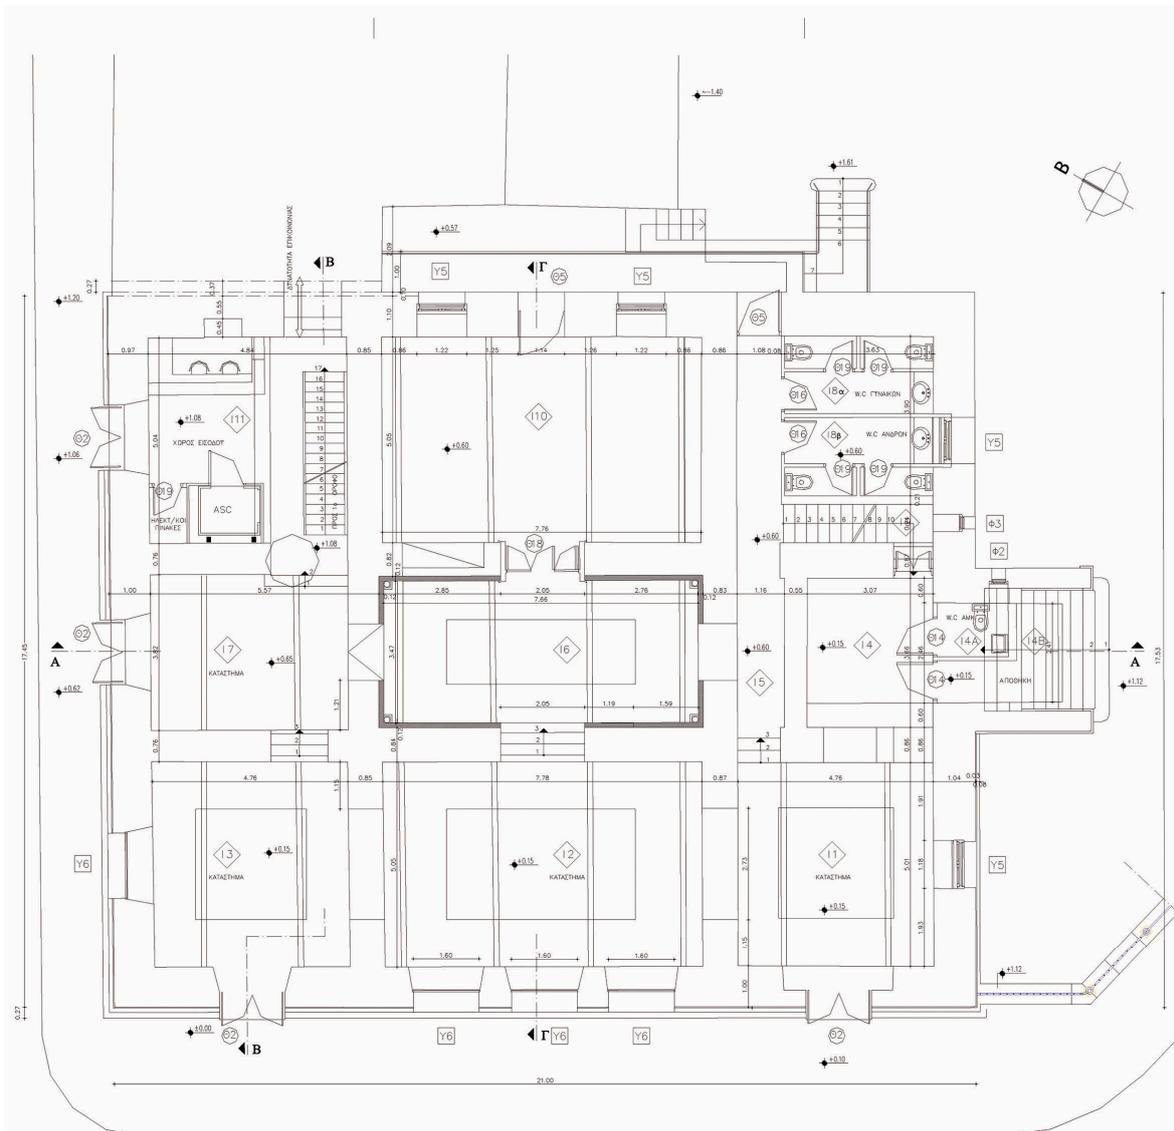
Figure 35. Plan of the ground floor (1999). Proposal. C.S.J.S.F. Archive.

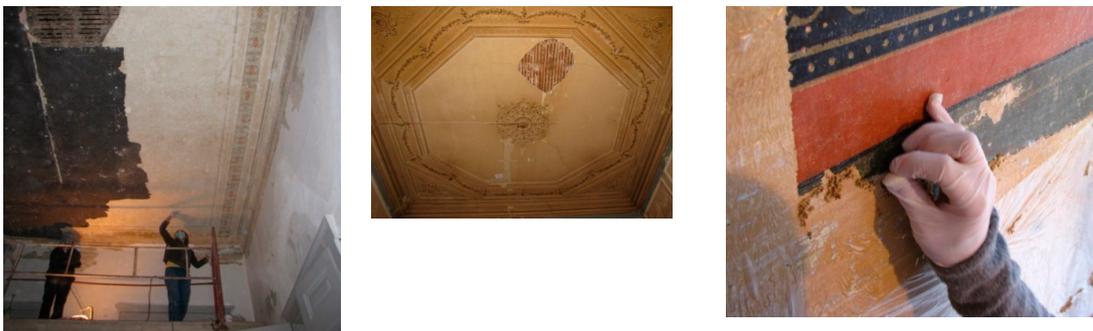
After the restoration of the mansion and the possibility of access to all its spaces, investigation was made on new surfaces, thus giving an overall picture of its ceilings and frescoes. The state of preservation of the embossed and painted decoration inside the building was divided into two sections depending on the extent of the deterioration and the type of restoration. The first ones concerned decorations, that were kept in such a condition, that they were restored in situ and the second ones were painted decorations that were not kept in good condition and would be reproduced (Figure 36) [15].

Figure 36. Restoration of the painting decoration.

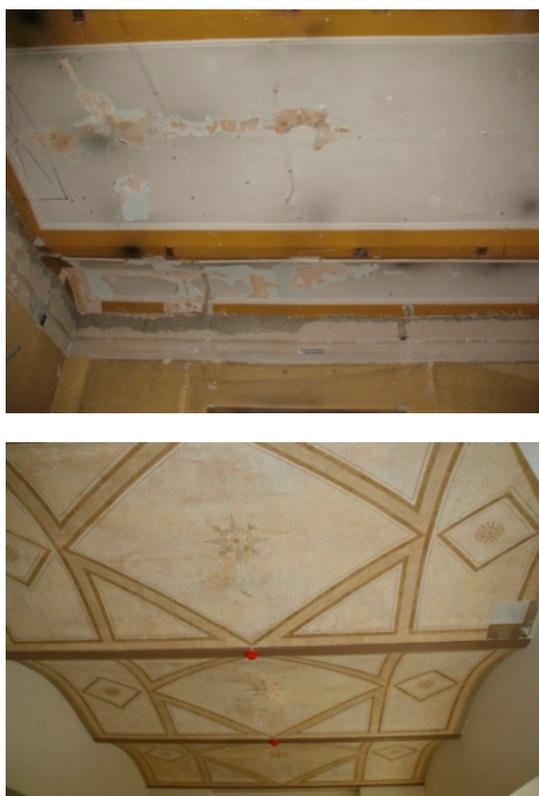
Figure 37. Painting decoration of the arches on the ground floor before (**top**) and after (**bottom**) the restoration works (2015).

Aesthetic rehabilitation interventions were done only in areas where there were losses, without extending to the authentic decoration. New colors were attributed to a lower color tone so as to be distinguished from the authentic decoration and not to break the aesthetic unity of the work. The aesthetic restoration and reproduction of the painting decoration was done with respect to the historical and artistic value of the work (Figures 37–40) [4,22].

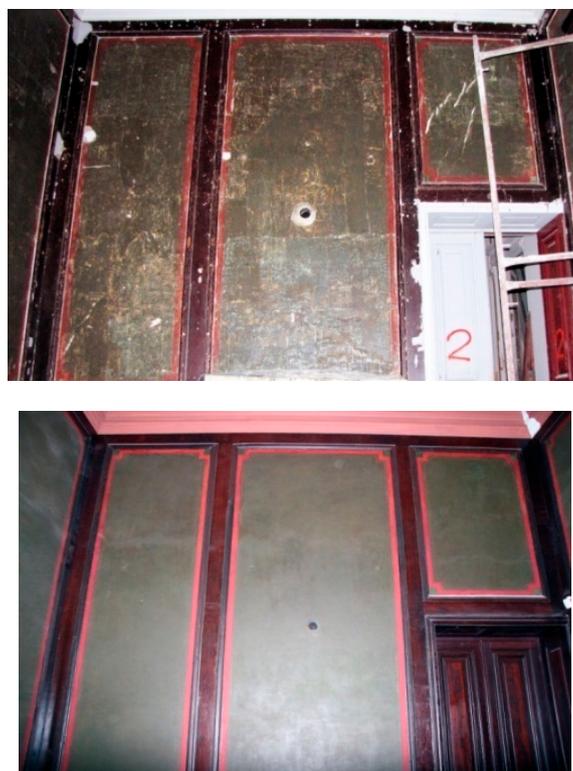
Figure 38. Painting decoration of walls of the 1st floor before (**top**) and after (**bottom**) the restoration works (2015).

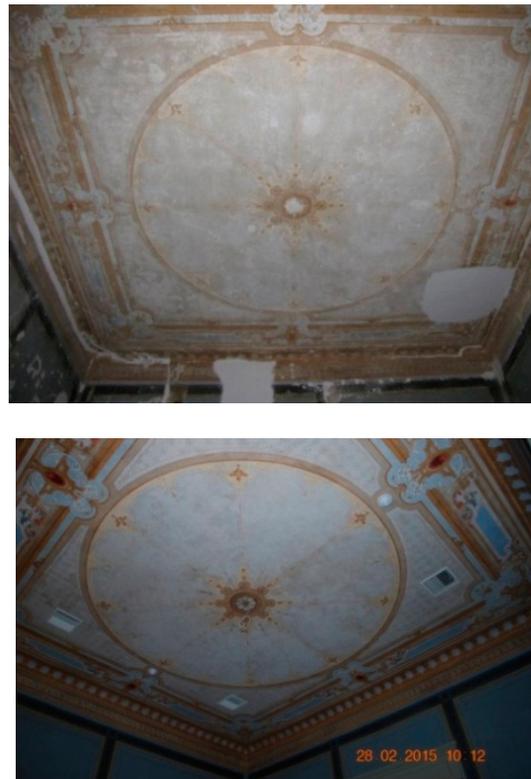
Figure 39. Painting decoration of a room ceiling of the 2nd floor before (top) and after (bottom) the restoration works (2015).

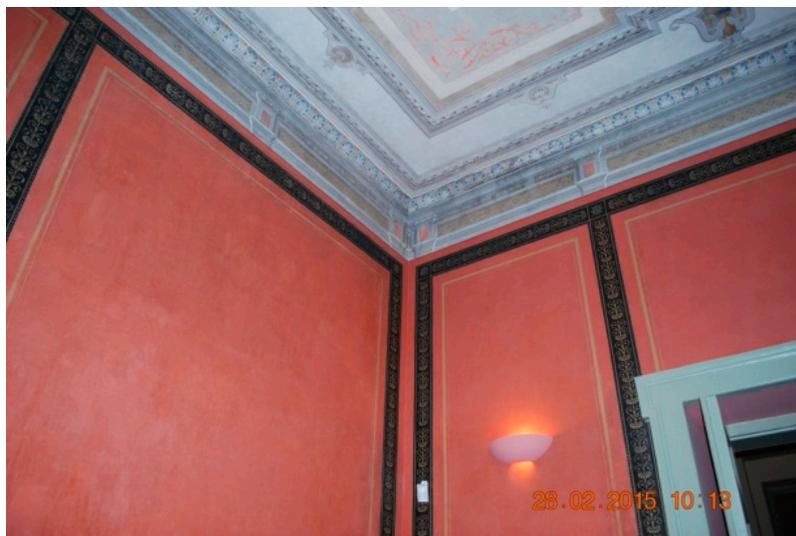
Figure 40. The painting decoration of walls of a room of the 2nd floor after the restoration works (2015).

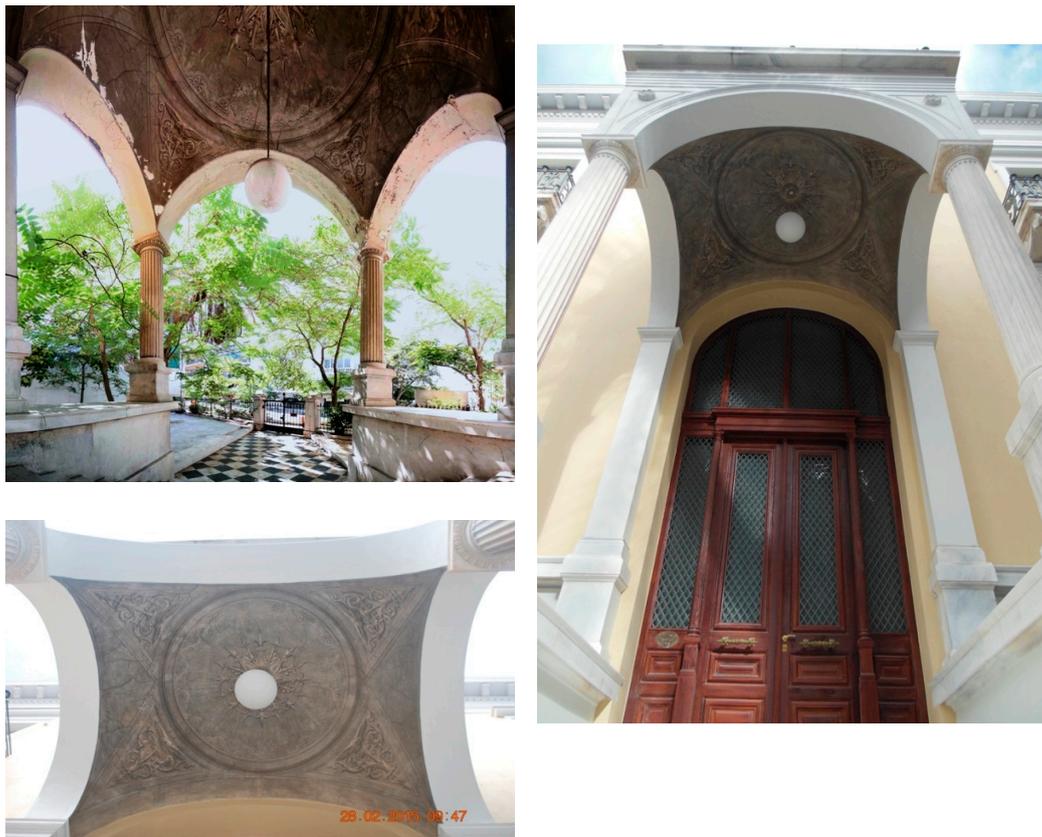
Figure 41. The portico of the entrance before and after the restoration works (2009).

The construction work concerned the replacement of simple coatings, fixings with a slightly reinforced polypropylene fiber coating (the original outer coating had already largely replaced), and repairing or replacing the damaged marble members of the external floorings—embossed decorations and the damaged pieces of rails of balconies and roof (Figure 41).

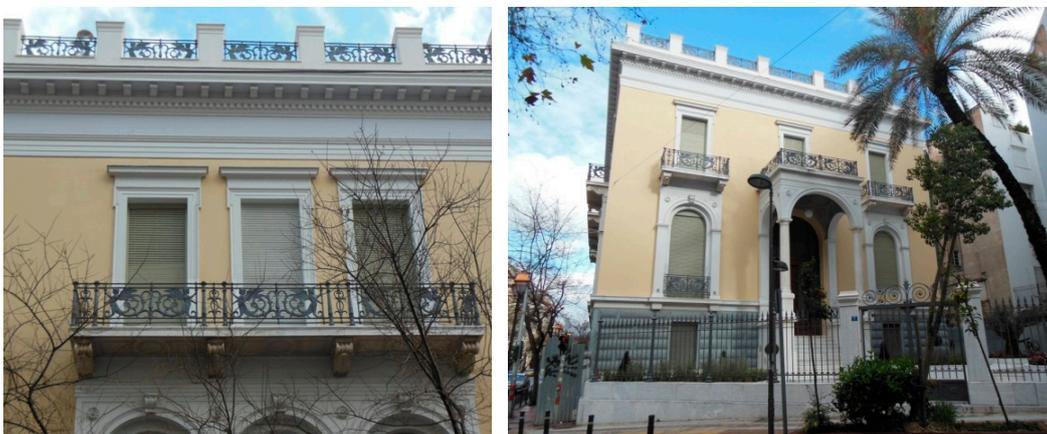
Figure 42. The Deligiorgi Residence after restoration works (2015).

From Ziller's original plans, which are found in the City Hall Archive of the Municipality of Athens, the designer chose the buildings color with respect to the classical principle of horizontal composition (Figure 42). The exceptionally light choices for the large color surfaces (white–umber) give the building the light elegance of the private residence [4,15].
