# Climate and Cultural Heritage: The Case Study of “Real Sito di Carditello”

**Abstract:** A monitoring campaign performed on the Real Site of Carditello (found in the commune of San Tammaro, province of Caserta, Italy) was aimed to evaluate the parameters related to air quality and then to control and prevent the degradation risk. The analyses were carried out in the context of the project “*Innovative methods and technologies for the conservation, valorisation and use of cultural heritage: environmental and archaeological analyses*”, within the CULTURA CREA-MIBAC program, which aims to provide innovative methods for conservation and enhancement of cultural heritage through environmental and archaeometric analyses. Preliminarily, using field equipment, non-destructive investigations were carried out to identify constituent, restoration, and/or degradation materials belonging to the wall paintings on the main floor and to assess their conservation state under the current environmental conditions. Environmental monitoring was performed both outdoor (to assess the effects of atmospheric pollution and changes in the climate of the structure) and indoor the rooms of the site (to evalu

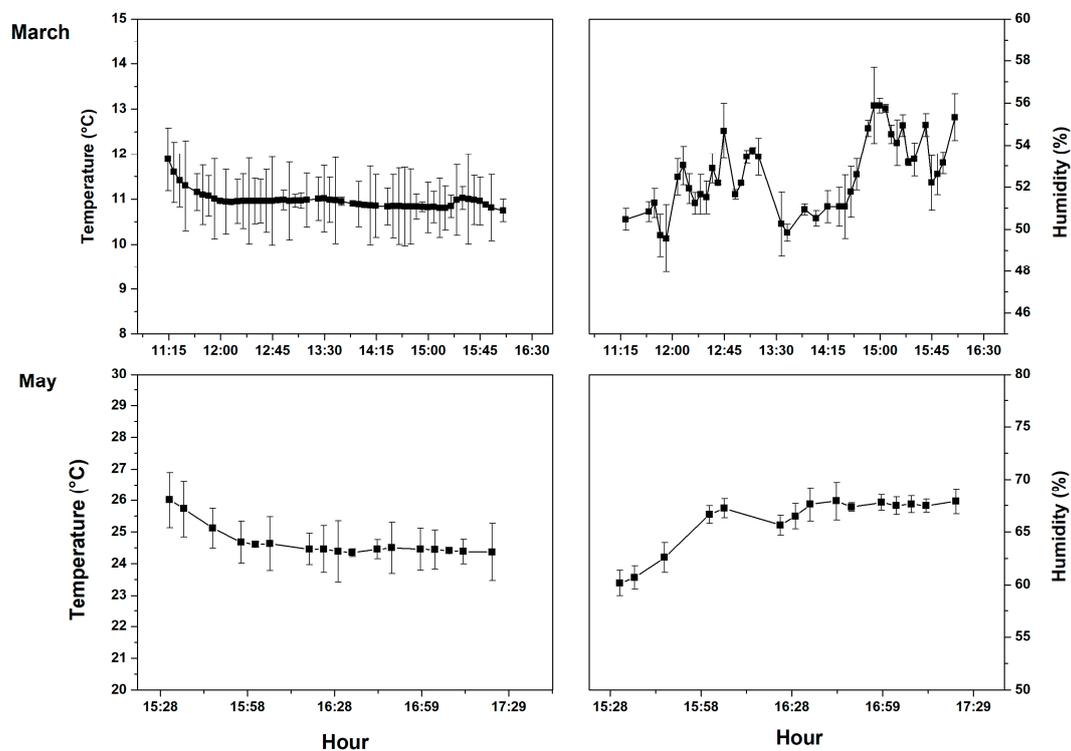
In Figure 1, the behavior of the indoor thermo-hygrometric parameters of March and May 2018 was measured in the central room on the first floor where different mural painting are present, and non-invasive measurements have been performed.

**Figure 1.** Indoor temperature and humidity trends (average values) for the months of March and May 2018.

The results are correlated with the building typology, the orientation, and position of monitored rooms, as well as with the fact that the Carditello Real Site has a reasonable thermal *inertia* with an

almost constant behavior of the internal thermo-hygrometric variables, compared to the outdoor thermo-hygrometric variations recorded in the same periods.

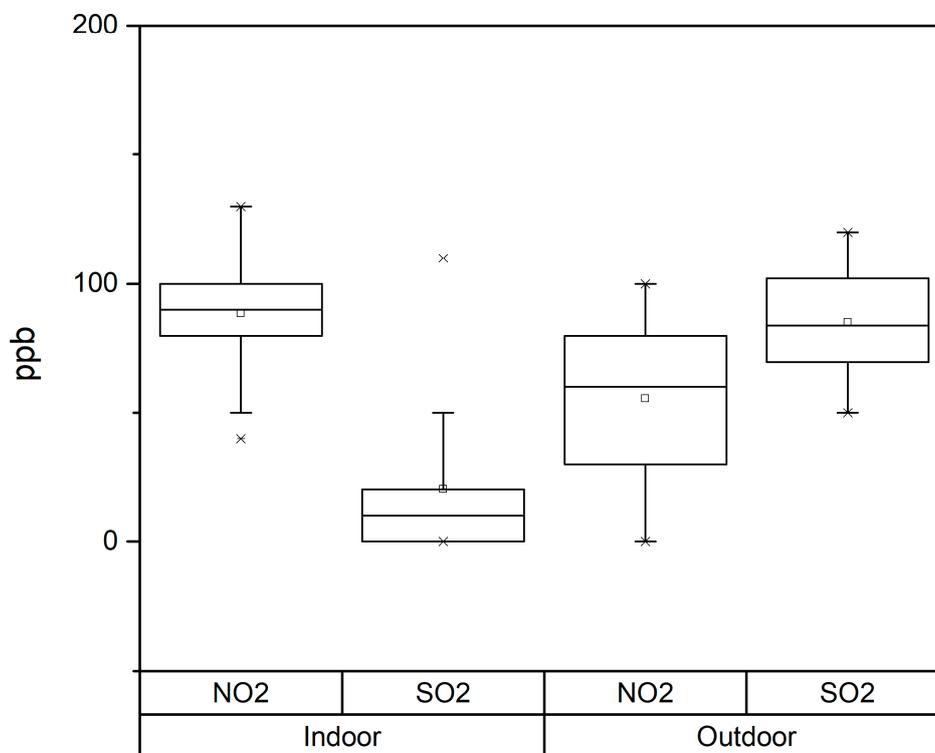
Figure 2 shows the box charts of the cumulative indoor and outdoor NO<sub>2</sub> and SO<sub>2</sub> values of the monitoring periods.

Figure 2. Box charts of the cumulative NO<sub>2</sub> and SO<sub>2</sub> parameters of the sampling periods.

The indoor detected NO<sub>2</sub> and SO<sub>2</sub> values shown a low variability with 90 ppb and 20 ppb average value, respectively. Outdoor nitrogen dioxide values also shown low variability and an average of around 50 ppb, while outdoor Sulphur dioxide values show a higher average than indoors (about 85 ppb). Finally, the ozone average value has been equal to 70 ppb during the two monitoring periods.

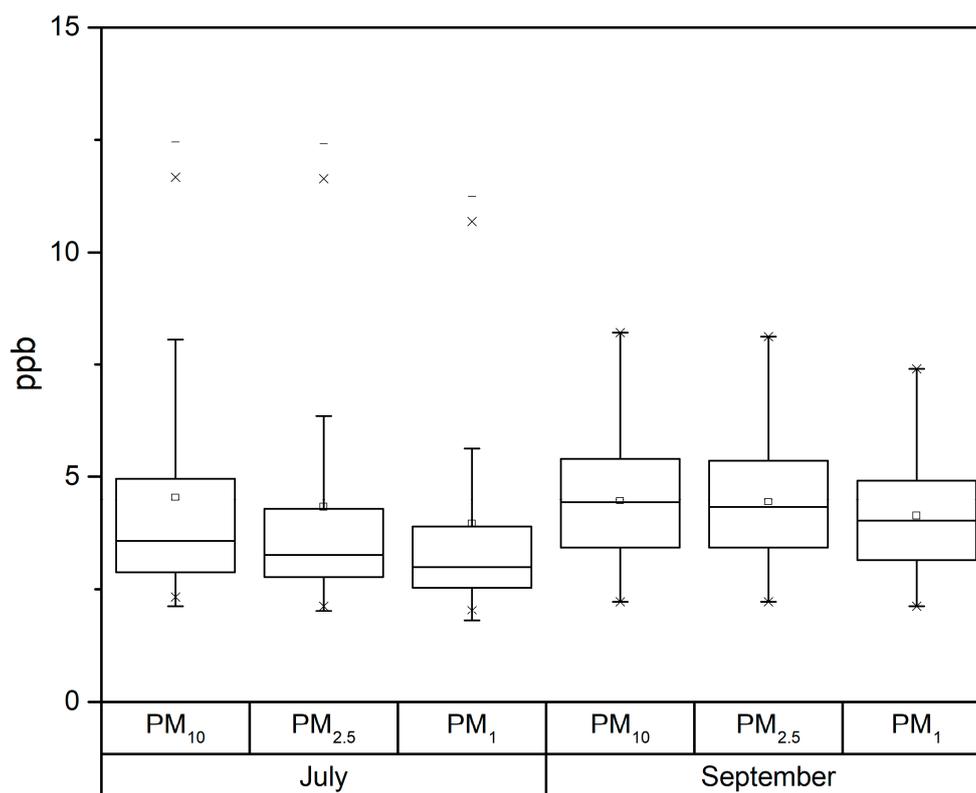
Figure 3 shows the PM values monitored during the sampling period. The average particulate values are about 5 ppb, with almost no difference between the months considered (July and September).

**Figure 3.** PM<sub>10</sub>, PM<sub>2.5</sub>, PM<sub>1</sub> values for July and September.

All environmental parameters, with the exception of PM, exceed the thresholds recommended by Ministerial Decree No. 10 of 2001 on air quality for museums (Table 3). Although the Carditello Real Site is not a confined environment like museums, it was decided to take these thresholds as a reference and to assess the permanence times of these average values in the long term. Therefore, a new environmental monitoring campaign has been planned in the next year.

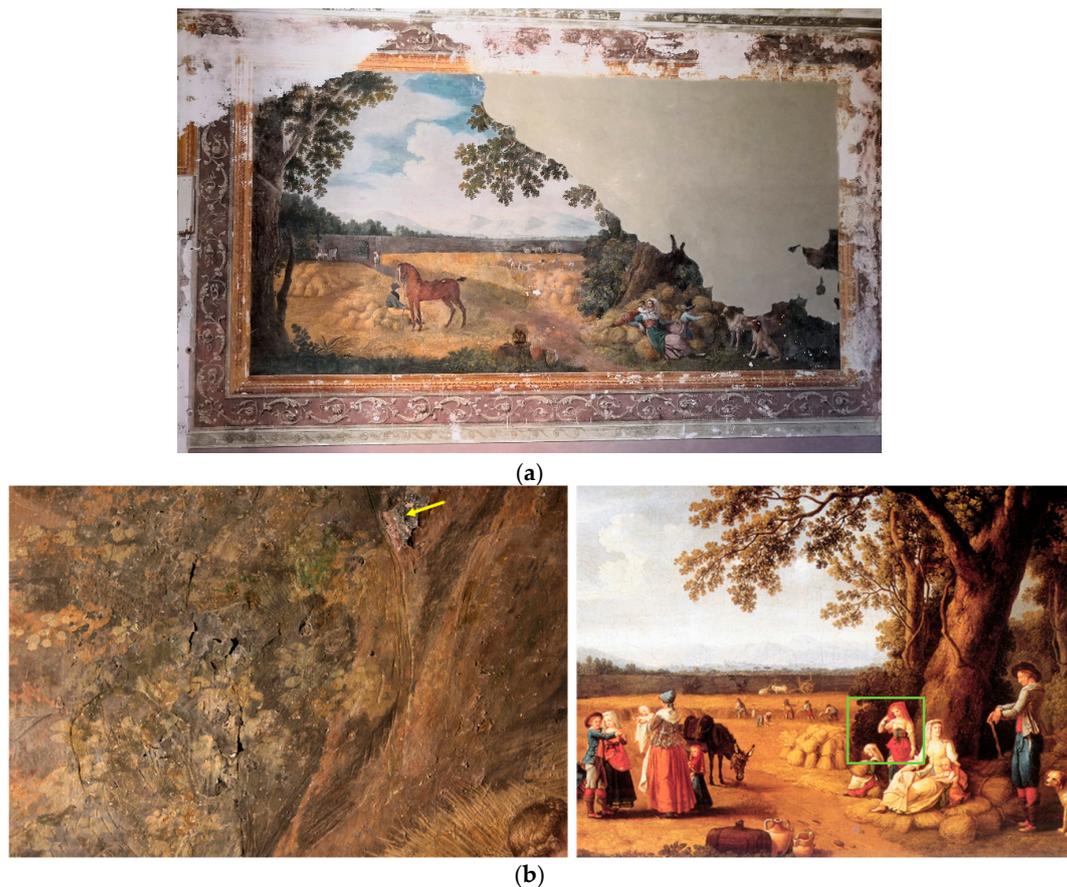
In the Area 1, the bedroom of the King, among the mural paintings depicting the allegory of the seasons, “The Reaping” has been selected for non-destructive in situ investigation (Figure 4a).

Historical information and results provided by the scientific analyses have led to discriminate the different phases of original execution and remakes, underlying the extensive inhomogeneity in the pictorial surfaces. This mural painting, indeed, is characterized today by wide falls, detachments, and overlaps.

The preliminary photographic documentation in raking light has shown morphological inhomogeneities referable to the damages of the wall paintings during the first revolutionary events in the years immediately after the construction of the site.

For example, it is probable that the compositional structure also provided for the group of two female figures (girls next to the queen), coinciding with the sketch by P. J. Hackert removed up to the preparation layer and subsequently replaced by vegetation (Figure 4b). The raking light highlights the cut along the outline of the two figures and the abrasions on the plaster to remove the pictorial layers.

**Figure 4.** (a) “The Reaping” whole mural painting present in the *Area 1*, the bedroom of the King, and characterized by extensive *lacunae* and detachment of the pictorial layers; (b) Detail in raking light of the area with vegetation near the female figure and comparison with the corresponding area (green rectangle) in the sketch by J.P. Hackert. The pictorial area delineated by a cut and characterized by deep and irregular incisions coincides with the two female figures in the sketch. The yellow arrow indicates a red pictorial layer inconsistent with the current painted subject, probably a trace of the headdress of the removed standing figure.

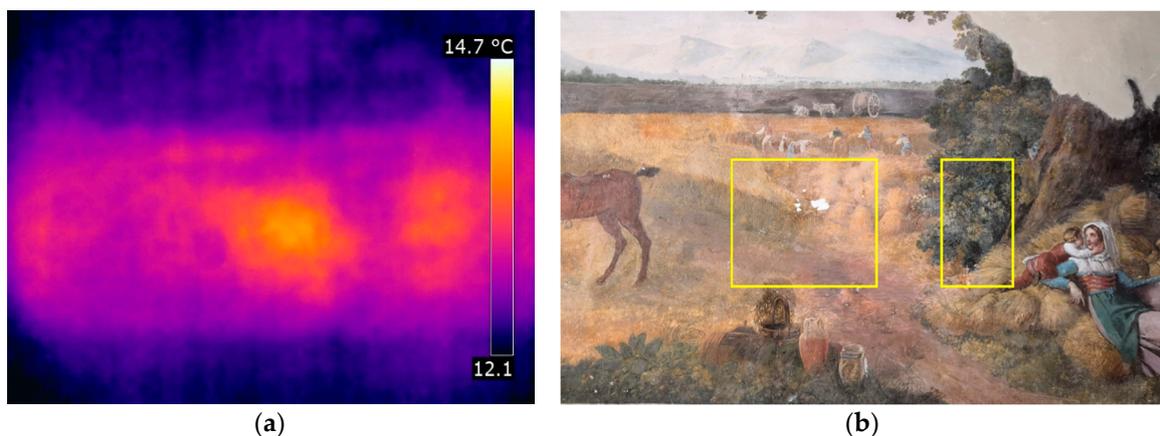
The IR thermography imaging allowed the confirmation of these hypotheses and documented the anomalies associated with repainted surfaces that result as warmer areas (Figure 5), due to detachments or materials discontinuity between the surface and the underlying layers (unlike the original areas, they appear more homogeneous and propagate heat inside the wall).

**Figure 5.** Comparison between (a) the IR thermogram and (b) the photographic image under the same grab angle. The acquisition after the switching off of the lamps confirms the presence of the thermic anomalies associated to the detachments (localized in correspondence of the areas highlighted by the yellow rectangles in visible picture) and different composition of the pictorial materials used during the XIX-XX century restorations.

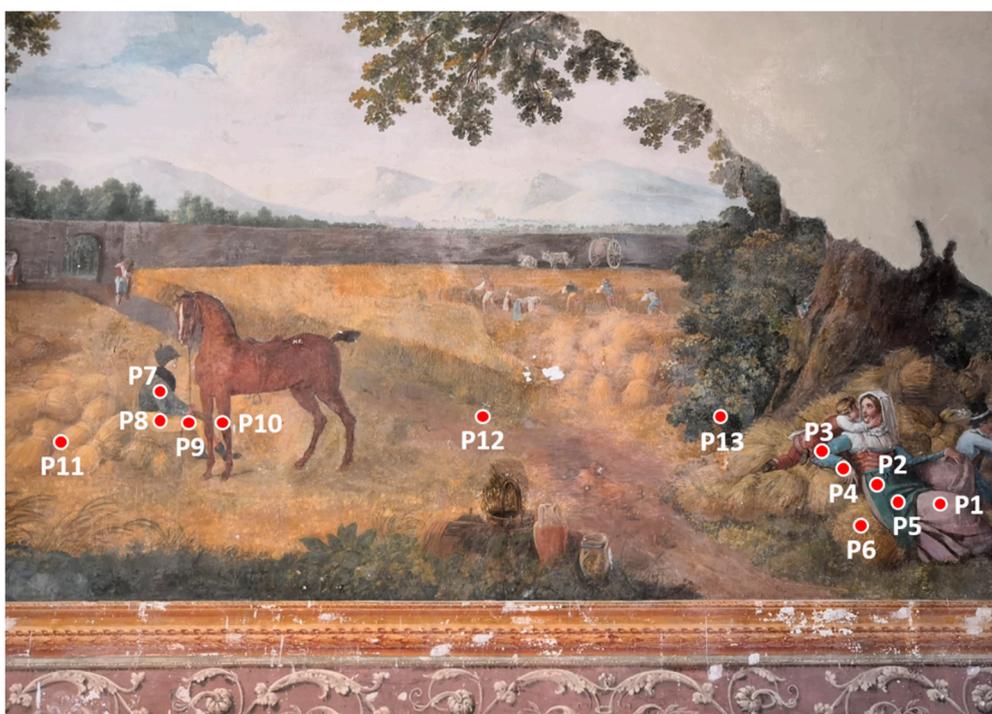
XRF analyses verified the different chemical composition of the original pictorial surface and subsequent restoration, confirming the mapping provided by imaging techniques. Moreover, through the identification of the pigments in mixtures, it was possible to distinguish the pictorial palette of the restorations carried out during the 19th century (after the 1799 Revolution and after the *Garibaldini* occupation) from that attributable to more recent restorations, subsequent to the first decades of the 20th century, not documented in the bibliography available to date consulted.

Figure 6 shows the map of the selected XRF spot analyses and Table 4 summarizes the elemental chemical composition relative to the pictorial mixtures in the all investigated original or restoration areas.

**Figure 6.** Map of the X-ray fluorescence (XRF) spot analyses aimed at identifying the pigments used both in the original layers and in the restoration ones localized on “The Reaping” mural painting thanks to the preliminary diagnostic imaging investigations.

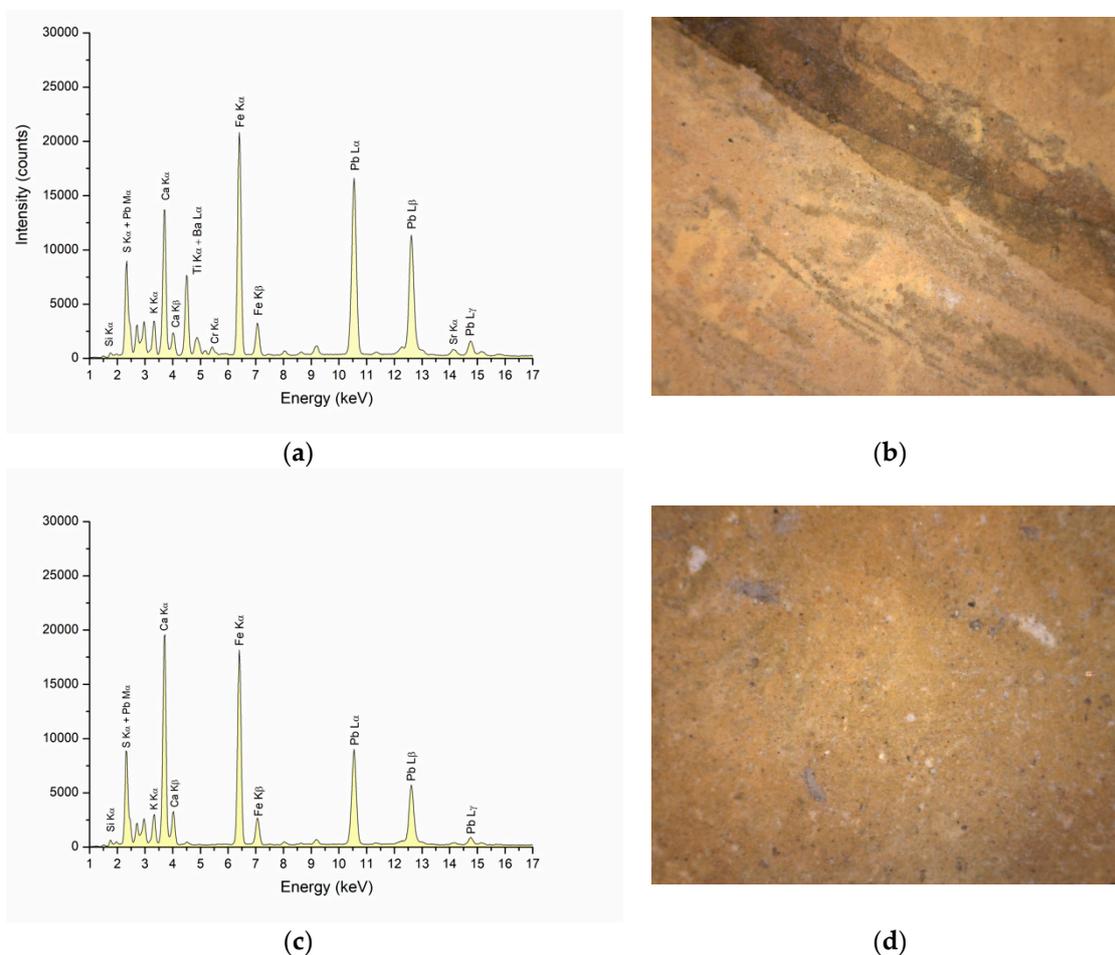
Also, for the yellow layers, it was possible to verify a difference of pigments used between the original and of restoration: For the former, it was found that yellow ochre was used, while for the restoration surfaces, chrome yellow ( $\text{CrPbO}_4$ ) was used, a synthetic pigment in use since the early 19th century, present in the analyzed area in mixture or overlapped with barium white and titanium white (Figure 7).

**Figure 7.** XRF spectra and digital microscopic images (50 $\times$  magnification) of yellow layer (P8 and P9 measurements areas) on restoration area (a and b) and original one (c and d).

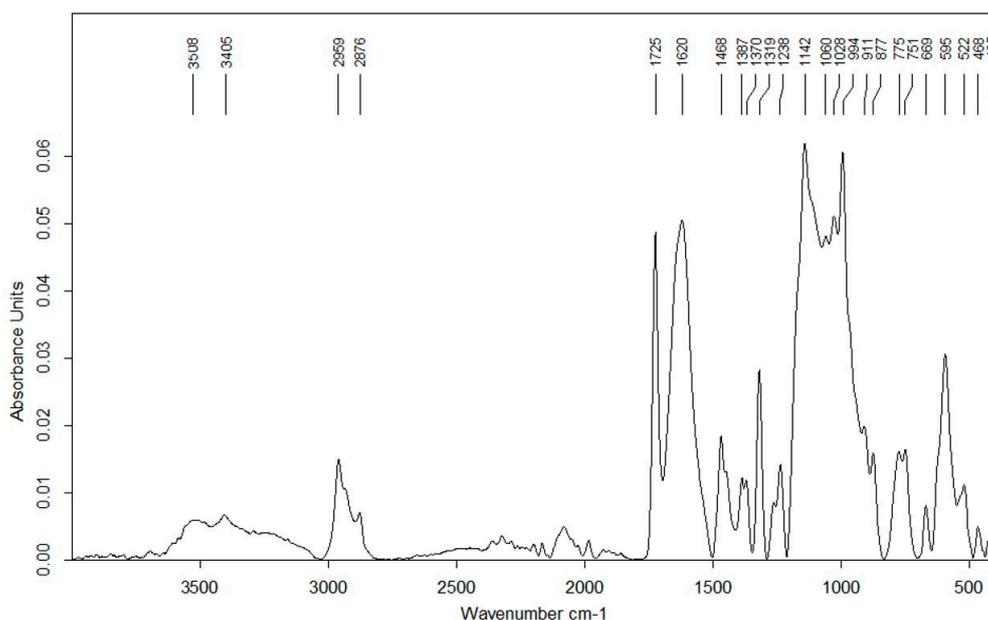
The preliminary diagnostic investigations and the macroscopic evidence of a chromatic alteration have suggested, on several pictorial surfaces in Area 1 and 2, the presence of an aged synthetic protective, referable to restorations conducted in the 20th century. This protective analysis was characterized by IR spectroscopy (FT-IR).

The spectrum, shown in Figure 8, consists of typical absorption bands of an acrylic resin, probably associated with Paraloid B67, visible at 2959, 2877 (C-H stretching), 1725 (C = O stretching), 1469, 1450, 1388, 1370 (C-H<sub>3</sub> and O-CH<sub>2</sub>/<sub>3</sub> deformation of the methyl and ethyl esters), 1264, 1238 (CH deformation), 1143 (C-O stretching of the esters), 1025 (deformation C-H), 994, 911, and 877  $\text{cm}^{-1}$ . Bands at lower frequencies (<800  $\text{cm}^{-1}$ ) were not considered to be very informative.

The FT-IR spectrum also revealed the sulphate absorption bands, probably associated to alteration products, clearly identifiable as 3508 ( $\nu_3$  H<sub>2</sub>O vibration), 3405 ( $\nu_1$  H<sub>2</sub>O vibration), and 1621  $\text{cm}^{-1}$  (H<sub>2</sub>O bending vibration). The other sulphate bands at approximately 1115 ( $\nu_3$  (SO<sub>4</sub>)<sup>2-</sup> stretching vibration), 670, and 600  $\text{cm}^{-1}$  ( $\nu_4$  (SO<sub>4</sub>)<sup>2-</sup> bending vibrations) tend, instead, to overlap the protective bands.

**Figure 8.** FT-IR spectrum of protective layer localized in the Area 1 and Area 2 pictorial surfaces.
