Multi-Analytical Characterization of Corvins' Castle—Deserted Tower. Construction Materials and Conservation Tests

Abstract: The aim of this paper is to analyze the construction materials (mortars) of an architectural monument (Deserted Tower (Lilly Tower) from Corvins' Castle, Romania). The mortars were characterized following a multidisciplinary approach, combining macroscopic observation with petrographic microscopy, mineralogical analysis (X-ray diffraction) and elemental analysis (X-ray fluorescence), hydric properties, and color of representative samples of the monument. The results revealed the use of gypsum mortars (produced by lumps with higher Fe content), with minor concentrations of crystalline dolomites of the Southern Carpathians, calcite, and quartz. The materials' effective porosity and their water absorption capacity were high. A possible solution to consolidate the damaged area with some consolidation products (hydroxyapatite carbonate and its derivatives with Ag and Sr) was investigated, too. The interactions between the mortar's specimens and the effectiveness of the consolidation treatments were evaluated by physico-chemical analyses (molecular structure by X-

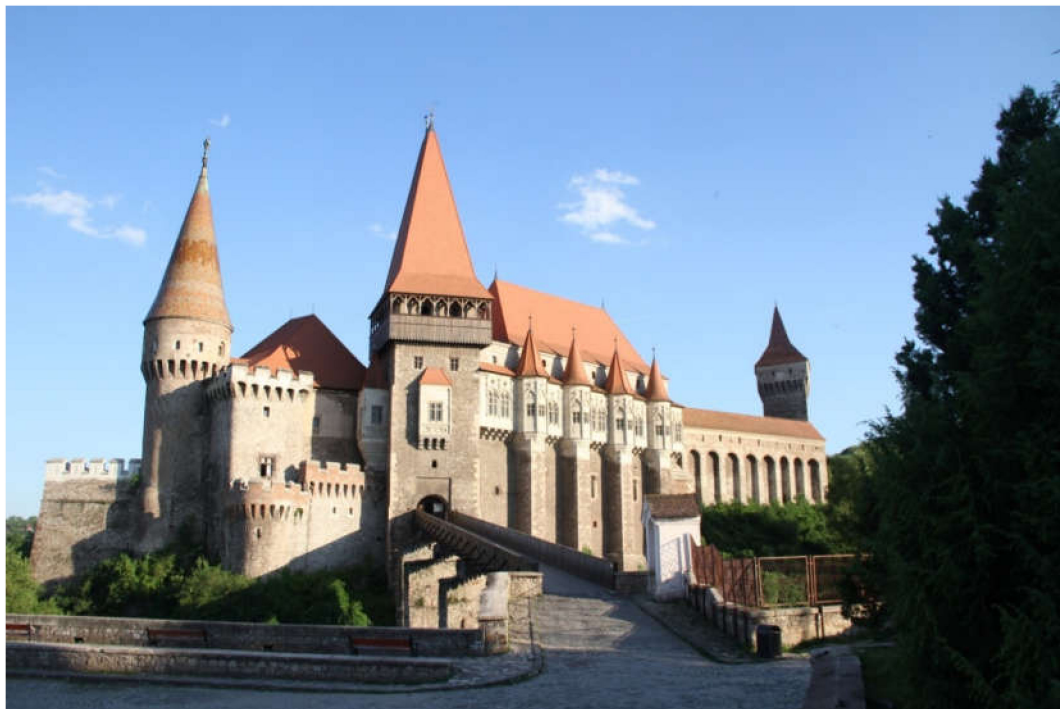
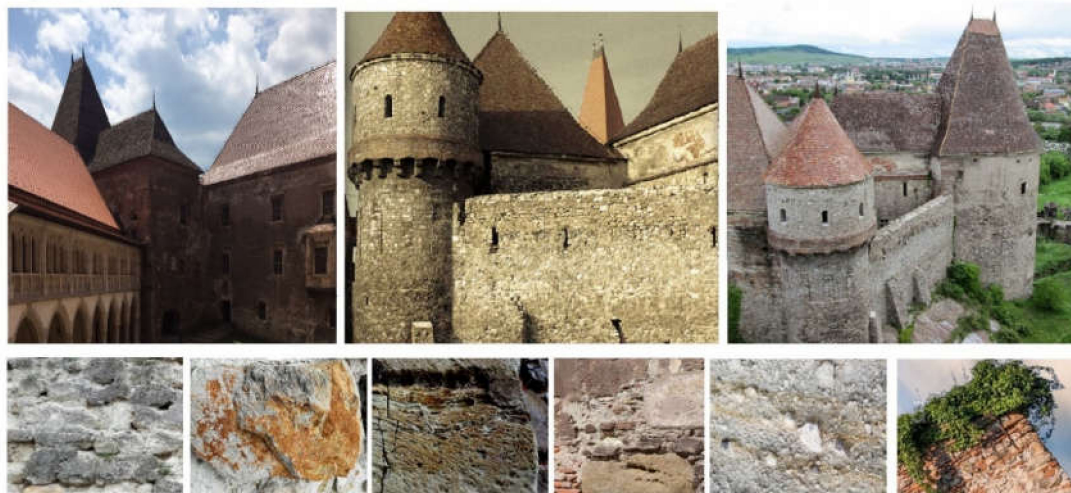
Figure 1. Photos of Corvins' Castle (a) and Deserted Tower (DT) (b): up from left to right: DT interior face of the castle; middle and right: DT exterior face of the castle; down: the main weathering forms.

After sampling the DT stones, the main forms of degradation were identified, visible through surface deposits (accumulation of dust, soil, black crusts, patinas (black and orange), and surface recession with detached crusts and differential erosion (mainly in the lower part of the tower), gaps and crevices). For ethical reasons, a very small number of samples of small size and without heritage value were taken, which do not affect the integrity of the monument. A map of weathering types is shown in Figure 1b.

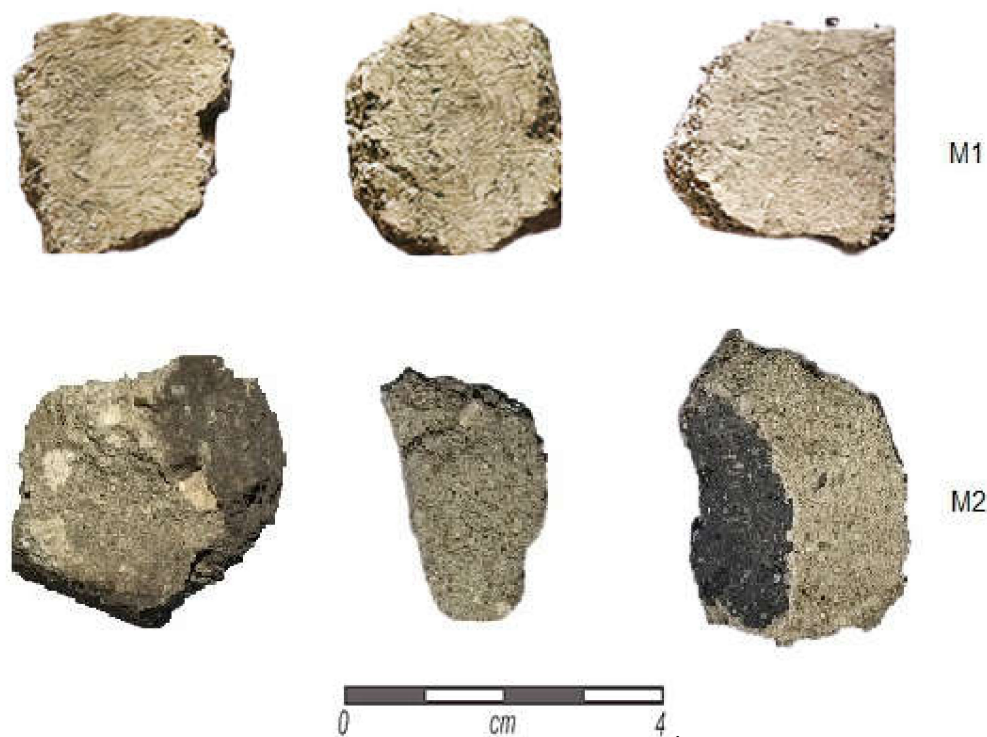
M1 is the masonry mortar, mixed colored: light grey, light brown, and white, as shown in Figure 2. Its aggregates, observable with the naked eye, are homogeneous and without preferential orientation.

Figure 2. Samples from Corvins' Castle—DT: (M1 and M2) masonry mortars. M1 is collected from the inside of the tower, while M2 is collected from outside of the castle.

M2 is the masonry mortar with a light grey binder. Its aggregates are slightly lighter than the matrix, homogeneously distributed, and without preferential orientation.

Except these, a whitish with light color tones (light yellow/whitish) coating mortar has been identified, distributed homogeneously, without preferential orientation, in some places covering the original surfaces (probably from the previous restoration procedure), as shown in Figure 2.

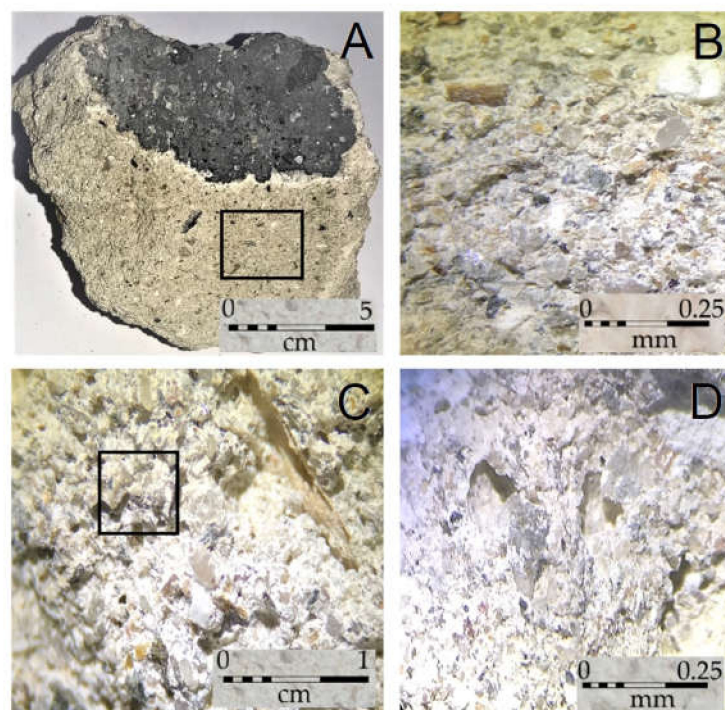
Figure 3. Main mortar types used (A, B: M2; C, D: M1).

The Corvins' Castle is located in the area of Paleozoic crystalline dolomites of the Southern Carpathians, and so other metamorphic rocks, such as mica schists, quartzites, gneisses, and graphitic schists, can be found on the geological map [36,37]. The sample of stone (A) is a whitish colored sample, with sand-size grains with a colored coating from iron oxides, knowing that this area is iron-rich, and recognized as a metallurgical area. The mortar samples from inside are light grey, without preferential orientation, with real damaged areas, gaps, and crevices (A, B), while the outside mortar is white, with traces of bricks glued to them and with exterior surface black, most probably due to environmental damages (C, D). From the mineralogical point of view, the composition of DT includes dolomite, quartz, calcite, and micas, similar to the literature results [38,39]. A small slice of the sample as evidence of the composition of the tower is shown in Figure 3.

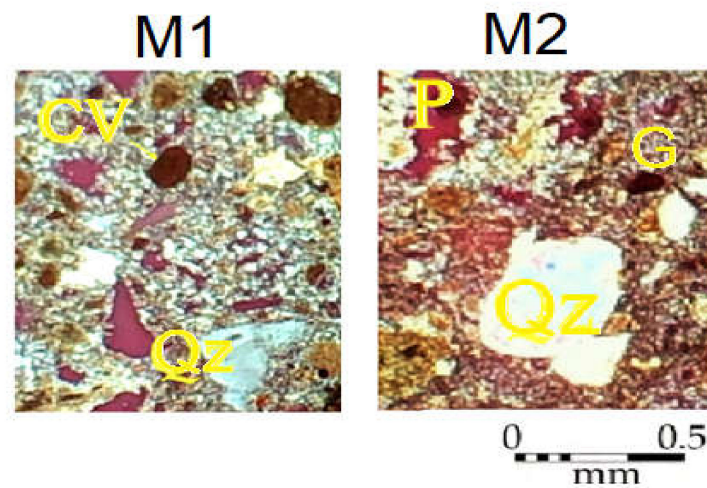
M1 has aggregates composed mostly of quartz with the size around 100–200 μm , with vegetal fragments. M2 has aggregates from quartz fragments and pores without any filling, as shown in Figure 4. This last sample has been detached from a brick most probably used at the last restoration work.

Figure 4. The microscopy image of the sample collected from DT (Qz = quartz; P = pore; L = lump; CV = calcined vegetable; G = Gypsum): mortars (M1, M2). The lumps could be identified as impurities from bricks possibly used at the recent restoration works.

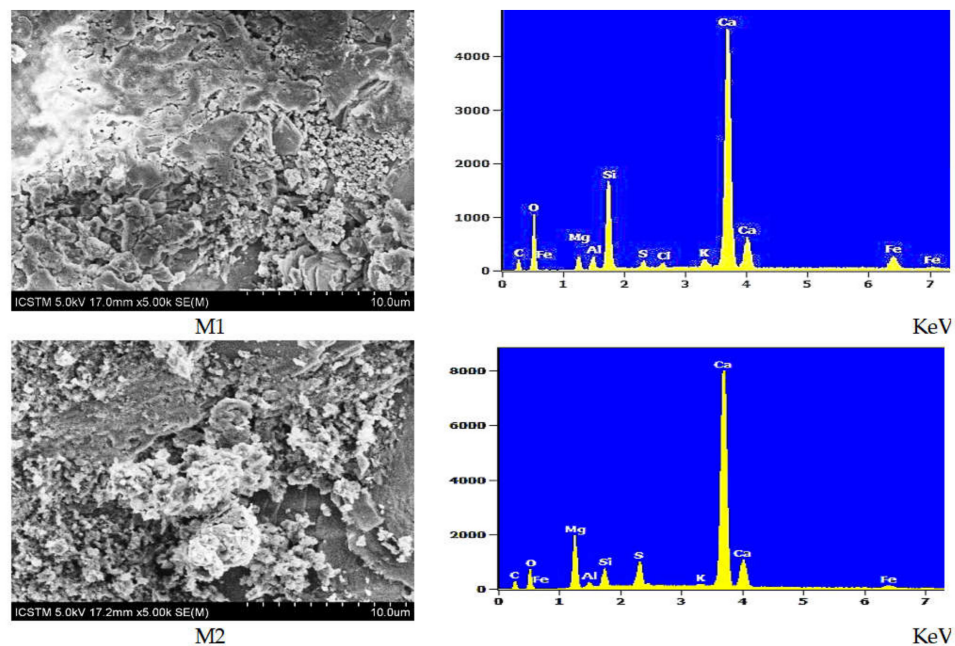
The presence of calcite, quartz, dolomite, gypsum etc. in different proportions could be proved by EDS technique, too, with the results presented in Figure 5 and Table 1. The mineralogical analysis with XRPD indicated the presence of these minerals, as shown in Figure 6 and Table 2.

Figure 5. FE-SEM images of the DT samples recorded at Vacc = 5 kV, WD = 18.4–18.7 mm, 3000× magnification (M1 and M2). The EDS patterns of the DT samples—the main element compositions are labeled (M1 and M2).

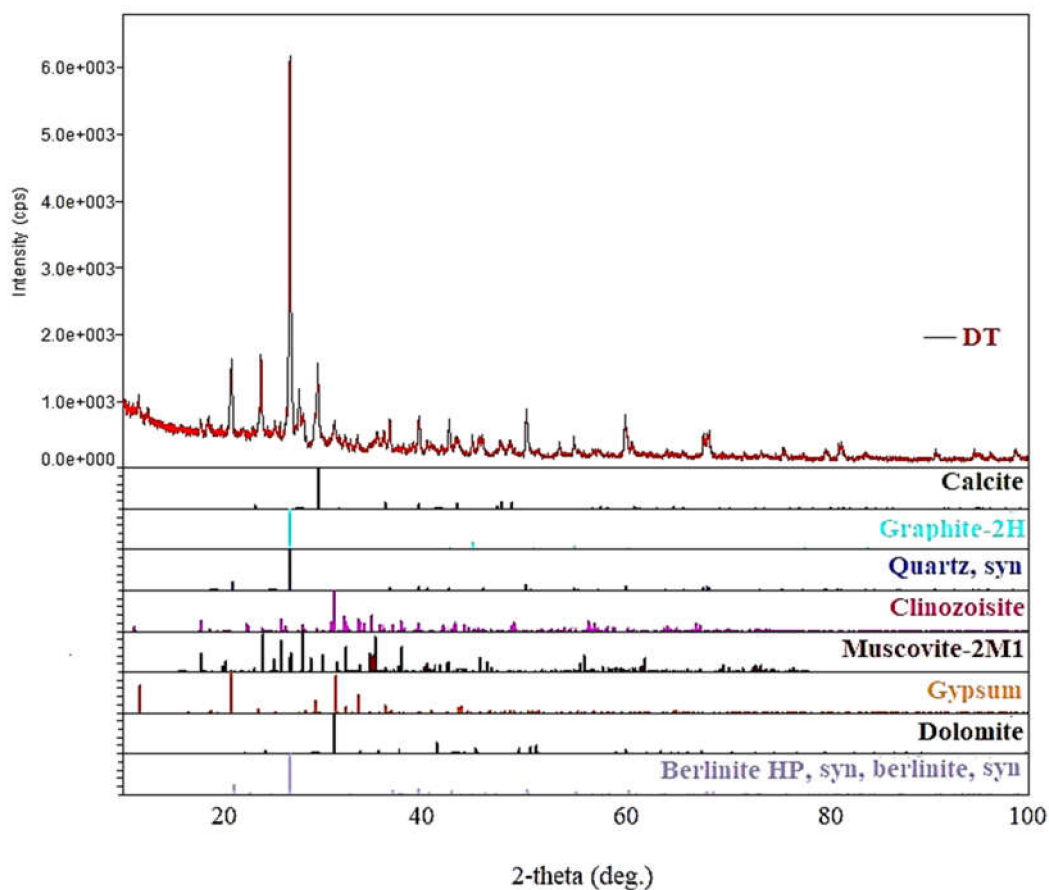
**Figure 6.** The X-ray powder diffraction (XRPD) diagram for the mortar sample with a Rietveld processing diagram.**Table 2.** XRPD peaks information.

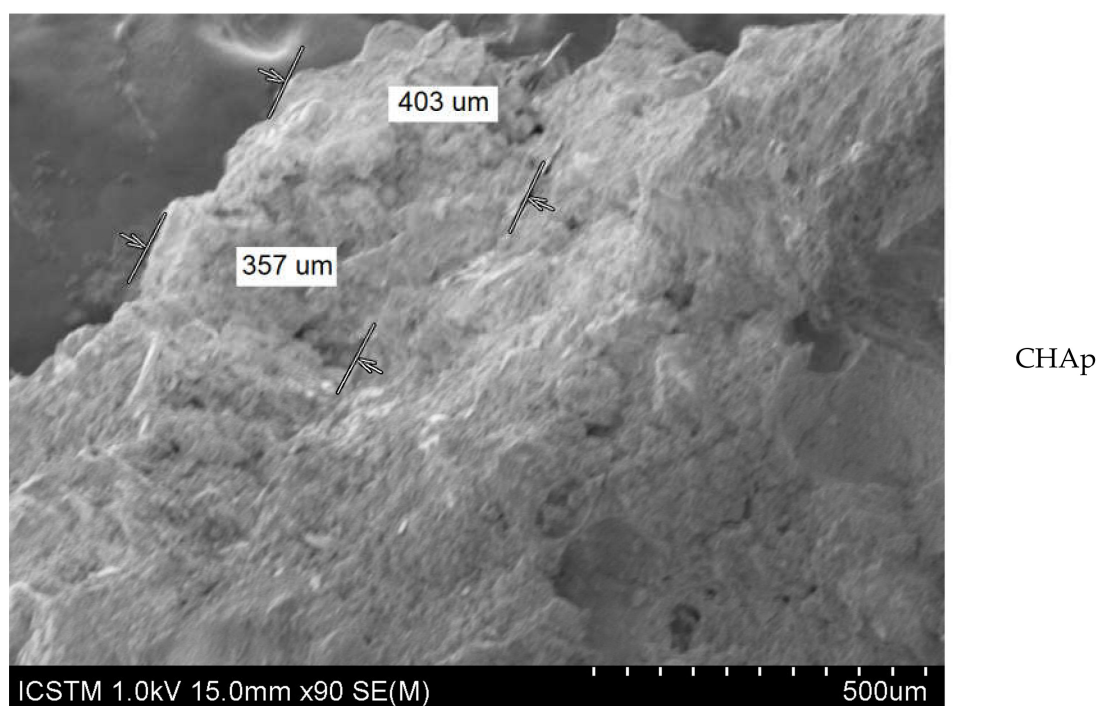
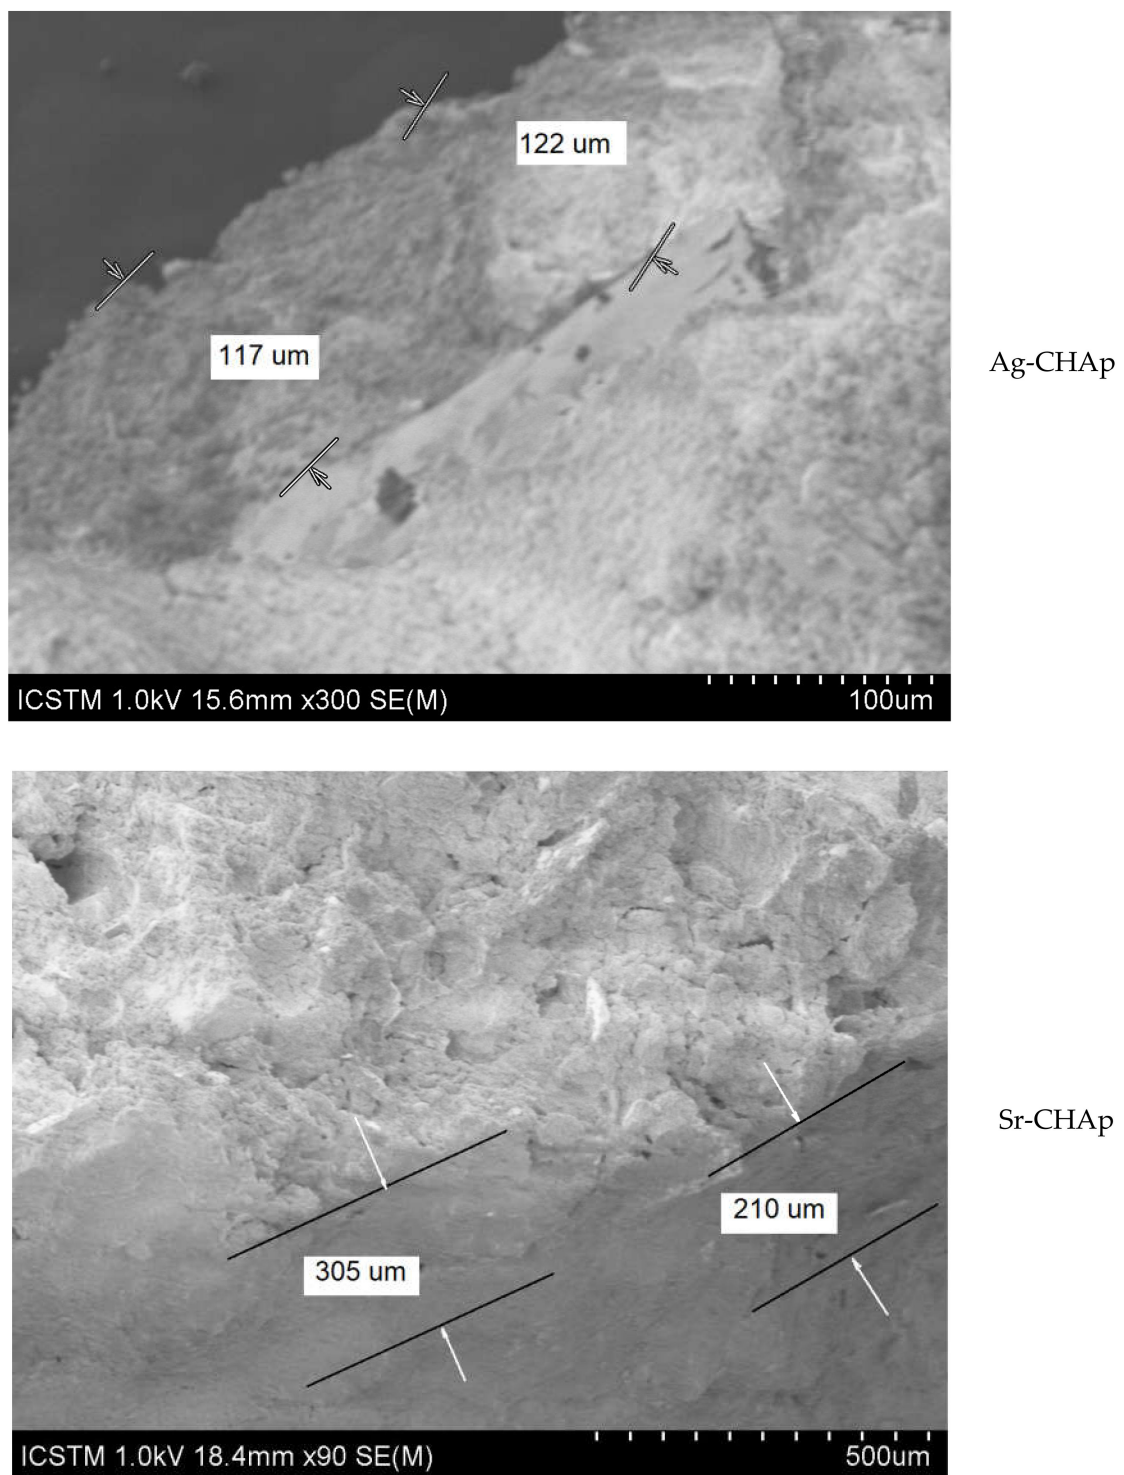
In Figure 7, SEM images for the samples collected from Corvins' Castle—DT treated with CHAp, Ag-CHAp, and Sr-CHAp are presented.

Figure 7. SEM images of mortar treated with CHAp, Ag-CHAp, and Sr-CHAp.

By brushing the carbonated hydroxyapatite derivatives on the samples, some layers with thicknesses between 100 and 400 μm are formed. The thicker layer is visible for Ag-CHAp, most probably due to the agglomeration capacity of this compound. These statements could be proved by the sizes of CHAp derivative particles measured by TEM. The obtained images show semi-spherical shapes, with a polydispersity, and agglomeration of small grains that form a grain of higher dimension, as shown in Figure 8, which is more accentuated for Ag-CHAp than for the others. TEM analysis confirms the presence of the different shape morphology (spherical or irregular polygon) of the prepared CHAp (a) and its derivatives with with Ag (b) or Sr (c). The particles' diameter varies from 100 to 700 nm, as shown in Figure 8.

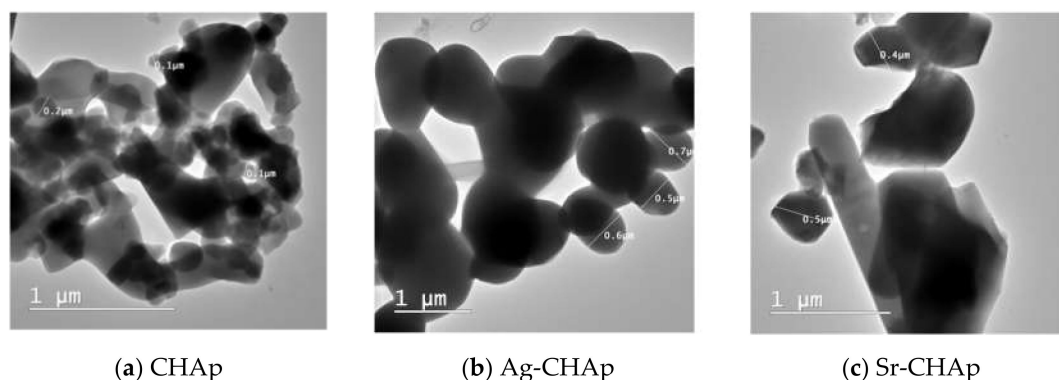
Figure 8. TEM images for CHAp (a), Ag-CHAp (b), and Sr-CHAp (c) particles.

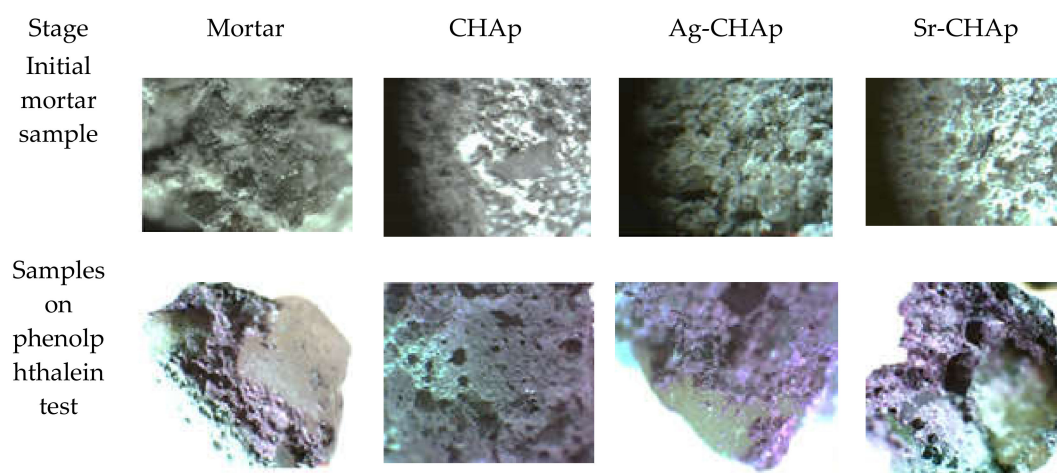
After performing the test with phenolphthalein solution (1 g phenolphthalein + 70 mL ethanol + 30 mL water) it can be observed that the areas exposed to the solution remained colorless, which means that the pH in the respective area is lower than 8.6 (suggesting carbonation), as shown in Figure 9. All these visual observations could be an indicator of the different restoration actions by using cement or concrete-based materials, which previously occurred at this tower.

Figure 9. Phenolphthalein tests for non-treated and treated DT samples.

After performing the test with phenolphthalein solution, it can be observed that the areas exposed to the solution remained colorless, which means that the pH in the respective area is lower than 8.6 (suggesting carbonation), due to the cement or concrete-based materials used for previous restoration or consolidation of this tower.

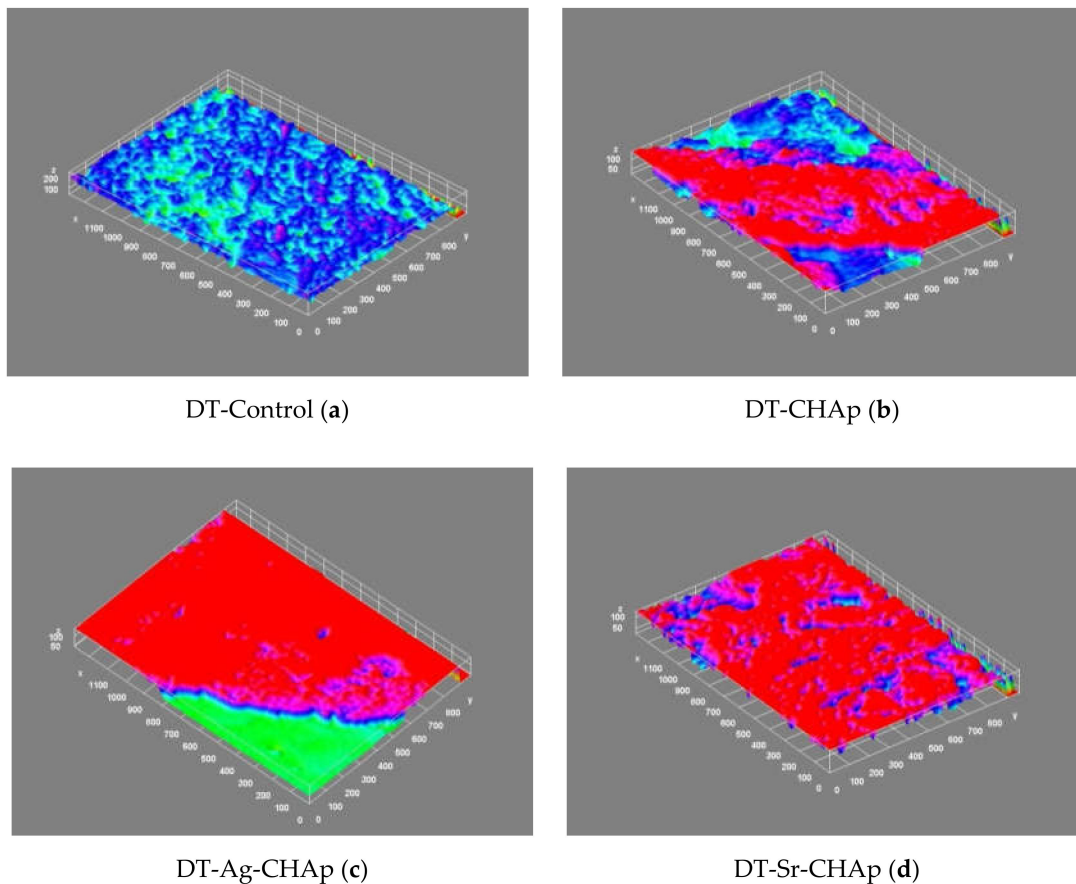
The sample collected from Corvins' Castle—DT has a uniaxial compressive strength of 7.92 MPa, so it is a soft stone (corresponding to a UCS between 15 and 5 MPa). Being a soft stone, no additional mechanical measurement was possible, so only a visual comparison of the estimated surface roughness of the investigated samples was preferred, generated based on the SEM images, using a dedicated image enhancing software. The microstructural surface features of the material are suggestively presented in Figure 10, in which the valleys marked with dark blue indicate the location of the pores within the material and the peaks marked with red are a predictor of the higher roughness of the material. Red peaks were observed mostly for samples treated with Ag-CHAp and Sr-CHAp, indicating a higher roughness of the material. The results presented in Figure 10 offer a general perspective on the surface roughness. It was observed that the historical surface of Sr-CHAp was closer to the control one.

Figure 10. Estimated surface roughness using ImageJ.

Being a soft stone, no additional mechanical measurement was possible, so it was preferred that only a visual comparison of the estimated surface roughness of the investigated samples was conducted, generated based on the SEM images, using dedicated image enhancing software. The microstructural surface features of the material are suggestively presented in Figure 10, in which the valleys marked with dark blue indicate the location of the pores within the material and the peaks marked with red are a predictor of the higher roughness of the material (Sr-CHAp was closer to the control one).
