Physical–Mechanical and Mineralogical Properties of Fired Bricks of the Archaeological Site of Harran, Turkey

Abstract: In this study, the physical–mechanical and mineralogical properties of bricks used in historical structures of the site of Harran, Turkey have been investigated. Harran was destroyed by the Mongol army, during the Turkish reconquest campaign around the 1260s. The remains of the buildings made of bricks and basalt/limestone were recently uncovered almost in their entirety. Several brick samples have been taken from the burial mound, the university, the city walls, the castle, and the great mosque. From the visual analyses, it was noted that the bricks have unique colors such as pottery, desert beige, and canyon. Physical analyses show that the absorption rates of the bricks are between 17.30–38.12%, their densities between 1.33–1.70 g/cm³, and porosities between 8.88–25.31%. For the mechanical analyses, the bending strengths have been found to be between 0.82–1.86 MPa and compressive strengths between 6.69–7.95 MPa. The thin-section images show that the bricks contain calcite, muscovite, and plagioclase quartz and pyroxene minerals.

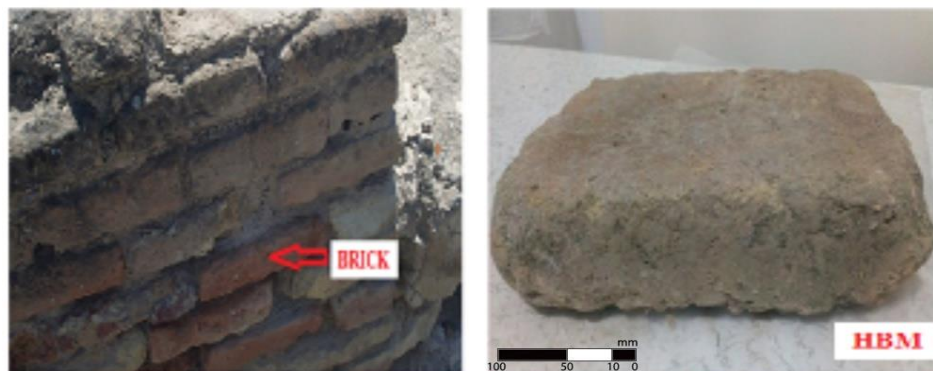
Figure 4. Brick sample taken from the burial mound (HBM).

Five brick samples were taken from different historical ruins of the city: the burial mound, the university, the city walls, the castle and the great mosque, from undisturbed parts of these buildings. While extracting the brick samples, special attention was paid not to spoil the unique structures of the bricks and photos of places from where the samples were taken, and photos of the taken brick samples were filed. The five selected buildings are shown in Figure 3. A detail of a wall of the burial mound is given in Figure 4.

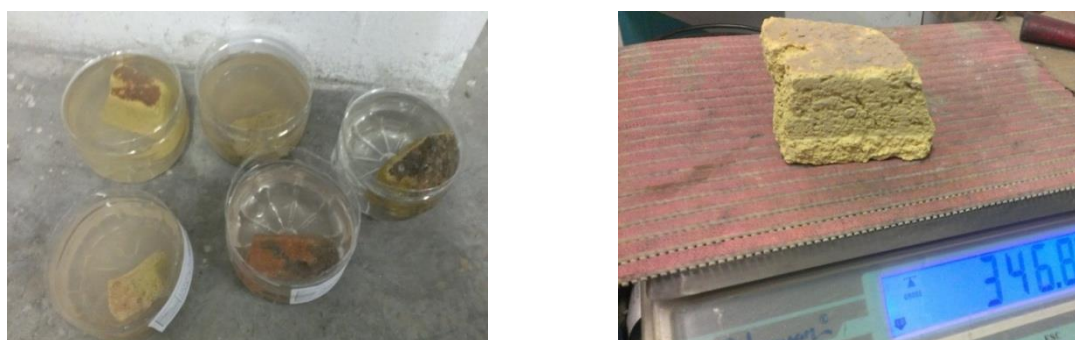
**Figure 6.** Water absorption tests.

Physical analyses allowed us to determine the water absorption rates by weight and by volume of the brick samples. Apart from the compressive strength, it is well-known that water absorption is an important property in brickwork masonry. This property can affect the quality of the brick itself and the bond strength between the brick and mortar in masonry structures and can result in reducing its strength properties. The authors [25] have previously conducted an experimental investigation to assess the physical, mineralogical, and chemical properties of the lime mortars used in the monuments of Harran. The test results carried out on the lime mortar and on the units (i.e., the bricks) could be critical for any future conservation measure and assessment of the structural safety of the masonry structures of the site of Harran: this could highly facilitate the estimation of the mechanical properties of the brickwork masonry. Water absorption rates by weight and by volume of the samples are given in Table 3. Figure 6 shows the tested specimen during soaking in water.

The water absorption rates of the brick samples by weight vary between 17.30% and 38.12%. The lowest water absorption rate by weight was obtained from brick samples taken from the city walls. The highest water absorption rate by weight was obtained from brick samples taken from the great mosque. The water absorption rates by volume of the brick samples vary between 25.54% and 45.43%. Brick samples taken from the castle have the lowest water absorption rate by volume. A mortar sample taken from the great mosque has the highest water absorption rate by volume. When the water absorption rates of the brick samples are evaluated in accordance with Turkish Standard 704 [54], it is seen that the water absorption rates are high. The reason for this might be the method or the ingredients used during their production.

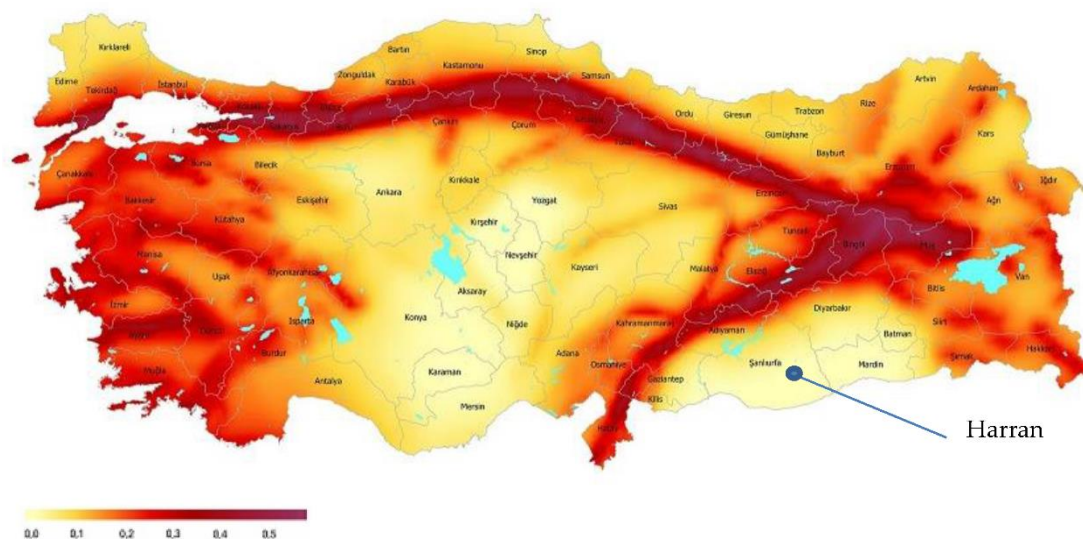
Figure 7. Seismic risk map of Turkey [56], in terms of the ratio between peak ground acceleration a_g and g (g = acceleration of gravity), for a probability of exceedance of 10% in 50 years (475 years return period).

Quaternary period, being the most recently laid geologic strata. Based on the low seismic risk of the area of Harran and its geology, with likely a low local amplification over a rocky soil, we can conclude that the seismic hazard for the site of Harran is relatively low. However, the site deserves a more in-depth analysis, also considering hazards from climate change (heavy rain falls, flooding, etc.) and their combined effects on the masonry monuments of Harran.

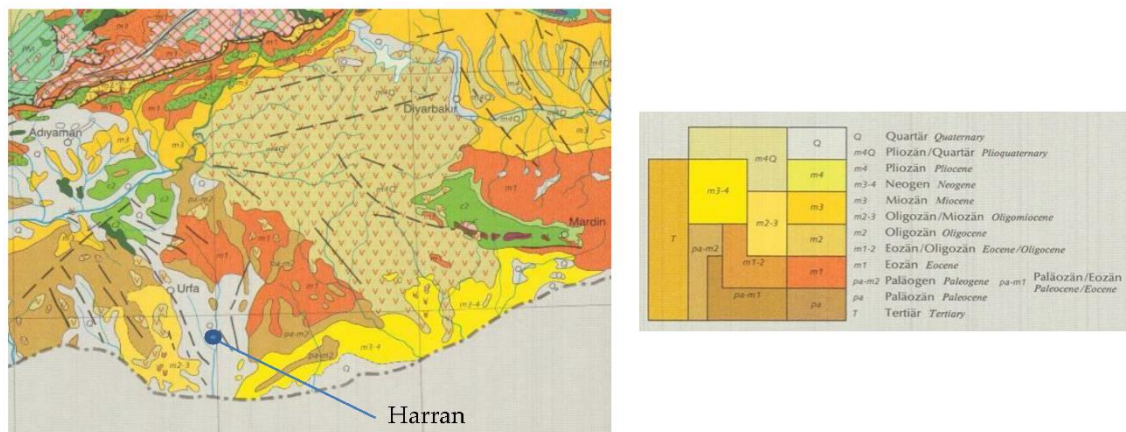
Figure 8. Geology of the area of Harran.

A large amount of information is available about the geology of the region of Harran. This is located in the basin of the Balikh river. This joins the Euphrates at the modern city of Raqqa. Figure 8 shows a geology map of the area of Harran: it can be noted that the rocks of the valley belong to the

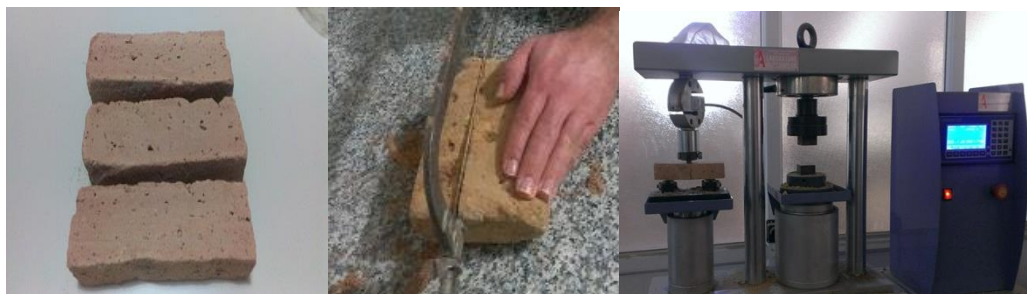
Figure 9. Specimen preparation and instrumentation used for bending and compression tests.

Figure 9 shows several brick specimens before these were reduced to the standard testing dimensions. This figure also shows the testing instrument used for both bending and compression tests. The bending strengths σ_{bend} of the brick samples vary between 0.82 and 1.86 MPa. The brick sample with the highest bending strength is the one taken from the burial mound. The brick sample with the lowest bending strength is the one taken from the great mosque.

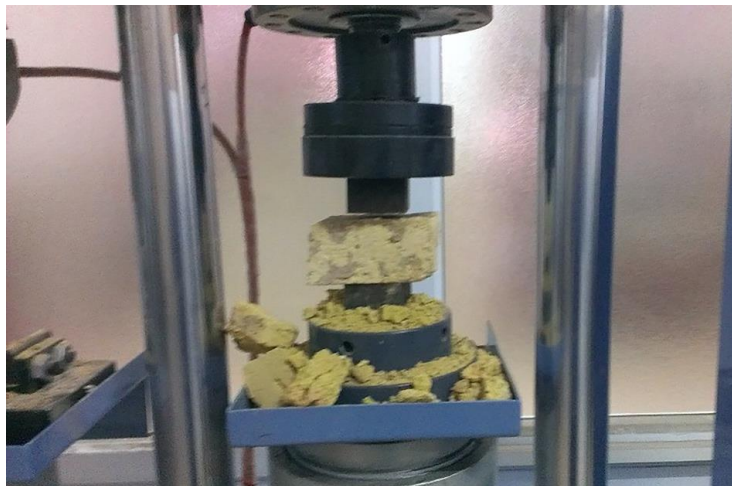
Figure 10. Compression test: the crumbling failure mode of brick specimens subjected to a compressive loading can be noted. This was the consequence of the low compressive strength and porosity.

The compressive strengths σ_{compr} of the brick samples vary between 6.69 and 7.95 MPa. The brick sample with the highest compressive strength value is the one taken from the burial mound. Figure 10 shows a brick specimen before being subjected to the compressive load: the underlying brick debris from previous tests clearly demonstrate that the samples' failure mode was due to crumbling/pulverization of the tile material. This is a well-known failure mechanism that is normal for low-strength, porous masonry materials [57].

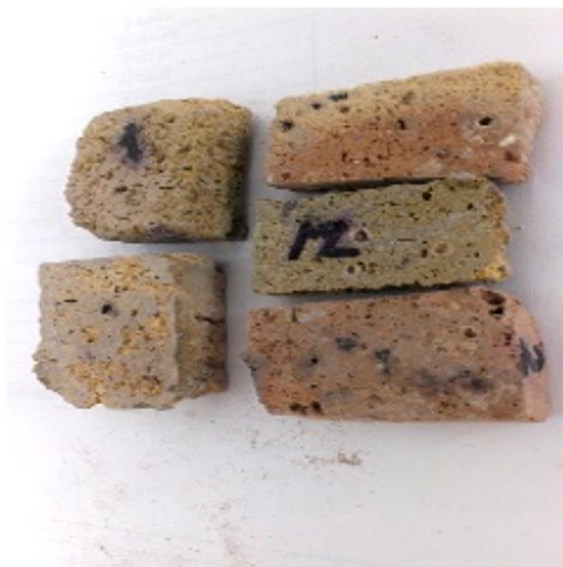
Figure 11. Detail of the brick cross-section.

The sample with the lowest compressive strength value is the one taken from the city walls. According to previous studies [58], it is possible to say that the compressive strength values of the brick samples are very similar and in a limited range (6.69–7.95 MPa). This could suggest that the Harran monuments, constructed in different periods of time, have been manufactured using a similar or non-time-varying technology, labor, resources, and environmental conditions. This could strengthen the hypothesis that local skills, construction materials, and methods were passed down from father to son for generations in family brick companies, also considering the frequent changing of rulers (from Parthians to Romans, from Byzantines to Arabs, and finally to the Mongols and Turkish). The thin-section images of the five brick samples taken from the historical structures are quite similar to each other (Figure 11).

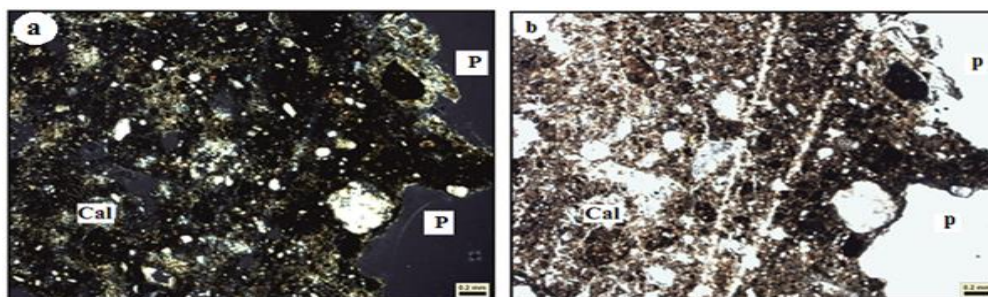
Figure 12. Photo micro graphs of polished thin sections of the HH brick sample, (a) in cross-polarized light and (b) in plane-polarized light (P: Pore, Cal: Calcite).

In order to scan the minerals and the pores in the brick samples more clearly, single- and two-Nicol prism filters were used to capture the images. There is an excessive amount of calcite mineral in the HBM brick sample. Also, it can be noted that it contains muscovite, plagioclase, and oxide minerals. These minerals are bonded with calcite (Figure 12). Excessive amounts of calcite mineral are also present in the HU brick sample. It was also concluded that it has a porous structure, containing,

in addition to calcite minerals, plagioclase and quartz minerals. Plenty of quartz and calcite minerals are present in the HCW brick sample, consisting of tiny grains.

5. The minerals seen in the thin-section images of the bricks are cryptocrystals, quartz, ferro magnesium, calcite, and opaque minerals. It can be said that the ferro magnesium minerals within the bricks provide a binding material support to the bricks by decomposition.
