Review

# Influence of Environment on Microbial Colonization of Historic Stone Buildings with Emphasis on Cyanobacteria

Christine C. Gaylarde

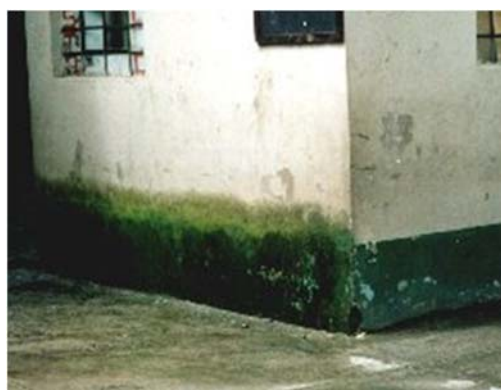
**Figure 1.** Heavy algal growth on the wet pediment of a building in Aguas Calientes, Peru.

Both algae and cyanobacteria can produce thick green biofilms in areas of high humidity (Figure 1), but in less wet areas the colors may vary, especially in the case of cyanobacteria (Figures 2 and 3).

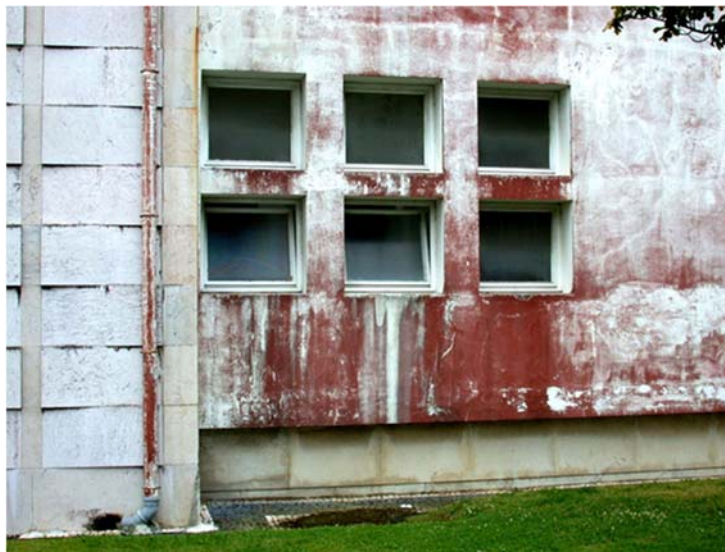
**Figure 4.** *Trentepohlia* algae forming deep red discoloration on the painted wall of a public building in Ponta Delgada, Azores, Portugal.

Not only cyanobacteria, but also some algae, can be responsible for non-green discolorations. An excellent example is the filamentous alga *Trentepohlia*. Although classified with the green algae, these cells are frequently identified when growing on external walls by their red coloration (Figure 4), caused by carotene-containing oil droplets within the cells.

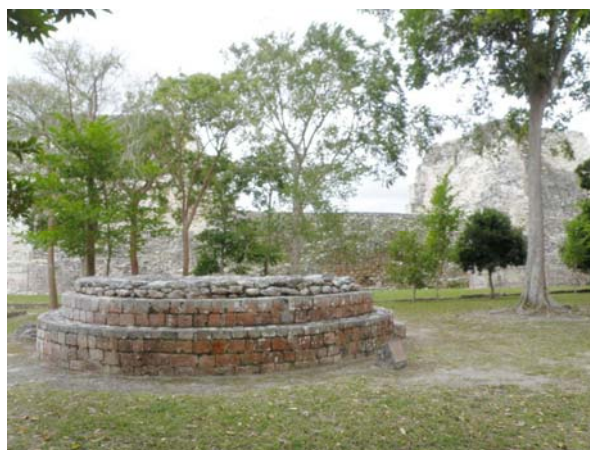
**Figure 5.** Stone altar in the architectural zone of Becan, Campeche state, Mexico, showing red staining (*Trentepohlia*) on North and East facing sides.

On the Rio Bec style Mayan buildings at Becán, Chicanná and Hormiguero (Campeche state, Mexico) it was found that red colorations caused by these algae were predominantly associated with North- and East-facing walls (Figure 5), or on otherwise orientated sites protected by tree canopies or architectural elements [19]. On more exposed sites, grey-black discoloration composed of dehydration- and UV-resistant cyanobacteria (the most common being the coccoid genera *Gloeocapsa* and *Chroococcidiopsis*) was dominant.

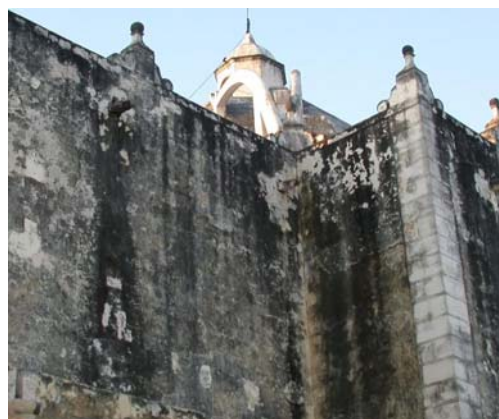
**Figure 8.** Black cyanobacterial crusts on the walls of the Our Lady of the Immaculate Conception cathedral in the center of Campeche, Campeche state, Mexico.

Black crusts of different origin can also be seen, however, on buildings in unpolluted environments. On historic baluartes (forts) and the cathedral in Campeche, Yucatan peninsula, Mexico (Figure 8), these black crusts were found to be composed almost entirely of Subsection IV and V filamentous cyanobacteria (as defined by [37]). The cells did not penetrate into the limestone, but remained as readily detached surface layers, leading to degradation by differential heating and water retention effects [38].

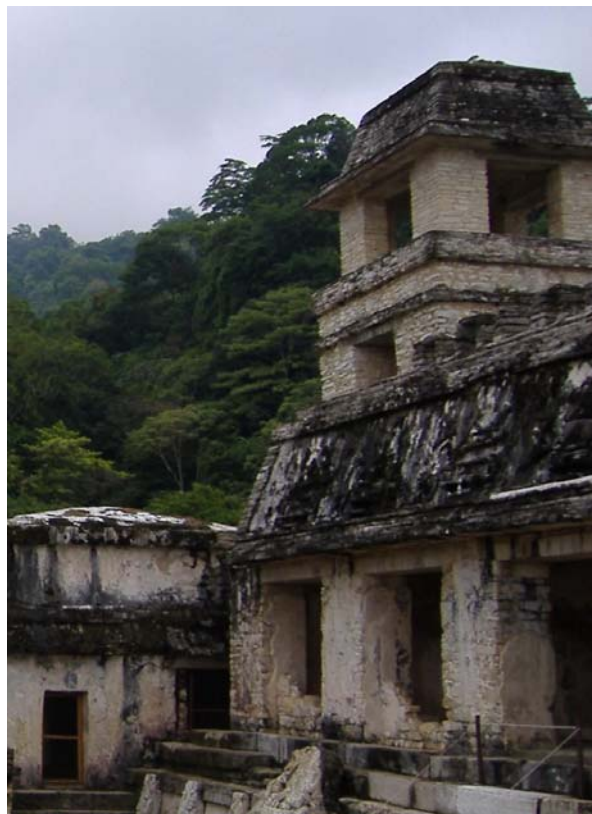
**Figure 9.** Thick black biofilms on buildings in the patio of the Captives, Palenque, Mexico.

important factor. Considering the primary colonizers, the body of work on cyanobacteria indicates considerable dependence of biofilm biodiversity on the level of humidity. Miller et al. [54] found that high values of water absorption by capillarity and open porosity of various types of limestone determined their bioreceptivity for the primary phototrophic colonizers. Subaerial biofilms on monuments in Eastern India varied greatly in their biodiversity between the hot tropical summer and the rainy season [55]. The only phototrophs detected during the former were cyanobacteria of the genera *Gloeocapsa*, *Gloeocapsopsis*, *Porphyrosiphon*, *Leptolyngbya*, *Lyngbya*, *Phormidium*, *Nostoc*, *Scytonema*, *Tolypothrix*, *Hassallia* and *Stigonema*. During the rainy season, however, the biofilms were more diverse, also containing *Cyanosarcina*, *Gloeocapsopsis*, *Phormidium*, *Pseudophormidium*, *Schizothrix*, *Lyngbya*, *Plectonema*, *Nostoc*, *Scytonema*, *Tolypothrix*, *Dichothrix* and *Calothrix*, together with the green alga *Chlorella sphaerica*. Ortega-Morales et al. [9], in their meta-analytical study, found that precipitation level was more important for overall phototroph growth, rather than for phototroph diversity. Thickest biofilms were present at the highest rainfall sites, Palenque, Mexico (Figure 9) and Laos, with precipitation levels of 2697 mm/y and 2069.5 mm/y, respectively, but the highest level of diversity was found at the Argentine missions, with an annual rainfall of 1281.7 mm/y and a rather low mean annual temperature of 19.2 °C. Biofilms at the latter site were, however, relatively thin.
