An Integrated Geometric and Material Survey for the Conservation of Heritage Masonry Structures

Citation: Betti, M.; Bonora, V.; Galano, L.; Pellis, E.; Tucci, G.; Vignoli, A. An Integrated Geometric and Material Survey for the Conservation of Heritage Masonry Structures. *Heritage* **2021**, *4*, 585–611. <https://doi.org/10.3390/heritage4020035>

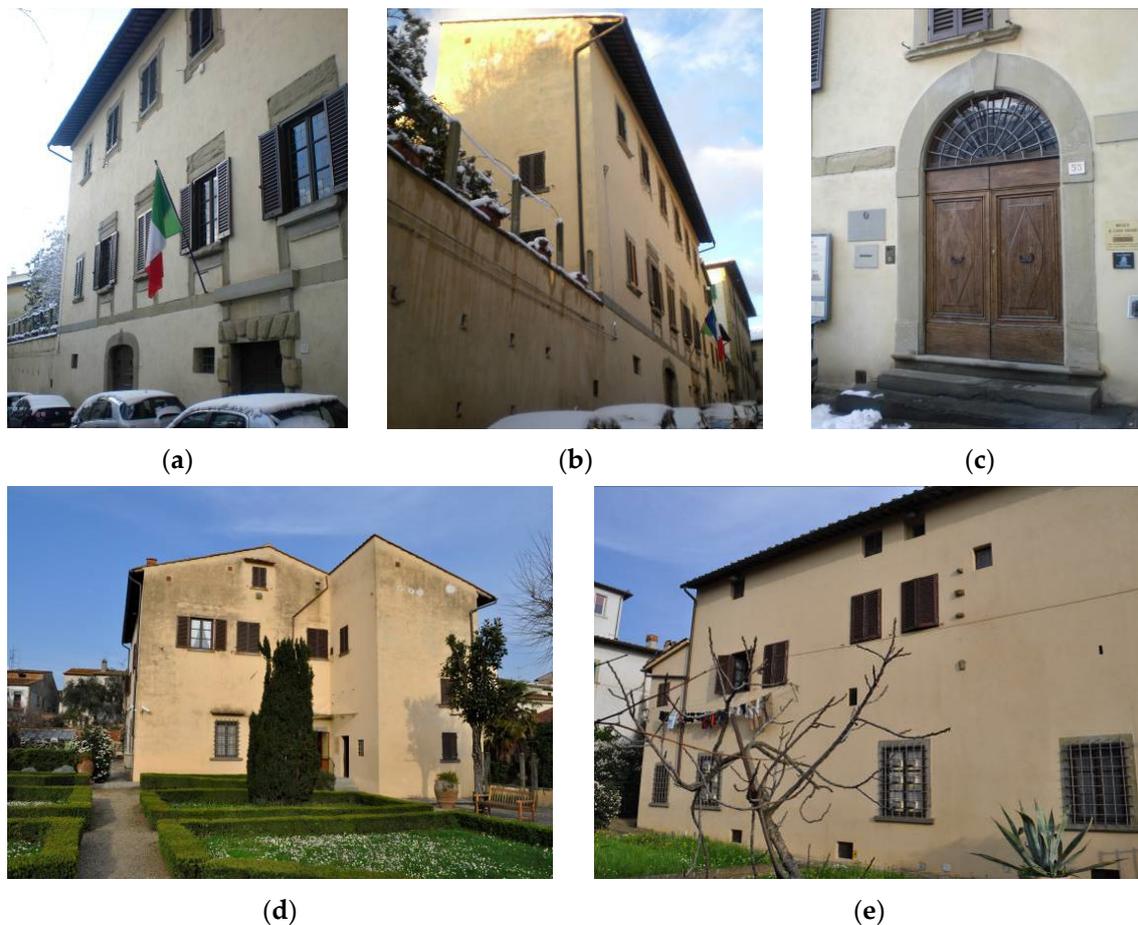
Figure 1. Views of the façades, (a–c) South-East front façade, views from the street (via XX Settembre), (d) South-West rear façade, (e) North-West rear façade.

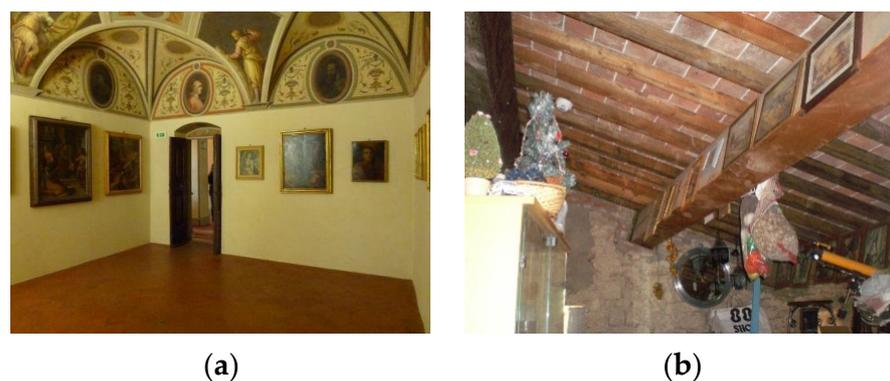
Figure 2. Internal views, (a) First floor, (b) Timber roof.

Inside the museum is kept the so-called Vasari Archive, a collection of sketches, paintings and private letters by Pope Pius V and Cosimo I de' Medici. Figure 2 shows some internal views of the museum.

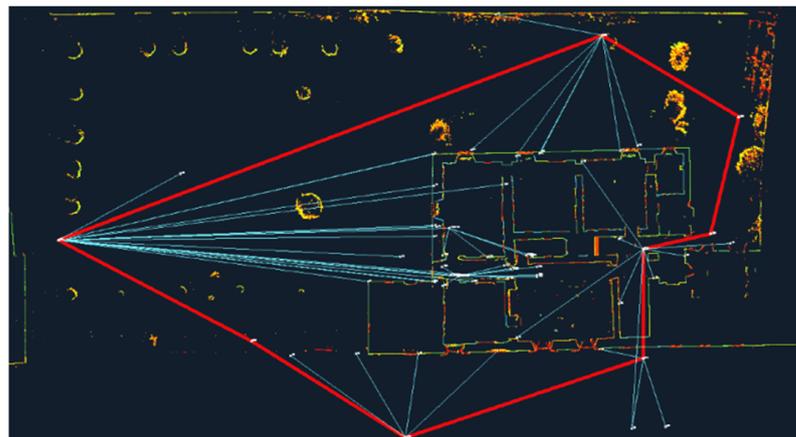
Figure 3. Control network supporting the 3D laser scanning survey.

The topographical survey is the least noticeable phase of the 3D survey, whose traces are not evident in the three-dimensional models and the final drawings. However, at the same time, it is the geometric structure that guarantees the reliability of the entire survey and is the way to correctly connect all the spaces, internal and external, of the building. It is in fact a matter of determining the position of a few points, whereas laser scanning and photogrammetry generate multi-million-point models. Yet, the control network plays a key role: in the Vasari's House museum, it consists of eight vertices. They are in the street in front of the building, in the back garden and at the beginning and end of the stairs leading to the main floor and a closed traverse connects them. A large part of the rooms on the second floor and in the attic were reached from the traverse vertices with topographic measurements through the windows (Figure 3).

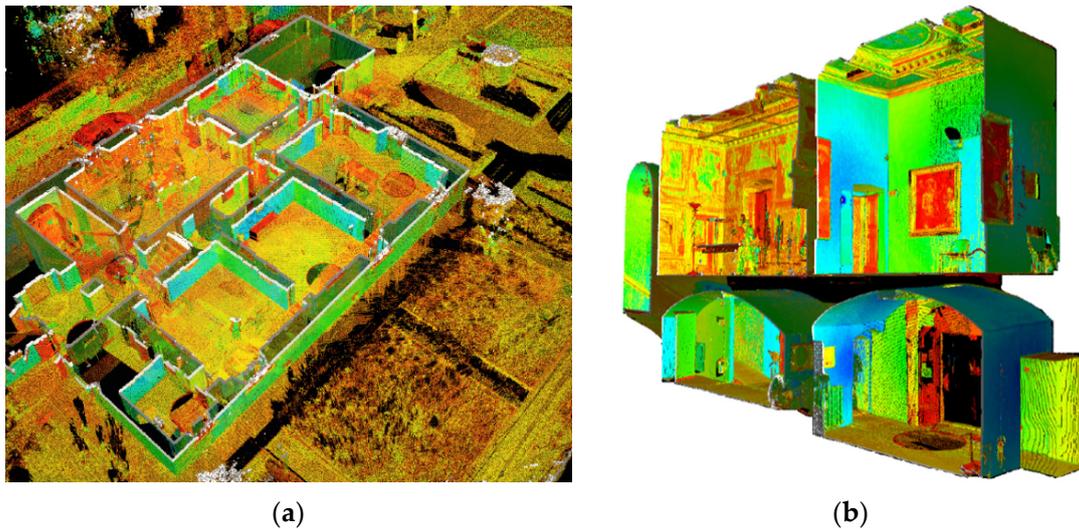
Figure 4. Digital reconstructions of the museum, (a,b) tridimensional views.

A terrestrial laser scanner has acquired the high-resolution 3D model. Fifty scan positions were set up in most of the rooms and all around the building, acquiring data with a 360° field of view. Forty-seven targets were measured starting from the control network and supported the alignment of the scans, further optimized by a global registration based on Iterative Closest Point (ICP) algorithm. Furthermore, 762 million points made the final 3D model (Figure 4).

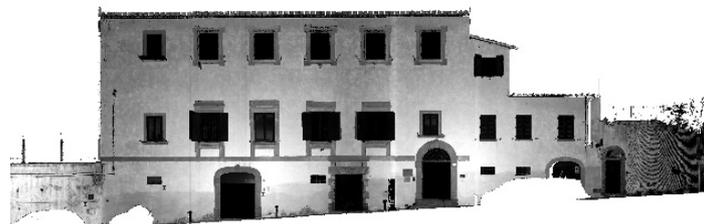
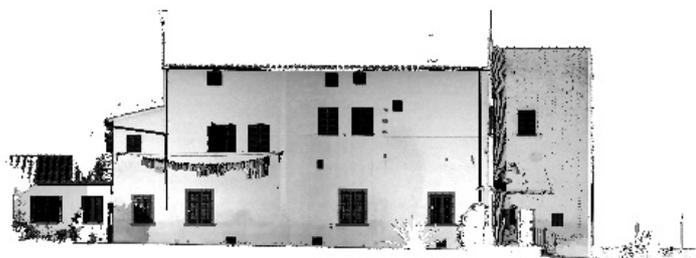
Figure 5. Orthoimages of the main façades (front (a) and rear (b)).

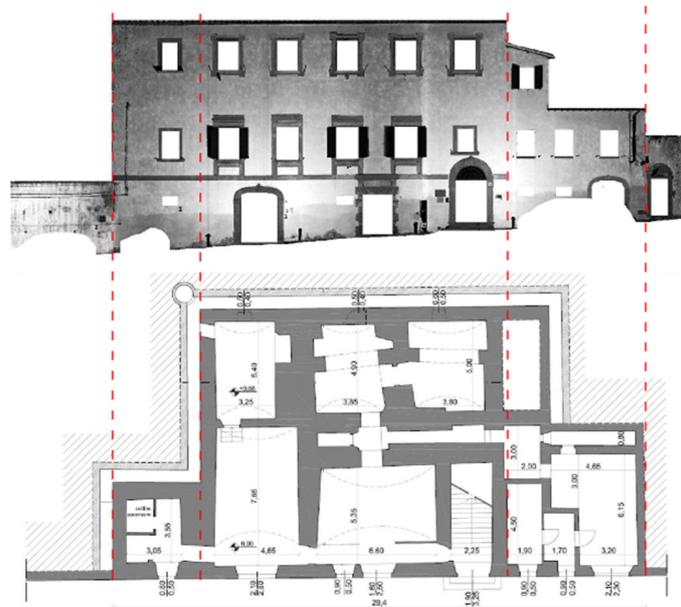
Figure 6. Representation of the façade on via XX Settembre and of the ground floor.

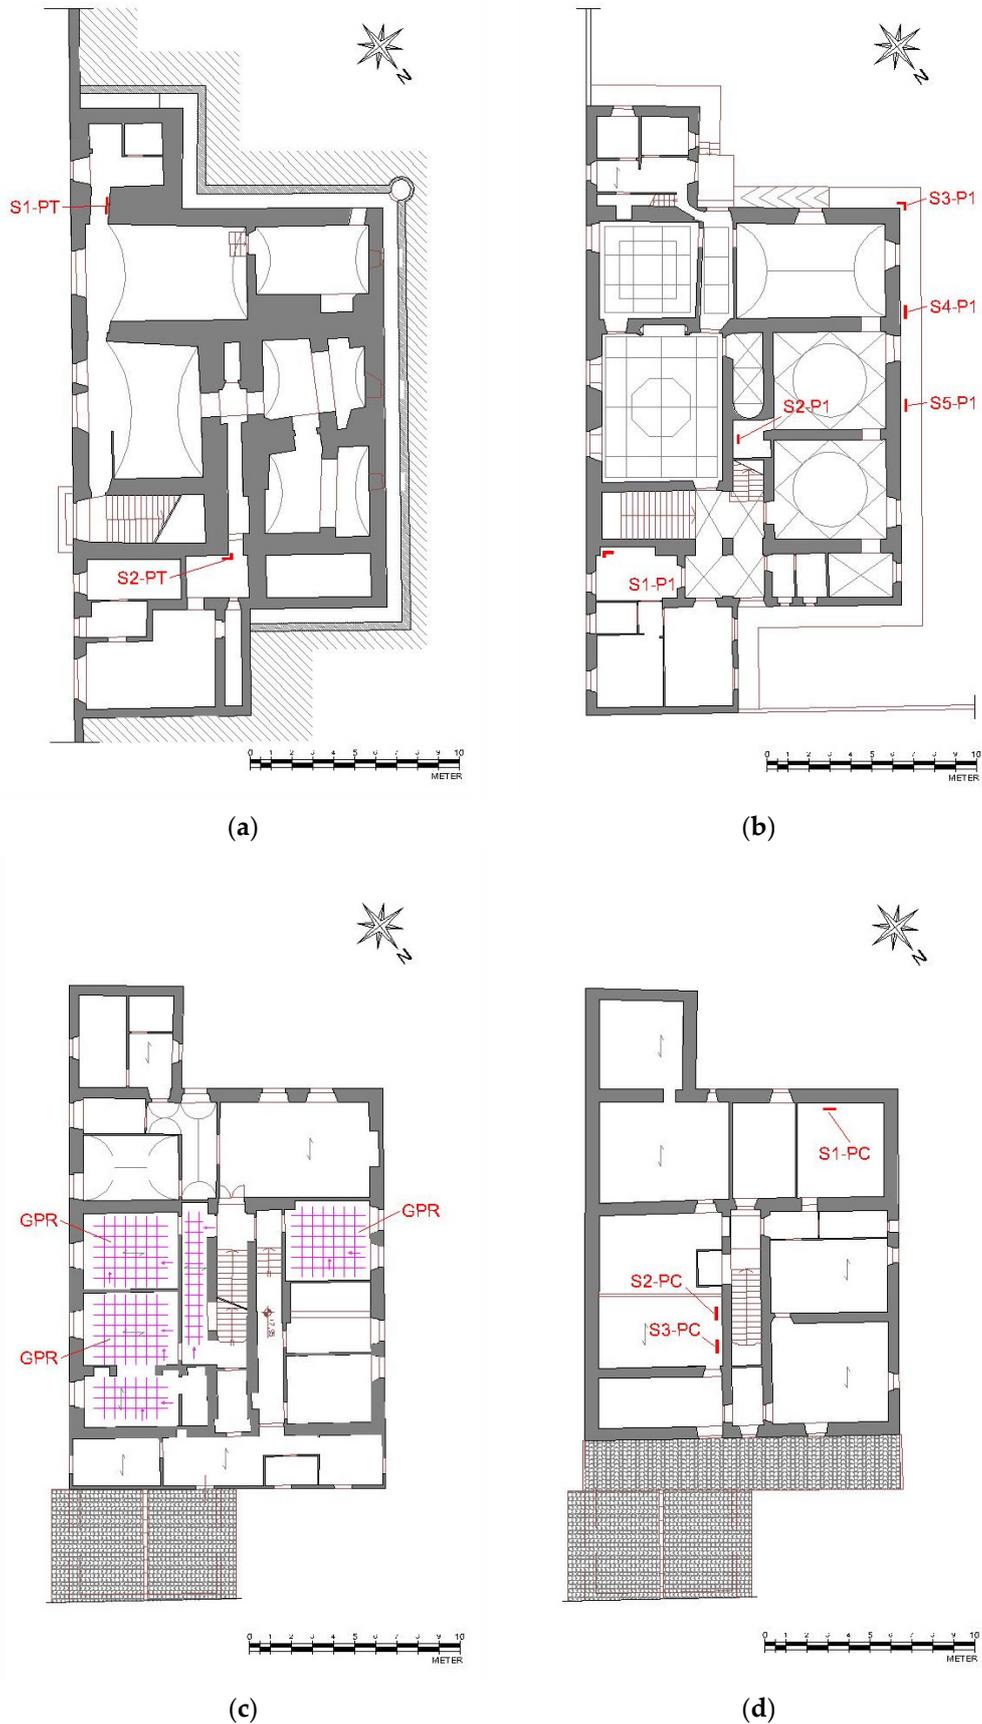
Figure 7. Plan layouts of the building with the positions of the tests, (a) ground floor, (b) first floor, (c) second floor, (d) attic.

A comprehensive survey composed by visual inspections and in situ tests was performed to assess the masonry typologies, the mortar quality, the typology of floors and roof and the effectiveness of the connections between the walls. The type and the position of the tests are resumed in Figure 7, and they included: 10 visual inspections on masonry (S) in different zones selected based on the historic survey, two flat-jack tests (FJ), 3 mechanical investigation of the mortar by the Drilling Resistance Measurement System (DRMS) technique [31] and a Ground Penetrating Radar (GPR) test to investigate the structure of the second level floor. Chemical analysis and X-ray diffraction analysis on three samples of mortar were also performed, as well as a complete exploration of all external and internal walls to detect cracks and defects.

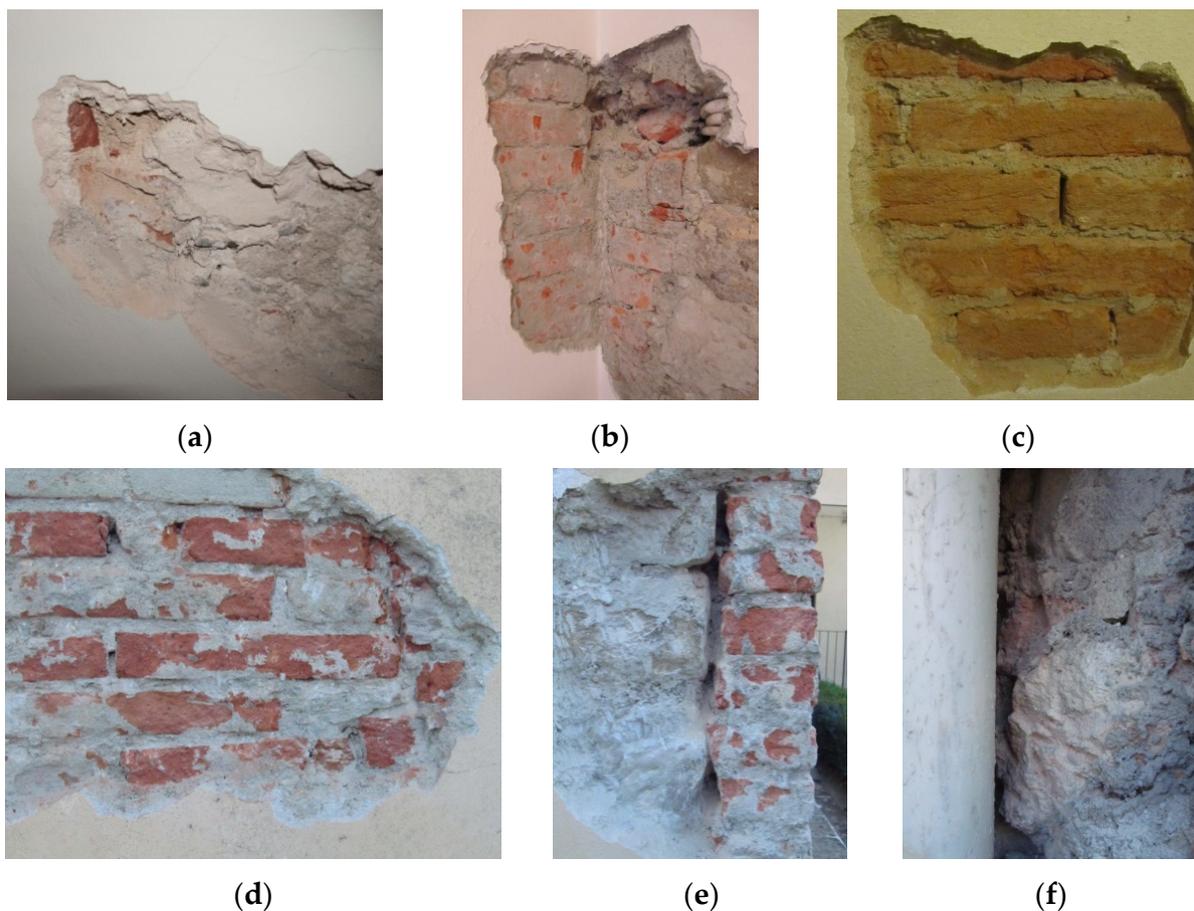
Figure 8. Details of the different textures of the walls, (a) S1-PT, (b) S1-P1, (c) S2-P1, (d,e) S3-P1, (f) S4-P1.

The examination of the walls in the zones S1-PT and S2-PT, which belong to the original nucleus of the building, evidenced single leaf walls constituted by irregular stone blocks with different sizes, few inclusions of bricks, mortar of low quality and a thickness of the plaster in the range 2–5 cm. A similar typology was detected in the zone S1-P1. The internal wall in the zone S2-P1 is made by a three heads regular brick masonry (with average dimensions of the units of 29 cm × 14.5 cm) and lime mortar with thickness of 1.5 cm.

The inspection in the zone S3-P1 was performed in an external corner of the building to detect the connection between the two orthogonal walls. The presence of a leaf of brick masonry with one head added on the original stone masonry wall is evident (Figure 8). Again, in the zones S4-P1 and S5-P1 the walls are made by a prevalence of irregular stone masonry with several inclusions of bricks and lime mortar with high thickness (3.5–4 cm). In the zones S1-PC, S2-PC and S3-PC (in the attic) the walls are made in prevalence of stone masonry with chaotic texture with some strips of bricks (S2-PC). This investigation allowed us to conclude that the vertical structures are mainly constituted by disorganized stone masonry walls along the perimeter (with thicknesses of about 1 m at the ground floor) and brick masonry walls for some of the internal alignments.

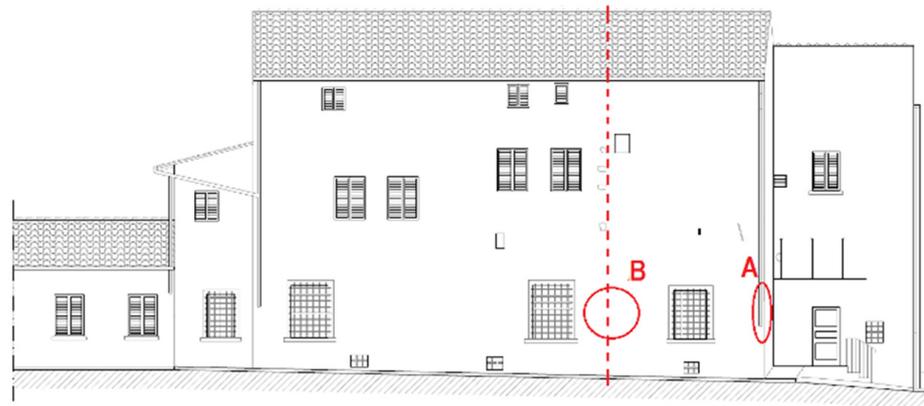
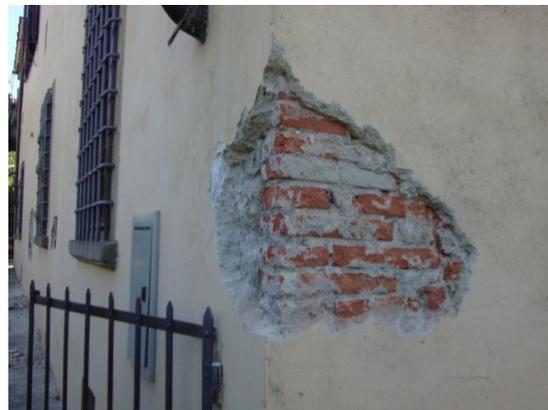
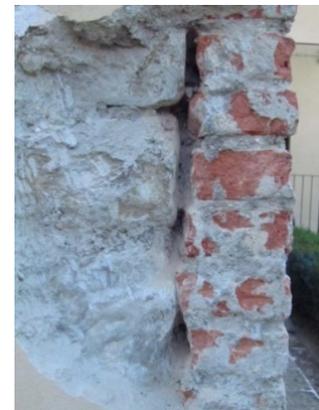
Figure 9. Vertical discontinuity on the Nord-West façade detected during the survey, (a) North-West façade, (b,c) Zone “A”, detail.

During the experimental campaign, some specific aspects were found. Particularly significant is the presence of a vertical discontinuity in the perimeter wall on the North-West façade (the one facing the garden), which seems to run throughout the whole height (line “B” in Figure 9). In addition, under the plaster on the corner (area “A” in Figure 9a), a one-left layer of bricks was found to cover the masonry stone wall.

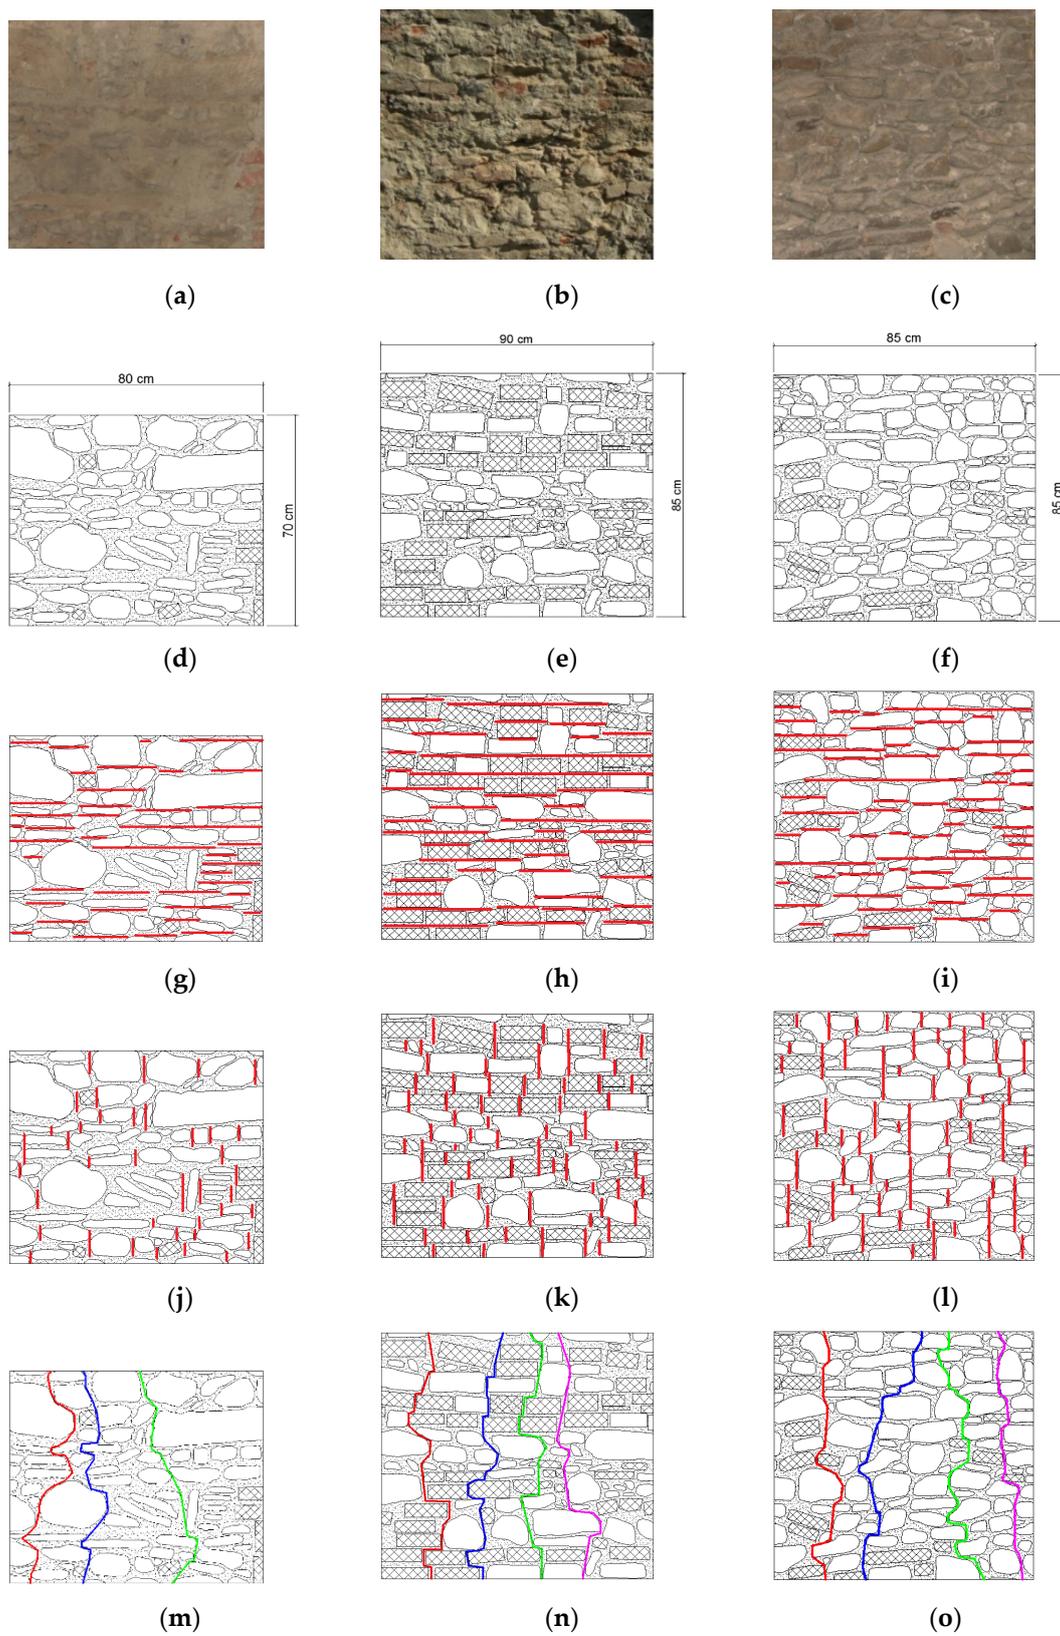
Figure 10. Details of some textures of the walls and material detection, (a–c) View of the textures, (d–f) reconstruction of the textures, (g–i) Horizontality of the bed joints (HJ), (j–l) Stagger properties of the vertical joints (VJ), (m–o) Calculation of ML. (a,d,g,j,m) S2-PT, (b,e,h,k,n) S5-P1, (c,f,i,l,o) S3-PC.

The panels S2-PT, S1-PC and S3-PC correspond to the first category (Cat. I) of the classification of the existing masonry reported in the Italian standards [34,35]. Although the ranges furnished in [35] are based on a national data base there is a good correspondence with those obtained by the MQI index. The panels S5-P1 and S2-PC belong to the same category; however, the horizontal layer of bricks improves the mechanical characteristics f and τ_0 and the coefficient 1.3 is suggested in [35]. Again, the MQI indexes are in agreement with such increase. ML indexes are similar for the five panels and no significant differences in the quality can be predicted (Figure 10).

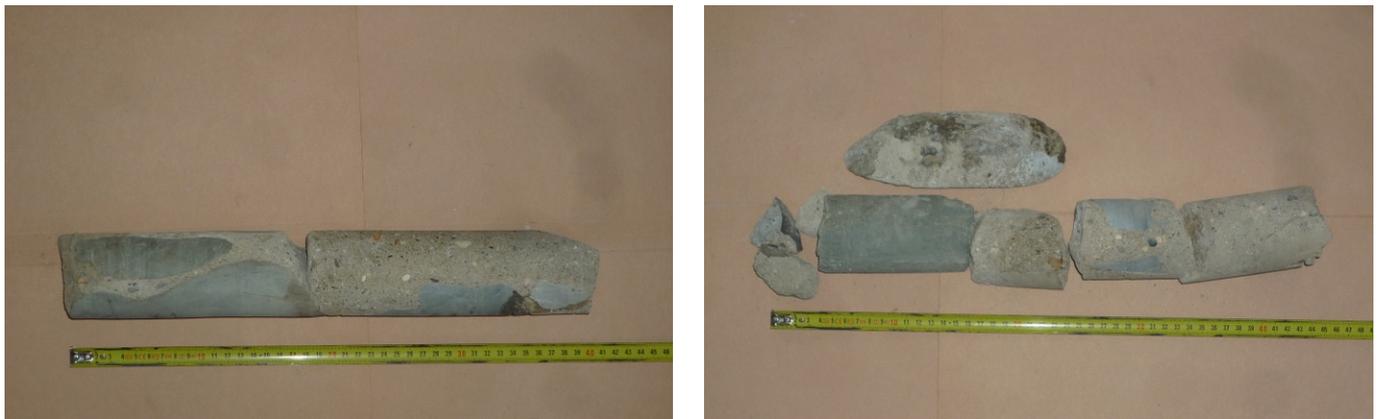
Figure 11. Examples of masonry cores (S2-PT).

Two masonry cores (COR) with diameter of 64 mm 42 cm length were extracted in the zone S2-PT to detect the inner material structure. The two examples illustrated in Figure 11 show the irregularity of the masonry and the high percentage of mortar.

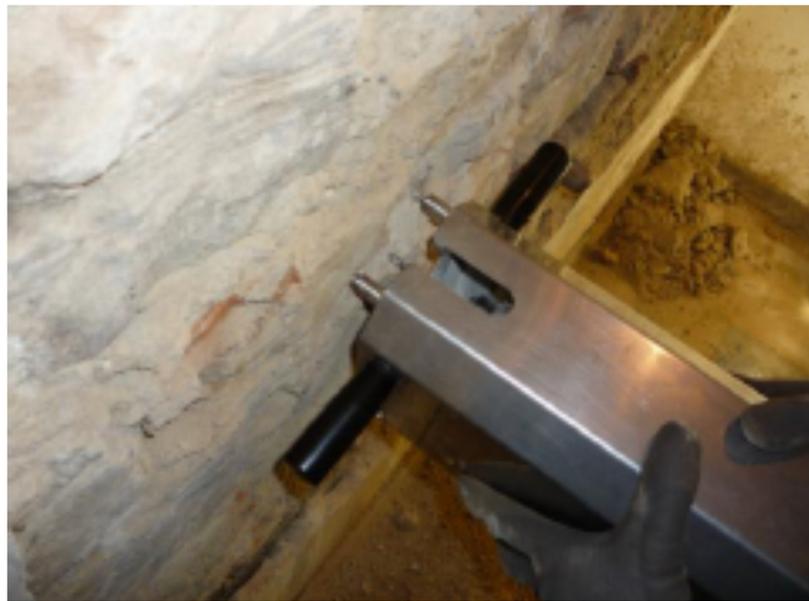
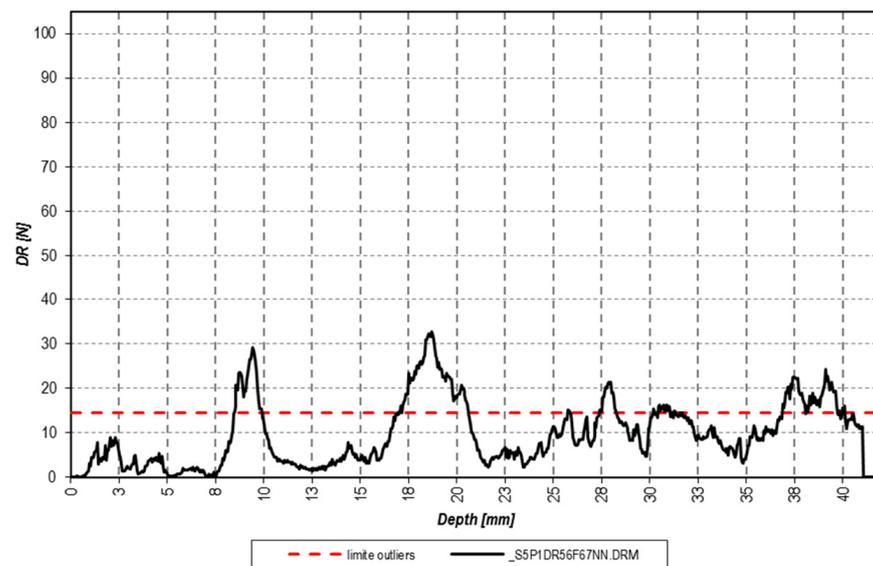
Figure 12. DRMS test on the mortar. (a) drilling device, (b) result of the DRMS test.

The quality of the mortar was investigated through DRMS tests (Figure 12) [31], performed in three different zones of the building, i.e., S2-PT, S5-P1 and S1-PC to obtain a spatial characterization of the mortar quality over the building. Each test consists in executing a set of perforations in the mortar by an instrumented drill which measures the force applied versus the depth of the hole, parameter correlated to the compressive strength of the mortar. The drill measures continuously the force of drilling, keeping constant the r.p.m. and the perforation velocity. The result of each perforation is a diagram which shows the drilling force versus the hole depth. The recorded samples are statistically treated, calculating the so-called data outliers and focusing on the values related to the inner part of the mortar joints. This assumption is necessary to exclude the data of the first and the last parts of the record, since they can be affected by errors, related to the local external conditions of the mortar and to the presence of the drilling dust in the last part of the hole. Laboratory DRMS and compressive tests (specimens with section 40 mm × 40 mm) were performed on a sample mortar (Sm) to calibrate the procedure. Some results are reported in Table 2. The mean and median statistics are referred to the part of the records from 5 to 35 mm of the perforation. Considering the high variability of the recorded data, it has not been possible to correlate the drilling forces with the in situ compressive strength of the mortar. Nevertheless, the results highlight that the mortar of the wall at the ground level has a low quality, while the mortar at the upper levels has better properties, comparable or even higher than that of the sample mortar, characterized by a compressive strength f_m of 2.5 N/mm².

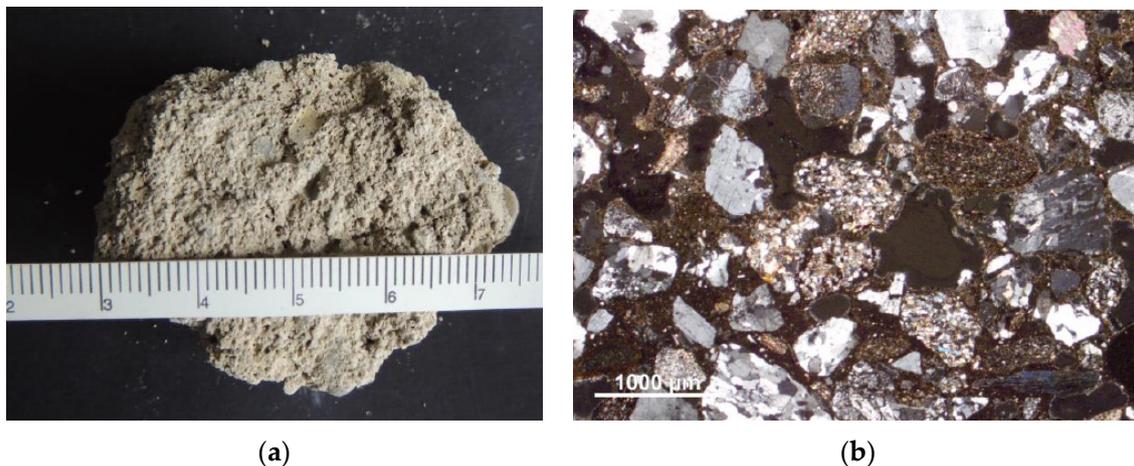
Figure 13. A sample of mortar (a) and an optical microscope view (b).

diffraction analysis. Three different mortar samples were tested. The results showed that the quantity of the binder is low, with a volumetric ratio binder/aggregates approximately equal to 1/3–1/4. The binder is composed of hydraulic lime, with a quite well distributed aggregate fraction. The optical microscope has highlighted the presence of pores, due to the lack of binder. The X-ray diffraction analysis confirmed a relevant presence of quartz in the aggregate fraction (Figure 13).

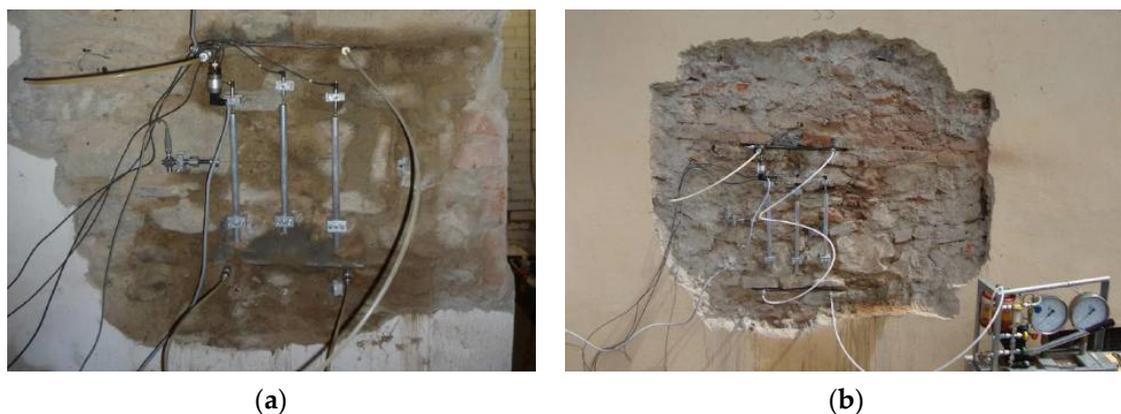
Figure 14. Double flat-jack tests performed, (a) S2-PT-D, (b) S5-P1-D.

Two flat-jack tests (FJ) [36,37] were also performed in the zones S2-PT and S5-P1. In each zone both the single (S) and the double flat-jack (D) versions of test were done (Figure 14). As well known, the test by single flat-jack allows for the estimation of the in situ vertical stress σ_0 acting on the masonry wall, while the double flat-jack test allows for the evaluation of the modulus of elasticity of the masonry E in the tested zone in the range of the applied compressive stress (generally the investigation is limited at low-to-medium compressive stress with respect to the masonry strength).

The obtained vertical compressive stresses of 0.10 and 0.33 N/mm² are in good agreement with the estimated stresses due to the gravity loads. Both the double flat-jack tests were performed with two load cycles, with maximum pressure inside the jacks approximately equal to 1.2 N/mm² for the first cycle and 1.4 N/mm² for the second one. Three vertical strain gauges were placed to measure the vertical deformation history and another strain gauge was positioned in the horizontal direction to control the lateral deformation.

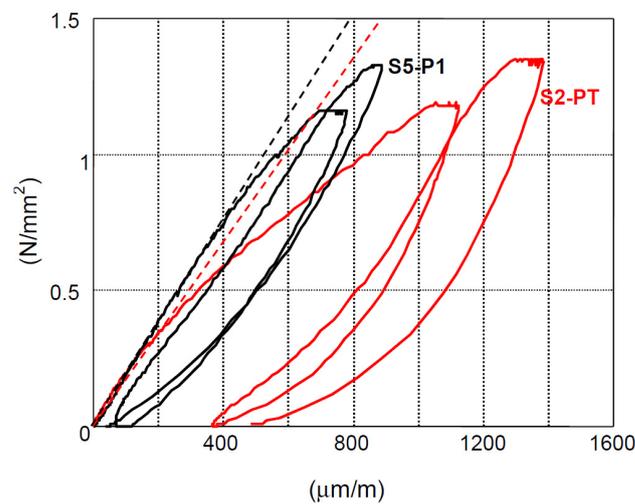
**Figure 15.** Stress–strain diagram obtained by the two double flat-jack tests.

Considering the diagram of Figure 15, it is possible to observe that the S2-PT test at the ground floor shows significant residual deformations at the end of the first cycle, while the second one has almost no plastic deformations. The S5-P1 test has negligible residual deformations for both cycles. Different interpretations of the double flat-jack test results have been used to evaluate the elastic modulus E , i.e., considering the initial slope of the stress–strain diagram, the slope of the unloading branch (in the first or in the second cycle) or the most representative part of the diagram which shows a linear behavior. In the present case E was evaluated as the secant modulus at a prefixed stress level. For the S2-PT test a range of E from 1600 N/mm² to 1200 N/mm² was obtained at level of stress of 0.5 N/mm² and 1.0 N/mm². Values of 1900 and 1800 N/mm² were obtained for the second test. As expected, these estimations of E are higher than those obtained by the MQI evaluation. This reflects the well-known general trend obtained in the flat-jack tests in which the size effects are relevant. It is interesting to cross the results obtained by the FJ tests with the ones of the DRMS tests on the mortar. The mortar sample of the first floor shows the highest compressive strength, which could be one of the reasons for the better behavior of the flat jack-test, together with the observed better weaving of the masonry.

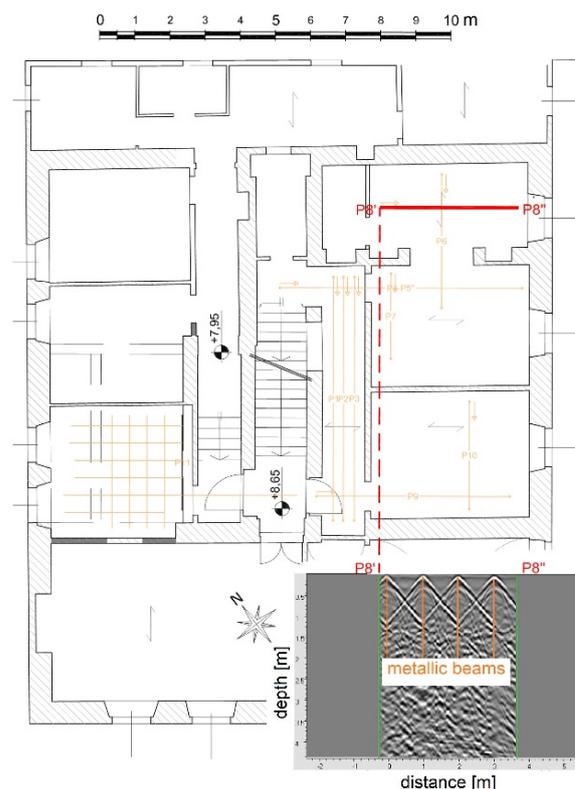
Figure 16. Ground Penetrating Radar (GPR) inspection for the identification of the structure of the floors.

The structural elements of the second floor were also investigated by the GPR technique. This procedure uses a radio transmitting apparatus, able to send multi-frequency

electromagnetic pulses in the subsoil and to receive reflections. The obtained profiles help in the individuation of the distances among structural elements and of the type of materials, as shown in the example of Figure 16, which allowed for the identification of a steel and hollow tiles floor at the second level.

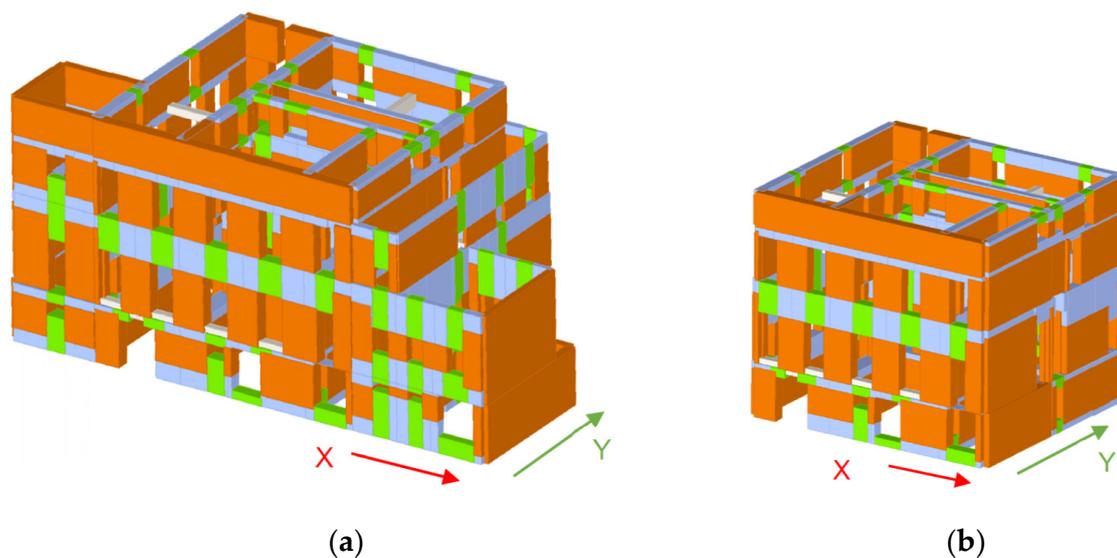
Figure 17. 3D views of the numerical models: (a) Model 1; (b) Model 2.

According to the historical information and by observing the differences of the thickness and of the material of the walls, it was possible to make some hypotheses about the layout of the building. The original structure had a rectangular shape, then the lateral buildings were added, altering the regular shape of the plan. The disconnection in the façade facing the garden (Figure 9) suggests an added part in the South-West corner. Consequently, to cover these features, two different numerical models were realized: Model 1 (Figure 17a) representing the actual configuration of the building and Model 2 (Figure 17b) representing the original configuration.

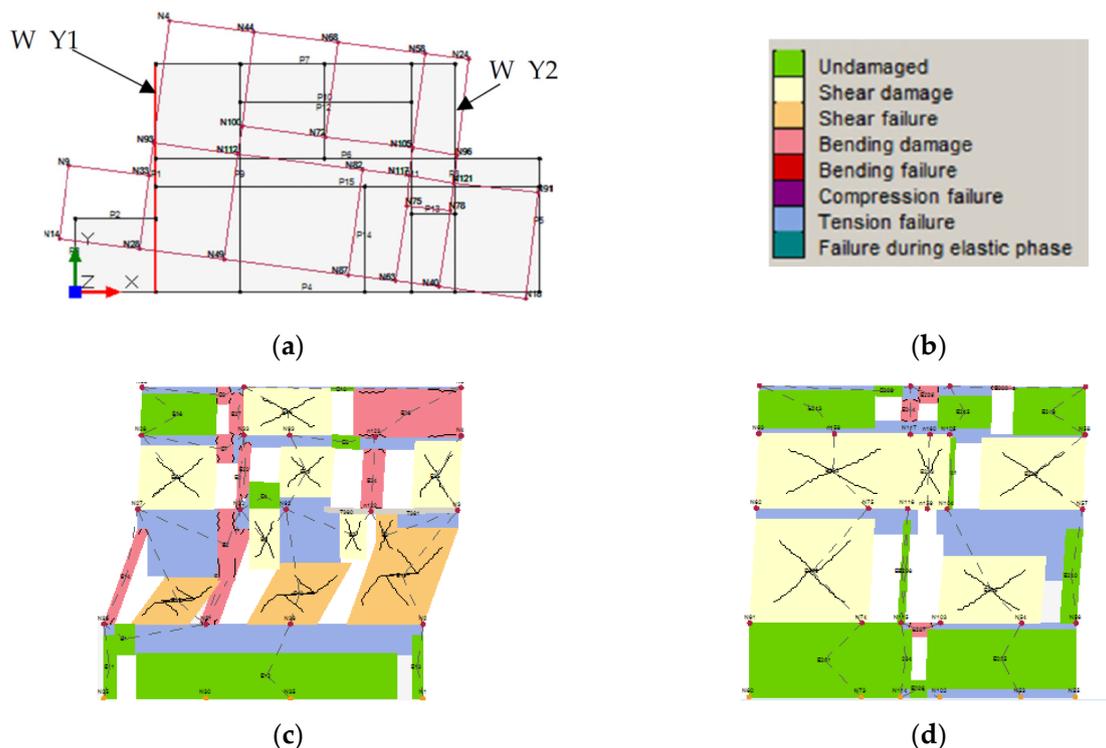
Figure 18. Pushover analysis in the transversal direction Y for Model 1: damage state at failure for the walls W_Y1 and W_Y2.

Model 1: the presence of the lateral annexes alters the in-plan regularity of the structure. The modal analysis highlighted a torsional behavior, with a percentage of activated mass equal to about 49%, while the longitudinal direction is characterized by a regular translational behavior (67% of activated mass). In both cases, the period is lower than 0.3 s. The pushover results showed that the transversal direction Y is the weakest one, with the minimum acceleration factor $f_{a,SLV}$ equal to 0.68 (obtained with the load profile G1 with an eccentricity of 5% L). The collapse pattern of the most representative walls indicated a concentrated damage in the first level in which several piers collapsed for diagonal cracking (Figure 18). Concerning the longitudinal direction X, the minimum value of the acceleration index of safety is equal to 0.84. In this case the structure behaves more regularly (Figure 19), with a widespread damage distribution along each wall, except for the ground level due to the high thickness of the walls.

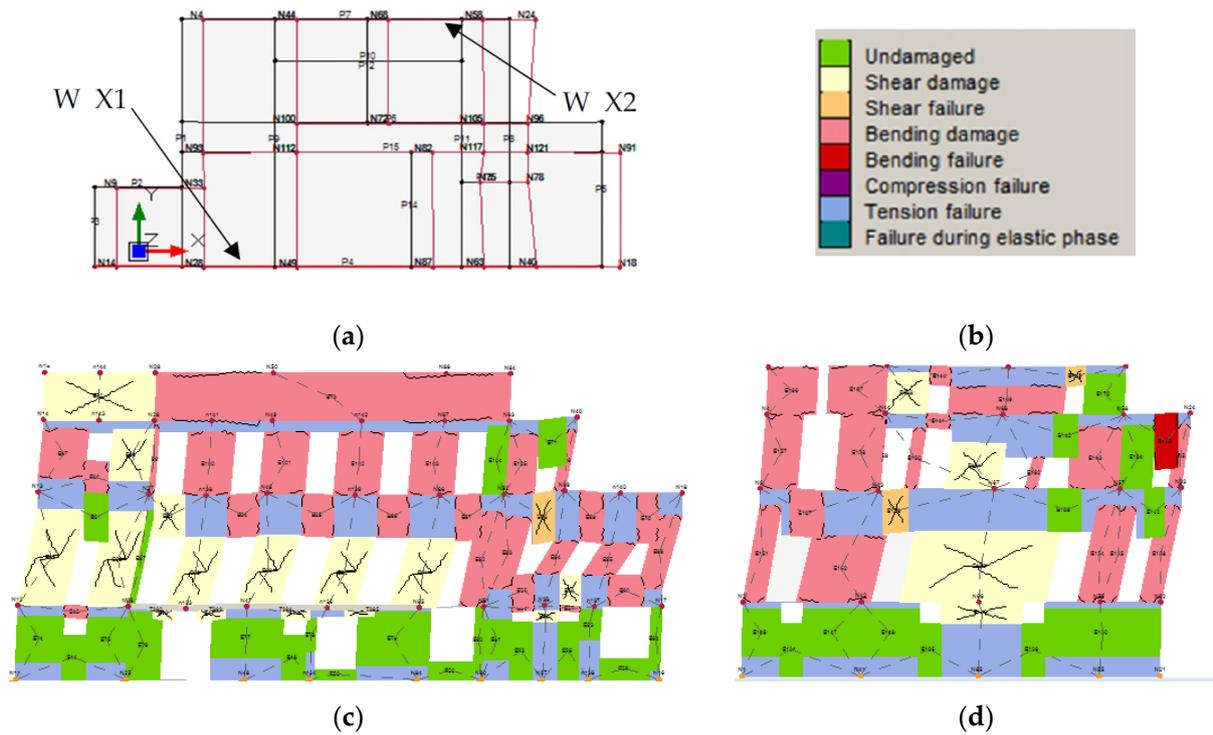
Figure 19. Pushover analysis in the longitudinal direction X for Model 1: damage state at failure for the walls W_X1 and W_X2.

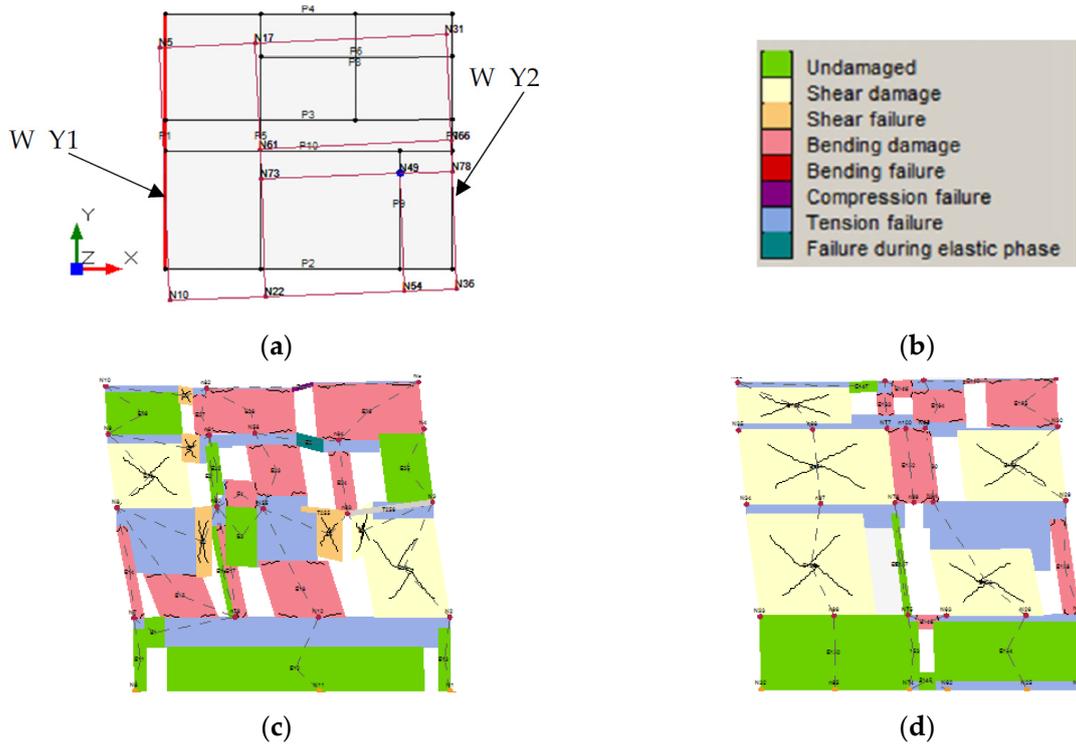
Figure 20. Pushover analysis in the transversal direction Y for Model 2: damage state at failure for the walls W_Y1 and W_Y2.

Model 2: the original configuration is characterized by a regular shape (with plan dimensions of 16 m × 15 m), even if the internal distribution of the shear walls is not symmetric along the two main directions. The results show that the building has almost the same safety index in both the directions, equal to 0.71 for the Y direction and 0.73 for the longitudinal one. With respect to Model 1 there is not a remarkable change in the level of safety in the Y direction whereas in the X direction there is an evident decrease of the index, since the exclusion of the added parts reduces the inertia of the longitudinal walls, causing a decrease of the capacity. The mode shapes are more regular than the previous ones, with reduced torsional components. In the Y direction we observe a more regular distribution of the damage along the height. In the longitudinal direction, we observe a different cracking pattern in the main façade, with the damage that reaches even the ground floor. The piers are mainly damaged by the bending behavior (Figures 20 and 21).

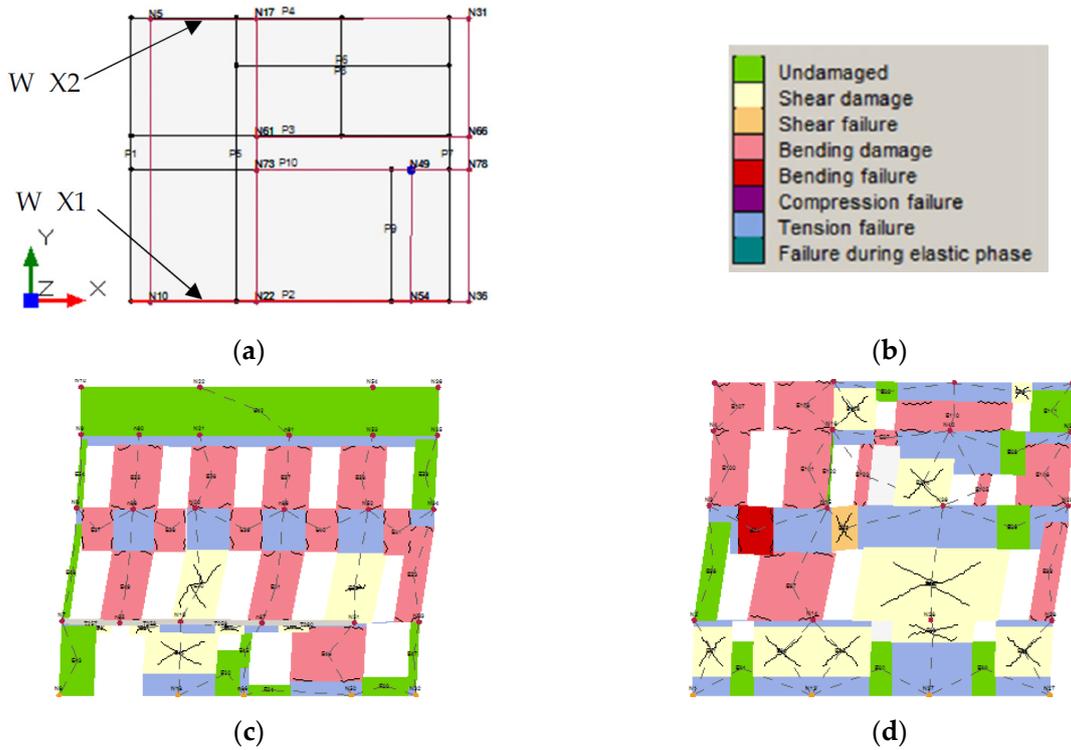
Figure 21. Pushover analysis in the longitudinal direction X for Model 2: damage state at failure for the walls W_X1 and W_X2.
