Article

Architectural Heritage Conservation in Nigeria: The Need for Innovative Techniques

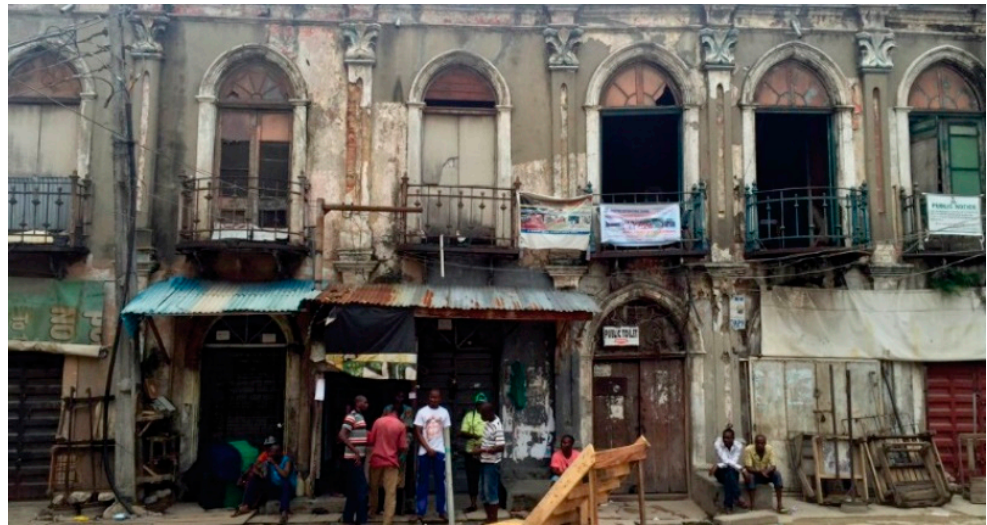
Figure 1. Deteriorated façade of Campos building, Lagos, Nigeria.

The need to conserve Nigeria's architectural heritage arises not only from its significance but also because of its deteriorating state (Figure 1). Generally, materials used in the construction of heritage buildings are prone to physical, chemical, and biological decay caused by changes in climatic conditions, wind, water, and anthropogenic activities [3,4]. Other causes of damage include salt, fire, microorganisms, and insects [5,6]. The effects of these agents of deterioration are manifested as cracks and bulges; patina, surface, and basal erosion; crust formation; and fragmentation.

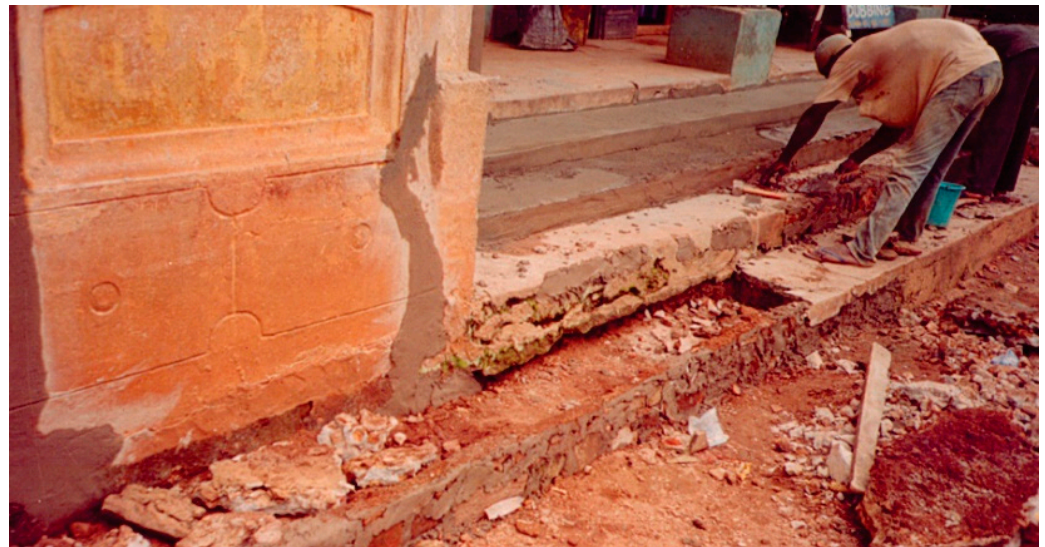
Figure 3. Conservation works on cracks in the entrance stair of another architectural heritage, Ologbenla House, Ile-Ife, Nigeria [19].

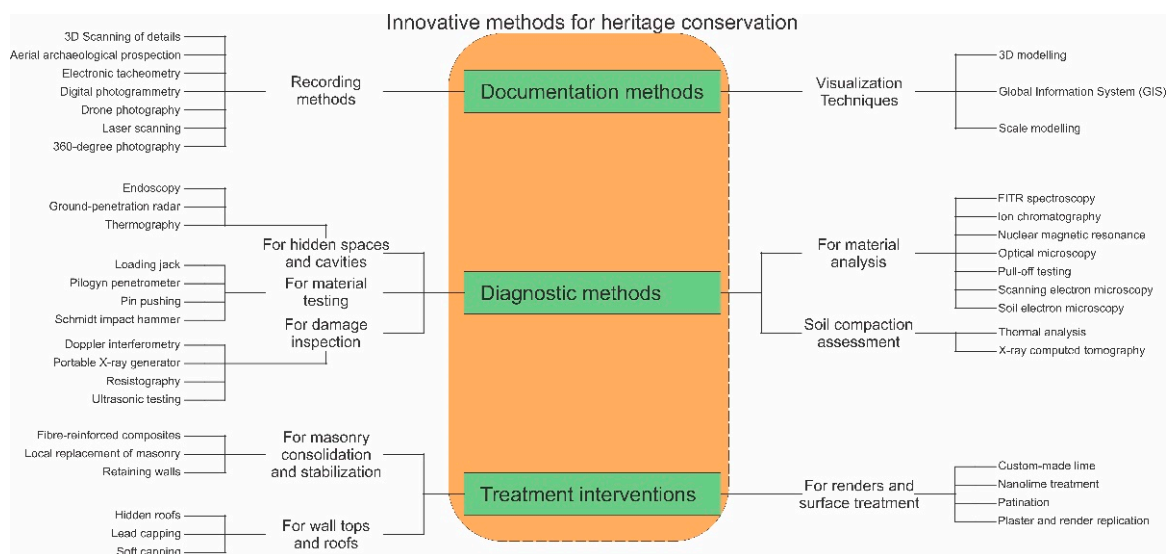
Figure 4. Innovative methods in the conservation of architectural heritage. Adapted from ICE [27].

In addition, ICE [27] categorized documentation methods into recording and visualization techniques (Figure 4). Hassani [30] described image-based techniques as methods based on production and archiving photographic data, which are used for interpreting, measuring, and modelling the architectural heritage. Non-image-based techniques, as well, produce images through separate processes that are not based on the surveying processes, while combinative methods take the advantage of image-based and non-image-based techniques.

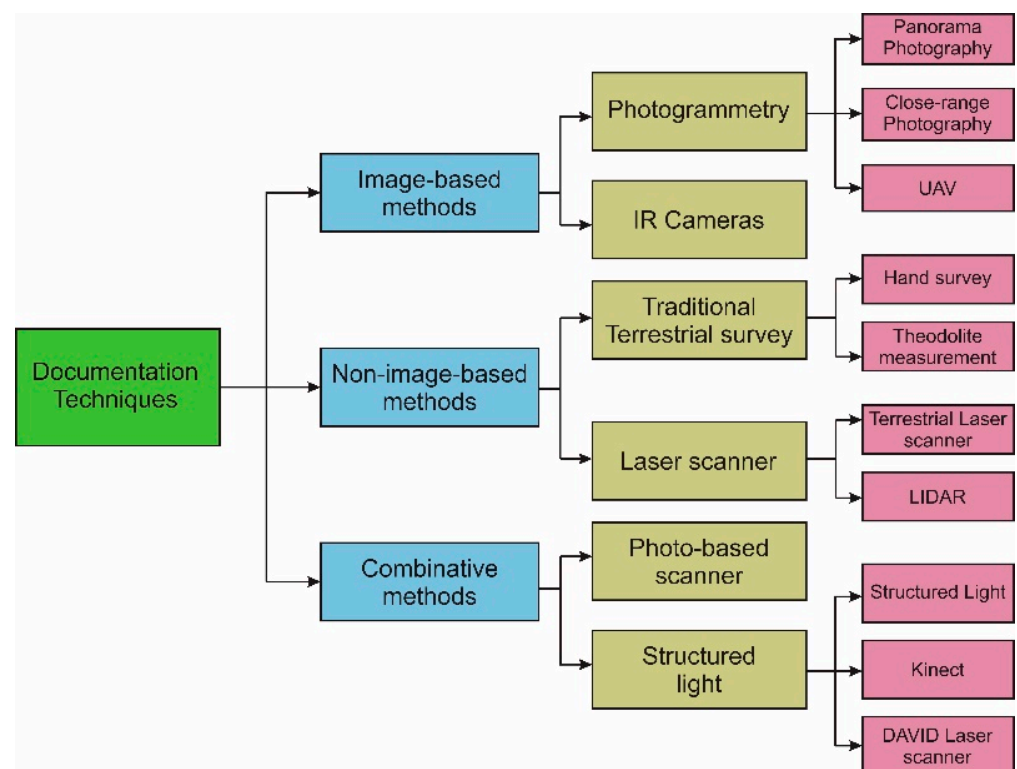
Figure 5. Categories of documentation methods adapted from Hassani [30].

Gulotta and Toniolo [29] assert that ‘each historical object has its unique characteristics according to its physical condition and time’. Conservation processes of architectural heritage, therefore, involve the understanding of the histories, values, and significance inherent in the physical and emotional features of the heritage [7]. Therefore, in view to understanding the heritage, it is vital to gather data about the physical condition such as condition of the materials and investigate the chemical composition, microstructure, and morphological features of the heritage [30]. Mohd-Isa and Zainal-Abidin [17] described documentation of architectural heritage to include surveying, recording, and presentation of the data. Innovative methods for documentation of architectural heritage are, therefore, classified into image-based, non-image-based, and combinative methods, as revealed in Figure 5.

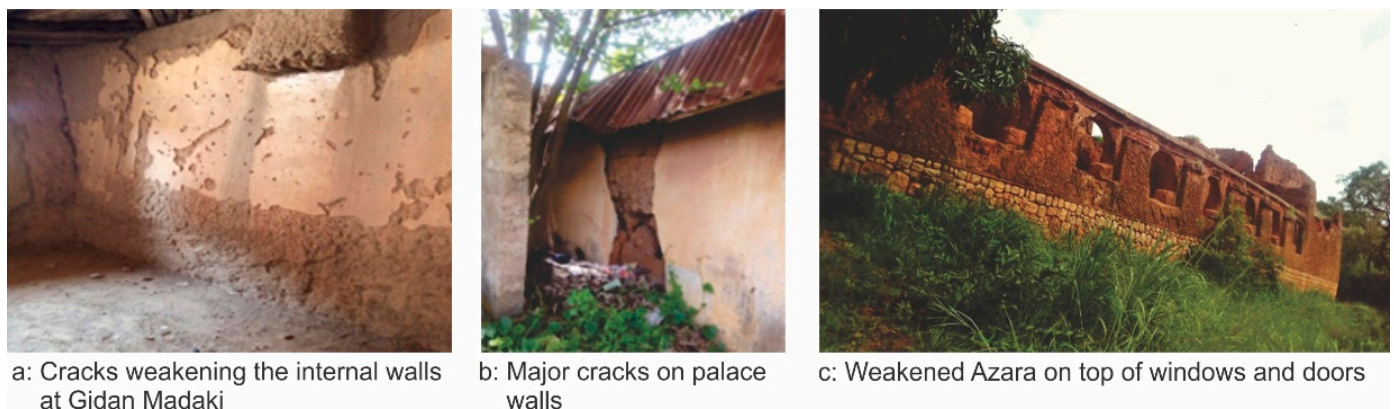
Figure 6. Observed defects on three national monuments in Nigeria (a). cracks weakening the internal walls at Gidan Madaki, (b). major cracks on palace walls, and (c). weakened Azara on top of windows and doors). Adapted from NCMM [59].

The three national monuments were built using mud bricks (tubali), stones, wood, sandcrete plaster, and local steel. The buildings, however, are threatened by termites, storms, floods, and other climate elements (Figure 6). Therefore, NCMM implemented conservation interventions from 2018 to 2021 to address the extent and impacts of defects threatening the values and safe use of the monuments. Table 8 discusses the processes and methods implemented by NCMM to address the observed deteriorations on the three national monuments. The defects observed on the three monuments were documented using digital photography and physical observation but none of the defects was diagnosed to understand the causes and extents of the defects. The heritage professionals from NCMM addressed the defects through processes for removal, restoration, and reconstruction (see Table 8).

Heritage Building	Observed Deterioration	Documentation Methods	Diagnosis Methods	Treatment Interventions
Gidan Madaki	Growth of weeds on the surrounding areas, inner courts, and roof	Digital photography, physical observation	Not implemented	<ul style="list-style-type: none"> - Clearing of weeds and debris - Spraying of herbicides
	Dilapidation and deterioration at Soron Salama, external and internal walls			<ul style="list-style-type: none"> - Mending deteriorated areas with polythene leather and mixed Makuba
	Damage to the dome and Azara in the roof of Soron Jakadiya			<ul style="list-style-type: none"> - Construction of new columns - Replacement of the damaged Azara
	Termite attacks on various parts of the building			<ul style="list-style-type: none"> - Fumigation of the whole building
	Dilapidation of load-bearing columns			<ul style="list-style-type: none"> - Removal of the dilapidated columns - Erection of new columns

Palace of Deeji of Akure Kingdom	Weed infestation of the courtyards	Digital photography, physical observation	Not implemented	<ul style="list-style-type: none"> - Removal of weeds - Application of herbicides
	Minor and major cracks on the palace walls and floors			<ul style="list-style-type: none"> - Mending the cracks with sandcrete mortar
	Blockage of drainages			<ul style="list-style-type: none"> - Removal of debris from drainages - Construction of new outlets
	Termite attacks in parts of the building			<ul style="list-style-type: none"> - Fumigation of the whole palace
	Collapse of parts of the floor slabs			<ul style="list-style-type: none"> - Removal of collapsed parts of floor slabs - Construction of new portions of floor slabs
	Damaged and blown-off roofing sheets at the courtyards			<ul style="list-style-type: none"> - Replacement of blown-off roof with new and old galvanized zinc sheets

Deterioration of roof carcass			<ul style="list-style-type: none"> - Mending of roof leakages with bituminous felts - Replacement of deteriorated roof carcass
	Dilapidation of load-bearing walls in parts of the palace			<ul style="list-style-type: none"> - Mending the cracks with reinforcement and concrete - Supporting portions of wall with buttresses
Zaria Friday Mosque	Deteriorated portions in the roof	Physical observation, Digital photography	Not implemented	<ul style="list-style-type: none"> - Removal of deteriorated roof covering and carcass - Installation of new roof covering and carcass
	Weakened Azara on top of windows and doors			<ul style="list-style-type: none"> - Removal of weakened Azara - Installing new Azara using local materials such as makuba, dunfuna, and rama
	Growth of unwanted plants in parts of the building			<ul style="list-style-type: none"> - Removal of weeds and other unwanted plants
