Article

Understanding the Impacts of the October 2017 Portugal Wildfires on Cultural Heritage

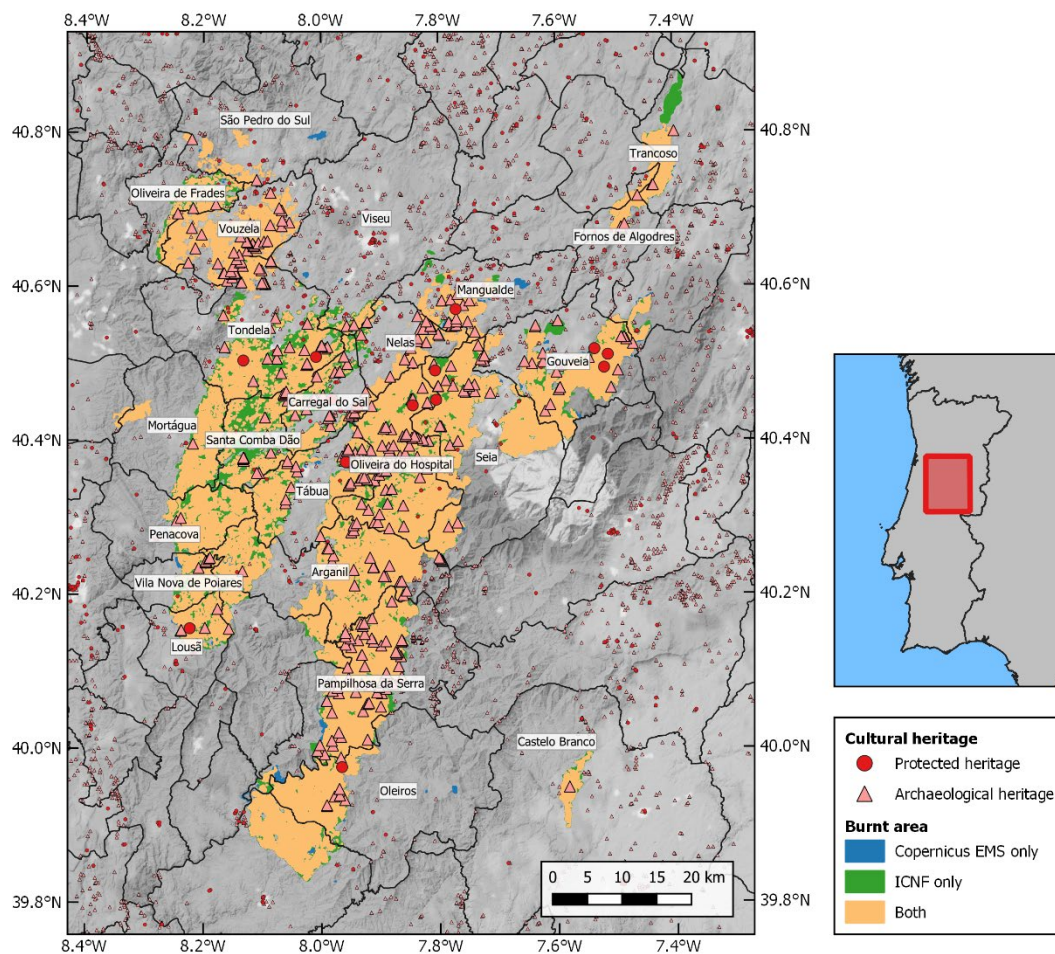
Figure 1. Map of the estimated burnt areas relative to the October 2017 wildfire, locations of protected and archaeological assets within the Copernicus Area of Interest (with larger icons indicating assets overlapping burnt areas), and names of the municipalities with potentially affected cultural heritage assets.

Figure 1 illustrates the overlap between the different databases described above for the October 2017 event, while the bar plot presented in Figure 2 summarises the results in terms of the number of affected assets by municipality.

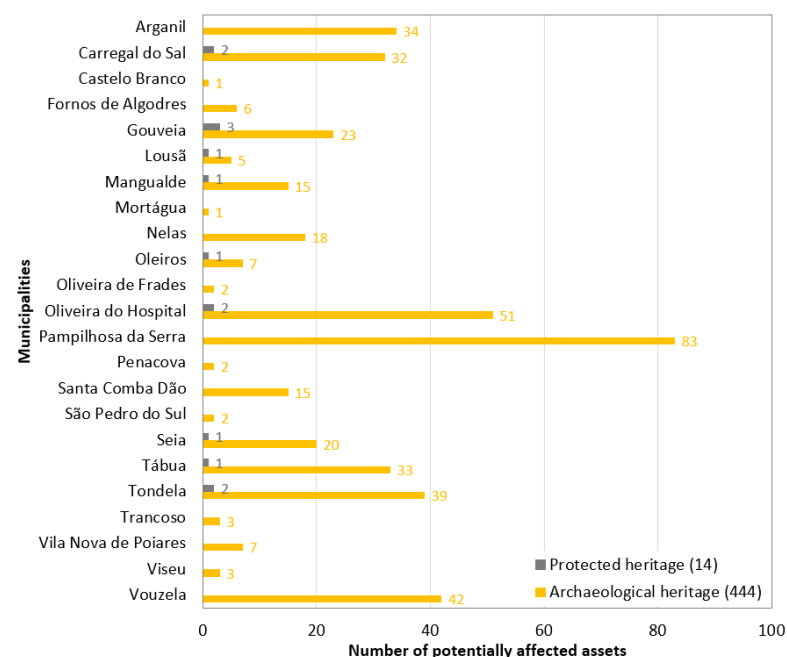
Figure 2. Bar plot representing the number of protected and archaeological heritage assets identified as potentially affected by the October 2017 wildfire by municipality.

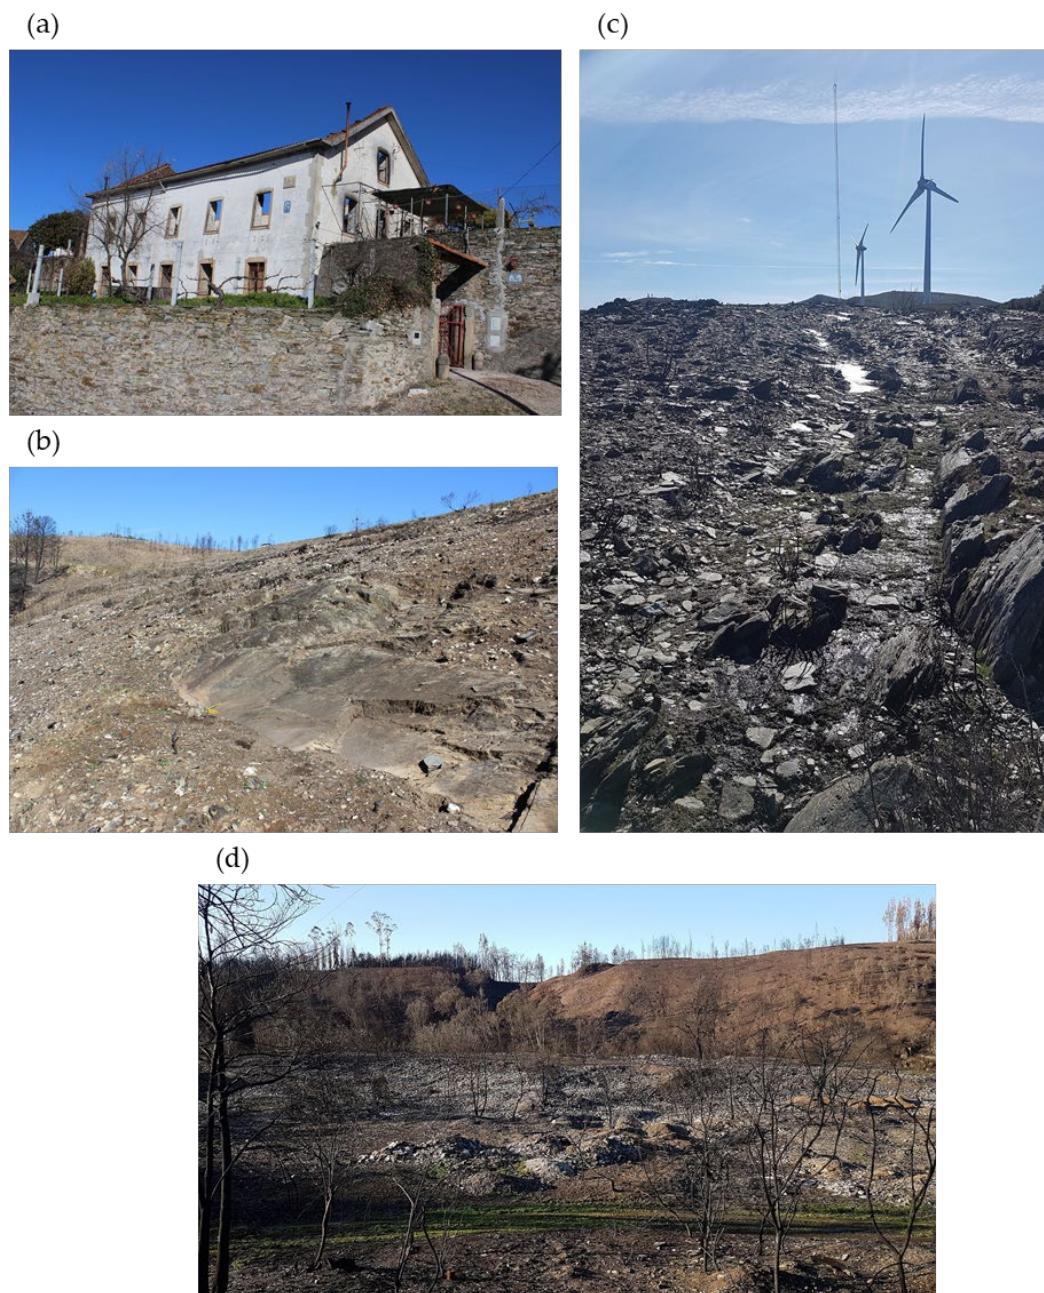
Figure 3. Photographs of some of the cultural heritage assets affected by the October 2017 fire in the municipality of Arganil: (a) House with coat of arms in the parish of Cerdeira e Moura da Serra, which was heavily damaged by the fire; (b) Rock art in the parish of Benfeita; (c) *Estrada Real* medieval road; (d) *Conheira* (heaps of pebbles related to alluvial gold mining).

The municipality of Arganil provided a list of 21 cultural heritage assets affected by the 2017 October wildfires, as well as photographs of some of those assets after the event (see Figure 3 for examples). In terms of architectural heritage, affected assets include the bell tower of the church *Igreja Matriz de Vila Cova do Alva*, which is a listed asset with public interest status, and three houses with coats of arms that collapsed, which had cultural relevance at the local level despite not being listed. Regarding archaeological sites, the municipality team carried out an archaeological survey (prospection) to ascertain the impacts of the fire. The municipality reported that the affected heritage comprised mostly rock art and part of the medieval road known locally as *Estrada Real*, although there was no physical damage. In addition, several *conheiras* (archaeological heritage consisting of heaps of pebbles related to alluvial gold mining located along the Alva River) and some rock carvings in the Benfeita area were also affected. The municipality also reported that rock art in the parish of Piódão was relocated after the event.

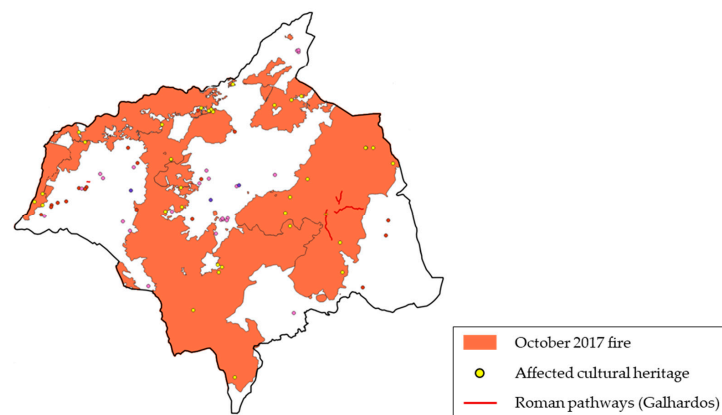
Figure 4. Map provided by the municipality of Gouveia.

The municipality team reported that, based on a spatial analysis performed using the QGIS geographic information system, 57 cultural heritage assets in the municipality were located within the area affected by the October 2017 fire. The map and asset list based on which this analysis was carried out were provided by the municipality and are shown in Figure 4 and Table 1, respectively.

Even though the municipality did not specify the data source it used to establish which areas had been affected, based on the provided map it can be observed that the area shapes are consistent with the ICNF geospatial database of the 2017 fires in Portugal (although they also appear to include a few polygons relative to previous fires from that year, perhaps erroneously). Out of the 57 cultural heritage assets supposedly within the affected area, the municipality reported that 21 are architectural elements located in urban areas, which did not suffer any damage for that reason. The remaining 36 cultural heritage assets are archaeological sites located in areas affected by the fire. These assets were classified by the municipality in two groups: archaeological sites (21) and relevant archaeological sites (15). This classification was assigned based on a series of internal parameters that were not further described by the municipality.

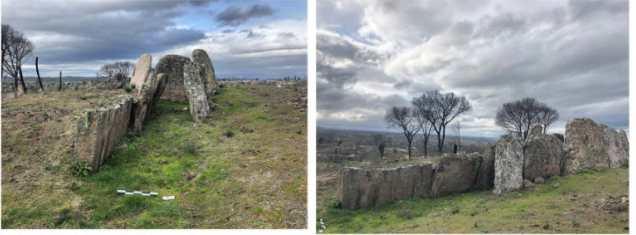
Figure 5. Illustrative site sheet developed by the municipality of Oliveira do Hospital, relative to *Anta de Curral de Mouros* (dolmen). This asset was indirectly affected during the forest clearing process when a charred tree fell onto one of the pillars of the corridor accessing the funeral chamber and tilted it.

After carrying out this work, the municipality team concluded that the impact of the October 2017 fire to the protected and archaeological heritage of Oliveira do Hospital was null or very low. The only directly impacted building was the chapel *Capela de São Bartolomeu*, located next to the homonymous archaeological site. As previously mentioned, some of the identified assets are archaeological sites consisting of graves dug in the rock, where the only evidence of the event is the presence of soot on the outcrop where the graves are inscribed. On the other hand, some of the archaeological sites were indirectly impacted; for example, at the dolmen *Anta de Curral de Mouros*, during the forest clearing process, a charred tree fell onto one of the pillars of the access corridor to the funeral chamber, tilting it.

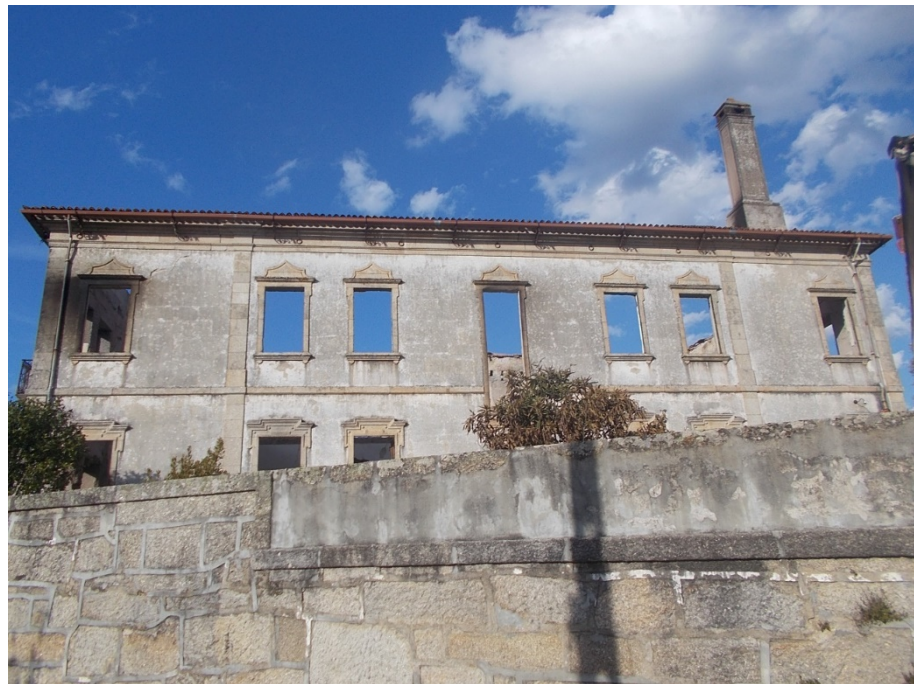
Figure 6. Photograph of *Palácio de Valverde* after the October 2017 fire, during which it was heavily damaged.

Upon further interaction with the municipality team, they also reported that some of the existing manor houses, important at the local level, burned down and remained so as of November 2019, such as the manor house of *Ribeirinho*, the manor house of *Esporão*, and *Palácio Valverde* (Figure 6). Many of these houses burned in the village centre of Midões, which was attributed to two main reasons: (1) the violence of the fire caused several projections towards the centre of the village; (2) the poor state of conservation (e.g., broken roofs and/or windows) or even abandonment of some properties, including lack of land clearing.

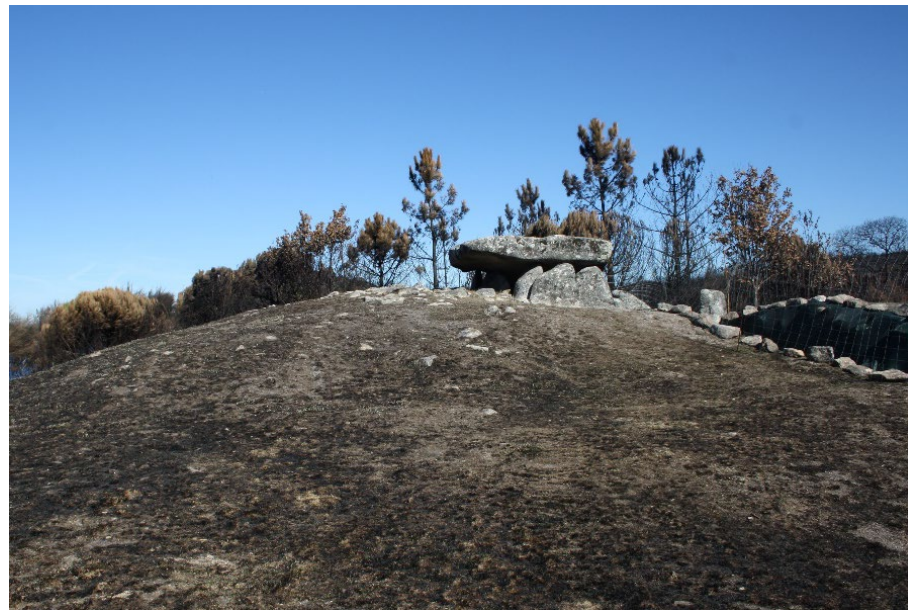
Figure 7. Photograph of the *Lapa de Meruge* archaeological site after the October 2017 fire. Although this area was affected by the wildfire, the municipality reported no visible damage to the dolmen.

Furthermore, the municipality team added seven assets classified as affected or at risk due to forestry work that were not present in the initial list. Regarding these two categories, in total, two assets were identified as affected (the *Abelheira* and *Adside* megalithic monuments) and twelve were identified as at risk. No assets were identified as directly damaged by the fire itself. The municipality provided a photograph of one of the archaeological sites located in the area affected by the fire (*Lapa de Meruge*), which is shown in Figure 7.
