# Joint Investigation with Ground Penetrating Radar and Infrared Thermography as a Diagnostic Support for the Restoration of Two Wall Mosaics in the Church of St. Mary of the Admiral in Palermo, Italy

**Abstract:** The church of S. Mary of the Admiral in Palermo, known as “La Martorana” and very famous for its Byzantine mosaics, has been a World Heritage site since 2015. The mosaic system of the church includes several groups of figures and scenes from the life of the Virgin Mary. From the western part of the ancient church only two mosaics survive, detached from their original position, and are now located in two internal chapels. On the occasion of several restoration works, these two mosaic panels were investigated with non-invasive techniques, in order to provide diagnostic support to the restoration and consolidation interventions. The investigations were aimed at detecting any air pockets that could cause the detachment of the tesserae or of possible differences between cement mortars under the tesserae. For this purpose, the integrated use of two non-invasive techniques namely infrared thermography (IRT) and ground penetrating radar (GPR) was considered. The joint analysis

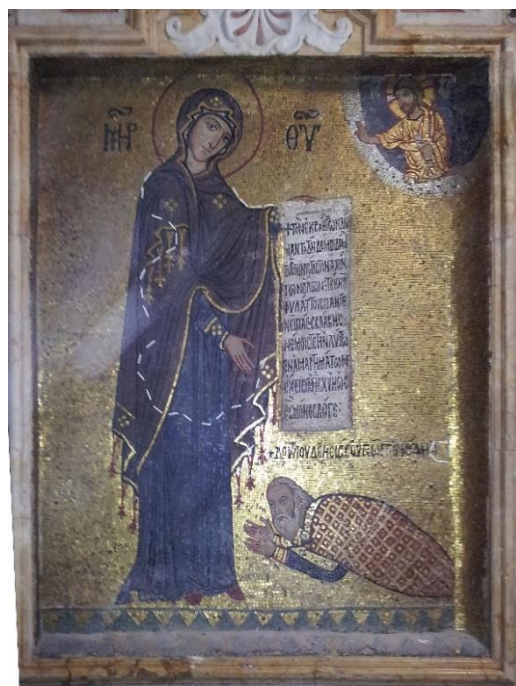
The *Dedication* panel (Figure 3) represents George of Antioch prostrate in front of the Virgin Mary and invokes for him the protection of Jesus who appears in the upper right corner of the mosaic. The left half of the panel is occupied in all its height by the figure of the Virgin Mary, her head in three-quarters profile and slightly tilted to the right. In the upper right corner of the panel, Christ is depicted in a blue sphere in the form of a small half-length figure. The Virgin holds out her right hand towards George of Antioch who is kneeling at her feet. With her left hand she presents an open scroll with an inscription in verse: a plea that she addresses to her Son in favor of George of Antioch [18–20].

**Figure 3.** Palermo, St. Mary of the Admiral, *Dedication* mosaic panel: George of Antioch prostrate at the feet of the Virgin Mary. The hatched lines indicate the areas affected by the risk of detachment of the tesserae, as previously indicated by the restorers.

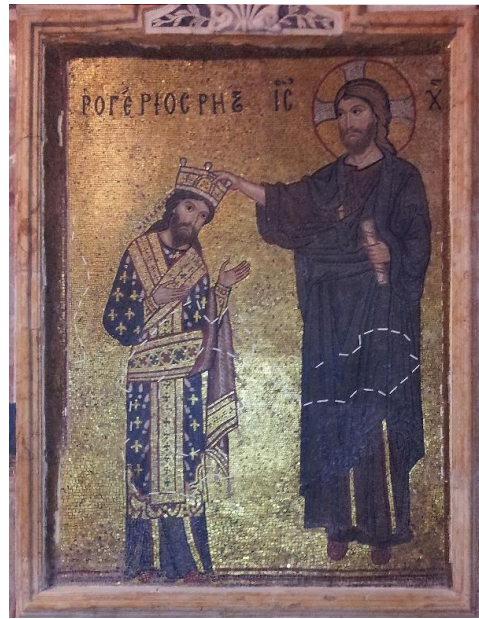
The *Coronation* panel (Figure 4) represents Christ crowning Roger II. The king stands before his supreme leader, his head tilted reverently, his hands outstretched to him in a gesture of prayer. Roger wears the costume of a Byzantine emperor: a long blue tunic with gold clubs, a shorter overtunic adorned with a regular motif of gold cornflowers and the loros, the sash that covers it [21]. On his head he has an open, relatively high crown. The figure of Christ is taller and larger than that of Roger.

**Figure 4.** Palermo, St. Mary of the Admiral, *Coronation* mosaic panel: Christ crowning Roger II. The hatched lines indicate the areas affected by the risk of detachment of the tesserae, as previously indicated by the restorers.

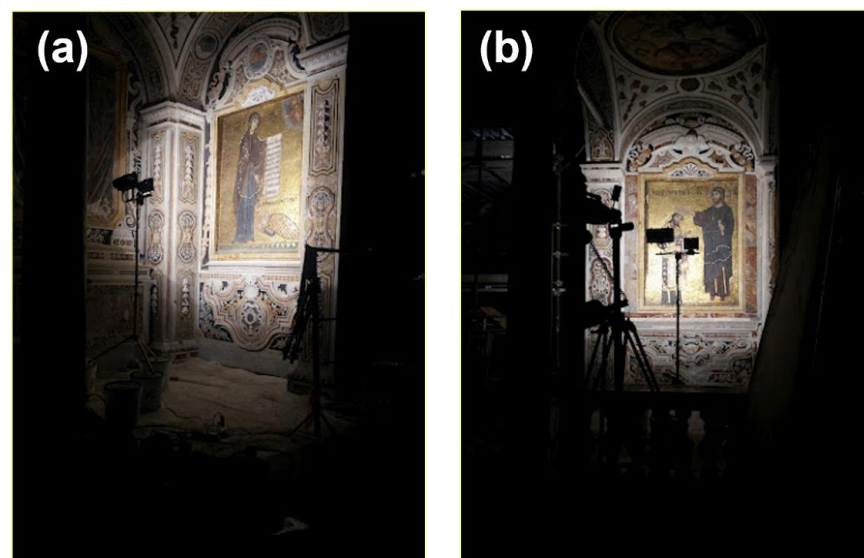
**Figure 5.** Palermo, St. Mary of the Admiral. Preliminary steps to the acquisition of thermographic images, with heating of the mosaic surfaces using halogen lamps: (a) *Dedication* mosaic panel; (b) *Coronation* mosaic panel.
