# UNESCO Historic Centre (Chorá) of Patmos Island: Conservation and Reconstruction of a Collapsed Urban House

**Keywords:** UNESCO; Chorá of Patmos; masonry urban house; restoration/reconstruction

**Citation:** Papatzani, S.; Michail, G.; Tzamalís, G.; Skitsas, G. UNESCO Historic Centre (Chorá) of Patmos Island: Conservation and Reconstruction of a Collapsed Urban House. *Heritage* **2022**, *5*, 3100–3132. <https://doi.org/10.3390/heritage5040161>

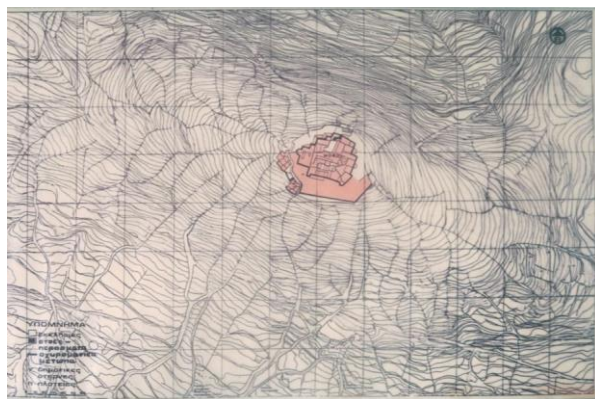
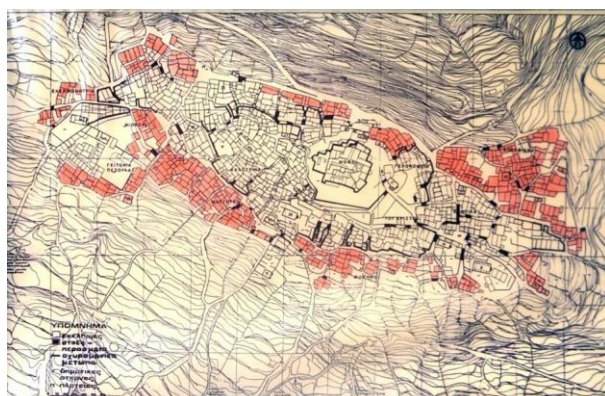
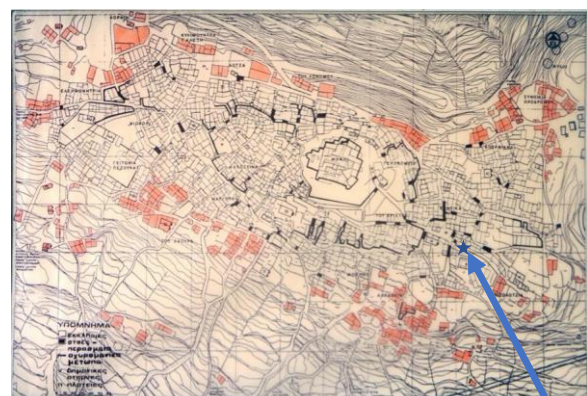
a) 1132 A.D.: the first settlement around the monastery is established

b) 1522 - 1636 A.D.: the first mansions are built belonging to byzantine families

c) 1650 A.D.: the first cottages are built

d) 1720 A.D.: the "Cretan" neighborhood is established

e) 1740 A.D.: the "Aporthiana" neighborhood is established

f) Neoclassicism: 19<sup>th</sup> century until the Italian invasion 1940 – location of the property

Figure 3. The evolution of Chorá since AD 1132 [3].

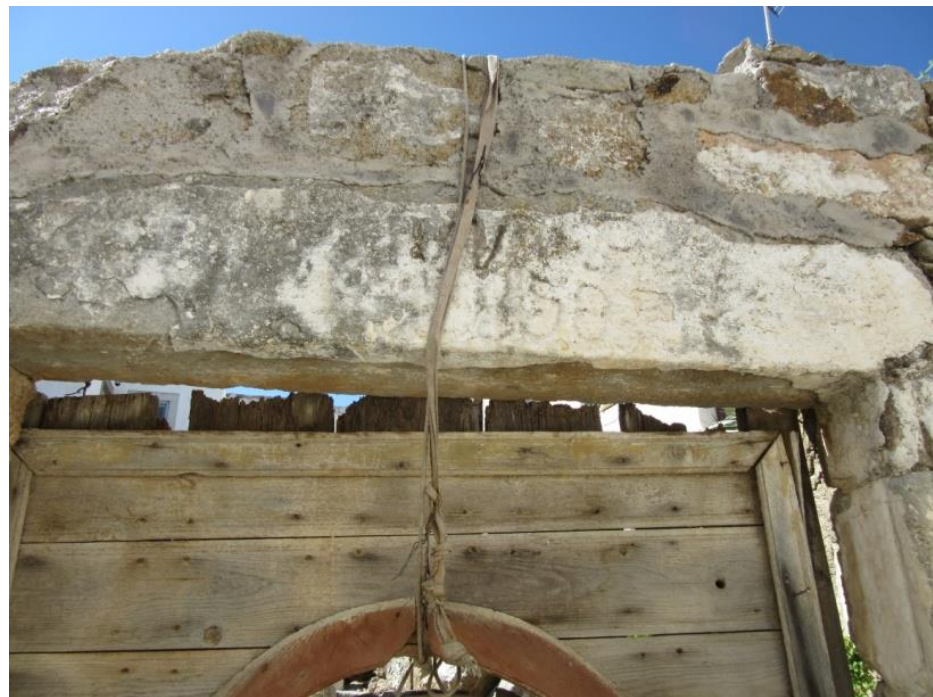
**Figure 4.** Engraving of the construction date (1850) of the building.

The inscribed date of 1850 (Figure 4) found on the lintel of the main entrance most probably corresponds to the original construction date of the house. The house features some later-dated additions, but there is no evidence of extended reconstruction in the past.

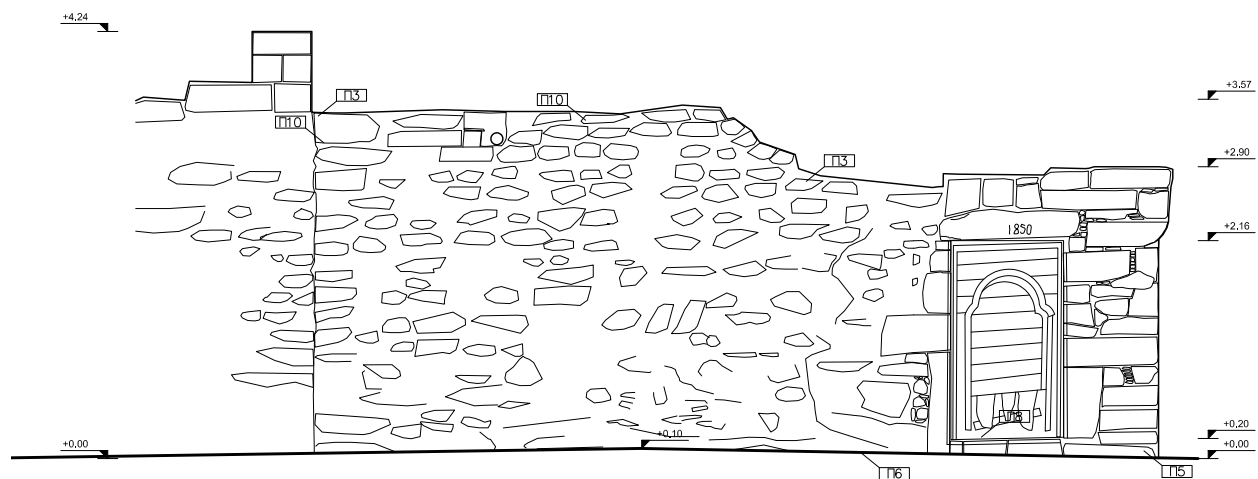
**Figure 8.** Eastern view of the building.

The eastern elevation, in contrast to the northern one, remains mostly intact. It reaches a height of 3.57 m above street level (Figure 8).

The main entrance door opening is located on the northern side of the elevation at a height of 2.16 m. The wooden door is also preserved, although in a deteriorated condition, but its form and design are perfectly visible.

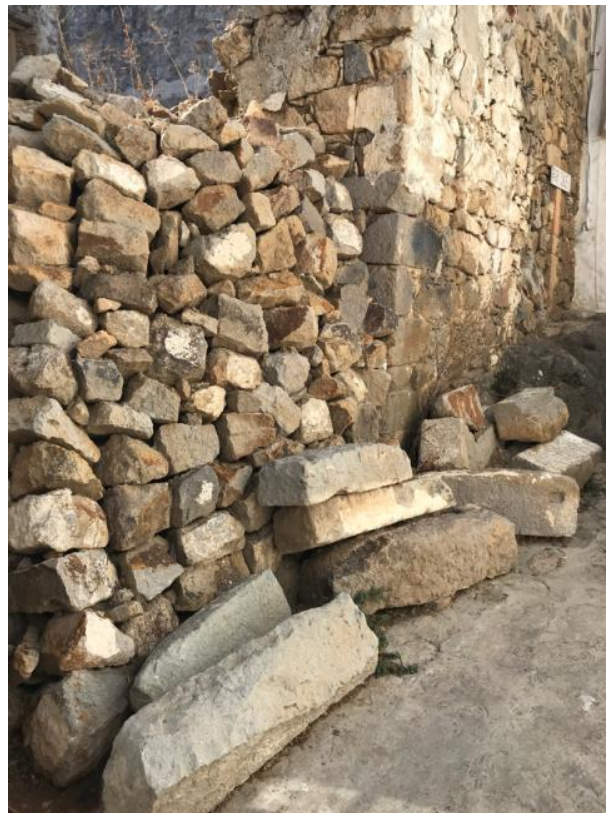
**Figure 15.** Salvaged stones and monolithic stone lintels of the building to be reused.

- The reuse of demolished material for conservation purposes for structurally strengthening masonry elements (Figure 15). Cracks will be repaired, depending on size, with grouting, stone stapling or localized removal of surrounding material and cleaning and re-introduction of fresh elements. Masonry will also be strengthened with the use of compatible injection grouting, as discussed in a later section of the paper;

A large number of stones found inside the house during the excavation and cleaning works have been collected, as shown in Figure 15. The proposal envisages the re-use of this material after sorting for the construction of the damaged parts and those which are in poor condition. The format will be similar to that of the existing sections. Mortar will be used as a binder, compatible with the existing binder and according to the static study.
