Article

Deterioration Effects on Bricks Masonry in the Venice Lagoon Cultural Heritage: Study of the Main Façade of the Santa Maria dei Servi Church (14th Century)

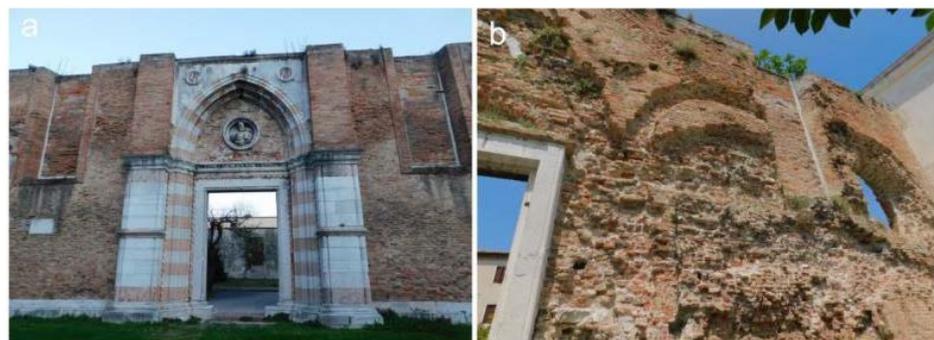
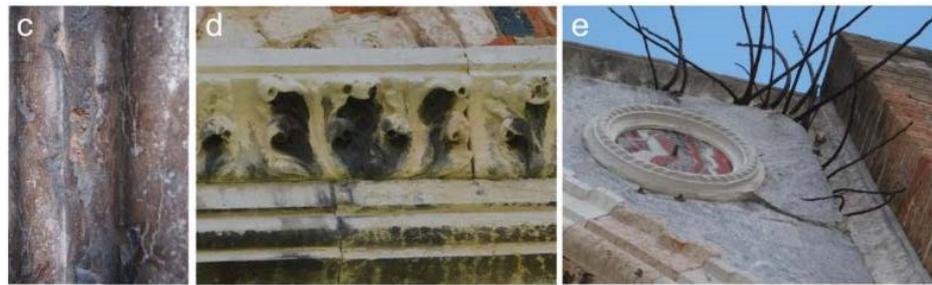
Figure 1. Details of the main façade of the ruins of Santa Maria dei Servi Church: (a) the external main portal; (b) the internal main portal; (c) exfoliation of red Verona marble used in the portal; (d) detail of ornamental Istrian stone use in the portal with black crusts in sheltered areas; (e) detail with Proconnesian marble (grey) and the *tondo* in *Cipollino marble* (red); secondary plants (*figus carica*) growth is also visible.

The main façade is characterized by the typical Venetian combined use of Istrian stone and red Verona marble. The main portal is surrounded by doorposts in Istrian stone and the architrave on which is engraved the inscription commemorating the consecration of 7 November 1491 [18]. The top of the portal is decorated with Proconnesian marble slabs (probably reused from another site due to the imperfect way they have been cut and implemented) and two small *tondos* made of dark red marble (*Cipollino* marble) (Figure 1a). Stones and bricks show exfoliation and material loss (Figure 1b,c), spalling (Figure 1c), and black crusts (Figure 1d), and the presence of moss-grown and secondary plants (Figure 1e).

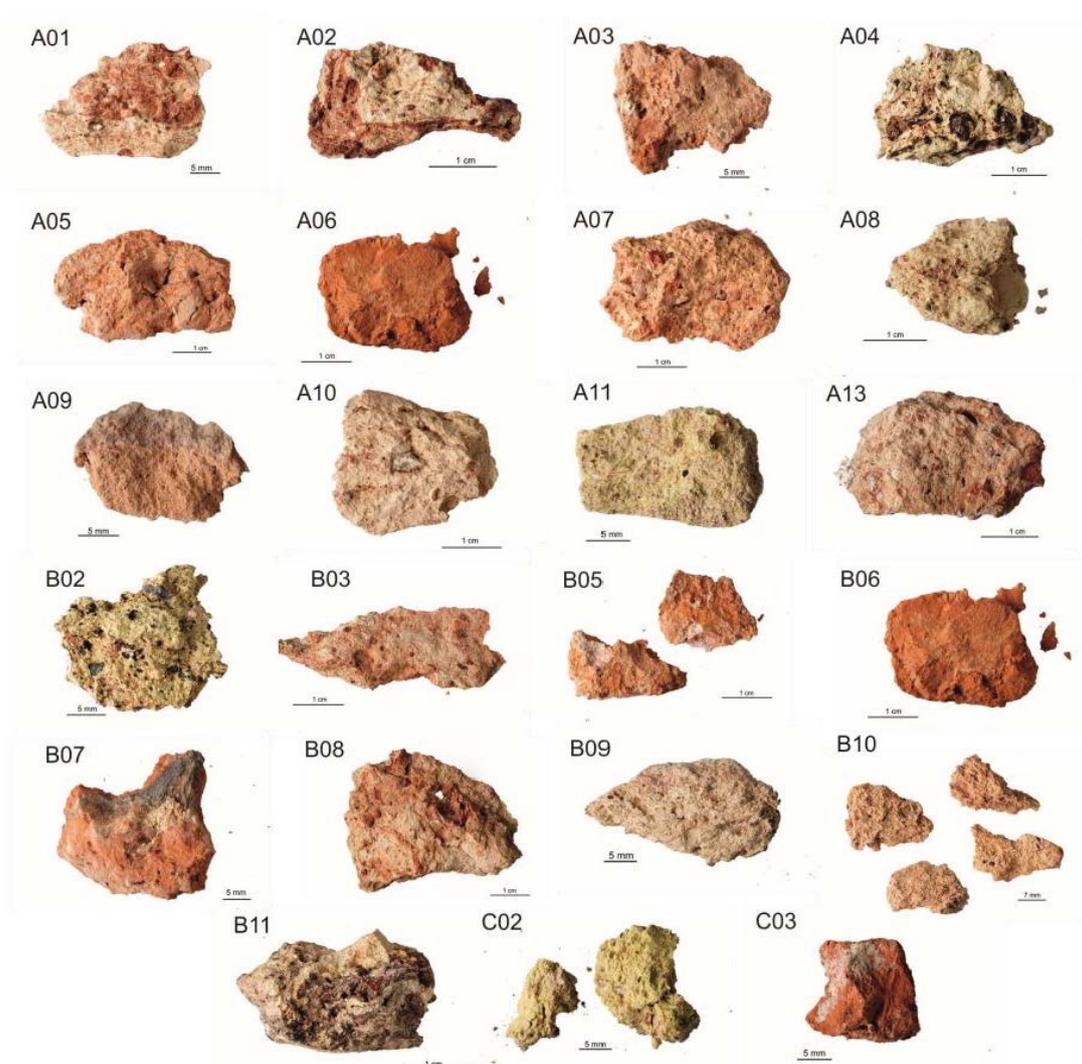
Figure 2. Macroscopic photographs of the twenty-three collected samples.

Twenty-three brick samples (Figure 2) were collected on the main façade of the Basilica of Santa Maria dei Servi. In order to guarantee good representativeness of the materials used and their decay conditions, samples were randomly collected, covering most of the surface of the façade.

- (i) side A, the outside masonry on the right of the main portal where eleven samples were collected: A01, A02, A03, A05, A06, A07, A08, A09, A10, A11, A13;
- (ii) side B, the outside masonry on the left of the main portal, where nine bricks were collected: B02, B03, B05, B06, B07, B08, B09, B10, B11;
- and (iii) side C, the backside of area B, corresponding to the inside of the construction, where two samples (C02 and C03) were selected.

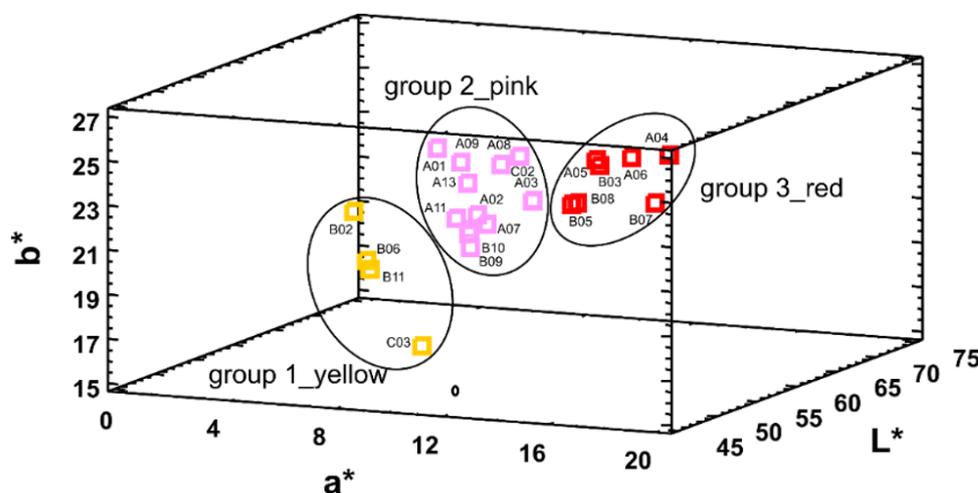
Figure 3. Colorimetry: dried bricks in Lab space. L^* , a^* , b^* = color coordinates.

According to colorimetric results in the Lab space (Table 2), bricks (in dry condition) can be defined into three main chromatic groups (Figure 3): yellow-colored bricks (group1_yellow), pink-colored bricks (group2_pink), and red-colored-bricks (group3_red). The most abundant category of bricks was the pink-colored (with twelve samples), followed by the red- (seven samples) and yellow-colored ones (four samples).

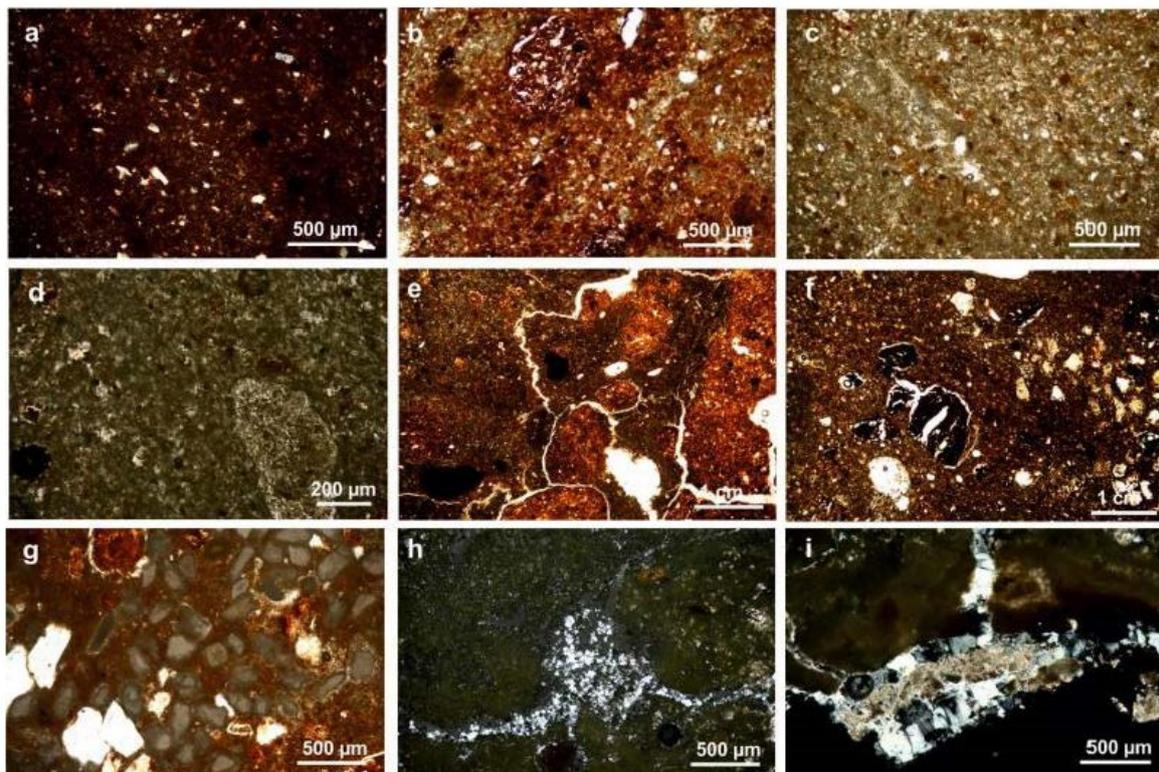
Figure 4. Photomicrographs in plane-polarized light (PPL) and crossed-polarized light (XPL) of bricks collected from Santa Maria dei Servi. (a) sample B07 (PPL): red-brown groundmass; (b) sample B08 (PPL): pale red groundmass; (c) sample B11 (PPL): yellow groundmass; (d) sample B02 (PPL): slightly active groundmass; (e) sample B05 (PPL): planar voids vesicles; (f) sample B08 (PPL): planar voids and vesicles; (g) sample B05 (PPL): grains of carbonate relicts; (h) sample C02 (XPL): secondary calcite filling pores; (i) sample C02 (XPL): gypsum crystals in pores and at surface materials.

Under a textural viewpoint, bricks displayed similar features, with a very low optically active groundmass, with color ranging between red or red-brown and yellow-light to brown (Figure 4a–c). Most samples (such as A10, A11, A13, B02, B06, B10, and C02) had a compact matrix, optically inactive, showing highly dense gelling portions (Figure 4c,d). Most samples had planar voids and vughs (Figure 4e), but the channel and vesicular pores were also present where clay pellets occurred (Figure 4f). Most inclusions (~30%) observed were grains of quartz and subordinately feldspar. Clay pellets were rather abundant (20%). Residual carbonates (calcite and/or dolomite) (Figure 4g) suggested that temperatures did not exceed 800 °C (such as in sample B05), a temperature over which they are completely decomposed [3,24,25]. The inactive optical groundmass in other samples (such as B02, Figure 4d) suggested the reaching of high temperatures (>1000 °C) during firing since phyllosilicates and carbonates in the matrix (fine-grained) lost all their interference colors

when they broke down. However, carbonate relicts testified to the occurrence of coarse calcite grains in the clay paste, which did not completely decompose during the firing process due to kinetic reasons (too rapid heating rate during firing and/or short soaking times). Moreover, secondary calcite could be derived from the carbonation of lime “lumps” formed during the firing of clays containing carbonate grains (calcareous clays) [26]. Post-depositional calcite was easily recognizable since it tended to partially fill pores (Figure 4h), even if gypsum crystals were also detected as weathering product filling pores and/or at the surface of the sample (where it was directly in contact with the lagoon environment) (Figure 4i).

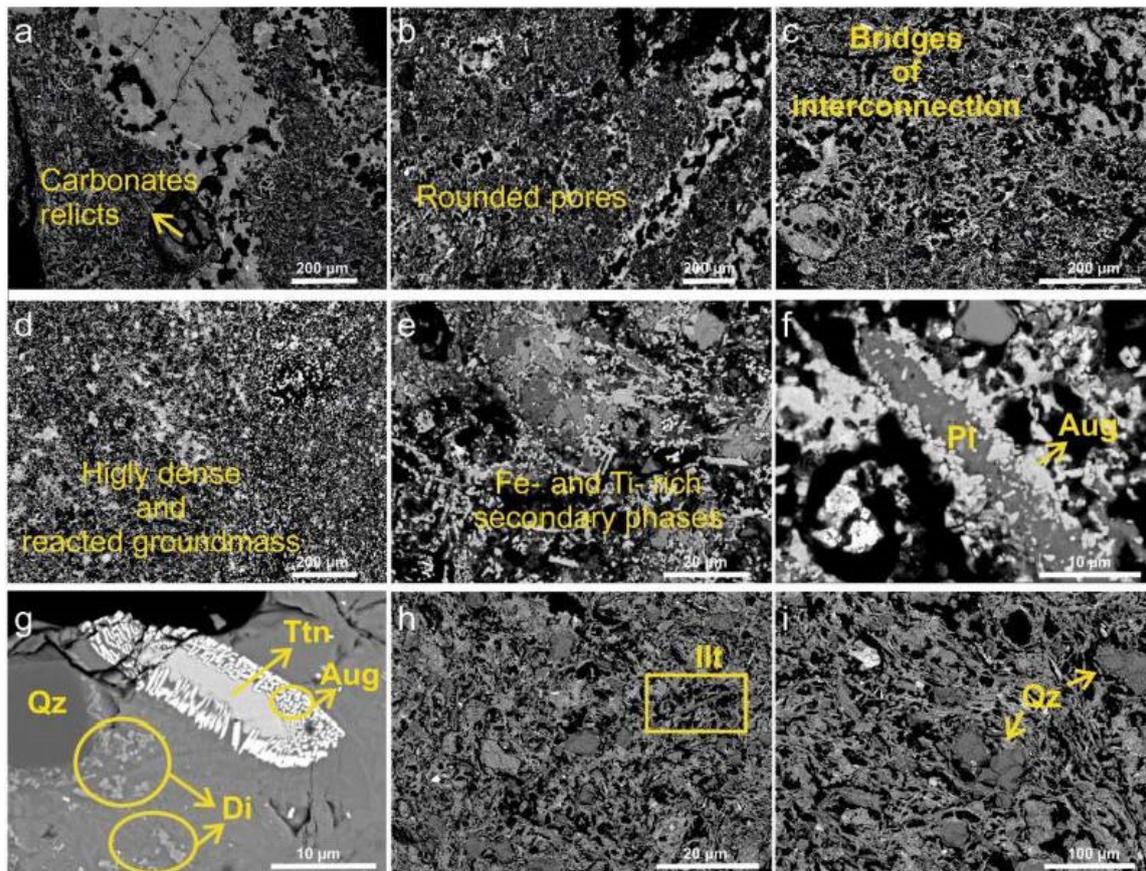
Figure 5. FESEM-BSE images of micro-texture of the bricks and minerals detected in the groundmass: (a) sample A08, secondary porosity (in black) and relict of carbonates; (b) sample A04, micro-texture characterized by rounded large pores (vesicles) and silicates crystallized during firing (high temperature silicates); (c) sample B02, bridges of interconnection between reacted grain minerals; (d) sample B06, high reacted groundmass and diffuse presence of newly formed minerals; (e) sample B06, new minerals formed during the firing process, mainly Fe- and Ti- rich silicates; (f) sample B06, augite (Aug) along feldspar (Pl, plagioclase) rims; (g) sample A08, new silicates, titanite (Ttn), augite (Aug) and diopside (Di); (h) sample C03, illite (Ill) relicts in a poorly sintered groundmass; (i) sample C03, unreacted quartz (Qz) grains embedded into a poorly sintered groundmass and low micro-textural evolution.

Further micro-textural observations were carried out under FESEM on a set of six samples (A04, A08, B02, B06, B10, and C03). BSE images confirmed what was drawn by petrographic characterization. Samples that displayed a high sintered matrix (samples A04, A08, B02, B06, B10) were characterized by a wide pore texture, with a prevalence of micro- and meso-rounded pores (vesicles) (Figure 5a,b) and pervasive phenomena of bridging interconnection (Figure 5c) in particular between residual grains of quartz and feldspar. Groundmass was highly dense (sintered) and reacted (Figure 5d) and raw minerals showed different states of decomposition according to the dimension of the grains, often with reaction rims where new silicates were formed [3,24,27,28] (Figure 5d). Carbonate relicts were also present (Figure 5a), although the high degree of textural evolution which suggested high temperature was reached during firing. Prismatic secondary minerals were also dispersed in the sintered matrix, mainly composed of Mg-rich silicates (diopside).

Meanwhile, Mg- Ti- Fe- rich pyroxenes (augite) were observed by the higher atomic density (chemical analysis was performed by EDS) formed [29] on reaction rims of feldspars (Figure 5e,f) or titanite minerals (Figure 5g). The presence of Ti-minerals suggested the use of lagoon sediments [30], mainly characterized by quartz, K-feldspar, and plagioclase, and heavy elements such as titanium. Iron-bearing phases also occurred in residual illite, where grains partially underwent melting and presented typical “bubble-like” porosity. However, illite still showed dehydroxylated basal sheets, such as in sample C03 (Figure 5h). This sample was characterized by the lowest textural evolution, fewer new silicate phases, a low interconnection between minerals, and jagged pores (Figure 5i) [10].

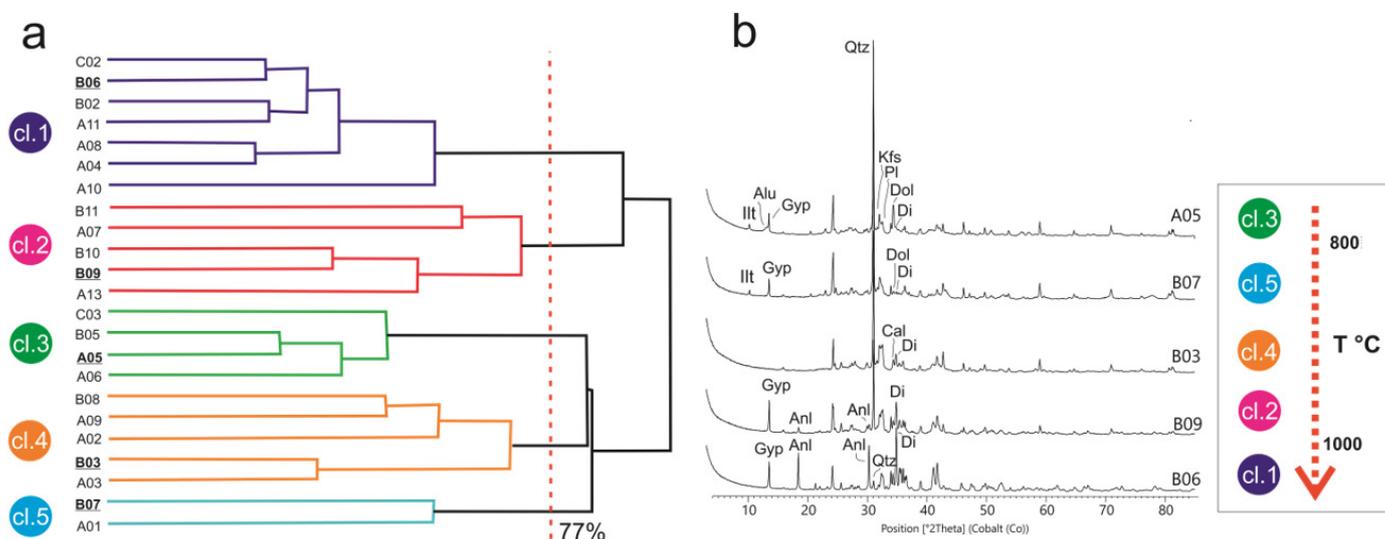
Figure 6. Hierarchical cluster analysis of XRPD data: five clusters grouped all samples according to peaks position and peak intensity: (a) dendrograms with clusters in different colors and the most representative samples were bolded. The red dotted line corresponds to the cut-off, defining the clusters; (b) comparison between diffractograms of the most representative samples of each cluster according to the firing temperatures defined on the basis of mineralogical associations detected by XRPD analysis.

Hierarchical cluster analysis carried out on diffraction patterns [36] allowed the statistical grouping of samples according to the peak position and intensity. Thus, bricks were grouped into five different clusters (Figure 6a), emphasizing differences between samples in terms of their firing temperatures as well as their weathering products. Cluster 3 and Cluster 5 grouped bricks fired at the lowest temperature, probably below 750 °C, marked in particular by the presence of illite and dolomite. They had the most representative brick of the set, samples A05 and B07, respectively (see diffractograms in Figure 6b), and they were distinguished by the peak (~7.79 Å, d-spacing) of Al sulfate-hydroxide minerals aluminite, (Al₂SO₄(OH)₄·7H₂O), weathering product attributed to the natural reaction of acidic sulfate with clay material [37]. Clusters 1 and 2 grouped bricks fired at a high temperature (above 950 °C). These are bricks that displayed a high density of matrix in optical microscopy and high micro-textural and mineralogical evolution by BSE analysis. Diffractograms of samples B06 and B09 (representative samples of Clusters 1 and 2, respectively) showed indeed the absence of carbonates, abundant new silicates (in particular from the pyroxene group, calcium-, magnesium-, and iron/titanium- rich varieties), and the absence of amorphous phases. These two groups, similar in terms of firing secondary phases, were distinguished by the presence of zeolite (analcime) as the weathering product,

whose peaks are predominant in Cluster 1. Cluster 4 is intermediate. It identified bricks probably fired between 800 and 950 °C since when illite disappeared, new mineral phases were formed, and diffractograms did not show amorphous bands. Moreover, this set of bricks also did not show weathering products.

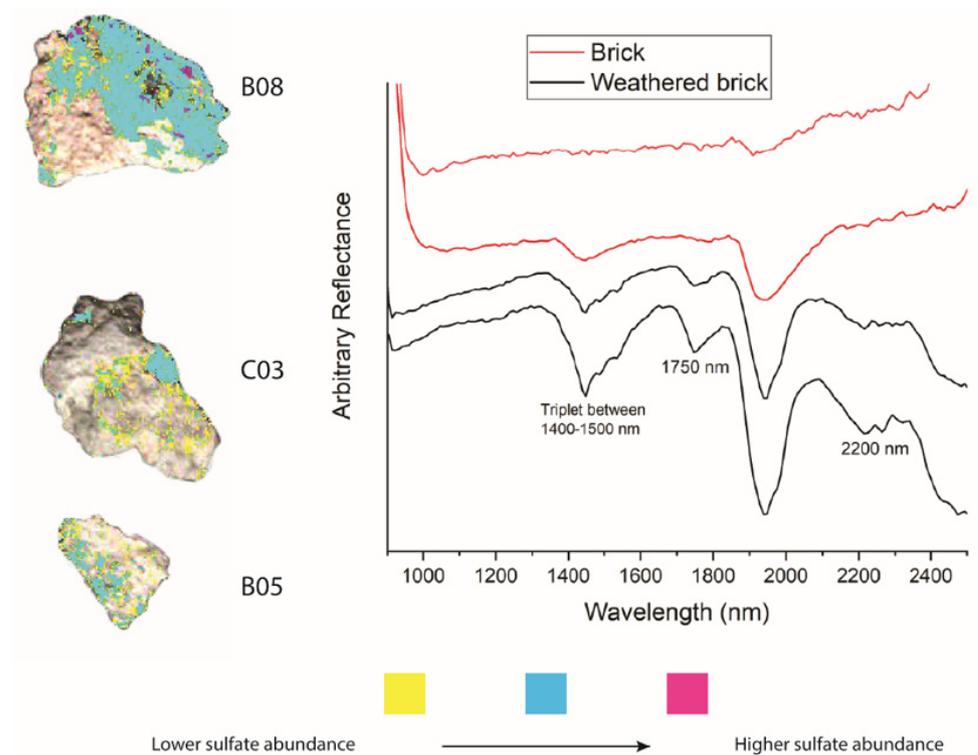
Figure 7. Spectral maps of the three fragments (Figure 2) of the Santa Maria dei Servi bricks show the sulfate abundance. The spectra are relatively featureless for un-weathered bricks (with only the 1900 nm band indicative of hydration). On the contrary, the weathered portions show a spectrum with distinctive hydrated sulfate bands (triplet between 1400–1500 nm, 1750 nm, and 2200 nm).

Laboratory tests were carried out on three samples (C03, B08, and B05) (Figure 7) in the laboratory by HA in order to define the dataset for secondary phases and biodeterioration identification to be then applied for the on-site (for all the monument surfaces here studied) mapping.

In agreement with XRPD, SWIR spectral maps highlighted areas rich in hydrated sulfates (e.g., gypsum or mirabilite), with the typical triplet absorption bands at ~1440 nm, ~1500 nm, and ~1540 nm and the band at 1750 nm (Figure 7). In the VNIR range, the most indicative band was the one related to chlorophyll, a tracer of biodeterioration, whose band center is at around 680 nm.

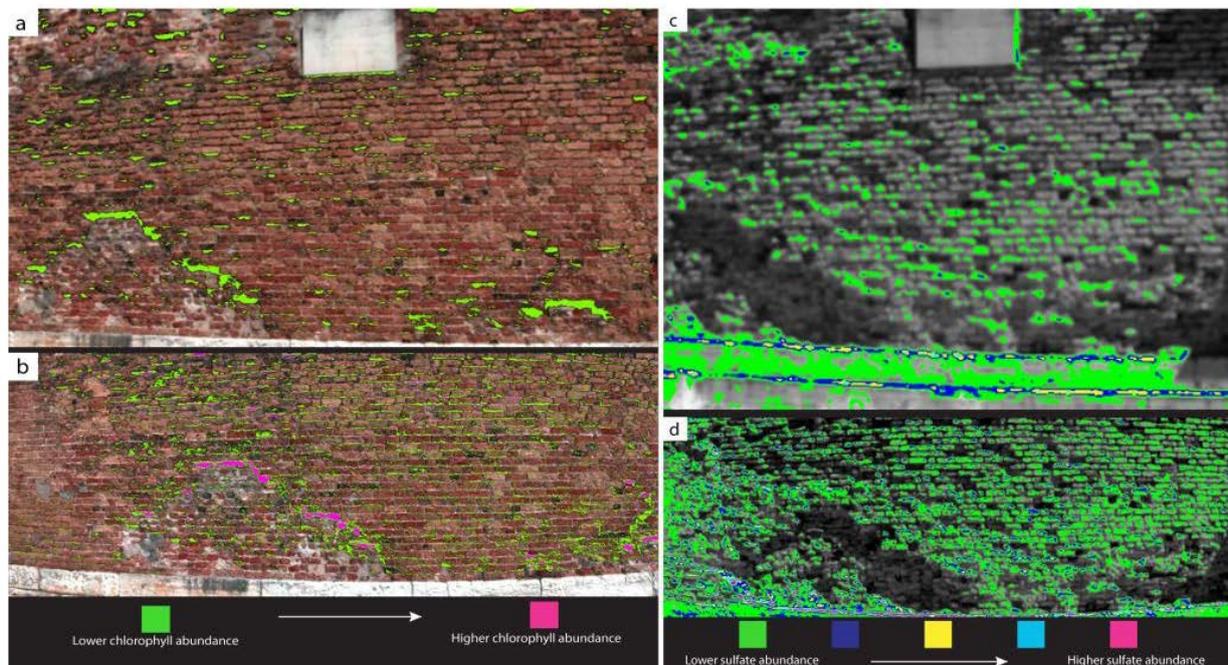
Figure 8. The on-site hyperspectral acquisition of the façade of Santa Maria dei Servi Church: (a) low-resolution and (b) high-resolution sulfate spectral maps based on the Shuai et al. [21] spectral index; (c) low-resolution spectral map showing the general trend of biodeterioration; (d) high-resolution map of the chlorophyll absorption band. Deeper chlorophyll band depth reflects a higher concentration of biodeterioration, highlighted in pink.

In the on-site hyperspectral acquisitions of the façade of Santa Maria dei Servi Church, SWIR ranges unfortunately were not observable due to the atmosphere absorption between 1334–1439 nm and between 1794–1938 nm. The 1750 nm band was completely obliterated, while the triplet between 1440–1540 nm showed some artifacts due to the close relationship with the 1334–1439 nm atmosphere absorption. For this reason, we used the spectral indexes proposed by Shuai et al. [21]. The two spectral indexes gave identical results, showing enrichment in sulfates in the lower part of the wall likely due to the capillarity rise of water (Figure 8a,b). A slightly higher concentration of sulfates was also seen on the top of the wall, especially when compared to the central part (Figure 8b). In this case, the enrichment is probably related to meteoric water and sea spray present in the lagoon environment. The on-site chlorophyll spectral maps (Figure 8c,d) showed a quite random distribution of biodeterioration. The chlorophyll band was a bit deeper in the lower part (closer to the ground) and the brick cracks, indicating a little enrichment in these areas.
