Combining Historical, Remote-Sensing, and Photogrammetric Data to Estimate the Wreck Site of the USS *Kearsarge*

Abstract: Colombia has hundreds of historical shipwrecks, but systematic research on this topic is scarce, which makes locating wreck sites problematic. Colombia is home to the Caribbean archipelago of San Andres, Old Providence, and Santa Catalina. Its complex environmental conditions make it a “ship trap”. On 2 February 1894, the USS *Kearsarge* ran aground on Roncador Cay, one of the Archipelago’s islets, and the location of the wreck site remains uncertain. Due to its role in the American Civil War, the *Kearsarge* is important naval heritage. Based on historical and cartographic records, orthophotographs, Landsat images, and light-detection-and-ranging (LiDAR) data, this study aimed to estimate the location of the wreck site in a Geographic Information System (GIS). Court-martial records, particularly nautical data and astronomical coordinates, were reviewed, including a study from 1894 indicating the wreck’s location on a map without coordinates. Nautical charts were also analyzed to find the *Kearsarge* wreck symbol. To identify the wreck site’s ordnance, logbook

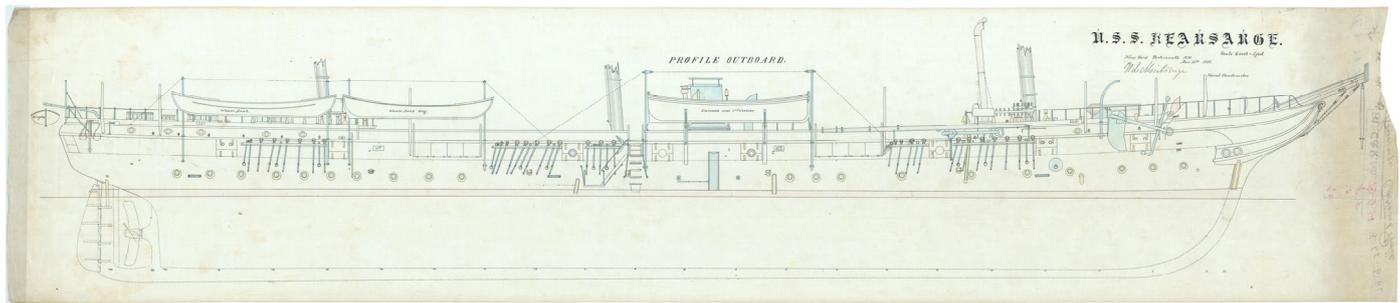
Figure 1. Plan for the USS *Kearsarge*-79-9-34F. Navy Yard, Portsmouth, NY. December 1888 (National Archives at College Park).

The USS *Kearsarge* was a Mohican-class sloop-of-war, launched in 1861 and designed by William L. Hanscom. The *Kearsarge* was one of the last few “old wooden” ships that remained in the US Navy, primarily due to its value and actions during the Civil War against the CSS *Alabama* in Cherbourg, France, in 1864 [22]. The *Kearsarge* was a three-masted steamship that could reach speeds of over 11 knots; it carried seven guns and 166 men, including officers. The machinery was a two-cylinder, horizontal, back-acting engine with a diameter of 54 inches and a stroke of 30 inches, with 822 horsepower [28] (Table 1). To provide a complete description, the USS *Kearsarge* is depicted from distinct angles in the plans from the 1888 shipyard period (Figures 1–3).

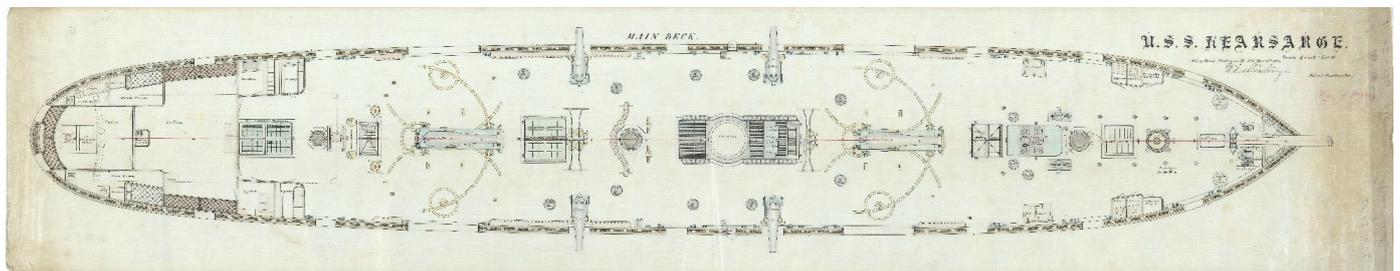
Figure 2. Plan for the USS *Kearsarge*-79-9-34E. Navy Yard, Portsmouth, NY. December 1888 (National Archives at College Park).

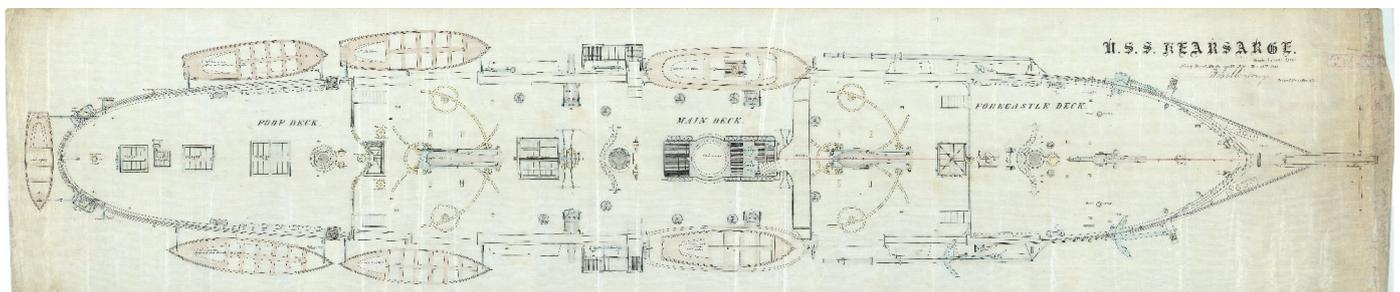
Figure 3. Plan for the USS *Kearsarge*-79-9-34D. Navy Yard, Portsmouth, NY. December 1888 (National Archives at College Park).

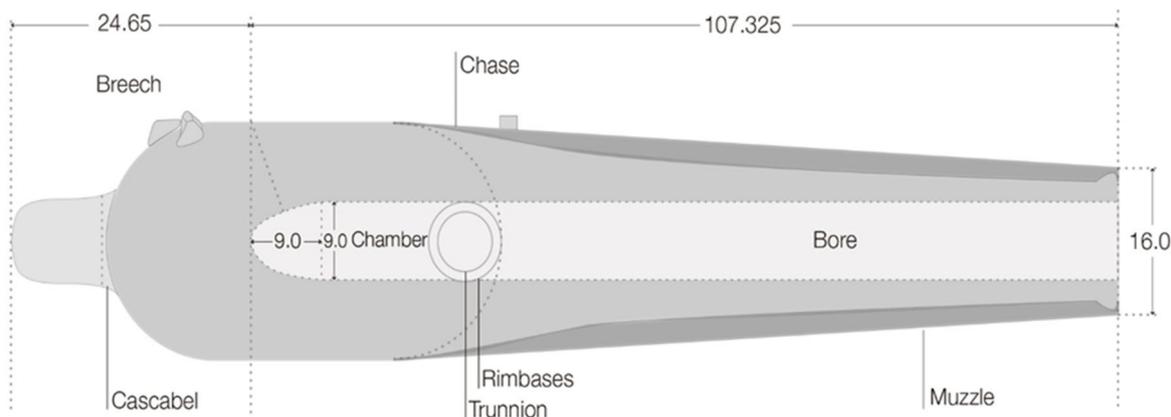
Figure 4. IX-inch Dahlgren shell gun (measurements are in inches). Own elaboration, based on [31].

The “Dahlgren” guns IX, X, and XI were designed in 1854 by Admiral John Dahlgren, known as the “father of American naval ordnance” [32]. These were mostly made from cast iron in the Fort Pitt and West Point foundries [31]. Dahlgren cannons feature a unique outer shape with a hemispherical form and a curvilinear reinforcer, earning them the nickname “soda-water bottles”. Dahlgren’s designs were unquestionably the most influential in nineteenth-century American naval ordnance [31].

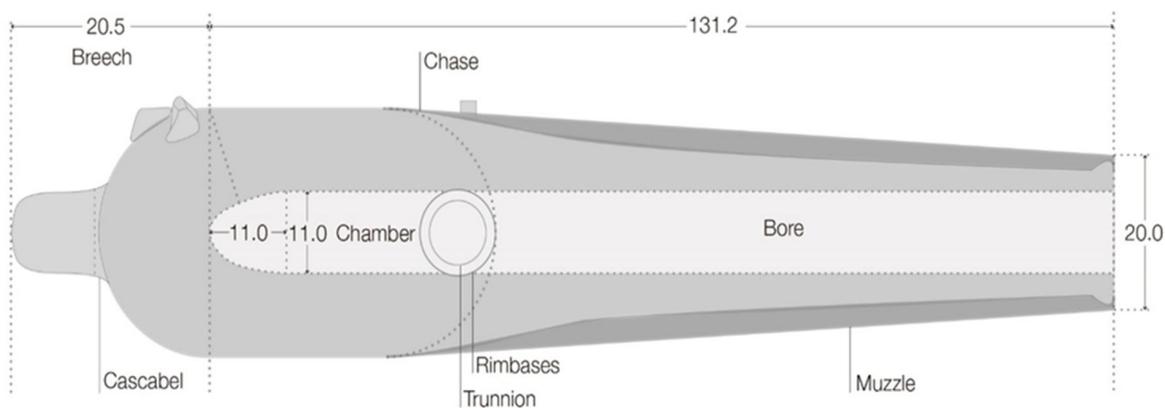
Figure 5. An 8-inch Dahlgren shell gun (measurements are in inches). Own elaboration, based on [31].

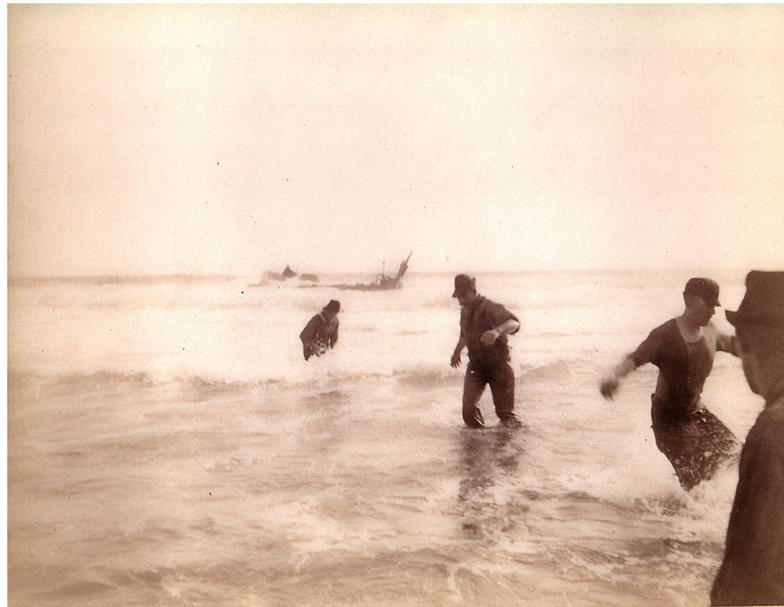
Figure 7. The wreck of the USS *Kearsarge* in Roncador Cay, 1894. The image depicts the salvage attempts as well as the depth of the wreck, between three and five meters. Copy of the original image (photograph from Rich Schmidt's personal archives).

The contract was awarded to the Boston Towboat Company with the steamer *Orion*; however, given the history of marine accidents involving US Navy warships, success was unlikely. For example, on 1 January 1865, the USS *San Jacinto* ran aground on Cay No Name in the Bahamas, and was looted and burned after the copper was extracted [52]. Similarly, after running aground on Assateague Island, off the coast of Virginia, on 10 October 1891, the USS *Despatch* was completely looted [53]. The *Orion* arrived in Roncador on 22 March 1894, and found signs of destruction and looting of the USS *Kearsarge* [54,55]. The *Kearsarge* sustained partial damage from an explosion in the magazine by a fire caused by fishermen who were acting in haste to extract the copper from the hull. Although the wreckers attempted to remove the cannons, they were too heavy [56–58]. These practices were widespread among the Cayman-Islands and Old-Providence-Island fishermen, due to the prevalence of shipwrecks in the vicinity [59]. Later that year, the US Navy recovered a logbook, bell, Union Jack and bronze plaque commemorating the 1864 encounter with the CSS *Alabama* from Cayman Island [60,61]. The crew of the *Orion* captured some images of the wreck and its surroundings, which may be the first to depict the archipelago's maritime landscape (Figures 7 and 8).

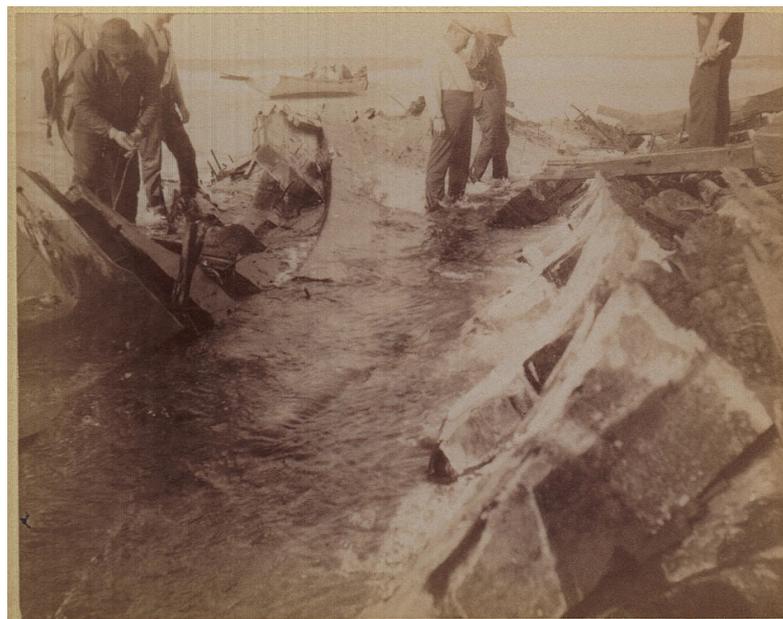
Figure 8. On the deck of the USS *Kearsarge*, 1894. Copy of the original image (photograph from Rich Schmidt's personal archives).

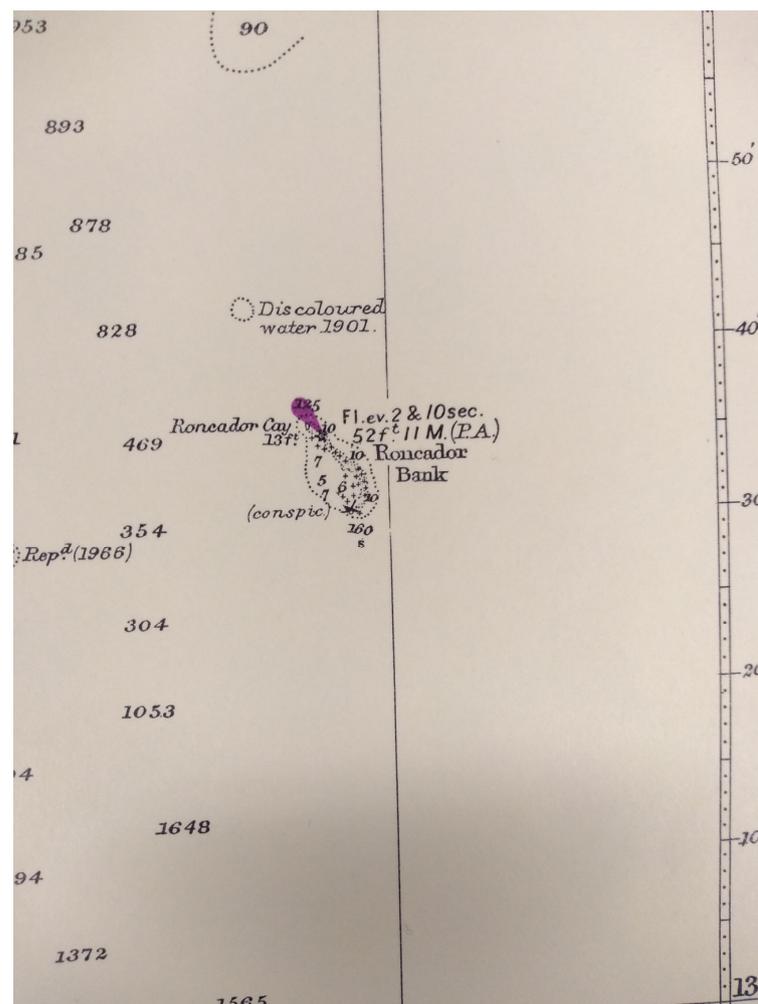
Figure 9. Extract from the chart OCB 1218 A22 West Indies, 1973 (UK Hydrographic Office). A wreck was noted south of Roncador Cay.

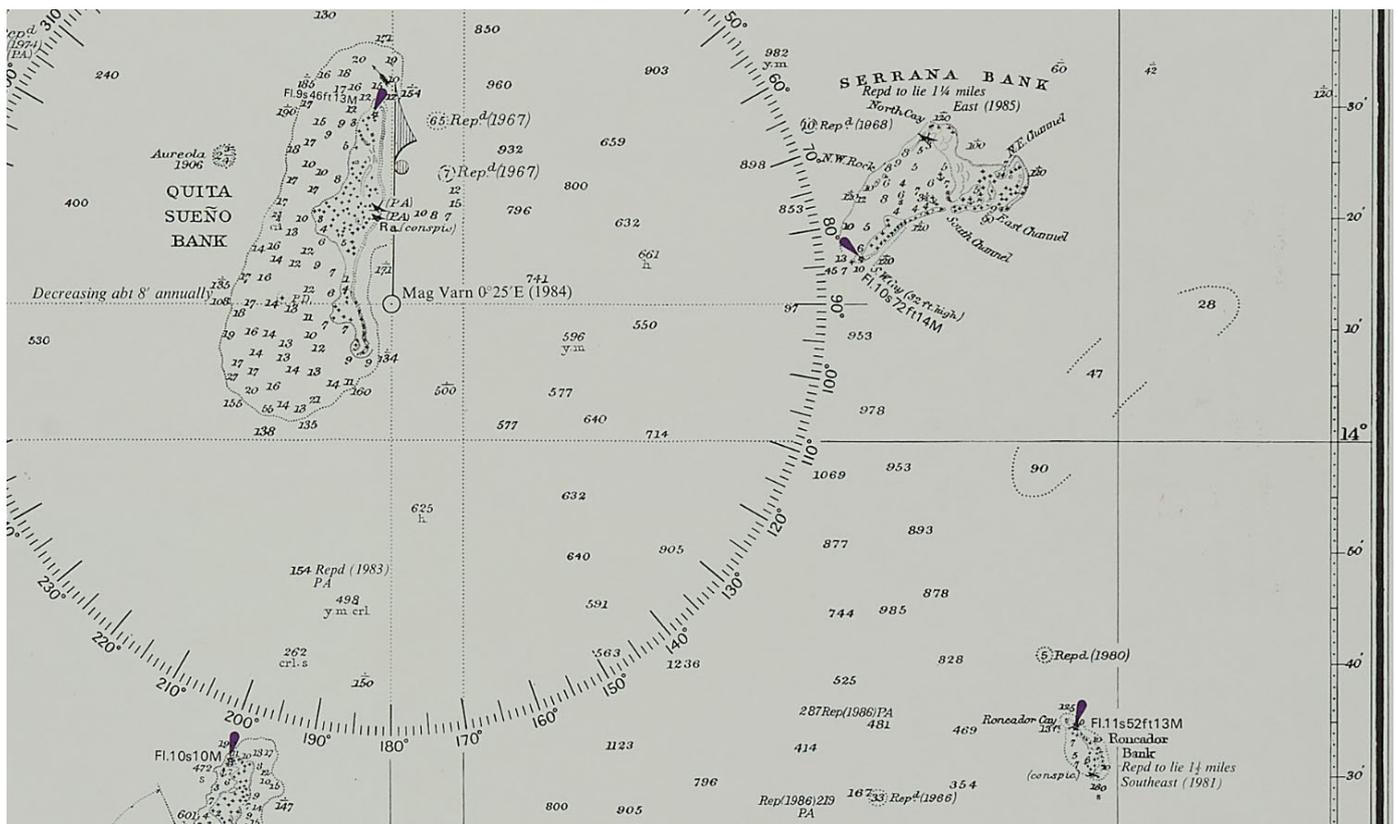
Figure 10. Extract from the chart OCB 1218 A29 West Indies, 1987 (UK Hydrographic Office). A wreck was noted south of Roncador Cay in 1981, as well as other wrecks in the surrounding banks (Quitasueño and Serrana Banks).

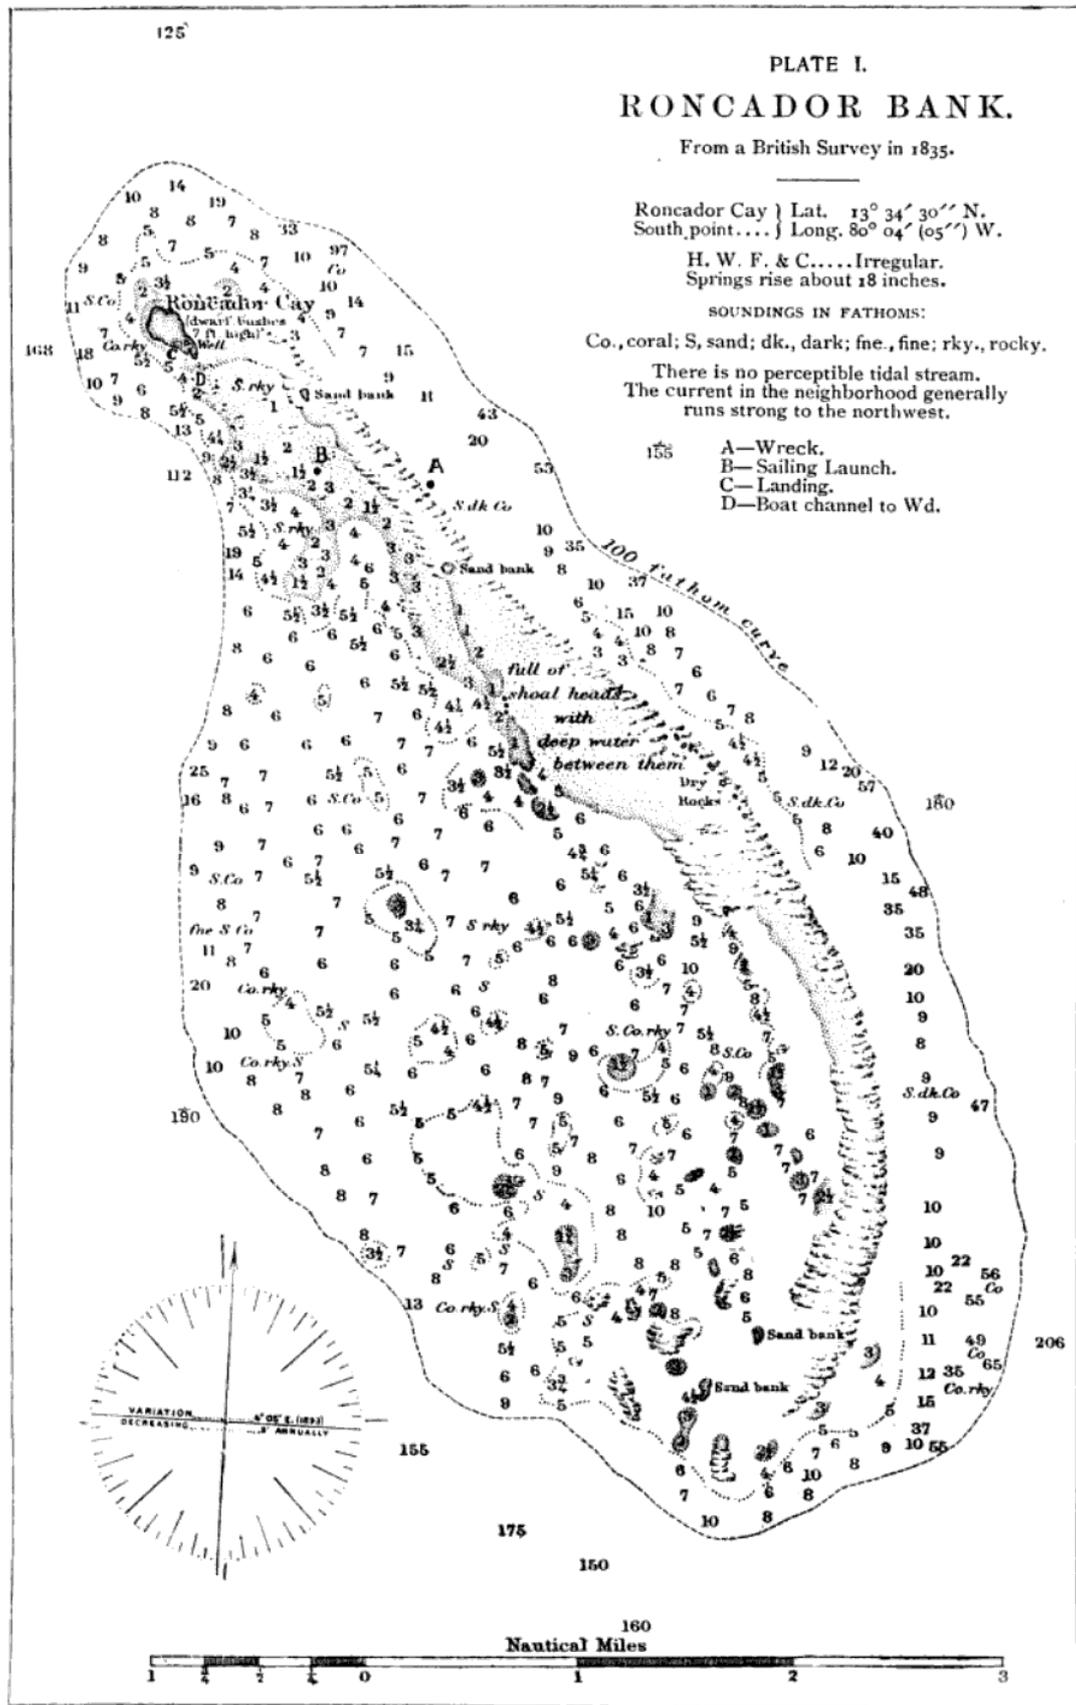
Figure 11. Plate I from the 1894 study. Roncador Bank from a British Survey in 1835. The location of the wreck is marked with the letter A. This plate was processed in GIS [41].

In order to obtain coordinates for the wreck location, indicated by the letter "A", the Plate I map was imported in a GIS. For this purposes, the plate was orthorectified using the most recent georeferenced chart of Roncador Cay: *Carta No 211 Isla Cayos de Roncador 4ta. Ed. 2017* (DIMAR) (the nautical chart from Roncador, 2017). Four control points from the 2017 nautical chart were selected, based on the presence of detailed features (coral reef and the cay) (Figure 13). The coordinates obtained from the Plate I letter "A" are *latitude* $13^{\circ}33'34.141'' N$ and *longitude* $80^{\circ}4'11.546'' W$. However, the nineteenth-century hydrographic techniques prevented us from determining the coordinates with any degree of precision.

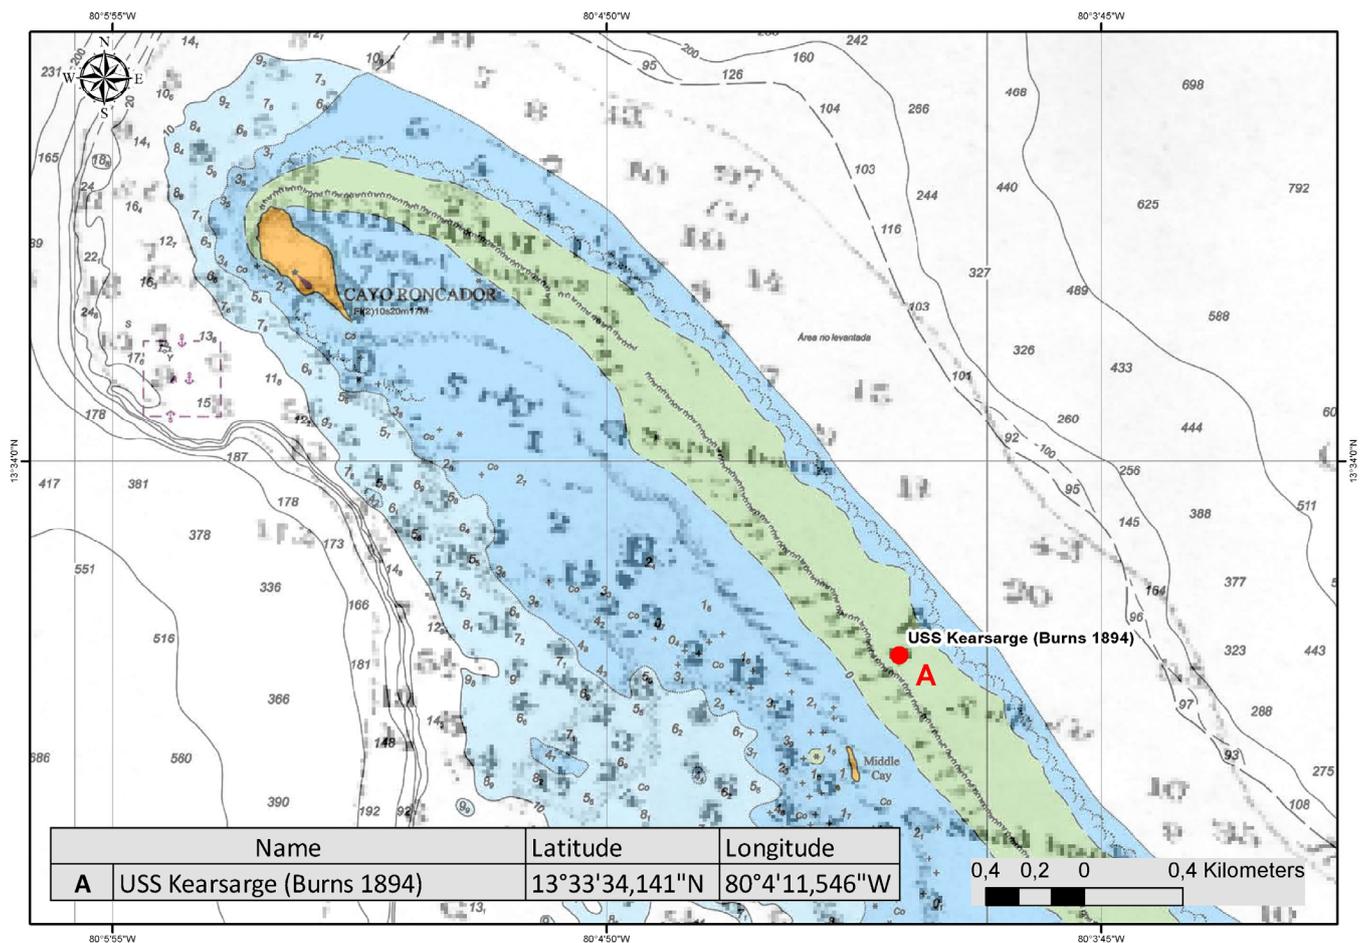
Figure 13. Plate I was orthorectified using the chart of Roncador Cay, *Carta No 211 Isla Cayos de Roncador 4ta. Ed.2017* (DIMAR) (the Nautical Chart from Roncador, 2017). Four control points from the 2017 nautical chart No 211 were selected, based on the presence of detailed features.

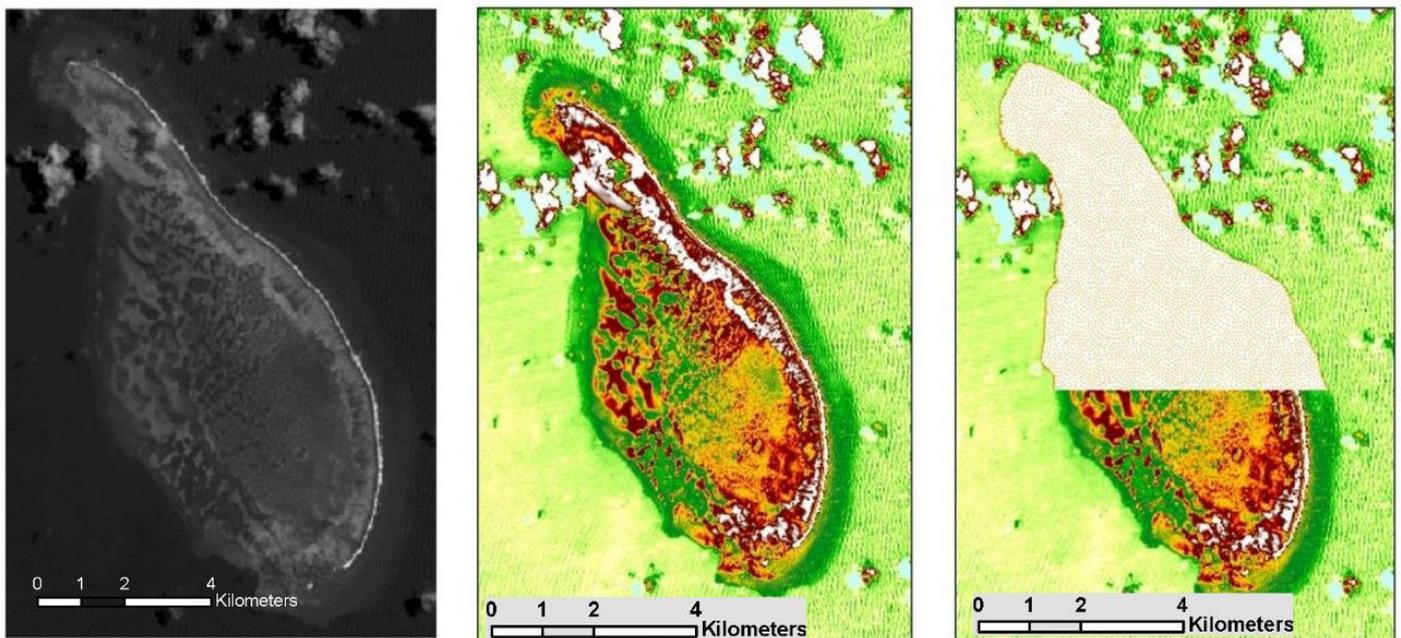
Figure 14. Roncador Cay. The image on the left is a Landsat-8 without digital correction. The central image was corrected and integrated with bathymetric data. The right image depicts a polygon in Roncador Cay (beige color). Own elaboration.

To determine the depths of Roncador Cay, Landsat-8 images were digitally corrected and integrated with bathymetric data (Figure 14). This integration enabled the research to analyze submerged features or geforms that could be associated with the remains, particularly the Dahlgren-gun shape.

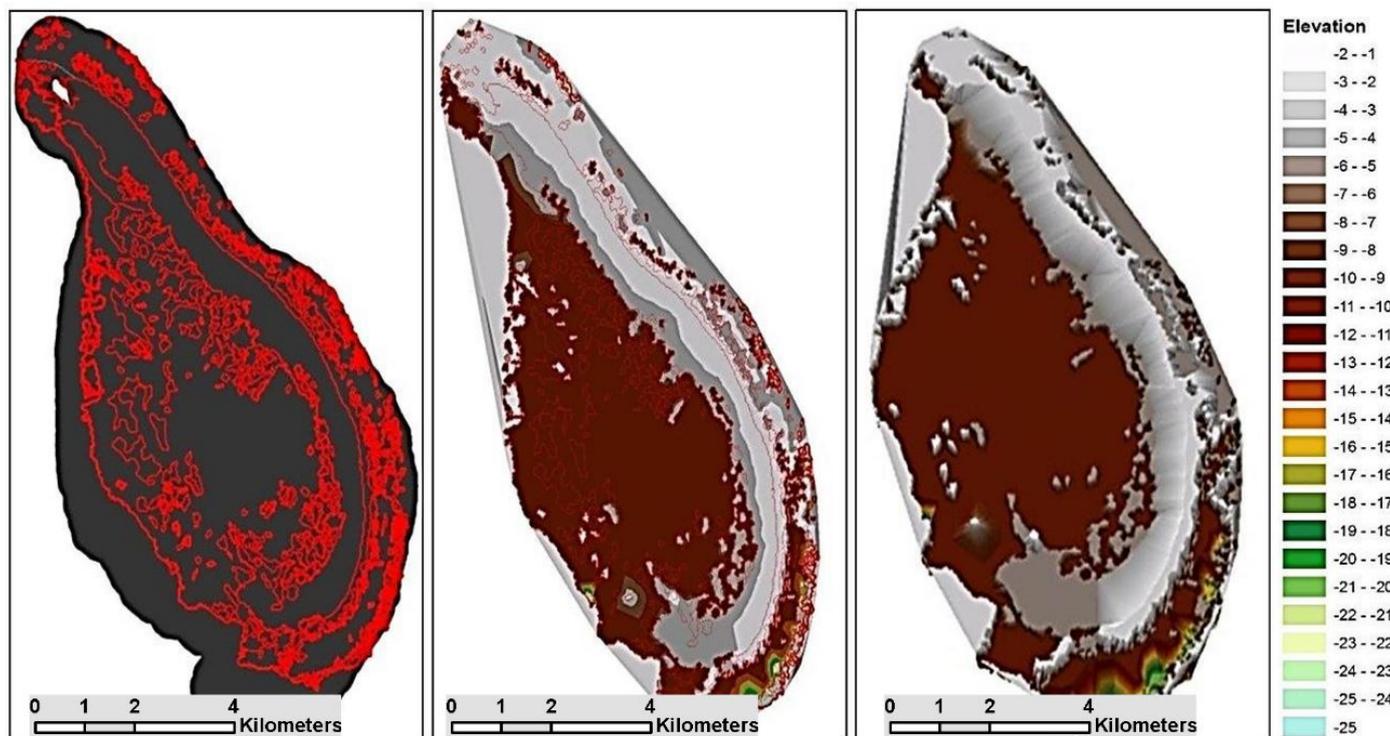
Figure 15. Left image, bathymetry 2014 (IGAC) loaded in ArcGis 10.6.1. Central image, triangulated irregular networks. Right image, 3D Bathymetric Model in ArcScene 10.6.1. Own elaboration.

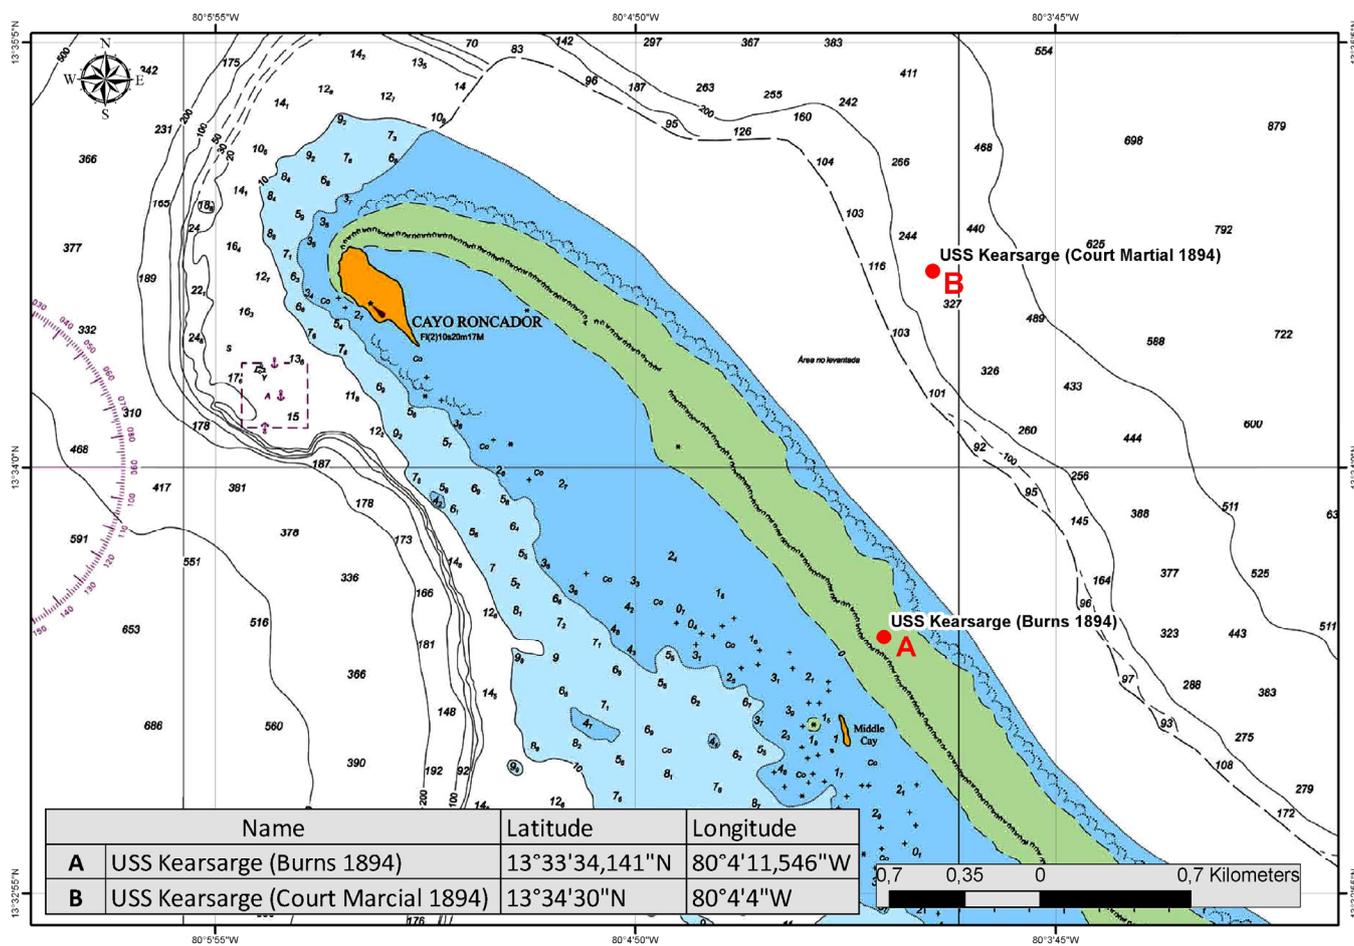
Figure 16. The coordinate system obtained from the 1894-study map (Burns 1894) and the astronomical coordinates of the accident shipwreck (court martial) were set on nautical chart No 211 (DIMAR). Due to the lack of accuracy of navigation techniques in the nineteenth century, the astronomical coordinates were located outside of the reef. The differences between the coordinates are depicted in the table on the left side of the image.

chart and approach this location, due to the absence of logbook entries for the two days preceding the accident [30]. Consequently, it was necessary to integrate the historical data with the remote-sensing data, to determine an area of uncertainty for the wreck site. For this purpose, the astronomical-coordinate data and the coordinates obtained from the Plate I were established in a geographic-information system (ArcGIS), in nautical chart No 211 of 2017 (Figure 16).

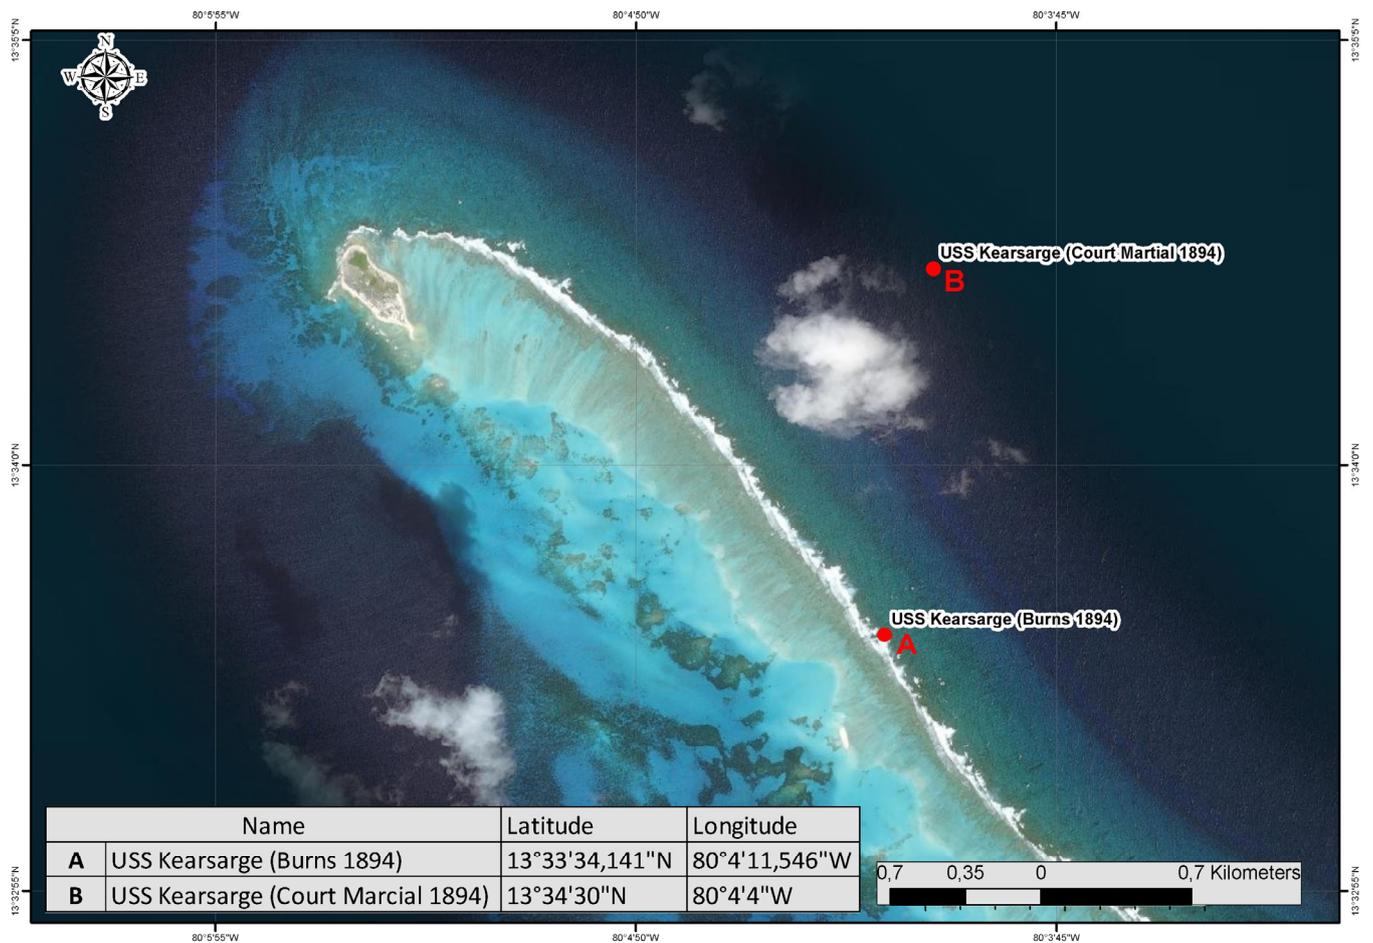
Figure 17. WorldView-2 satellite image of Roncador Cay of 2020. The coordinate system obtained from the 1894-study map (Burns 1894) and the astronomical coordinates of the accident shipwreck (court martial) were set on the satellite image of Roncador Cay.

Additionally, the coordinates obtained from Burns’s Plate I point “A”, as well as coordinates from the court martial, were assigned to a processed satellite image of Roncador Cay of 2020 (Figure 17).

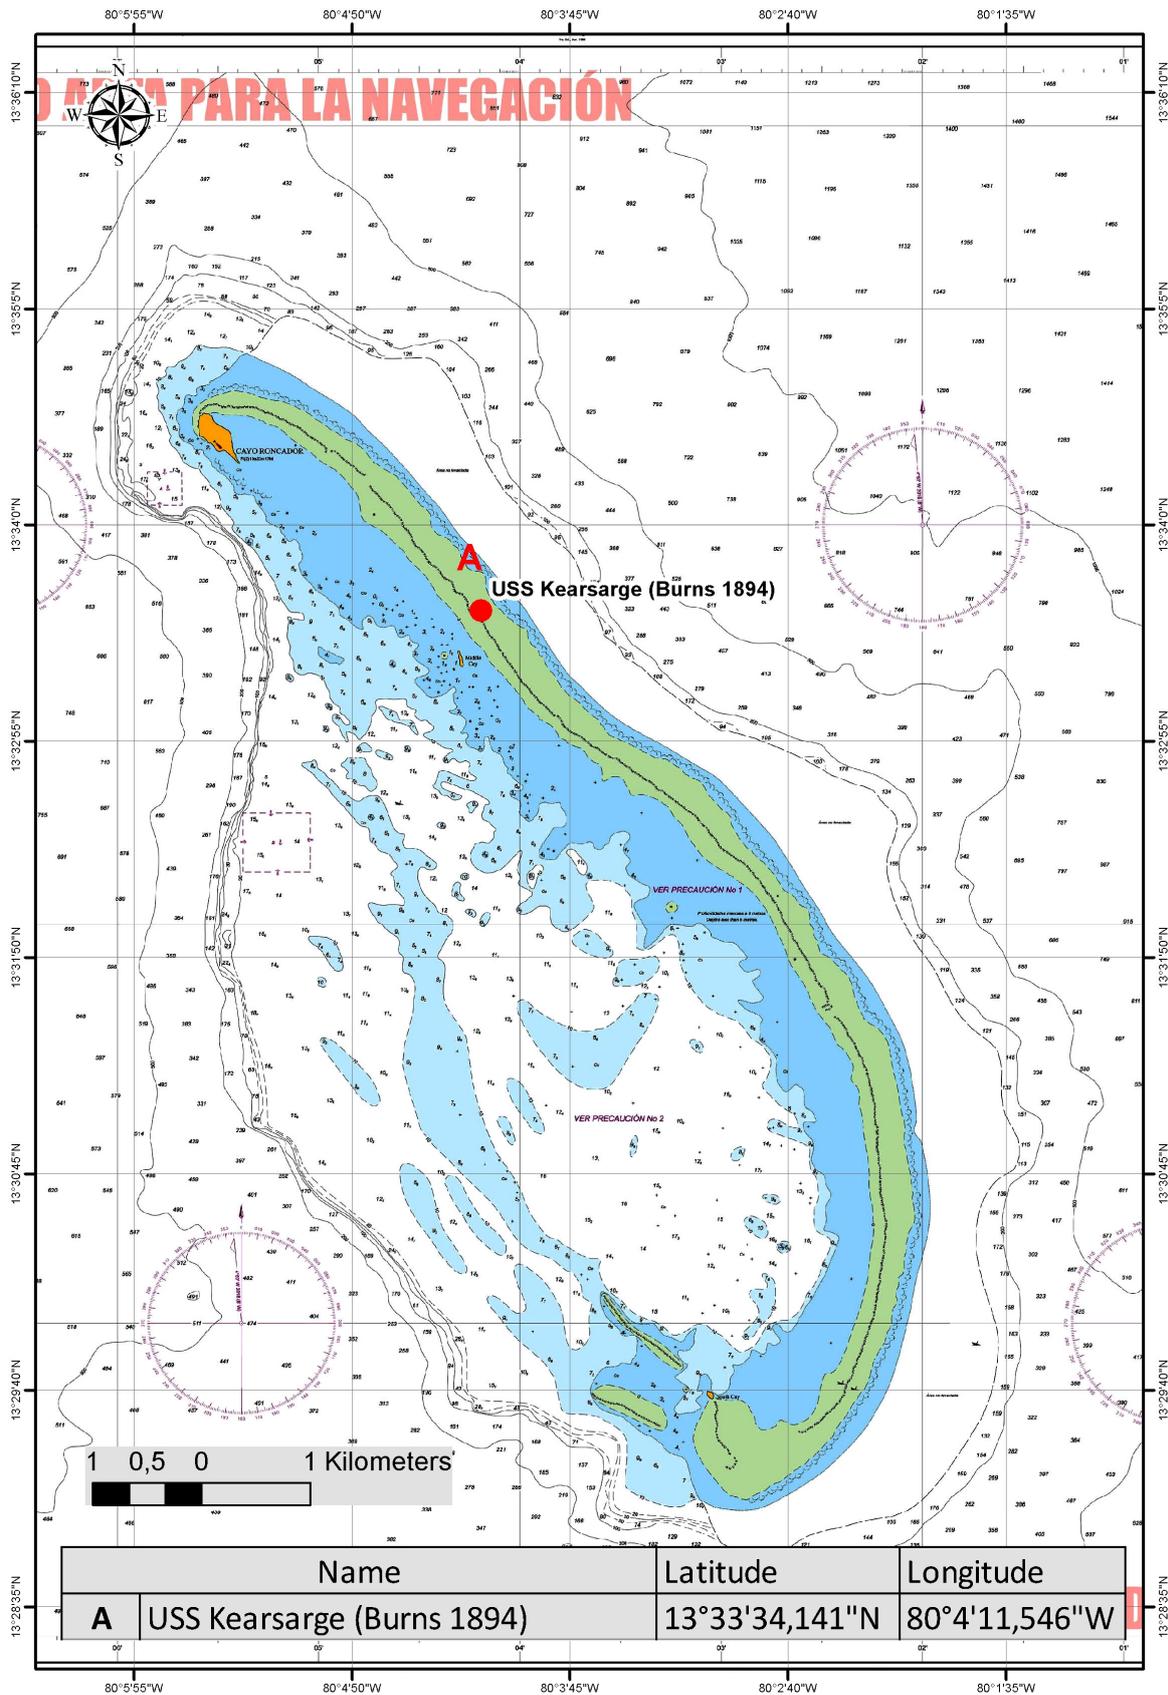
Figure 18. Nautical chart No 211 of Roncador Cay, 2017 (DIMAR). The potential location in which the wreck could be located (red point) was determined using the coordinates obtained from the 1894-study map (Plate I).

The USS *Kearsarge* ran aground close to the shoal at depths of approximately three and five meters, at the bow and stern, respectively, according to historical evidence from the court martial and the 1894 study. The astronomical coordinates were set outside of the reef and in deep waters, due to the lack of accuracy in the nineteenth century. Based on the shipwreck's historical data, these coordinates were rejected as a potential location, and only those found on Plate I were accepted as a potential location. Although the estimated area (Figure 18) does not corroborate the exact location, it provides a limited-spatial area in which remote-sensing data can be applied to locate artifacts or remains from the wreck site. Additionally, these data can be helpful in further identification studies.

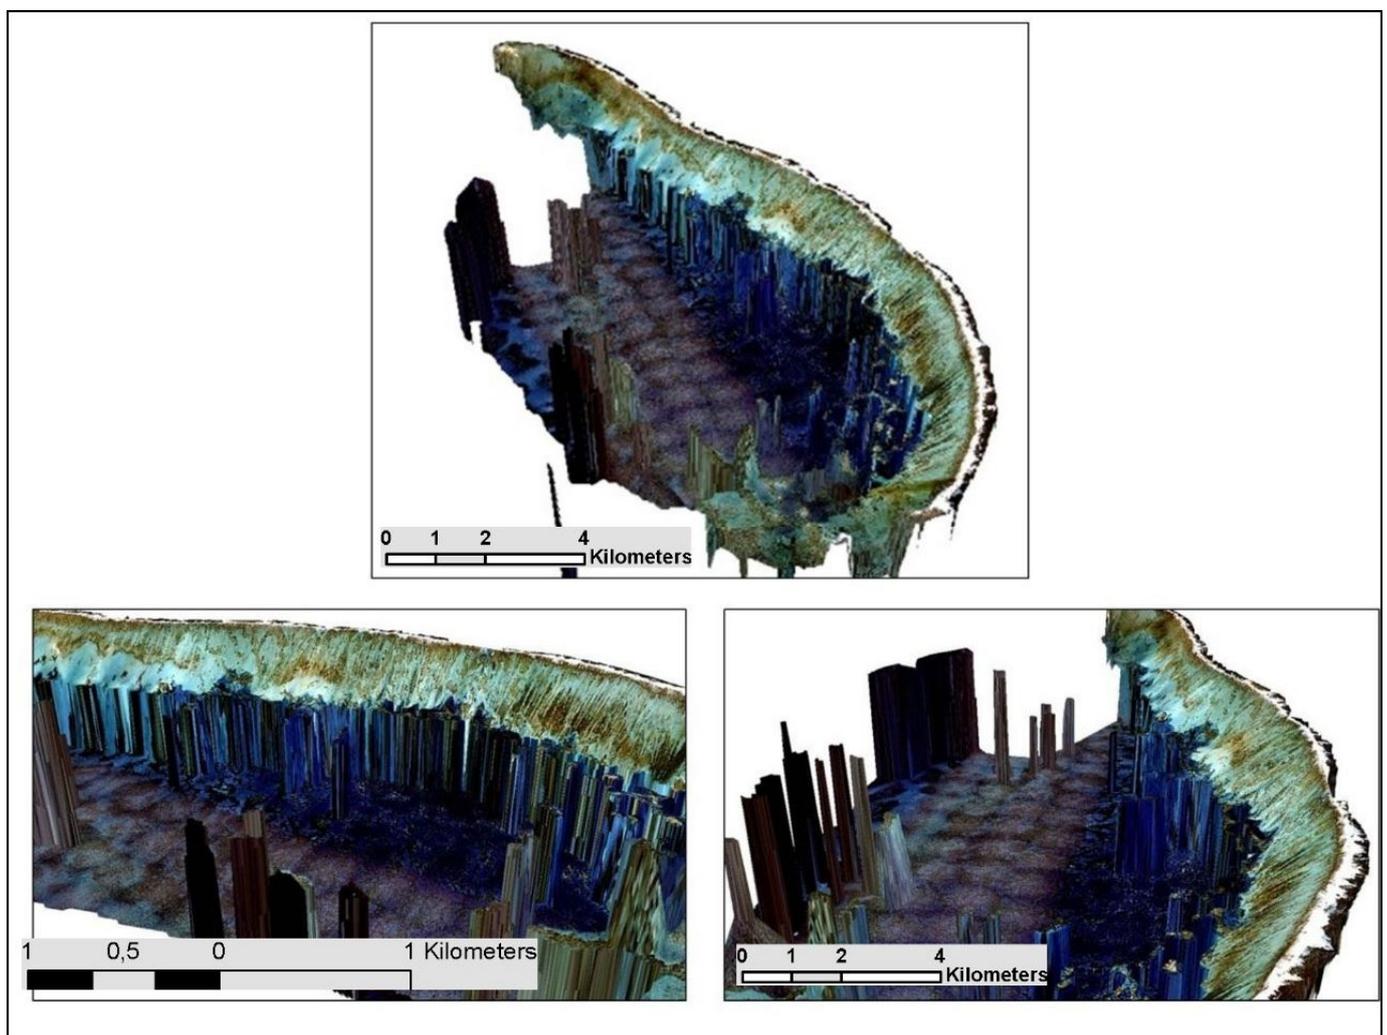
Figure 19. Images from different observation points regarding the superposition of digital aerial photography and 3D-bathymetric model in Roncador Cay. The image above depicts the entire Cay. The right and left images corresponded to the area of the coordinates obtained from Plate I. These images have different angles and scales. Own elaboration.

Finally, the 3D-bathymetric model was superimposed on Landsat-8 data and digital aerial photographs, using the generated limited-spatial area (Figure 19). The images were processed to detect different shapes, patterns, colors, and textures that might be connected to the wreck or cylinder shapes associated with the Dahlgren guns, in shallow and clear waters. Furthermore, an analysis based on the ArcGIS software's digital-terrain model was conducted, to generate perspective views and a terrain-slope map of Roncador Cay in the area of interest (Figure 20). However, identification was not possible, for two primary reasons. First, the low resolution of the images prevented the accurate identification of depth-related shapes. Despite the information regarding the depth of the wreck that was obtained from the court martial, suggesting it was between three and five meters, it was not feasible to locate relevant shapes. The second significant factor was the prevalence of coral reefs, which prevented identification.

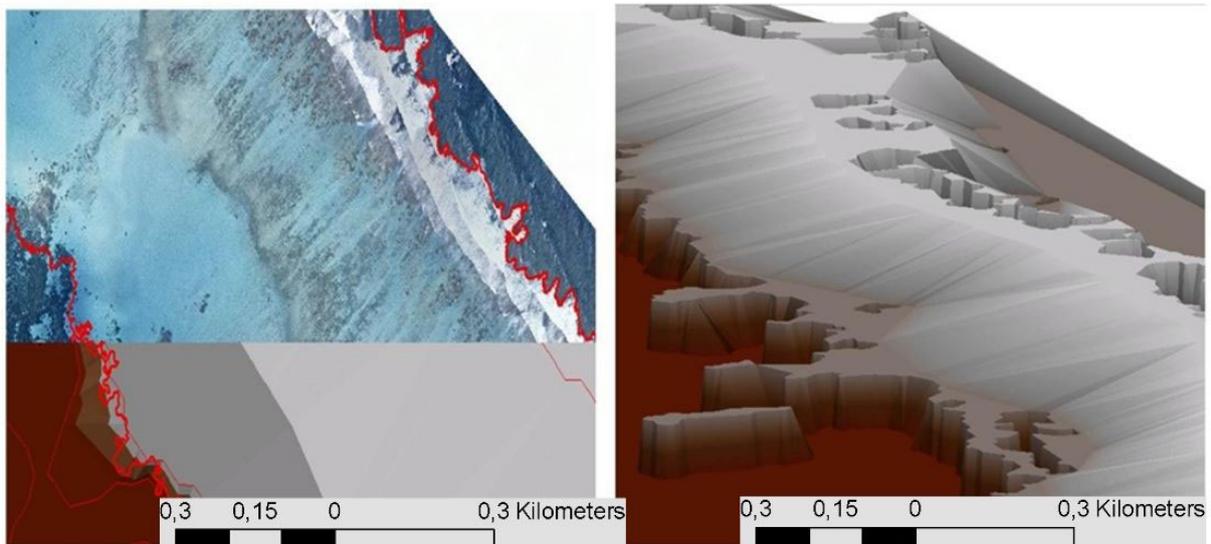
Figure 20. Bathymetric-image visualization and a 3D-bathymetric model of Roncador are used to detect shapes associated with the shipwreck. The right and left images corresponded to the area of the coordinates obtained from Plate I. Own elaboration.
