The Flight of Saint Mary Magdalene—A Case Study of the Dismantling, Repositioning and Restoration of a Votive Aedicule and Wall Painting in Nardò, Lecce, Italy

Abstract: The work carried out as part of construction on a ring road around Nardò (Lecce, South Italy) involved a votive aedicule attached to the perimeter wall of a rural building that had been scheduled for demolition. Provision was made for the movement and relocation of the building, dedicated to St. Mary Magdalene, to an adjacent area, in addition to the restoration of the pictorial decoration itself. The intervention was designed to conserve the building as testimony of its use for future generations, given its value and sense of identity for the local community. The project was largely conservatory, thus guaranteeing the continuity of its still active devotional function. In this sense, the restoration of the building was also associated with an educational aim of raising awareness of the importance of eco-compatible care of the landscape. So, this project highlights the importance of social, as much as environmental, sustainability.

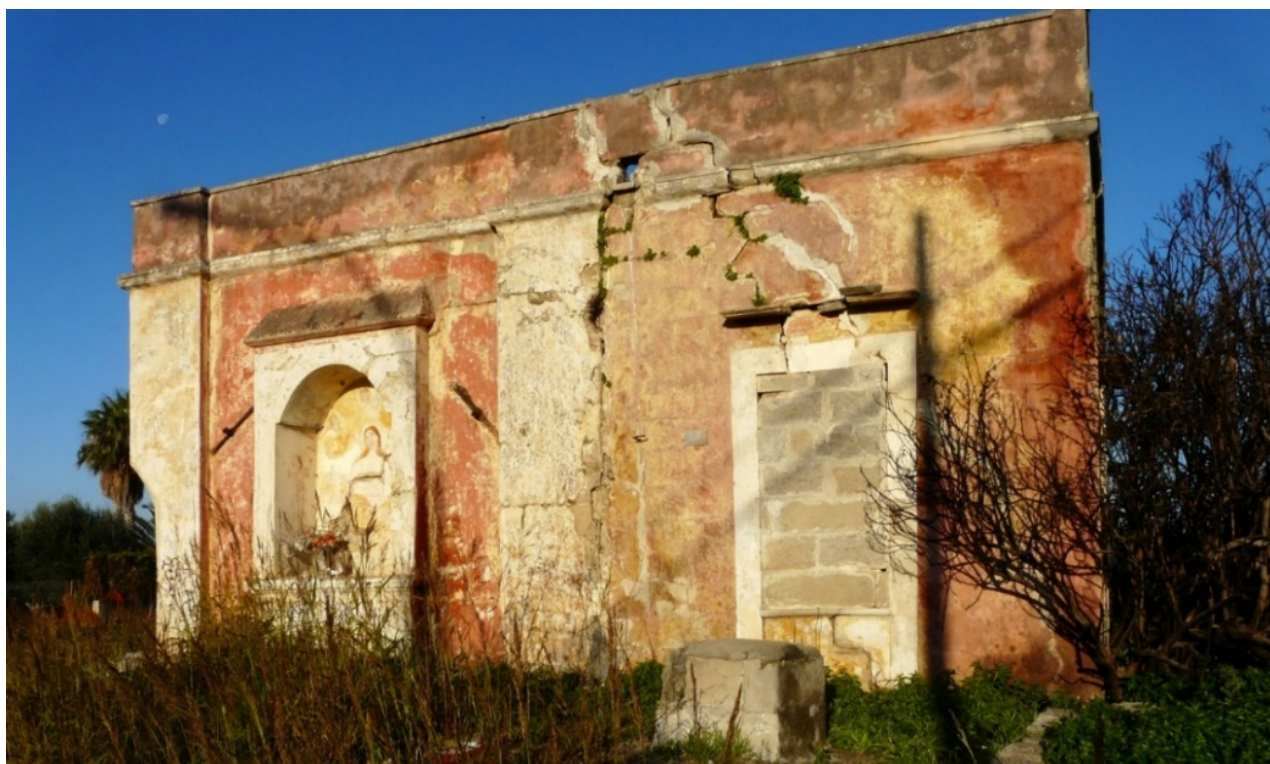
Figure 1. The rural building, from the southeast; on the left, the Magdalene aedicule.

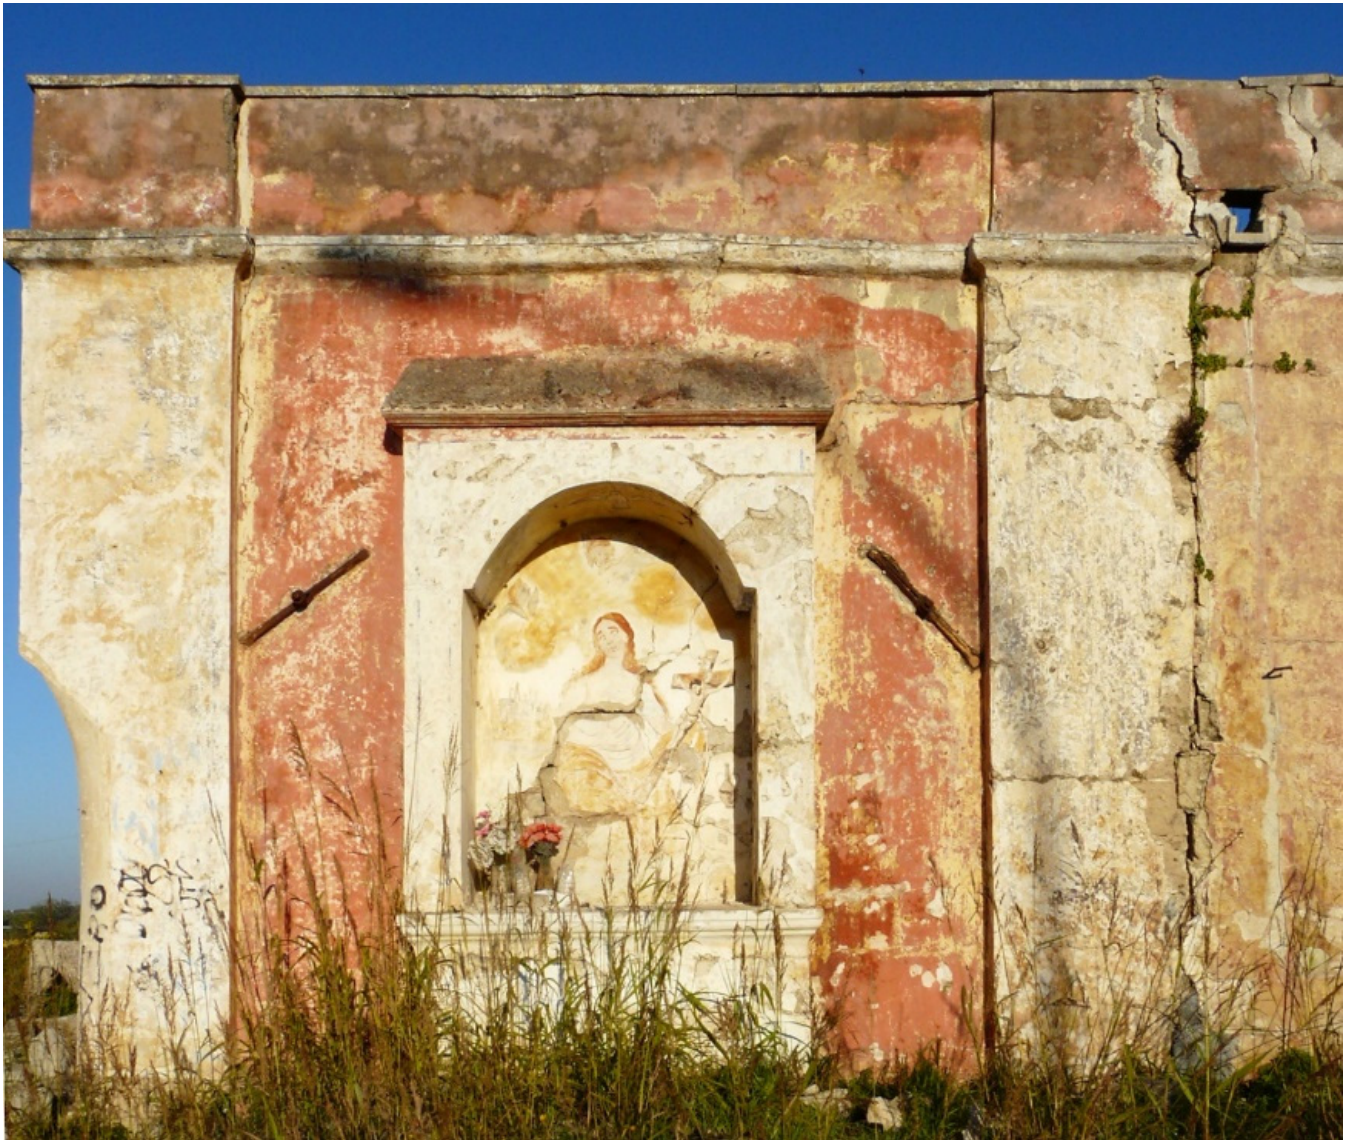
The aedicule, entirely stuccoed and decorated, sits on a base resembling an altar table finished at the top with a moulded cornice. On the front are fragmentary traces of a now illegible epigraph. Flanked by two lateral jambs, it ends at the top with an arch surmounted by a further cornice protected by a short roofing overhang made with opus signinum (Figure 4). It leans against a plastered curtain wall framed by two pilasters (the one on the left rounded to accommodate passing vehicles), delimited at the top by a cornice surmounted by a parapet protected by a layer of Lecce stone paving.

Figure 4. Votive aedicule.

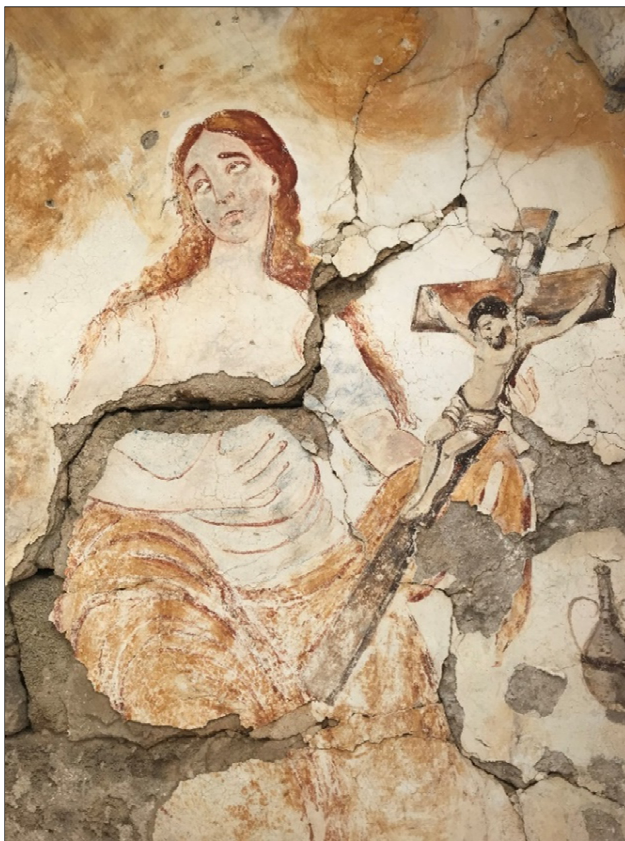
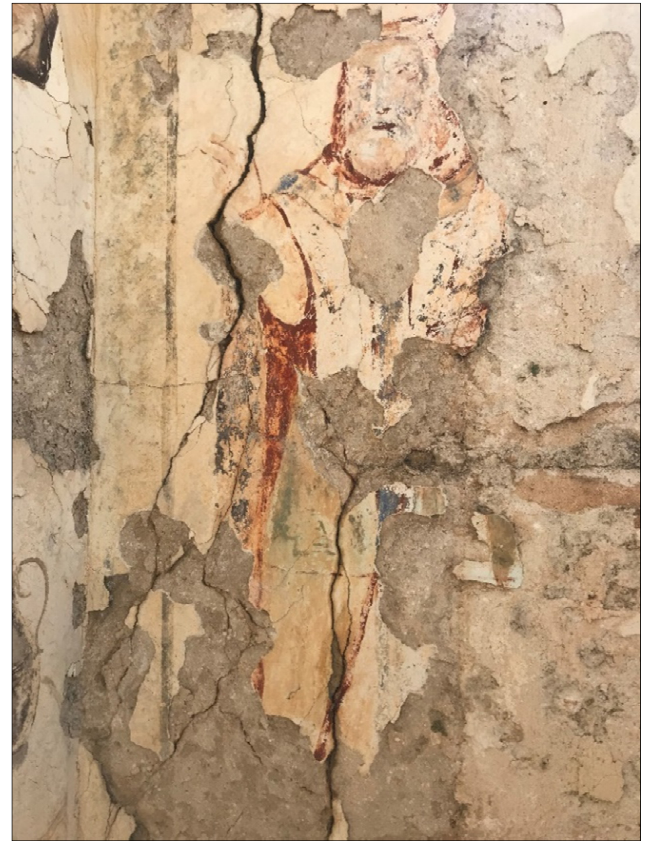
The pictorial decoration appeared in a very bad state of conservation. It is a “mixed” painting, with “dry” parts—lime paint, probably tempera—on single-layer plaster laid on the masonry face in regular ashlars of local tuff (Pliocene biocalcarenite). Execution appears simple and without the canonical rough coat-*arriccio-intonachino* stratification, which would have been typical of better-quality wall paintings, especially when using the *a fresco* or *mezzo fresco* techniques.

Adhesive qualities of the plaster to the masonry support were compromised in several points due to the poor grip qualities of the underlying stone, favoring its detachment with the consequent formation of pockets and visible areas of layer lifting, which entailed the loss of parts of the paintings (lacunas), concentrated above all in the intradossal portion of the vault. The plaster, in addition to a dense network of micro and macro cracks, has suffered widespread biological attack (biological patina) and surface deposits.

Generally abraded due to exposure to atmospheric agents, the pictorial film presented lacunas and was fragile and partially or totally missing, mainly in the lower part of the painting, with the greatest loss in the lower area of the image of Mary Magdalene and *San Gregorio Armeno* (Figure 8a,b).

Figure 8. Details highlighting the poor state of conservation: St. Mary Magdalene (a); *San Gregorio Armeno* (b).

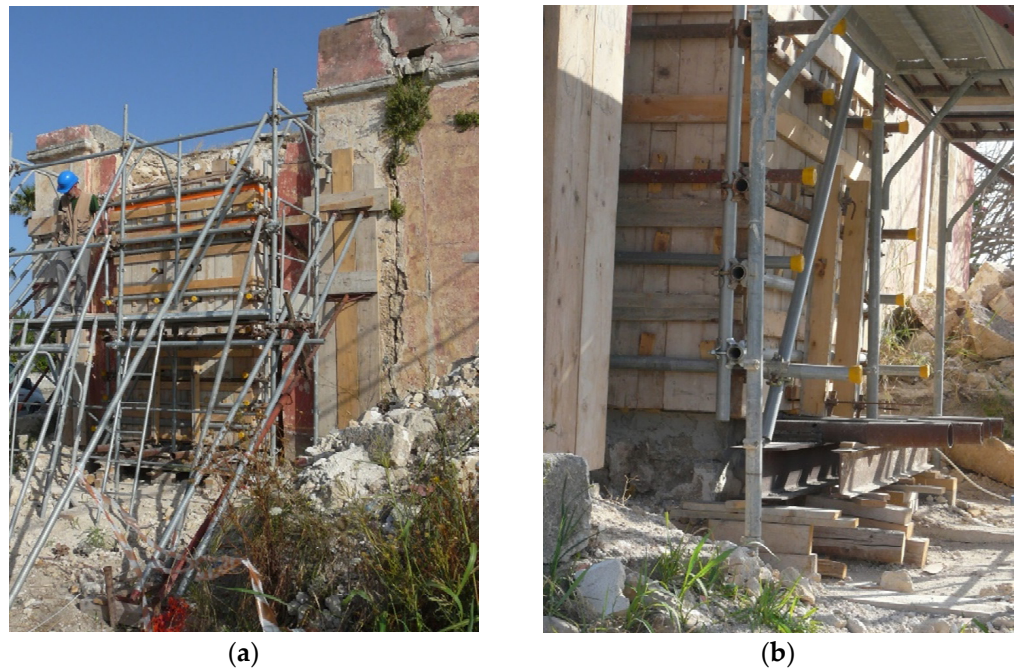
Figure 10. (a,b) Scaffolding work.

Prior to the detachment phase and transport of the aedicule, necessary temporary shoring, cambering and slinging of the entire masonry body of the building was carried

out. This involved both vertical and horizontal wooden shoring to prevent sagging or structural movements, using mainly wooden beams, with bracing and wedging of sections. A scaffolding cage was made of carefully placed scaffolding tubes and wooden planks incorporating the entire masonry body of the votive aedicule ready for transfer to the new location. Prior to this, the entire fresco was protected with support straps and the entire pictorial surface was covered to prevent any danger of detachment of the painted surfaces or of the support plaster during handling and transport. Finally, the entire masonry envelope was protected by an insulating membrane to separate the masonry structure from the scaffolding itself.

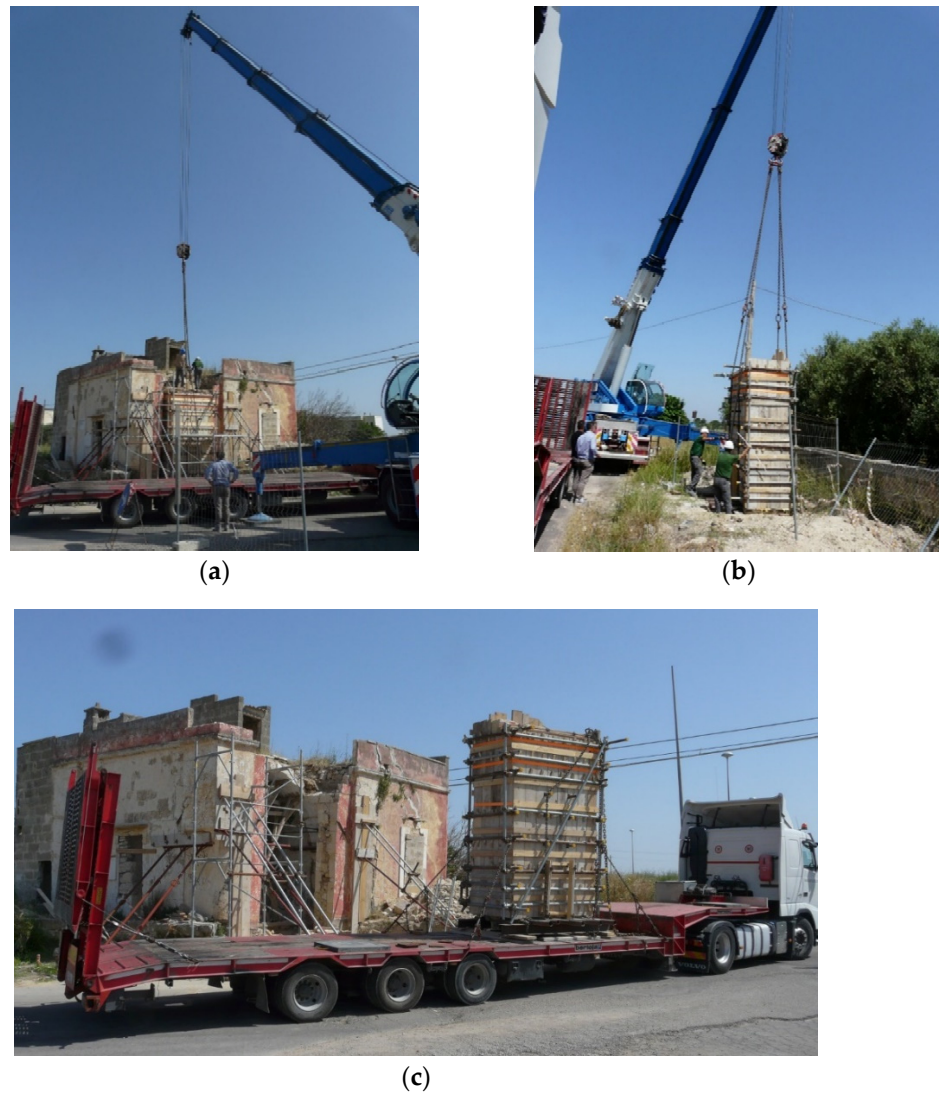
Figure 11. (a–c) Handling.

Prior to the transfer, a portion of the wall the aedicule was leaning against was cut vertically. Disassembly of overhanging portions of the wall was carefully carried out with both electric and manual equipment. The operation of detachment from the entire body of the building also included the assembly of scaffolding and work surfaces and their subsequent disassembly when the operation was completed.

We then proceeded with the handling of the product and transport to the reassembly location using a mobile crane (Figure 11a–c).

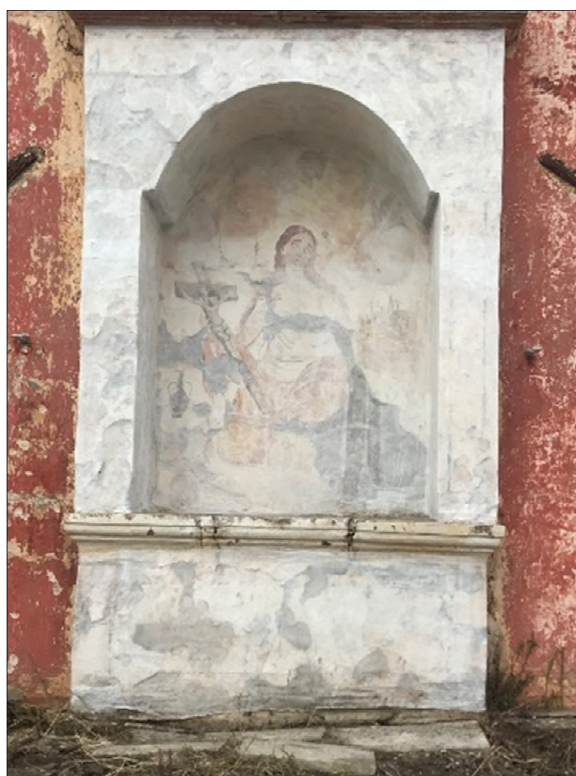
Figure 13. The aedicule covered by protective gauze.

The first fundamental interventions, prior to the dismantling of the votive aedicule, consisted of ensuring the safety of the portions of the painted plaster at risk of falling. The cracks and gaps were filled with mortar based on hydraulic lime and river sand, while pre-consolidation was performed with injections of PLM premixed mortar. The cohesion defects of the pictorial film were resolved, and surface deposits were removed. Three layers of cotton gauze were then applied with Paraloid B72 acrylic resin diluted with trichloroethane. This operation was aimed at protecting the surface of the painting to prevent parts of the pictorial film and of the preparatory layers or of the support from falling (Figure 13).

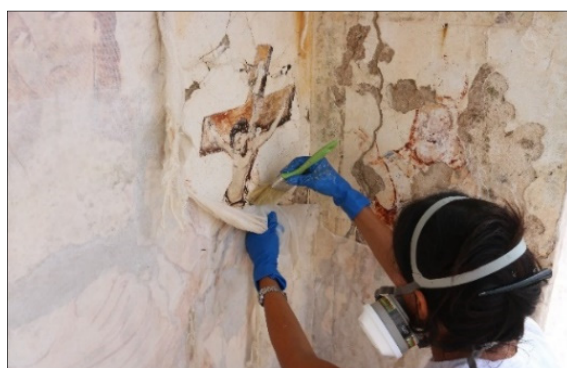
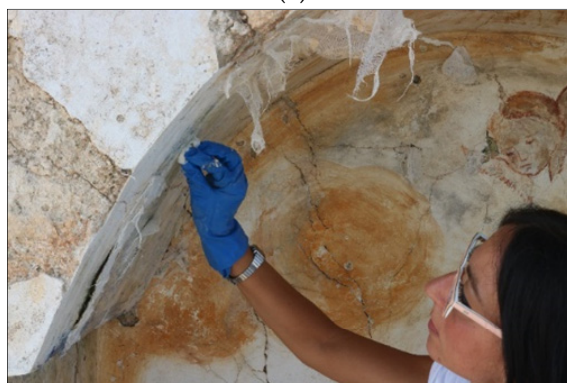
Figure 14. Bandage removal (a,b).

After the reassembly in the new site, the layers of gauze were carefully removed with the aid of brushes and solvent along with the subsequent elimination of PARALOID residues from the entire painted surface with cotton wool and solvent (Figure 14a,b).

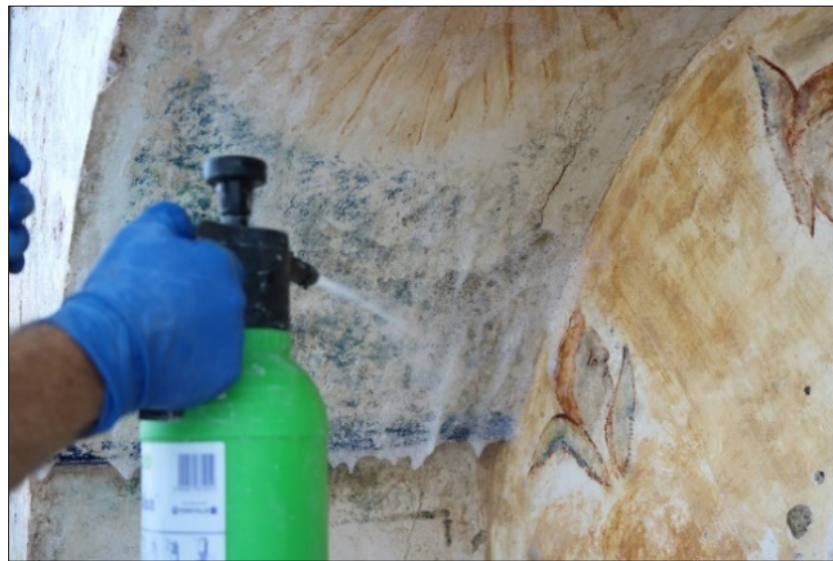
Figure 15. Nebulization of the biocide.

The next phase saw the nebulization of BIOTIN T, a biocidal product, over the entire surface to preserve and protect the surface from microbiological attack (Figure 15). Biodeteriogen residues were removed with soft brushes, and then neutralization was carried out by washing with deionized water.

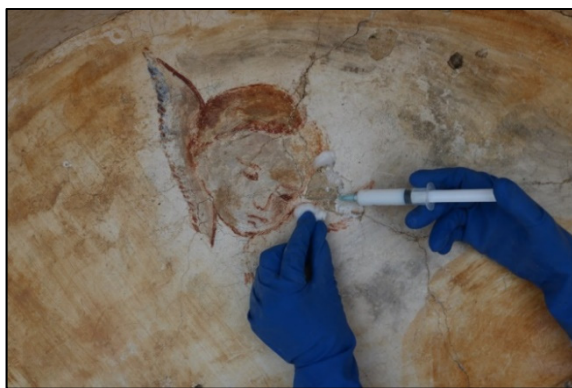
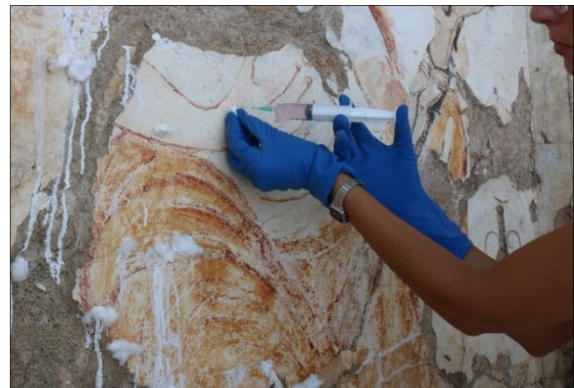
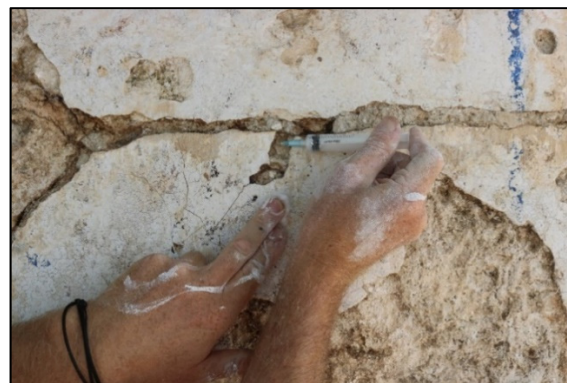
Figure 16. Consolidation operations and application with a syringe (a–c).

We then proceeded with the reinforcement. For the deep filling of the plaster that had detached from the stone support, we injected a water-based calcium hydroxide mortar, PML 33, with demineralized water injections and alcohol. We then worked on the more superficial detachments between the plaster and the painted plaster, injecting acrylic resin (ACRIL 33) in a 5% aqueous solution (Figure 16a–c).

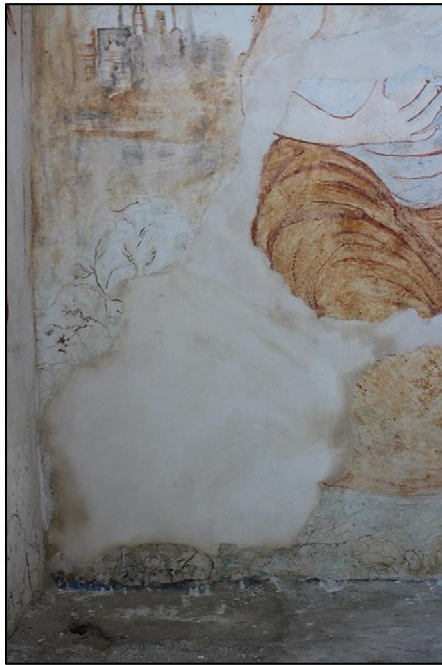
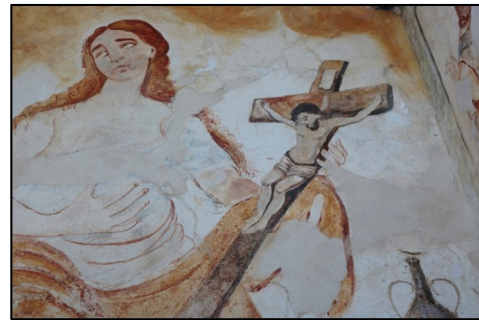
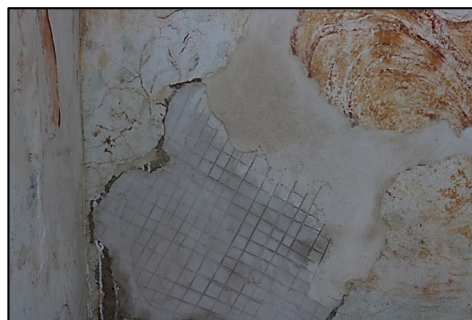
Figure 17. (a–c) Plaster grouting.

Subsequently, the grouting of the gaps and fractures was carried out, levelled with hydraulic lime mortar, using a variety of grain-sized river sand according to gap depth; yellow *cocciopesto* plaster was added to match the original chromatic tone (Figure 17a–c).

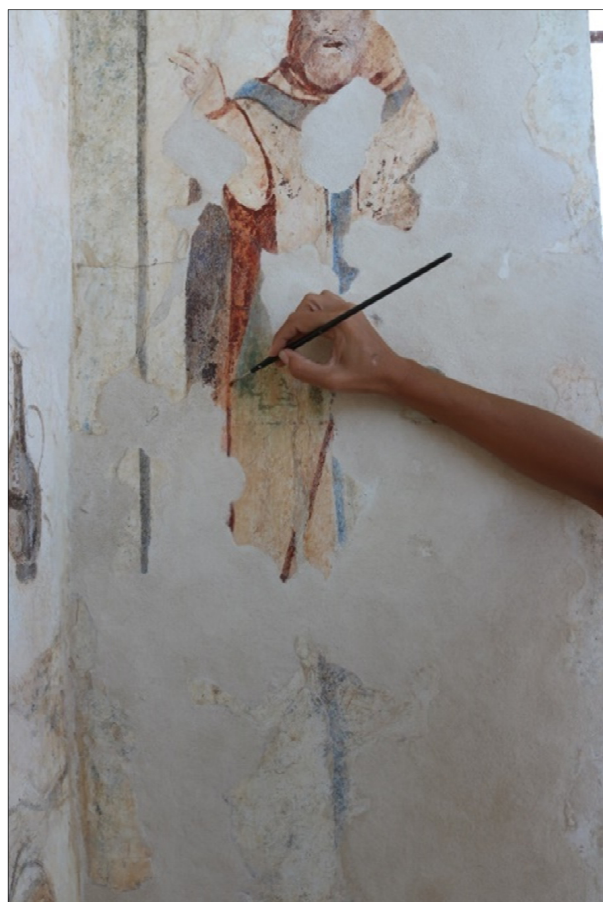
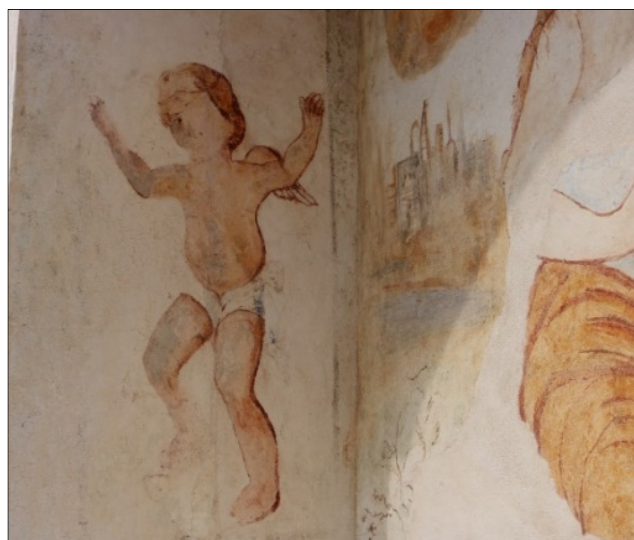
Figure 18. Pictorial integration of *San Gregorio Armeno* (a) of the face of Mary Magdalene (b) and of an angel (c).

The pictorial intervention, aimed at reducing the visual disturbance caused by the evident gaps and abrasions, was strictly limited to the area to be integrated and always in full respect of the original pictorial layout (Figure 18a–c). For the reintegration, carried out with an undertone veiling technique, pure CTS pigments were used, bound with very diluted solutions of acrylic resin to ensure low alterability over time.

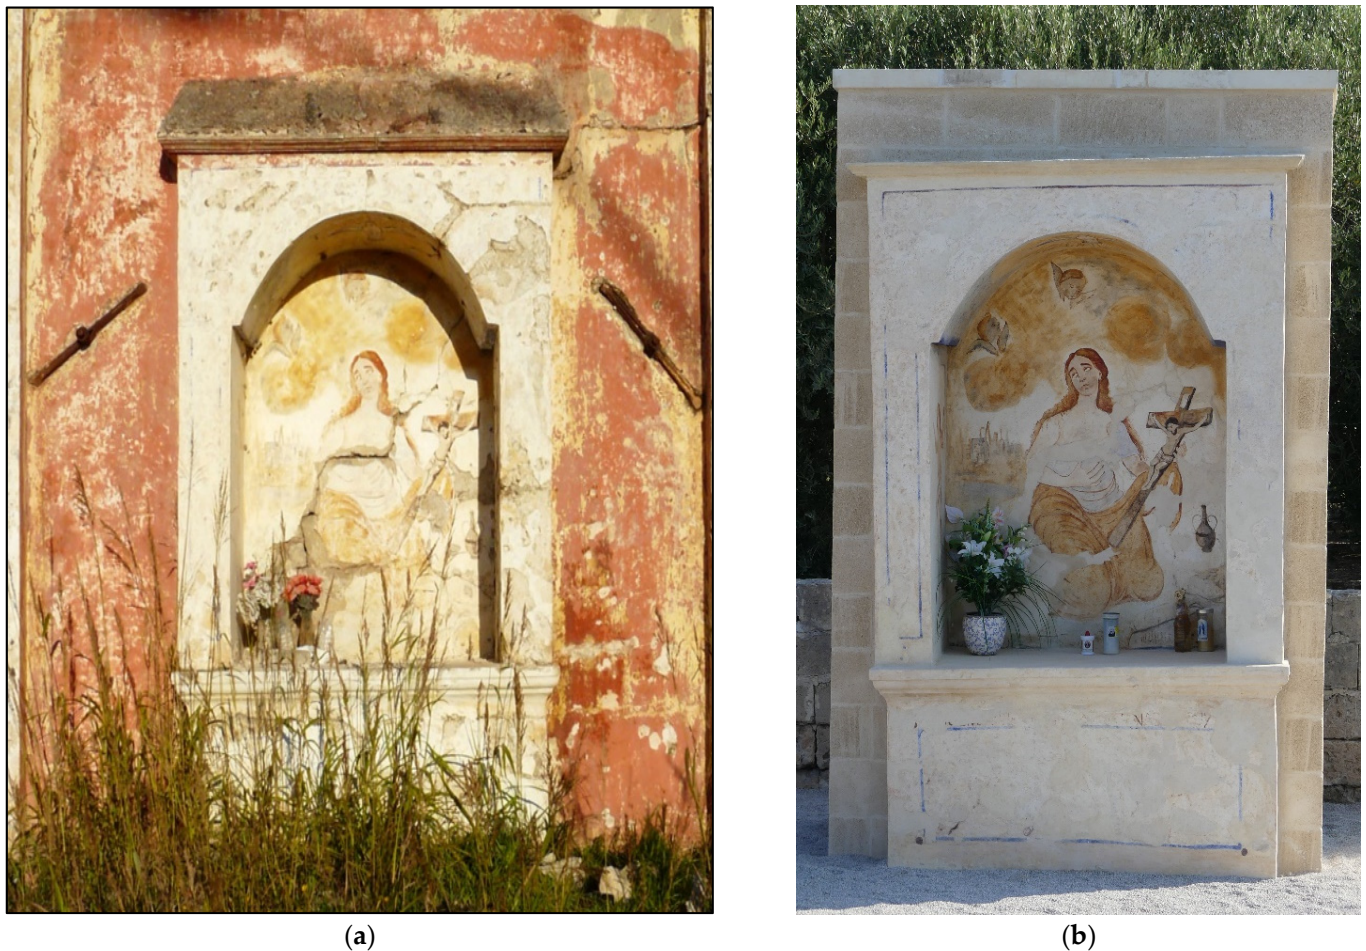
Figure 19. The aedicule before (a) and after (b) intervention.

As part of the final report, photographic documentation and chronological documentation of the entire work (pre, during and after restoration) was provided (Figure 19a,b).
