## Article

# Mortar Characterization of Historical Masonry Damaged by Riverbank Failure: The Case of *Lungarno Torrigiani* (Florence)

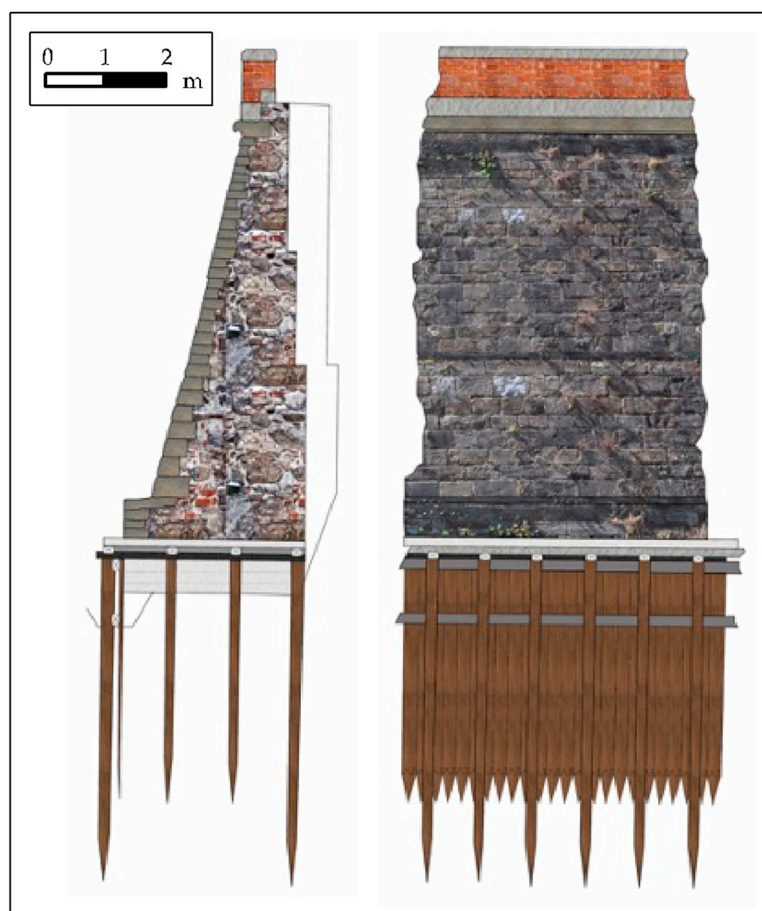
**Figure 2.** Construction techniques of the *Lungarno Torrigiani* riverbank (modified from original drawings preserved in the municipal historical archive of Florence).

According to the Poggi project, by the Budini and Gattai construction company (active in many construction sites in Florence [17]), the retaining wall of *Lungarno Torrigiani* riverbank is composed of a massive scarp with four rows of wood piles driven 1.20 m under the medium level of the river (Figure 2). The masonry is made up of a vertical foundation wall of 0.75 m, a massive scarp wall of 7.17 m and a brick railing of 1.20 m high from the road surface complete the riverbank.

The wall is constructed with an external layer and an internal core using the rubble masonry building method. The former consists of a cortical wall constructed of various squared stones, quarried near Florence and therefore widely used in the city's buildings (mainly Pietra Serena sandstone, and in other stretches of the Lungarno also with Pietraforte sandstone and Pietra Alberese marly limestone, as reported by the municipal historical archive of Florence). The latter consists of mortar made of coarse aggregate (mostly stone elements and, in some levels, also bricks) bound together by a binder filling the interior.
