A Knowledge and Evaluation Model to Support the Conservation of Abandoned Historical Centres in Inner Areas

Citation: Trovato, M.R.; Sanzaro, D. A Knowledge and Evaluation Model to Support the Conservation of Abandoned Historical Centres in Inner Areas. *Heritage* **2024**, *7*, 1618–1664. <https://doi.org/10.3390/heritage7030077>

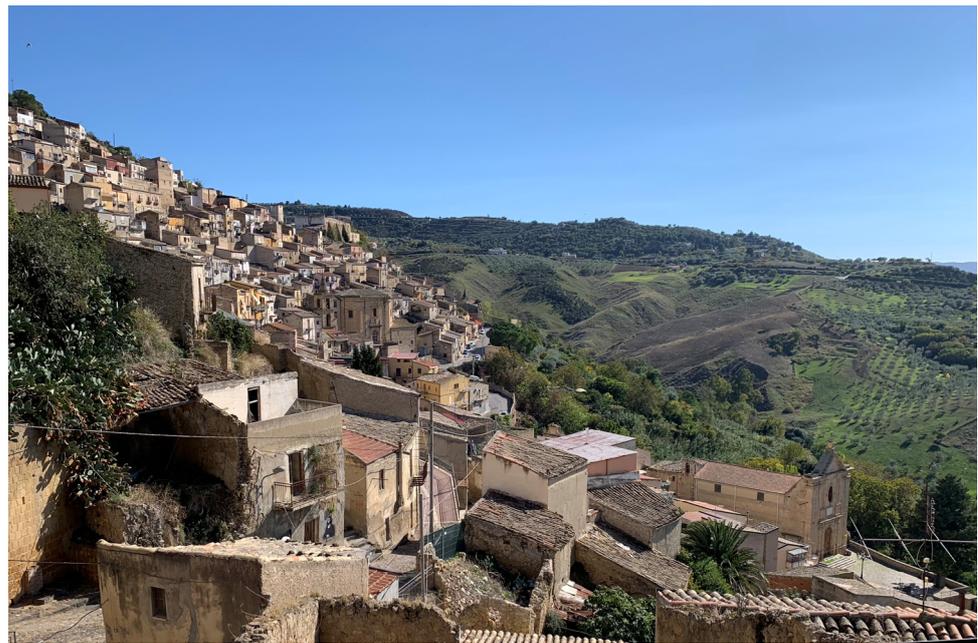
Figure 1. The view of the southern edge of the town shows the relationship with the orography and the landscape. This photo also highlights the fragmented condition of the buildings' state of preservation and use.

The first field surveys immediately revealed the neighbourhood's state of decay and abandonment (Figure 1). Through a closer reading of the historical fabric, a rather diversified picture of the state of use and preservation of the built environment emerged. In fact, in the neighbourhood, there are buildings in good condition and still inhabited, abandoned buildings, and others in a state of ruin [16]. Moreover, while some buildings have retained the architectural qualities ascribable to a configuration close to the original, others have undergone heavier transformations that have sometimes distorted their vernacular character.

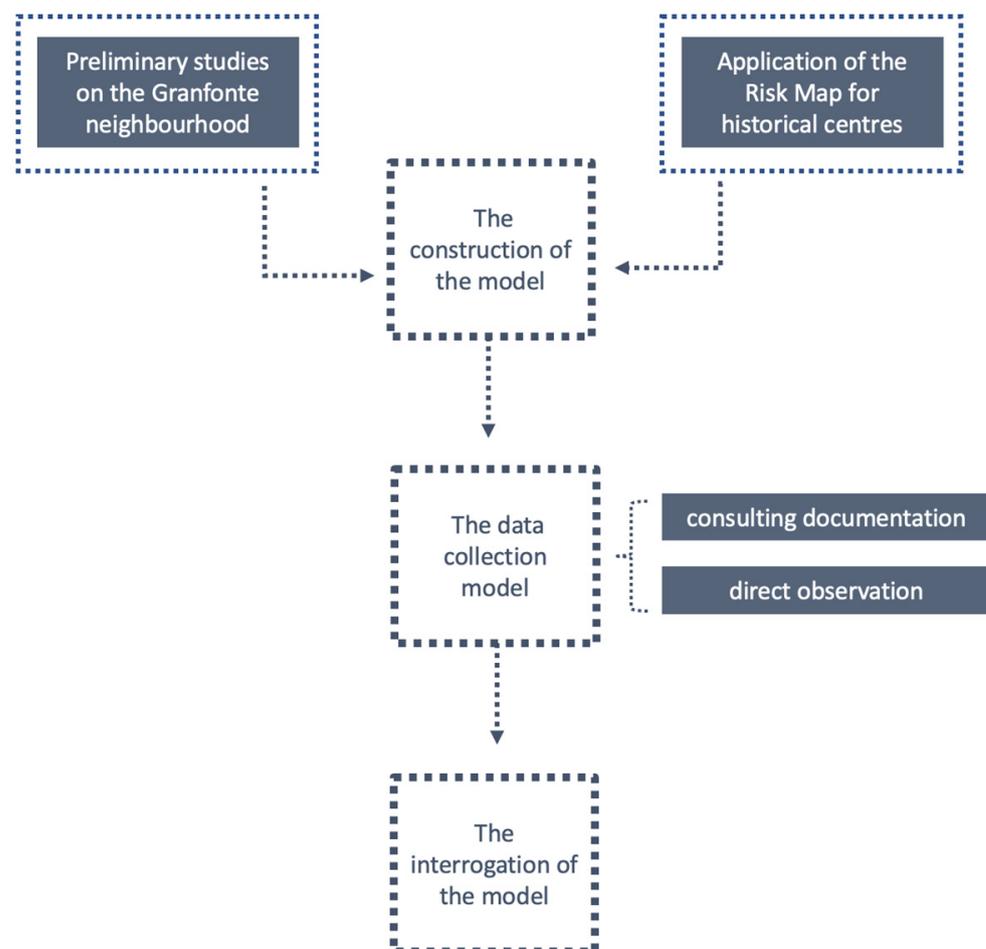
Figure 2. Flowchart of the methodological approach.

The methodology adopted consists of three phases (Figure 2):

- The construction of the model;
- The data collection model;
- The interrogation of the model.

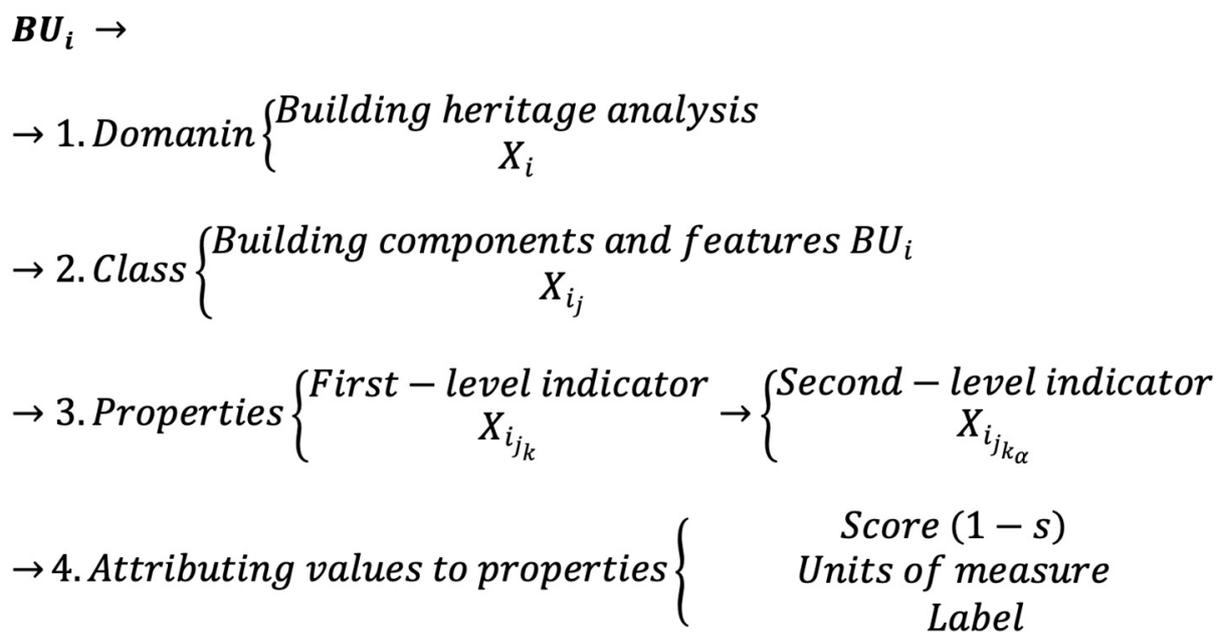
Figure 3. Hierarchical structure of the cognitive model.

The proposed cognitive model has a hierarchical structure, as shown in the Figure 3.

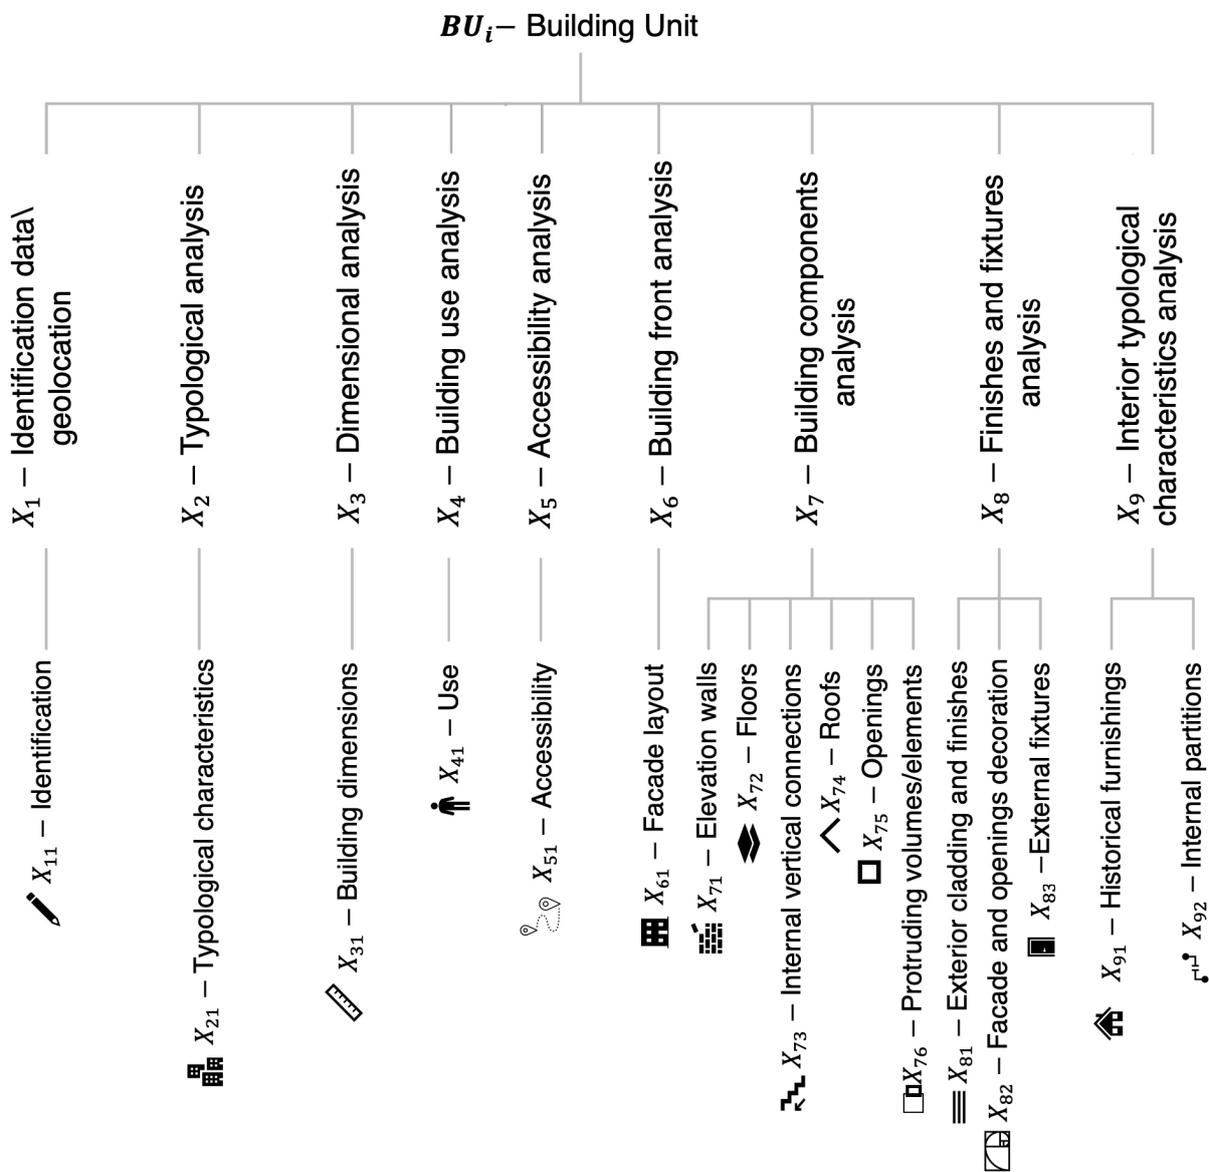
Figure 4. Dendrogram of the first two model levels (Analysis domain and classes).

The first level identifies seven domains of analysis that relate both to the general configuration of the building and to its architectural and construction characteristics, namely: X_1 —identification data and geolocation, X_2 —typological analysis, X_3 —dimensional analysis, X_4 —building use analysis, X_5 —accessibility analysis, X_6 —building front analysis, X_7 —building components analysis, X_8 —finishes and fixtures analysis, and X_9 —interior typological characteristics analysis (Figure 4).

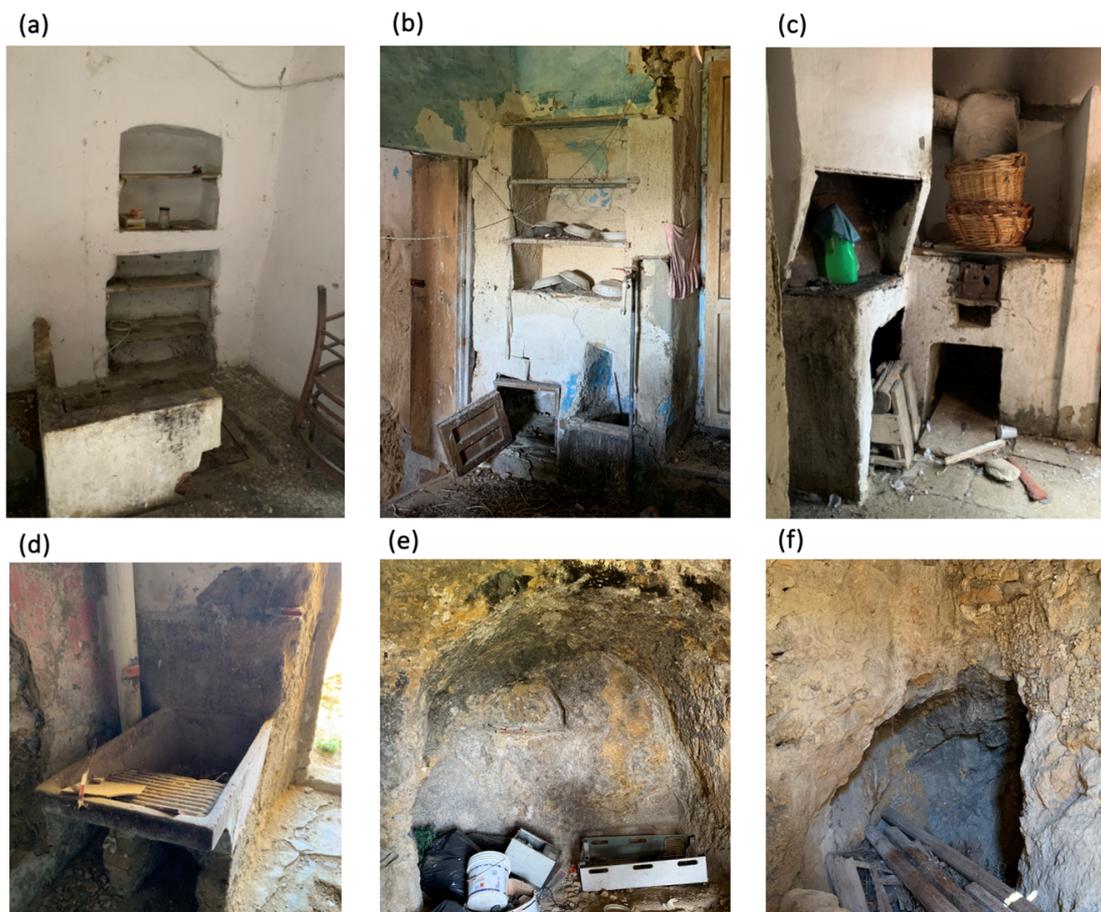
Figure 5. Examples of historical furnishings and internal partitions detected inside dwellings: (a,b) wall niches with shelves; (c) oven/brazier; (d) washstand; (e) alcove; and (f) Cave.

- For the class X_{92} —internal partition, we selected properties relating to the traditional organisation of the interior layout of the dwellings: X_{921} —alcove, X_{922} —alcove—state, X_{923} —reed and plaster partitions, and X_{924} —reed and plaster partitions—state. This class also includes the properties X_{925} —cave and X_{926} —cave—state. The widespread use of natural cavities is indeed a long-lasting phenomenon that characterises this area [147]. They are often exploited as an integral part of the domestic environment and thus belong to the building culture of the neighbourhood (Figure 5).

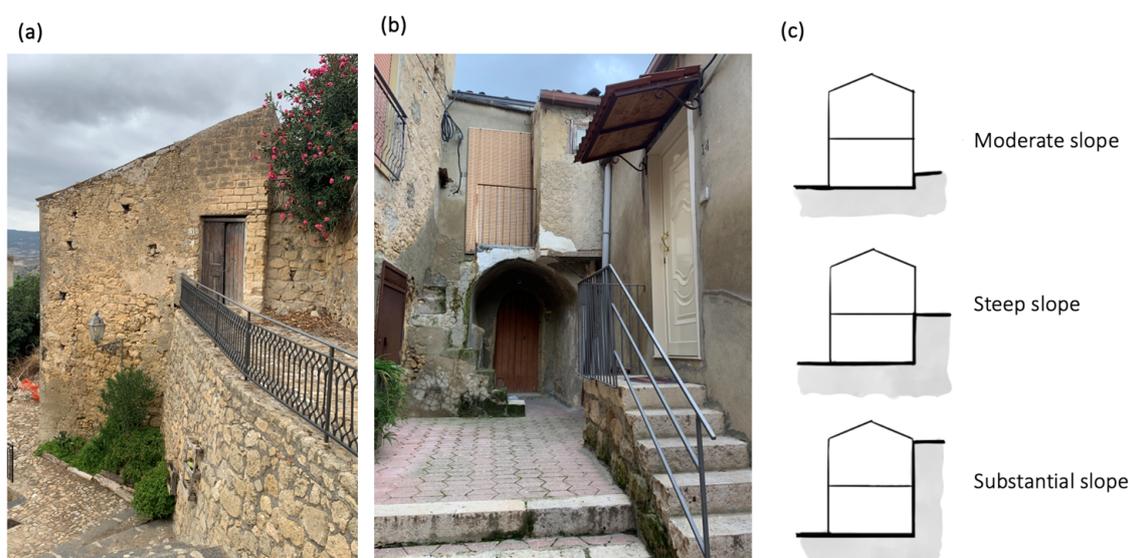
Figure 6. The building types in the Granfonte neighbourhood: (a) the on-slope type and (b) the type with an external staircase (profferlo); (c) layouts related to the three slope proportions.

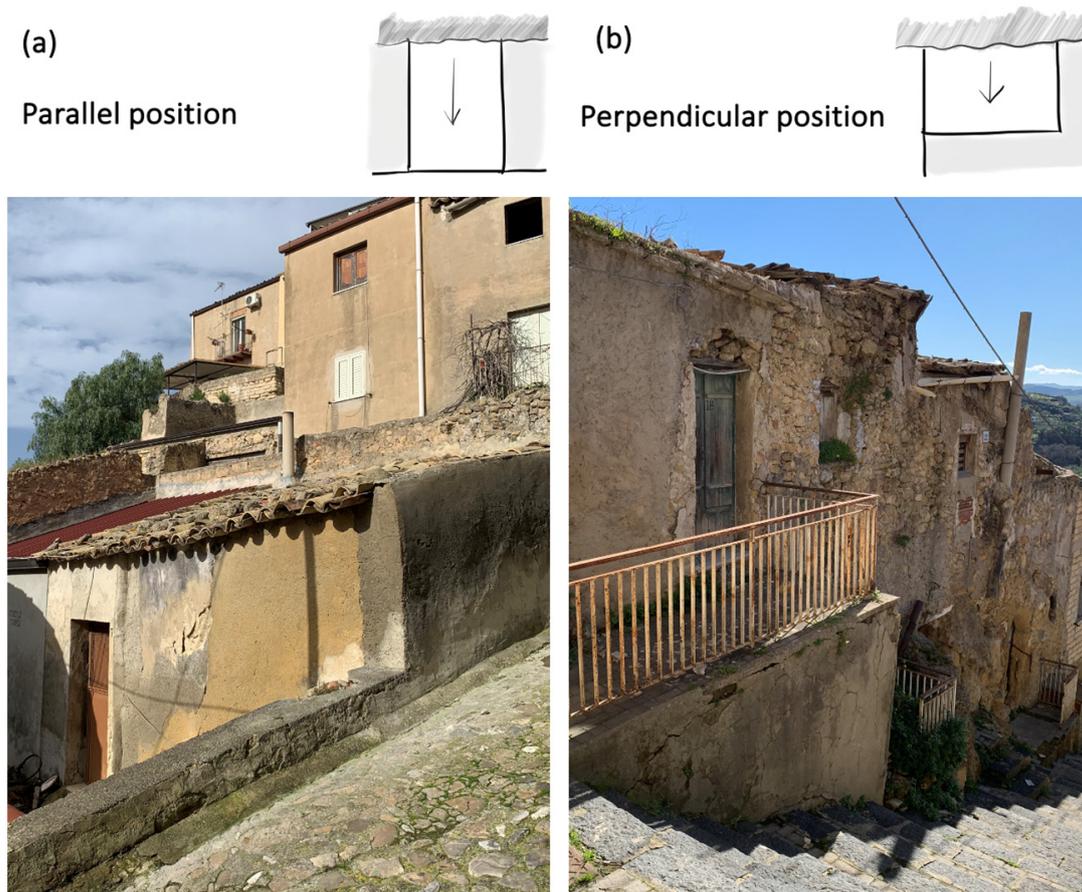
Figure 7. Building units position related to the slope: (a) parallel position, (b) perpendicular position. In our drawings the arrows define the direction of the roof slope.

- To the property X_{215} — BU_i position related to the slope, we assigned a label L_{215h} . By simplifying the nature of the height difference, it is possible to distinguish two types of placements of the building unit with respect to the slope: L_{2151} —parallel position and L_{2152} —perpendicular position. Typically, in the neighbourhood, the first condition is the most recurring. Usually, the rocky difference in height is used as a support for the two transverse walls, while the facade wall, with a run parallel to the rock, serves as a closure to the room. There are situations in which the difference in altitude develops following several main directions. In these cases, the entry refers to the greater difference in height, which is usually used to economize the construction of the house itself (Figure 7).

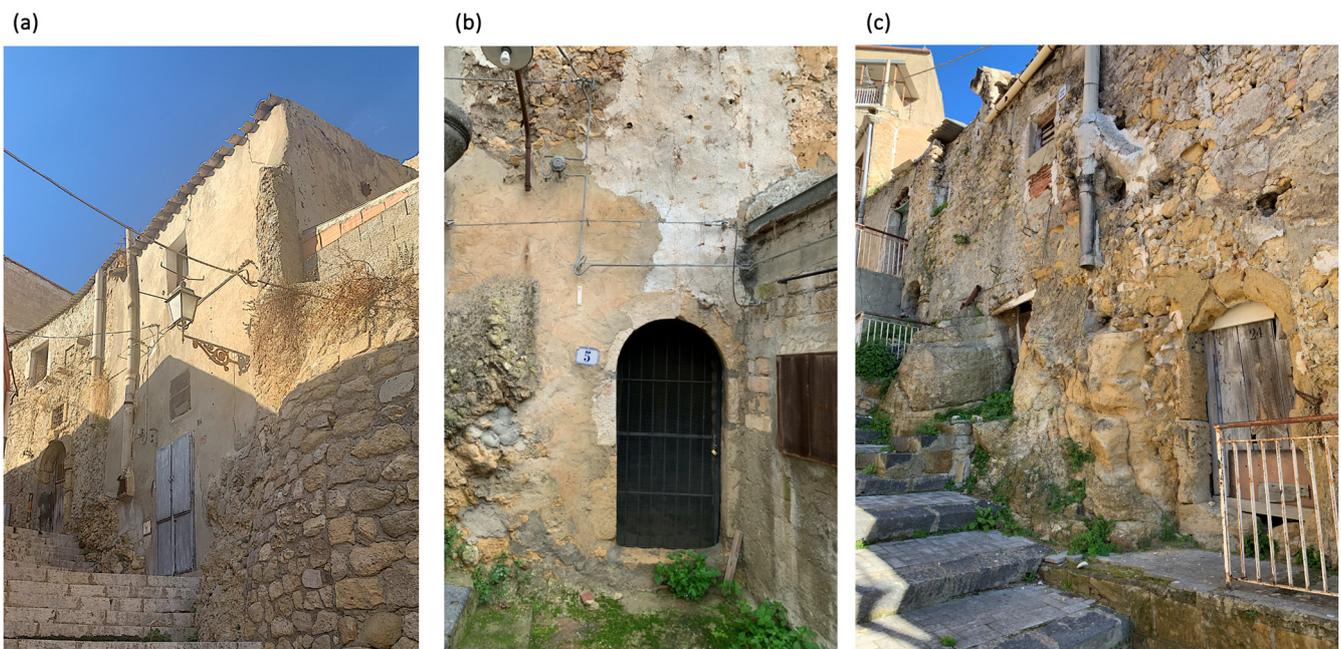
Figure 8. Examples of ground level junctions and relation with the rocky outcrops: (a,b) less high; (c) higher.

- To the property X_{216} —ground level junction, the score S_{216} is given. This property, which takes the voices of the field data sheets of the Risk Charter, describes the type of attack on the ground, allowing the presence of emerging rock to be reported. In the case of the Granfonte district, it was considered appropriate to distinguish the lower and the higher outcrops, which can rise to the first level. The evaluation of the S_{216} score is therefore attributed on the basis of a range (1–3), in which the values identify the following characterizations of the property: Score 1—finished ground floor level, Score 2—on rocky outcrop (less high), and Score 3—on rocky outcrop (higher). The coexistence of rock and built-up areas constitutes a qualifying element of the architecture of the neighbourhood (Figure 8).

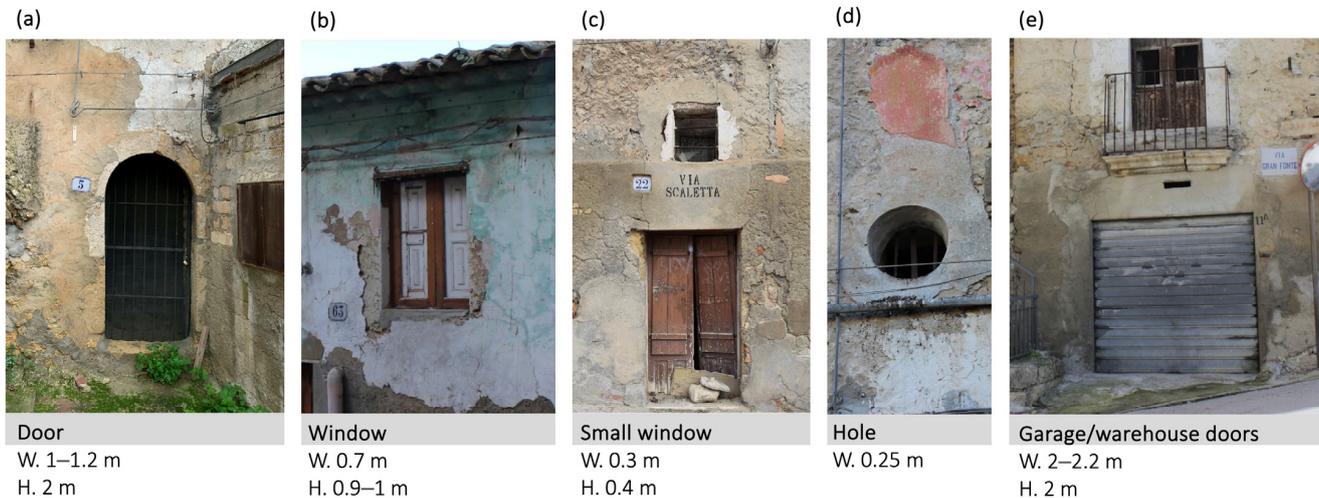
Figure 9. Identification of standard sizes of openings for the purpose of calculating the window area: (a) door, (b) windows, (c) small windows, (d) holes, and (e) garage/warehouse door.

- The evaluation of the properties of class X_{61} —facade layout depends on the geometrical-dimensional characteristics of the openings on the building front expressed in terms of units of measurement. A dimensional classification of the openings was carried

out, which supported their classification in terms of doors, windows, small windows, doors/doors-windows, garage/warehouse doors, and holes. For each type of opening identified, therefore, standard dimensions were taken from the survey in the neighbourhood (Figure 9).

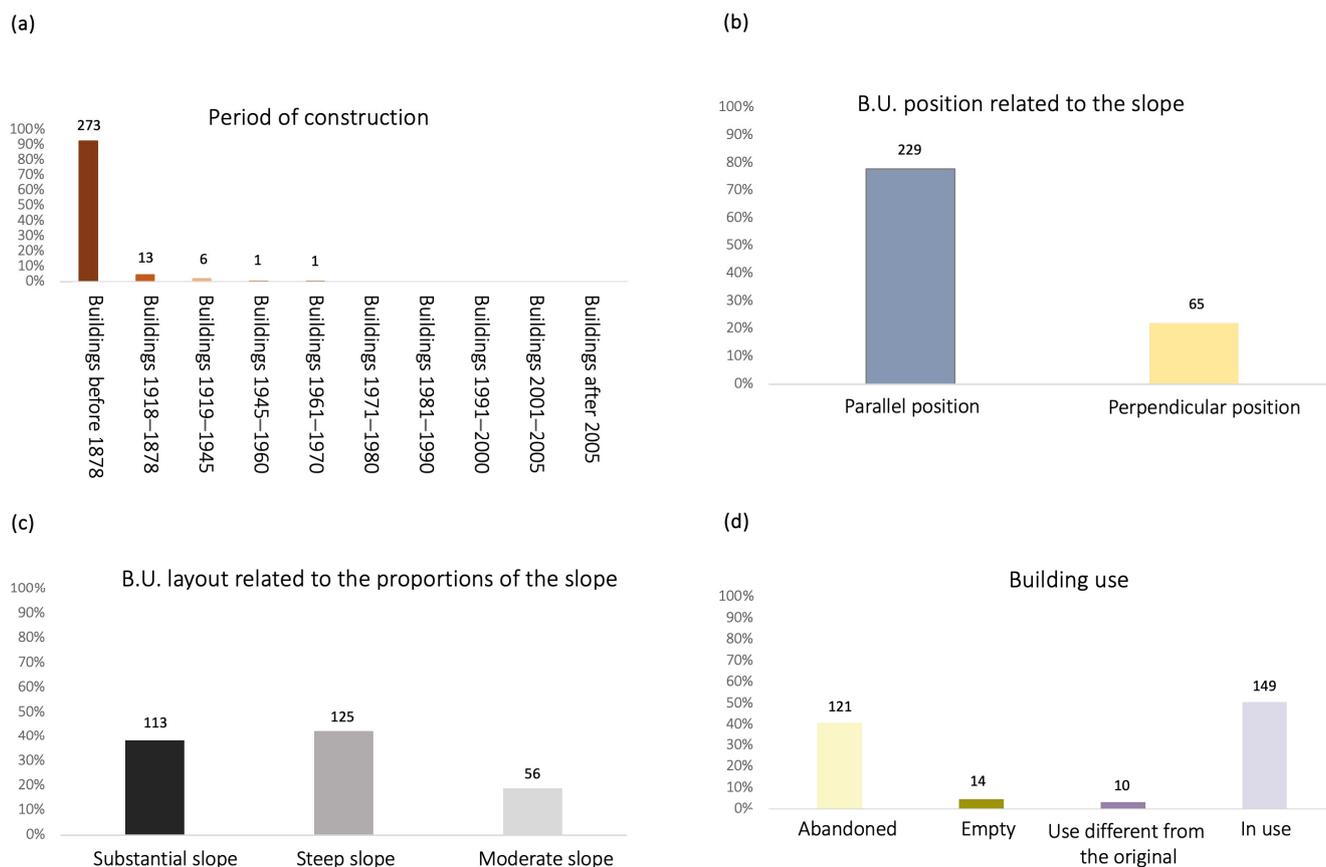
Figure 10. Querying the model on some characteristics of the building units in the neighbourhood: (a) about period of construction; (b) about BU_i position related to the slope; (c) about BU_i position related to the slope; and (d) about state of use.

With reference to the period of construction, the results of these queries showed that 92.85% of the BU_i are buildings that already existed in 1878, 4.42% can be dated to the period 1878–1918, and 2.04% can be traced to the period 1819–1945. Finally, 0.34% of the BU_i can refer to the construction period 1945–1960 and the same percentage refers to the period 1961–1970 (Figure 10a). With reference to the BU_i position related to the slope, the results show that 77.89% of the BU_i are arranged in parallel position to the slope, while 22.11% of them are arranged in perpendicular position to the slope (Figure 10b). On ground level junction, it is shown that 38.44% of the BU_i are settled on a substantial slope, 42.52% on a steep slope, and 19.05% on a moderate slope (Figure 10c). Furthermore, on the state of use, it is shown that 41.16% of the BU_i are abandoned, 4.75% are empty, 3.40% have a different use than their original use, and 50.68% are still in use (Figure 10d).

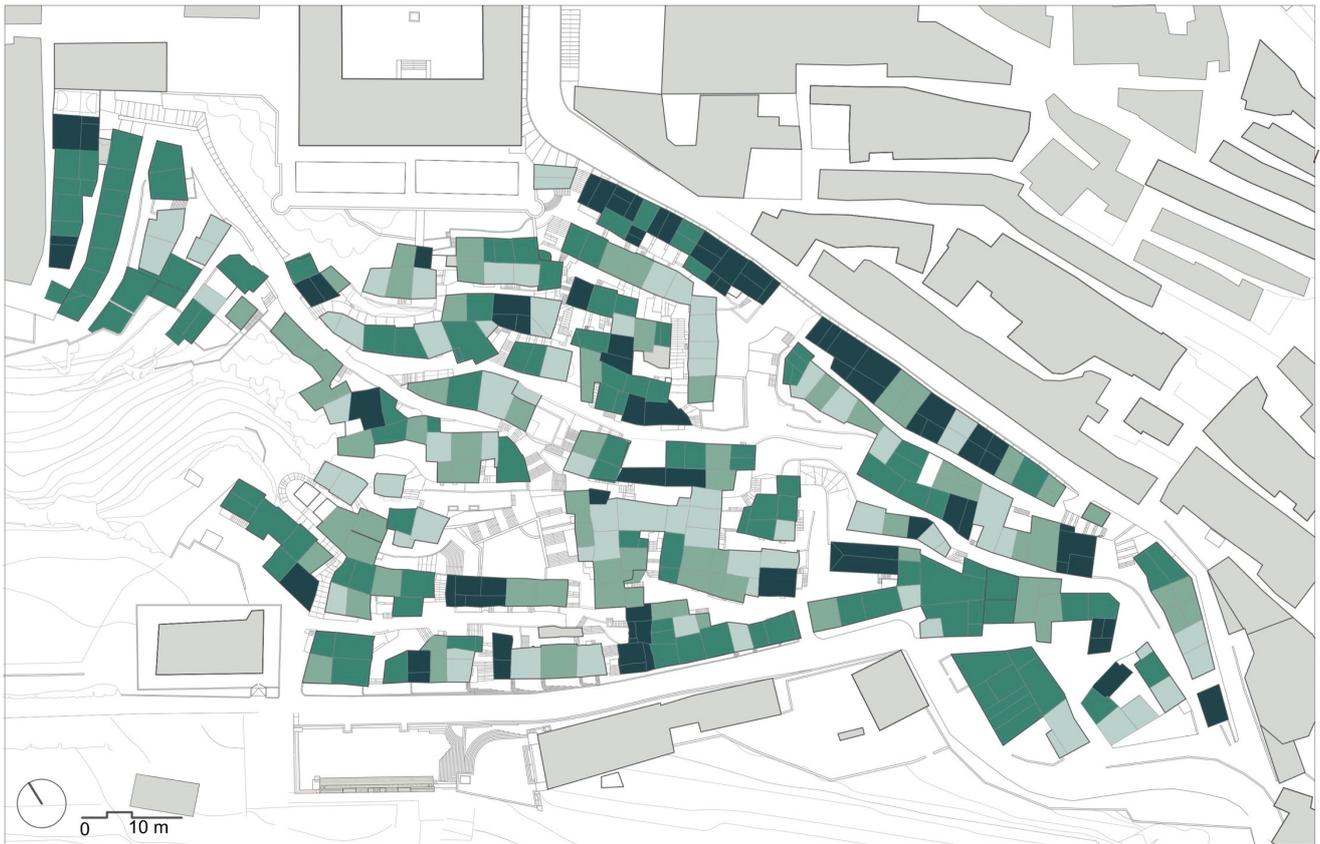
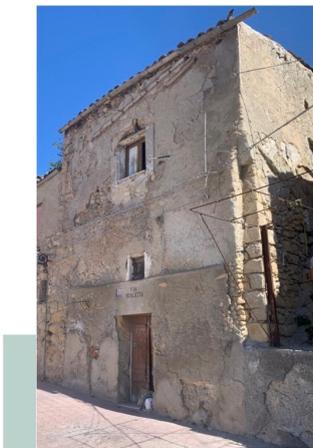
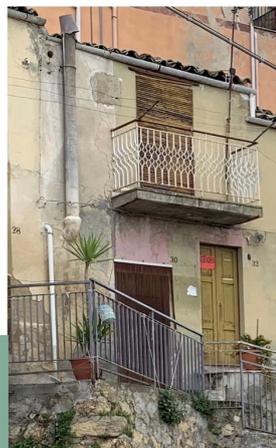
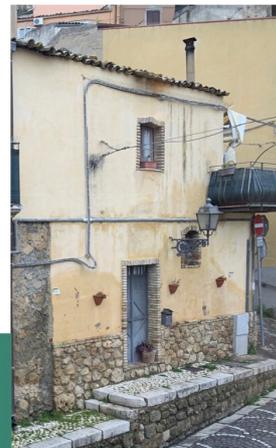
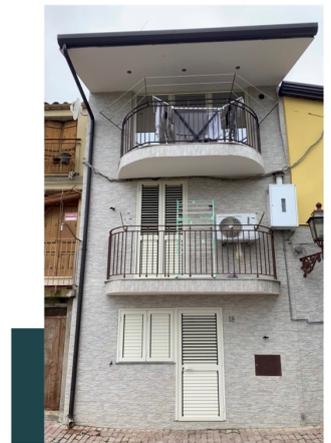
Figure 11. The distribution of the I_{TI} index in the Granfonte neighbourhood.

The second quartile corresponds to a medium-high level of I_{TI} , and refers to the BU_i that have undergone significant transformations of original structures and elements compared to their original condition. Significant losses of original building elements and systems as well as alterative transformations can be detected. The 38.10% of BU_i fall into this class.

In fact, despite the alteration and decay processes that have affected some areas, 50% of the units fall into the low and medium I_{TI} classes, corresponding to the building units that have undergone fewer transformations while preserving more permanent characteristics. This figure concretises the qualities and values of the neighbourhood in which marked characters of local specificity are still preserved. This result opens a reflection on the tools and methods to be put in place to ensure the conservation of this heritage.

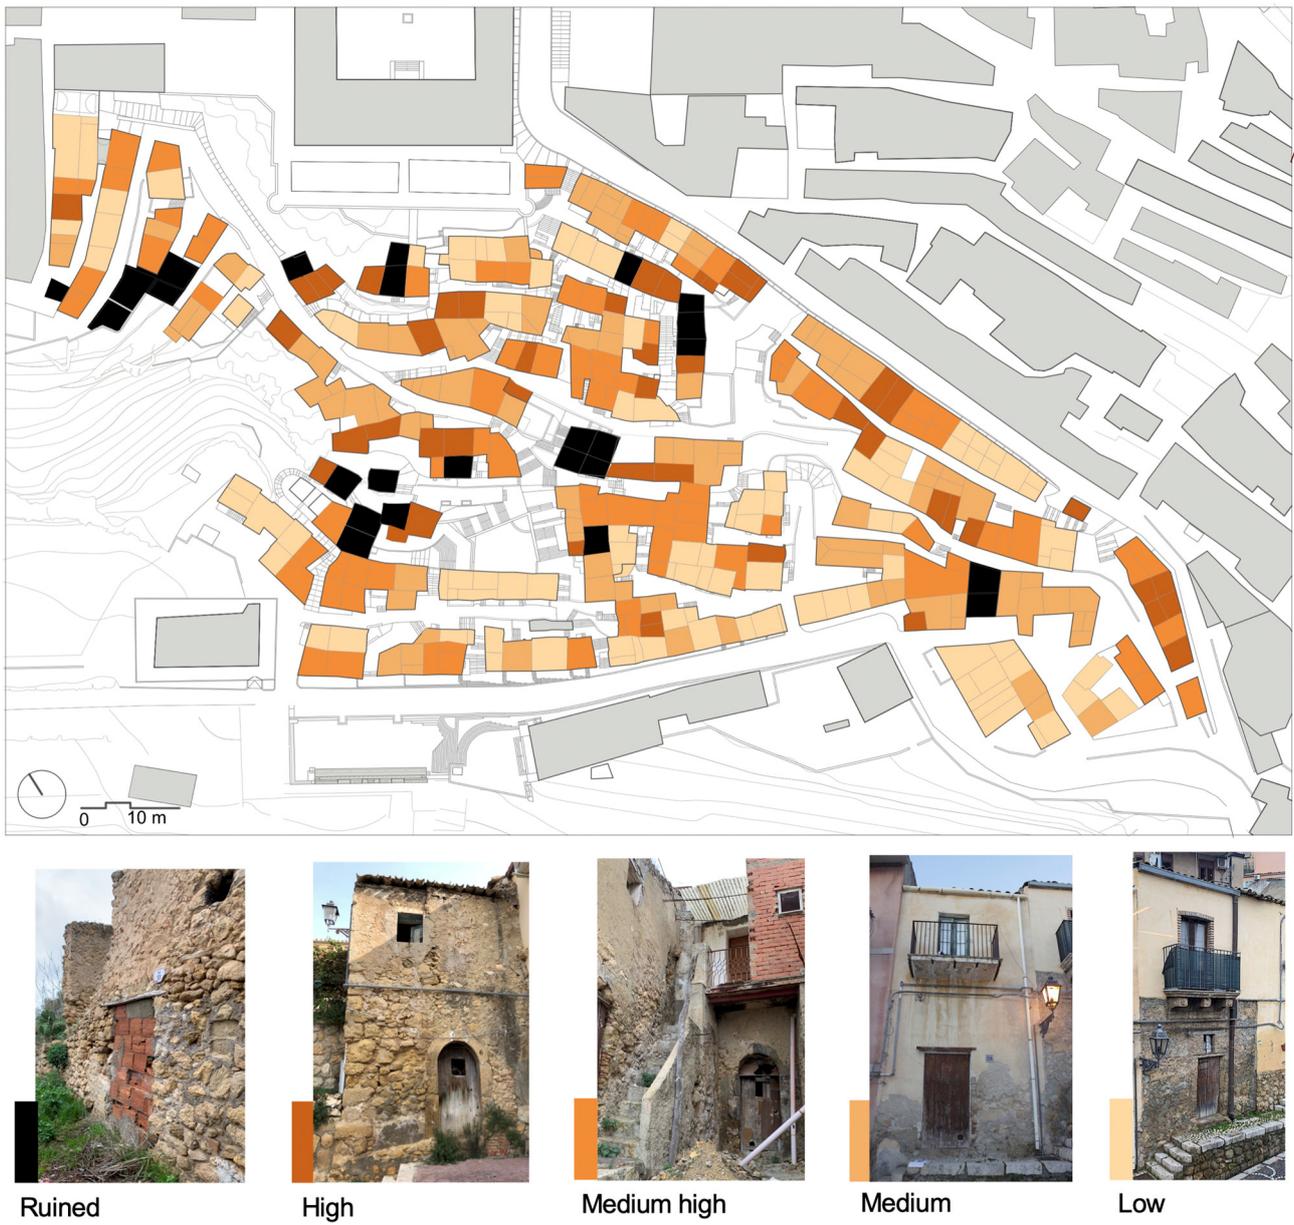
Figure 12. The distribution of the I_{D_i} index in the Granfonte neighbourhood.

The first quartile identifies a high level of I_{D_i} , and includes the BU_i affected by severe degradation. Considering the results obtained in a previous study on ruderization in the neighbourhood, it is possible to refine this level by distinguishing the buildings in a state of overt ruin, conventionally attributed to buildings that present the collapse of at least 50% of the roof. The remaining buildings characterised by a high I_{D_i} present severe structural failures of the load-bearing elements and partial collapses. The elevations show marked forms of degradation with significant gaps.

In the second quartile, which identifies a medium-high level of I_{D_i} , belong the BU_i that present moderate structural disruptions with significant collapse of non-load-bearing elements. There are partial gaps in the elevations and moderate forms of degradation.

The third quartile identifies a medium level of I_{D_i} and includes the units affected by medium and slight deterioration. The units show moderate structural deterioration with partial collapse of non-load bearing elements. There are partial gaps in the elevations and mild forms of degradation.

The fourth quartile identifies a low level of I_{D_i} and includes structurally sound buildings with punctual forms of decay.

Figure 12 highlights the distribution of the I_{D_i} index in the Granfonte neighbourhood, highlighting the areas where the BU_i are most degraded.

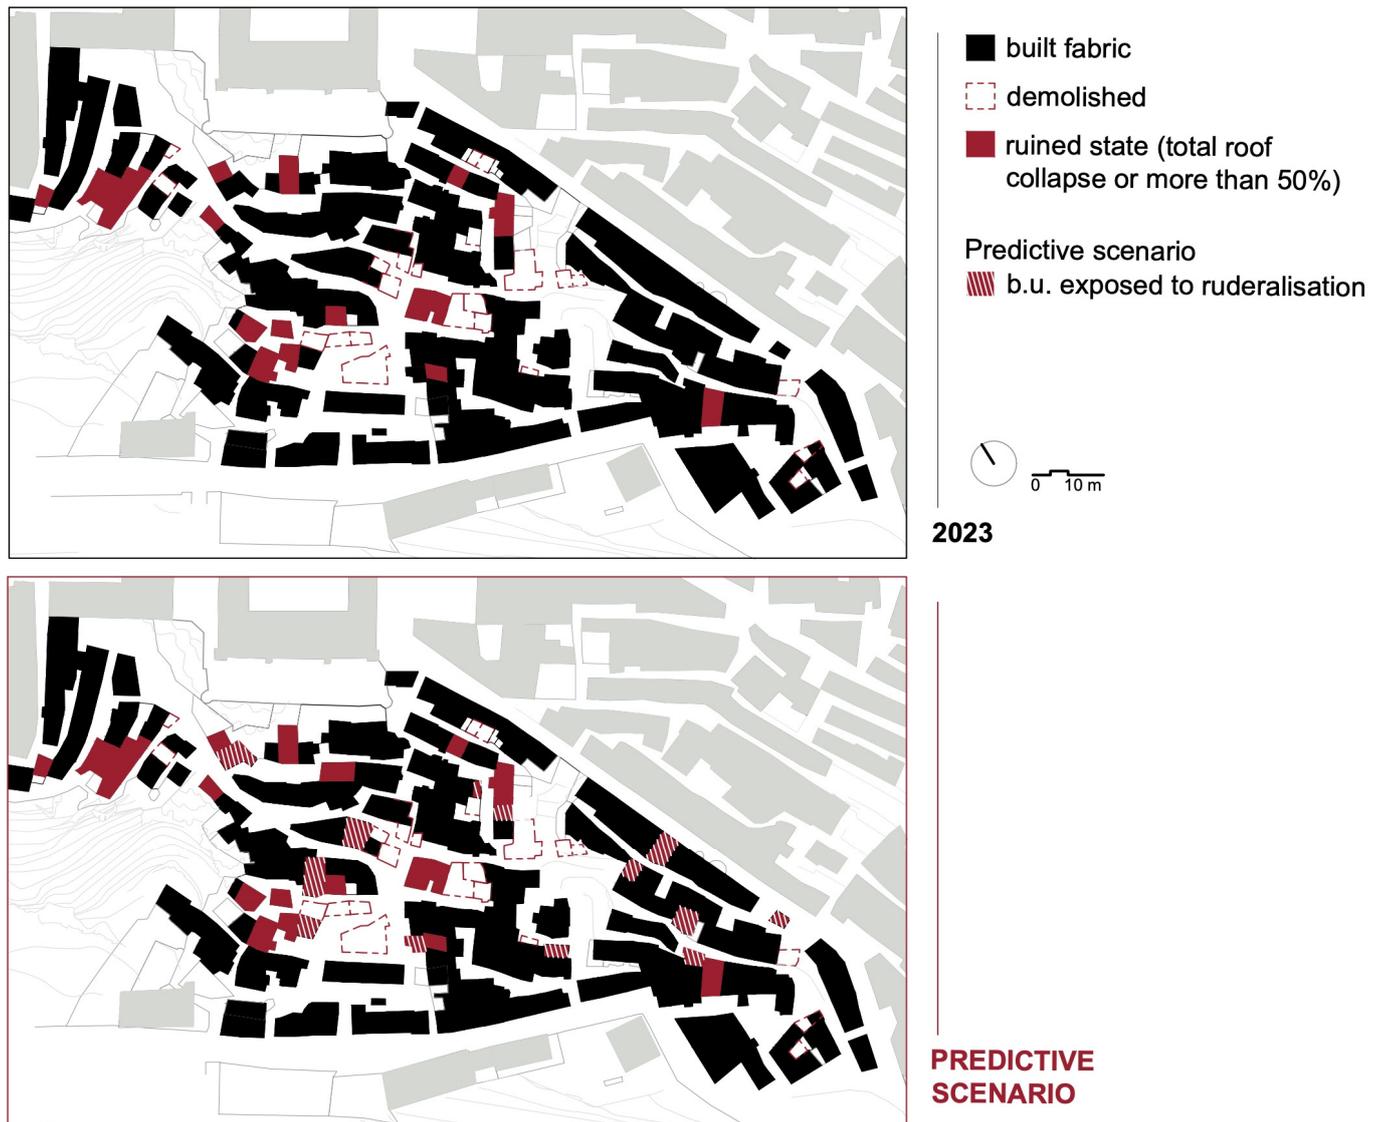
Figure 13. Comparison of the ruination phenomenon between the current and forecast scenarios.

In this case, the relationships between the properties are defined based on the regressors of the implemented multivariate regression model. This multivariate regression model was implemented on the dependent variable ruination level and the independent variables, i.e., drivers of ruination (see previous publications for more details).

Figure 13 proposes a comparison between the ruination of BU_i in the current state for the Granfonte neighbourhood and the prediction scenario.
