Emergency Actions for the Documentation, Stabilization, and Consolidation of the Early Bronze Age Fortifications at Khirbat Iskandar, Jordan

Emergency actions for the documentation, stabilization, consolidation, and conservation of the EBA fortifications at KI-RC02

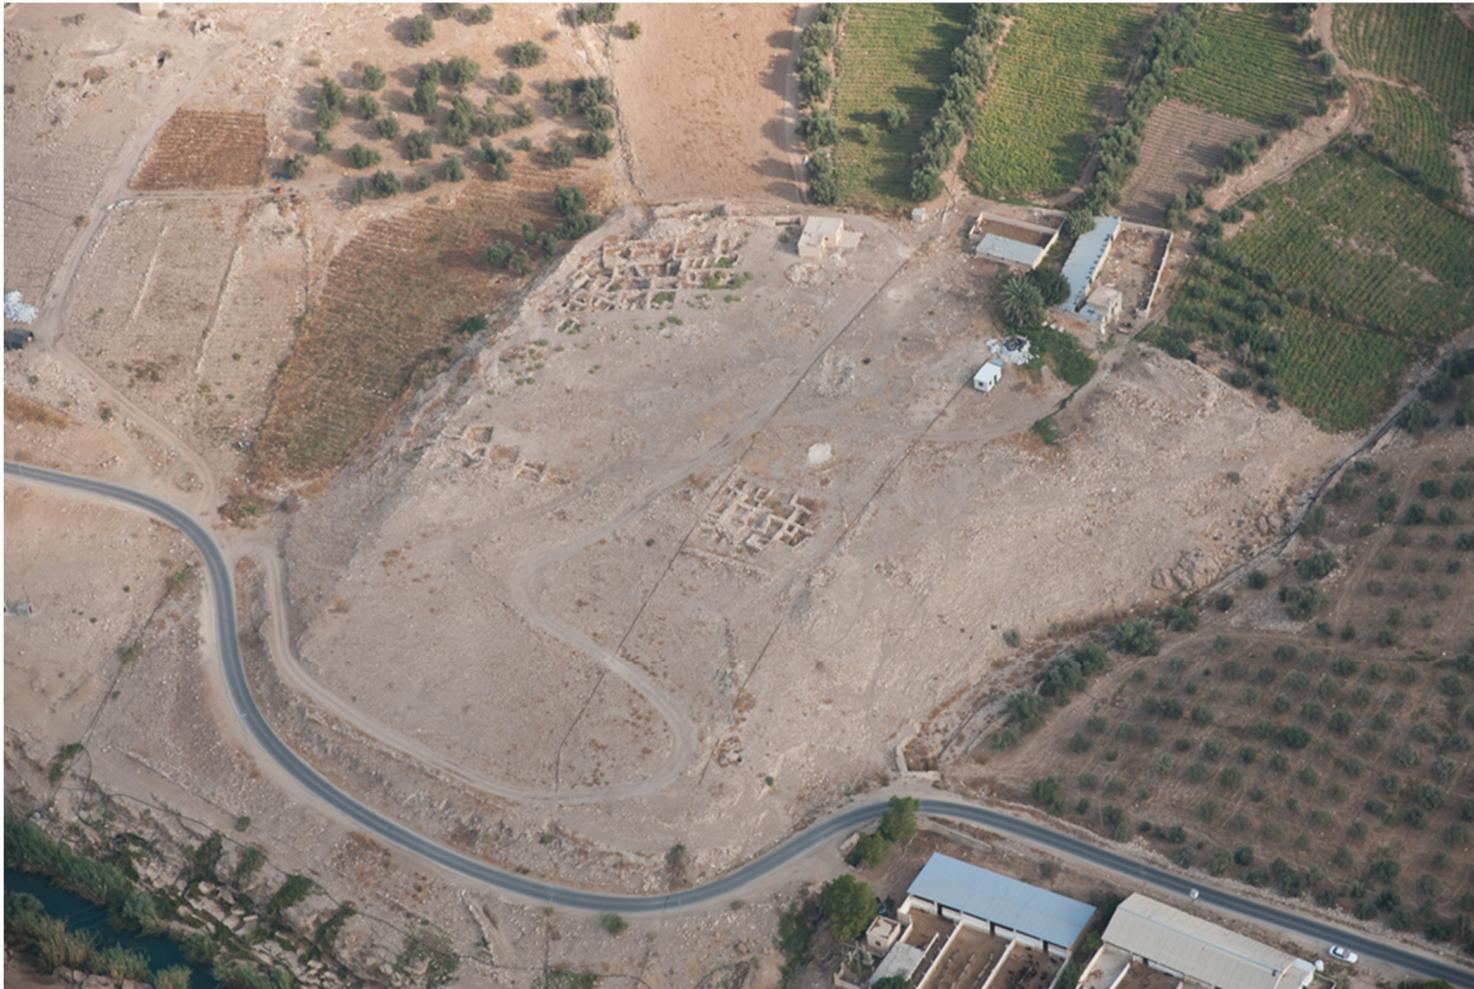
Figure 3. Aerial view of Khirbat Iskandar, showing the perimeter of the *tall* site shaped by buried fortifications (photo: copyright by APAAME_20141013_REB-0162; photographer: Rebecca Banks).

Khirbat Iskandar is a *tall* site, i.e., an artificially mounded site formed by subsequent archaeological deposits, the contour of which is shaped by the presence of buried fortifications (Figure 3). They are a crucial element of the site's topography through the third millennium BCE, with at least three major rebuilds between ca. 3100/3000 BCE and ca. 2500/2400 BCE, which have been investigated through excavations in the north-western sector of the site ([3] (pp. 356–362) and [4]). This long sequence symbolizes the trajectory of an early urban site that thrived, was destroyed, and survived collapse. This was most likely sustained by its location within an ecological niche where the site's inhabitants had

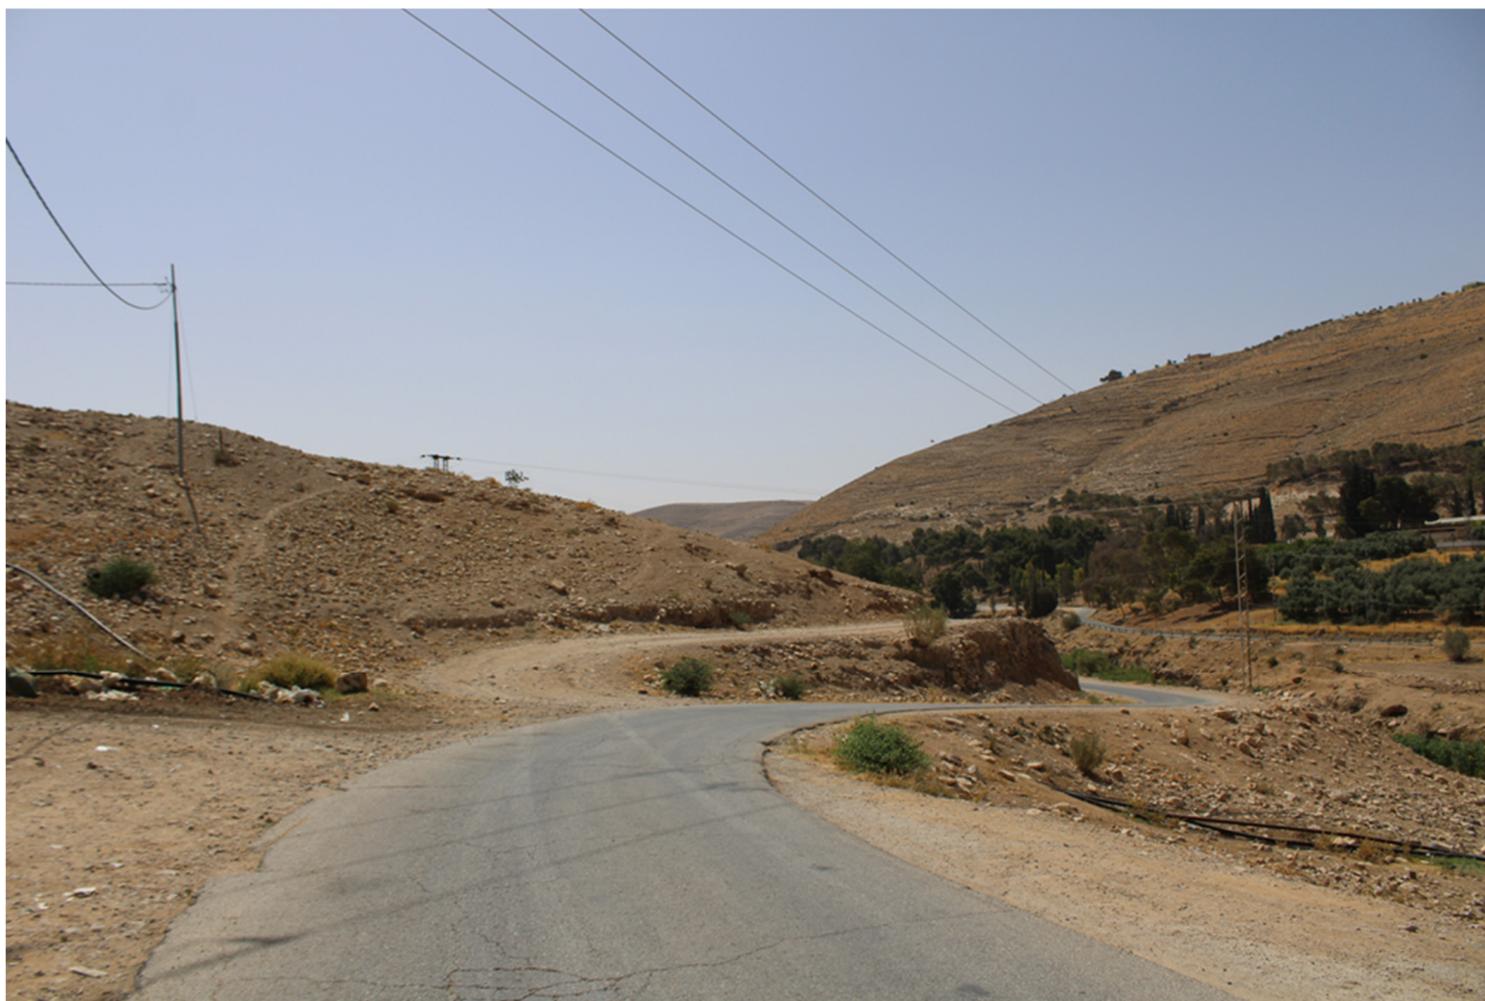
At Khirbat Iskandar, the southern and south-eastern slopes of the mound have been severely affected by modern construction activities. In particular, two road cuts damaged archaeological assets: an upper dirt road used by modern farmers to travel upward to the hill, where outbuildings for animals and supplies are placed, and a lower paved road running parallel to the Wadi al-Wala and connected to the King's Highway at a short distance from the site to the east. These two roads clearly cut through the southern edge of the *tall* site (Figures 3 and 4), and have damaged ancient stratigraphy and architecture and exposed archaeological assets to the threat of decay prior to being documented. For these reasons, in 2023, the Archaeological Expedition to Khirbat Iskandar and Its Environs undertook urgent documentation, consolidation, and stabilization actions to salvage this endangered sector of the site from destruction. In this paper, we present the objectives and results of these activities and discuss the documentation, stabilization, and consolidation actions undertaken in connection with the conceptual/methodological and practical challenges of identifying best practices in the conservation and preservation of antiquities that collapsed prior to being excavated. We finally discuss the potential of these actions for making the significance of the archaeology and cultural heritage at Khirbat Iskandar more accessible to the public, national and international.

Figure 4. Khirbat Iskandar: the *tall* site looking eastward with the two road cuts, in June 2022 (photo by Marta D'Andrea, © Archaeological Expedition to Khirbat Iskandar).

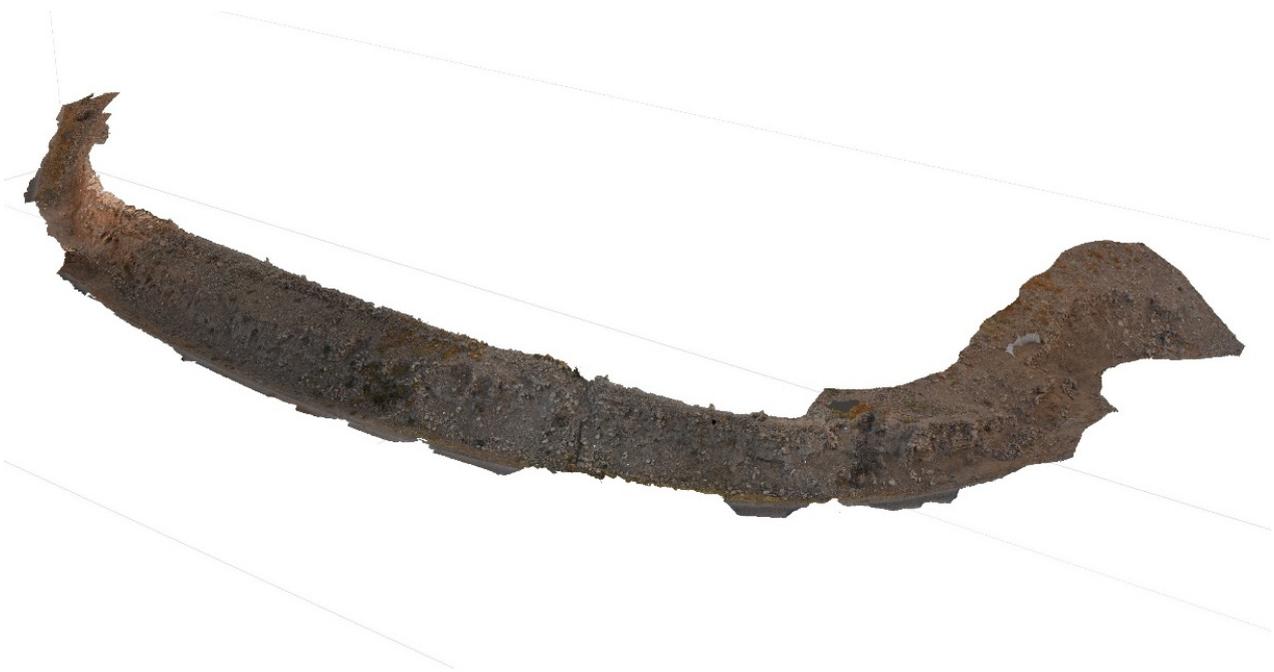
Figure 6. Three-dimensional model of the southern and south-eastern slopes of Khirbat Iskandar produced by the post-processing of photogrammetric records with the software Agisoft Metashape version 1.7 (elaboration by Nicola Lanzaro, © Archaeological Expedition to Khirbat Iskandar).

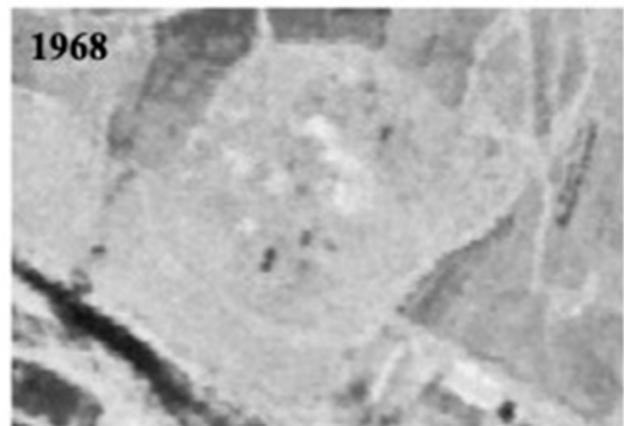
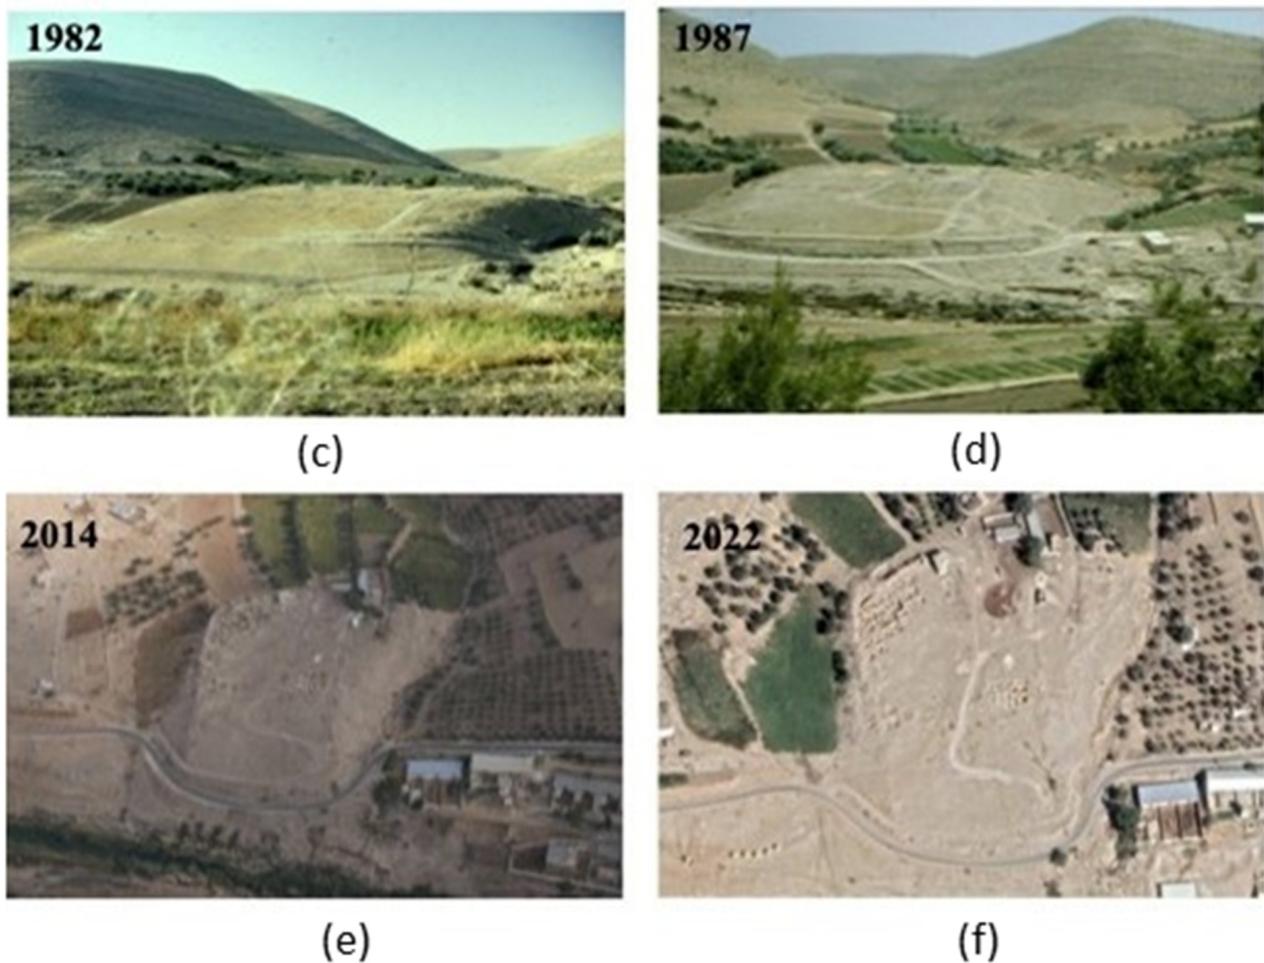
Figure 7. Comparison between older and recent aerial views, showing the impact of erosion on the preservation of the southern slope of the site ((a) CORONA, September 26, 1967; (b) CORONA, August 20, 1968, Esri, DigitalGlobe, GeoEye, EarthstarGeographics, CNES/Airbus DS, USDA, USGS, AeroGRID, IGN, HERE, Garmin, © OpenStreetMap contributors, and the GIS user community; (c,d) © Archaeological Expedition to Khirbat Iskandar; (e) 2014, copyright APAAME; APAAME_20141013_REB-0163.jpg, © APAAME, photographer: Rebecca Banks; (f) © Google Earth, 2022).

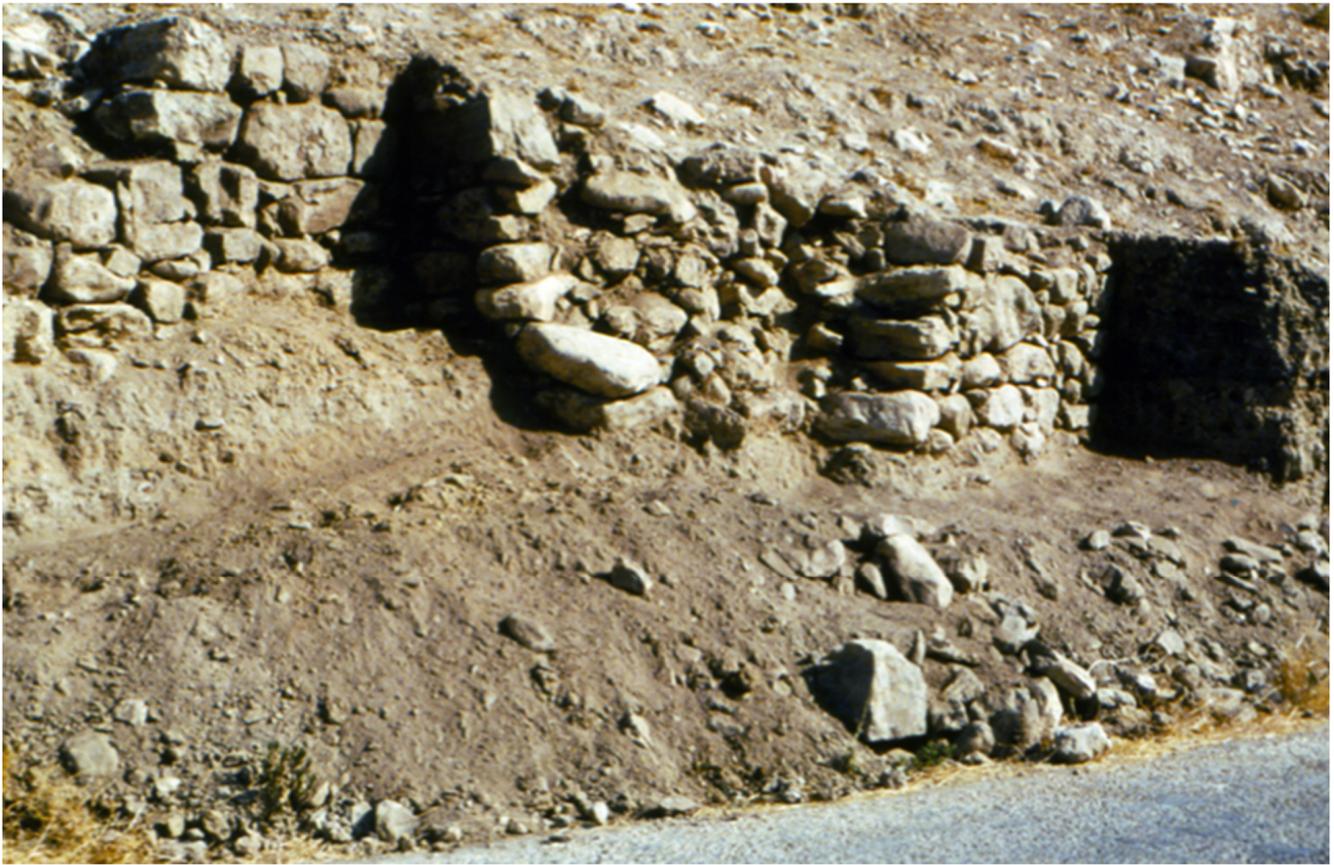
Figure 9. Khirbat Iskandar: the Early Bronze III architecture uncovered by bulldozer cuts for modern construction activities photographed in 1987 in KI-RC02 (photo by Edyth Skinner, © Archaeological Expedition to Khirbat Iskandar).

By rechecking the photographs of the ancient architecture exposed by modern construction activities taken in 1987, we clarified that the walls shown on the photos correspond to a blocked gate connected with a rectangular tower (Figures 11 and 12), this latter being part of the area where we undertook major consolidation works in this season. Although it was very difficult to identify the gate on site because of the decay (Figure 11), we were able to locate it and to clarify and demonstrate its connection to a rectangular tower to the east, part of which was consolidated in the 2023 season (see below; Figure 12). We proceeded to a general cleanup of the area between the blocked gate and the stretch of the fortifications to the east of the collapsed wall with the help of local workers, in order to remove the grass and refuse. Following this, we took record shots of the collapsed and damaged architecture before starting any interventions (Figure 13). We then proceeded to the photogrammetric documentation of this sector of Khirbat Iskandar, which allowed us to record the stratigraphic relations between the different interconnecting walls in this area prior to stabilization and consolidation. In particular, the connection between the walls forming the tower to the east—that is, where the most substantial actions for urgent stabilization and consolidation works were undertaken—is clearly visible in our photogrammetric records (Figure 14).

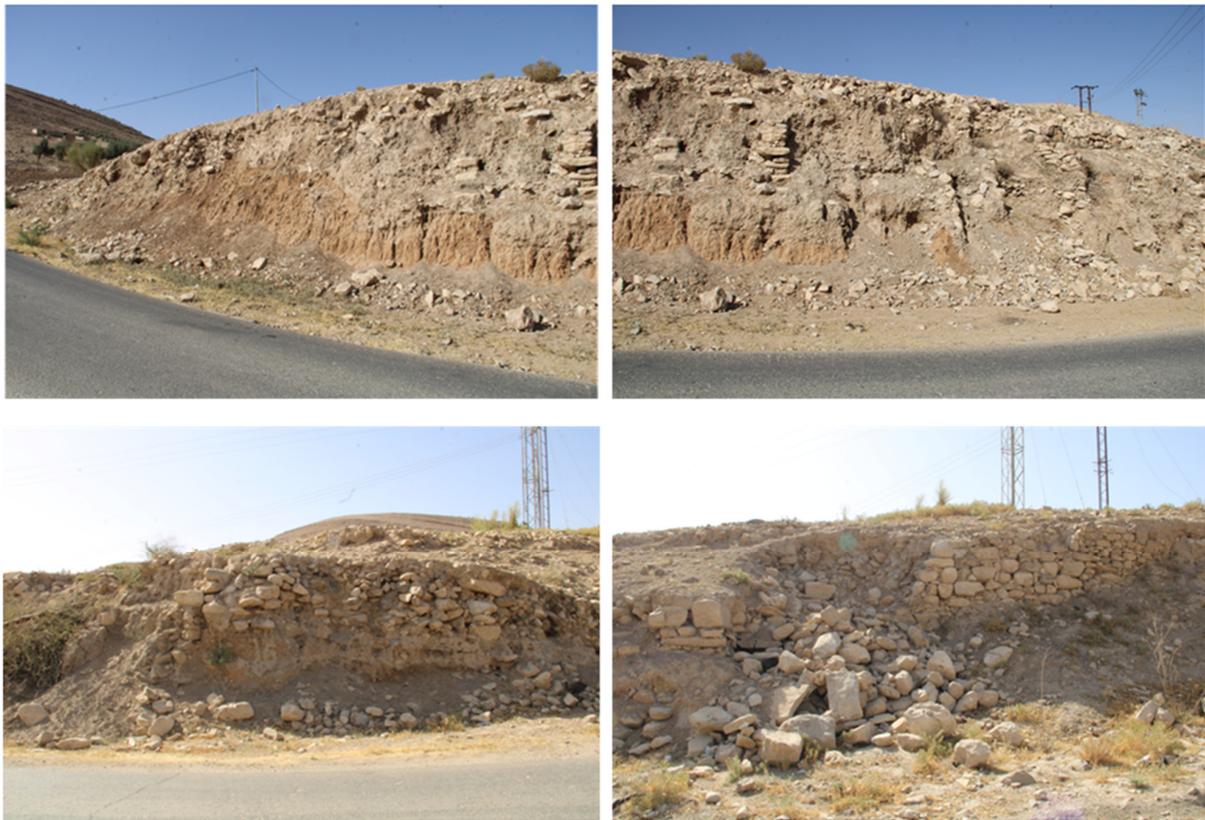
Figure 10. Khirbat Iskandar: stratigraphy and architecture exposed and damaged by the roadcut along the southern and south-eastern slopes of the *tall* site, in June 2022, looking northward (photos by Brigitta Fracchia, © Archaeological Expedition to Khirbat Iskandar).

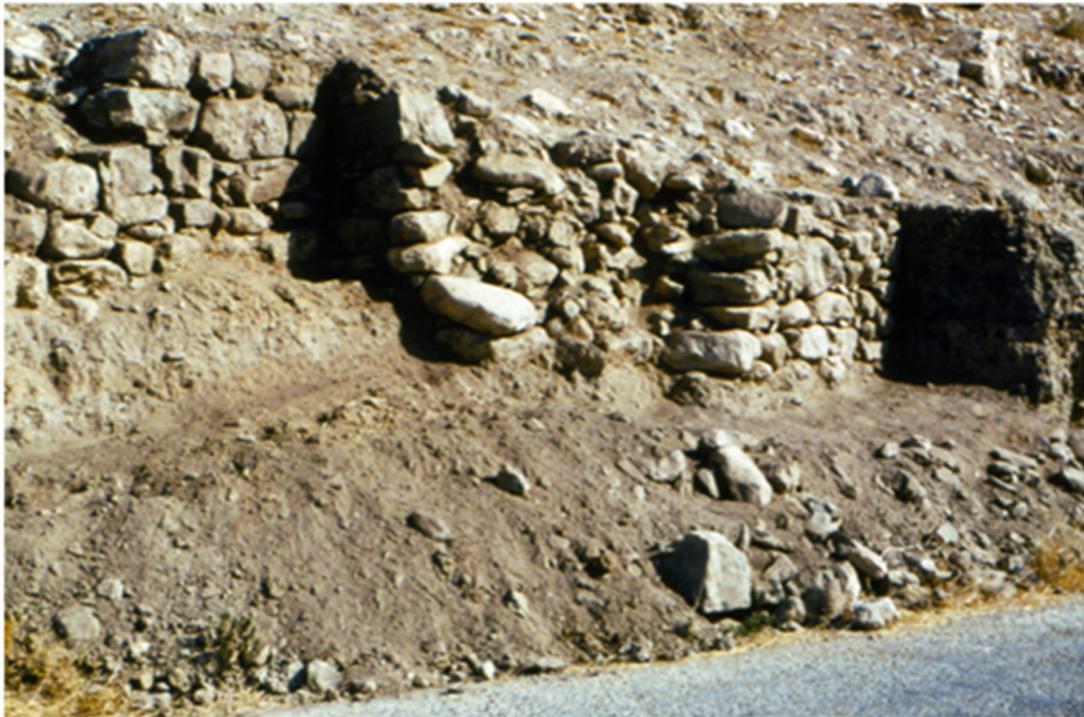
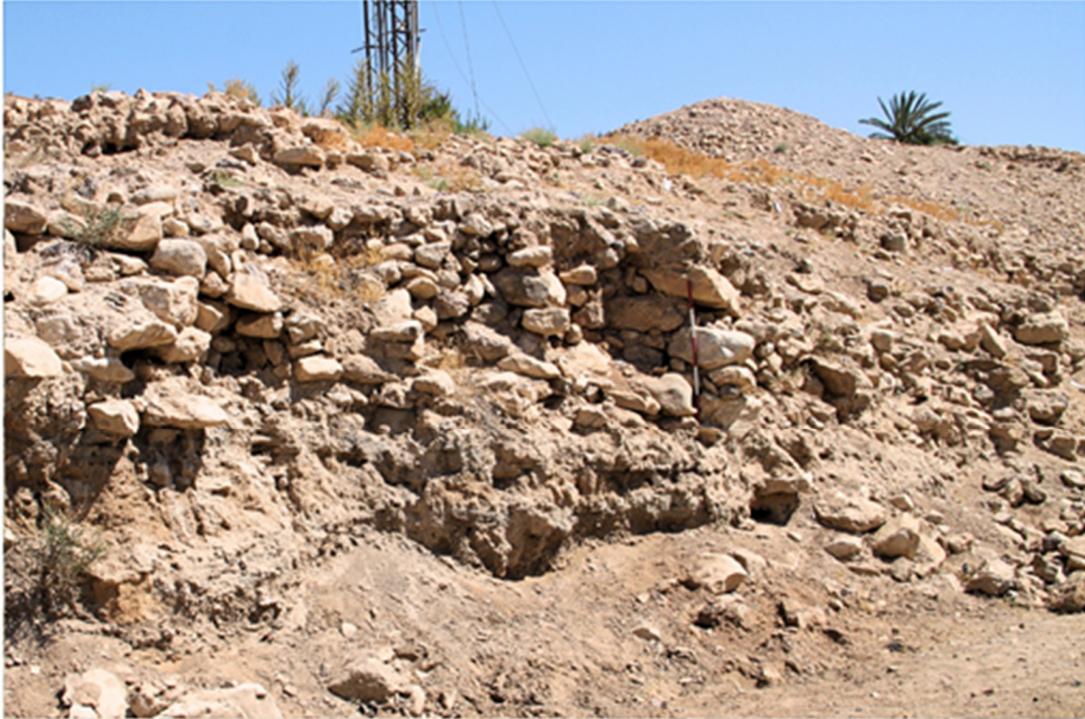
Figure 11. Gate with blockage at the south-eastern edge of Khirbat Iskandar in 1987 (**top**) vis-à-vis 2023 (**bottom**), looking toward the north-west (upper photo by Edyth Skinner and lower photo by Marta D'Andrea, © Archaeological Expedition to Khirbat Iskandar).

the adjacent gate taken in 1987 and those from 2023 (Figure 11) effectively shows the rate and degree of degradation induced by erosion following bulldozer cuts in this sector. It was, therefore, necessary to intervene with remedial conservation before more loss and deterioration occurred, while carrying out preventive conservation on the easternmost stretch of the wall that had been exposed but had not yet collapsed. As reported above, the ICOMOS-CC acknowledges that this kind of action may modify the appearance of the assets subject to the interventions [21].

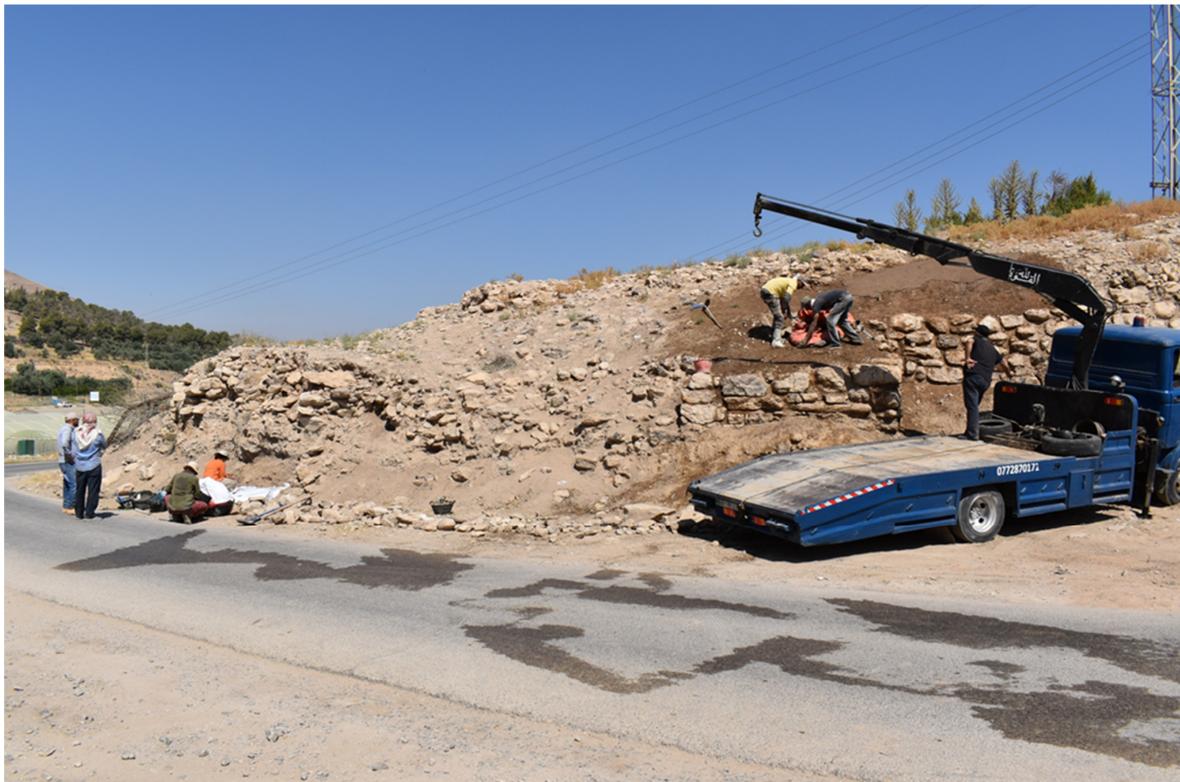
Figure 12. Khirbat Iskandar, KI-RC02: the area of the trimming and probing operation (**on the left**) and the area of the stabilization/consolidation/conservation activities (**on the right**), looking westward (photo by Marta D'Andrea, © Archaeological Expedition to Khirbat Iskandar).

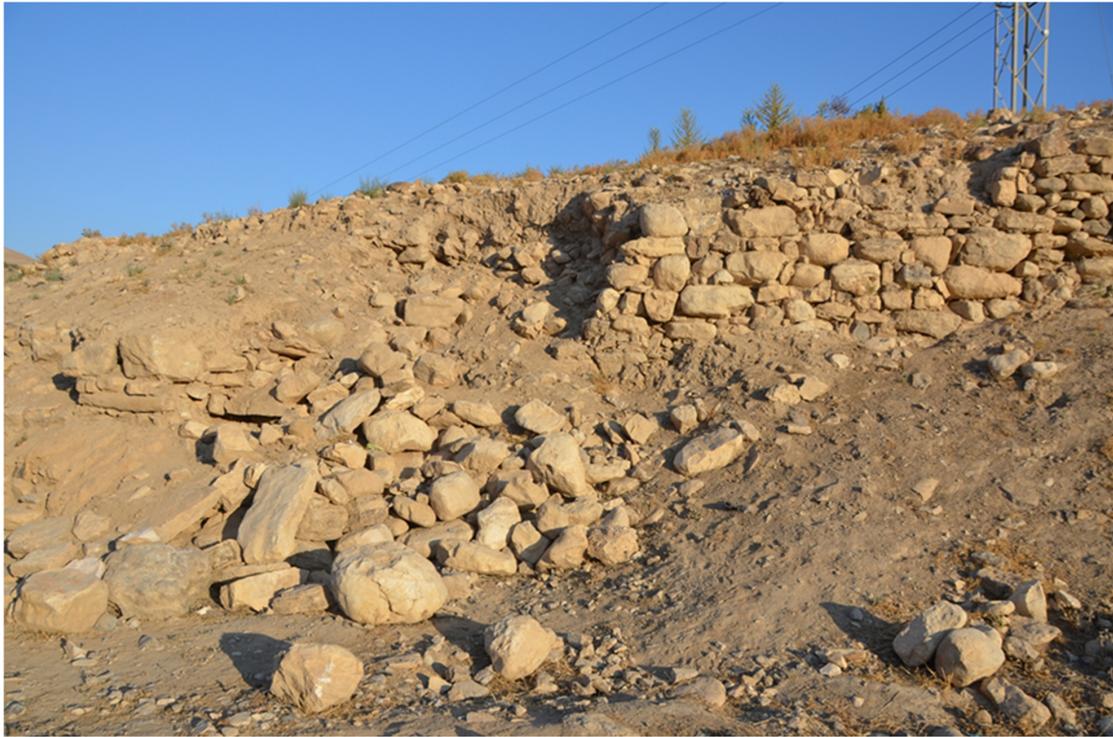
Figure 13. Khirbat Iskandar: collapsed Early Bronze III fortifications in KI-RC02, looking toward the north-west (photo by Khaled Al Wekhean, © Archaeological Expedition to Khirbat Iskandar).

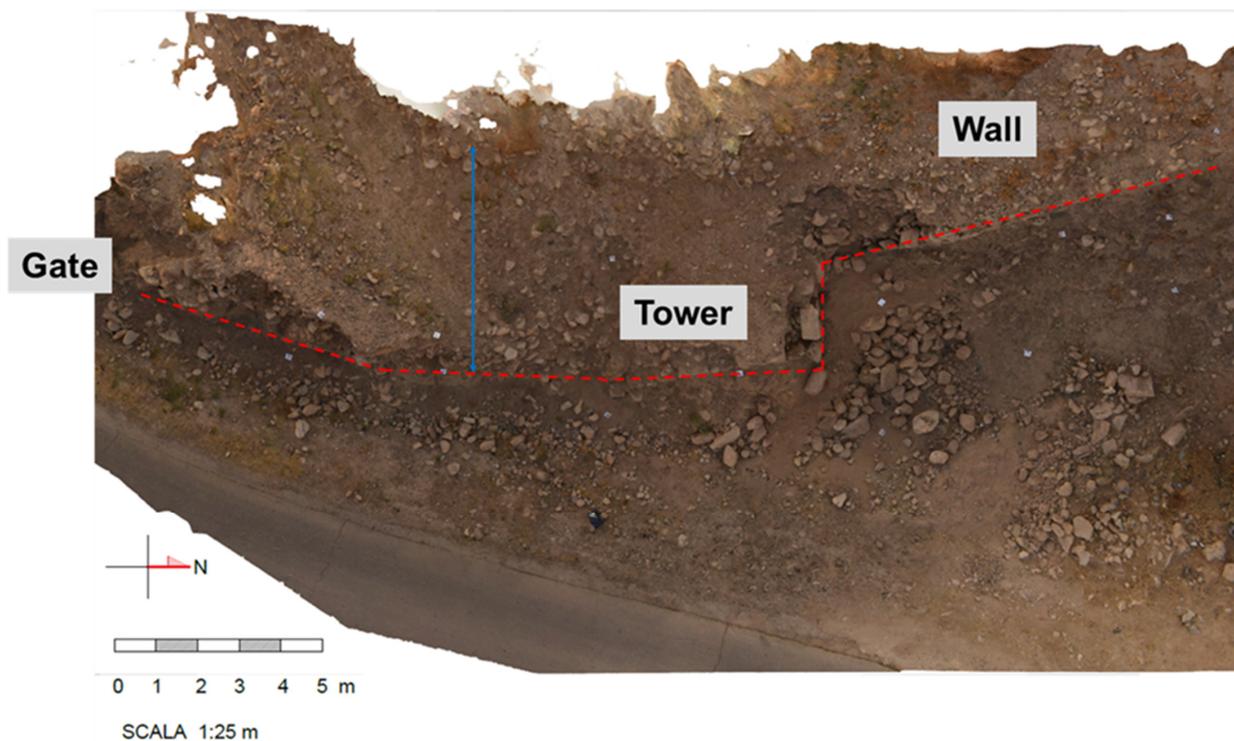
Figure 14. Photogrammetric record of the Early Bronze III fortifications in KI-RC02 after cleaning and before conservation, showing the stratigraphic relationship between the tower and the fortifications on the northern side (**on the right**) walls; view from the top (photographic elaboration by Nicola Lanzaro, © Archaeological Expedition to Khirbat Iskandar); the red dashed line shows the suggested outer perimeter of the walls, the blue arrow the suggested thickness of the tower (to be verified in the 2024 excavations).

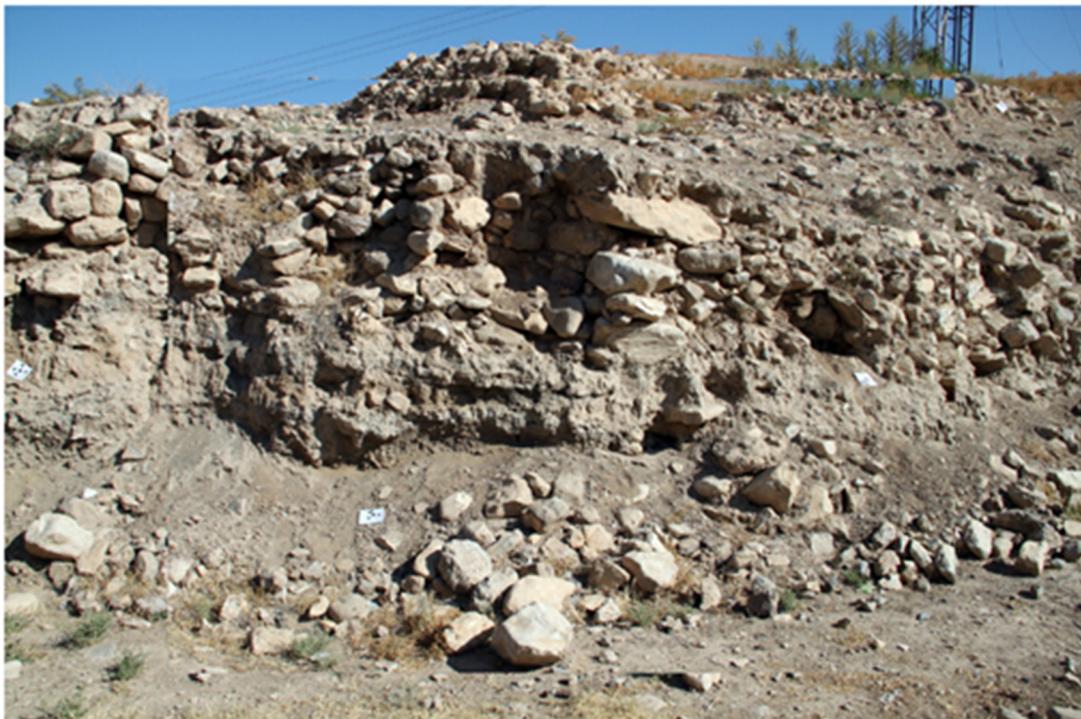
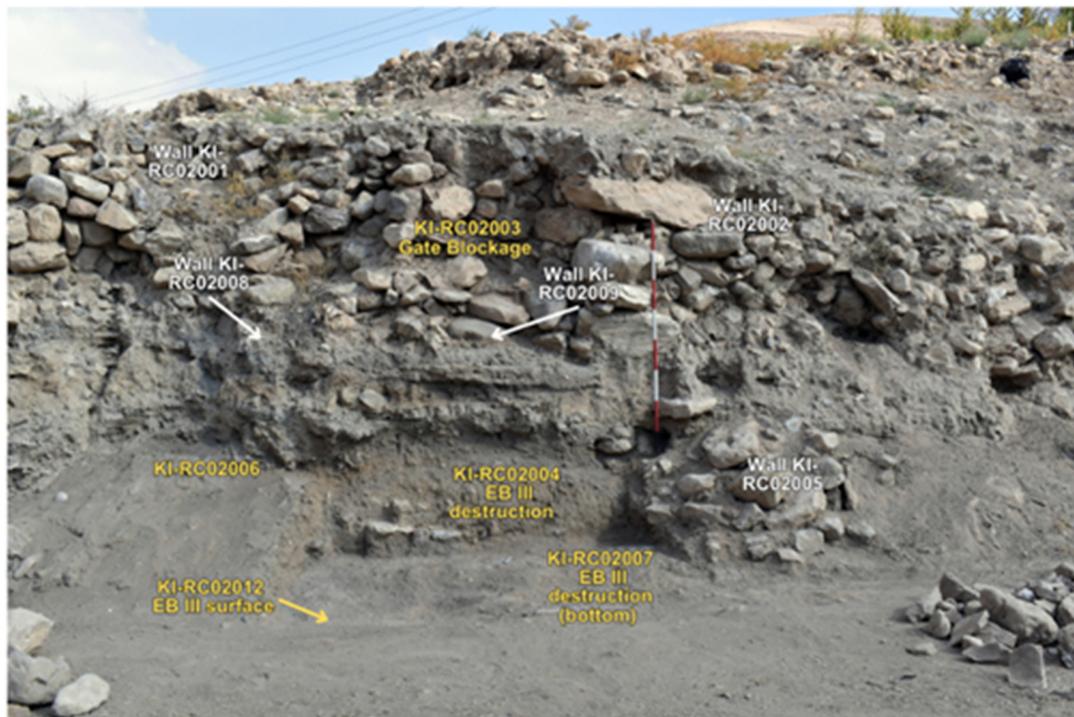
Figure 15. Khirbat Iskandar: the area of the trimming and probing operations in KI-RC02 before and after these activities in 2023, looking westward (photos by Marta D'Andrea, © Archaeological Expedition to Khirbat Iskandar).

Through stratigraphic trimming, we clarified that the blockage of the gate preceded the destruction of the city, because it was abutted by the thick layer of mudbrick and ash layers that should correspond to the destruction of the earlier Early Bronze III site that most likely happened around 2700 BCE. Whether this means that the permeability of the fortifications was reduced at some point during the first half of the Early Bronze III according to a pattern observed also at other sites in Jordan ([7] (pp. 101–105) and [18] (p. 11)) or that the gate was blocked because of an imminent attack is an open question that needs a broader analysis of the entire fortification system to be answered. However, the stratigraphic trimming and probing allowed us to achieve a stratigraphic profile of this sector and important topographic information, such as the presence of a gate with a tower facing the Wadi al-Wala. These operations were fundamental because they allowed us to obtain substantial chronological information to date the fortifications and about their historical and archaeological meaning before proceeding to stabilize and consolidate the parts that had collapsed, as well as to correlate and synchronize the areas of intervention along the southern slope (KI-RC01 and both sectors at KI-RC02).

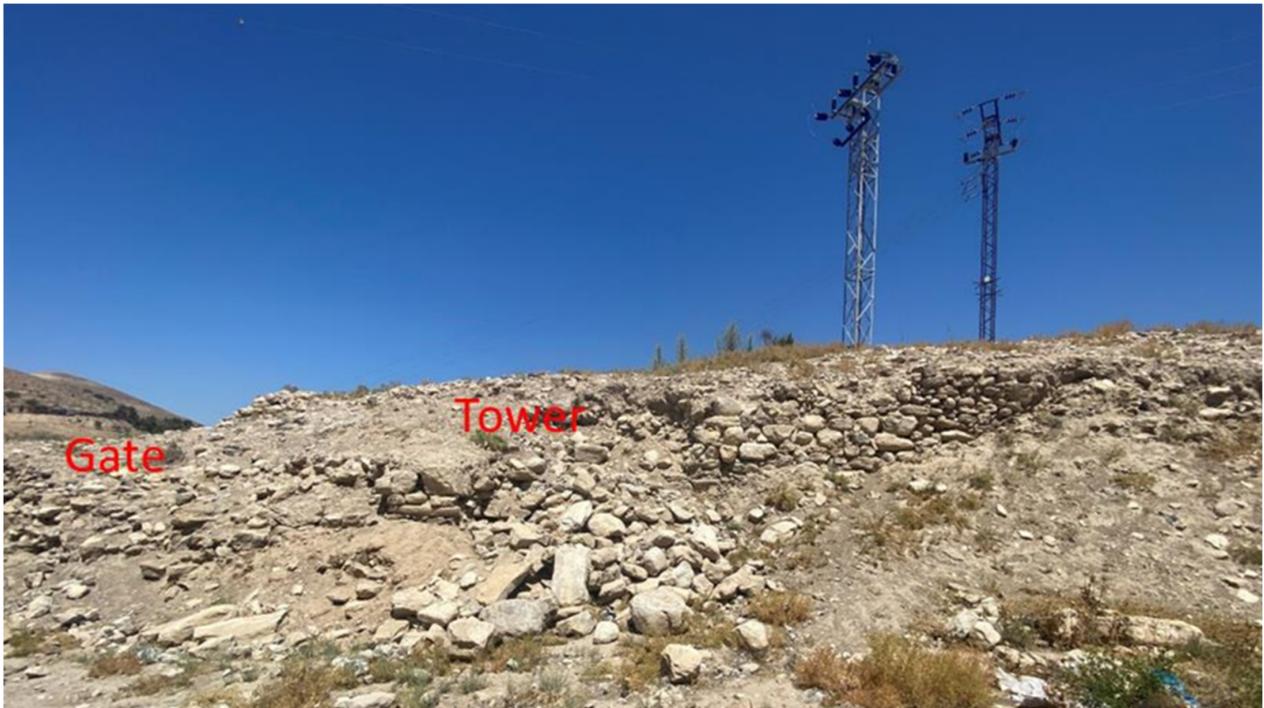
Figure 16. Khirbat Iskandar, KI-RC02: conditions of the area before cleaning, rescue actions, and conservation, in June 2023 (photo by Marta D'Andrea, © Archaeological Expedition to Khirbat Iskandar).

East of the area where the stratigraphic trimming was undertaken and the probe was opened, a 16-meter-long stretch of the wall that continues from the gate area and forms a tower with it was exposed by modern construction activities; here, following erosion and weathering, there was some wall collapsed (Figure 11 (bottom), Figures 13 and 16). In this sector, a team of specialized workers coordinated by the project's restorationist proceeded to clean and clear the area from the debris and, subsequently, to stabilize the architecture at risk and to perform some conservation of the collapsed sections. The materials used in the fortifications are limestone and limestone conglomerates that are naturally available in the surroundings of Khirbat Iskandar. The masonry includes both semi-dressed boulders and undressed stones carefully laid to provide a regular appearance to the exterior face of the wall; rubble was used as chinkstones between the boulder to strengthen the wall cohesion and stability.

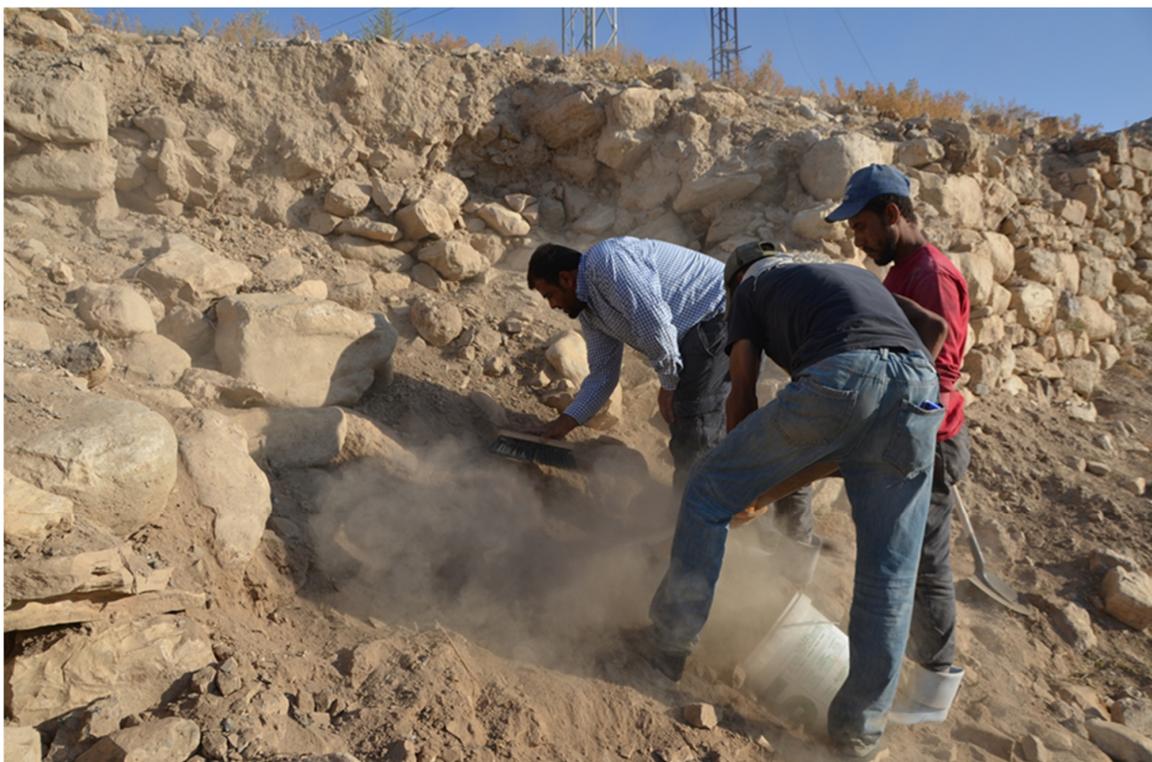
Figure 17. Khirbat Iskandar, KI-RC02: primary cleaning operations prior to conservation, in July 2023 (photo: Khaled Al Wekhean, © Archaeological Expedition to Khirbat Iskandar).

The first phase of the work consisted in the removal of the unstable soil mainly from the surface (Figure 17), and then a rough coating of earth was made between the joints of the stones to provide stability to the external parts of the collapsed walls (Figure 18). Thereafter, the various stone blocks from the collapse were removed and divided according to their size and order of reinsertion, for the appropriate spaces left by the collapse (warping). Stone walls in this sector tumbled most likely after the use of mechanical means applied in modern construction activities, which weakened their stability, leading over time to undocumented collapses; however, it was possible to restore the walls, giving to them an appearance that is very close to the original one because part of the stone blocks and associated earthen materials were still on site. In fact, visual analyses of the collapsed stones and their location and of the still standing walls allowed us to reinstate the wall fabric following a methodology that was as close as possible to the original (Figure 19), considering the passage of time from the collapse, erosion, and washout that displaced

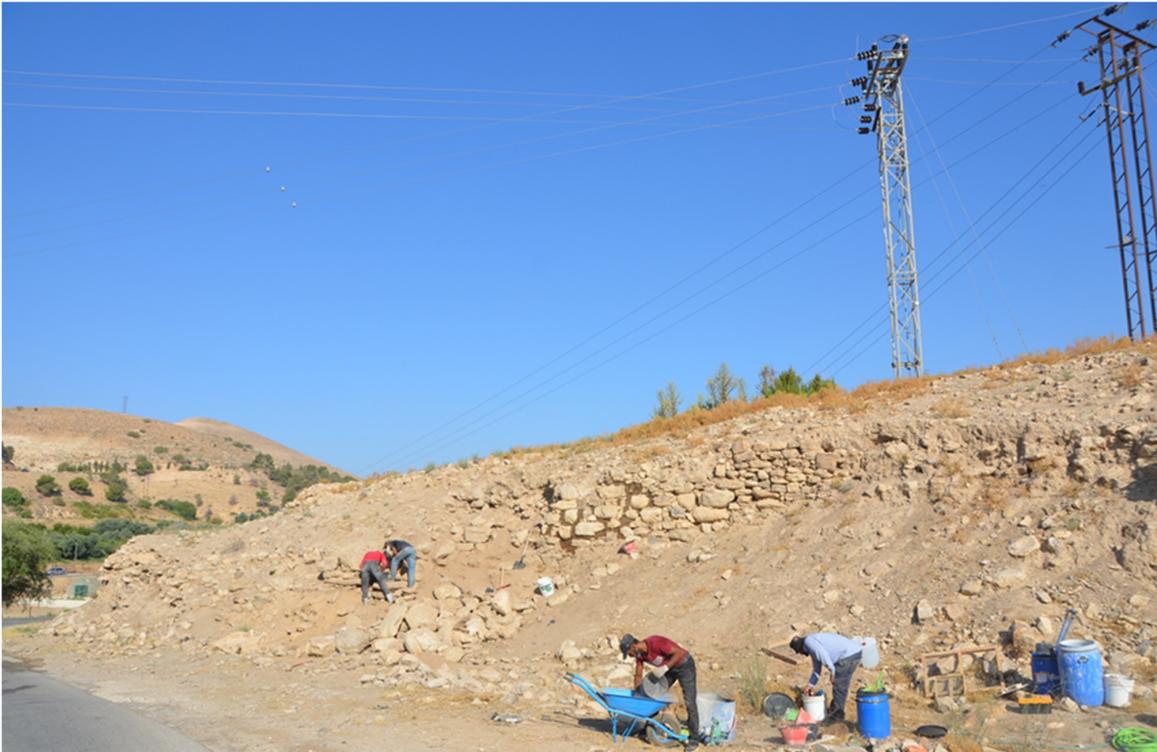
Figure 18. Khirbat Iskandar, KI-RC02: the application of the rough earthen coating on the restored façade of the collapsed walls, looking toward the south-west, in July 2023 (photo by Khaled Al Wekhean, © Archaeological Expedition to Khirbat Iskandar).

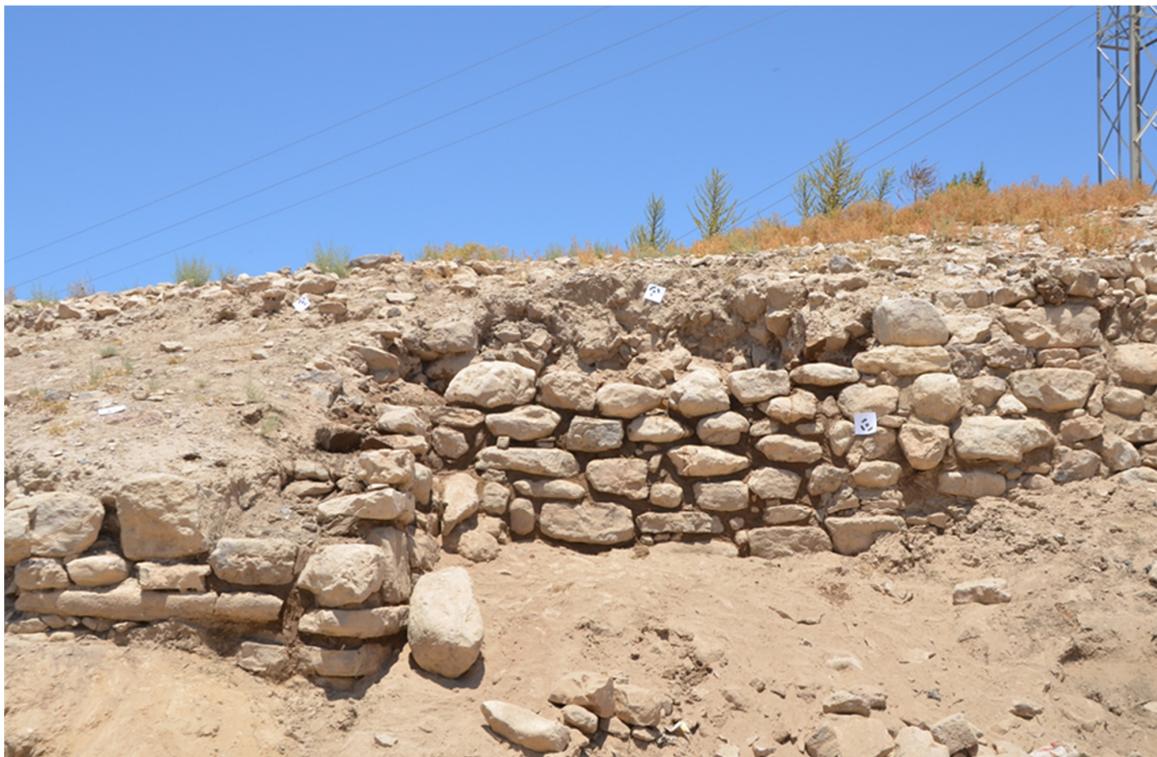
Figure 19. Khirbat Iskandar: the Early Bronze III fortifications in Area B and in KI-RC02 showing the original building techniques with large boulders and chinkstones to the left, vis-à-vis the reinstated part to the right, in July 2023 (photo by Khaled Al Wekhean, © Archaeological Expedition to Khirbat Iskandar).

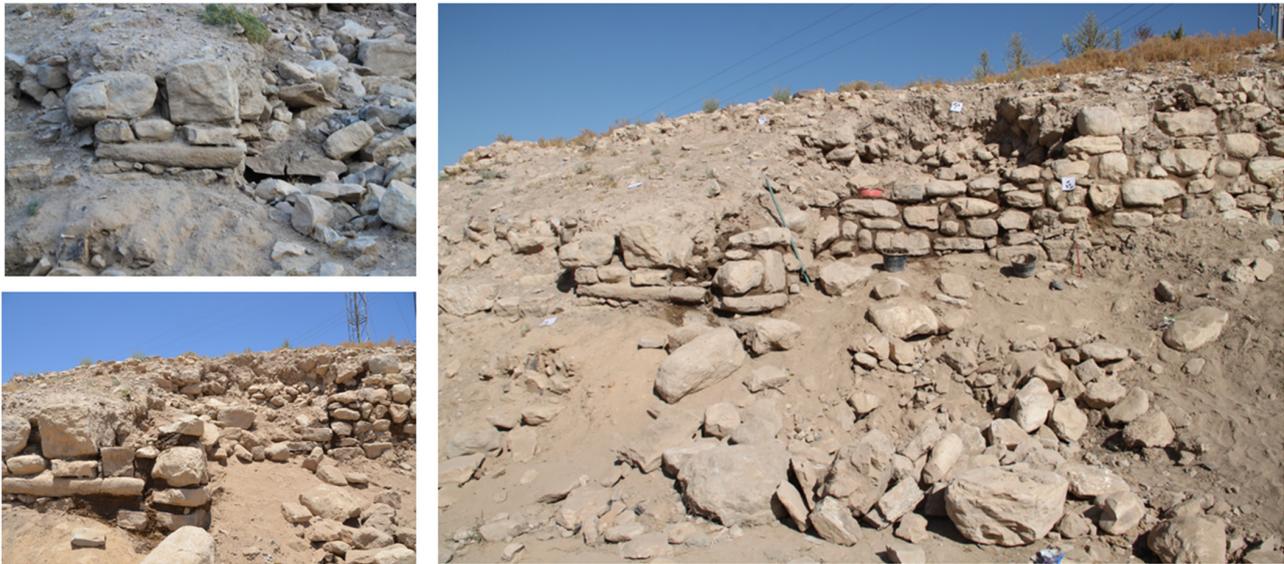
Figure 20. Khirbat Iskandar, KI-RC02: the reinstatement of the collapsed stone boulders to their original placement, in July 2023 (photos by Khaled Al Wekhean and Marta D’Andrea, © Archaeological Expedition to Khirbat Iskandar).

some of the stones. Whenever possible thanks to a careful analysis of the collapse, the stone boulders were put back exactly where they were originally placed (Figure 20).

The use of a mechanical crane was necessary to move the larger boulders; a plastic tarp was used to protect the stones while moving them. The re-arrangement of the stone blocks took place in stages; the external boulders were re-integrated first and cemented with mud and straw mortar (Figure 21). Subsequently, on the inside, the empty spaces were filled with earth and crushed stone, and this filling at each consecutive level was abundantly wetted, to give it greater stability (Figure 22). Subsequently, a fabric was laid on the inside of the collapsed wall before filling it in order to separate the original from the restored parts, to stabilize the inside, and to regulate water drainage (Figure 23). The inner space above the fabric was afterward filled with earth and stones. Mud, straw, and sifted soil from the other operations were used in the consolidation (which left no dumps from the trimming and probing on site). Once the wall was completely restored, the upper part was leveled so as to protect it and to provide it with some slope that could serve as a means to canalize rainwater and make it flow downstream to avoid water percolations on the face of the walls (Figure 24). Finally, two contour lines made of mortar indicate the limits of the stretch of the walls that underwent conservation and consolidation on the east and west, respectively (Figure 25). In addition, the adjacent eastern stretch of the wall that was still standing was consolidated with mud and straw mortar to prevent future collapse.

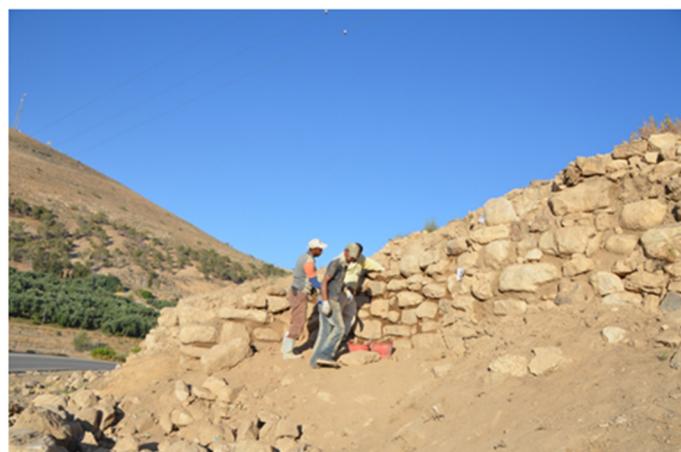
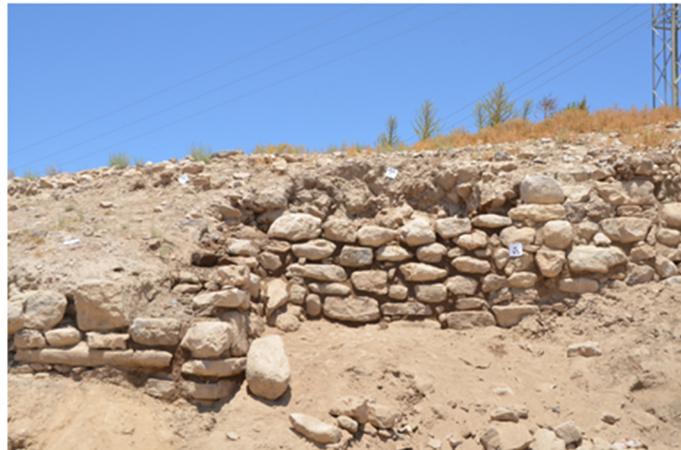
Figure 21. Khirbat Iskandar, KI-RC02: the reintegrated external boulders were cemented with mud and straw mortar, in July 2023 (photos by Khaled Al Wekhean, © Archaeological Expedition to Khirbat Iskandar).

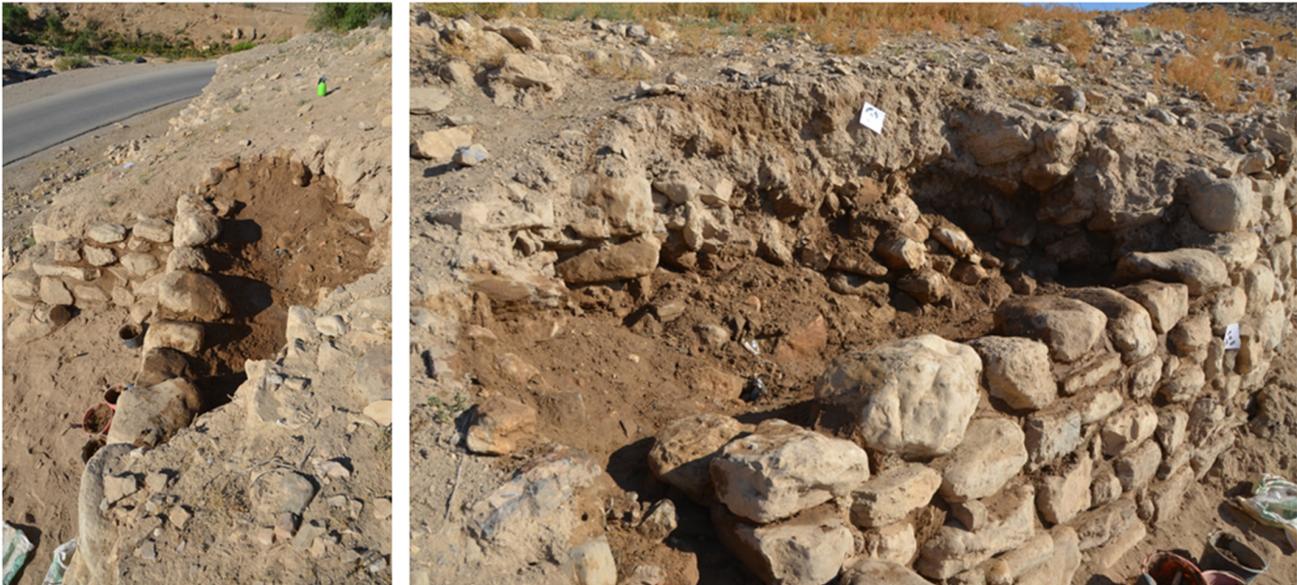
Figure 22. Khirbat Iskandar, KI-RC02: inside filling with earth and crushed stones, in July 2023 (photos by Khaled Al Wekhean, © Archaeological Expedition to Khirbat Iskandar).
