Emergency Actions for the Documentation, Stabilization, and Consolidation of the Early Bronze Age Fortifications at Khirbat Iskandar, Jordan

Emergency actions for the documentation, stabilization, consolidation, and conservation of the EBA fortifications at KI-RC02

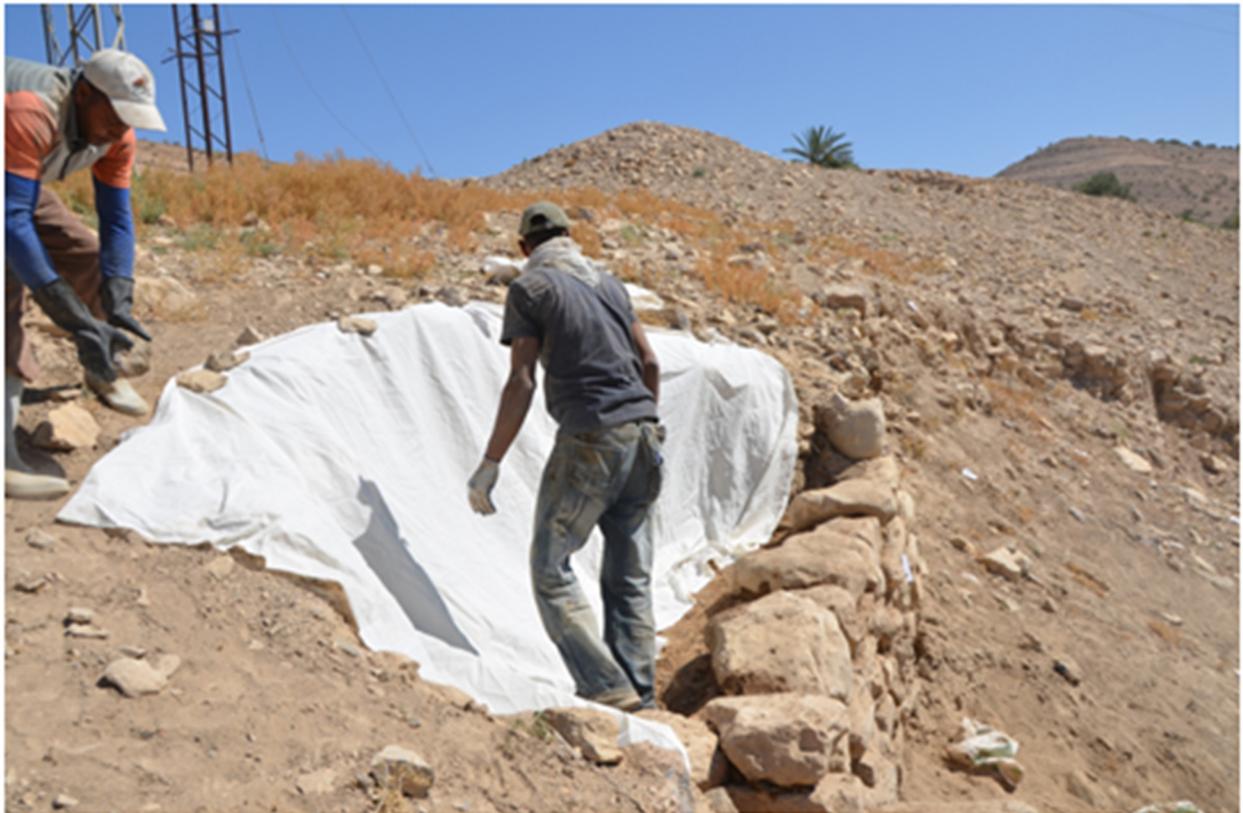
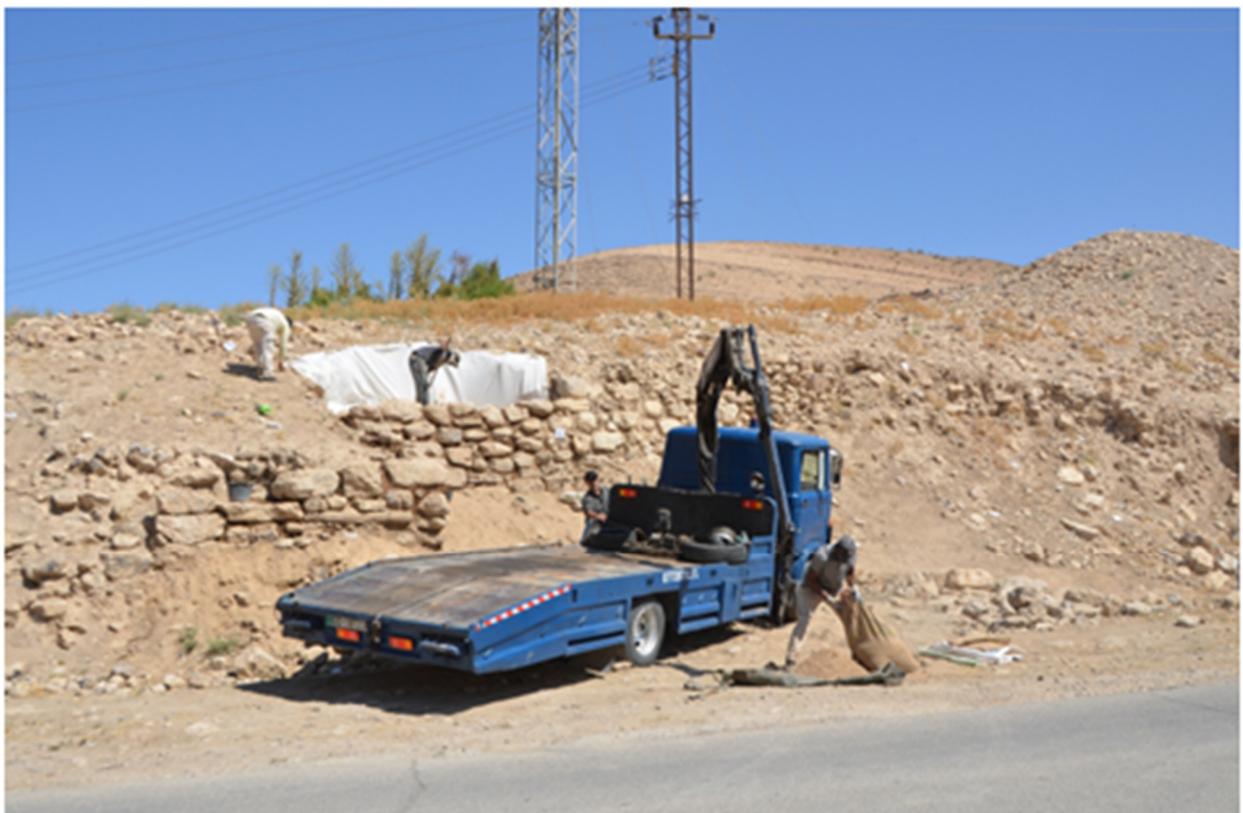
Figure 23. Khirbat Iskandar, KI-RC02: fabric inside the restored wall to separate the original from the restored parts, to stabilize the inside, and regulate water drainage, in July 2023 (photos by Khaled Al Wekhean, © Archaeological Expedition to Khirbat Iskandar).

(a) They are *recognizable* because the fabric on the inside and the contour lines made of mortar on the outside mark visibly the beginning and the end of the stretch of the fortifications that underwent stabilization and conservation.

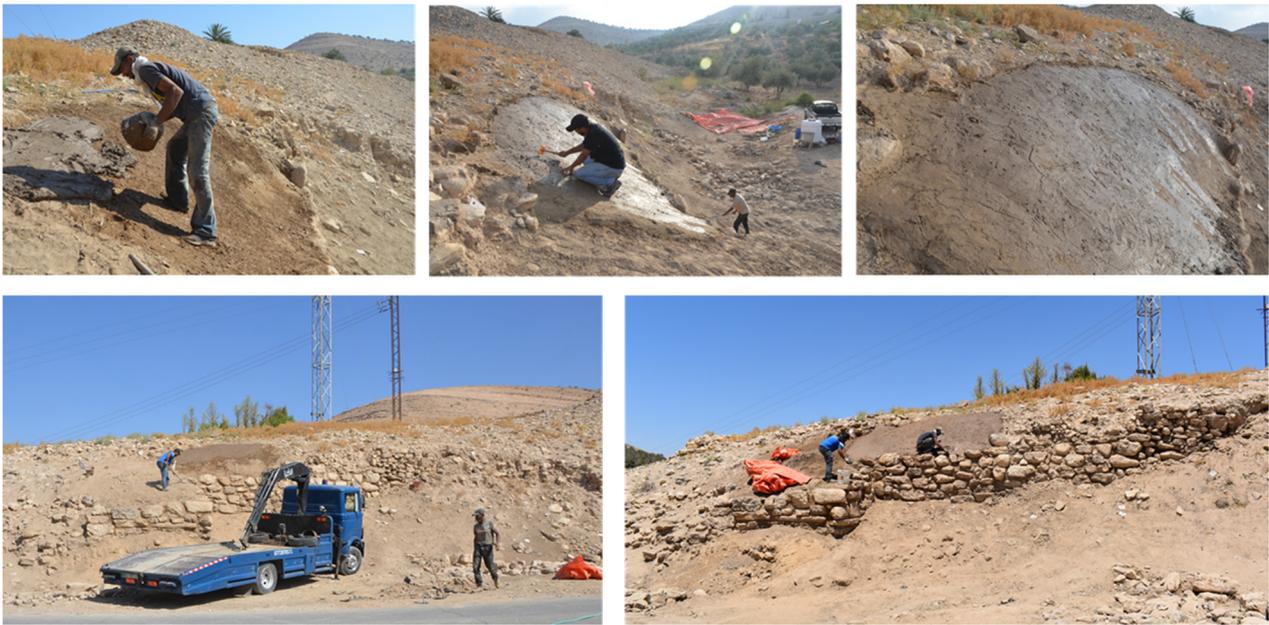
Figure 24. Khirbat Iskandar: levelling of the upper part of the walls with mud and straw, in July 2023 (photos by Khaled Al Wekhean and Marta D'Andrea, © Archaeological Expedition to Khirbat Iskandar).

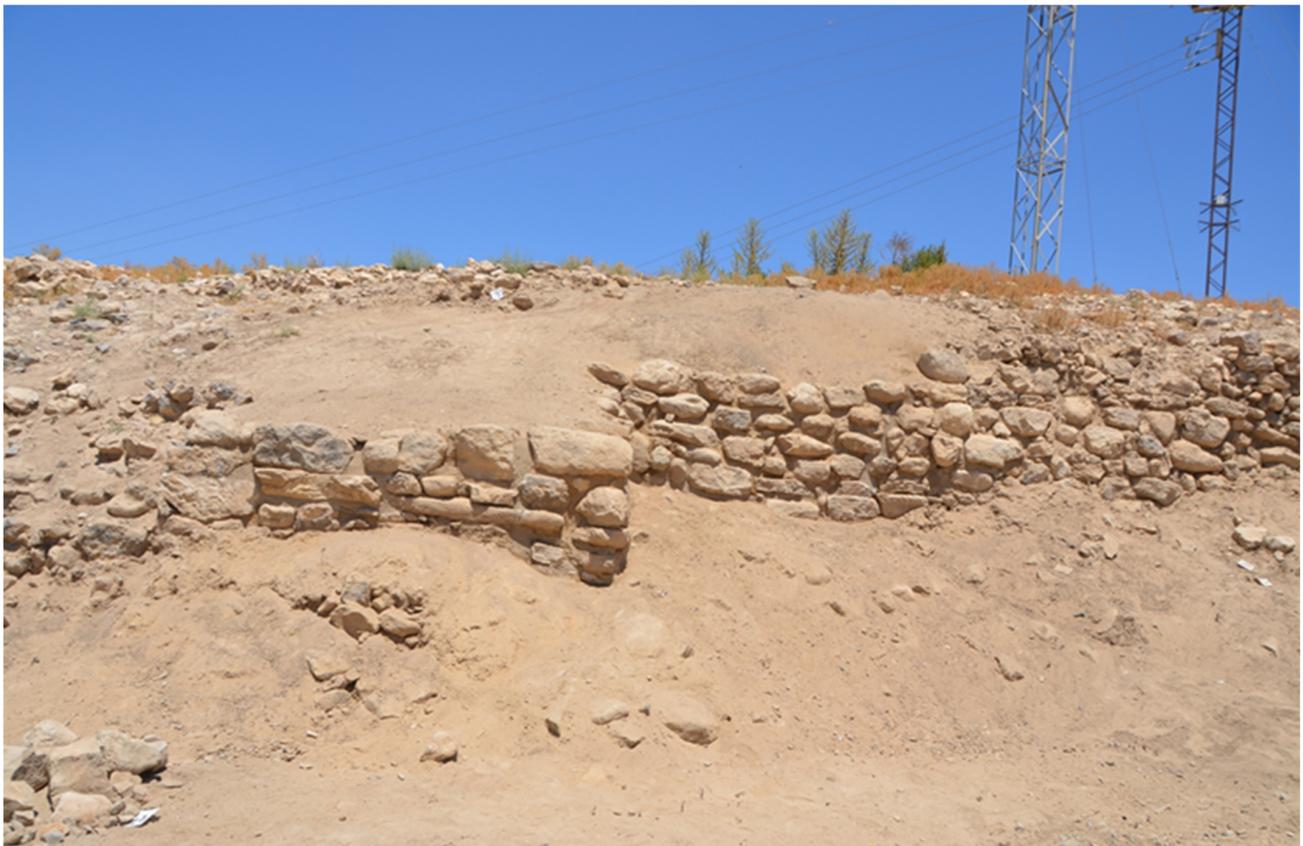
Figure 25. Khirbat Iskandar, KI-RC02: contour lines made of mortar indicate the limits of the stretch of the walls that underwent conservation and consolidation on the east and west, in July 2023 (photo by Khaled Al Wekhean, © Archaeological Expedition to Khirbat Iskandar).

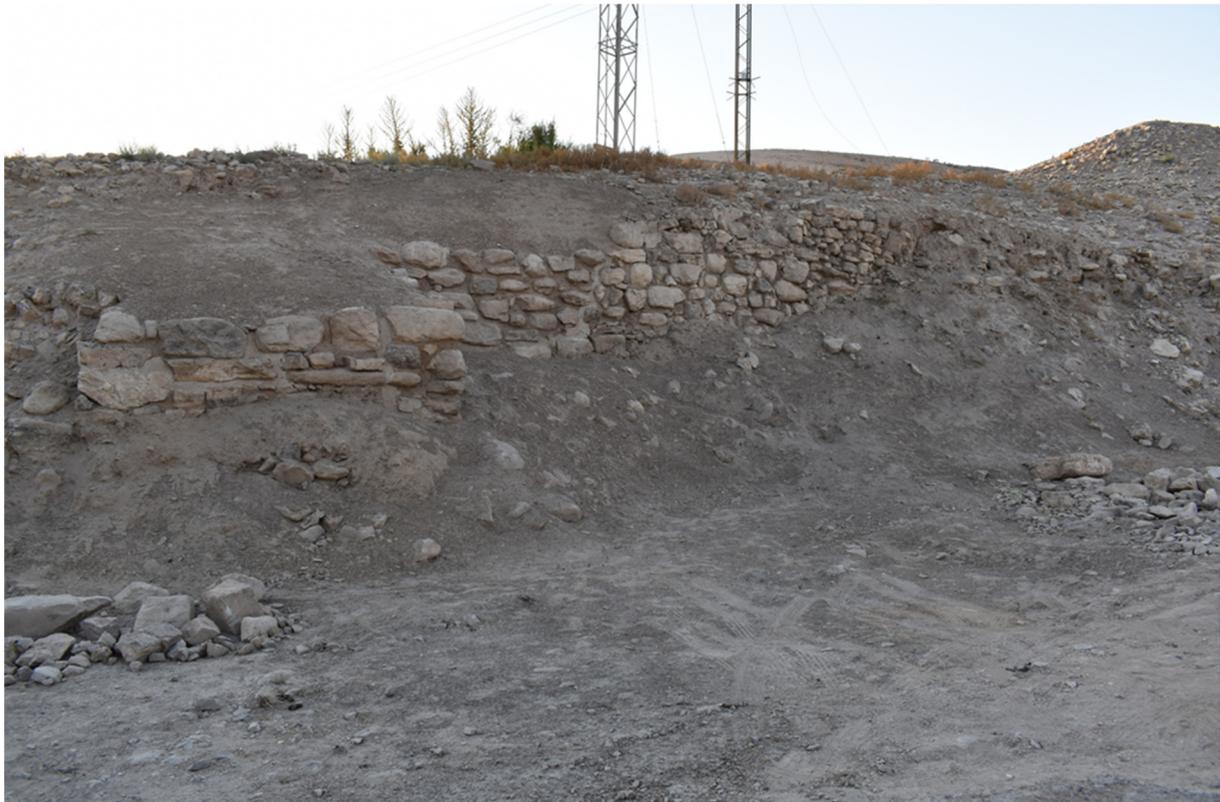
Figure 26. Khirbat Iskandar, KI-RC02: general view of the fortifications after the urgent stabilization/consolidation/conservation actions, looking westward, in July 2023 (photo by Marta D'Andrea, © Archaeological Expedition to Khirbat Iskandar).

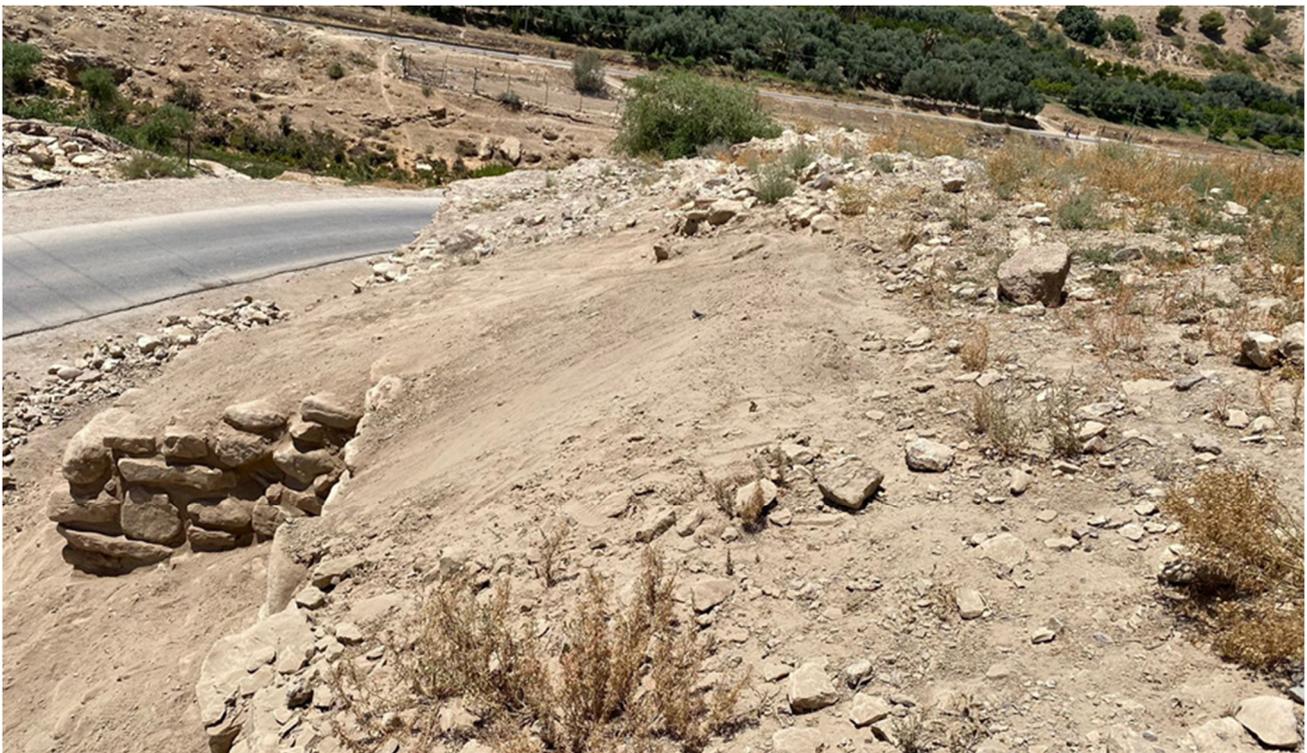
Figure 27. Khirbat Iskandar, KI-RC02: the fortifications after the urgent stabilization/consolidation/conservation actions (view from the top looking southward), in July 2023 (photo by Khaled Al Wekhean, © Archaeological Expedition to Khirbat Iskandar).
