# Towards a More Cohesive and Accessible City Centre: Bridging the Gap Between Historical Identity and Modern Community's Needs—Case Study: Lugoj City, Romania

**Keywords:** heritage; public space; restoration; cohesion; accessibility

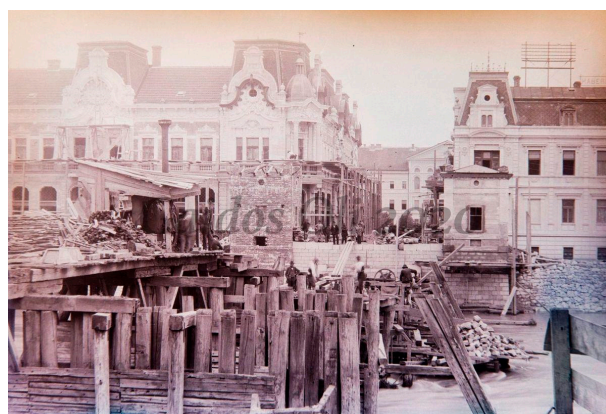
**Figure 6.** Old photo from the construction of the iron bridge; the old wood bridge can be observed and the customs houses [26].

The Iron Bridge was a highly anticipated project for the people of Lugoj, which became a reality in 1902, thanks to the contribution of the local municipality to the city’s urbanisation process. The introduction of the Iron Bridge into the city’s architecture also required several modifications to organise the area: the widening of the old Bridge Street—now Unirii Street—and the flanking of it with two monumental palaces, Bejan (1901–1902) and Haberehrn (1899–1900). The municipality proposed the construction of the Iron Bridge starting in 1887, but this was not possible until July 1901 due to economic reasons [25] (Figure 6).

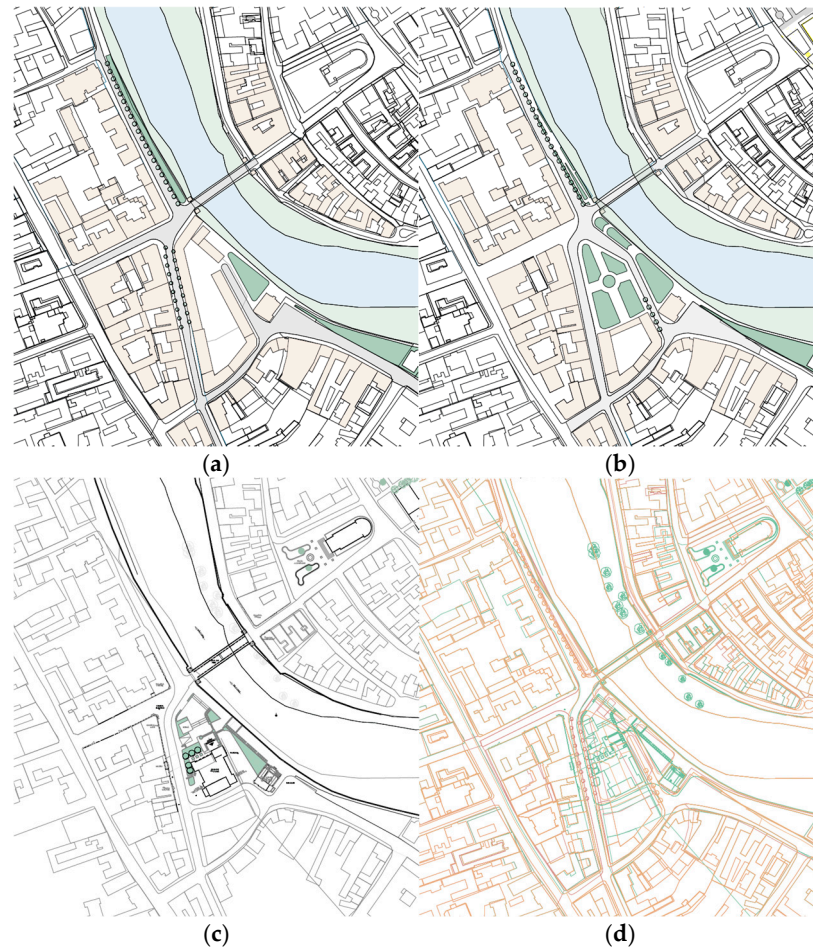
**Figure 7.** (a) Town's plan from 1934; (b) town's plan from 1950; (c) town's plan from 2023; (d) overlap of all three plans; all plans are reconstructed based on historical photographs and on-site measurements [27].

Figure 7 is an overlap of the old map of the town over a Google map and it can be observed that not only are the bridges in the same spot but also the churches are. This means that the town kept the historic ones or reconstructed new ones in the same spot. This increases the value of both the bridge and the churches, since their place is not random but rather intentional.

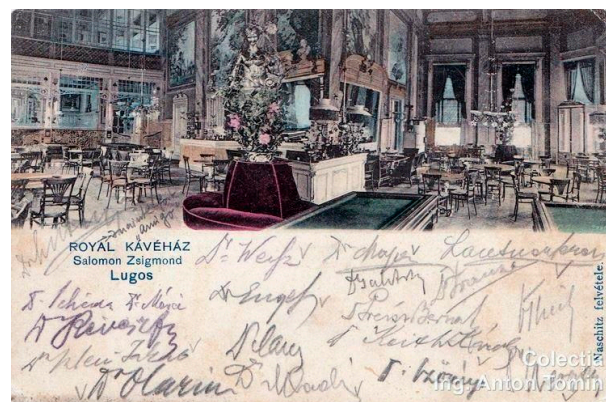
**Figure 9.** The interior of the “Royal Restaurant” [23].

The old theatre that stands on the corner, across from the Dacia Hotel, was first mentioned in documents in 1733; however, now it no longer represents the old appearance of the building. First, the building was built as a coffee shop and restaurant with social games. During 1835, in the courtyard, the first theatre in Lugoj was built. In 1866, the new owner built the building as it is known today, but its first floor was not built until 1900, right before the introduction of electricity. The building is a classical architecture having Corinthian columns and, between the columns, there are imitations of metopes decorated with griffins, and the interior is heavily decorated (Figure 9) [31].

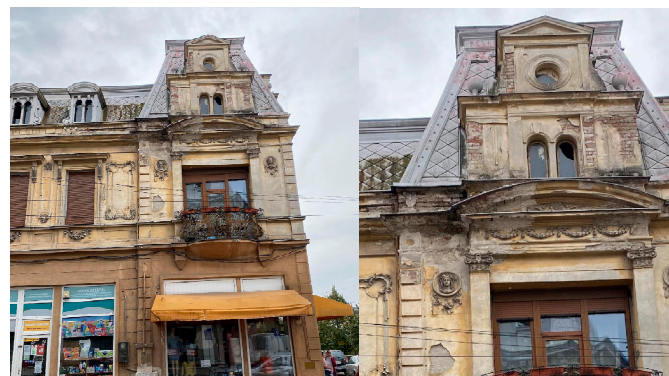
**Figure 10.** The Haberehn Palace moderate deterioration. The picture was taken in 2021.

The Haberehn Palace is in a state of moderate deterioration. It can be observed that the building suffered some improper and invasive interventions on the ground floor, as seen in Figure 10.

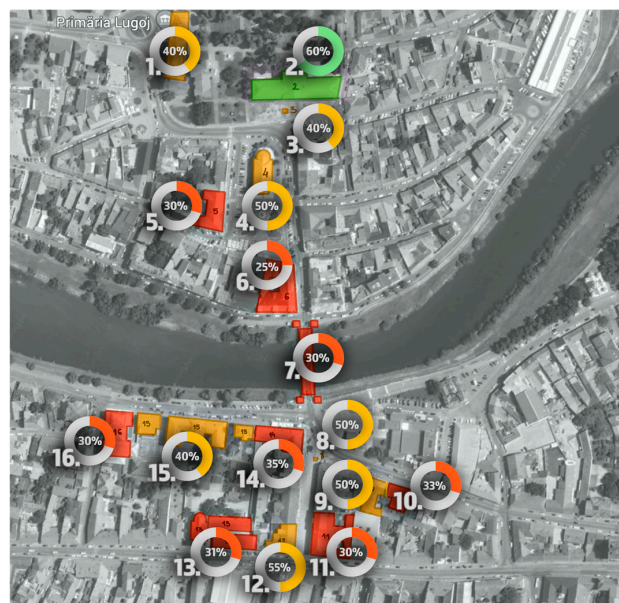
**Figure 16.** Accessibility map—evaluation score (1. City Hall, 2. Former Prefecture, 3. Heroes Monument, 4. Catholic Cathedral, 5. Police station, 6. Bejan Palace, 7. Iron Bridge, 8. Electric Watch, 9. History Museum, 10. Military circle, 11. Dacia Hotel, 12. Old Theatre, 13. Catholic Church and Parish, 14. Vertes Palace, 15. Coriolan Brediceanu College, and 16. Traian Grozavescu Theatre).

For a synthetic visualisation of the general level of accessibility, a thematic map (Figure 16) was created in which each building in the sample is graphically represented according to the average score resulting from the evaluation.

Alongside this, the summary table highlights the scores obtained for each analysed criterion, differentiated by the two types of special needs (visual and locomotor). The percentage representation provides a clear overview of the discrepancies between buildings but also of the correlation between the time of restoration and the level of compliance with accessibility standards. Recently restored buildings tend to obtain higher scores, while unrenovated historical monuments or those with a commemorative function (such as monuments or some churches) remain profoundly inaccessible. The map thus allows for a comparative, contextual, and spatial reading of the data, bringing an additional dimension to the quantitative interpretation and supporting the idea that accessibility is not just a technical issue but an urban one, integrated into the logic of the functioning of the city centre.

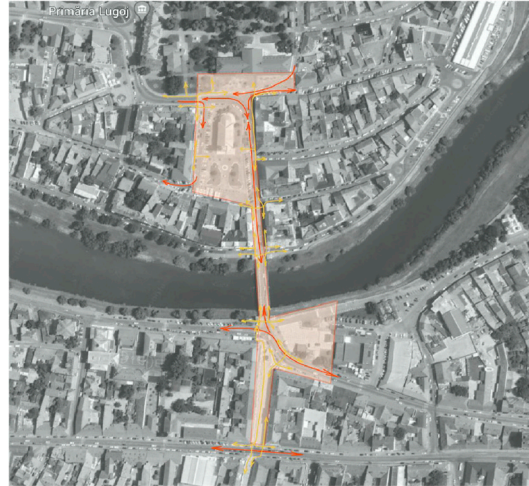
**Figure 18.** Existing traffic for cars (in red) and people (in yellow) [27].

Moreover, the traffic in the actual situation is perceived as a factor that does not allow people to perceive the public space as a whole (Figure 18), so the ideal situation would be to extract car access from the historical promenade, or at least to apply traffic calming strategies that will prioritise the people, for example, applying cubic stone instead of asphalt.
