# Multidisciplinary Approach of Proactive Preservation of the Religions Complex in Old Cairo—Part 2: Structural Challenges

Hany M. Hassan <sup>1,2</sup>

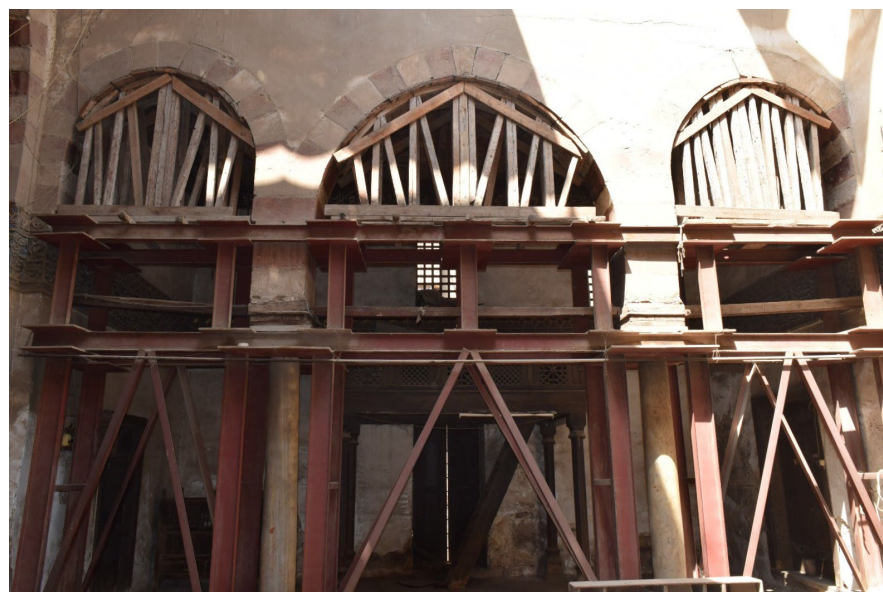
**Figure 2.** Example of historic monument in Old Cairo, after the 1992 earthquake. Photo by the authors.

Among various influencing factors, the moderate 5.9-magnitude earthquake that struck the city of Cairo in 1992 was generally recognized, over the years, as one of the most important threats (see [5–7] and Figure 2). A major response to some concerns raised by an International Council on Monuments and Sites (ICOMOS) monitoring mission—regarding the urban and architectural heritage after the 1992 earthquake [8]—come from the Ministry of Culture (MoC), which organized an International Symposium on the Conservation and Restoration of Islamic Cairo, held in February 2002 [9]. This event brought together conservation experts to discuss the challenges of preserving cultural heritage in Old Cairo as a vibrant urban environment [10].

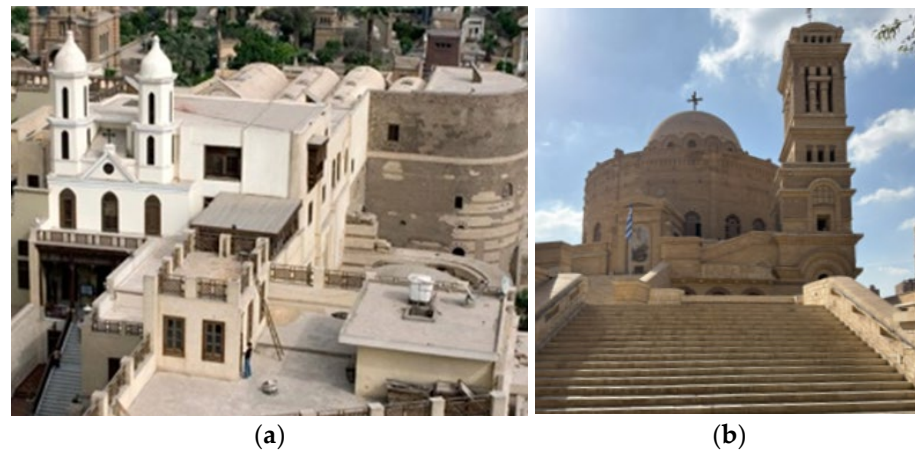
**Figure 4.** Examples of Coptic Cairo monumental buildings. (a) Hanging Church, (b) The Church of Mar Girgis (St. George).

Churches in old Cairo can be found with square and rectangular floor plans (Figure 4). Their layout combines the basilica and the Byzantine styles. According to [16], some of

these churches have a rectangular layout that consists of a main façade and a transverse vestibule entrance, with longitudinal structures and porticoes, such as those that can be seen in some monuments of Old Cairo (e.g., Hanging Church, Barbara Church, and Abu Seifin Church). Other examples with a typical square layout are not very common (e.g., the Church of Prince Tadros Al-Mashriqi). Most of these churches underwent renovations after being damaged in the Fustat burning during the reigns of Harun al-Rashid (Abbasid era) and Al-'Aziz Billah (Fatimid era); see [16].

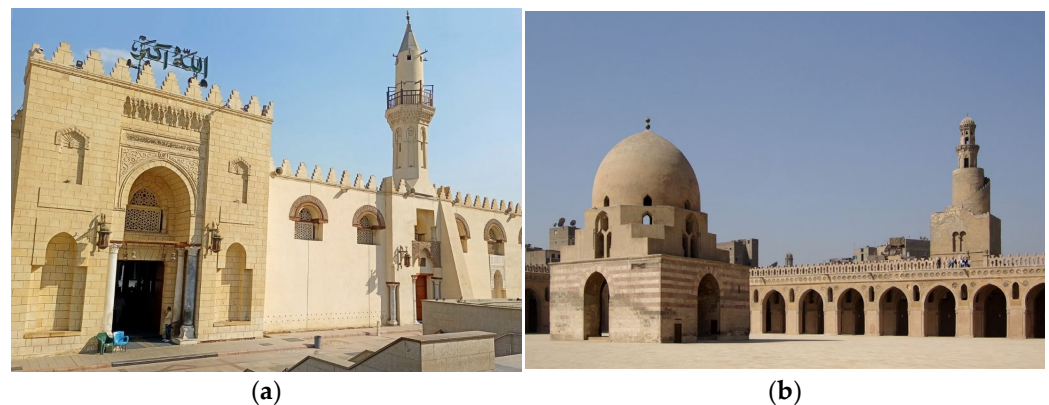
**Figure 5.** Examples monumental buildings in Cairo: (a) Amr ibn al-As mosque (the first and oldest mosque ever built in Egypt) and (b) Ahmad Ibn Tulun mosque. Photos by the authors.

The architectural styles of Samarra, Baghdad, and Damascus influenced Tulunid monuments. The only surviving example of this period, in Old Cairo, is a Samarran-style mosque (Ahmad Ibn Tulun; Figure 5b). This mosque was constructed with well-fired red brick, stucco coverage, and fine plaster decoration [18]. It is a mosque with a large *sahn* (courtyard), a flat hypostyle roof, and a unique minaret style, with exterior stairs around the square base that convert into a spiraling stair in the upper part, according to a Mabkhara top style (i.e., incense burner-shaped); see [19].

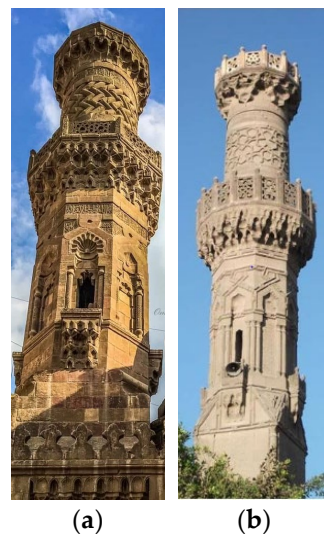
**Figure 7.** Examples of minarets in Old Cairo without top: (a) the minaret of Aydumur al-Bahlawan and (b) the minaret of Khushqadam al-Ahmadi. Adapted from [34] with permission.

without tops represent common damage patterns, especially in the Mamluk top style. Examples of minarets that have lost their top include Aydumur al-Bahlawan, Yashbak min Mahdi, Qanibay al-Jarkasi, Ahmad al-Mihmindar, the Khushqadam al-Ahmadi minaret, and Emir Mugulbay Taz (see Figure 7).

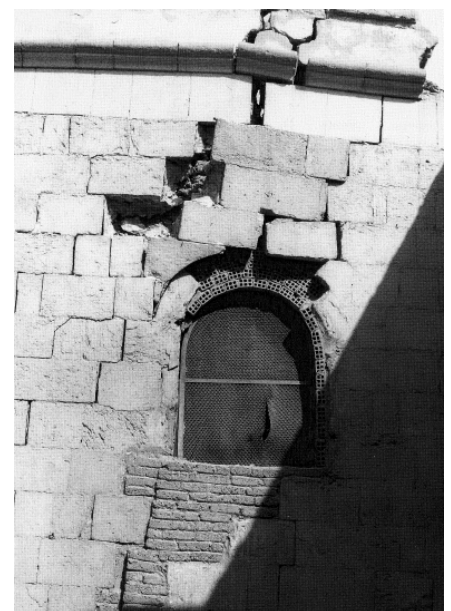
**Figure 12.** Examples of severe damage in the Citadel after the 1992 earthquake. Adapted from [15] with permission: (a) Mint and (b) Saraya el-Adl.

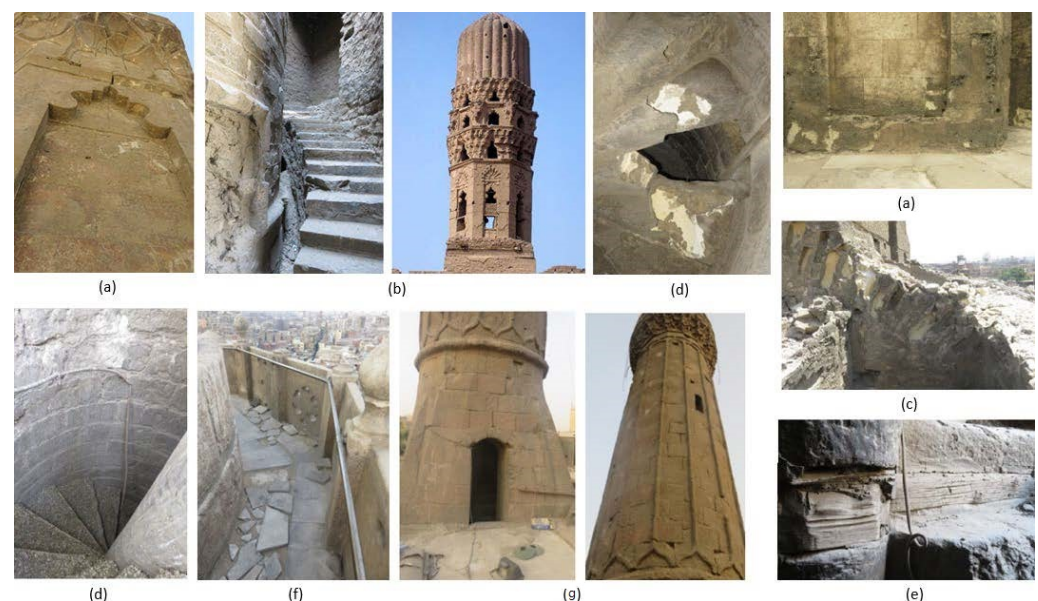
**Figure 14.** Examples of structural vulnerability studies of historic masonry minarets in Old Cairo. Adapted from [49] under the terms and conditions of a CC BY 4.0 agreement. Different patterns of deterioration found in (a) the uppermost part of the Ibn Tulun minaret; (b) the body and the upper part

of the northern minaret of al-Hakim mosque; (c) the portion beneath the octagonal section and Mabkarah of the southern minaret of al-Hakim mosque; (d) the staircase and interior surface of the second floor of the southwest minaret of Sultan Hasan mosque; (e) the wooden tie at the northeast minaret of Sultan Hasan mosque; (f) the chipped tiles of the west minaret of al-Mu'ayyad Shaykh mosque; (g) the shaft of Yusuf agha al-Hin minaret.

Sallam et al. [49] investigated the seismic vulnerability of eight different masonry minarets located in Old Cairo. A detailed inspection of each minaret was carried out (Figure 14). The assessed vulnerability index values for these minarets ranged from 10.3 to 26.1, indicating a relatively high level of vulnerability to seismic events. Additionally, vulnerability curves were created for each minaret, visually illustrating the potential damage scenarios across various seismic intensity levels, as per the EMS-98 scale. In support of the analysis, vibration tests and data were elaborated by using the peak-picking method to obtain the dominant frequencies of the selected minarets. As a noteworthy contribution by the study in [49], a new empirical equation was introduced and validated to estimate the fundamental period of minarets in Old Cairo, based on their height. However, the major limitation of the study is its application to specific types of minarets—namely, the historic masonry minarets of Old Cairo. In this sense, the approach should be extended and validated to different minaret styles. Furthermore, it faces major challenges that derive from the need for detailed 3D structural models of the minarets object of study, in order to properly capture their dynamic response.
