# In-Situ Corrosion Testing of Carbon Steel and EHLA Clad Materials in High-Temperature Geothermal Well

Carbon steel casing material in high-temperature deep geothermal wells can be prone to severe corrosion and premature failure due to the oxidation capacity of H<sub>2</sub>O, H<sub>2</sub>S, CO<sub>2</sub>, and more corrosive species in geothermal fluid. Due to the higher temperature and pressure and phase state of fluid in high-temperature deep geothermal wells, the rate and extent of corrosion can be expected to be different than in low-temperature geothermal wells. To reduce the extent of corrosion damage and corrosion rate, and increase the lifetime of geothermal wells, one mitigation method is to clad the internal surface of the geothermal casing with a more noble, corrosion-resistant material. Conventional cladding, however, has been an expensive and time-consuming process up to the current date, but recently, a more economical and productive method has been established, i.e., EHLA cladding. In this study, a 14-day corrosion performance test was conducted on stainless steel and nickel-based alloy clads on a carbon steel substrate in a 262 °C and 95 bar geothermal well in t

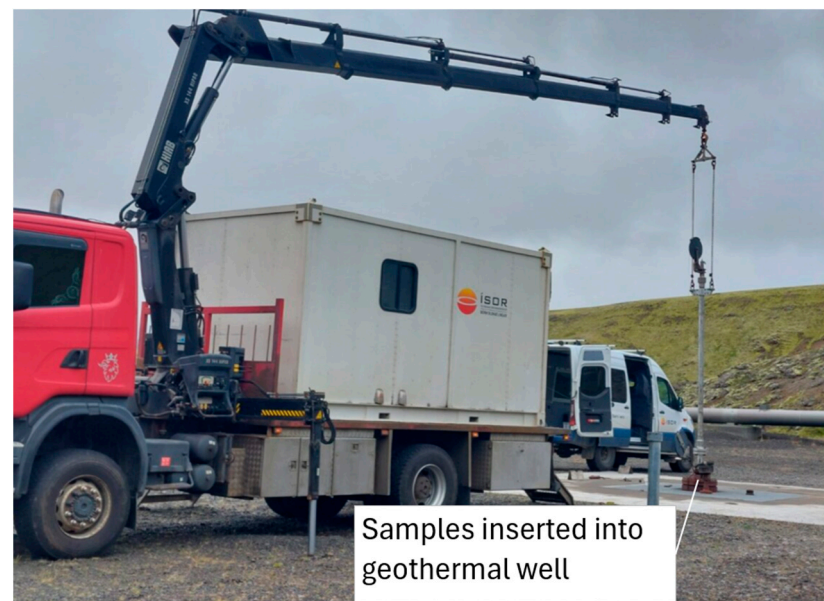
**Figure 7.** Samples in the sample holder unit were inserted down to a 1300 m depth in well HE-52, where the temperature was 262 °C and the pressure was 95 barG.

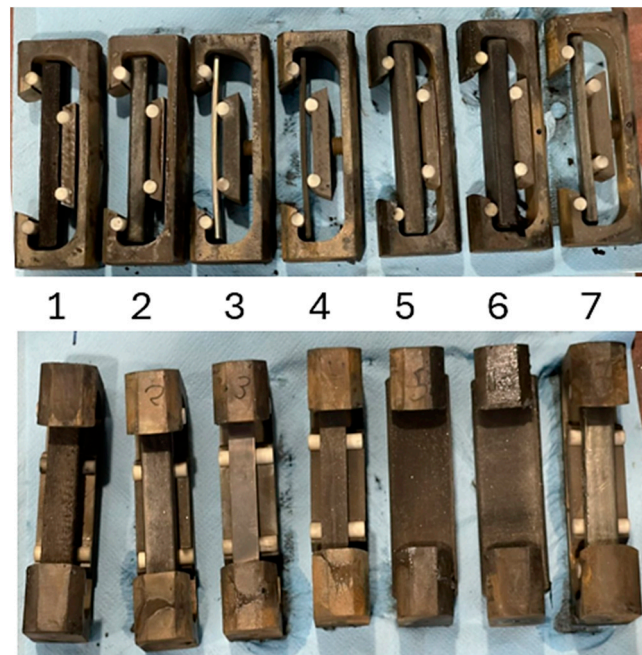
**Figure 22.** Samples in jigs 1 to 7 (according to Table 1). Samples #5 and #6 had no stress, samples #1 and #2 had a stress load level of 30% YS, and samples #3, #4, and #7 had a stress load level of 100% YS.

Seven samples in total were put in jigs (see Figure 22), of which five were stressed (two with 30% YS and three with 100% YS) at the testing temperature. Two of the samples in the jigs were tested with no stress. The aim of testing the stressed samples was to investigate the clad's susceptibility to SCC. The aim of testing the two clad unclad samples was to investigate the corrosion effect of the geothermal environment on the clads when the external surface of the carbon steel substrate was fully covered with clad material (i.e., with no galvanic effect between the clad and substrate).
