Seismic Vulnerability Assessment and Strengthening Interventions of Structural Units of a Typical Clustered Masonry Building in the Campania Region of Italy

Abstract: The present paper aims at inspecting the structural behaviour of a typical masonry aggregate located in the historical centre of Cercola, a municipality in the province of Naples. The clustered building under study consists of four structural units mutually connected to each other made of tuff stone and deformable floors. Two distinct structural units, namely in heading and intermediate places, in both isolated and aggregate conditions, are examined to estimate the influence of structural positions on the global seismic response of the examined case study buildings. For this purpose, non-linear static analyses are performed using the 3MURI software. Pushover analyses are conducted to both evaluate the seismic behaviour of examined structural units and improve their earthquake performances while considering proper retrofit interventions on vertical and horizontal structures. The analysis results are plotted in terms of risk factor, stiffness, and ductility. Finally, a set of fragility functions are derived to point ou

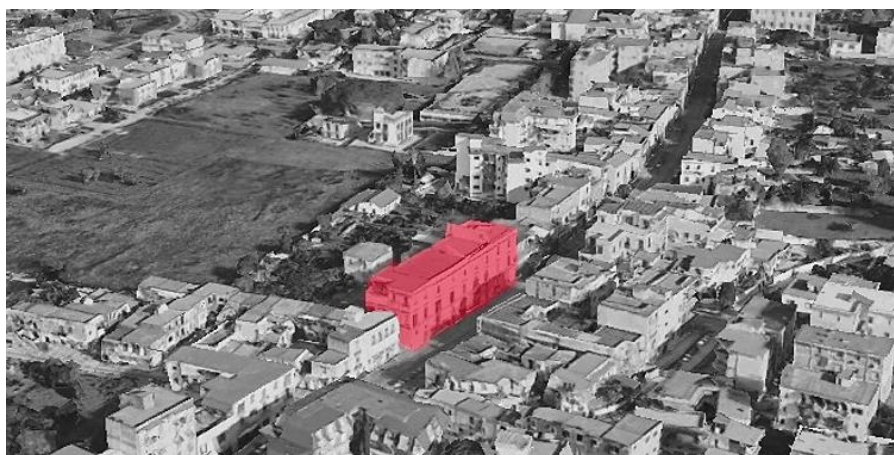
Figure 1. Identification of the case study building.

The reference building is an existing masonry aggregate (Figure 1) located in the municipality of Cercola, an urban district located within the province of Naples (Italy).

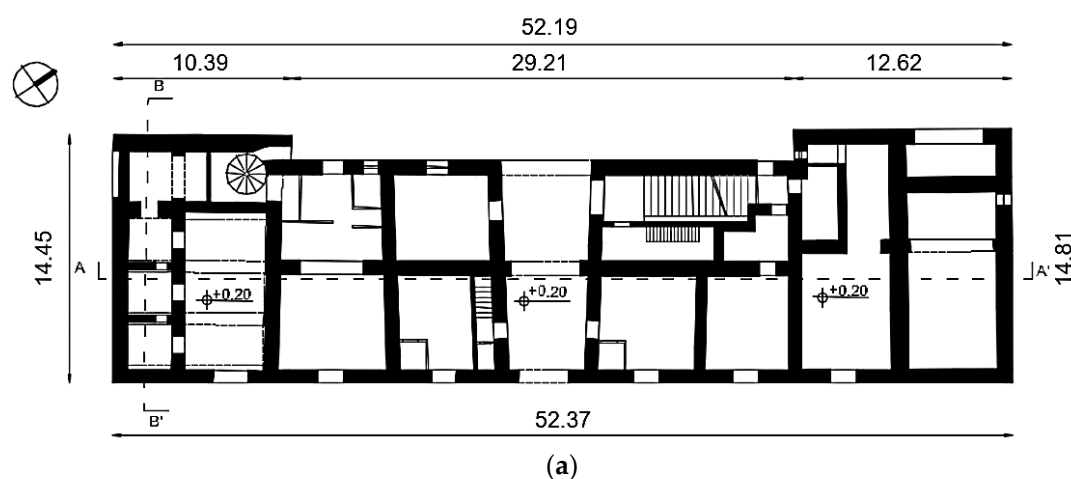
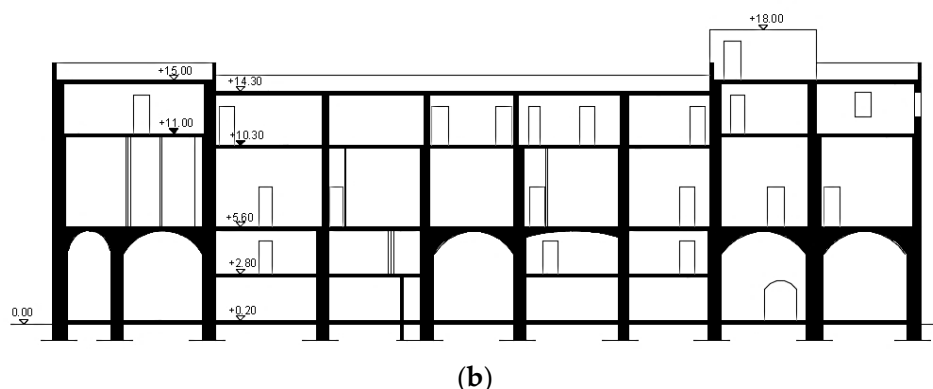
Figure 2. The masonry aggregate geometric configuration: (a) plan layout and (b) section A-A' (measurements in meters).

From a structural point of view, it is composed of 4 structural units mutually interacting, represented by two external cells occupying the head position and two internal ones placed in intermediate position), which spread over 3 floors above ground with an average inter-story height of 2.80 m. The masonry walls, characterized by Neapolitan yellow tuff stones, have an average thickness of 0.80 m at the ground floor and 0.50 m on the other floors.

The first level floors of the head structural units consist of masonry vaults, whereas the remaining floor systems are made of wooden structures simply supported to the walls. Besides, in the middle of the 20th century, new horizontal structures using steel beams were erected between the first and second floors of the intermediate SUs. The geometric configuration of the examined clustered buildings is suitably reported in Figure 2.

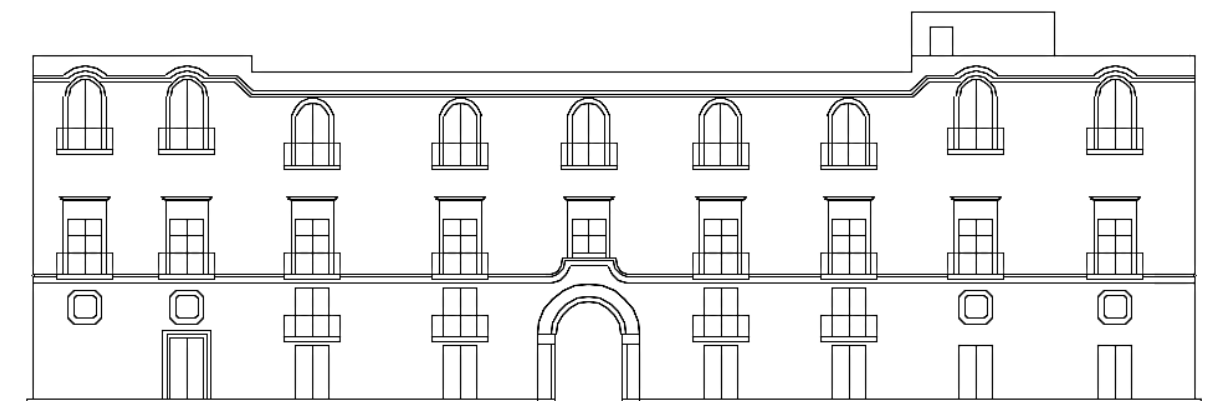
Figure 3. Building aggregate frontal view.

Figure 3 shows the external view of the main façade of the case study aggregate. In particular, there are shops on the ground floor, while the upper floors are used for residential purposes.

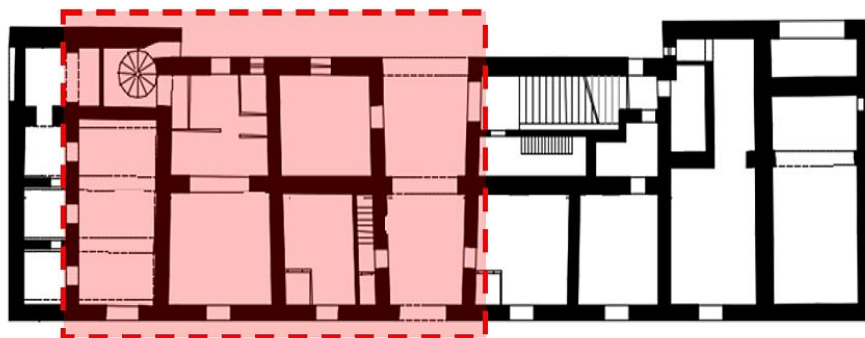
Figure 4. Intermediate structural unit in aggregate condition.

Three different case studies were analysed to estimate the influence of mutual interaction among adjacent structural units: (i) the whole aggregate (see Figure 2a); (ii) the intermediate structural unit (see Figure 4); (iii) the heading structural unit (Figure 5). Furthermore, the same structural units were also studied in isolated configurations, as reported in Figures 6 and 7.

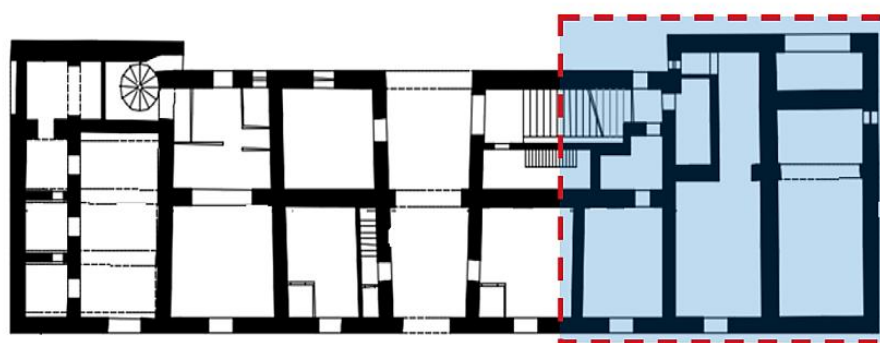
Figure 5. Heading structural unit in aggregate condition.

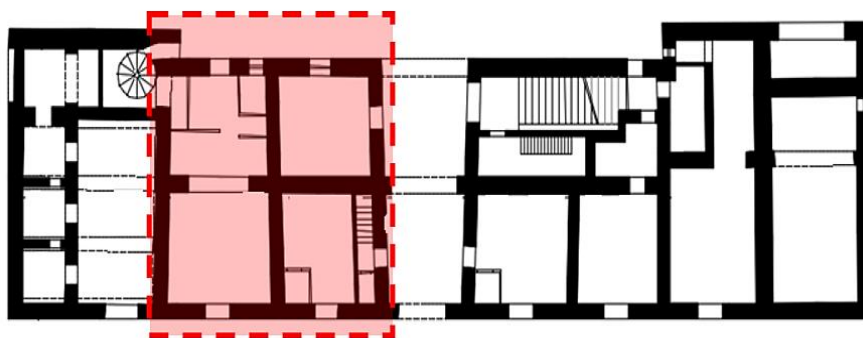
Figure 6. Intermediate structural unit in isolated condition.

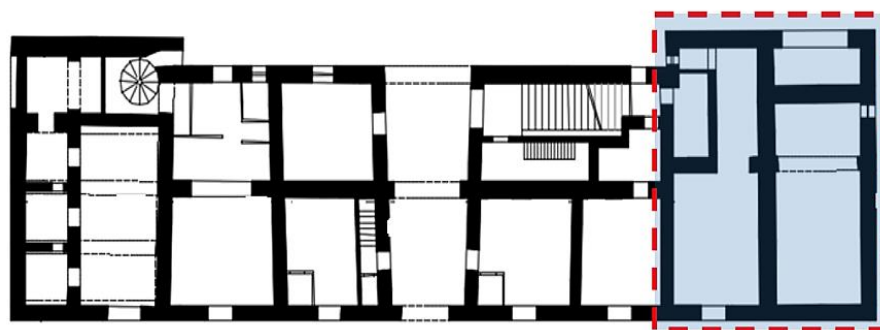
Figure 7. Heading structural unit in isolated condition.

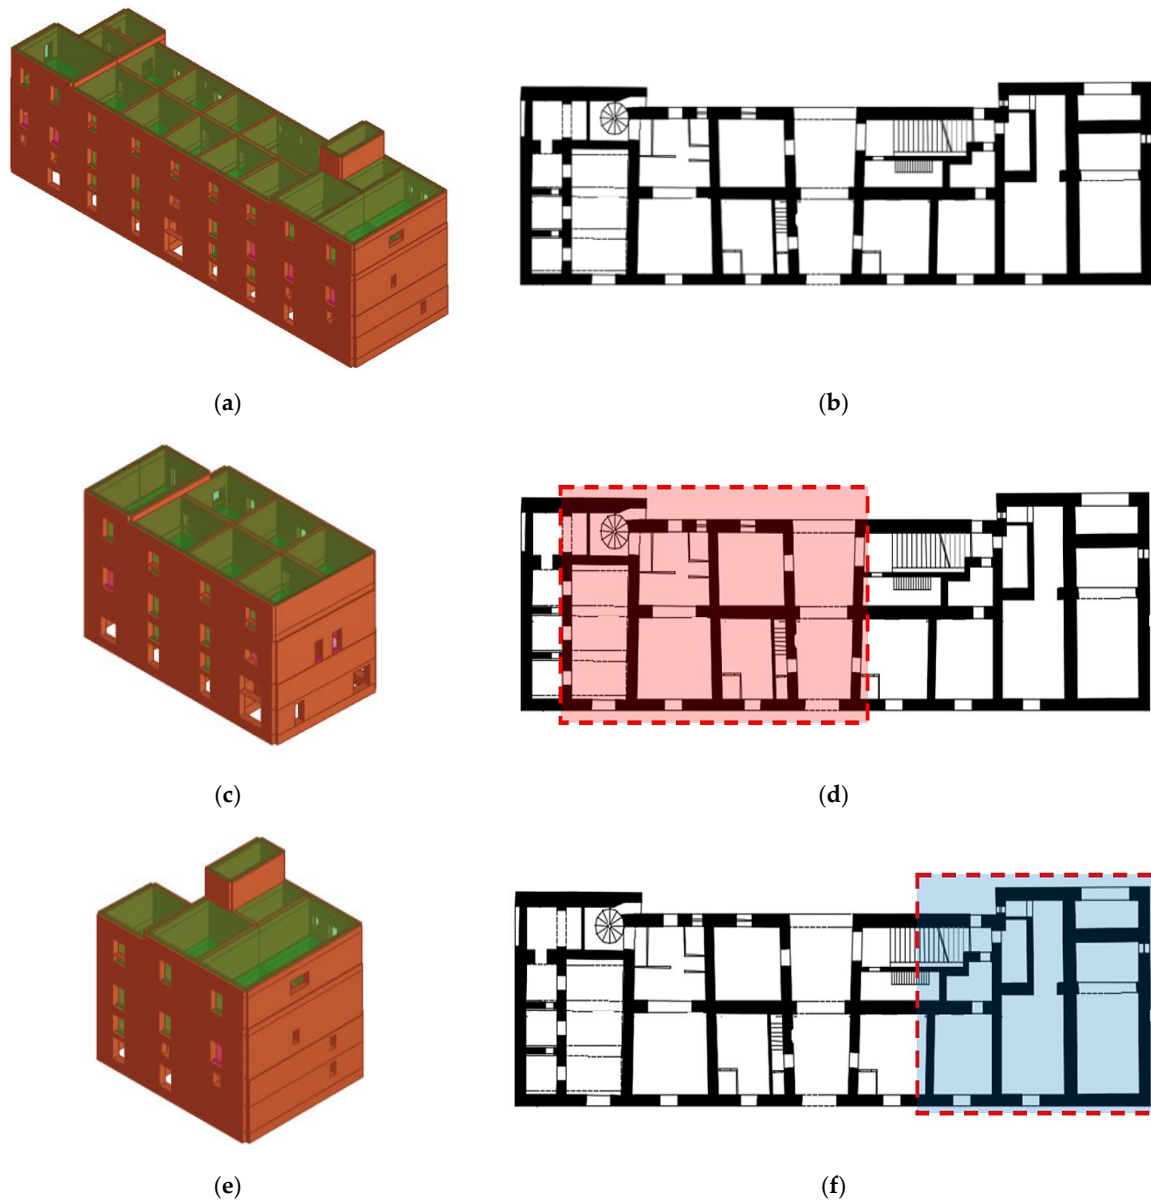
Figure 8. Numerical model of the case study buildings: (a,b) whole aggregate; (c,d) intermediate S.U.; (e,f) head S.U.

In Figure 8, the structural models of the whole masonry aggregate (see Figure 8a,b) and the corresponding intermediate (Figure 8c,d) and heading (Figure 8e,f) SUs were depicted. It is worth highlighting that, to consider the confinement effect of the structural units contiguous to the reference one, both intermediate and heading SUs were modelled considering half part of adjacent structural cells accounting for their contribution in terms of stiffness and mass.

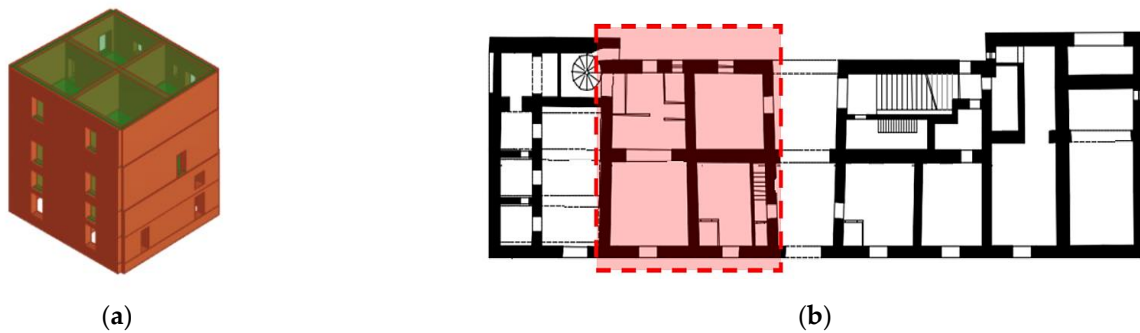
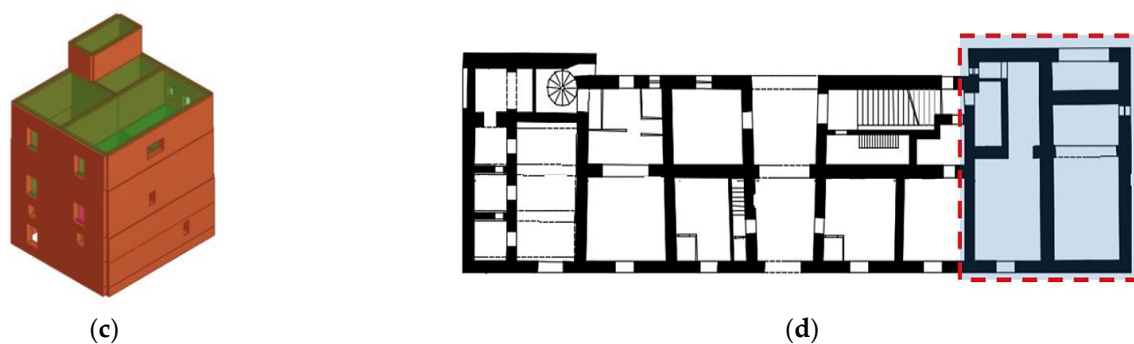
Figure 9. A numerical model of the isolated S.U. located in the intermediate (a,b) and head (c,d) positions.

Simultaneously, the previously mentioned structural units were also analysed in isolated conditions to estimate their global seismic response compared to that of SUs placed in clustered conditions. These structural models are presented in Figure 9.

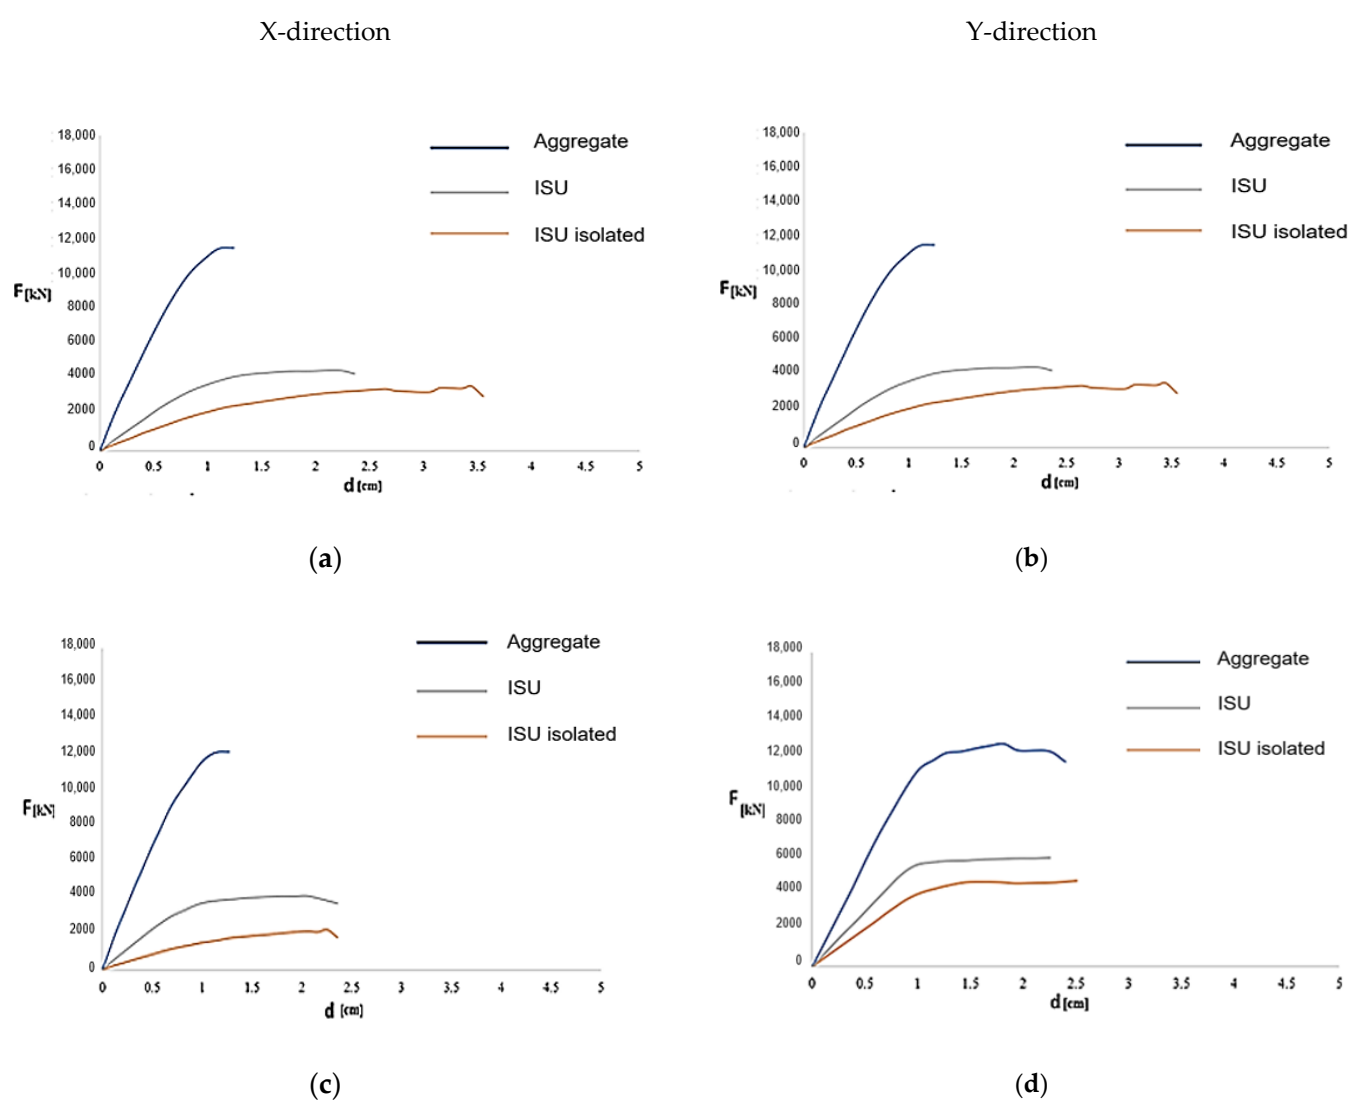
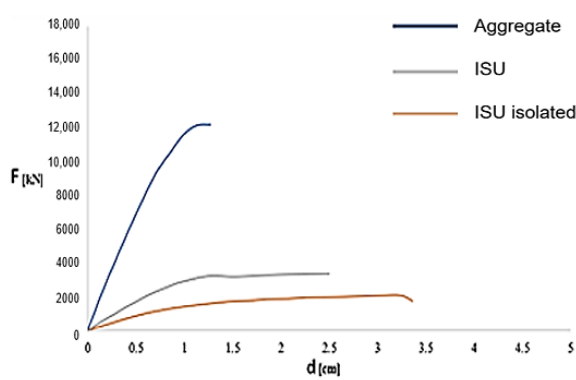
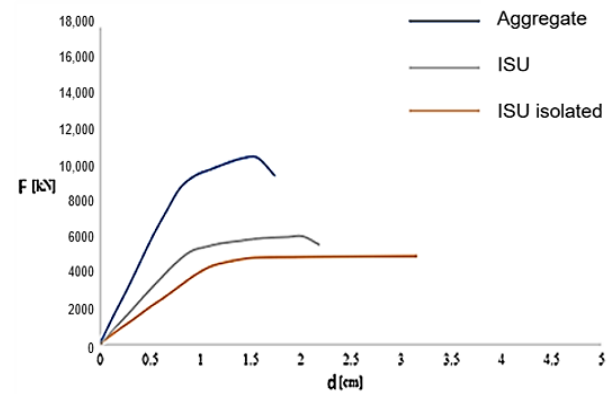
Figure 10. Pushover curves of the worst analysis scenarios for the whole aggregate (a,b), the intermediate structural units in aggregate (ISU) (c,d), and the isolated (ISU isolated) (e,f) configurations.

Figures 10 and 11 show the comparison in terms of pushover curves between the entire aggregate and monitored SUs, respectively the intermediate structural unit (ISU) and heading one (HSU), in both structural configurations (isolated and aggregate).

In general, from the obtained results, it was observed that strength and stiffness increase proportionally passing from the SU placed in isolated condition to the corresponding one grouped in aggregate. In contrast, the structural ductility offered by the structural system in isolated conditions is more accentuated compared to the estimated ductility evaluated for the structural system in aggregate configuration.

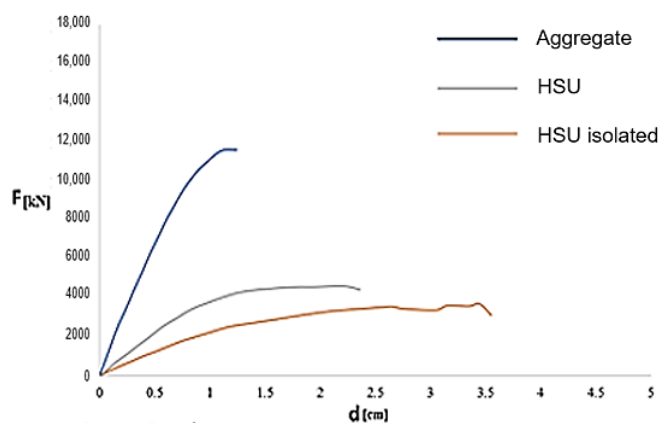
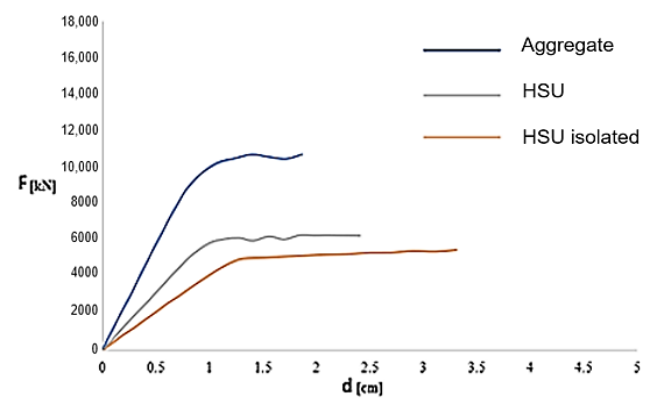
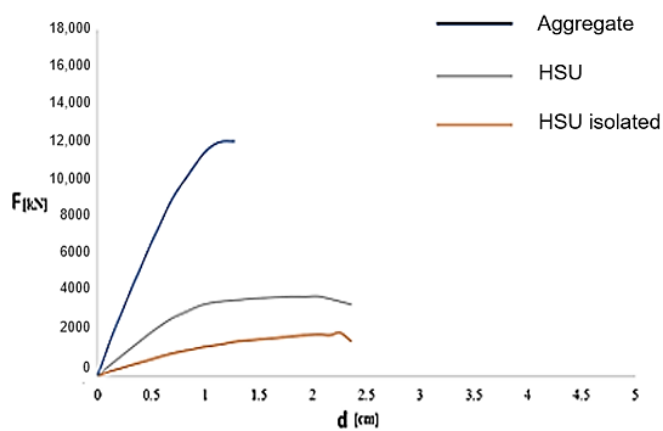
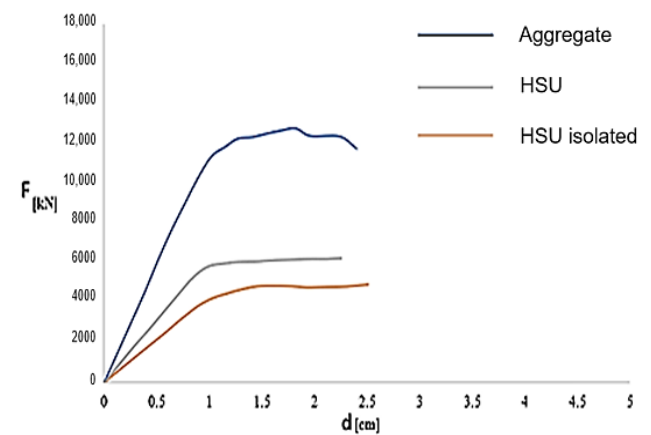
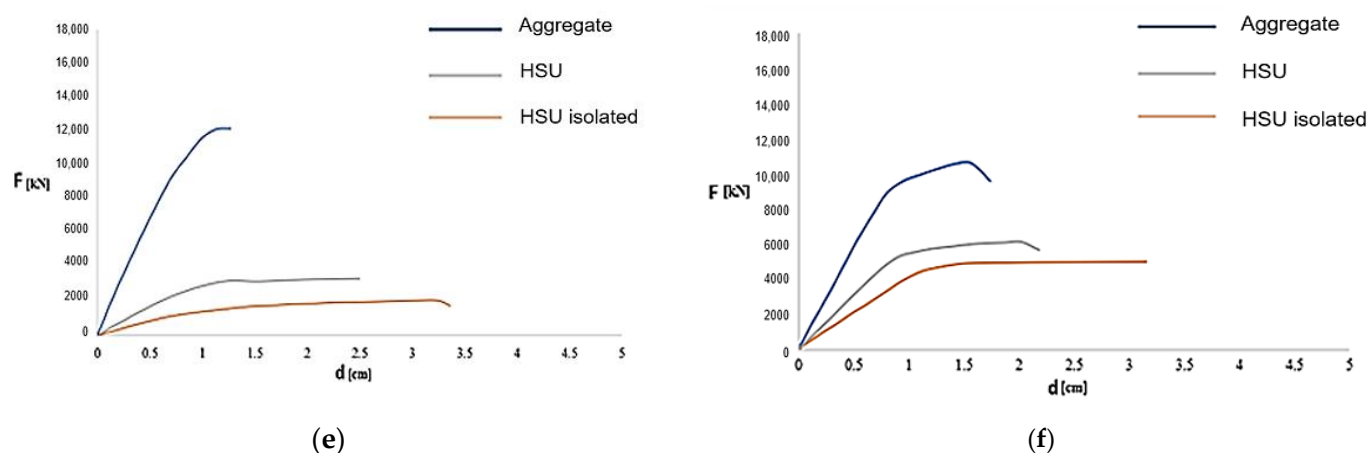
Figure 11. Pushover curves of the worst analysis scenarios for the whole aggregate (a,b), the heading structural units in aggregate (HSU) (c,d), and the isolated (HSU isolated) (e,f) configurations.

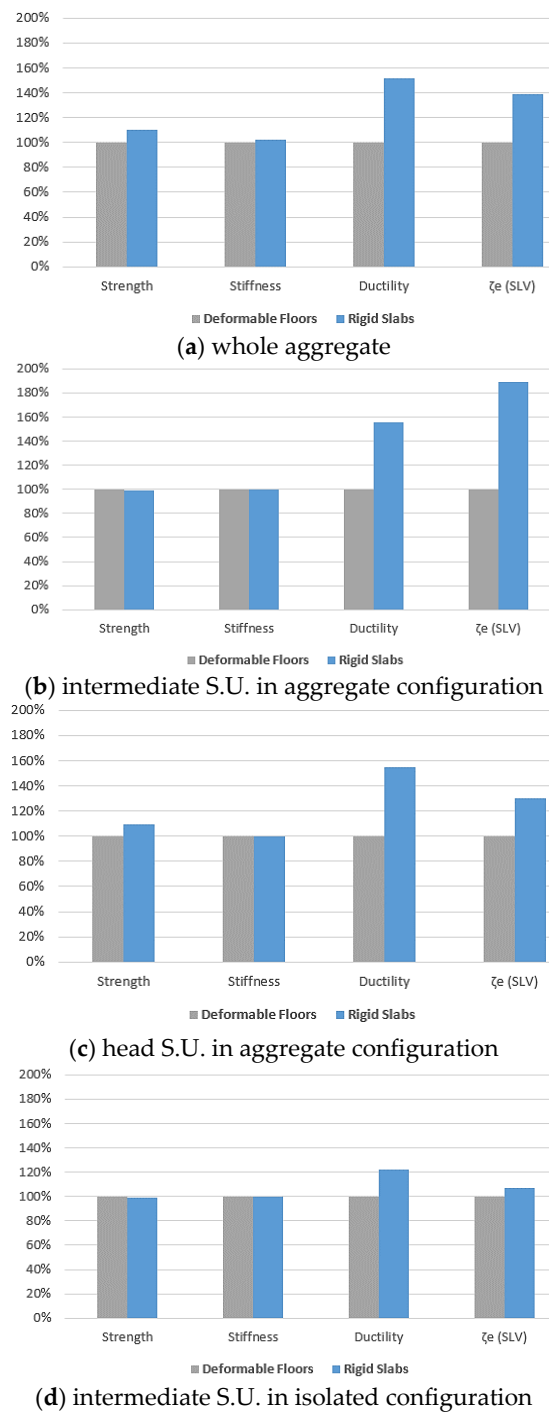
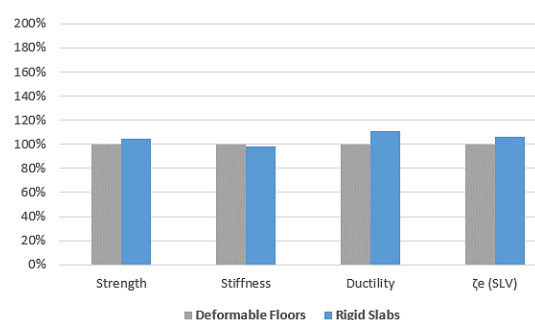
Figure 12. Influence of rigid floors on the seismic behaviour of the whole aggregate and the monitored S.U.s.

In Figure 12, the results obtained from using the two different types of floors are plotted and compared in terms of the strength, stiffness, ductility, and safety index.

From the results achieved, it was observed that, globally, the intervention proposed does not apport structural improvements in terms of strength and stiffness, but there is an appreciable increase of both the structural ductility and seismic safety factor for both the whole aggregate and the intermediate SU. Moreover, the proposed stiffening of floors also offers a noticeable increase of ductility and safety factor for the SU considered in the isolated condition.

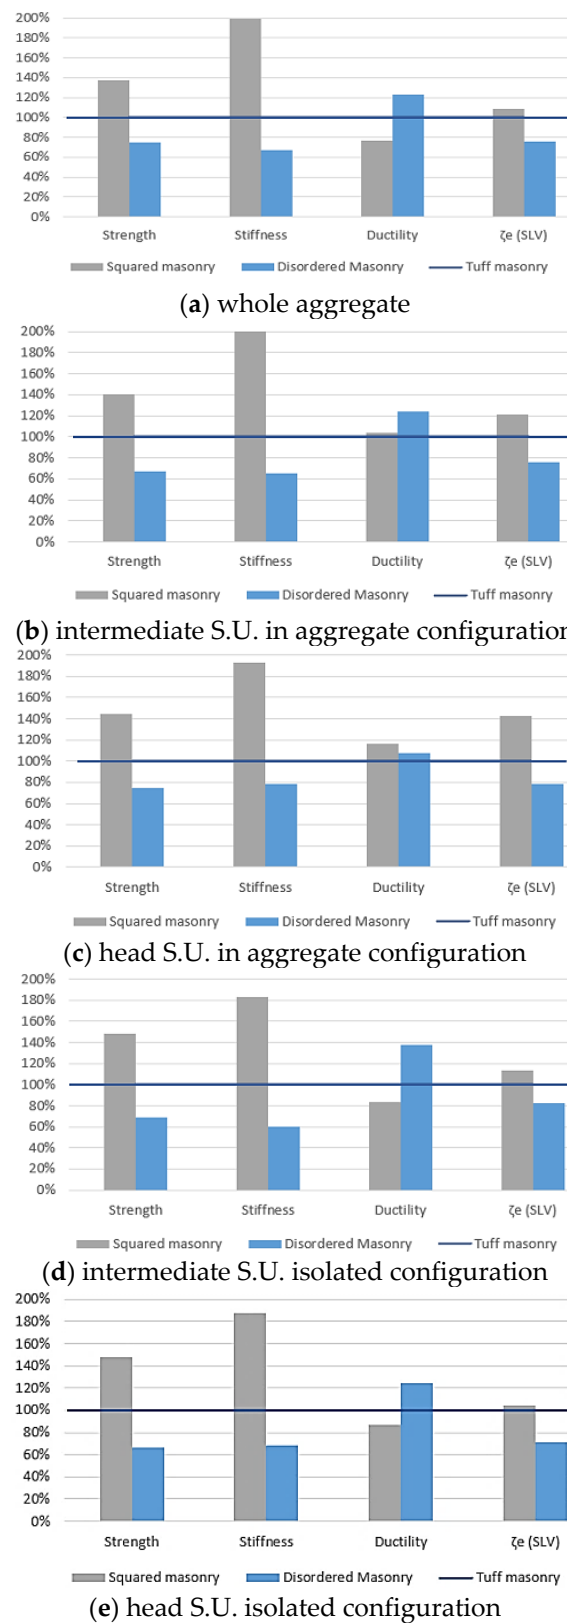
Figure 13. Influence of masonry types on the seismic behaviour of the whole aggregate and the monitored S.U.s.

The results of pushover analyses are presented in Figure 13 by comparing the performances of inspected buildings in terms of the strength, stiffness, ductility and safety index. In this figure, the horizontal blue line indicates the target attained by buildings made of the basic material (tuff stones) before the proposed interventions.

The results highlight how the use of good quality masonry provides an important increase in terms of resistance and stiffness rather than the structural ductility, which has

increased by 22% both for the whole aggregate and the head SU in aggregate condition and only by 10% for the intermediate SU placed in aggregate. Moreover, as expected, the characteristics in terms of the stiffness, strength, and risk factor are reduced considering the poor mechanical characteristics of the masonry.

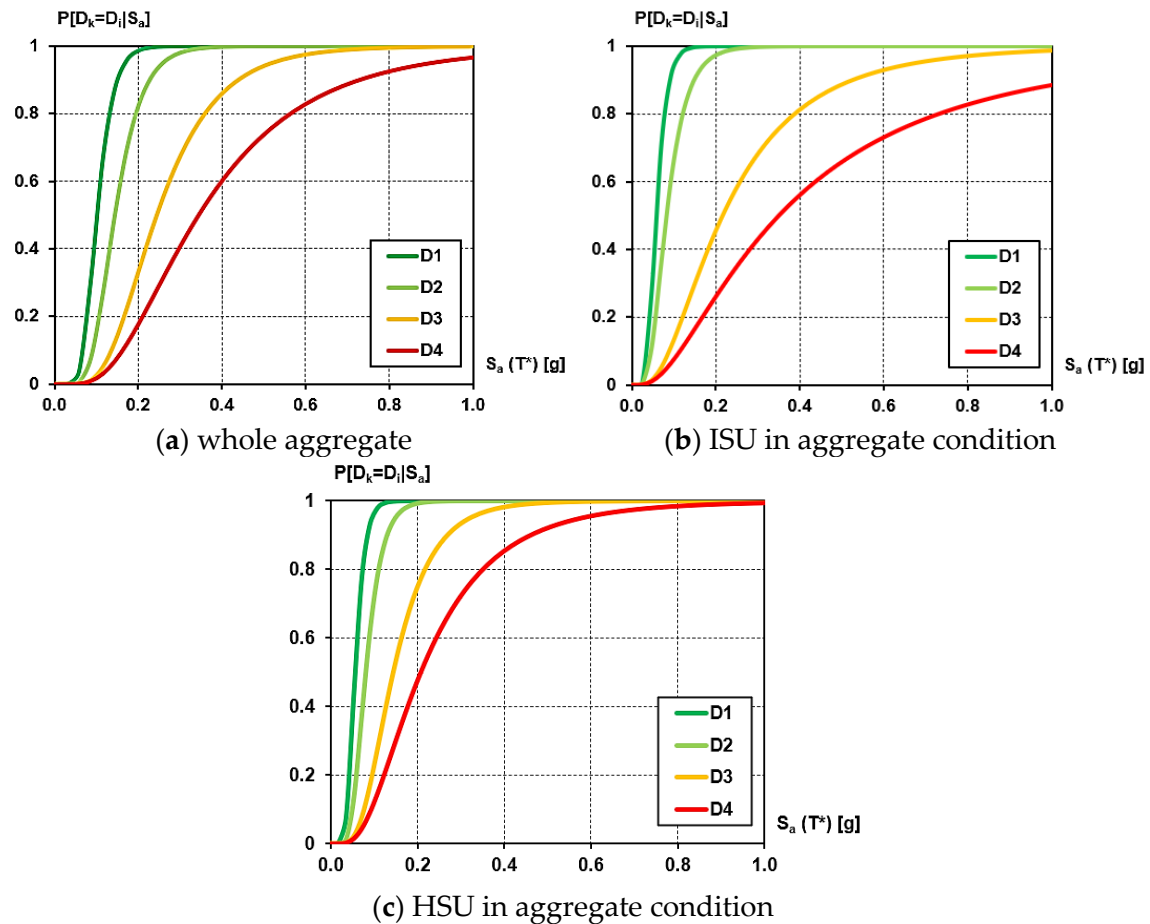
Figure 14. Typological fragility functions derived for the whole aggregate (a), the intermediate S.U. (b), and the head S.U. (c).

Based on these considerations, the typological fragility curves were plotted considering the most adverse structural analysis conditions, both for the existing whole aggregate and the other isolated and aggregated SUs, as reported in Figure 14.

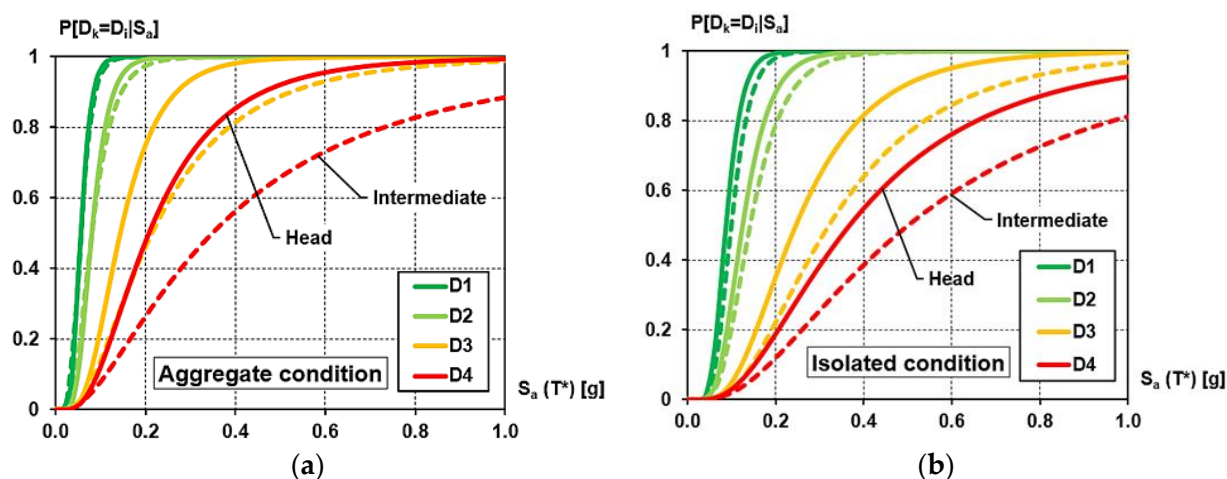
Figure 15. Comparison of fragility curves between intermediate and head S.U.s in aggregate condition (a) and isolated one (b).

As reported in Figure 15a, the HSU provides expected damage higher than the intermediate one. For the sake of example, it was noted that for $PGA = 0.2$ g, the damage thresholds D1 (slight) and D2 (moderate) for both SUs are comparable. Conversely, for $PGA > 0.2$ g, there is a marked difference between the expected damage level.

More in detail, for $PGA = 0.4$ g, referring to the damage threshold D3 (near collapse), the probability of damage associated to the HSU is 98%. Instead, for the ISU this damage probability reduces to 80%, with a damage percentage decrease of about 18%. On the other hand, considering the damage threshold D5 (collapse) and the $PGA = 0.4$ g, the ISU shows a percentage reduction of 41% compared to the corresponding HSU.

The same structural performance condition was also found by comparing the same SUs in the isolated configuration (see Figure 15b). In a general overview, by considering a $PGA = 0.2$ g, a D1 and D2 damage levels were found to be reached for the SUs monitored. However, considering an increase of the intensity measurement, for PGA equal to 0.4 g, it was possible to observe that for the ultimate limit state, D5, the HSU provides a probability of damage equal to 60%. Contrary, the ISU exhibits a percentage decrease of 42%, highlighting once again how it is less susceptible to damage than the HSU [27].

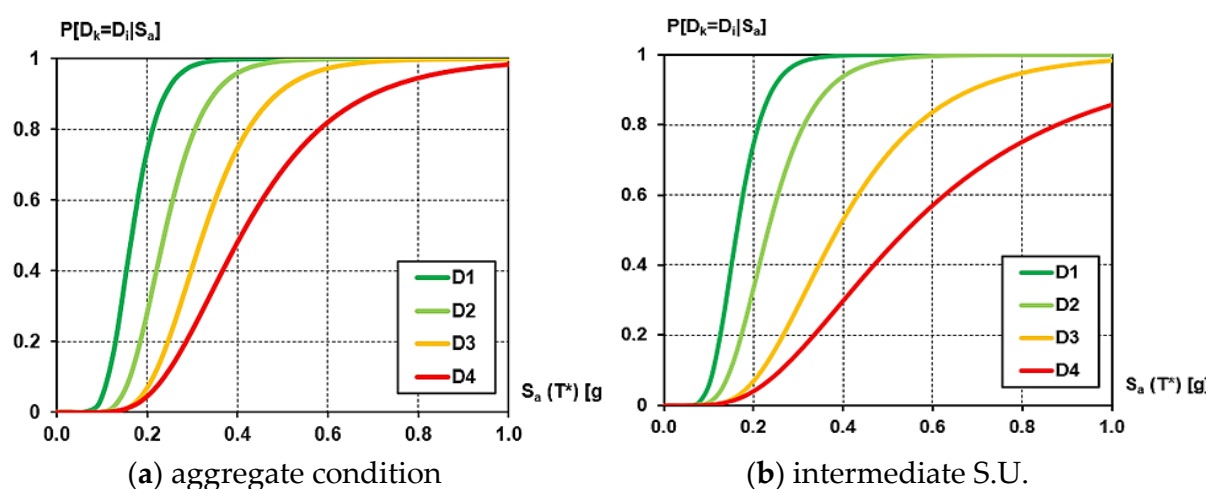
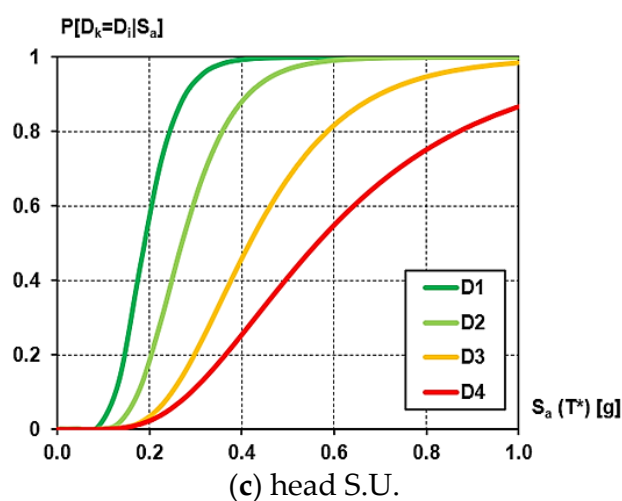
Figure 16. Fragility curves for the whole aggregate (a), intermediate S.U. (b), and head S.U. (c) after floor stiffening intervention considering the most unfavourable pushover case in each analysis direction.

Besides, the fragility curves were derived even for the retrofitted buildings by adopting rigid floors. The results are plotted in Figure 16.

The results achieved show a clear increase of the structural performance levels provided by all the monitored configurations examined (whole aggregate and two SUs). Specifically, by examining the performance thresholds obtained through the proposed strengthening interventions with those presented previously (see Figure 14), an improvement of the capacity response of the examined structural units was observed with a consequent reduction of the corresponding damage probabilities thresholds, DS_i .
