# Simulation of the Influence of Braking System Damage on Vehicle Driving Safety

Sławomir Kowalski

This article presents an analysis of the effects of braking system damage on the course of the vehicle collision and driving safety. Research was conducted using simulation methods in the V-SIM 7.0 environment, analysing the collision between a car and a truck at three speeds—50, 60, and 70 km/h—under the assumption of a braking system malfunction in the car. The obtained results showed that as the speed of the truck increased, the total kinetic energy of the system nearly doubled, resulting in deformation of the vehicle's body front of up to 0.6 m. The maximum force acting on the car decreased with increasing speed, which was due to the change in the point of impact. The recorded acceleration values of the car indicate a moderate level of overloads, which should not cause serious injuries to the passengers but do suggest significant stress on the vehicle's load-bearing structure. The research may serve as a foundation for further work on braking system diagnostics, the development of friction materials, and the modelling of energy absorption processes in collisions involving vehicl

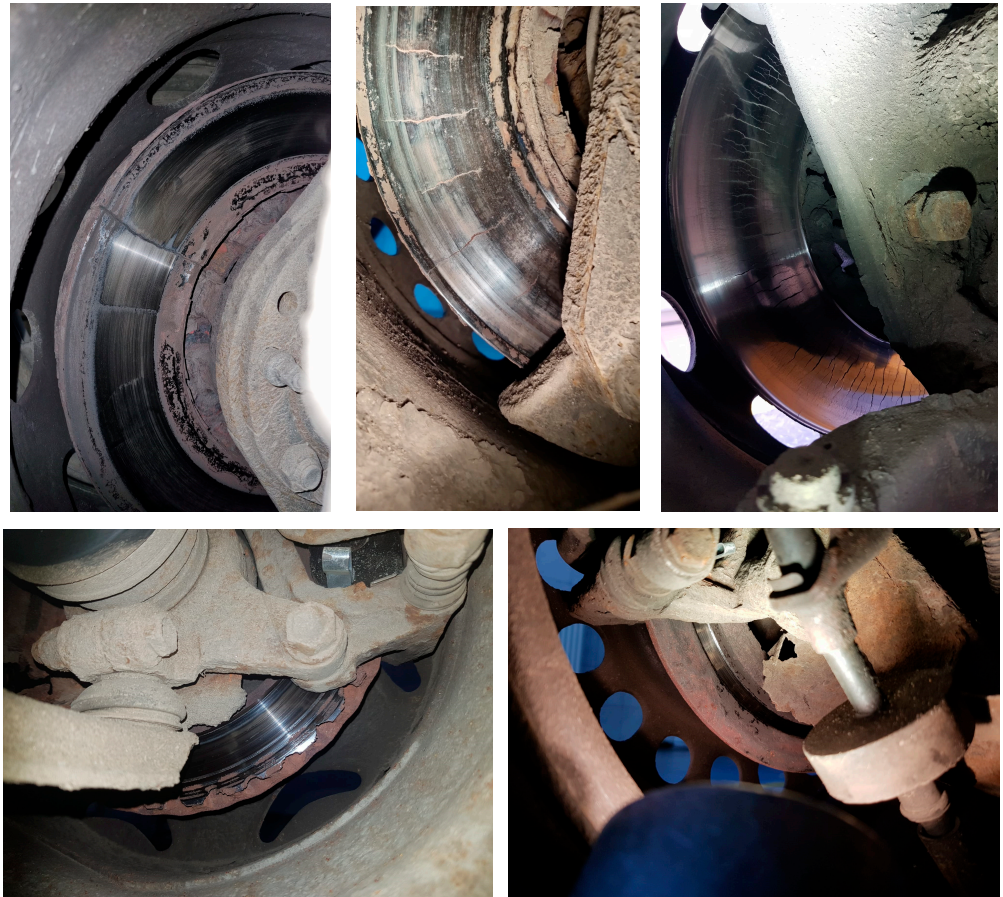
Figure 1 illustrates examples of braking system component damage, observed at a diagnostic station during technical inspections. Long-term observations of customer vehicles at the diagnostic station indicate that brake disc cracking is the most prevalent issue.

**Figure 1.** Examples of braking system component damage.

Drivers were often unaware of the damage and continued to operate their vehicles until the next technical inspection, which led to the development of additional fatigue cracks. Fortunately, no complete disc cracking occurred, avoiding potential road accidents caused by impaired braking performance. These vehicles were not allowed to continue operation until the cracked or otherwise damaged discs were replaced.

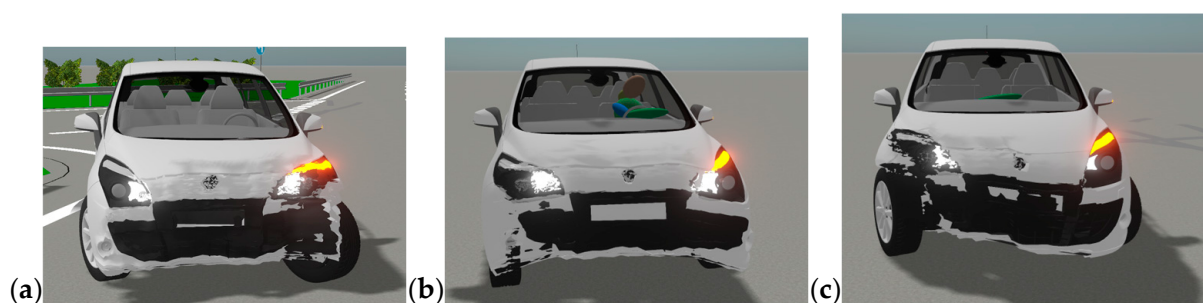
**Figure 9.** Damage to the car after collision with the truck: (a) truck speed—50 km/h, (b) 60 km/h, (c) 70 km/h.
