# Zn-Pb Dumps, Environmental Pollution and Their Recultivation, Case of Ruda Śląska-Wirek, S Poland

**Abstract:** This article describes the results of a study on the Zn-Pb heap, which is located in the center of the city of Ruda Śląska. The heap dates back to the 19th century but was rediscovered in the 21st century and abandoned. Located in the center of the city, it is eroded and contributes to the spreading of pollutants. The authors performed a study on the components of the dump using microscopic observations and geochemical analyses. The results indicate that the components of the heap are mobile, mainly due to the infiltration of meteoric waters affecting the contamination of soils and plants. The present work is devoted to a review of the state of the environment in the area of the heap and a proposal for its reclamation by covering it with an isolation layer or moving it to a protected place away from the city center. It is possible, in the future, to build an Environmental Education Center, for education and the monitoring of environmental problems in Upper Silesia.

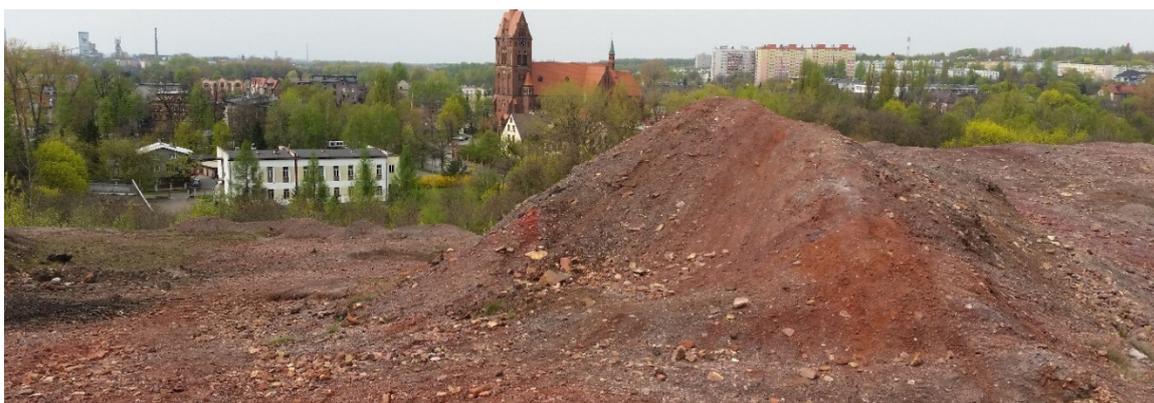
**Figure 1.** Landscape of an exposed heap in the center of the city of Ruda Śląska.

The conditions of the heaps in question vary. Located north of Nowara Street, the smaller heap is overgrown with vegetation, has developed mulch and shows no secondary changes (on the surface). The southern heap in question is in a much worse condition due to its stripped surface and partially exposed profiles and poses a major threat to the surrounding environment [9–24]. The subsections below cite the results of the analyses of slag, soil and plant samples taken from the southern heap.

The surface of the heap in question was exposed due to mining operations. Soil has not yet covered its full volume. Usually, some accumulation of dusty fraction substances can be found on the open surface, occurring as a result of airborne (wind) transfer or as a result of snow nivation. In some places, patches of carried soil were preserved for protection. Initial soil formed by the crumbling of heap components is currently forming in many places, as confirmed by microscopic observations and the characteristic brick-red color of this soil. Analysis in the micro-area showed that they are analogous or homogeneous with the heap components. There are grains of quartz, feldspar, clay substances, carbonates and sulfates (including barite); admixtures of oxides and hydroxides of iron and manganese; and numerous metal elements such as zinc, lead and copper titanium (Figure 7, Table 2).

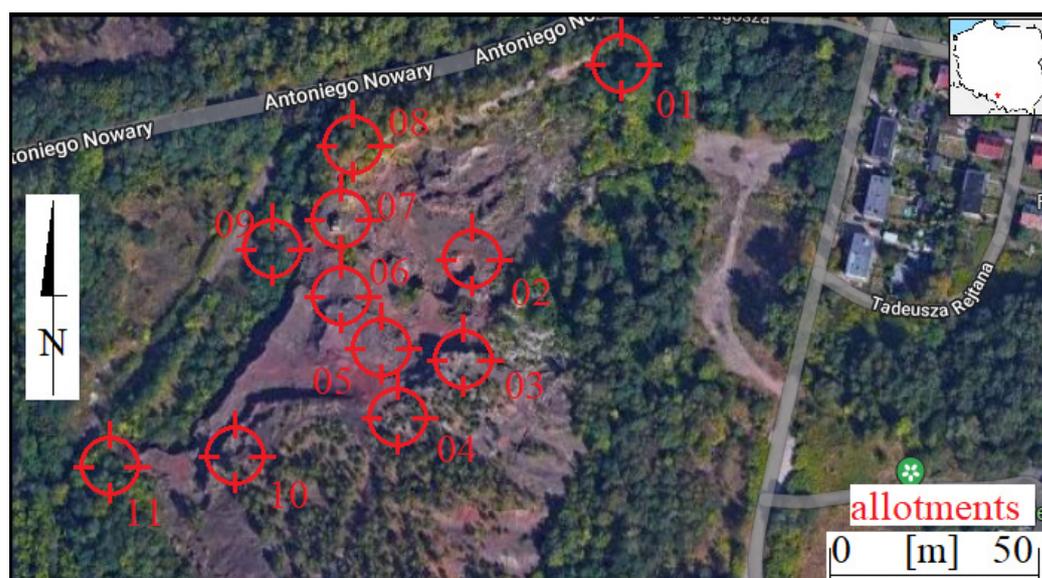
**Figure 2.** Location of sampling points for heap, soil and plants (on Google Maps).

The heap in question is located in the area of Nawara Street and is situated in such a way that the street cuts the heap into two parts (Figure 2). The entire area under study is an approximate rectangle measuring  $320 \times 500$  m. The northern part of the heap is currently covered with forest. The height of the trees there reaches 50 m. They are mainly common birch (*Betula pendula* Roth), common maple (*Acer platanoides* L.), ash maple (*Acer negundo* L.) and robinia (*Robinia pseudoacacia* L.). The southern part is only partially overgrown, adjacent to the street. Further away, behind a small ditch, there is an exposed heap (Figure 2). Samples for the study were collected in the area of the southern heap, where there are walls with an exposed, visible profile of the heap. Although the heap in question was mainly built in the 19th century [7], a detailed analysis of it indicates that younger waste including modern garbage is also present. At present, the heap is surrounded by buildings including residential houses; in some cases, local people in close proximity to the heap have cultivated gardens; and on the heap itself, wild resting places for the public are visible (traces of bonfires and bicycle and motocross “paths”). In some places, the heap is overgrown with sparse vegetation (self-sown trees), mainly common birch (*Betula pendula* Roth) [8].

The samples were taken in the southern heap at Nowara Street. The focus was on sampling open exposures in the heap that resulted from its stopped mining (points 02–04, Figure 3B,C). These sites contained fresh exposures of heap material. They also allowed

for the possibility of reviewing the vertical profile of the heap. Other sampling sites were located at the top of the heap (points 05, 06). At the top of the heap, perennial processes and plant succession were observed (Figure 3D). Samples were also collected in the periphery of the heap (points 01, 07–11, Figure 3A).

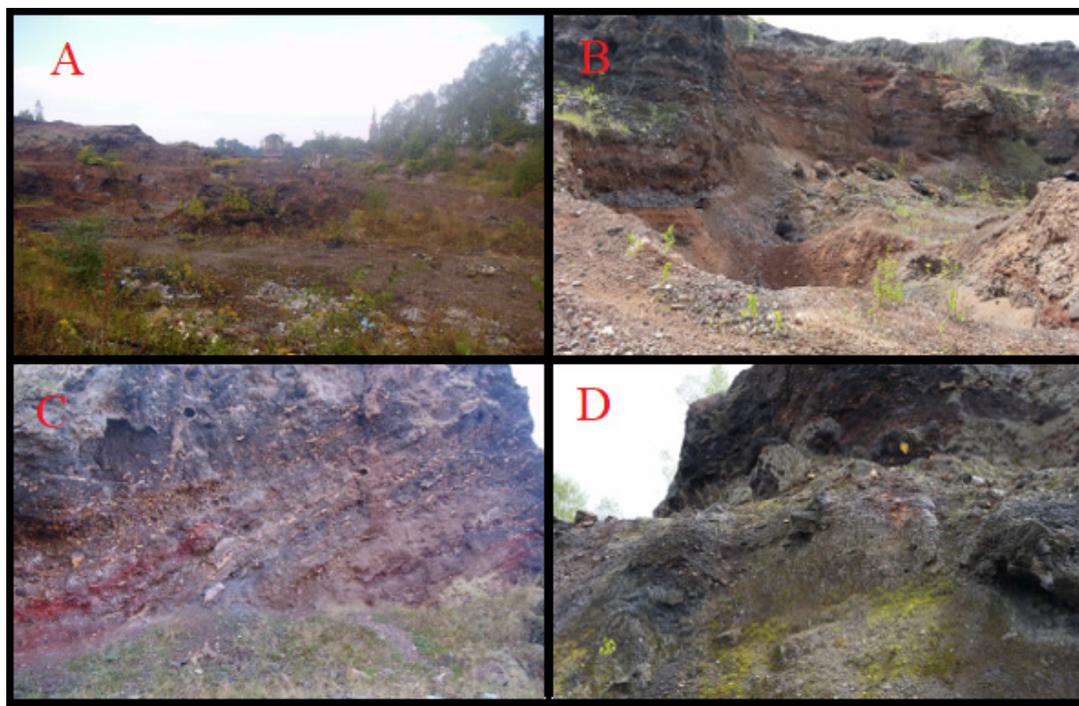
**Figure 3.** Photo documentation of the condition of the heap at the time of the survey: showing the exposure of the heap (A), its layered nature (B), fragments of ceramic metallurgical elements (C), mosses and lichens on the heap (D).

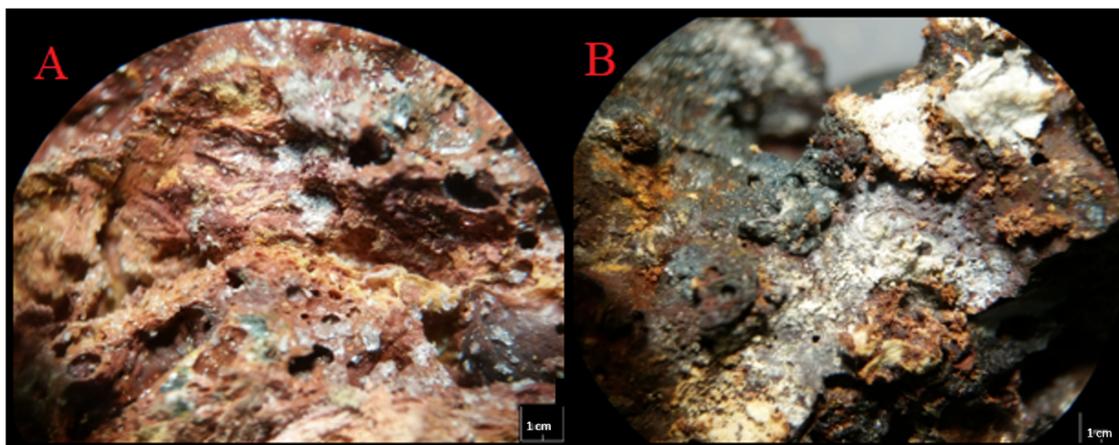
**Figure 4.** Examples of binocular magnifying glass microphotographs showing slag from the heap with visible enamel fragments (A) and precipitates (B).

Detailed studies of the heap profiles indicate that they contain slag formed as waste during the processing of Zn-Pb ores [8,25]. It now forms a compacted material and is mixed with the ceramic lining of the furnaces. Other waste associated with economic activities, such as coal and ash fragments, are also present. Macroscopically, the material is highly porous, spongy and brick-red in color. It has a varying degree of devitrified enamel with numerous bubbles in which air is generally present. Examination with a magnifying glass indicated that in some cases fragments of sulfides are embedded in the glaze, probably representing ore that was not completely melted in the smelting furnace. In the microscopic image, the heap material is a heterogeneous assemblage of mixed waste containing vitrified varieties of slag, residual ore minerals and new phases formed as a result of high-temperature processes in the blast furnace process, as well as secondary phases formed after the heap was deposited by water infiltration (Figure 4). Due to the highly porous nature of the slag and the heterogeneity of the heap, the sulfide minerals there represent different degrees of liberation. In the intact zones, this factor is relatively small, while it increases significantly in the zones of secondary fractures and cracks, where rainwater can freely migrate. There, precipitates of secondary phases (sulfates, carbonates and complex compounds) are formed. Due to the unstable nature of the subsoil (mining movements) and the partial mechanical exposure of the heap, there is a high risk that metal ions may be released throughout the area, increasing the coefficient of liberation.

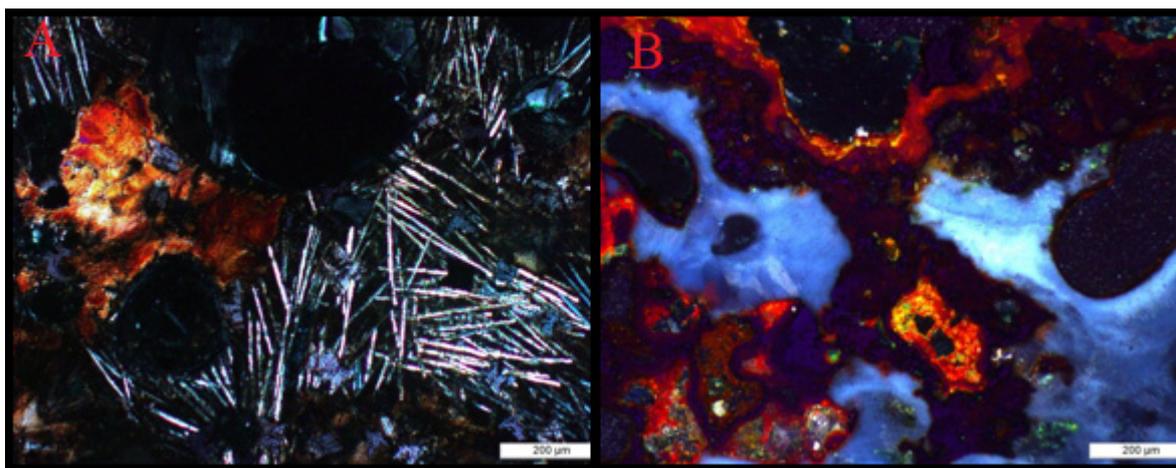
**Figure 5.** Microphotographs of slags with visible devitrified glaze (A) and iron oxides and hydroxides located in the background of the glaze and voids (B).

In the slag material, pyroxenes and melilites can be identified, which were formed by annealing processes on the material. Glaze samples have a radial texture, resulting from devitrification processes and the presence of crystallites. They are highlighted by the presence of hematite and goethite, forming rims around the slag glaze. These minerals also surround the ore grains (galena, sphalerite, pyrite). The void zones contain secondary minerals classified as sulfates and oxides that form druse, radial structures, filling the voids in question (Figure 5). These minerals crystallized due to the migration of aqueous solutions, penetrating the material in question.

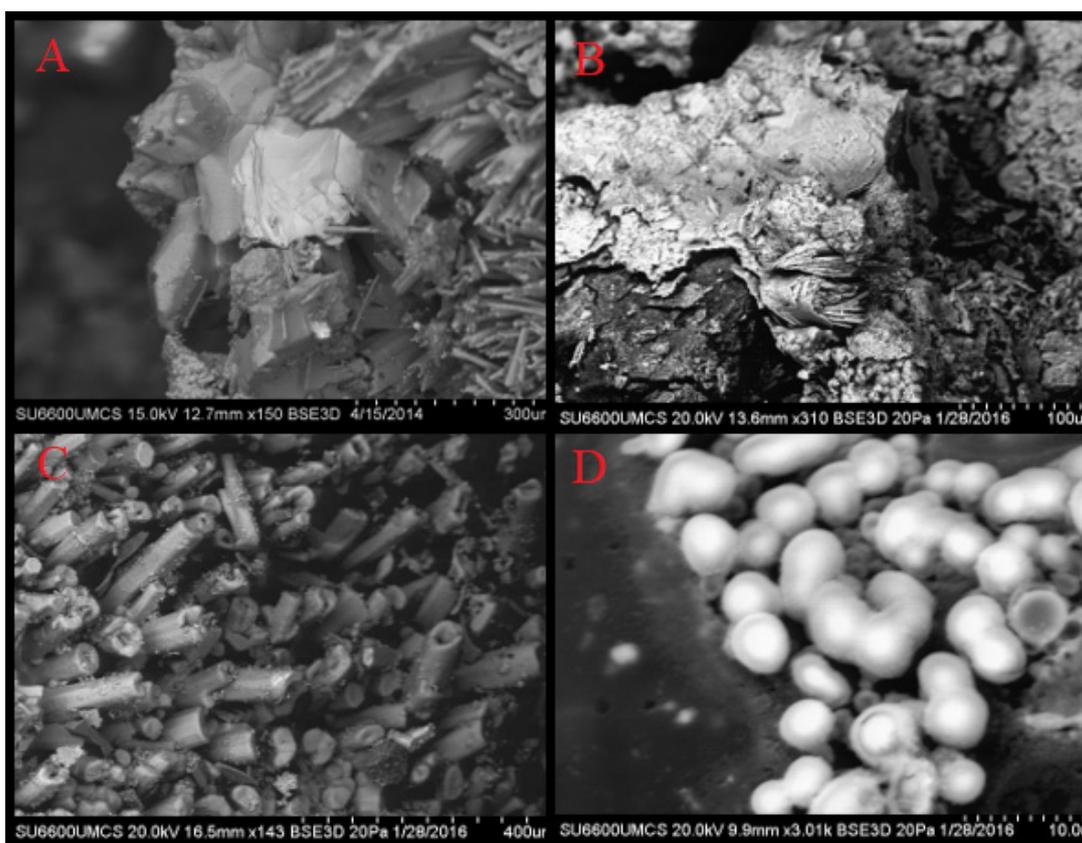
**Figure 6.** Backscattered electron (BSE) microphotographs showing the structure of the slag and the phases present: iron oxides and carbonate needles (A), copper, zinc and iron sulfides (B), gypsum crystals (C) and iron and zinc alloys (D).

The micro-area studies were directed at tracing the phases involved in glaze devitrification, as well as identifying ore minerals and derived products associated with the migration of meteoric water in the slags in question. These studies have identified a certain diversity in these substances. Metals such as Zn and Pb with admixtures of Cu; Ti; and also Ni, As and Cd were found in these samples. Silicates were found in the glaze; they also formed their own phases, such as pyroxene and melilite. They were also accompanied by zinc silicates such as wilemite. In the case of ore minerals, mainly sulfides, such as pyrite, chalcopyrite, galena, sphalerite (or wurtzite), were found, which were concentrated in the form of intrusions and epidotes within the slags (Figure 6). In addition to these minerals, metal alloys (mainly iron with admixtures of tin, zinc, copper) and polymetallic intrusions with lead, arsenic and cadmium in amounts sometimes reaching up to 30% by weight were found in the discussed minerals. Sulfates, carbonates and oxides were found in voids and efflorescence. Sulfates are mainly represented by gypsum (or barite) and carbonates by calcite. In addition to calcite, cerusite and smithsonite were also identified. Oxides of barium, zinc, lead and iron were also found located in the pores of the slags. In addition, as a result of the interaction of the solutions in the slag samples in question, complex compounds were formed, accompanying the phases in question. Along with the presence of hematite accompanied by iron hydroxides, becherite  $((\text{Zn,Cu})_6\text{Zn}_2(\text{OH})_{13}[(\text{S,Si})(\text{O},\text{OH})_4]_2)$  was also found. These phases generally form epidote and efflorescence in the migration zones of water infiltrating the heap.

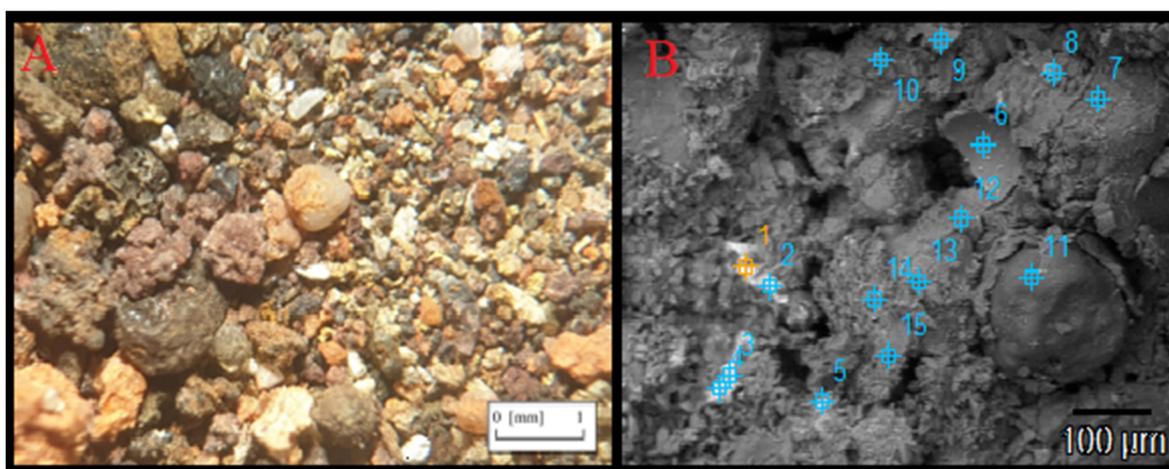
**Figure 7.** Microphotograph under reflected polarized light showing the grains of the initial soil taken from the heap (A) and microphotograph BSE of the soil sample with the points of microanalysis (B).

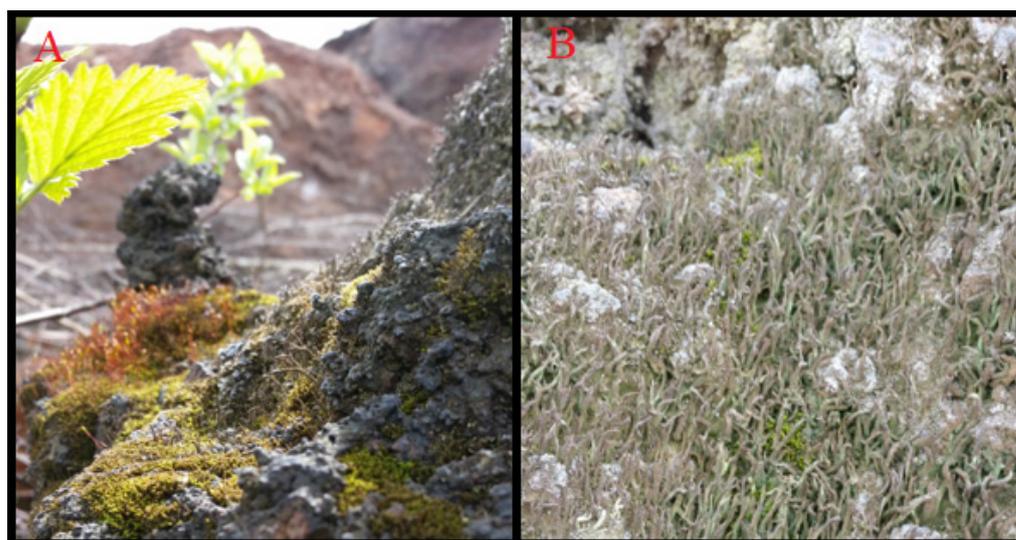
**Figure 8.** An example of firefly moss (*Polytrichum commune Hedw.*, **A**) and lichen (*Cladonia sp.*, **B**) growing on a heap.

Shrubs and tree seedlings usually utilize crushed material and accumulations of dusty substances; their root system also takes advantage of cracks in the heap, formed due to uneven ground settlement, and its destabilization as a result of mining and exposure of batches of heap material. In the course of the field survey, samples of firefly moss (*Polytrichum commune Hedw.*) were taken from 10 sites, as well as lichen (*Cladonia sp.*) and the leaves of the common birch (*Betula pendula Roth*) at one site (Figures 2 and 8).

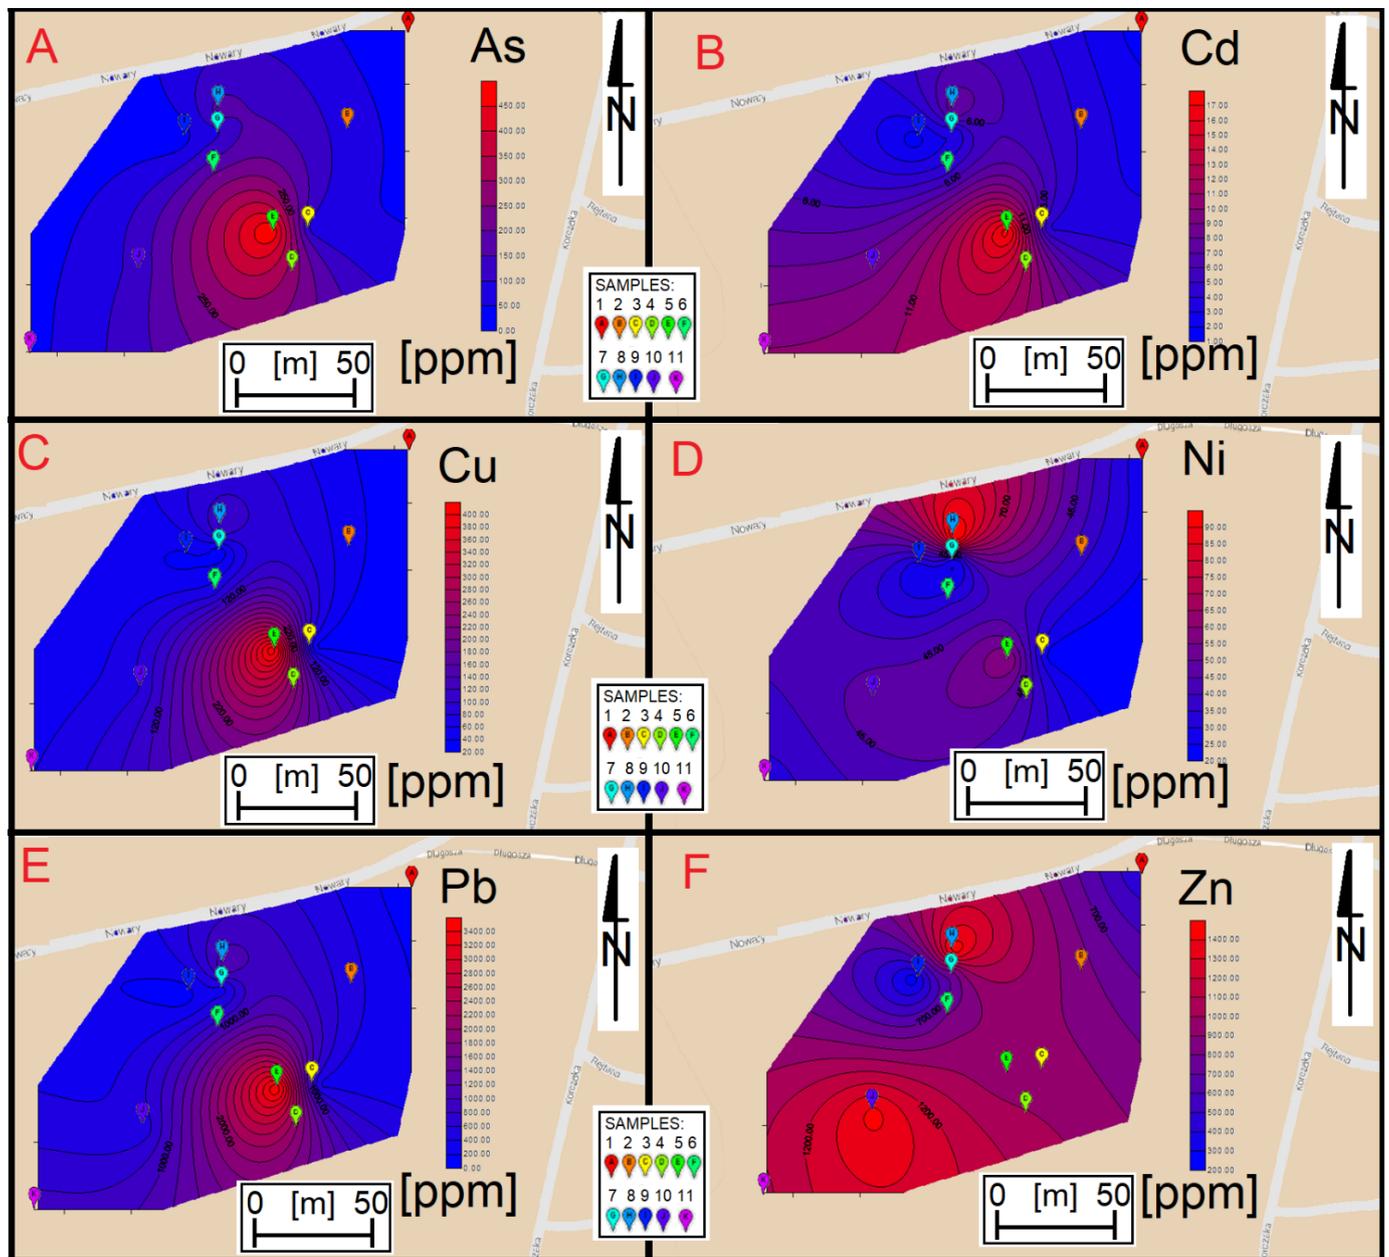
Figure 9. Maps showing the distribution of heavy metal elements in the heap area Maps were made respectively for: arsenic (A), cadmium (B), copper (C), nickel (D), lead (E) and zinc (F).

The distribution of heavy metal elements on the surface of the slag heap is not uniform. In the case of As, Cu, Cd and Pb, it can be concluded that the highest concentrations of these elements are located in the central part of the heap (Figure 9). The distribution of Ni shows higher concentrations in the vicinity of Nowara Street and, to a lesser extent, in the south of the heap. The same is true for zinc [38].
