Effective Parameters on the Wear Behavior of High-Pressure Grinding Rolls and the Development of the Process for Iron Ore

Ali Tahaei ^{1,*}, Ehsan Fadaei ², Farzin Ghadami ³

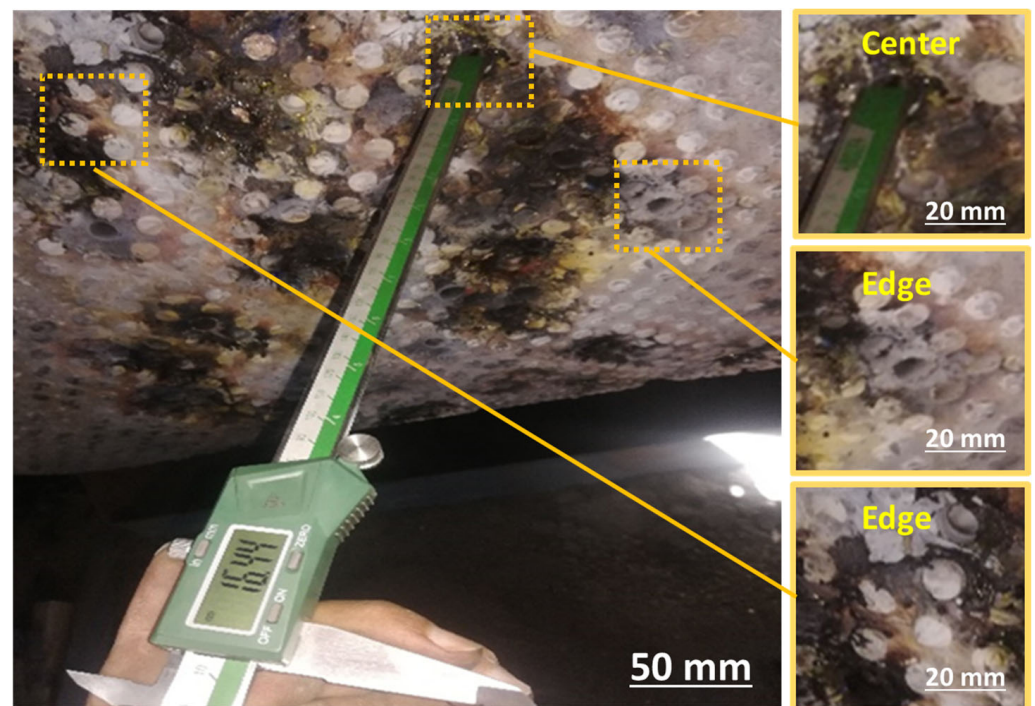
each stud has a diameter of 16 mm and a height of 45 mm, of which 5 mm protrudes above the tire surface, while the remaining 40 mm is embedded within the tire (Figures 3 and 4).

Figure 3. Tire shell thickness at the center and edge of the roll for stud placement.

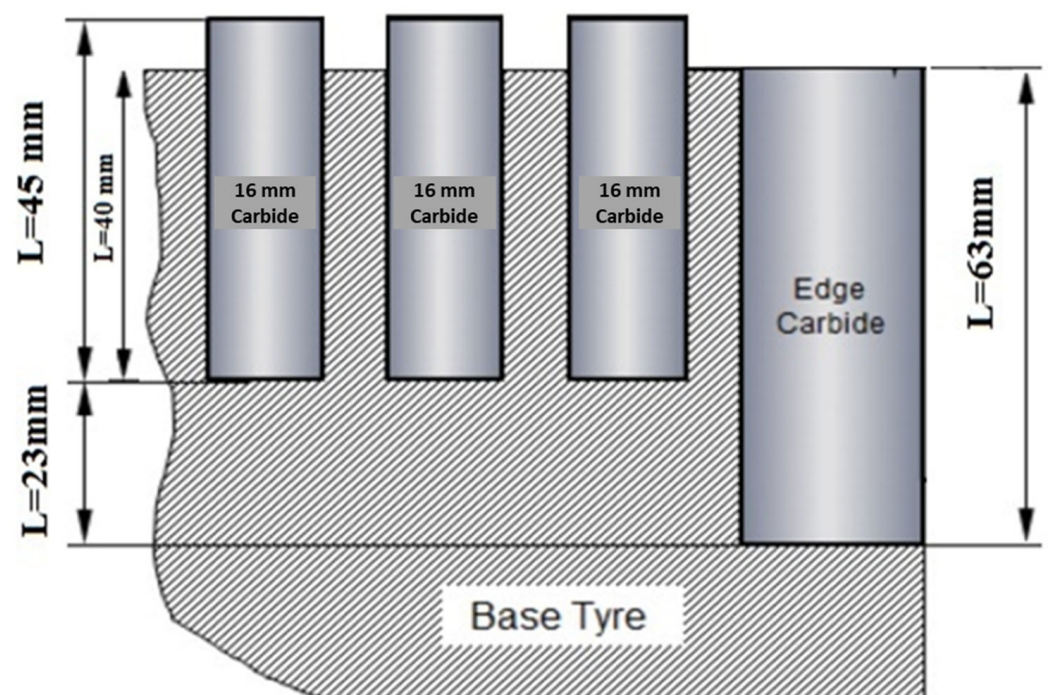
Figure 4. Arrangement and dimensions of studs and edge blocks inside the tire.

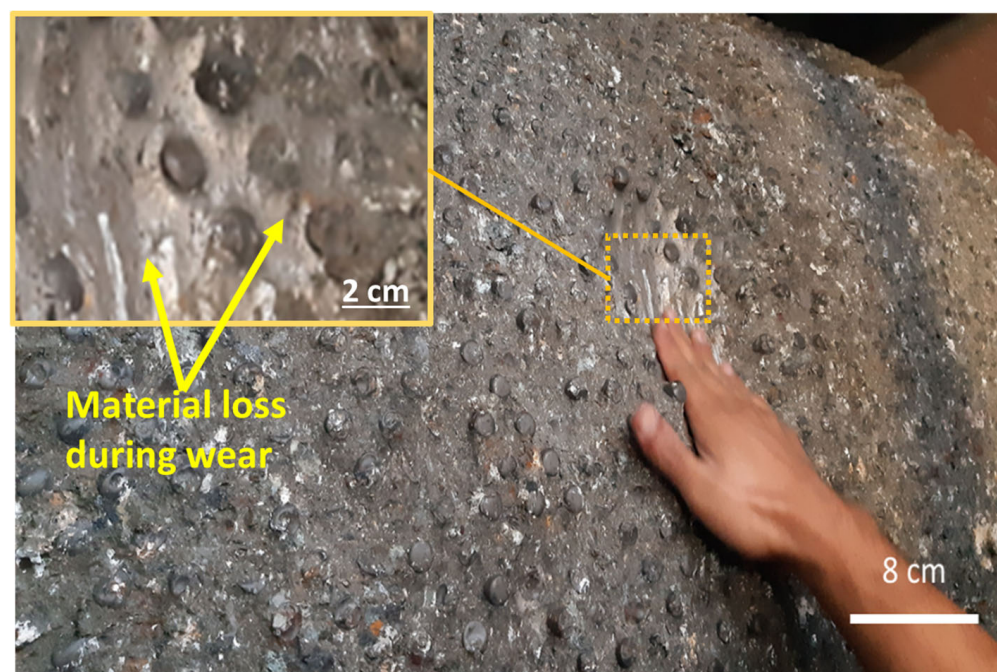
Given the surface deterioration observed in certain sections of the tire after processing 4.8 million tons of iron ore lumps (Figure 5), along with the evaluation of roll surface wear over specified time intervals, the additional monitoring of key parameters influencing roll wear was conducted. These parameters encompass the physical and chemical properties of the feed material as well as the machine settings, as detailed below.

Figure 5. Initiation of roll surface wear due to stud loss (operating at 6000 h).

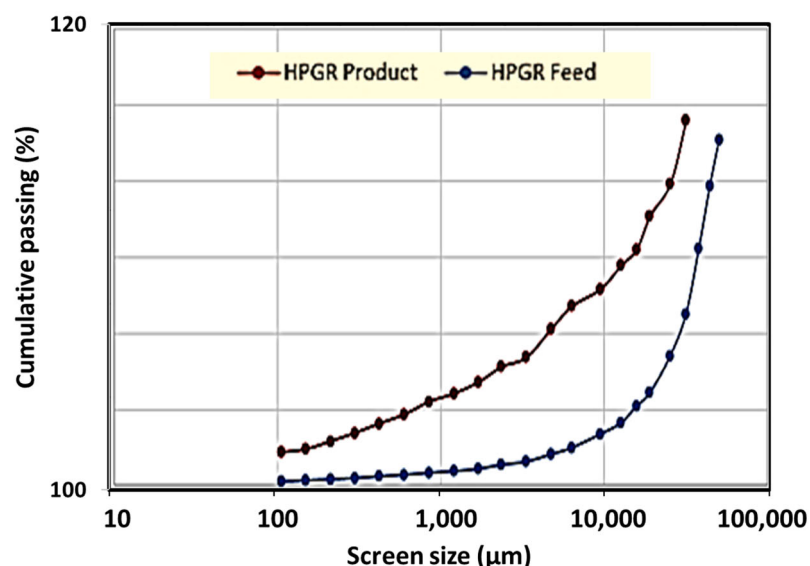
- In total, 80% of the HPGR product has a particle size of less than 25 mm ($D_{80} = 25$ mm), while the remaining 20% exceeds 25 mm.
- The results indicate an increase in feed particle size, leading to a corresponding rise in HPGR product size from 8 mm to 25 mm and an increase in circulating load from 40% to 50%. The increase in circulating load directly impacts the reduced fresh feed throughput and alters the particle size distribution of the HPGR feed (see Figure 6).

Figure 6. Feed and product particle size distribution.

- An increase in the HPGR feed particle size ($D_{100} = 70$ mm, $D_{80} = 45$ mm) has been a major cause of oversized product particles, stud breakage, and reduced tire lifespan. The larger feed size to the HPGR is due to crusher inefficiencies, including the wear and tear of screen segments, excessive wear and gap increase in the cone crusher, and oversized control screen segments before the HPGR due to wear. Also, the work index of the input iron ore fluctuates between 13 and 17 kWh/t, directly affecting energy consumption and tire lifespan. In addition, the ore Abrasion Index tripled compared to the original design specifications, indicating an accelerated wear rate of the equipment.

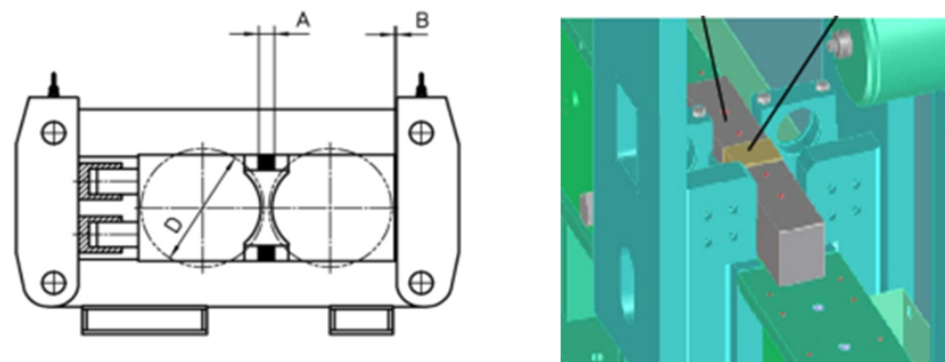
To adjust the gap, an initial hydraulic pressurization was applied to bring the floating roll as close as possible to the fixed roll. The gap measurement was then conducted using a paste test, and type 2 shim plates were removed to establish the zero gap (Figure 7).

Figure 7. Placement of gap adjustment shims (Shim A) at the top and bottom sections (Shim B). Placement of type A shim plates for zero-gap adjustment. D indicates inner diameter.

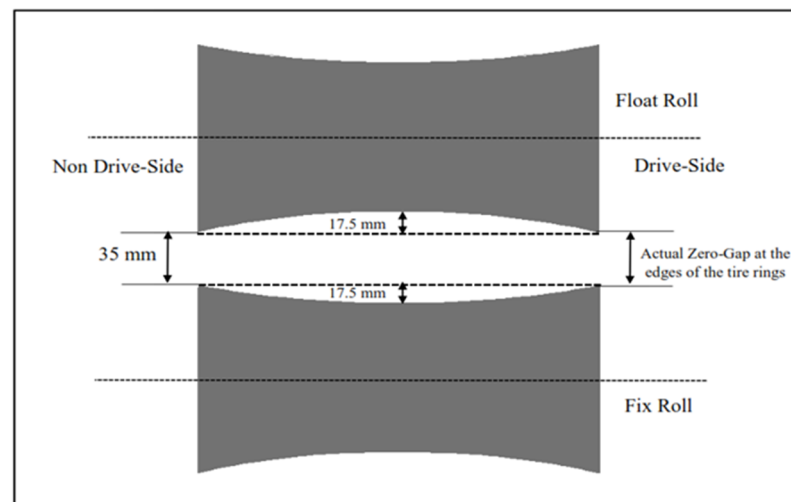
Investigations revealed that no gap adjustments were made during operation, despite roll wear and changes in feed size distribution. As a result, the zero gap increased from 35 mm to 70 mm (Figure 8) without any adjustment to the shim plates. In other words, the zero gap exceeded the required working gap of 55 mm.

Furthermore, when the rolls experienced severe wear and the target product size was not achieved, the operations team—unaware of the wear severity due to uncalibrated distance sensors—reduced the hydraulic pressure to 145 bar in an attempt to attain the 55 mm working gap. However, this action resulted in the following:

Figure 8. Zero-gap measurement (equipment operating at 9500 h). Gray areas indicate float and fix rolls as well as drive side directions which are shown as dash lines.

- A chemical analysis of representative feed samples shows a silica content increase of up to 16%, making the ore harder and contributing to higher wear rates. Throughout the operational period, the HPGR feed rate remained below its design capacity, having no significant effect on roll wear. Moreover, the wear pattern indicates that the center of the roll experiences more wear than the edges. A key reason for excessive roll flute wear is the failure to adjust the zero gap in response to wear, thereby restricting roll movement.

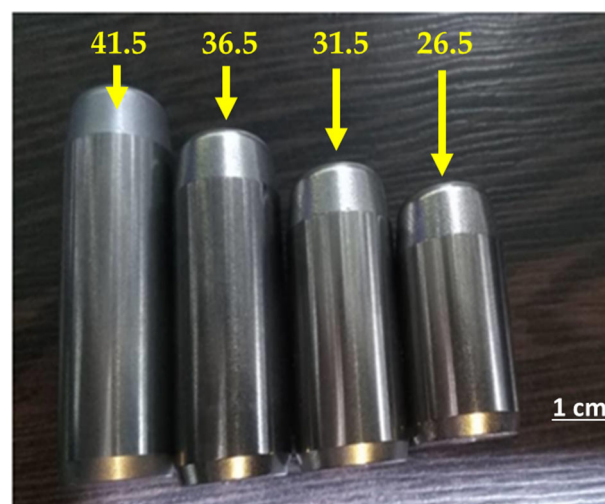
Stud fractures occur when iron fragments or foreign objects larger than the zero gap enter the space between the rolls. Additionally, some studs completely detach due to excessive tire wear, making the tire more vulnerable to damage. In cases of stud fracture or detachment, immediate replacement is necessary to prevent the failure of adjacent studs. However, the height of replacement studs is not always uniform (Figure 9). As the tire shell thickness decreases, shorter studs are selected to minimize height differentials, which could otherwise lead to increased localized wear or stud failure (Figure 10). Investigations indicate that there has been no systematic inspection program for monitoring the tire surface and stud condition, resulting in prolonged replacement intervals.

Figure 9. Sizes of replaceable studs: 26.5, 31.5, 36.5, 41.5.

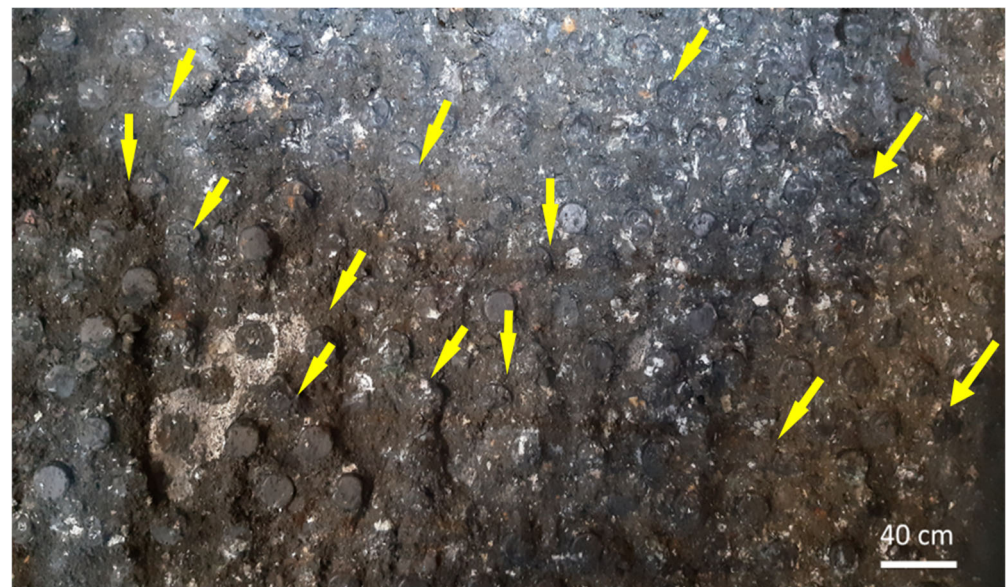
Failure to promptly replace broken studs (every 175 h) led to the loss of multiple adjacent studs and, ultimately, the deterioration of the tire surface. Given the wear rate, 26.5 mm studs—the smallest available size—were installed at the center of the rolls, resulting in a maximum protrusion of 11.5 mm above the tire surface. These replacement studs fractured shortly after the comminution process resumed (Figure 9), a problem observed in all excessively worn locations. It is important to note that the entry of iron materials is nor-

Figure 10. Failure to replace broken studs and continuation of the crushing operation. Arrows indicate regional failures.

- Failure to calibrate the distance sensors on both the drive end (DE) and non-drive end (NDE) resulted in operator errors in hydraulic pressure adjustments, leading to an increased product particle size and a higher recirculating load from the screen. Additionally, reducing the sensitivity of the metal detector—intended to limit two-way chute activations and reject load—allowed more metallic contaminants to enter the rolls, causing frequent stud breakage. The lack of regular roll surface inspections and the delayed replacement of broken studs further contributed to the loss of adjacent studs and the accelerated degradation of the tire surface.

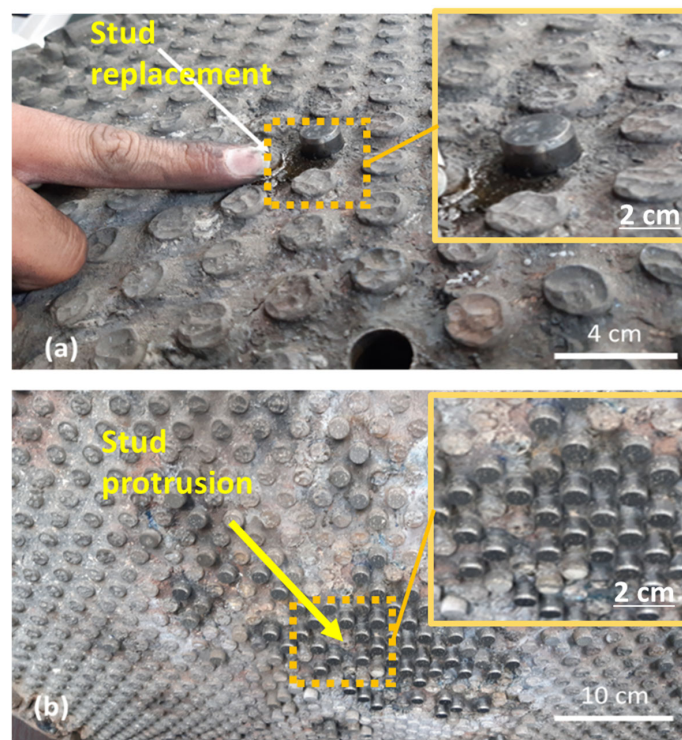
mally controlled via a metal detector, calibrated to a sensitivity of Zero Gap/0.9. However, an analysis of control room trend data and operational testing reveals that the detector's sensitivity diminished over time. Additionally, operators intentionally deactivated the detector during production due to its frequent triggering, which resulted in the diversion of part of the feed via the two-way chute. This reduction in sensitivity, along with manual deactivation, significantly contributed to stud and tire surface damage caused by iron intrusion. In some instances, the passage of such materials even triggered the mechanical safety fuse, resulting in unscheduled equipment shutdowns (Figure 11).

Figure 11. (a) View of the simultaneous replacement of multiple studs. (b) Stud protrusion from the tire surface.

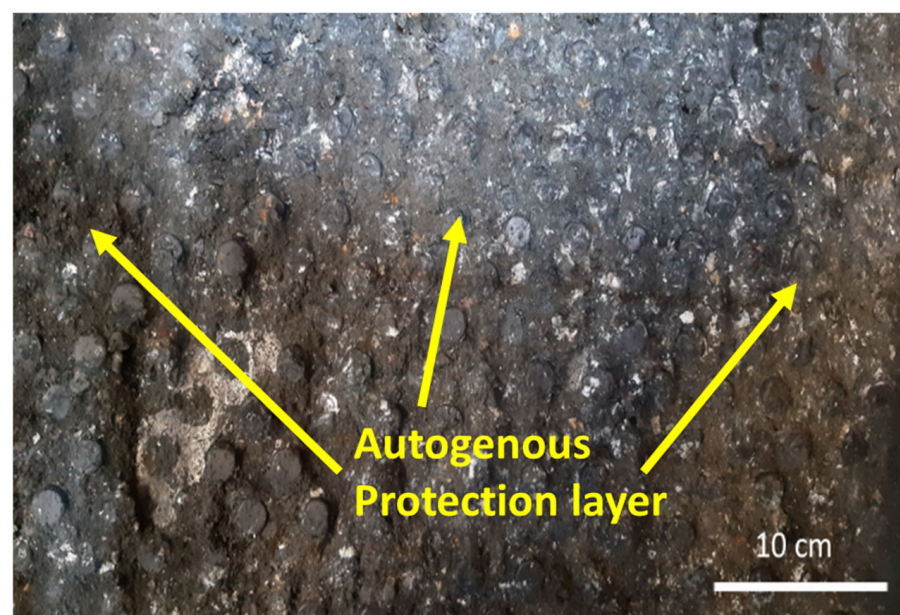
In this manner, the roll surface becomes coated and shielded from direct abrasive contact with the mineral feed (Figure 12). The autogenous surface generally prevents larger rocks from directly impinging on the roll surface and provides a shield from the abrasive movement of material parallel to the roll surface. For generating a competent autogenous wear surface, the feed of a high-pressure grinding roll should contain a moderate level of moisture. The amount of moisture in the feed entering HPGR should be below 5%. Under current operating conditions, the feed moisture for HPGR unit 120MI01 is maintained at 3–4%, which facilitates the consistent formation of a protective surface layer on the rolls.

Figure 12. Formation of APL for tire surface protection.

- Acceptable moisture levels in the recirculating load contributed to regulating feed moisture and promoting the formation of an autogenous protective layer on the tire surface. Additionally, the replacement studs of inferior quality (non-OEM parts) showed significantly higher breakage rates compared to OEM studs. Improper spacing between check plates and tires led to edge-block fractures and severe check plate wear.

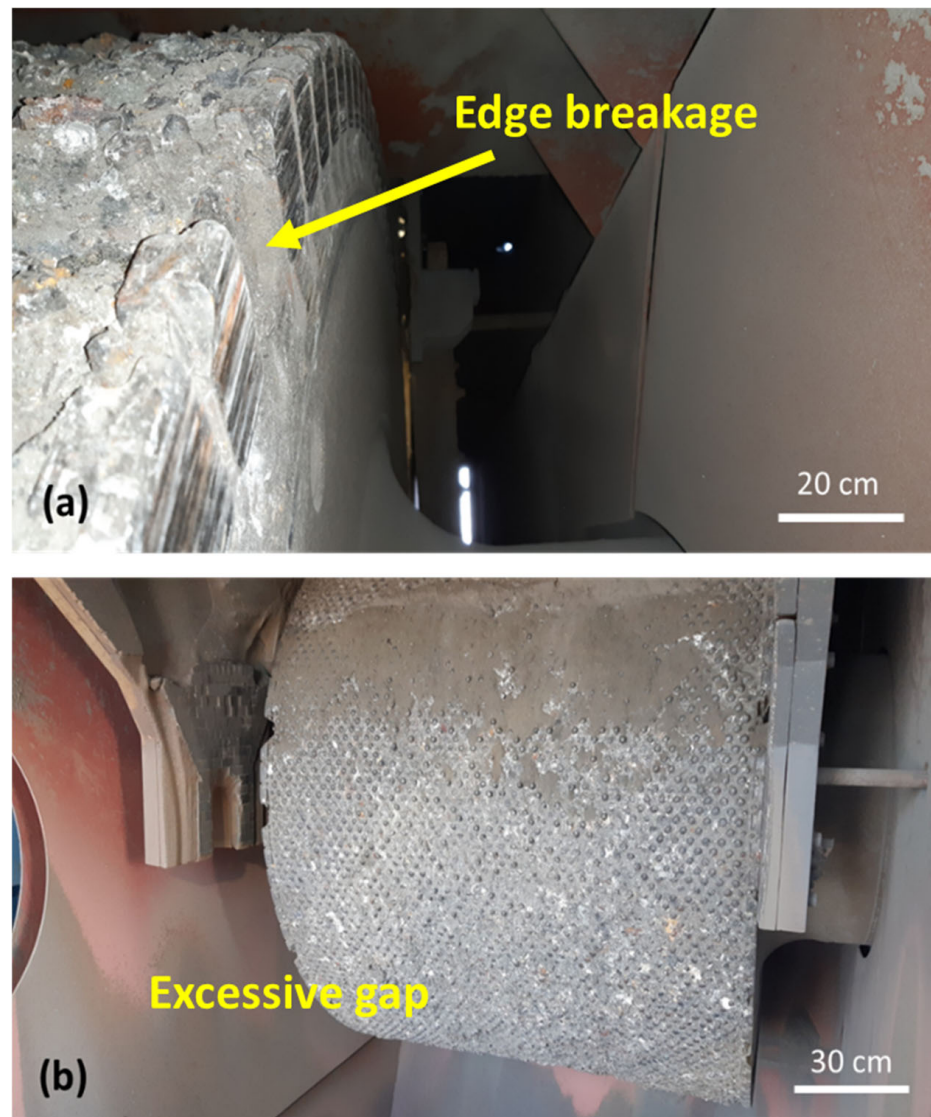
Check plates are installed on both the drive side (DS) and non-drive side (NDS) of the feeding device. These plates are designed to minimize the passage of un-compressed material, thereby improving comminution efficiency. They are mounted in a way that allows them to deflect in response to the skewing of the movable HPGR. Once the roll returns to its parallel alignment with the fixed roll, the check plates automatically return to their original position via a pre-loaded spring assembly. The check plate is of a split design to be capable of separately changing the bottom part of the check plate, which is subjected to maximum wear. This is a further contribution to lowering the cost of wear. Figure 13 illustrates a failure case in which the check plate did not adjust properly, resulting in roll surface wear and edge-block damage.

Figure 13. (a) Improper check plate adjustment leading to edge-block breakage and check plate surface damage. (b) Excessive gap between the check plate and the tire.

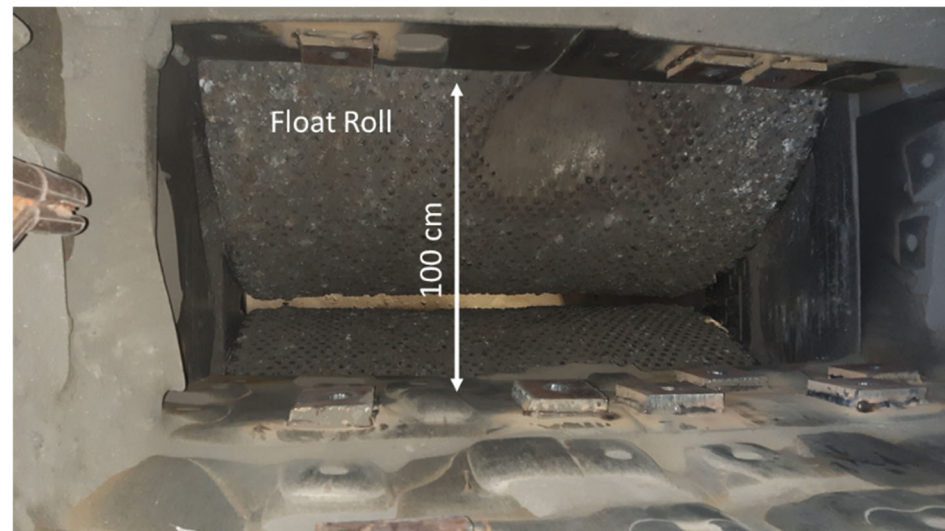
Figure 14 illustrates that in HPGR120MI01, the spacing between the rolls was 100 cm, whereas it should have been adjusted to a maximum of 20 cm. Failure to comply with this requirement by the operator directly contributed to accelerated wear on the roll flutes, stud breakage, and a reduction in tire service life.

Figure 14. Misalignment of the gravity feeder, causing material spillage onto the flute roll.

- The improper alignment of the gravity feed chute resulted in a direct impact of feed material on the roll flute surface, causing excessive localized wear on the movable roll and ultimately contributing to premature tire failure.

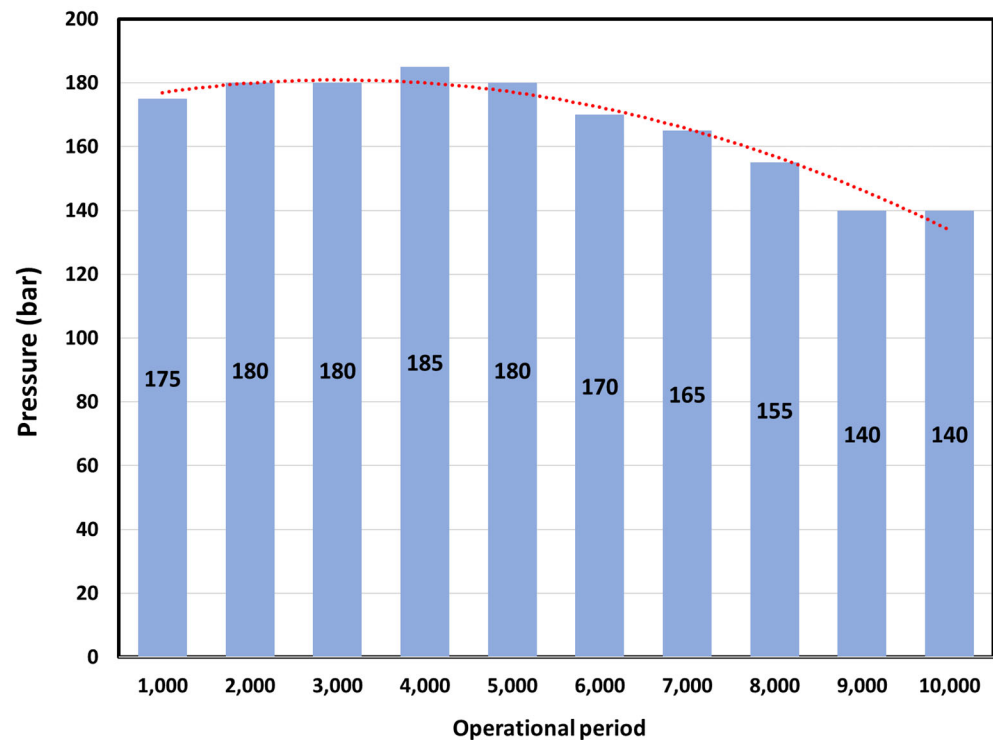
The proportional valve's initial pressurization setpoint during pre-startup is configured at 80 bars. When the hydraulic system's DS and NDS pressure gauges indicate 80 bars, material feeding begins. As the slide gate opens and material enters, the system automatically increases the proportional valve's setpoint from 80 to 130 bar. According to operational records, at the beginning of the commissioning phase, the system pressure was set between 180 and 185 bar to achieve the desired product particle size. Over time, as roll wear increased, operators reduced the pressure. Between 8000 and 10,000 operating hours, the average working pressure used was around 145 bar (Figure 15).

It is noteworthy that increasing the pressure from 185 to 200 bar did not yield any significant reduction in product particle size, indicating that pressures beyond this threshold do not necessarily enhance product fineness.

Figure 15. Trend chart of roll pressure variations during the operational period. Red dotted line indicates power regression.

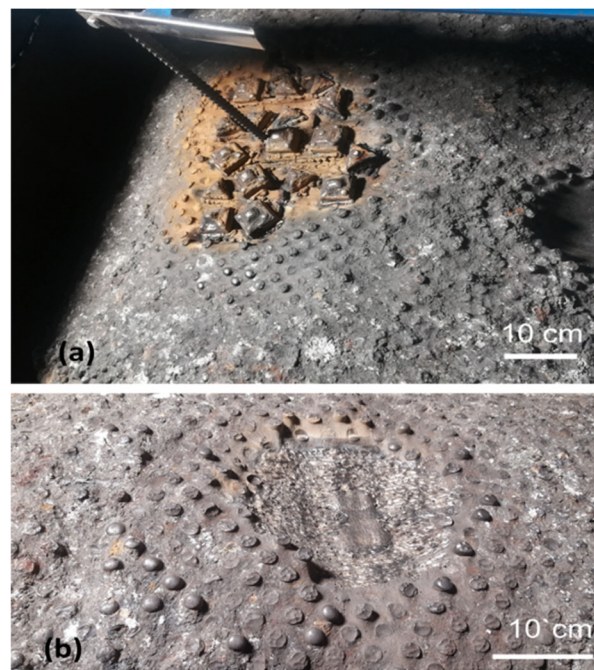
Due to increased wear on the tire surface, elevated vibration levels, and frequent unplanned stoppages resulting from non-compliance with the aforementioned operational parameters, welding and refilling the tire surface were implemented as a temporary corrective measure by the operator. This practice continued until the roll was replaced at 10,256 operating hours (see Figure 16).

Figure 16. (a) Filling and welding of the tire surface; (b) wear and loss of the welded section.

However, this corrective action did not lead to any measurable improvement in HPGR performance and ultimately resulted in additional operational downtime and increased maintenance costs. Furthermore, welded sections of the tire surface experienced rapid wear, reverting to their original degraded condition within a short operational period, thereby rendering the repair ineffective. The weld on the surface of the tire quickly deteriorates due to the high hardness of the input materials and the pressure from the rollers, as well as the wear of the studs. Moreover, due to the absence of a protective layer, incompatibility between the type of weld and the tire shell material occurred.
