Article

Development of Soil Moisture Content and Soil Matric Suction Model Based on Field Instrumentation and Electrical Resistivity Imaging (ERI) for Highway Slopes Constructed on High Expansive Clay Soil

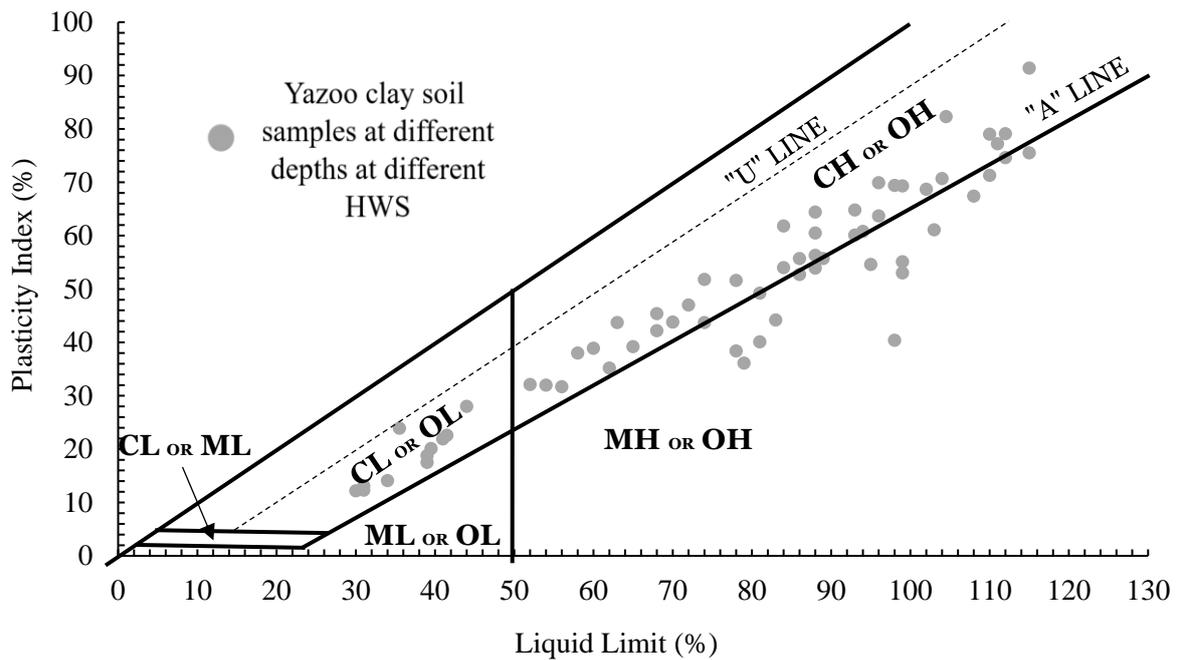
Figure 2. Atterberg limits test results.

Representative Yazoo clay samples were collected from the six HWS at different depths up to 30 ft (9.1 m). The samples were from either a stable area or an area susceptible to failure. An estimate of the plasticity index is necessary to classify the soils, particularly in highly expansive clays. Figure 2 shows the Atterberg limits (liquid limit (LL) and plastic limit (PL)) derived from the lab investigation. It is evident that the majority of the collected soil samples have a high range of LL and PL, showing a high plastic characteristic. Furthermore, these consistency limits are valuable in understanding the soil’s stress history and general properties.

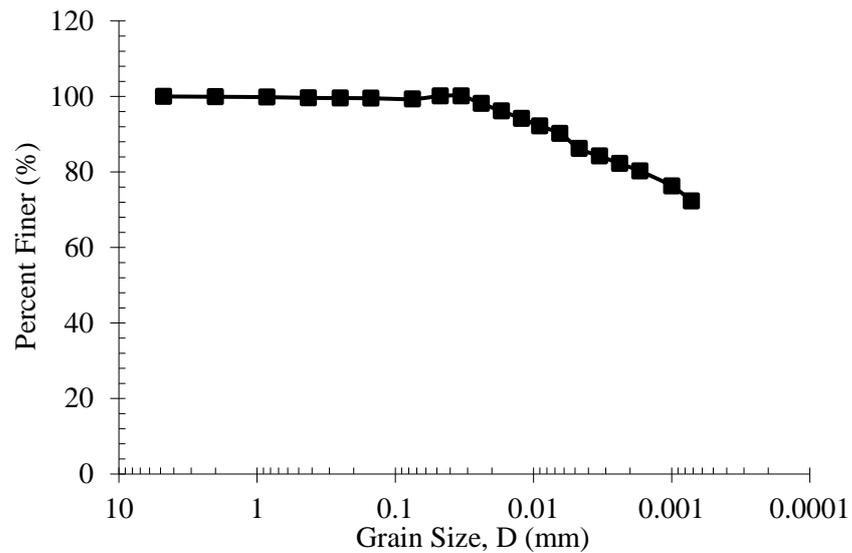
The hydrometer test was performed according to ASTM D7928-17 test method. The combined particle size distribution curve of the Yazoo clay soil is presented in Figure 3.

Figure 3. Combined particle size distribution curve of Yazoo clay.

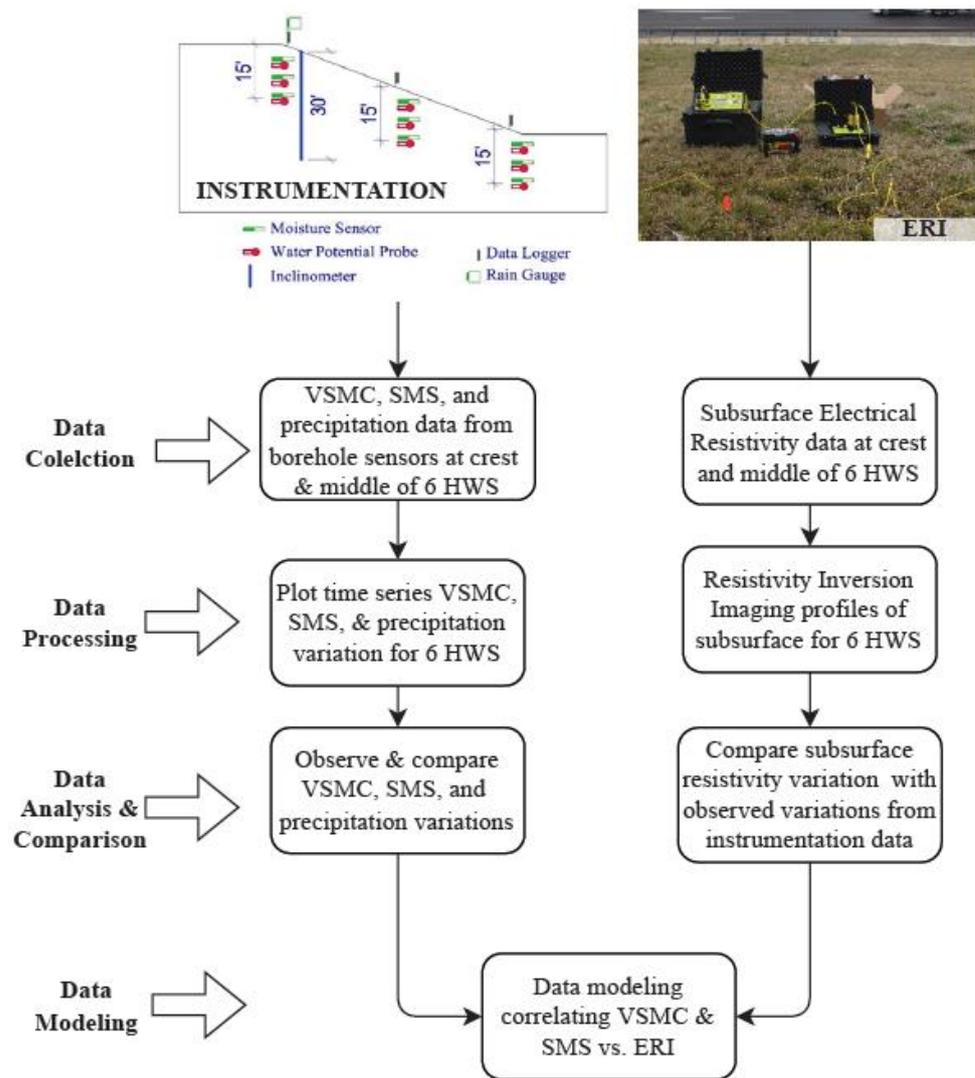
The methodology adopted in this study is presented in the form of a flowchart in Figure 4. It consisted of four stages: data collection followed by data processing, analysis and data modeling. In the data collection stage, SMC, SMS and precipitation data were collected from the six instrumented HWS using an in situ data logger. ERI tests were performed on each HWS and resistivity imaging data were recorded. The connections between ERI and observed VSMC and SMS from instrumentation are studied in the data analysis stage. In the data modeling stage, multiple models were developed based on interdependencies between ERI vs. SMC and SMS. These models were further evaluated to investigate their potential to forecast SMC and SMS capacities using ERI tomography data.

Figure 4. Current study guideline flowchart.

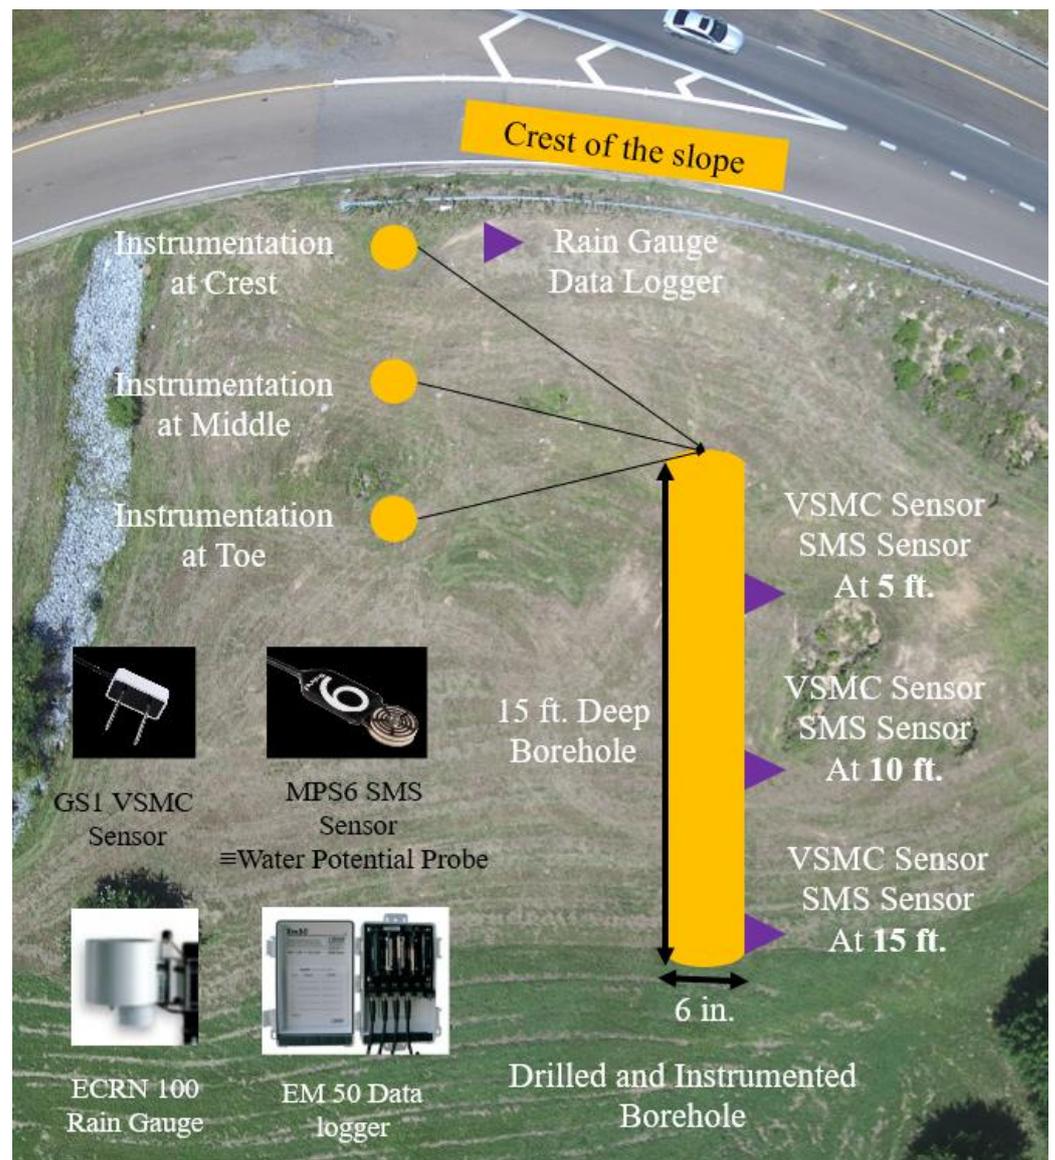
The VSMC, SMS and rainfall intensity were all measured on the six slopes using extensive field instruments. Additionally, two 30 ft (10 m)-long inclinometer casing pipes were placed to monitor the slopes' movement. Sensors were put at the top, middle and bottom of the slope. Moisture and water potential sensors were installed in three 15 ft (3 m) deep boreholes at depths of 5 ft (1.5 m), 10 ft (3 m) and 15 ft (5 m) (Figure 4). It should be noted that the types of the instrumentation are as follows; VSMC (Type: GS1-Decagon Devices), SMS (Type: Teros 21 (MPS6)-Meter Group), rain gauge (Type: ECRN-50-Meter Group) and data logger (Type: Em50-Meter Group). The instrumentation configuration for a typical HWS site is depicted in Figure 5. Moisture sensors and water potential probes were put within the HWS and data were collected biweekly from sites. At 5 ft (1.5 m), 10 ft (3 m) and 15 ft (5 m) depths, the VSMC and SMS (water potential) were determined. Furthermore, instrumentation readings were taken at the HWS' crest, middle and toe. Only data collected at the crest and center of the HWS were considered for this investigation. Additionally, ERI research was undertaken on each of the six HWS. The ERI investigations were conducted at the crest and middle of the six HWS. The ERI survey lines spanned approximately 270 ft (82 m) across each of the six HWS surfaces. The electrodes were spaced at around 5 ft (1.5 m) distance and resistivities of the subsoil were recorded at a depth of at least 15 ft (5 m) and up to 65 ft (19 m).

Figure 5. Typical Instrumentation locations on a HWS (Drone Image-top view) (1' = 1 ft = 0.305 m).

The sensor selection, arrangement and layouts are the same as the previously mentioned HWS instrumentation plans (Figure 5). Figure 25 presents the change in VSMC and SMS profiles with daily rainfall recordings at the crest and middle of the HWS and at different depths. Specifically, the results are recorded at three instrumentation locations (I, II and III) and at three different depths 5 ft (1.5 m), 10 ft (3 m) and 15 ft (5 m). Since the slope has experienced a failure during the early part of this study, special emphasis was given to the rainfall before the failure. Based on the instrumentation results, the SMS of the slopes remains constant after the preliminary 2–3 months of the observation period. In addition, the lower SMS value was present at the top part of the slope, which signifies low shear strength and high VSMC. The slope has experienced a significant VSMC variation during the dry period, mostly at 5 ft (1.5 m) and 10 ft (3 m) depths. This significant variation of VSMC indicated that the slope had shrinkage cracks during the summer, creating a preferential path for rainwater infiltration.

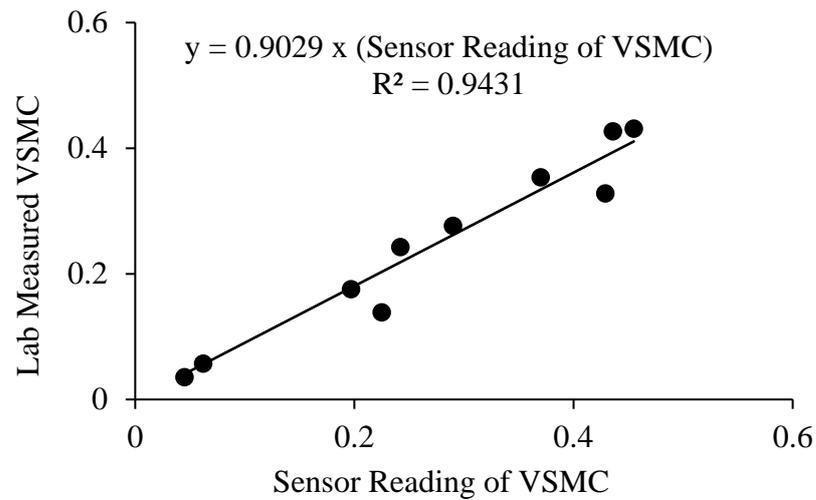
Using the collected soil samples, VSMC was measured in the lab. The laboratory-measured VSMC was then compared with the sensor-measured volumetric water content, which revealed an excellent correlation. From this comparison, a calibration correlation equation was built using the mathematical model for curve fitting. There was good agreement between laboratory measurements of VSMC and sensor readings of VSMC. The supplied data are best matched by a linear equation, as shown in Figure 6. The linear regression correlation illustrates the validation of laboratory-measured VSMC against that from the sensor readings. After developing the calibration function, it was applied straight to the sensor scaling software.

Figure 6. Validation of lab measured vs. sensor reading of VSMC [25].

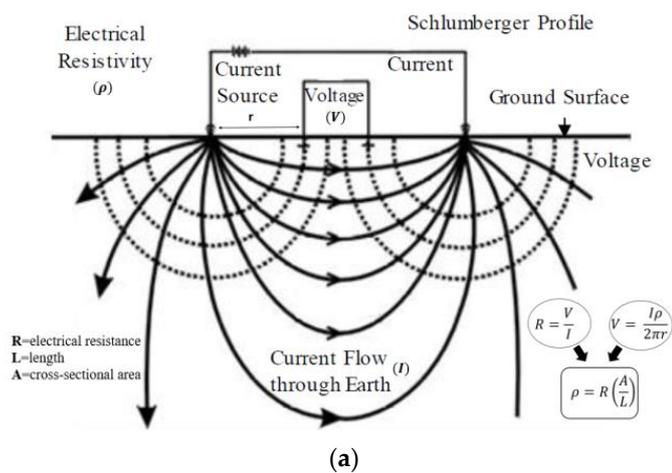
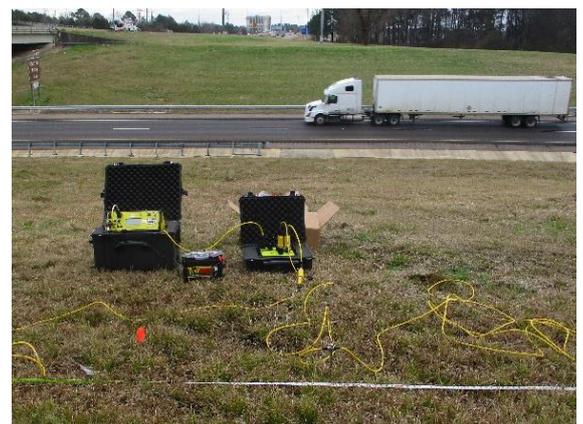
The SI unit for resistivity is the Ohmmeter, abbreviated as $\Omega.m$. Figure 7 depicts the resistivity profile in the ground, as well as the resistivity equipment and arrangement. The electrical resistance of a cylindrical body of length L and cross-sectional area A is denoted by R . Electrical resistance is defined by Ohm’s law as the ratio of potential difference to electric current, where V denotes the potential (or voltage) difference in volts and I denotes the current in amperes. The voltage (V) at the radial distance (r) in a homogeneous medium with the current electrode generating I amperes [12]. The ERI field test was conducted utilizing a SuperSting R8/IP resistivity meter from Advanced Geosciences Inc. (AGI) (Figure 6).

Figure 7. (a) ERI Subsoil current flow profile [25] (b) ERI equipment and field investigation.

The SuperSting R8/IP is a multichannel system with eight survey channels and eight receivers, each of which is capable of taking eight readings for each current injection. The multichannel system made use of a total of 56 electrodes. The SuperSting R8 determines the resistance of the soil body to an electric current sent through it via a line of up to 56 or more electrodes put up to a depth of 6 in (0.15 m) in the ground. The operation begins by

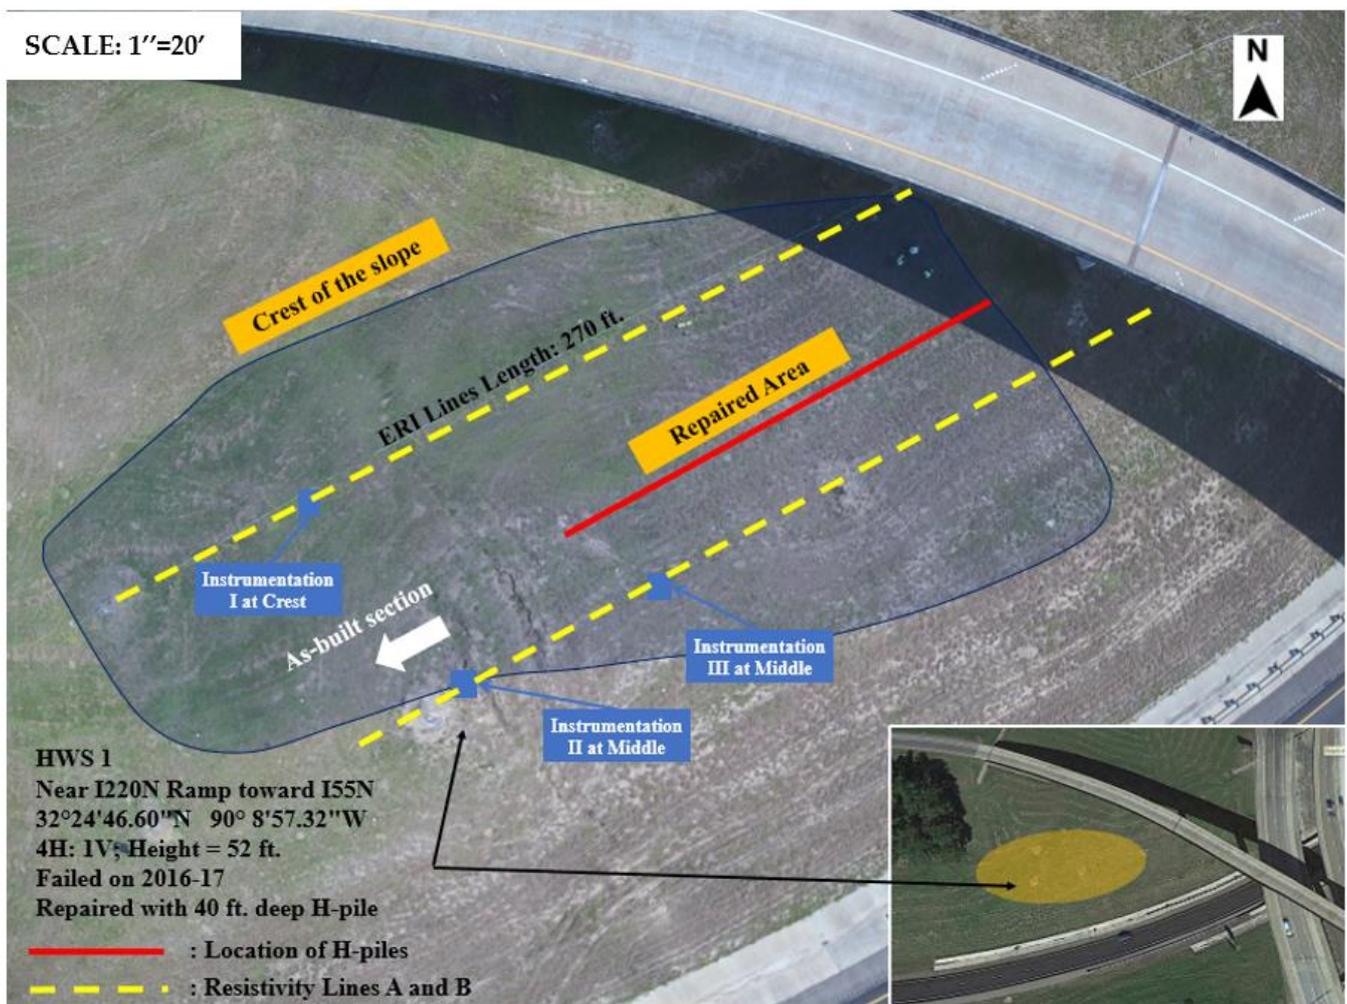
Figure 8 clearly describes HWS1 in terms of its name, location, geometry, history, instrumentation layout and ERI test locations. The failed HWS1 was repaired with a series of deep H-piles. The rebuilt section of the HWS1 is positioned on the east side and the as-built area is located on the west side.

Figure 8. HWS 1 ERI and instrumentation layouts along with its characteristics (drone image-top view) (1' = 1 ft = 0.305 m).

Deep boreholes were drilled and then instrumented in the repaired area at the crest and middle of the HWS1, which is designated as Instrumentation I, II and III, respectively (Figure 8). Instrumentation I and Instrumentation II are located in the as-built section and Instrumentation III is close to the repaired section. The instrumentations were installed at the repaired and as-built sections with the intention of comparing and studying the variations between the two sections over time. In each of the instrumentation locations, at 5 ft (1.5 m), 10 ft (3 m) and 15 ft (5 m) depths, a moisture sensor and a potential water sensor were installed. Additionally, a rain gauge and air temperature sensor were installed at Instrumentation I at HWS1 (Figure 5). Based on the field instrumentation results, variations of in situ VSMC and SMS profiles at three different depths with rainfall at the crest and middle of the HWS1 are presented in Figure 9. The sensors provided data at the crest and middle of the slope. It was observed that after January 2020, the highest rainfall occurred in late August 2020. Furthermore, VSMC varied for all three depths at both crest and middle of the slope. On the other hand, SMS showed very little variations at the crest of the slope and some variations in the middle of the slope. The VSMC dropped at the 5 ft (1.5 m) depth in the middle of the slope during fall 2020. The drop in VSMC can be explained by either the soil movement at that depth or a change in vertical hydraulic conductivity. The existence of voids might also result in acute VSMC variations.

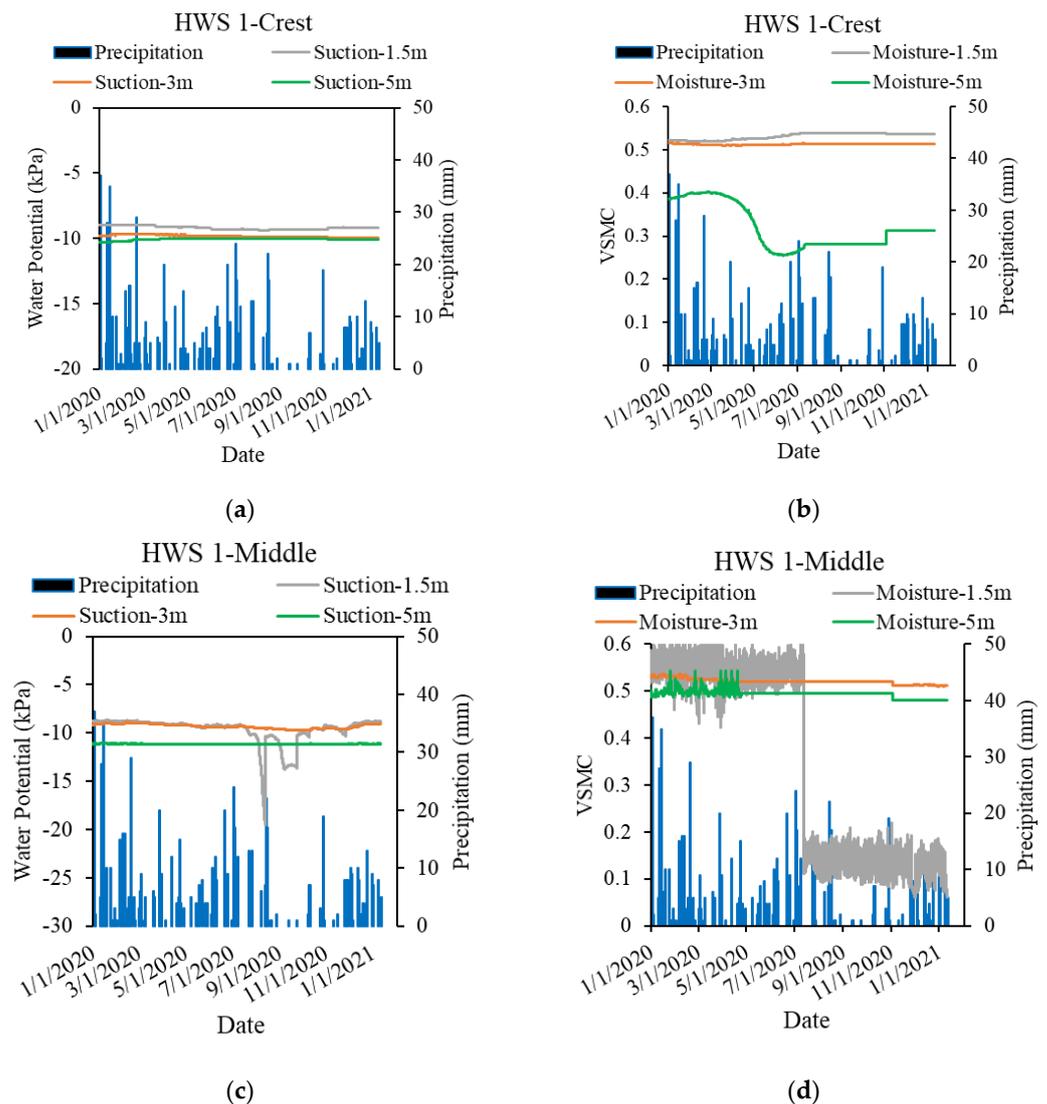
Figure 9. HWS 1 in situ variations with rainfall (a) SMS across the crest of the slope (b) VSMC across the crest of the slope (c) SMS across the middle of the slope (d) VSMC across the middle of the slope (1 m = 3.28 ft; 1 mm = 0.039 in; 1 kPa = 20.89 psf).

At the crest of HWS 1, 4 and 6, it was observed that the VSMC decreases with depth (Figures 9, 17 and 25). A likely explanation for this observation is that rainwater runoff from the highway is absorbed by clay in the shallow layers of the HWS's crest and takes time to percolate to the lower depths. Therefore, the upper soil layers at the crest are wetter than the deeper layers. On the other hand, in the middle of the HWS, the VSMC increases with depth. This data is corroborated up to some extent by the ERI data as well, as shown in Figures 9 and 10. The middle of the HWS is not affected by the runoff water from the highways and maintains dryer soil at the shallow levels and wetter soil at greater depths.

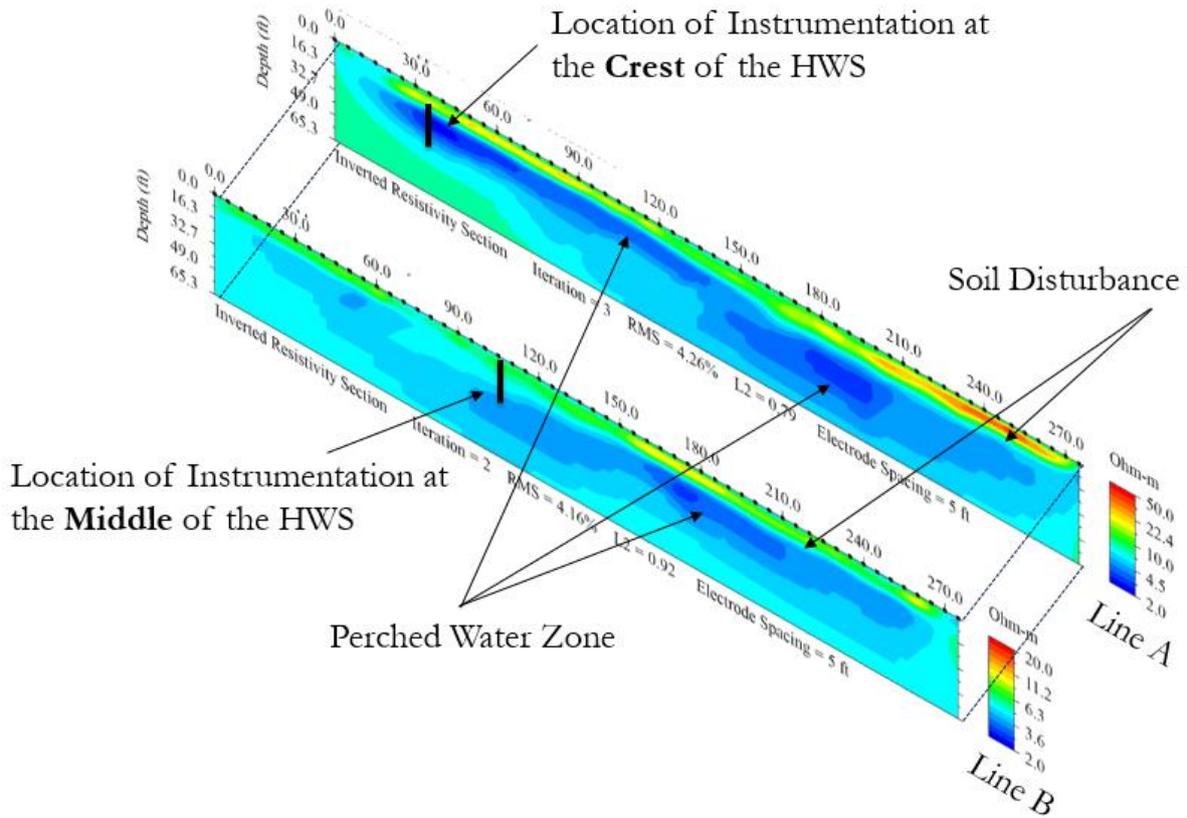
At HWS 1, the ERI test was conducted along a 270 ft (82.3 m) length and the inverted resistivity profiles at Line A and Line B, which correspond to the crest and middle of the slope, respectively, presented in Figure 10. ERI test lines were strategically placed to pass the instrumentation location so that the ERI subsurface imaging results could be compared with the sensor-measured data.

Figure 10. HWS 1, 2D ERI test profile at line A and line B tested on 5 January 2021 (1 ft = 0.3 m).

The field instrumentation provides subsurface data at a confined location (point data), whereas the ERI results provide spatially distributed subsurface information (2D data). Comparing and combining these two results will provide a better understanding of the spatial variations across a wide area and various depths of the HWS. It was observed that the topsoil moved and the surface cracks allowed rainwater to infiltrate and perch in zones up to 30 ft (5 m) depths. It should be noted that the low resistivity values indicate that the soil area was fully saturated. However, the high resistivity values indicated that either the soil area was refilled with another soil type, or the soil had been displaced or the area filled with high stiffened materials.

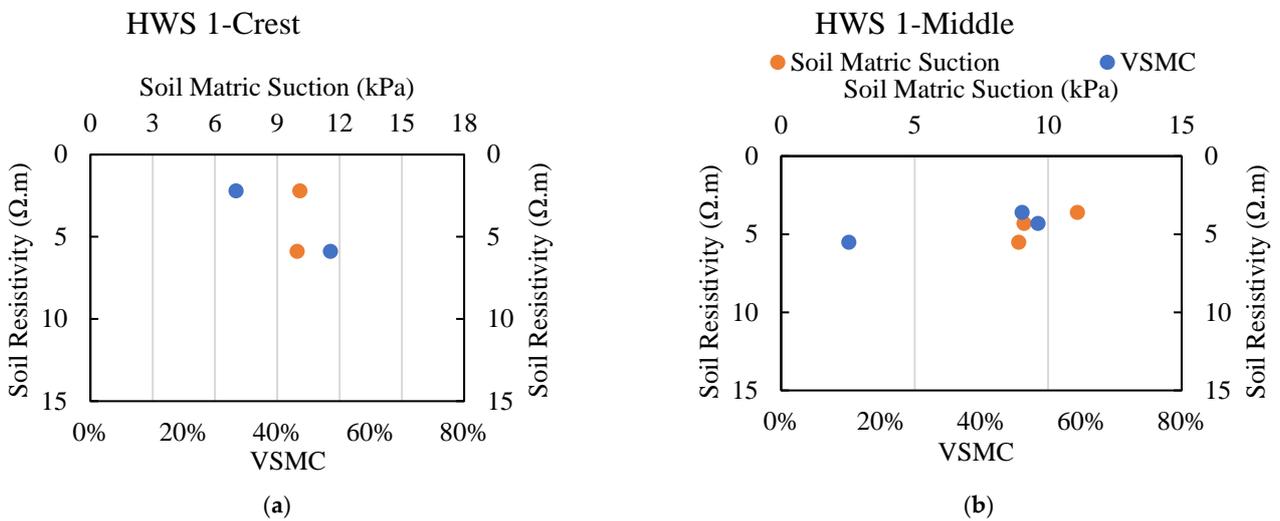
The comparison of ERI and field instrumentation results (VSMC and SMS) at the crest and middle of the HWS 1 is presented in Figure 11. It was observed that the soil around the instrumentation location at both crest and middle of the slope was fully saturated, showing low resistivity values. Since the soil has been conditioned in a fully saturated zone for a long time with the existence of daily to weekly rainfall, the SMS was low and constant.

Figure 11. HWS 1 comparison of 2D ERI test profile with field instrumentation (a) At crest of the slope (b) At middle of the slope (1 m = 3.28 ft.; 1 mm = 0.039 in.; 1 kPa = 20.89 psf).

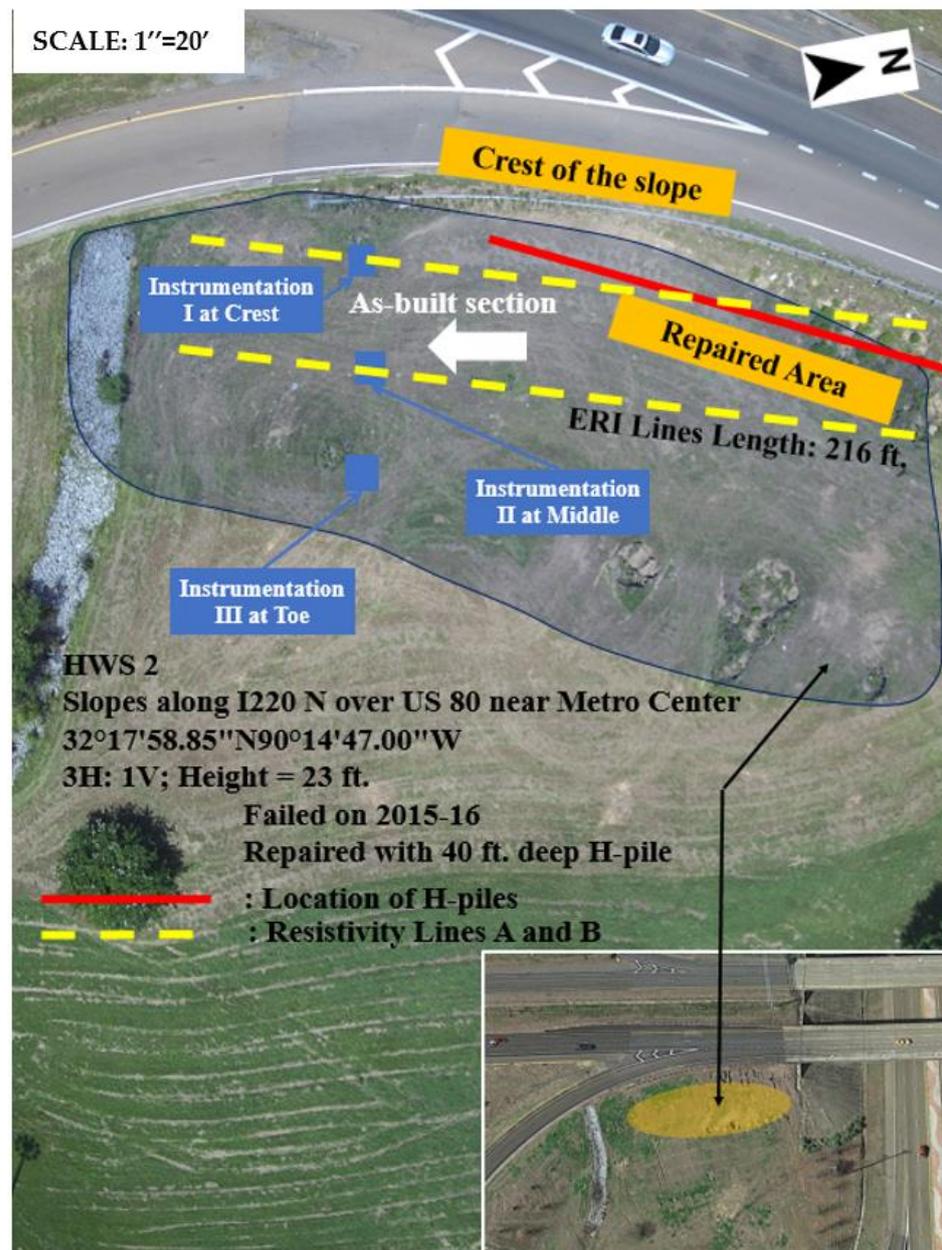
The HWS2 is located along I220 N over the ramp from US 80 E and has a reinforced and as-built section, as presented in Figure 12. The failed HWS2 was repaired with a series of deep H-piles. Three 15 ft (5 m) boreholes were drilled and then instrumented at the as-built section at the slope’s crest, middle and toe, designated as Instrumentation I, Instrumentation II and Instrumentation III, respectively. The failed and the repaired section of the HWS2 is on the north side and the as-built section is on the south side of the HWS2 as illustrated in Figure 12.

Figure 12. HWS 2 ERI and instrumentation layouts along with its characteristics (drone image-top view) (1' = 1 ft = 0.305 m).

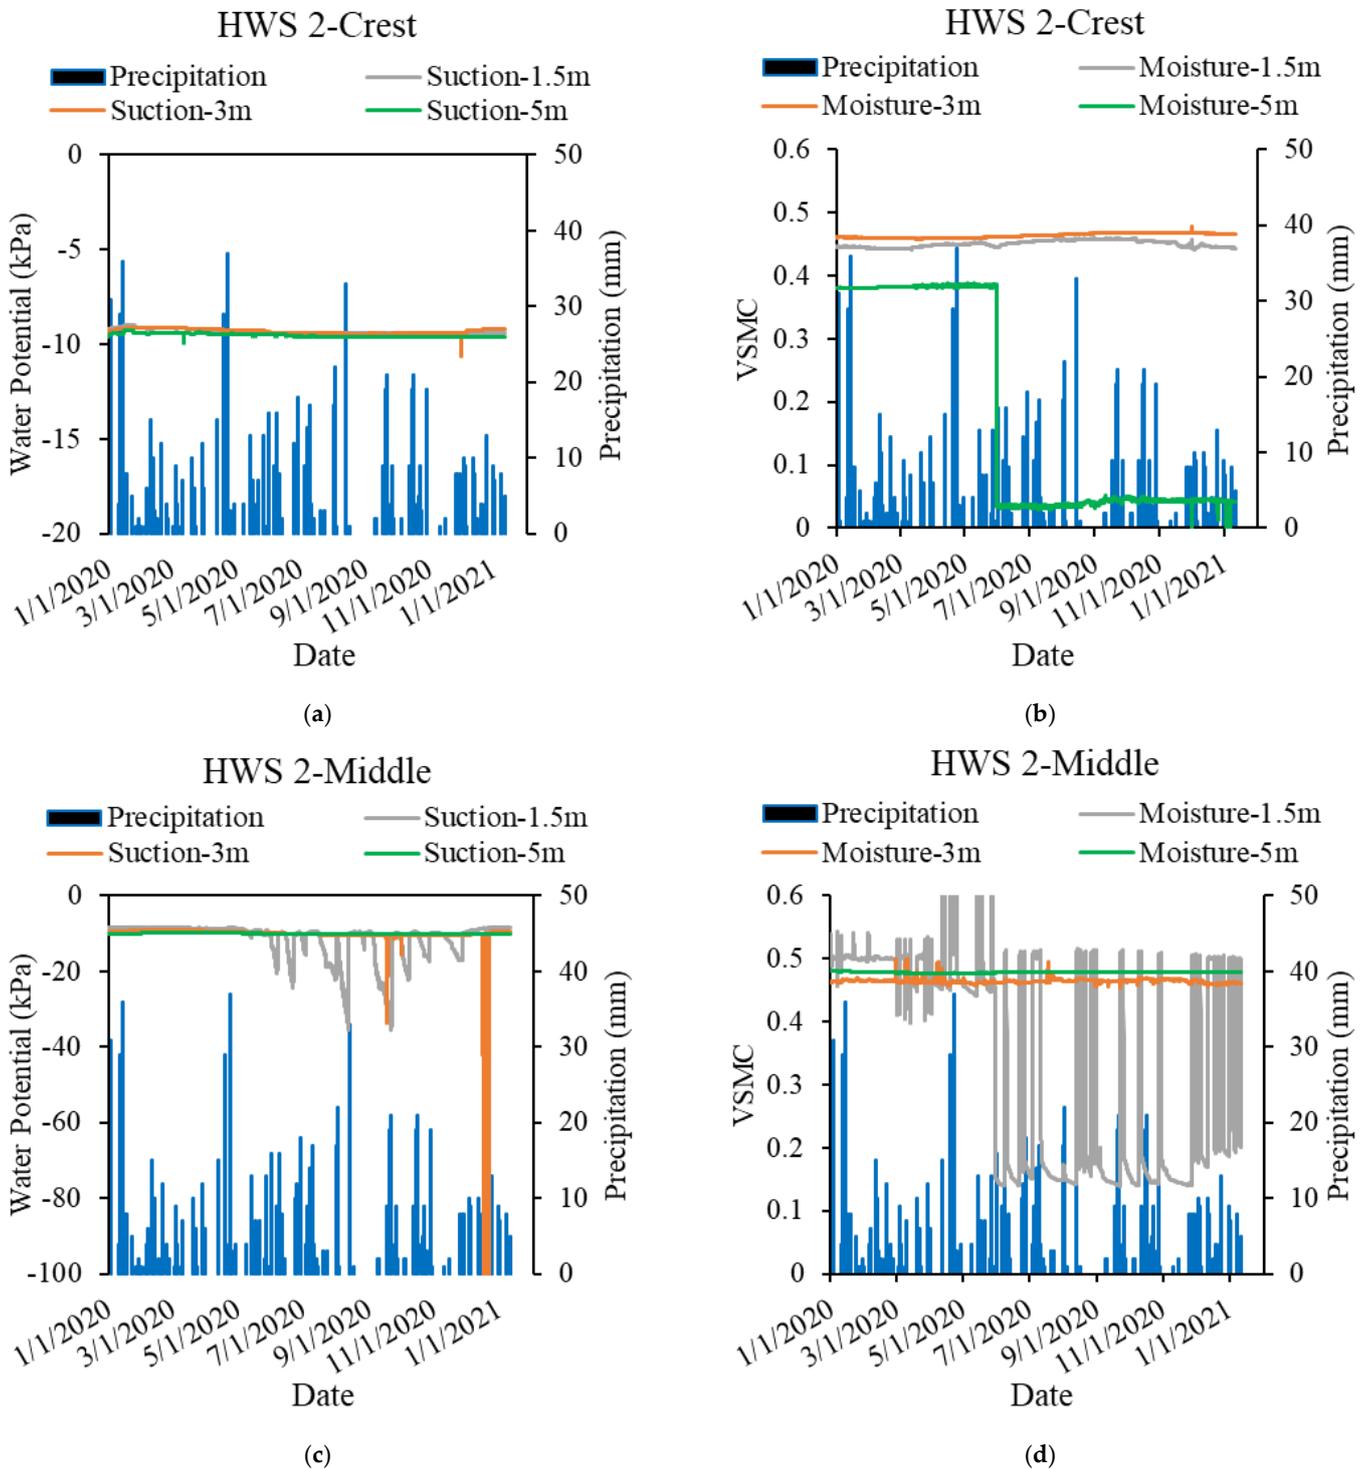
In each of the instrumentation locations, at 5 ft (1.5 m), 10 ft (3 m) and 15 ft (5 m) depths, a moisture sensor and a water potential sensor were installed. Additionally, a rain gauge and air temperature sensor were installed at Instrumentation 1 at HWS2 (Figure 5). Variations of in situ matric VSMC and SMS profiles at three different depths with rainfall at both crest and middle of the slope are presented in Figure 13. At Instrumentation I and Instrumentation II, an initial VSMC variation was observed within the first 3 months after instrumentation installation, which can be considered as the adjustment period of the moisture distribution. It should be noted that the SMS at those locations did not present any changes due to the fully saturated condition. In the middle of the slope in Instrumentation II, a variation of the VSMC was observed during the summer 2020 up to late December, indicating rainwater infiltration. The high variation of the VSMC indicated the rainwater infiltration through the surface cracks that were either pre-existing or newly formed during

Figure 13. HWS 2 in situ variations with rainfall (a) SMS across the crest of the slope (b) VSMC across the crest of the slope (c) SMS across the middle of the slope (d) VSMC across the middle of the slope (1 m = 3.28 ft; 1 mm = 0.039 in; 1 kPa = 20.89 psf).

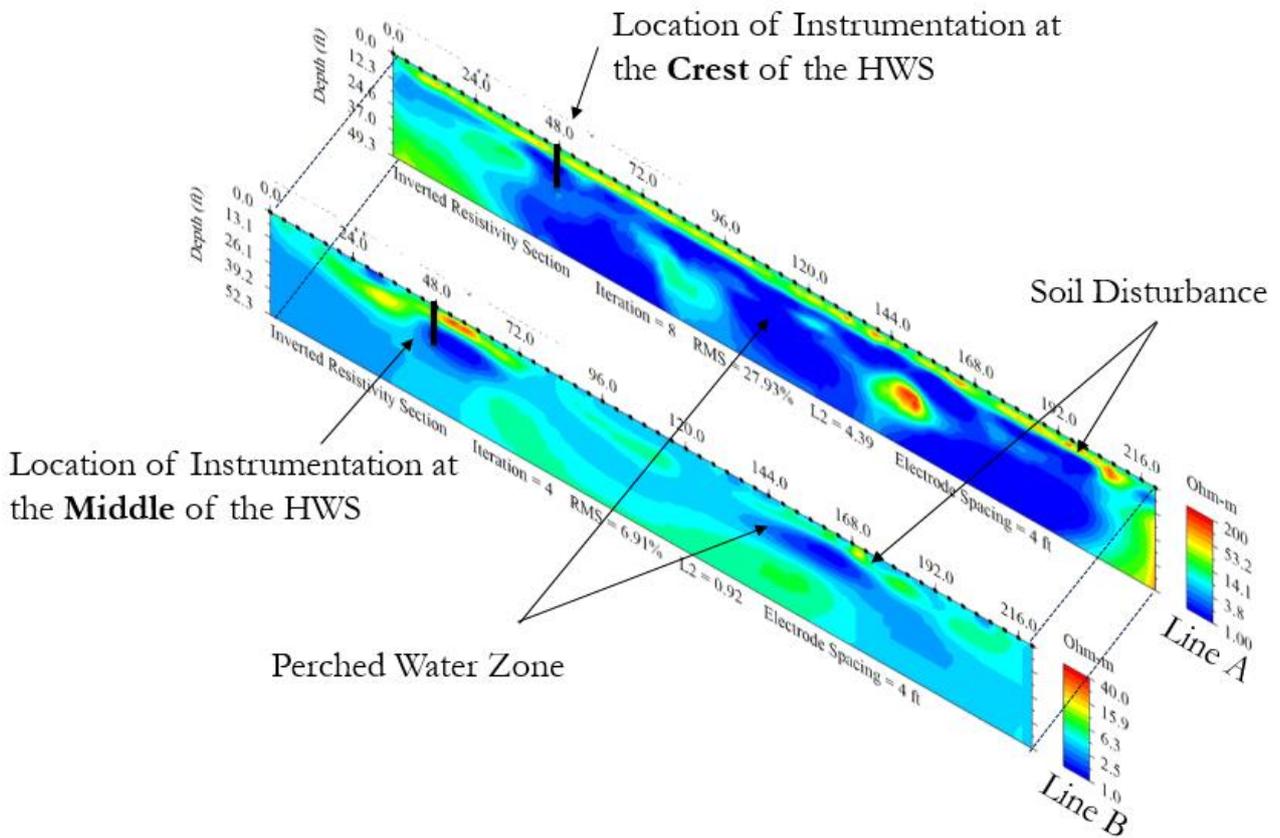
low SMS. These are the characteristics of a soft and low soil strength, which is prone to show signs of movement in the near future. There are perched water zones directly below the unsaturated soil zones in the center of the slope (Figure 14). The high resistivity values indicated the soil had been displaced due to the slope movement.

Figure 14. HWS 2, 2D ERI test profile at line A and at line B tested on 7 January 2021 (1 ft = 0.3 m).

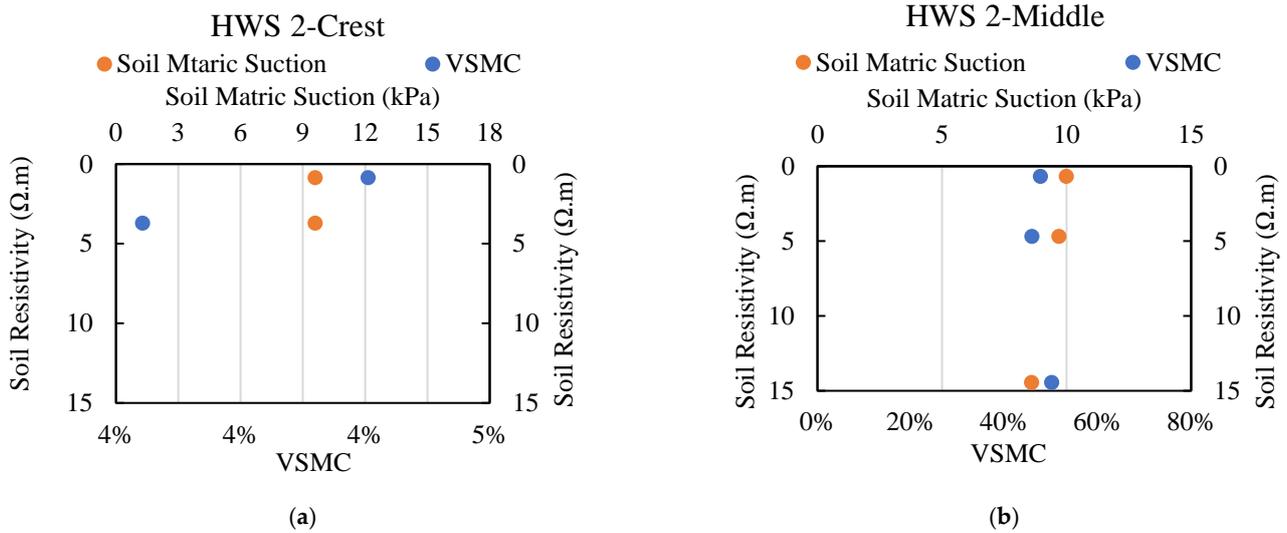
The VSMC and SMS from field instrumentation were compared numerically with ERI test results at both crest and middle of the HWS2, as depicted in Figure 15. It was observed that at the middle of the slope, the inverse relationship between resistivity and low VSMC and relatively high SMS does not exist due to the soil’s high degree of saturation. Similar findings were found in this study for other HWS at different depths and locations as well. It was also observed that with a very low VSMC, the SMS has a relatively higher SMS value, which did not impact the resistivity values. Based on ERI results, it was observed that the HWS was fully saturated at 5 ft (1.5 m) depth at the instrumentation location.

Figure 15. HWS 2 comparison of 2D ERI test profile with field instrumentation (a) At crest of the slope (b) At middle of the slope (1 m = 3.28 ft; 1 mm = 0.039 in; 1 kPa = 20.89 psf).

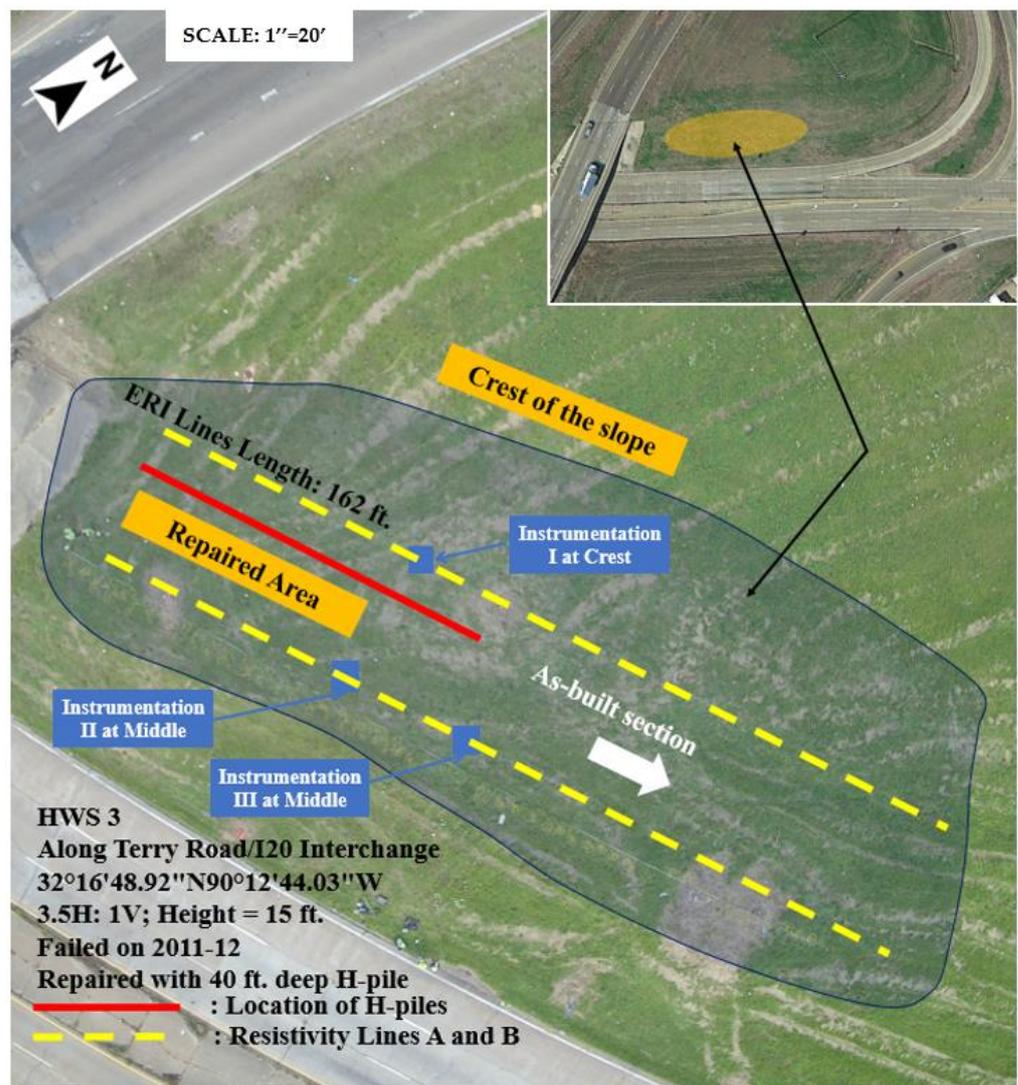
HWS3 is located at I20 E exit toward Terry Road and has reinforced and as-built sections, as presented in Figure 16. The failed HWS3 was repaired with a series of deep H-piles. Two 15 ft (5 m) boreholes were drilled and then instrumented at the repaired sections. These two boreholes were designated as Instrumentation I and Instrumentation II (Figure 16). The third 15 ft (5 m) deep borehole was drilled close to the as-built section and then instrumented; this instrumentation location was designated as Instrumentation III. Instrumentation I is at the crest, whereas Instrumentation II and Instrumentation III are at the middle of the slope.

Figure 16. HWS 3 ERI and instrumentation layouts along with its characteristics (drone image-top view) (1' = 1 ft = 0.305 m).

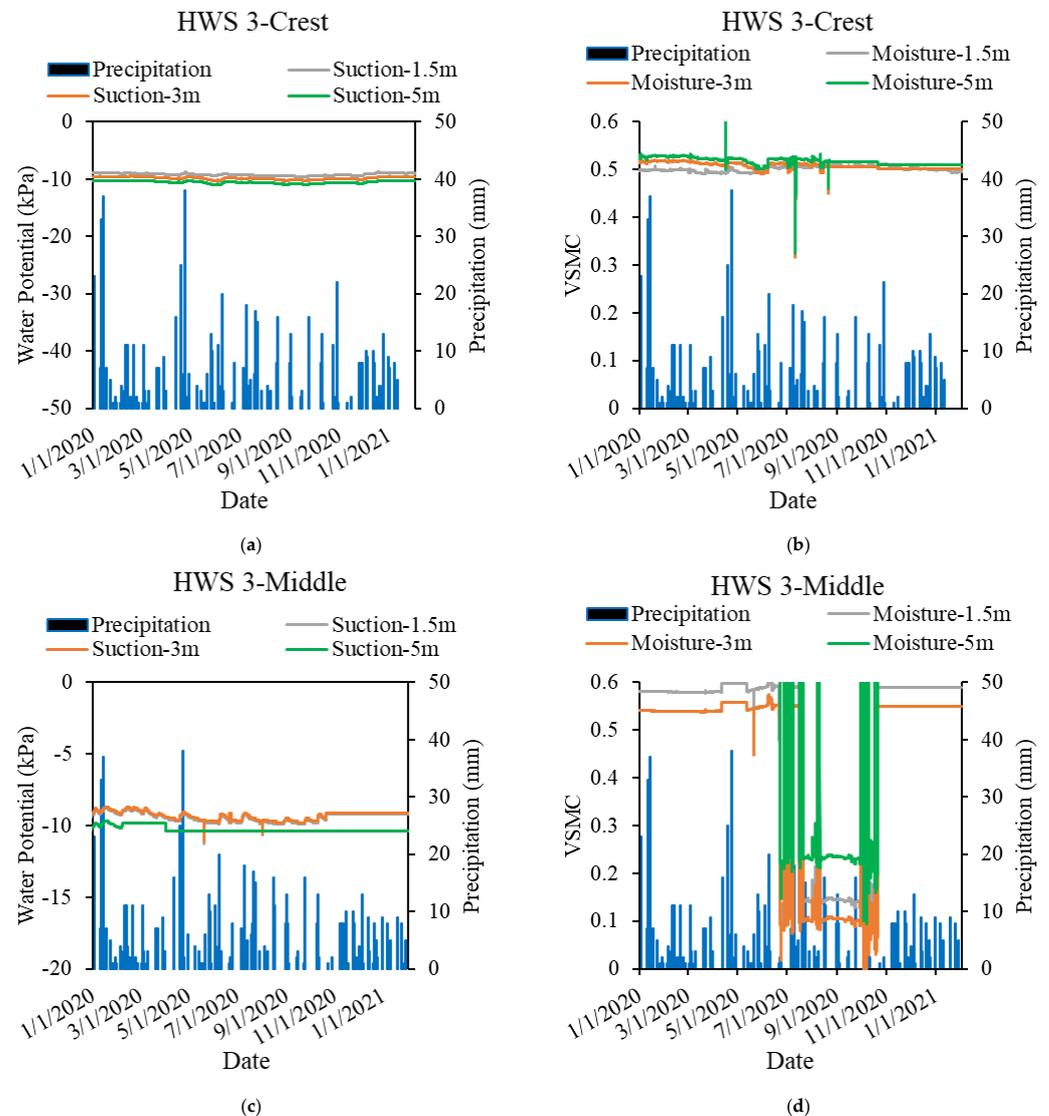
In each of the instrumentation locations, at 5 ft (1.5 m), 10 ft (3 m) and 15 ft (5 m) depths, a moisture sensor and a water potential sensor were installed. Additionally, a rain gauge and air temperature sensor were installed at Instrumentation I at HWS3 (Figure 5). Variations of in situ VSMC and SMS profiles with rainfall and depth at the crest and middle of the HWS3 are presented in Figure 17. The SMS sensor recorded a high number for around three months and then reached an equilibrium condition with minor variations until the end of the monitoring period. The VSMC showed high variations at different depths and at different locations due to infiltration. The constant VSMC at the slope is highly possible when there is no moisture variation or when the soil is in a fully saturated condition. The low SMS values signify that the soil is practically close to a fully saturated condition. This is likely possible when there is a formation of perched water conditions at the slope. It should be noted that the as-built section of HWS3 has experienced shallow movement starting in January 2019 [25]. In addition, it is evident from the instrumentation results that there is a presence of perched water conditions at the slope. Therefore, the movement at the as-built section of the slope is taking place due to the formation of perched water with the top part of the slope.

Figure 17. HWS 3 in situ variations with rainfall (a) SMS across the crest of the slope (b) VSMC across the crest of the slope (c) SMS across the middle of the slope (d) VSMC across the middle of the slope (1 m = 3.28 ft; 1 mm = 0.039 in; 1 kPa = 20.89 psf).

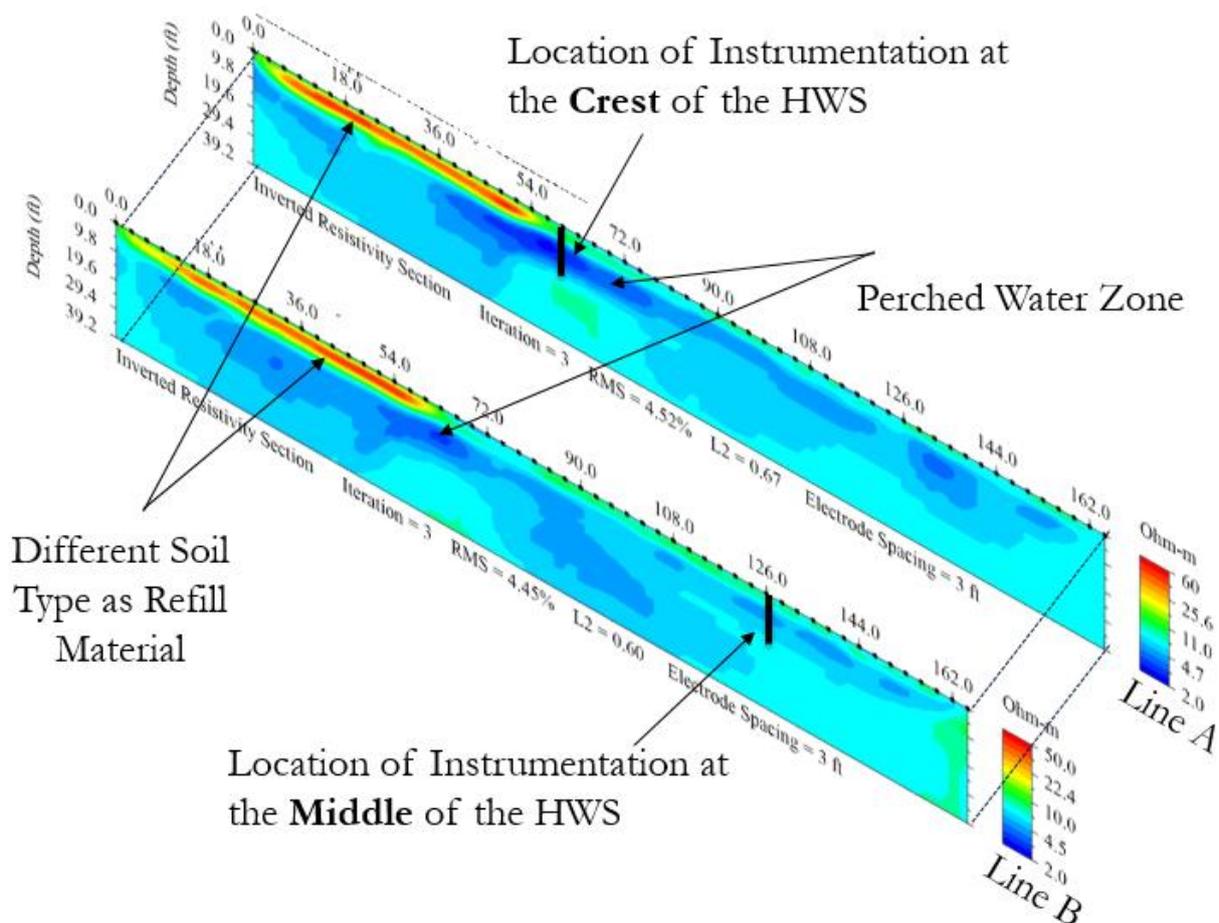
Figure 18 presents the ERI test along a 165 ft (50.2 m) length of the crest and middle (lines A and B) of the HWS3. The ERI inversion images show high resistivity at the top-soil layers due to the different soil types (low plastic soil) as it was used during the reconstruction of the failed slope. The filled soil type had higher resistance than the previously existing soil and in this case, the high resistance was not due to soil body displacement. It is observed that the location field instrumentation is located in the fully saturated zone. The perched water zones were located at deeper soil layers along the slope.

Figure 18. HWS 3, 2D ERI test profile at line A and at line B tested on 9 January 2021 (1 ft = 0.3 m).
