Article

Development of Soil Moisture Content and Soil Matric Suction Model Based on Field Instrumentation and Electrical Resistivity Imaging (ERI) for Highway Slopes Constructed on High Expansive Clay Soil

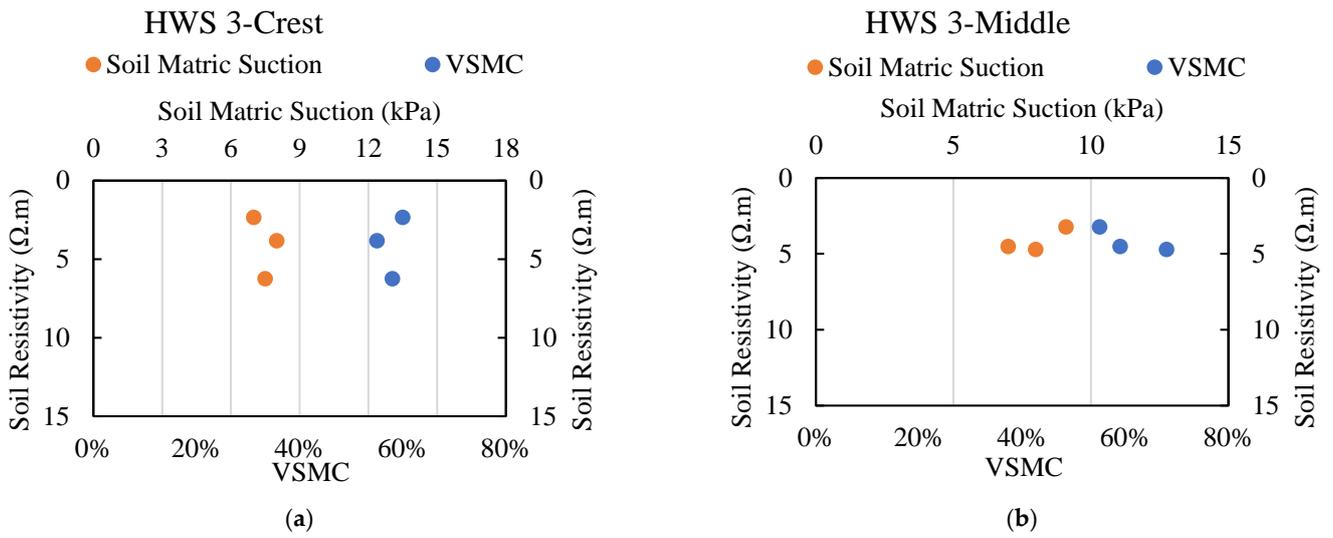
Figure 19 shows the ERI and field instrumentation results comparison. It is observed that the values of the VSMC and SMS at the depth and location of the instrumentation did not have a significant impact on the soil resistivity variation. High VSMC and low SMS observations at the crest and middle of HWS3 coincided with low soil resistivity values, which was a common finding at all the slopes in this study.

Figure 19. HWS 3 comparison of 2D ERI test profile with field instrumentation (a) At crest of the slope (b) At middle of the slope (1 m = 3.28 ft; 1 mm = 0.039 in; 1 kPa = 20.89 psf).

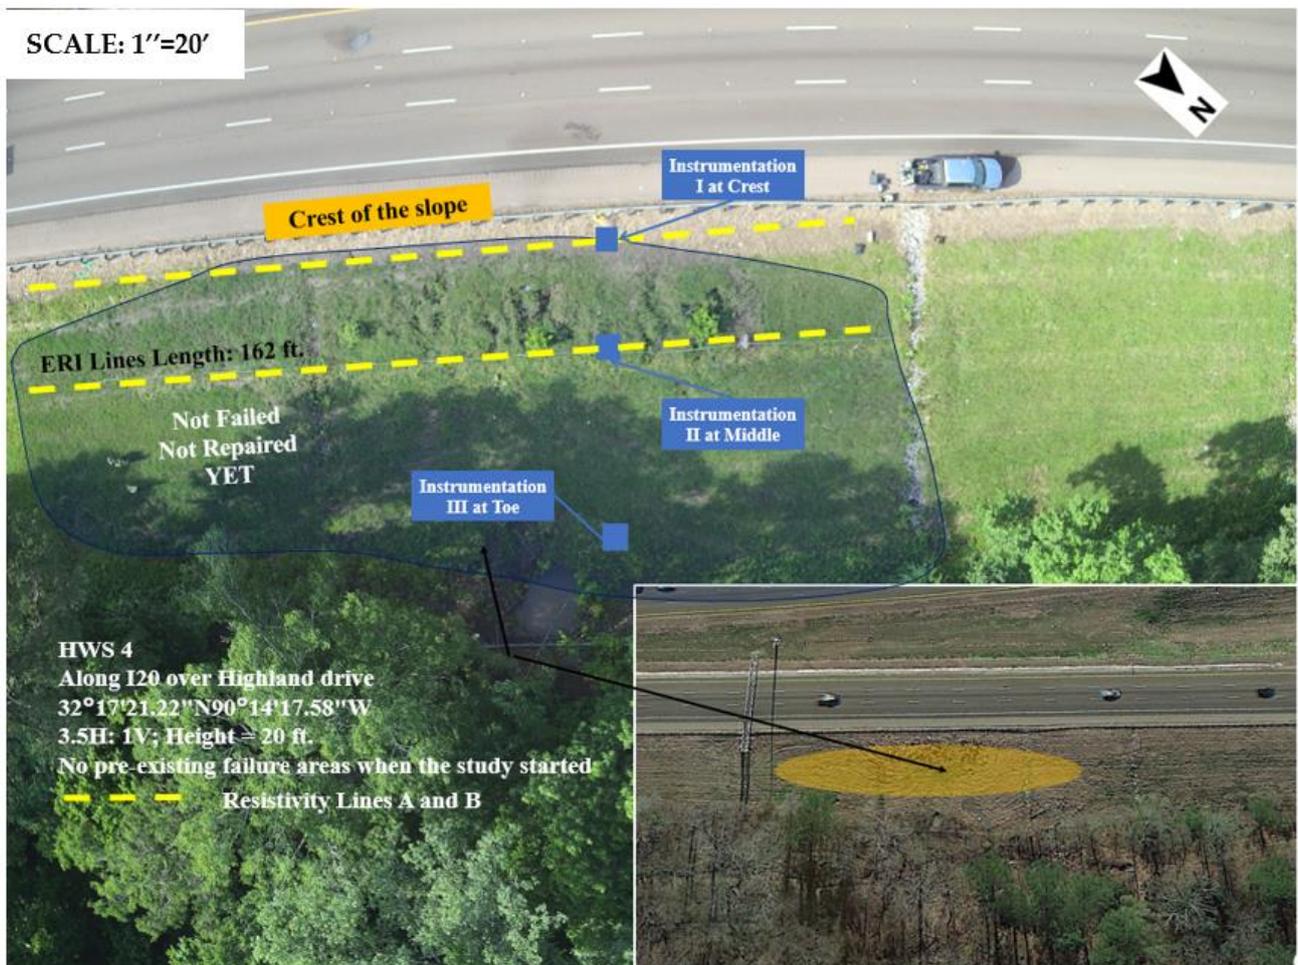
The HWS4 is located along I20 E near Highland drive, as presented in Figure 20. Three 15 ft (5 m) boreholes were drilled and then instrumented at the crest, middle and toe of the HWS, which were designated as Instrumentation I, Instrumentation II and Instrumentation III, respectively. The HWS showed signs of soil body movements from the project starting the day of monitoring. Over time, multiple voids have developed on the slope, which has impacted the permeability of the soil and associated flow characteristics.

Figure 20. HWS 4 ERI and instrumentation layouts along with its characteristics (drone image-top view) (1' = 1 ft = 0.305 m).

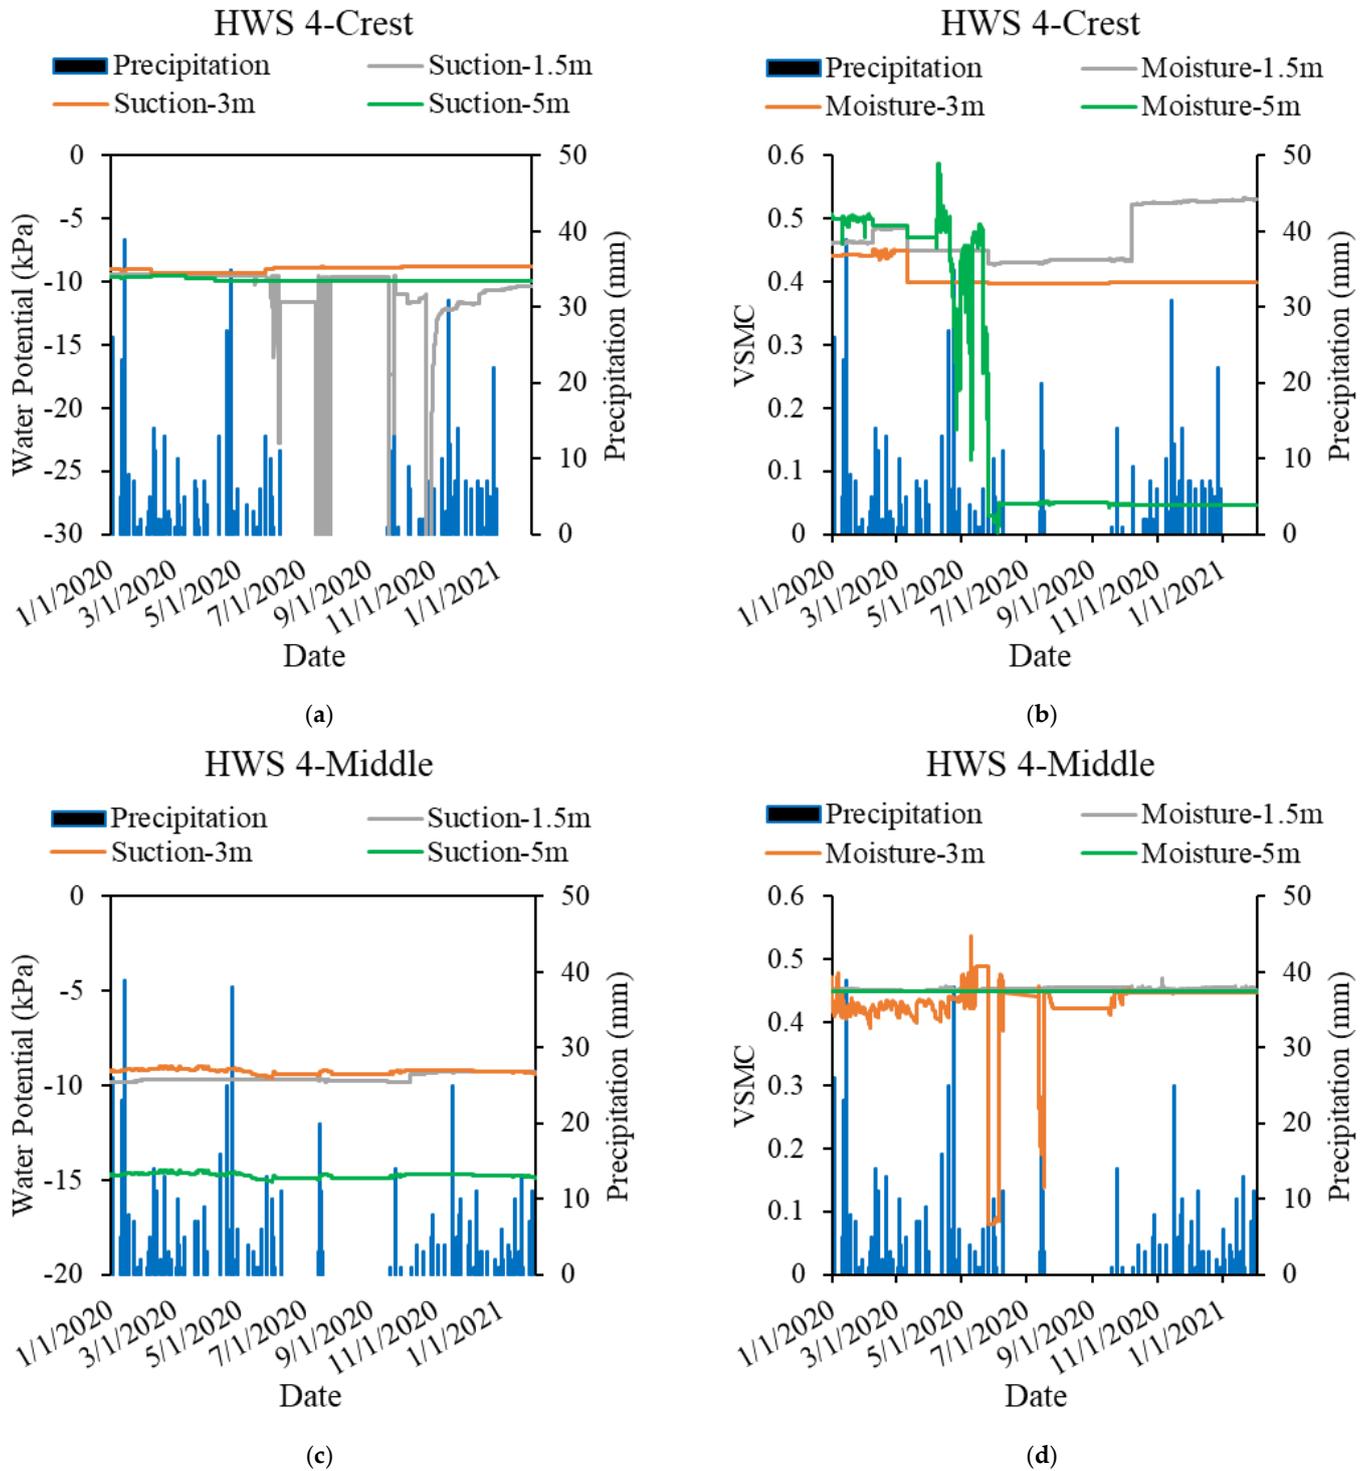
at three different depths and different locations with rainfall. Based on the field monitoring results, it was observed that due to the existence of voids at the field, at a shallower depth in the slope soil body, a high variation of VSMC and SMS occurred. The formation and development of perched water zones are observed at deeper soil layers, which impact the variation of both VSMC and SMS.

Figure 21. HWS 4 in situ variations with rainfall (a) SMS across the crest of the slope (b) VSMC across the crest of the slope (c) SMS across the middle of the slope (d) VSMC across the middle of the slope (1 m = 3.28 ft; 1 mm = 0.039 in; 1 kPa = 20.89 psf).

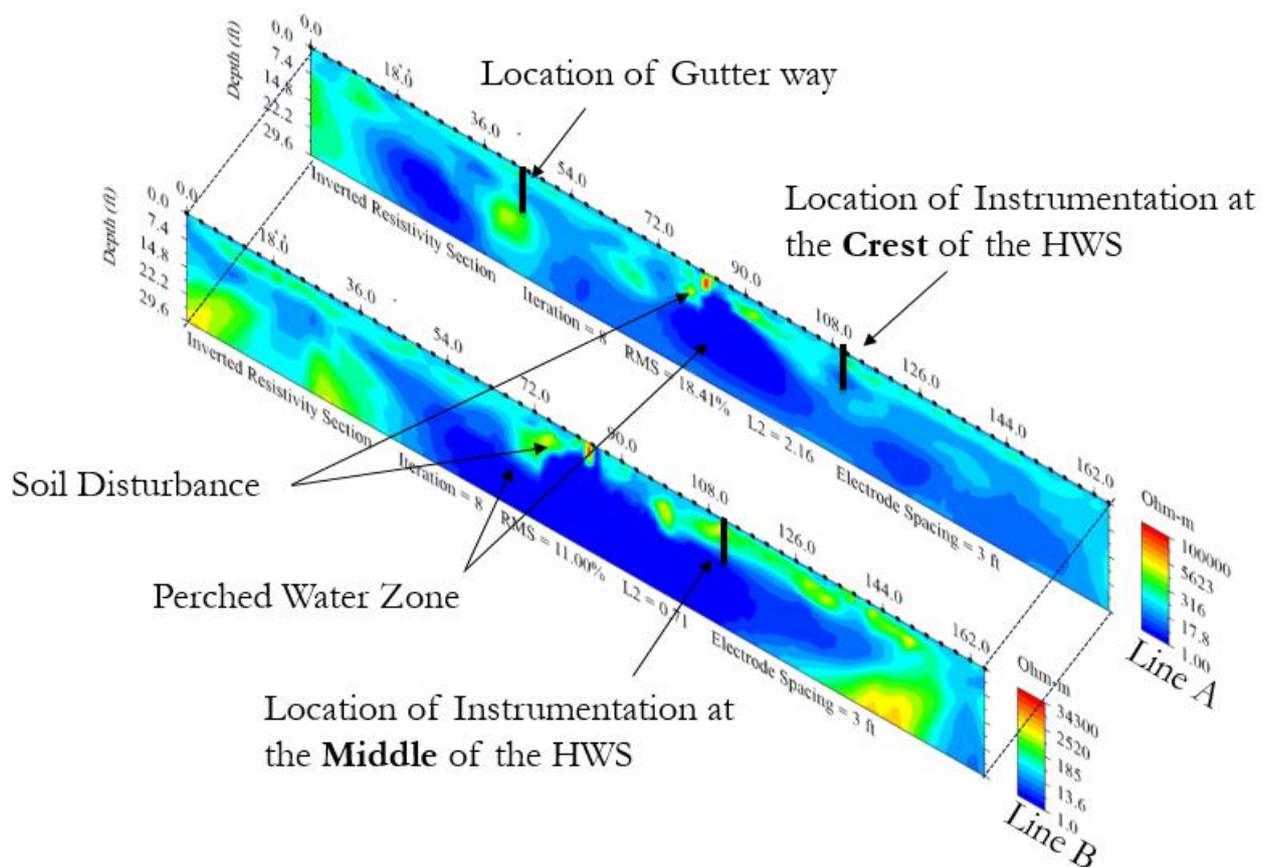
The ERI test was conducted at HWS 4 for a horizontal length of 162 ft (49.3 m) between the crest and the middle of the HWS (Lines A and B). The results of the ERI inversion profile are shown in Figure 22. The ERI results show that extremely high resistivity zones were discovered at both the crest and middle of the HWS. High resistive areas were observed at the surficial levels in the middle, mostly due to the existence of voids. At deeper levels, perched water zone development is noticeably indicated in blue on ERI results in Figure 22.

Figure 22. HWS 4, 2D ERI test profile at line A and at line B tested on 11 January 2021 (1 ft = 0.3 m).

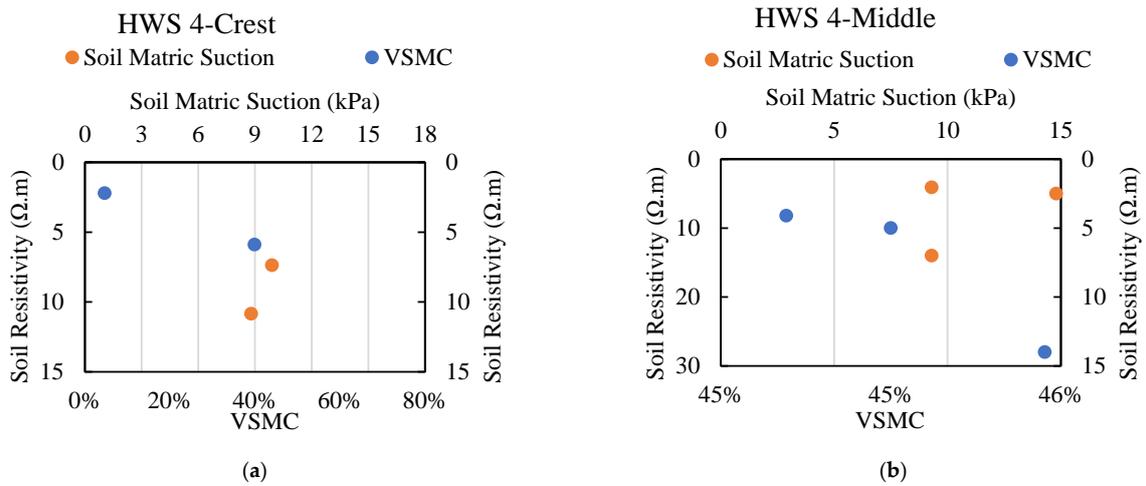
The ERI, VSMC and SMS results at instrumentation locations were compared and are presented in Figure 23. Similar to other HWS studied in this paper, it was observed that the instrumentations located at the top of the perched water zone resulted in low values of soil resistivity and SMS with high VSMC.

Figure 23. HWS 4 comparison of 2D ERI test profile with field instrumentation (a) At crest of the slope (b) At middle of the slope (1 m = 3.28 ft; 1 mm = 0.039 in; 1 kPa = 20.89 psf).

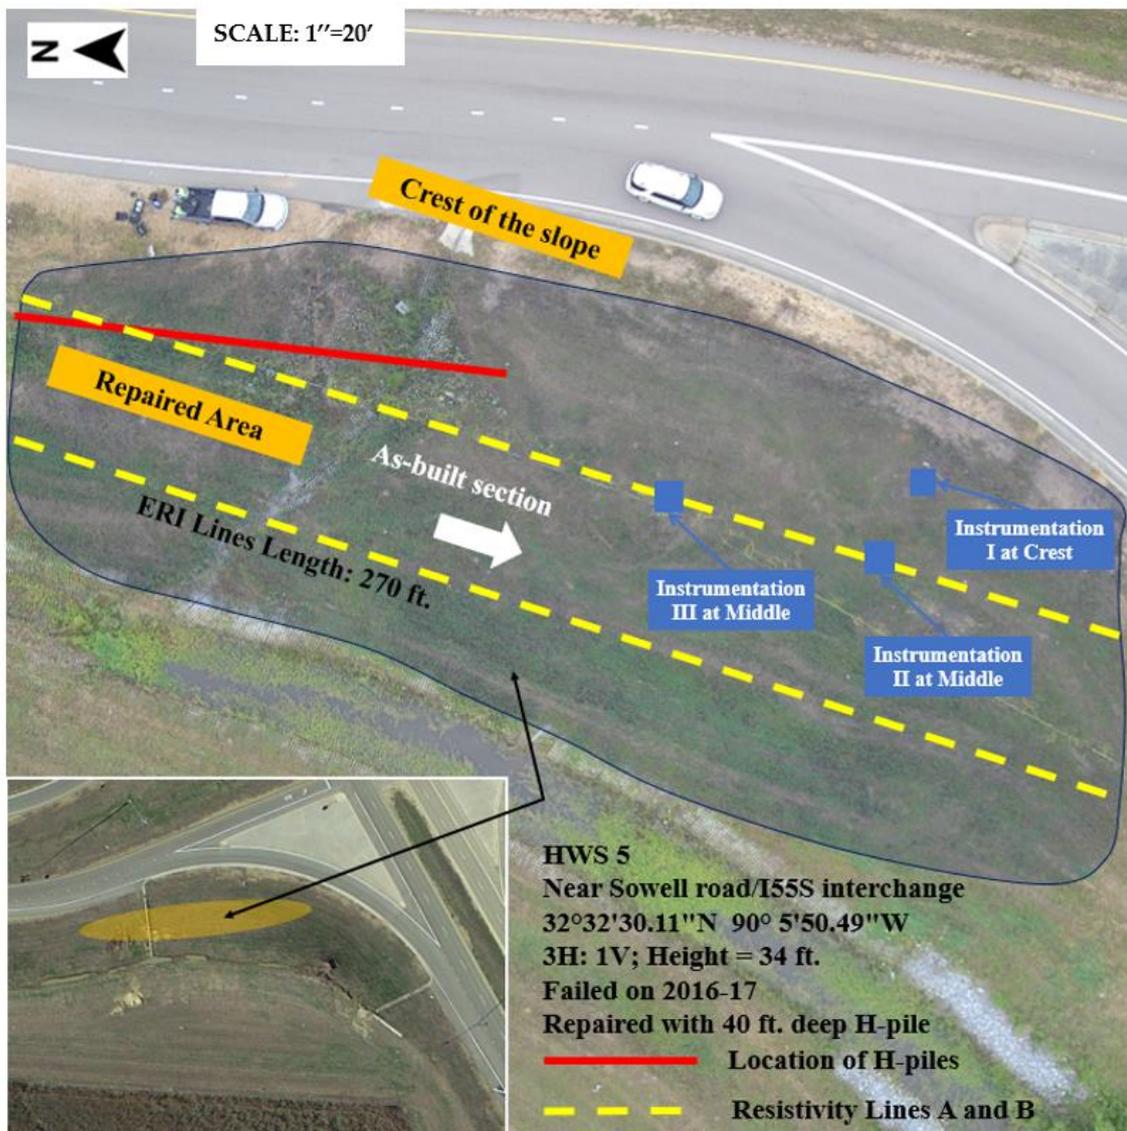
HWS5 is located along I55 South and Sowell Road and has reinforced and as-built sections, as presented in Figure 24. The failed area was repaired with a series of deep H-piles. Two 15 ft (5 m) boreholes were drilled at the as-built sections for instrumentation. These two boreholes were designated as Instrumentation I and Instrumentation II. A third 15 ft (5 m) deep borehole was drilled and then instrumented close to the reinforced section, which was designated as Instrumentation III. Instrumentation I was located at the crest, whereas Instrumentation II and Instrumentation III were located in the middle of the slope.

Figure 24. HWS 5 ERI and instrumentation layouts along with its characteristics (drone image-top view) (1' = 1 ft = 0.305 m).

The SMS varied with time only at the 5 ft (1.5 m) depth of all the HWS except for HWS 5, where significant SMS variation was observed at the middle of the slope as well (Figure 24). Following a brief decline in SMS potential at shallow depths, SMS values rebounded during the summer. This correlated to a decrease in the VSMC level at 5 ft (1.5 m) depth during the summer months because of decreased rainfall and increased temperatures. This suggests that in the slope soil layers (Yazoo clay) upper unsaturated zone, an inverse relationship exists between VSMC and SMS. However, there were no significant changes in SMS or VSMC associated with rainfall at depths of around 10 ft (3 m) and 15 ft (5 m). As a result, it can be inferred that the soil layers are completely saturated beyond the 10 ft (3 m) depth. Additionally, consistent with previous research on Yazoo clay HWS [25], rainfall water is retained in perched water zones at the shallow levels of the high-plastic Yazoo clay HWS. Furthermore, water infiltration to deeper levels takes a significant period of time, leading to trapped perched water zones.

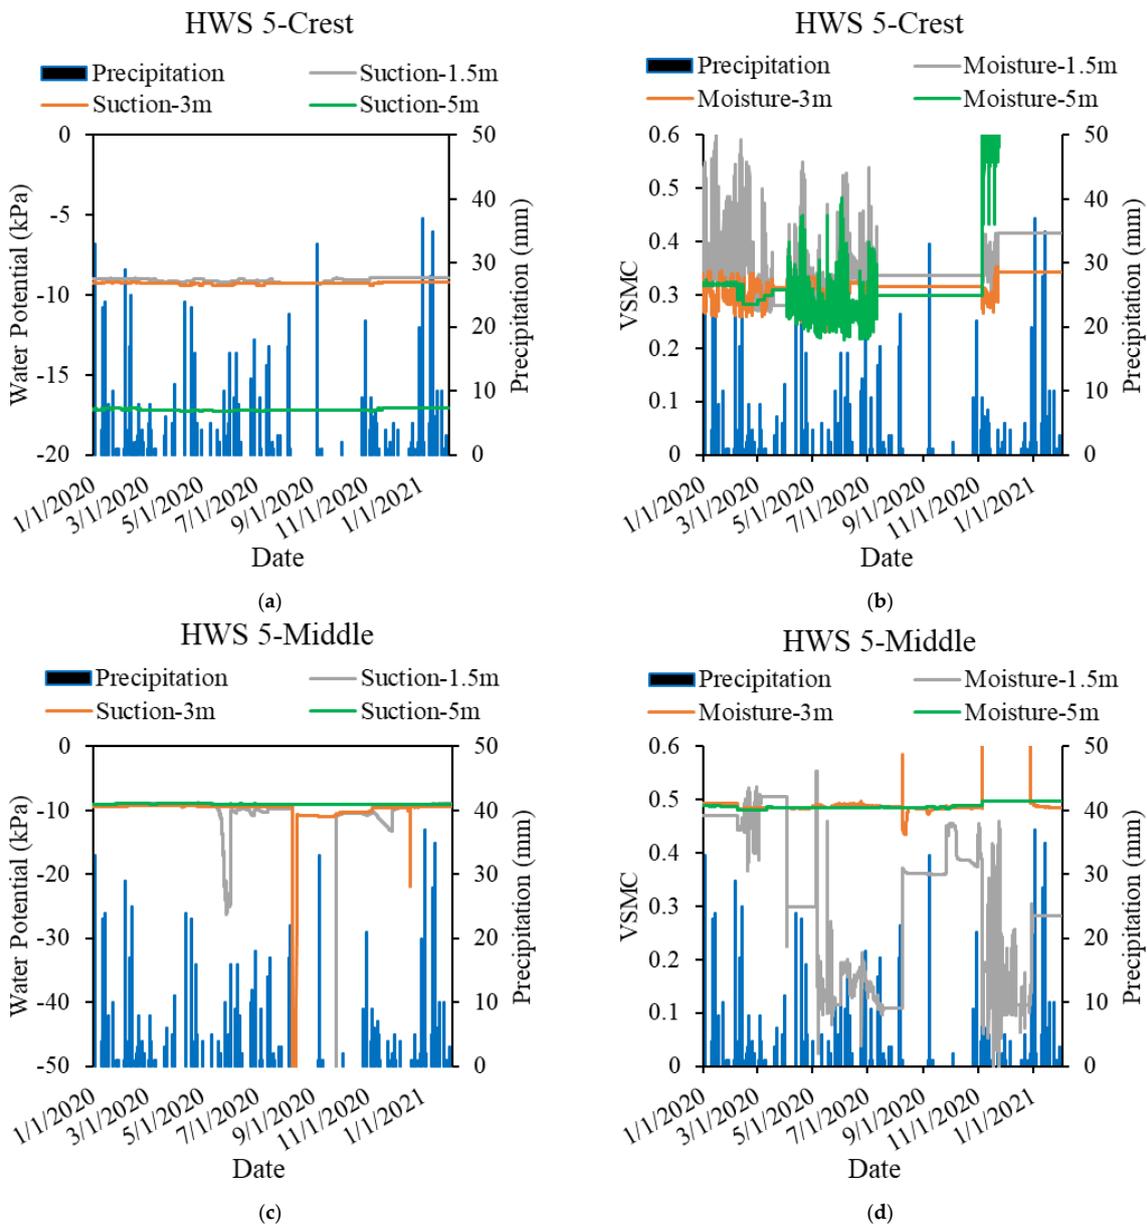
The sensor selection, arrangement and layouts are the same as the previously mentioned HWS instrumentation plans (Figure 5). Figure 25 presents the change in VSMC and SMS profiles with daily rainfall recordings at the crest and middle of the HWS and at different depths. Specifically, the results are recorded at three instrumentation locations (I, II and III) and at three different depths 5 ft (1.5 m), 10 ft (3 m) and 15 ft (5 m). Since the slope has experienced a failure during the early part of this study, special emphasis was given to the rainfall before the failure. Based on the instrumentation results, the SMS of the slopes remains constant after the preliminary 2–3 months of the observation period. In addition, the lower SMS value was present at the top part of the slope, which signifies low shear strength and high VSMC. The slope has experienced a significant VSMC variation during the dry period, mostly at 5 ft (1.5 m) and 10 ft (3 m) depths. This significant variation of VSMC indicated that the slope had shrinkage cracks during the summer, creating a preferential path for rainwater infiltration.

Figure 25. HWS 5 in situ variations with rainfall (a) SMS across the crest of the slope (b) VSMC across the crest of the slope (c) SMS across the middle of the slope (d) VSMC across the middle of the slope (1 m = 3.28 ft; 1 mm = 0.039 in; 1 kPa = 20.89 psf).

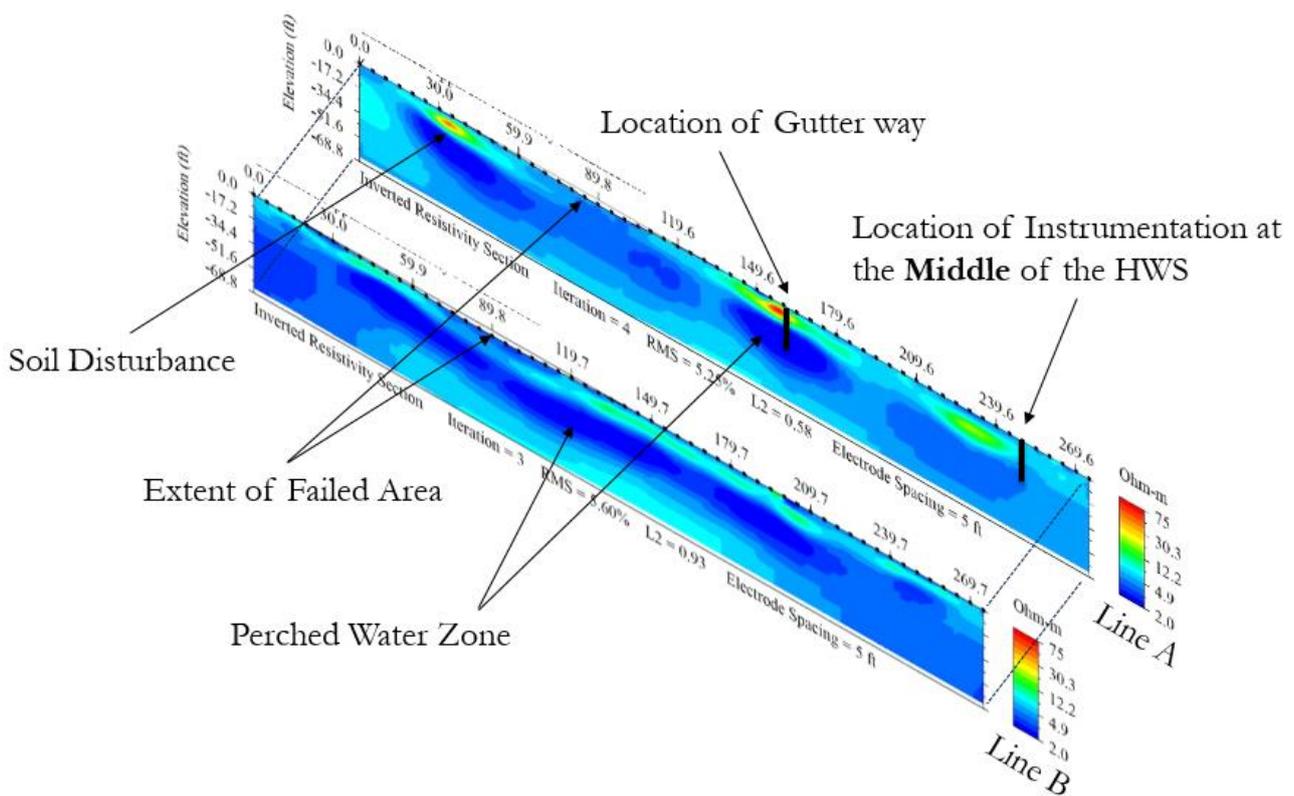
Figure 26 presents the ERI inversion profile results for both line A and line B. The formation of the perched water zone can be noticed in deeper soil layers and along the slope. Some minor soil displacements occurred at the slope soil surficial layers. The developed perched water zone under the location of the gutter way indicated that part of the rainwater infiltrated and trapped in deeper soil layers, which are high plastic clay soils. Comparing ERI results with the field instrumentation results, it is observed that both VSMC and SMS showed higher variations along depths. It was observed that the location of the instrumentation in the middle of the slope is not close to the perched water zone, unlike the other slopes in this study.

Figure 26. HWS 5, 2D ERI test profile at line A and at line B tested on 13 January 2021 (1 ft = 0.3 m).

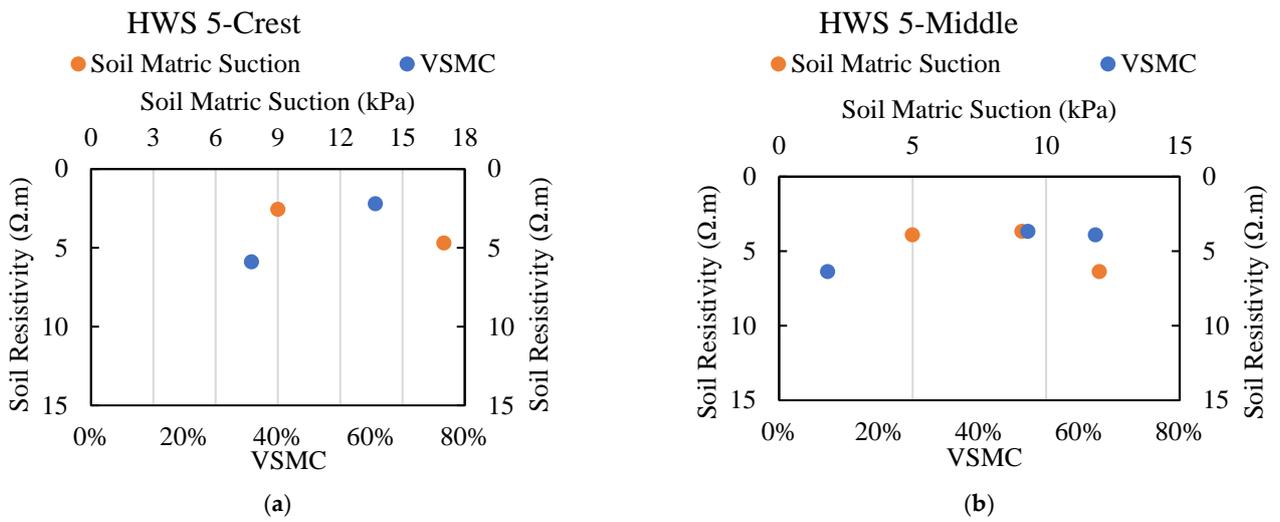
The ERI test results comparisons with VSMC and SMS at different locations are presented in Figure 27. The expected relationship between resistivity, VSMC and SMS is such that lower resistivity values correspond with higher VSMC and lower SMS. However, in most of the HWS in this study, the expected relationship between ERI, VSMC and SMS did not exist. Resistivity and SMS values were observed to be low for HWS5, and the VSMC did not play a role in impacting these values. This is because the HWS soil body was either partially saturated or fully saturated for most of the year due to recurrent rainfall events. ERI results show low resistivity values all over the HWS subsurface, indicating the likelihood of perched water zones all over the subsurface.

Figure 27. HWS 5 comparison of 2D ERI test profile with field instrumentation (a) At crest of the slope (b) At middle of the slope (1 m = 3.28 ft; 1 mm = 0.039 in; 1 kPa = 20.89 psf).

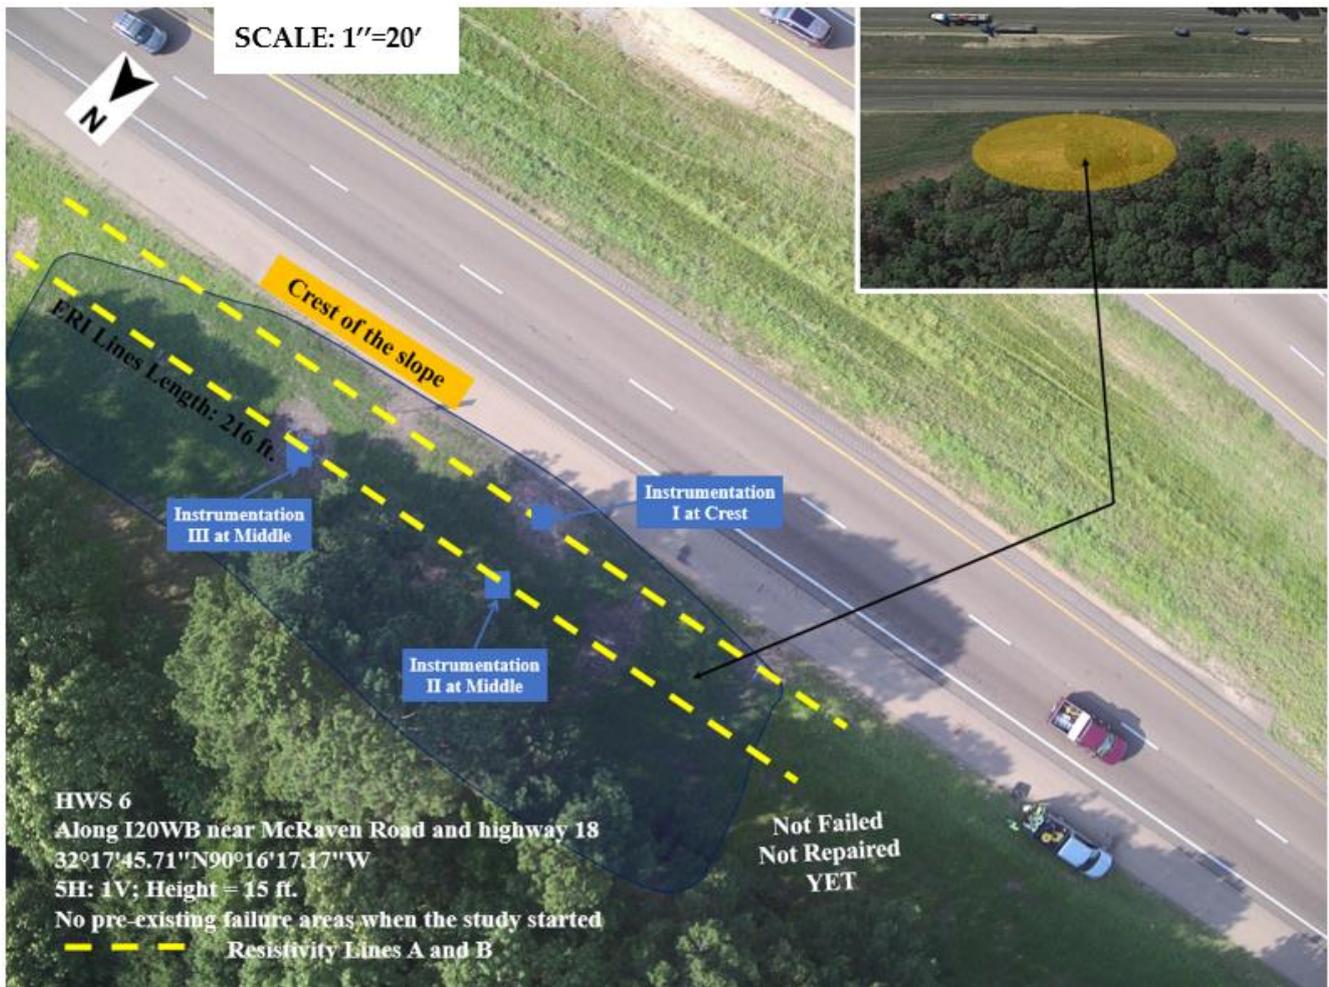
HWS 6 is located along I20 E near McRaven road. The HWS6 descriptive illustrations are presented in Figure 28. The HWS has shown signs of movement. Three 15 ft (5 m) boreholes were drilled and then instrumented at the crest, middle and toe of the slope. In Figure 28, the three instrumentation locations are designated as Instrumentation I, Instrumentation II and Instrumentation III.

Figure 28. HWS 6 ERI and instrumentation layouts along with its characteristics (drone image-top view) (1' = 1 ft = 0.305 m).

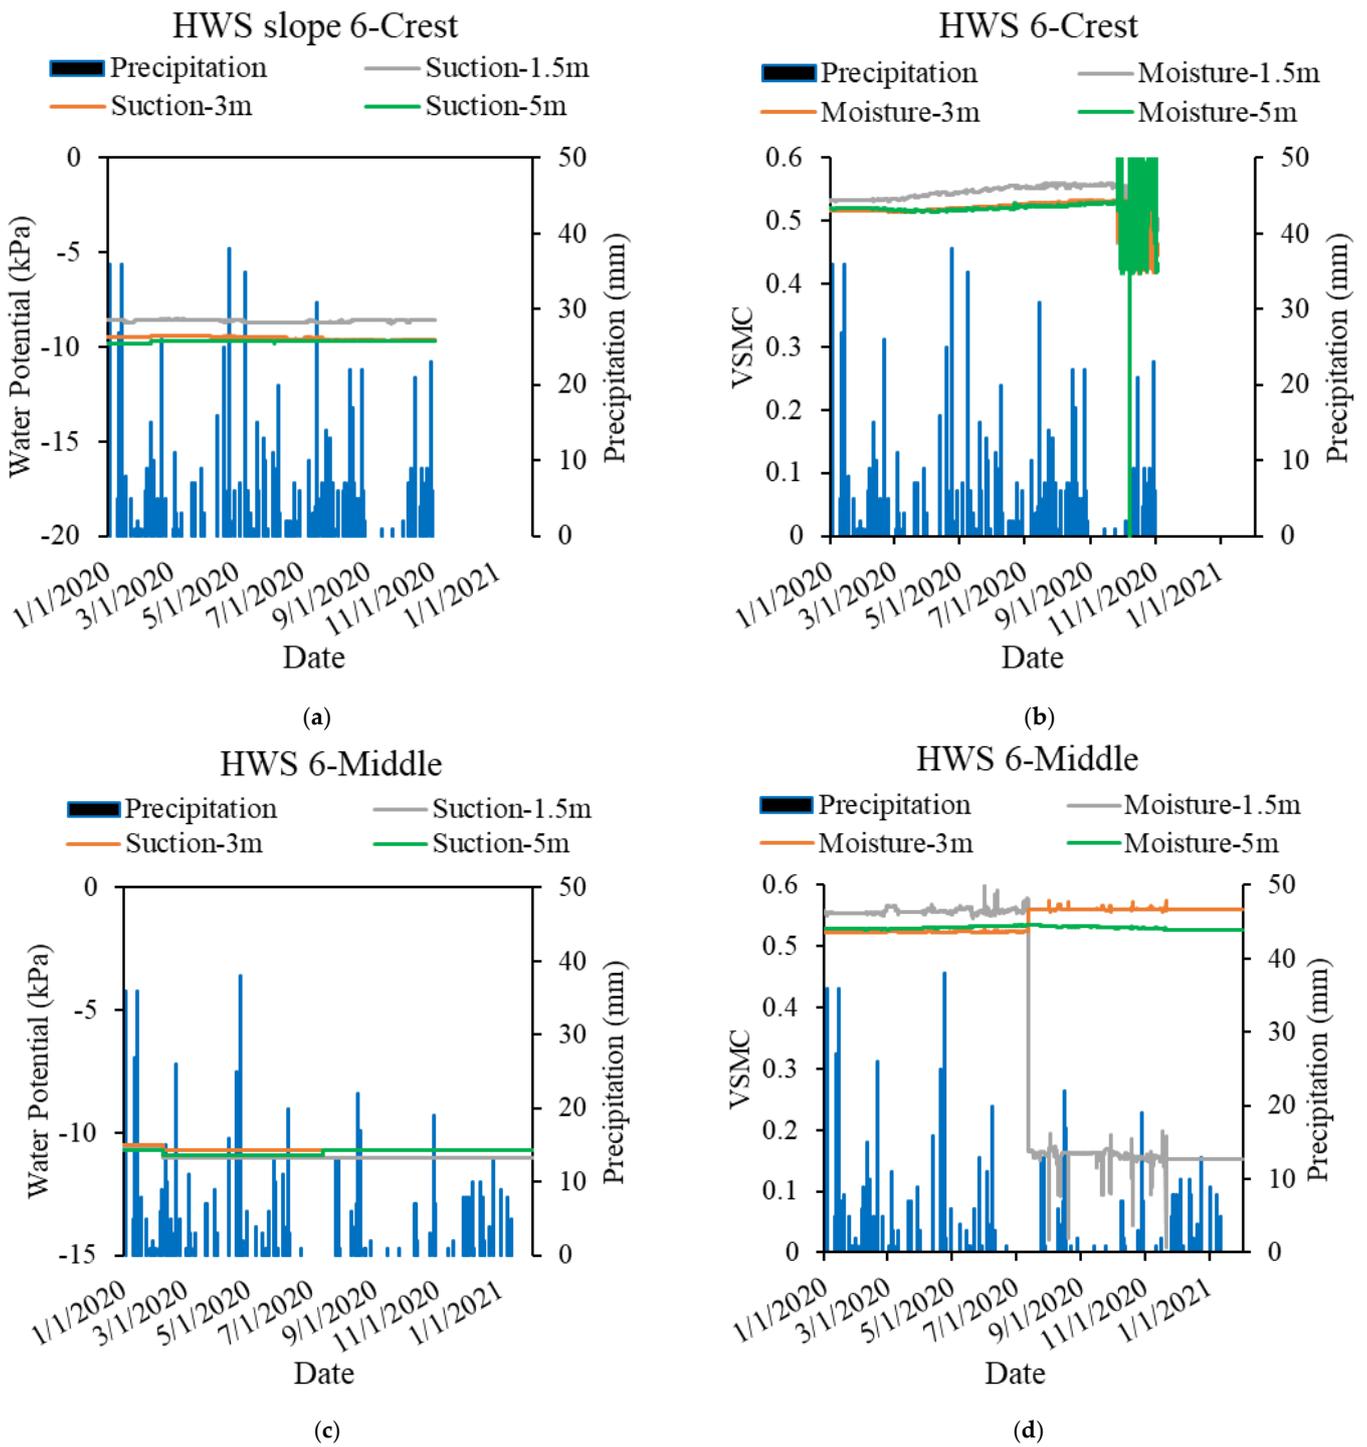
Similar to the previously mentioned HWS, in each of the instrumentation locations, at 5 ft (1.5 m), 10 ft (3 m) and 15 ft (5 m) depths on HWS6, a moisture sensor and a water potential sensor were installed. Additionally, a rain gauge and air temperature sensor were installed at Instrumentation 1 at slope 6 (Figure 5). Variations of in situ VSMC and SMS profiles at 5 ft (1.5 m), 10 ft (3 m) and 15 ft (5 m) depths with rainfall at the three instrumentation locations are presented in Figure 29. Based on the field monitoring results, the SMS has a high number for around three months and then reached an equilibrium condition. SMS values observed were low and did not change much over the course of the monitoring period, similar to other HWS. VSMC also showed low variations throughout the monitoring period, except during late 2020 and early 2021. As observed from the ERI results shown in Figure 30, the soil is likely to be close to a fully saturated condition. Therefore, VSMC and SMS did not show many variations.

Figure 29. HWS 6 in situ variations with rainfall (a) SMS across the crest of the slope (b) VSMC across the crest of the slope (c) SMS across the middle of the slope (d) VSMC across the middle of the slope (1 m = 3.28 ft; 1 mm = 0.039 in; 1 kPa = 20.89 psf).

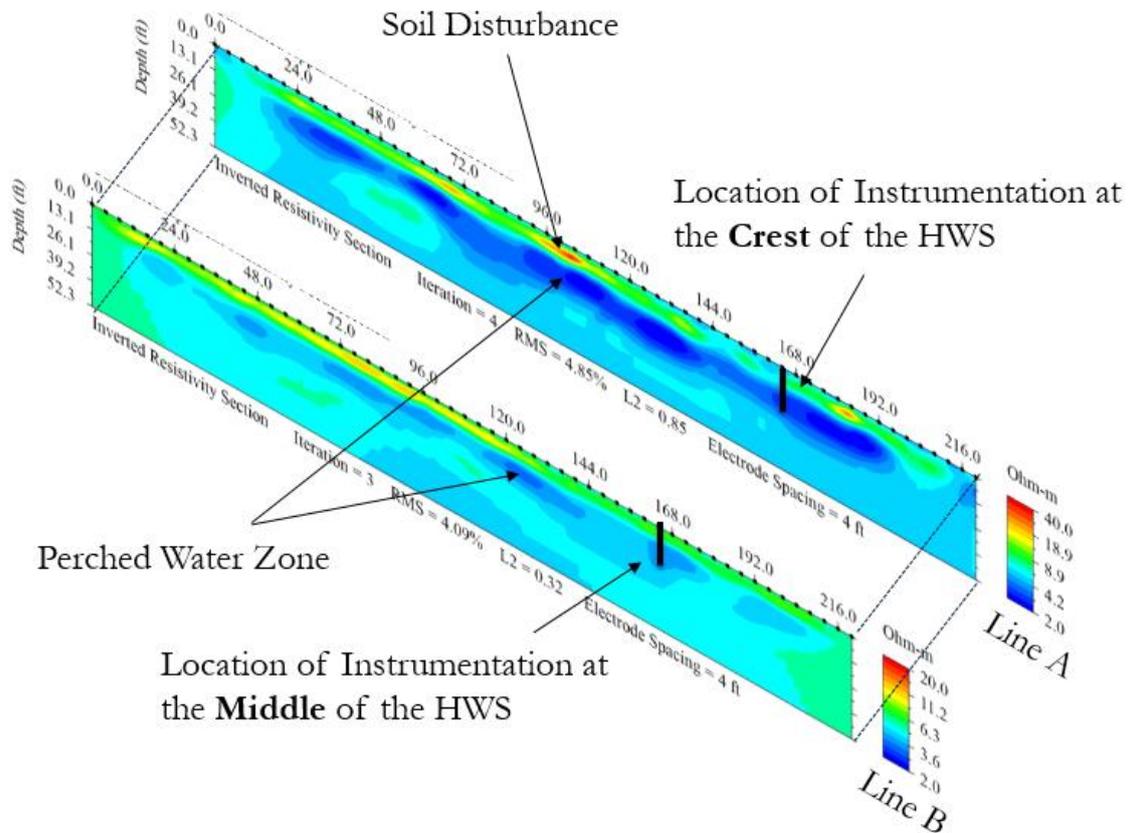
Figure 30 presents the ERI test along a 217 ft (66.1 m) length of the crest and middle (lines A and B) of the HWS6. The ERI inversion images reveal a relatively high resistivity at the top-soil layers due to the soil disturbance. It is observed that the location of field instrumentations located at the fully saturated zones with the developed perched water zones directly impacted the low variations in both VSMC and SMS in that specific area. Unlike the middle of the slope (ERI line B), the development of perched water zones was observed to be located almost in all deeper soil layers along with line A at the slope.

Figure 30. HWS 6, 2D ERI test profile at line A and at line B tested on 15 January 2021 (1 ft = 0.3 m).

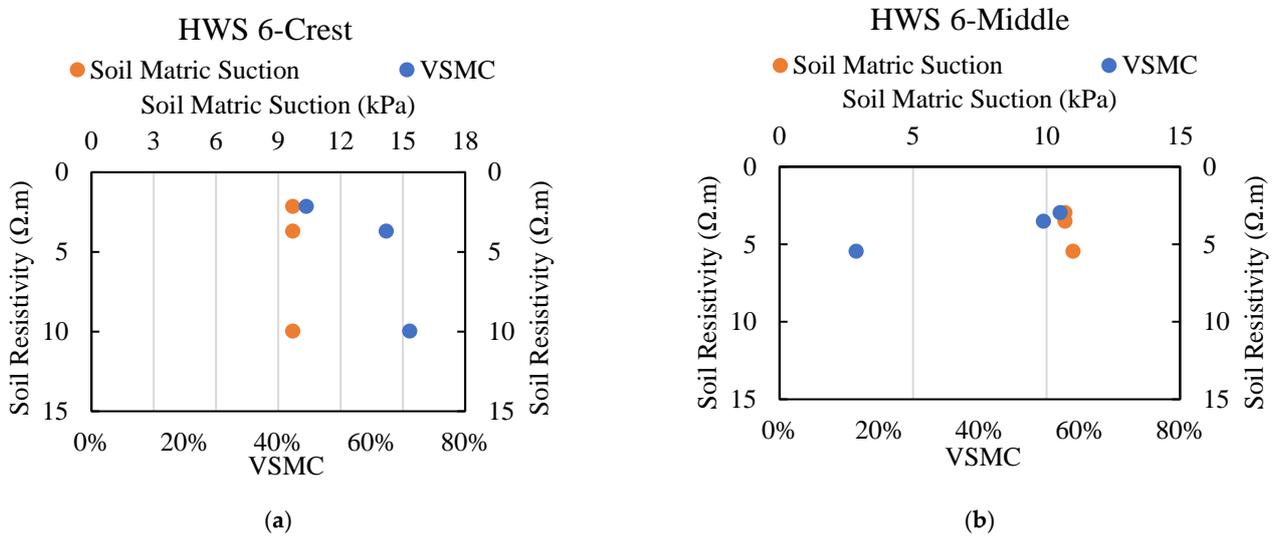
Figure 31 shows the ERI and field instrumentation results comparison for HWS6. It is observed that the values of the VSMC and SMS at the depth and location of the instrumentation did not have a significant impact on the soil resistivity variations. Due to the formation of perched water zone, recurrent rainfall events, soil type characteristics (high plastic clay soil) and the existence of shrinkage cracks, the soil has a low resistivity, relatively high VSMC and low SMS, which could be repeatedly observed in all studied HWSs.

Figure 31. HWS 6 comparison of 2D ERI test profile with field instrumentation (a) At crest of the slope (b) At middle of the slope (1 m = 3.28 ft; 1 mm = 0.039 in; 1 kPa = 20.89 psf).

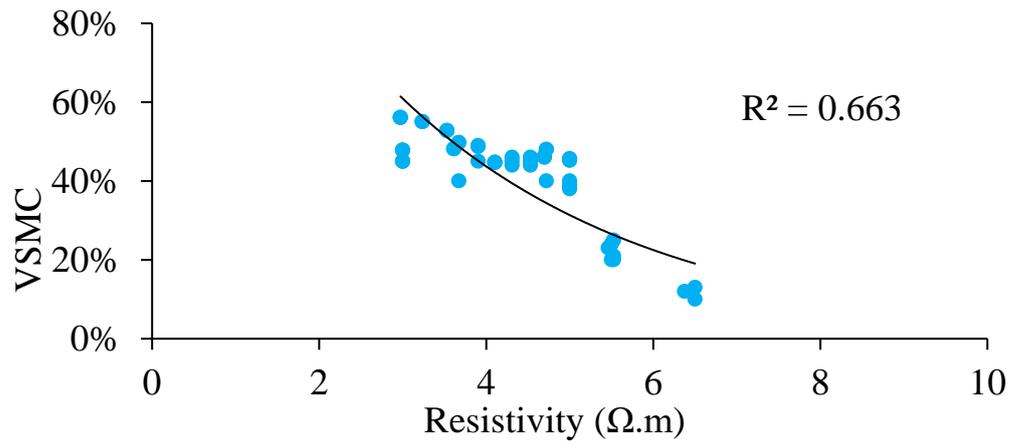
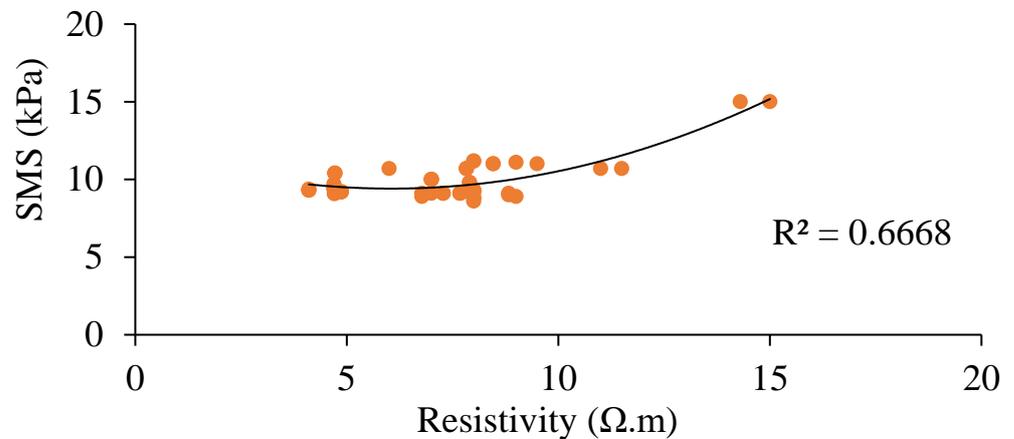
The variations of resistivity with soil SMS at the crest and the middle of the Jackson metro HWS as a group are presented in Figure 32b. In contrast to the exponential relationship between VSMC and resistivity, a polynomial function of the second degree provided a better fit (determination coefficient of 0.67) between SMS and resistivity. The analysis resulted in the following proposed model function (one-parameter model) expressed by Equation (7), where the soil resistivity and the soil SMS are denoted as ϵ and ω , respectively. It should be noted that the constants B_1 , B_2 and B_3 are fitting parameters as 12.04, -0.87 and 0.072 , respectively.

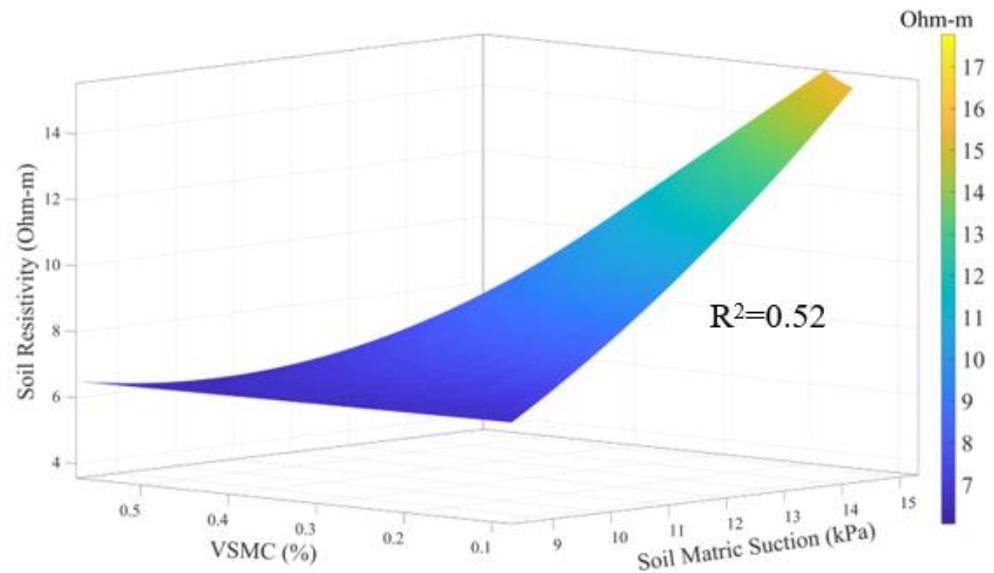
A 3D integrated model of the resistivity, VSMC and SMS is presented in Figure 33. The 3D plot showed that resistivity decreases as VSMC increases. On the other hand, resistivity increases while SMS increases. This symbiotic relationship between resistivity, VSMC and SMS can be very useful in inferring missing geotechnical parameters. For instance, using the predictive models developed in this study, the VSMC and SMS potential can be determined by resistivity data obtained from the non-destructive ERI test. In the presented 3D model, the soil resistivity, VSMC and soil SMS are denoted as ϵ , δ and ω , respectively. Then, the soil resistivity of the high expansive clay soil (HECS) of the HWS in an unsaturated two-parameter model can be described in Equation (8), where C_1, C_2, C_3 and C_4 are 3D media fitting parameters as 0 (when fixed at bound), 0.26, 24.11, 0.065 and -2.94 , respectively. It

Figure 33. Three-dimensional illustration of field-based soil resistivity function (1 kPa = 20.89 psf; 1 mm = 0.0396 in).

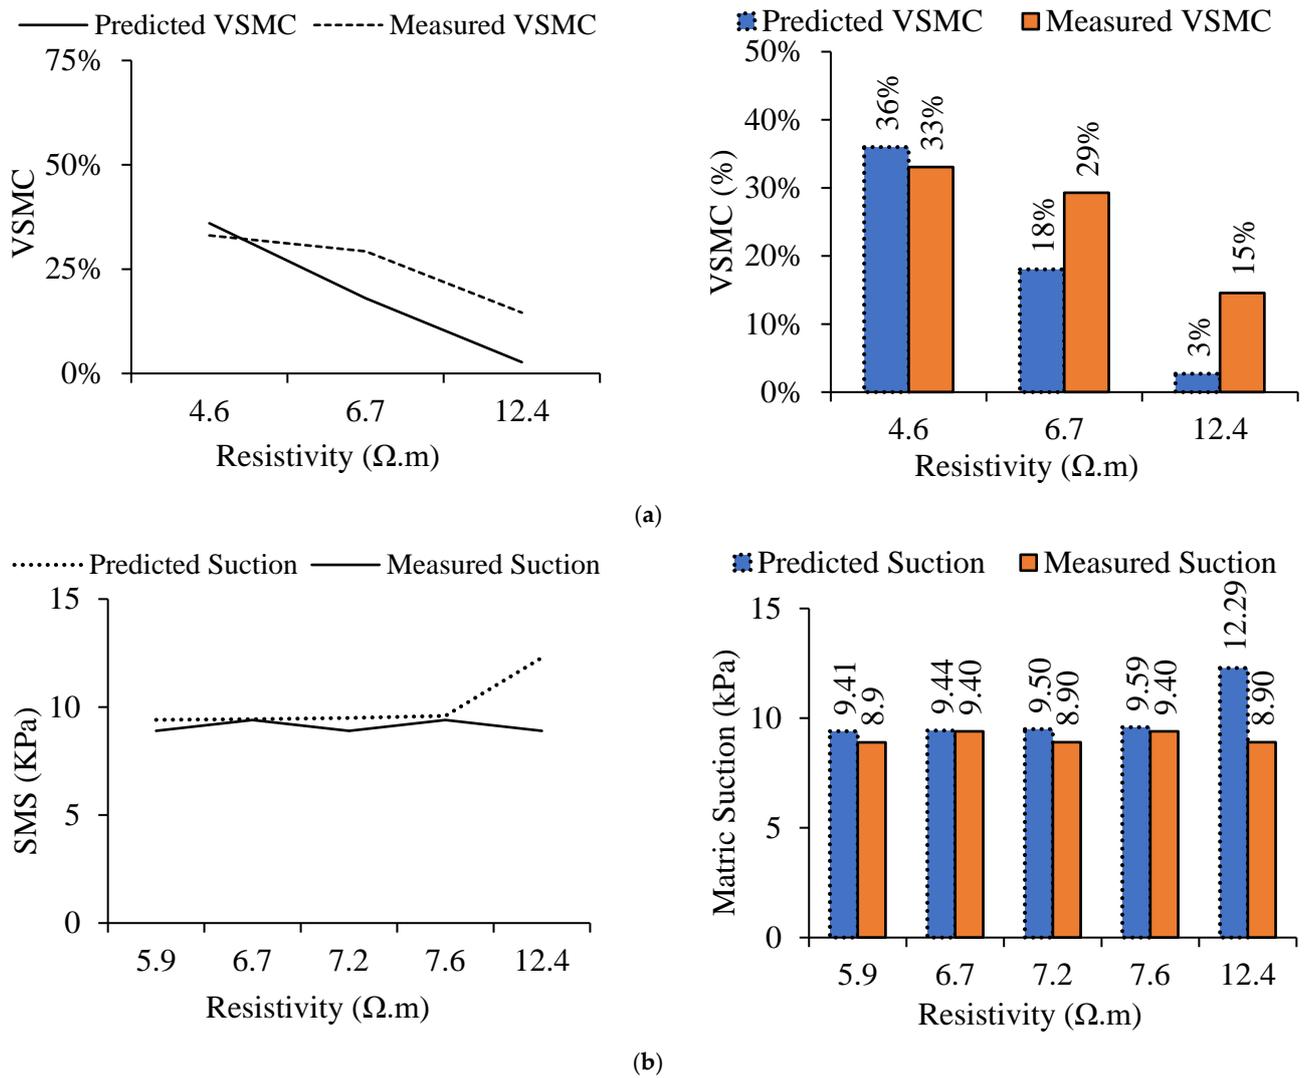
Figure 34 illustrate that for a given set of resistivity values at various depths, the exponential model predicted VSMC with fair accuracy, especially at the crest of the slopes. The VSMC recorded by the moisture sensor at the middle of the slopes was considerably higher than what the model predicted and therefore failed the validation test and has been excluded from the validation test. Figure 34 illustrate the capability of the developed model in predicting the SMS potential for a given set of ERI values. Five out of the six predicted SMS values were within a 10% error margin when compared with measured values, thus indicating a healthy predicting model.

Figure 34. Validation of the developed field-based models (a) VSMC (b) SMS (1 kPa = 20.89 psf).

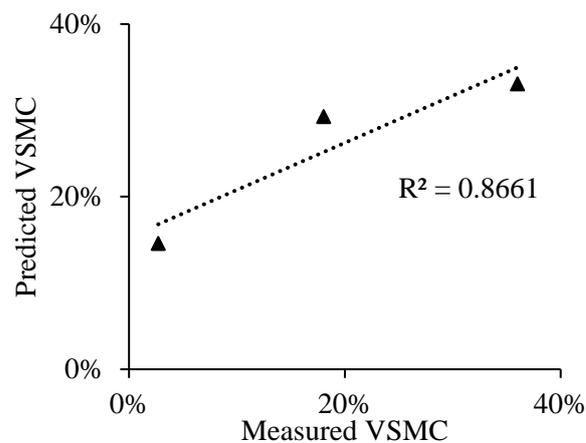
To test the accuracy of the predicted models, a comparison of the predicted and measured values for VSMC is presented in Figure 35. The prediction accuracy for VSMC is good (determination coefficient of 0.86), especially for the three data points for the crest of the slopes. The middle data of the VSMC predictions have been excluded as the exponential model predicted lower VSMC values compared to the measured ones. Figure 34d shows that over 80% of predicted SMS values matched with the measured values with minimal error margins. These results inspire confidence in the developed models to predict VSMC and SMS through resistivity data obtained from the ERI investigation.

Figure 35. VSMC field-based model prediction accuracy.
