Article

Earthen Construction: Acceptance among Professionals and Experimental Durability Performance

Keywords: earthen construction; natural materials; rammed earth; sustainability; CEB

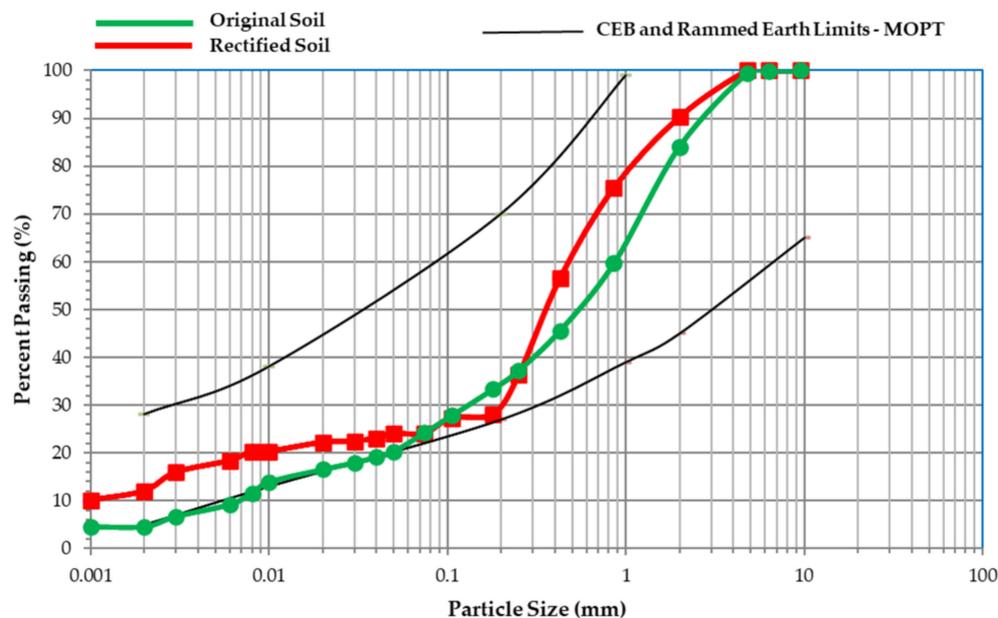
Figure 6. Particle size distribution curves of the original soil and the soil corrected with 8% kaolin. (Values of MOPT apud Muguda et al. [24]).

The soil used in this study was obtained from the Minho region in Portugal and was characterised through field and laboratory tests. In the first contact, observation, and field tests, it was possible to notice that it had a very rough and sandy characteristic. With little plasticity, the soil presented a need for correction with clay particles to become more propitious for earthen construction experiments, and 8% kaolin was added to facilitate this process. The granulometric curves of the original soil and the soil with the addition of kaolin can be observed in Figure 6 and are within the ideal parameters for useful soil in construction [22]. A granulometric analysis of the soil by sedimentation was carried out based on the LNEC E-196 standard [23]. The study used a clear, yellowish kaolin which was washed with a hydrocyclone and dried at the factory. According to data provided

by the company Mibal, kaolin has a density that varies between 2.4 and 2.7 g/cm³ and a fineness that is essentially between 2 and 30 µm. To reduce the shrinkage content, the soil used for producing the RE specimens was supplemented with 40% fine gravel (up to 10 mm).

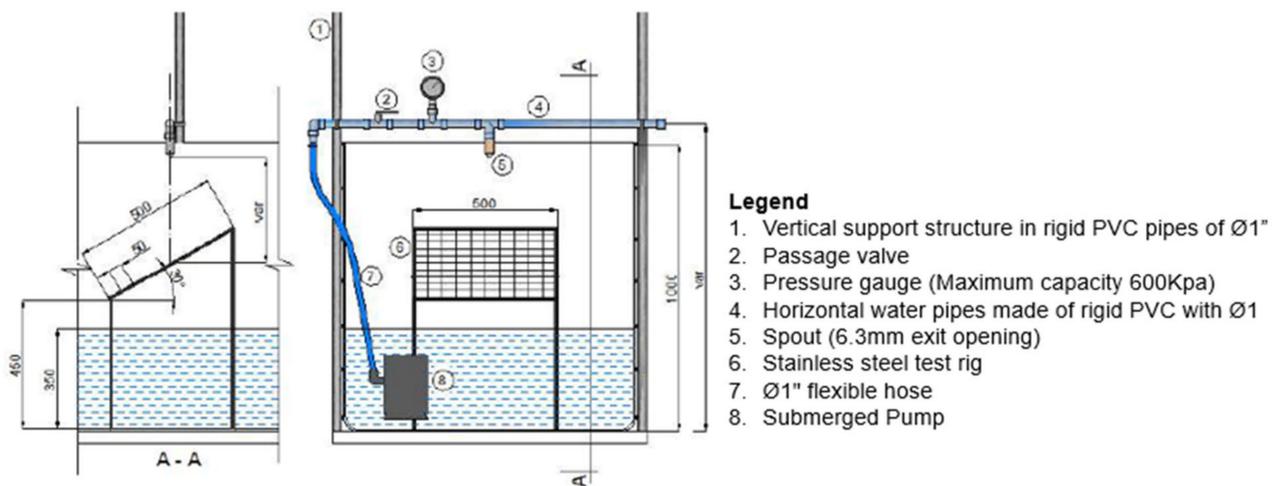
Figure 7. Rain simulating equipment (mm) (image source: Rezende et al. [32]).

This test is based on the ASTM D559 [31] standard and the method developed by Rezende [32] to evaluate an accelerated degradation test rain simulator. At 60 days of curing, the samples were placed in an oven at 70 °C for an initial drying period. They were then weighed and left at an ambient temperature for a few hours to cool down. The rain simulation was then initiated, alternating with drying periods of at least 14 h at 70 °C in an oven. During the rain simulation, the specimens were positioned on a 50 mm × 50 mm stainless steel grid platform that allowed the water to fall (Figure 7). The wetting and drying cycles were repeated for three consecutive days. The water erosion test simulated periods of rain, considering the highest average annual rainfall in Portugal and corresponding to an exposure time to weathering of between 43 and 64 years, depending on the type of specimen and distance from the water jet, according to the methodology of Rezende et al. [32]. Therefore, the longevity level of the two studied construction techniques can be estimated.

The sample was subjected to a flow rate of 14.26 litres/min and a water outlet pressure at the nozzle of 45 kPa, which is consistent with the pressure values for erosion tests referenced in international standards [32], see also Figure 8. The results were analysed after three cycles, and the mass losses and changes in the water volume of the specimens were verified. The mass variation was checked at the end of each cycle, and the ratio between the mass of the specimen after the first and third cycles was used to evaluate the change in mass of the specimens. The result was computed based on the NBR 13554 standard [33]. Following each rain simulation cycle to which the specimens were subjected, a visual evaluation was performed to document the changes.

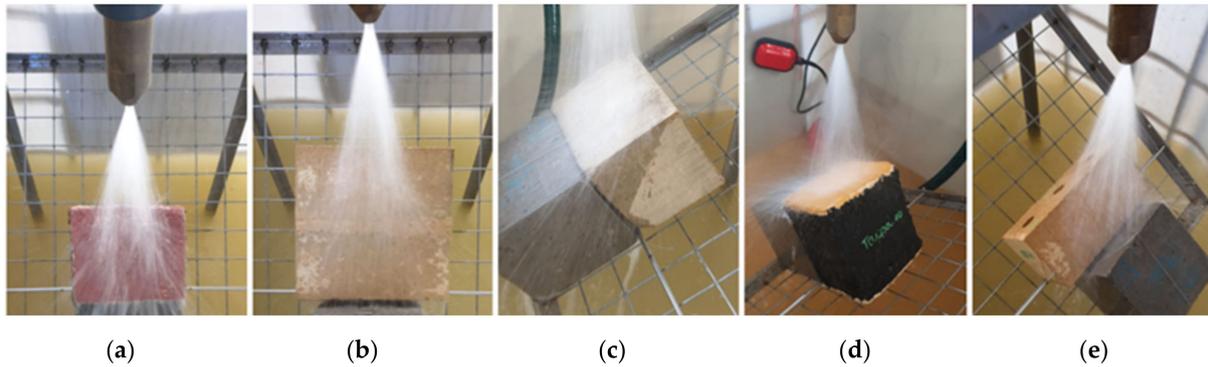
Figure 8. Testing specimens of different types: (a) RE specimen with mortar and paint; (b) CEBs united; (c) RE specimen without finishing; (d) RE specimen with two-sided plaster and paint; (e) CEB.

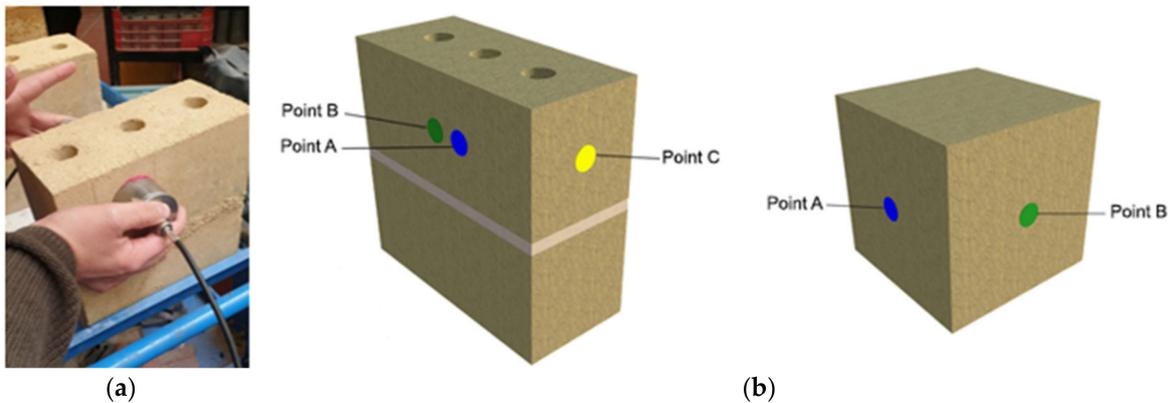
Figure 9. Ultrasonic test: (a) equipment, transducers and specimen; (b) measurement reference points in each specimen typology.

The equipment used was the *Pundit Lab + Ultrasonic Instrument* from PROCEQ. With cylindrical transducers, a mass was used as a conductor between the transducers and the specimens’ surfaces. Prior to the beginning of the measurement, it was always necessary to calibrate the transducers so that they had a calibration of 25.4 μs. The frequency used was 54 kHz, the length to be measured and adjusted before each measurement [34]. The testing process was based on EN 12504-4 [35], and Figure 9 shows the reference points for the measurement of the RE and CEB specimens.

As direct measurements of the specimens were made, the transducers were positioned face-to-face on opposite sides of the specimens, and each measurement was performed three times and then averaged. The readings were made before the durability tests and at the end of the cycles. The measuring distances are present in Table 2.

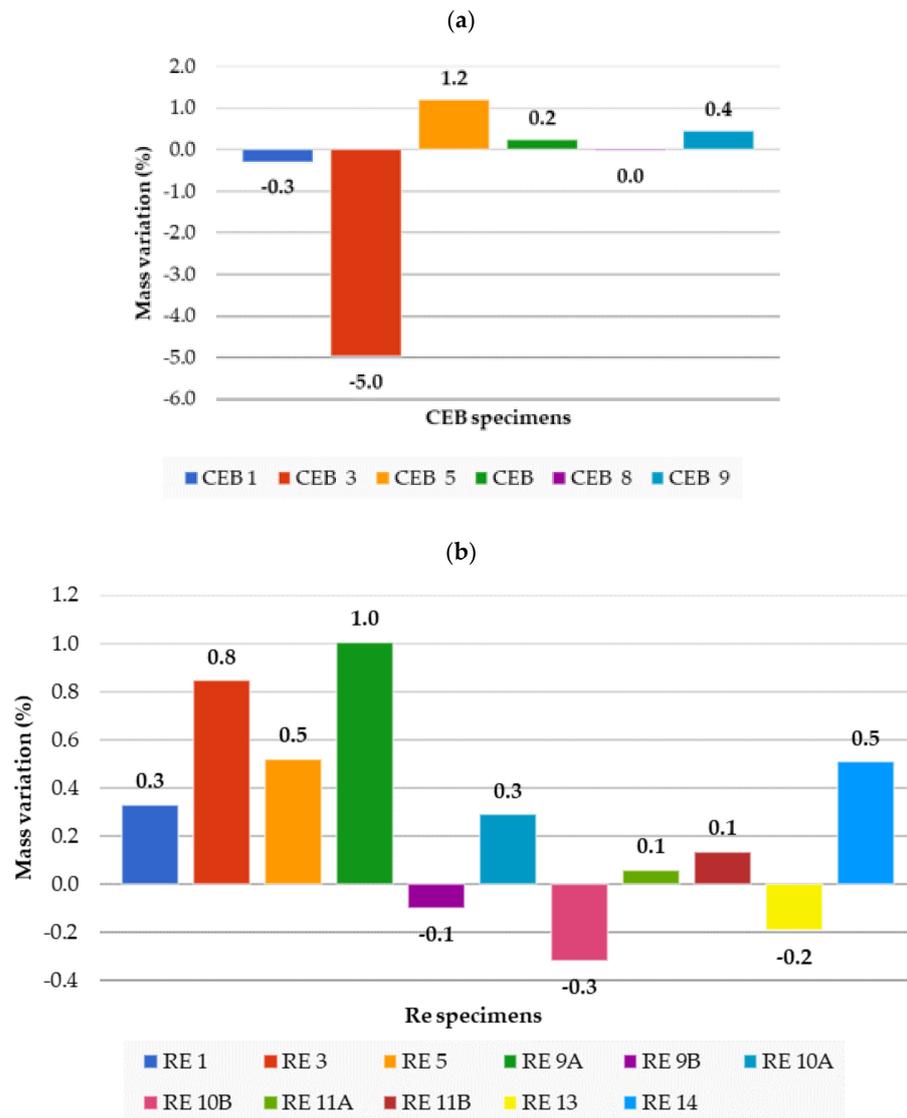
Figure 10. Mass variation: (a) CEB specimens; (b) RE specimens.

During the cycles, all visual changes suffered by the specimens were observed, such as colour change, the appearance of or increase in cracks or holes, a change in surface texture, and the loss of protective finishing. Regarding mass loss, some non-stabilised samples suffered a significant mass loss in the erosion test, resulting one of the non-stabilised rammed earth specimens losing more than 42% of its mass in 15 min of exposure to water. However, specimens with stabilizing materials or with coating mortars obtained lower variation values that were almost null (Figure 10).

Depending on the composition of the specimens, some showed no signs of erosion and even increased in mass. However, with the addition of hydrated, the specimen CEB 3 experienced a 5% decrease in mass, which suggests a potential material loss or an increase in voids. Despite this loss, there were no visual indications of mass loss. The study by Guettala [10] on CEB revealed that there is a mass loss of 1% in soils with the addition of 5% cement and a mass loss of 2% in soils with the addition of 8% lime, which compares well with the results obtained in this study, see Figure 6. One factor that masks the mass loss is the drying period, which may not be sufficiently long enough to completely evaporate the water contained in the specimens at the time of measurement. Repeating the tests with specimens of the same type can also help to identify the variation trend of each type of composition.

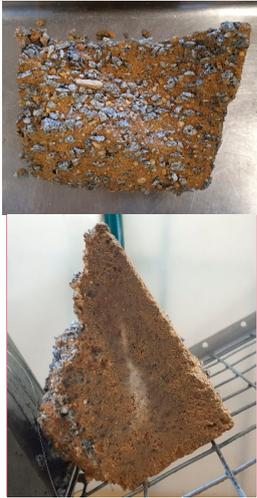
-	-
	2	Loss of much of the volume in 15 min of water jet exposure.	-	-
	3	Loss of almost 50% of volume	-	-

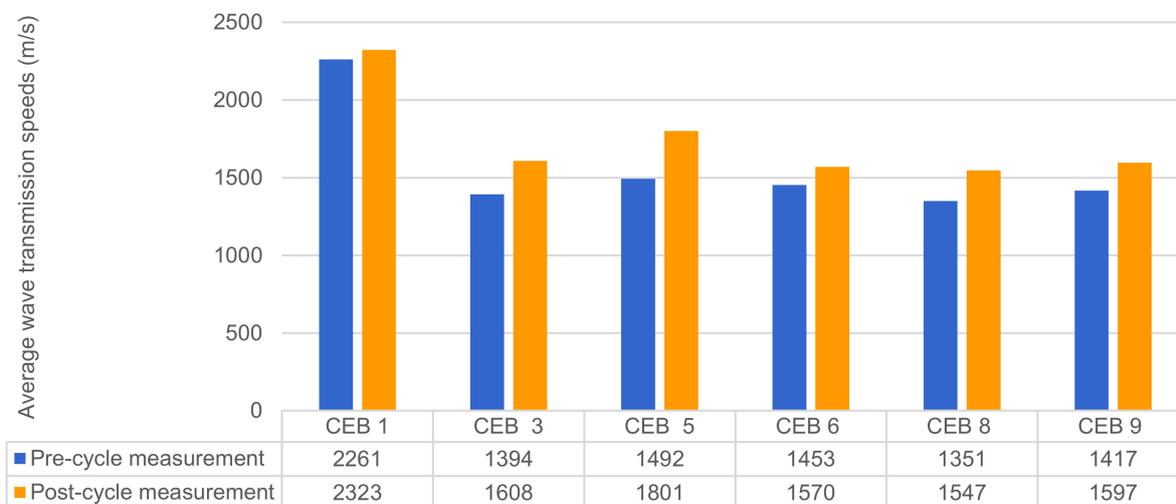
Figure 11. Comparison of the average variation of CEBs before first and third cycles.

Figure 11 shows the average of the three ultrasonic readings taken before and after the cycles. CEB 1, which received cement additions, demonstrated a velocity significantly higher than the other CEBs with lime additions. This difference seems to indicate that the

Concerning the variation in wave velocity in the CEBs before and after the cycles, it is possible to observe that this variation is always positive. In the case of cement, the presence of water increased the formation of solid crystals and promoted the cohesion of the material. In the case of quicklime, the hardening was due to carbonation, which can also be increased in the presence of water since water carries CO₂, also promoting the cohesion of the material. However, it takes a long time due to the slow carbonation process, which justifies the higher values since the first measurement for specimens with cement at the test age (between 60 and 70 days). Another study using specimens stabilised with lime stated that the honeycomb structures can be broken up but will agglomerate again and form more entangled structures that improve cohesion; although they have more voids, they have less bonding between them [42].

It can also be seen that the specimens with added lime obtained greater variations before and after the cycles. CEB 5, with the addition of quicklime and traditional varnish painting, was demonstrated the greatest variation of more than 20%. This may be because the drying time was insufficient for this specimen due to the varnish layer. It was observed during the tests that this specimen created an area of vapour between its base and the surface where it rested during the ultrasonic measurements. Among the CEBs with a lime addition, CEB 6, which had a lime addition and was without finishing, presented the lowest variations in wave velocity.

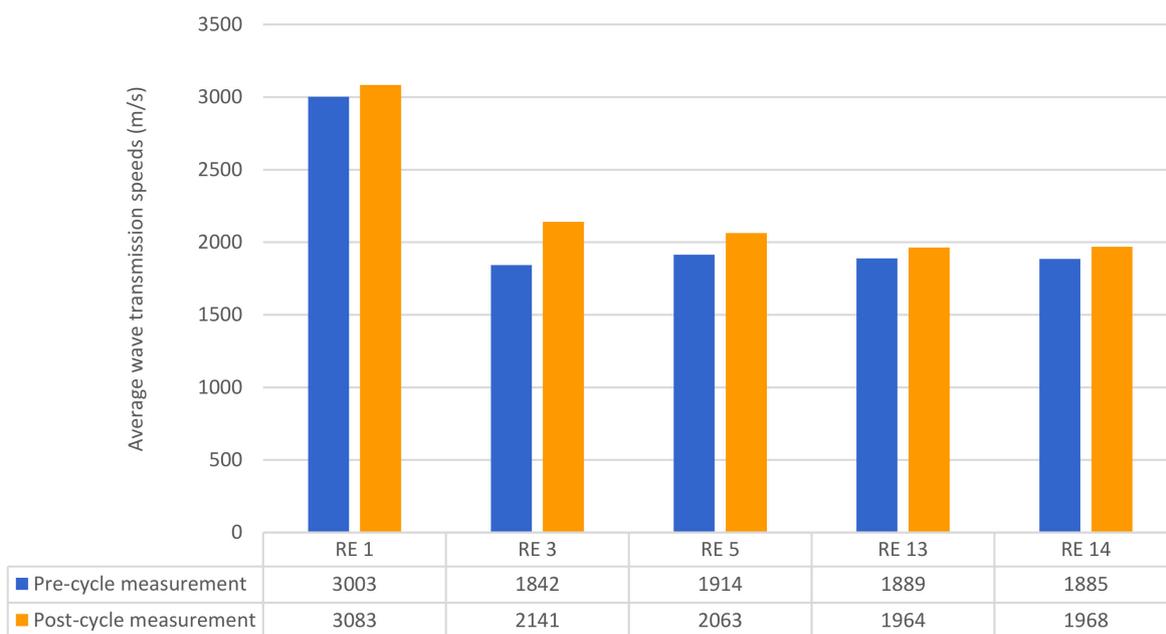
Figure 12. Comparison of the average variation of RE specimens between first and second cycles.

Figure 12 shows the results of the ultrasonic analysis performed on the RE samples. Here, a similar behaviour to the CEB samples was found, but with lower variation values. The results show that RE1, with the addition of cement, had a higher velocity and was very expressive concerning the other lime addition samples, confirming the trends already discussed for CEB samples.

The RE 3 specimen showed the highest variation (the addition of hydrated lime and without mortar). The washing of the hydrated lime and fines likely caused a considerable readjustment of the materials, with a greater chemical bond between the additive and the soil, although more characterization tests would be necessary to prove this reaction. The RE 1 sample (the addition of cement) varied the least, with a very small difference concerning the RE 13 sample of only just over 1%, followed by the sample of RE 14, with which it also maintained a small difference of almost 2%. The RE samples that received different finishes on more than one face did not have their ultrasonic measurements checked because the result of the ultrasound analysis would be inconclusive since the specimen would be influenced by the tests previously performed on one side with a different finish.

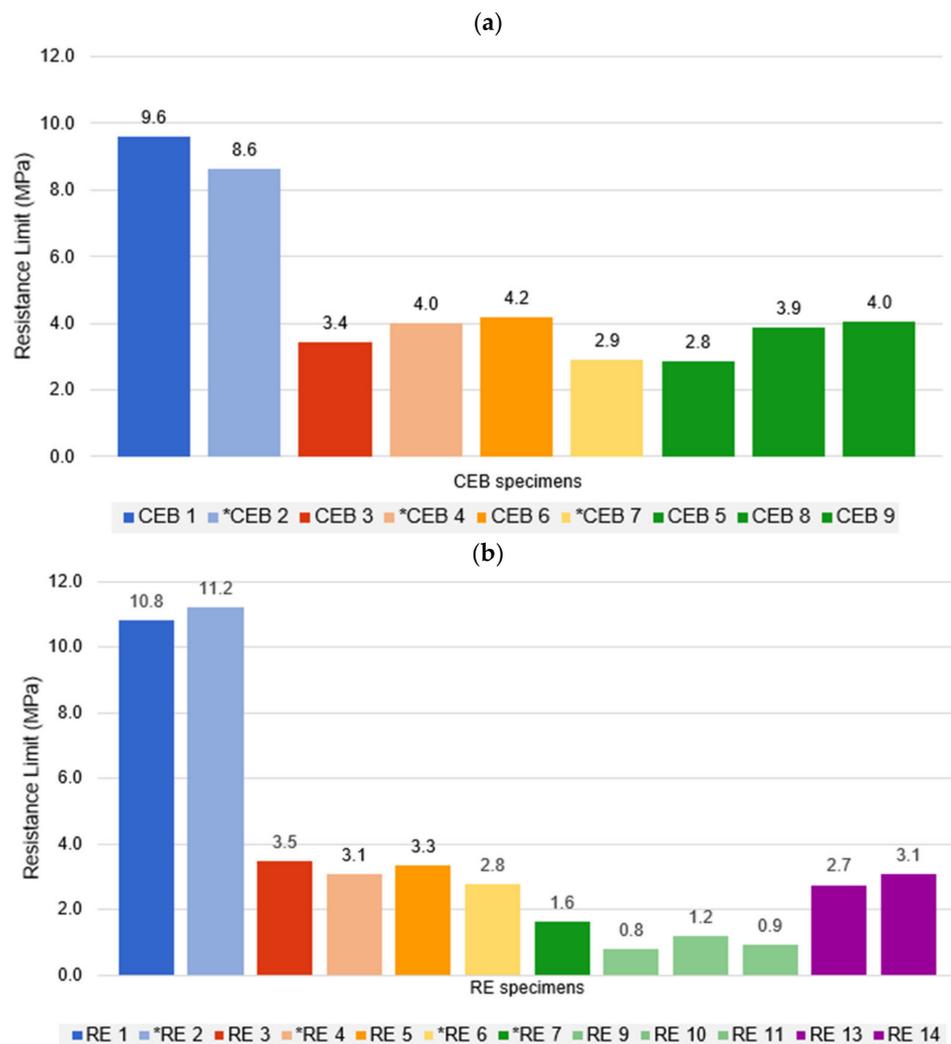
Figure 13. Compressive strength: (a) CEB specimens; (b) RE specimens (specimens marked with an asterisk were not tested for erosion).

The samples in blue colours represent those with cement additions, which presented higher compressive strength results, as expected. The dark blue specimens are the ones previously submitted to the erosion test. In the case of the CEBs, water-exposed CEBs presented higher strengths than their equivalents that were not exposed to water, because the action of water on the specimens, as a cohesion factor of the composite materials, caused an improvement in their performance in terms of compressive strength. The same increase occurred with the samples of RE that had additions of hydrated lime and quicklime. On the other hand, the RE specimens with the addition of cement showed a slightly lower strength limit than similar specimens that were not exposed to water, and the same occurred for the CEBs with an addition of hydrated lime (Figure 13).

The specimens with different surface finishes can only be compared with those without finishes. The green coloured CEBs with the addition of quicklime and protective finishes can be compared with CEB 6 and CEB 7 (without finish), which obtained equivalent results. In the RE results, the light green specimens with different finishes and without stabilizer can be compared with specimen 7 (without stabilizer), though it was not exposed to the rain test. These specimens (RE 9, 10 and 11) have lower resistances and the lowest of all specimens produced, which can be explained by the fact that these specimens had twice the exposure time to water action than the rest of the RE specimens since they had two sides with different plasters and finishes which were tested on separate occasions. The purple-coloured specimens, with added quicklime and paints, showed results equivalent to the specimens RE 5 and 6, with the same type of stabilizer and without protective finishes.
