# Feasibility of Using Green Laser in Monitoring Local Scour around Bridge Pier

**Abstract:** Scour around bridge piers is considered as one of the major factors which causes failure of bridges in the United States. An undetected scour can affect the stability of the bridge, eventually leading to the collapse of the bridge. The experimental investigation of scour around a pier using a non-contact measuring method is carried out in this research. A green laser-based non-contact ranging technique is performed on a prefabricated scour hole to study the factors influencing the ability to reconstruct the shape of a scour hole. The experiment was conducted in a 10 ft diameter pool and Leica scan station II was used for the scanning of the scour hole. The turbidity of the water was changed by adding Kaolinite powder to the water. The turbidity was varied from 1.2 NTU to 20.8 NTU by adding Kaolinite. The lab experiments involved changing the turbidity of water to simulate real world conditions. The results from the experimental study show that the turbidity of the water has a direct dependence on the efficiency of the green laser to map the underwater scour profile. The ability of the gre

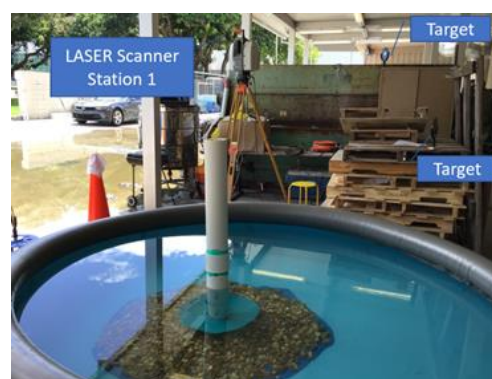
**Figure 6.** Scan station one in operation [35,36] (used with permission).

The penetration depth of the green laser depends on the type and power of the green laser, relative Secchi depth and the turbidity of the water [39]. To get full 360° view of the scour hole, two scan stations are set up as shown in Figures 6 and 7. The six set of trials were conducted at these two stations. The parameters considered here during the underwater scanning are point density, reflectance, minimum range, and maximum range. For the experiments, the point spacing considered is 5 mm at 15 feet range. 1% reflectance of incident energy is also considered here for the scanning. Once the pool is setup with a fabricated scour hole and pier, the tripod with laser scanner is levelled and connected to cyclone software for data collection. A total of five targets were used to record (merge) the three-dimensional laser scan data collected from the two stations. Two out of the five targets are visible in Figure 6. All the five targets used for registration were visible from both the stations.

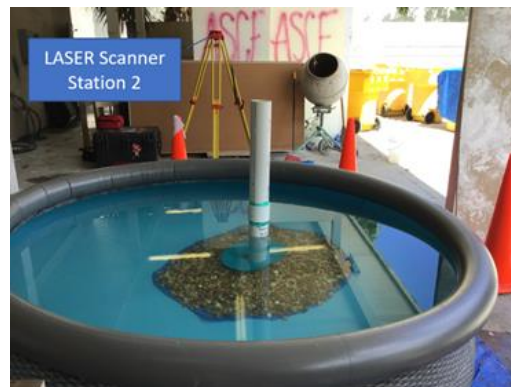
**Figure 7.** Scan station two in operation [35,36] (used with permission).
