# Incorporating the Effect of Windborne Debris on Wind Pressure Calculation of ASCE 7 Provisions

Karim Farokhnia

School of Engineering, Murray State University, Murray, KY 42071, USA; kfarokhnia@murraystate.edu

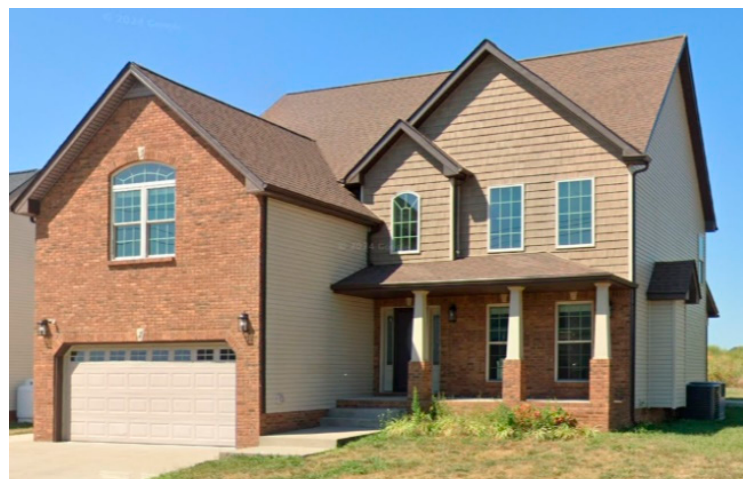
A structural inspection was conducted on 3 February 2024 to assess a residential building located in Clarksville, Tennessee (Figure 1). The subject structure is a two-story, wood-framed residential house, constructed in 2012 (per Realtor.com records), with no basement. Figure 1 illustrates the building prior to the tornado damage.

**Figure 1.** Case study 1: Two-story wood-frame residential building in Clarksville, TN.

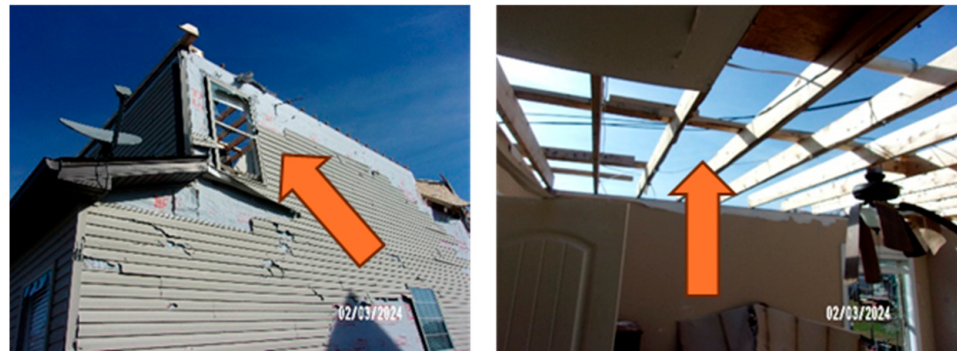
A key observation was that only a couple of windows located on the upper level windward exterior wall were blown-out (Figure 3). In contrast, most other windows across the building envelope remained intact (Figure 4).

Notably, in the vicinity of the blown-out windows, roof panels were uplifted and completely detached, indicating significant internal pressurization following the initial window failure (Figure 4). This suggests that roof panel uplift occurred primarily in areas near the failed windows, while the remainder of the roof—associated with intact windows—sustained comparatively less damage.

**Figure 3.** (Left): Damage to the windward window. (Right): Damage to the roof panels.

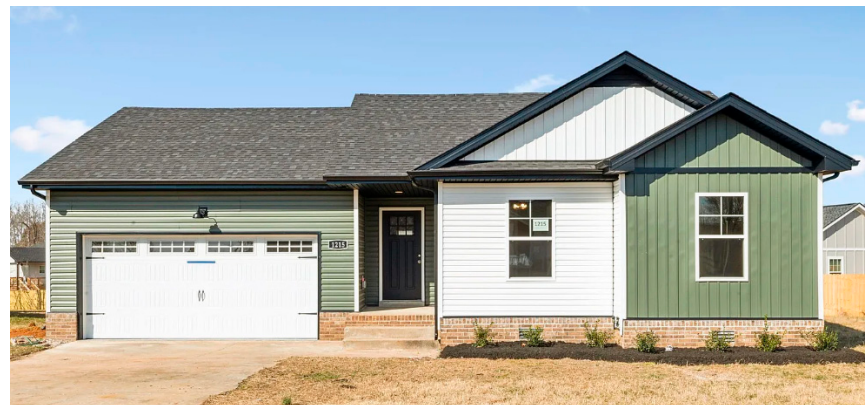
A structural inspection was conducted on 20 April 2024, on a residential building located in Clarksville, Tennessee (Figure 5). The subject building is a one-story, wood-framed residential structure with no basement, constructed in 1999 according to Zillow.com records. Figure 5 illustrates the building post-repair following the tornado event.

**Figure 5.** Case study 2: One-story wood-frame residential building in Clarksville, TN.

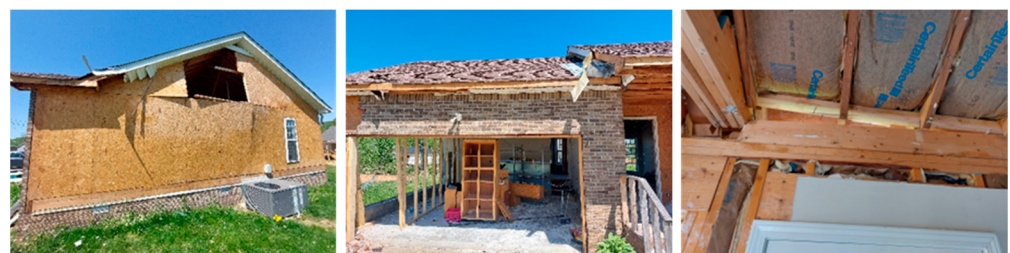
The house was hit by an EF2-level tornado on 9 December 2023 (see the tornado path below in Figure 6). During the structural inspection of the building, several significant damages were identified as a result of tornado-induced wind loading (Figure 7).

The structural frame exhibited extensive damage, including a completely dislodged garage door and wall on the west side of the house, damaged ceiling joists and panels primarily affecting the western portion of the structure, a tilted and partially dislodged exterior wall on the east side, and widespread misalignment of interior stud walls and top plates throughout the building. The concrete masonry unit (CMU) stem walls on the north and west sides also displayed substantial cracking and separation between and within the

A key observation was that, while the windward garage door and the adjacent wall were completely blown-out, the windows on the remaining portions of the building envelope remained mostly intact (Figure 8). However, a large section of the exterior wall and the adjacent roof framing sustained significant damage due to the increase in internal pressure following the initial breach at the garage door.

Similar to Case 1, the evidence suggests that gable-end panel failure was a consequence of increased internal pressure following localized garage door blowout, rather than occurring simultaneously with or prior to window failure elsewhere on the structure.

**Figure 7.** Case study 2: Damage to the front garage door, the adjacent wall, and the gable-end wall.

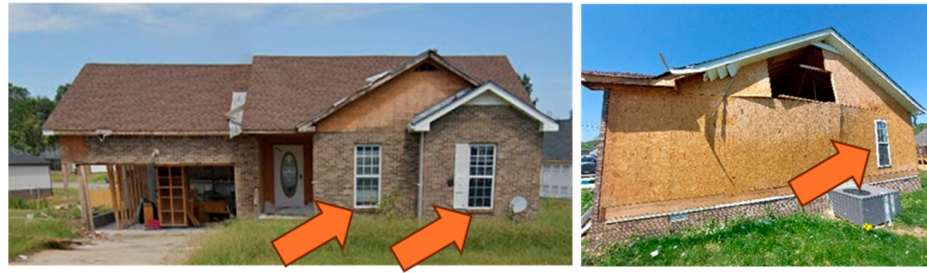
**Figure 8.** Case study 2: Intact glazing on windows and doors across the remaining areas of the building envelope outside the primary damage zone.

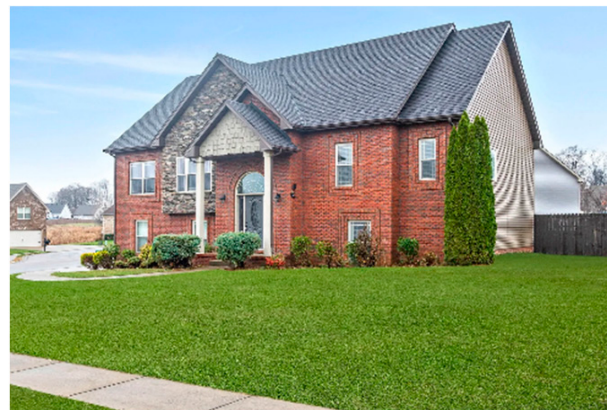
A structural inspection was conducted on 15 May 2024 to evaluate a residential building located in Clarksville, Tennessee (Figure 9). The subject property is a two-story, wood-framed house with no basement, constructed in 2014 according to Zillow.com records.

**Figure 9.** Case study 3: Two-story wood-frame residential building in Clarksville, Tennessee, damaged due to the tornado event in December 2023.

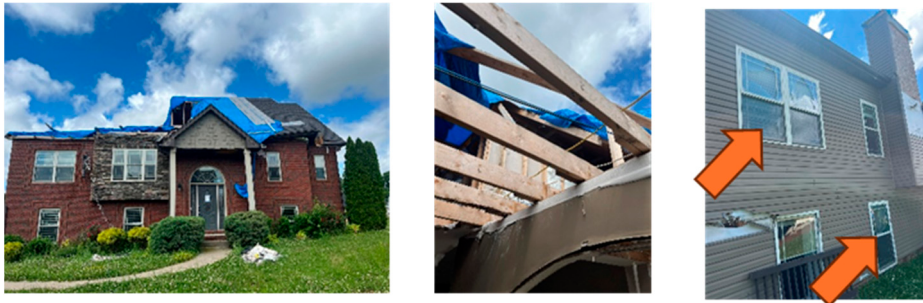
The inspection revealed that most of the roof structure, including trusses, rafters, and roof decking, had been displaced by wind uplift forces, with only a portion of the roof elements near the attic access remaining intact (Figure 11).

**Figure 11.** Case study 3: (Left) and (Center): Roof damage. (Right): Blown-out windows.

A similar failure pattern is observed in this case study: a couple of windows were blown-out due to wind pressure and windborne debris, followed by the uplift failure of roof panels as a result of increased internal pressure.

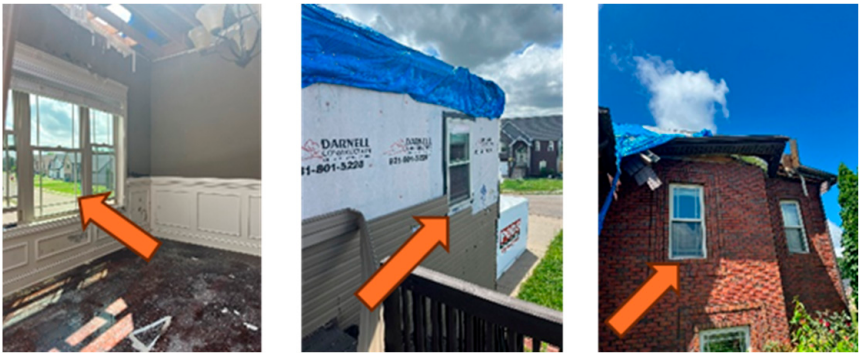
Despite the significant damage to the roof assembly caused by increased internal pressure and external suction, and although the windows on one side of the building were mostly blown-out, the windows on the rest of the building envelope remained largely intact (Figure 12).

**Figure 12.** Case study 3: Intact window glazing on the building envelope.
