Article

The Performance of Large Diameter Threaded Cast Iron Pipe Fitting Joints Used in a Fire Suppression System: Experimental and Fragility Analysis

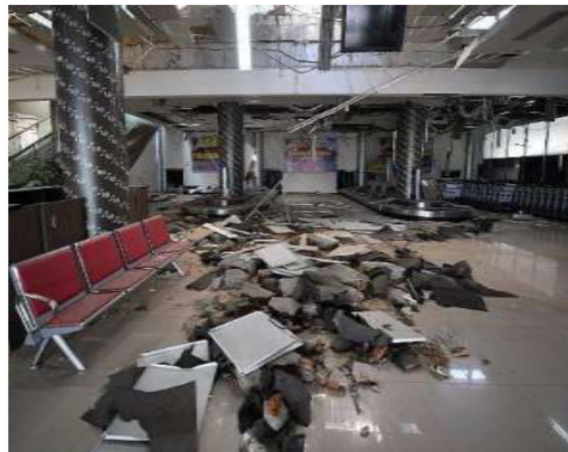
Figure 1. Non-Structural Damage that Occurred in the 2018 Palu Earthquake.

Historical earthquakes have repeatedly demonstrated the vulnerability of non-structural systems to seismic events. For instance, the 1994 Northridge earthquake caused widespread disruption, including the collapse of ceiling tiles, shattering of glazing systems, and failure of HVAC and piping infrastructure, ultimately resulting in the temporary shutdown of numerous businesses [4–7]. In the 2011 Tohoku earthquake in Japan, non-structural damage, particularly to piping systems, was especially severe, contributing to approximately 49% of the total economic losses incurred [8]. Similarly, significant non-structural damage was observed during the 2010–2011 Canterbury earthquakes in New Zealand and the 2014 South Napa earthquake in California, further emphasizing the systemic vulnerability of mechanical and architectural components during seismic events [9,10]. Reconnaissance findings from the 2018 Palu earthquake, as reported by the University of Notre Dame, documented similar patterns of damage. The associated report includes Figure 1, which depicts the extent of non-structural failures observed at affected sites [11].

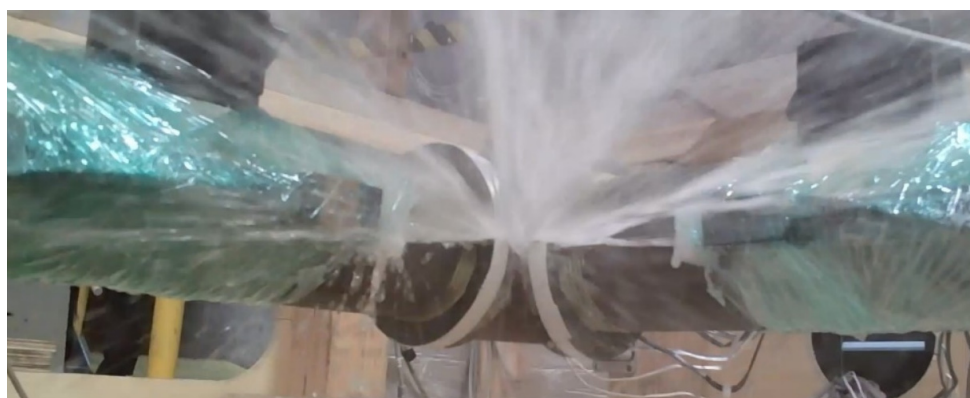
Figure 9. Elbow Fitting Rupture Observed from Lab.

Figures 9–13 illustrate the observed deformation patterns and failure modes across the tested configurations and Table 3 provides an overview of their observed damage. Elbow fittings exhibited consistent behavior, with deformation occurring primarily in the adjoining pipe segments and no observable damage to the fitting body. In contrast, tee fittings demonstrated more complex responses, with failure typically initiating within the fitting itself. Fracture was frequently observed along the casting seam, indicating a likely material discontinuity associated with the manufacturing process. Additionally, 3-inch tee specimens occasionally exhibited visible leakage at the pipe–fitting interface prior to failure, whereas 4-inch fittings more frequently exhibited abrupt fracture without visible precursors. These observations highlight the influence of both fitting geometry and size on failure behavior.

Fitting Type/Configuration	Observed Damages and Description
Elbow	No detectable signs of early damage prior to failure;
	Catastrophic rupture occurred suddenly along the casting seam in both 3-inch and 4-inch elbow fittings (Figure 9)
Tee in Primary Configuration	Occasional early-stage leakage observed in 3-inch tee assemblies at the pipe-to-fitting interface (Figure 11a);
	In cases where leakage was present, a gradual increase in leakage occurred prior to rupture; 4-inch tee assemblies exhibited no early leakage and failed suddenly without prior indication (Figure 11b)
Tee in Secondary Configuration	Similar to the primary configuration, early leakage was sporadically observed in 3-inch tee assemblies at the pipe-to-fitting interface;
	Leakage, when present, increased marginally prior to failure; 4-inch tee assemblies demonstrated no precursory leakage and experienced sudden rupture

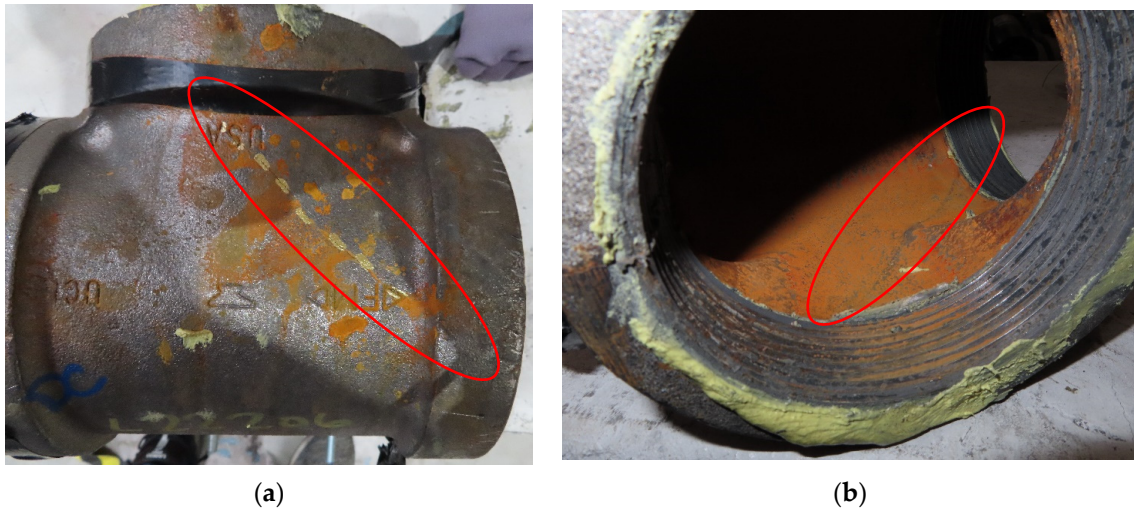
Figure 12. Post Disassembly Tee Fitting Body Rupture Images: (a) Body Rupture Outside of Fitting; (b) Body Rupture Inside of Fitting.

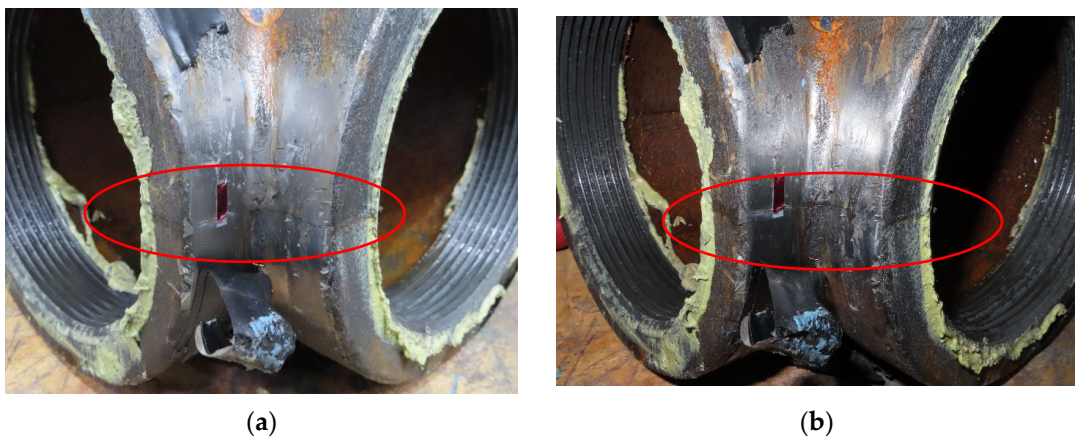
Figure 13. Post Disassembly Tee Fitting Casting Line Rupture Images: (a) Casting Line Tee Rupture 1; (b) Casting Line Tee Rupture 2.

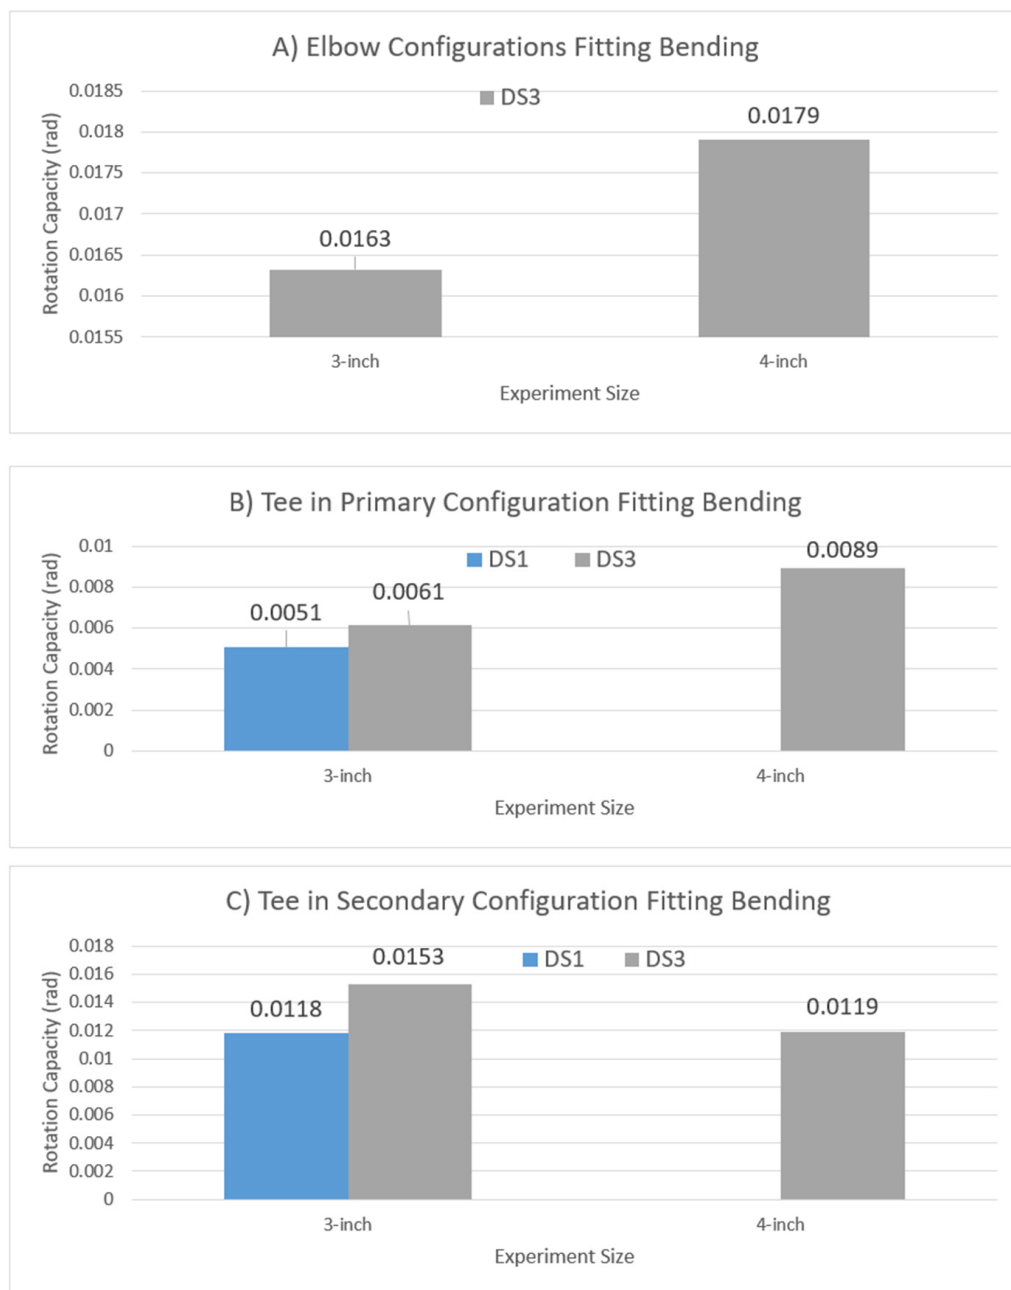
Figure 14. Measured Rotational Capacity of the Fitting (Fitting Bending): (A) Elbow Configuration; (B) Tee in Primary Configuration; (C) Tee in Secondary Configuration (Unit: rad).

Rotational capacities corresponding to the defined damage states (as listed in Table 4) were quantified for each fitting size and configuration. These capacities were obtained by averaging results from three (3) tests per configuration. Two rotational metrics were evaluated: (1) rotation of the fitting itself (fitting bending), and (2) rotation of the loading pipe relative to the face of the fitting (pipe rotation). For elbow configurations, the rotations measured at both connected pipes (Pipe 1 and Pipe 2) were averaged due to their symmetric characteristics. The computed rotational capacities for fitting rotation and pipe rotation are depicted in Figures 14 and 15, respectively, in the form of comparative bar charts. In both figures, subsection (A) corresponds to elbow assemblies, subsection (B) to tees loaded in the primary configuration, and subsection (C) to tees in the secondary configuration. The damage states are color-coded, with DS1 denoted in blue and DS3 in gray. 4-inch fittings exhibited greater rotational capacity at DS3 compared to their 3-inch counterparts. However, the 3-inch configurations demonstrated consistently higher pipe rotations across all damage states. It is important to note that Damage State 2 (DS2) was

not observed in any test configuration. Among all configurations tested, elbows exhibited the highest rotational capacities, significantly exceeding those of the tee fittings. Tee assemblies displayed comparable rotational behavior between the primary and secondary loading configurations.

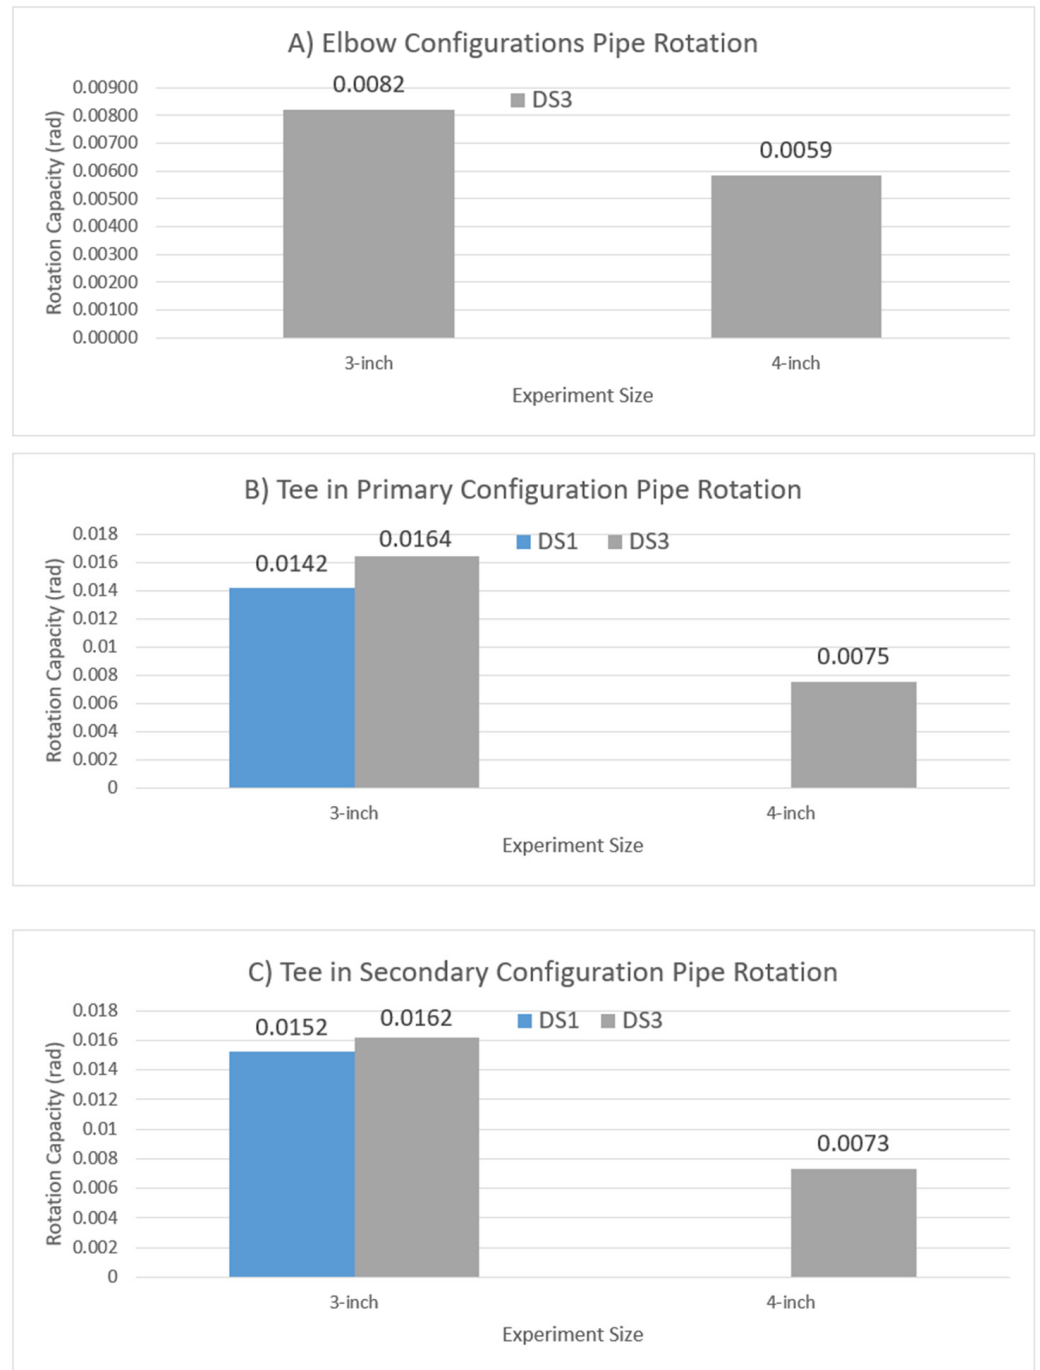
Figure 15. Measured Rotational Capacity of the Pipe About the Face of the Fitting (Pipe Rotation): (A) Elbow Configuration; (B) Tee in Primary Configuration; (C) Tee in Secondary Configuration (Unit: rad).

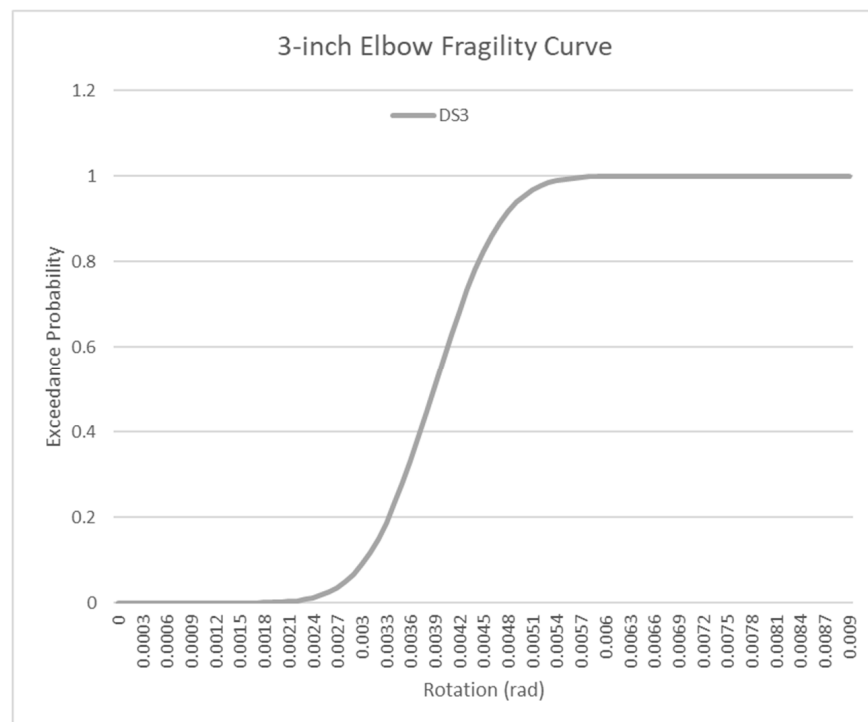
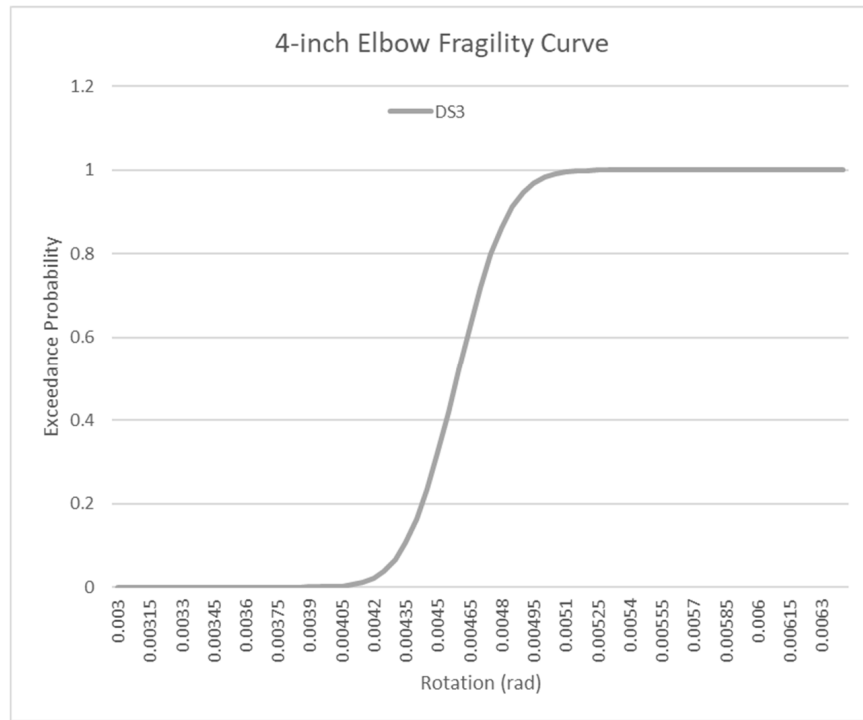
Figure 22. Elbow Configuration Fragility Curves: (a) 3-inch; (b) 4-inch.

A summary of the experimental outcomes is provided in Table 6, and the corresponding fragility curves are shown in Figures 22–24. Figure 22 depicts the fragility curves for the elbow fittings, Figure 23 illustrates the fragility curves for the tee fittings tested in the primary configuration, and Figure 24 presents the results for those tested in the secondary configuration. It should be emphasized that the number of specimens tested in this study is limited, and while the results provide valuable insight into the behavior of large-diameter fittings, additional testing is necessary to improve statistical confidence and more comprehensively evaluate the influence of geometric parameters, material variability, and system conditions on the resulting fragility relationships.

- (5) As depicted in Figures 22–24, the fragility curves demonstrate a higher susceptibility to damage initiation in 3-inch fittings, which reached defined damage states at lower rotation levels compared to 4-inch fittings. This suggests that, despite their smaller size, 3-inch fittings may be more vulnerable under seismic deformation demands. No significant differences were observed between tee configurations regarding their damage probabilities.

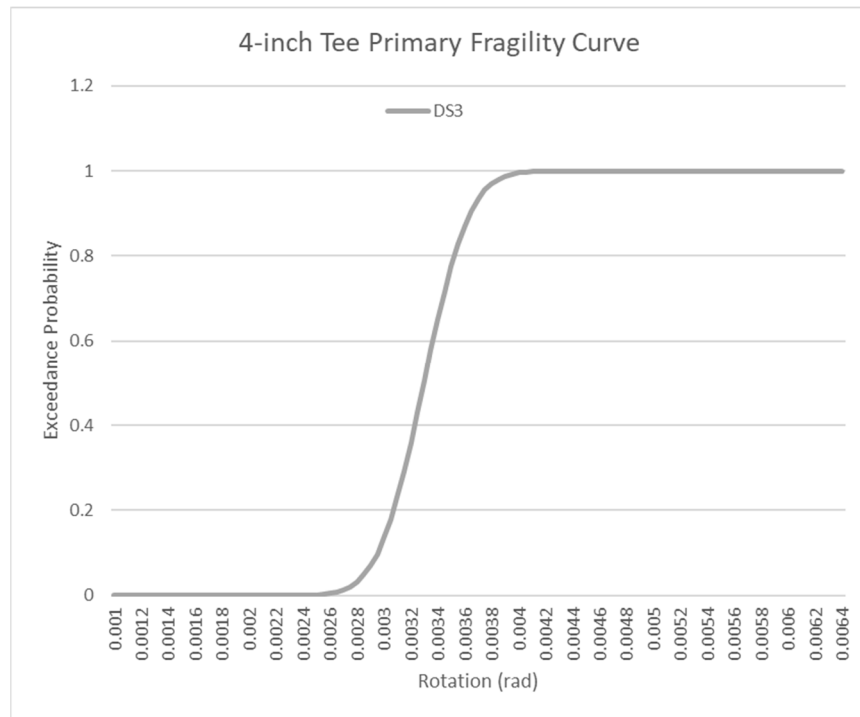
Figure 23. Tees in the Primary Configuration Fragility Curves: (a) 3-inch; (b) 4-inch.

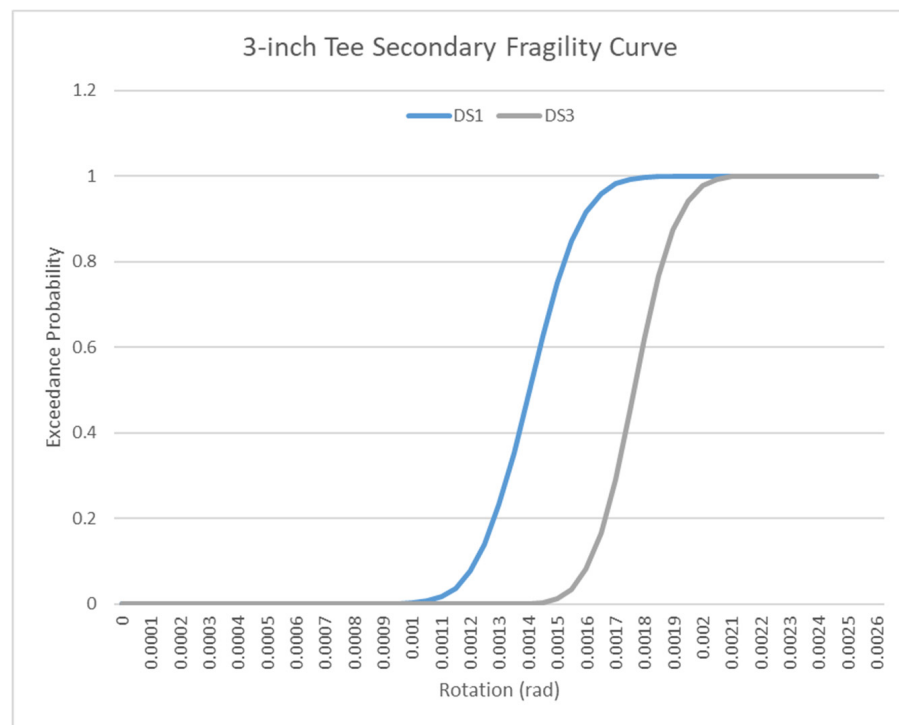
Figure 24. Tees in the Secondary Configuration Fragility Curves: (a) 3-inch; (b) 4-inch.
