# The Memorial Chapel (formerly Holy Trinity Church) in the *Tempio Evangelico Valdese* (Florence). Surveys and characterization of decorative plasters for a conservative recovery

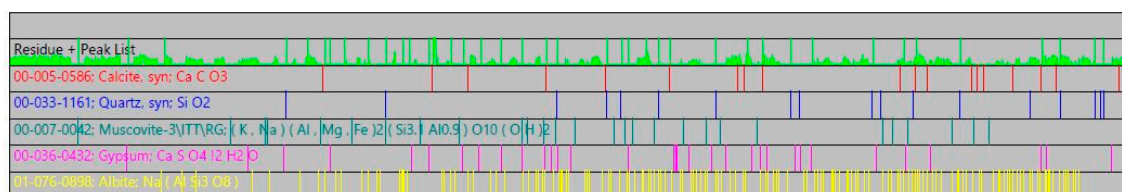
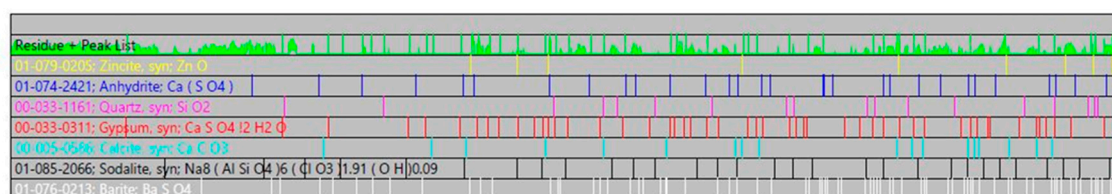
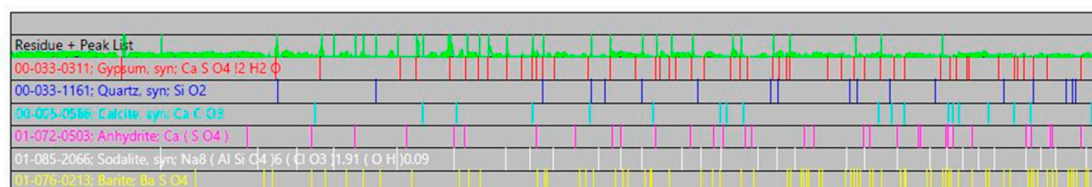
**Figure S1.** Series of XRPD spectra of salt (MC1E), plaster mortar (MC2, MC3, MC4, MC9, MC10, MC11) and painted layer samples (MC5 green, MC6 red, MC7 green, MC8 RED, MC9 green, MC10 pink).
