# Evaluation of the Degree of Degradation of Brake Pad Friction Surfaces Using Image Processing

**Abstract:** The improvement of drilling rig systems to ensure a reduction in unproductive time spent on lowering and lifting operations for replacing drilling tools and restoring the performance of drilling equipment units is an important task. At the same time, considerable attention is paid to the reliable and efficient operation of the braking systems of drilling rig winches. In the process of operation, the polymer pads periodically come into contact with the outer cylindrical surface of the metal pulley during braking, work in extreme conditions and wear out intensively, so they need periodic replacement. Tests were carried out on a modernized stand and in industrial conditions for the brakes of drilling winches. A methodology for evaluating the degradation of the brake pad friction surface during its operation is proposed. The assessment of the degradation degree is carried out based on the image of the brake pad surface using image processing techniques. Geometric transformations of the input image were performed to avoid perspective distortions caused by the concave shape of t

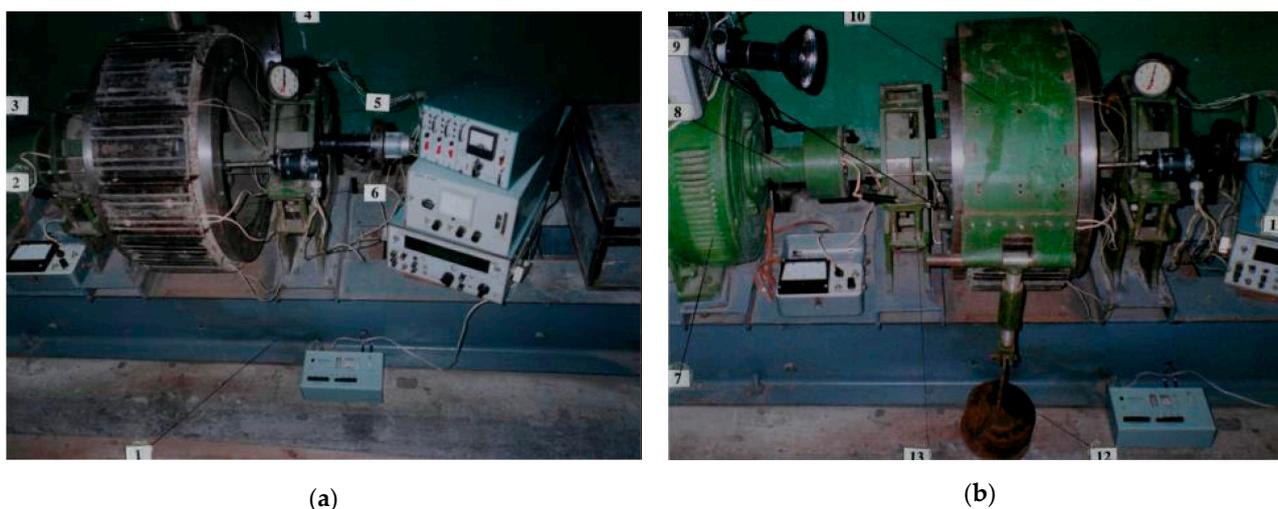
**Figure 1.** General view of the workbench with a band brake with an open (a) and a closed brake band (b): 1—frame beams; 2, 3, 4—friction pads with external and internal working surfaces, respectively; 5—brake pulley, 6—thermocouple terminals; 7—electric motor for driving the brake pulley; 8—brake pulley shaft with elastic coupling; 9—outputs of the microammeter; 10—brake band; 11—tachometer; 12—load node; 13—shaft bearing supports.

The authors modernized a workbench [107,108] for conducting experimental studies. The workbench allows simulation of the operation of the belt brake of the drilling drawworks (Figure 1). During the modernization of the workbench, the requirements of the Interstate Standard GOST 12.2.088–83 “Standards System of Labor Safety. Field Equipment for Well Repair and Realization. Safety General Requirements” [109] were taken into account. The following requirements were imposed on the brake workbench: execution of single and long-term braking; implementation of emergency braking to assess the maximum temperatures on the working surfaces of metal–polymer friction pairs; simulation of real operating conditions of brake friction pairs with the possibility of changing the energy load of their surface layers.

At the same time, the following parameters of the band brake operation were subject to registration: braking time; number of brakes; angular velocity of the metal brake pulley; temperature of the metal brake pulley; temperature of the friction working surface; and wear of the working surfaces of the metal brake pulley and friction pads. Friction pairs of various types of friction assemblies and materials were subjected to the study of the energy load on the brake stand. At the same time, the coefficient of friction in metal–polymer pairs was determined.

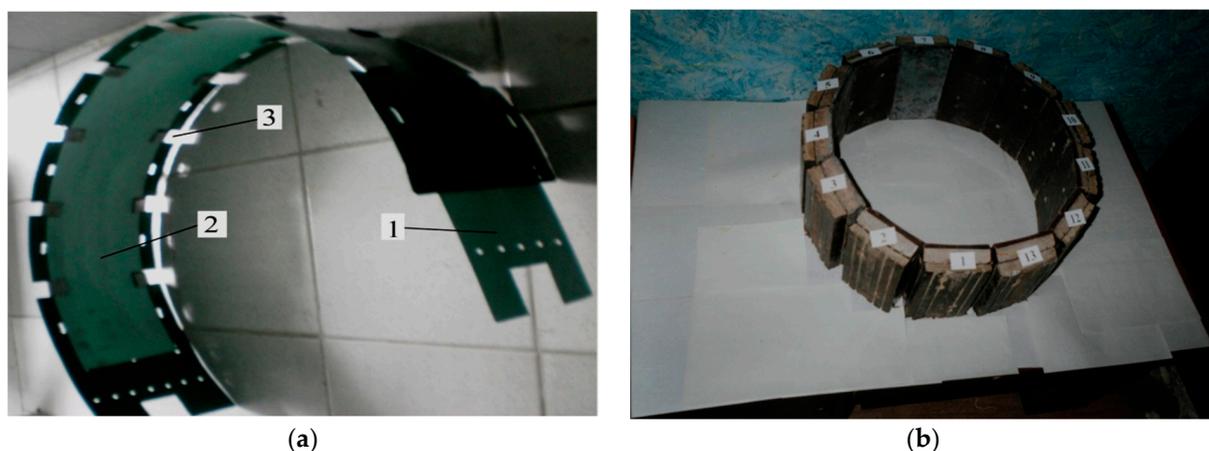
**Figure 2.** The brake belt (a) and bandage made of friction pads (b) are the main components of a multi-pair friction unit: 1—main brake belt; 2—additional brake tape; 3—fastening elements of friction pads.

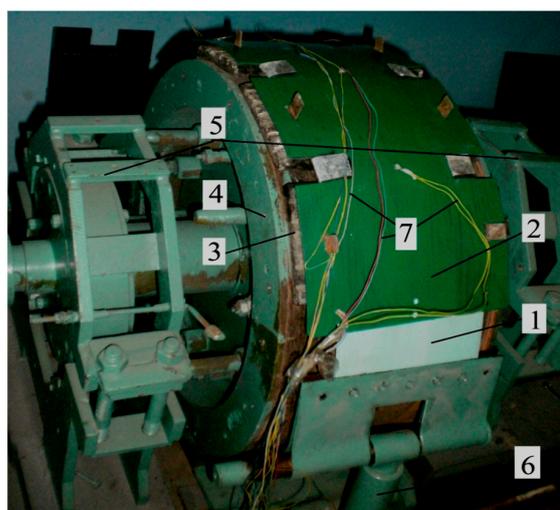
**Figure 3.** General view of the friction units of the belt brake with sensors: 1—the main brake belt; 2—additional brake tape; 3—friction pads; 4—brake pulley; 5—bearing supports of the brake pulley; 6—load node; 7—connecting wires of sensors.

Temperature measurements in the friction contact zone of the brake were carried out with an automatic electronic potentiometer of accuracy class 0.5 equipped with a chromel-copel (E) thermocouple of the ChK type. To complete the tribological tests, the power to the electric motor was turned off, the load was removed from the brake belt and the brake friction pads were dismantled. Brake friction pads were weighed again and the amount of their linear wear was measured. In addition, the formation of cracks on the working surface of the brake friction pads and brake pulleys on the stand and in the operating conditions of drilling equipment for the National joint-stock company “Naftogaz of Ukraine” was investigated.

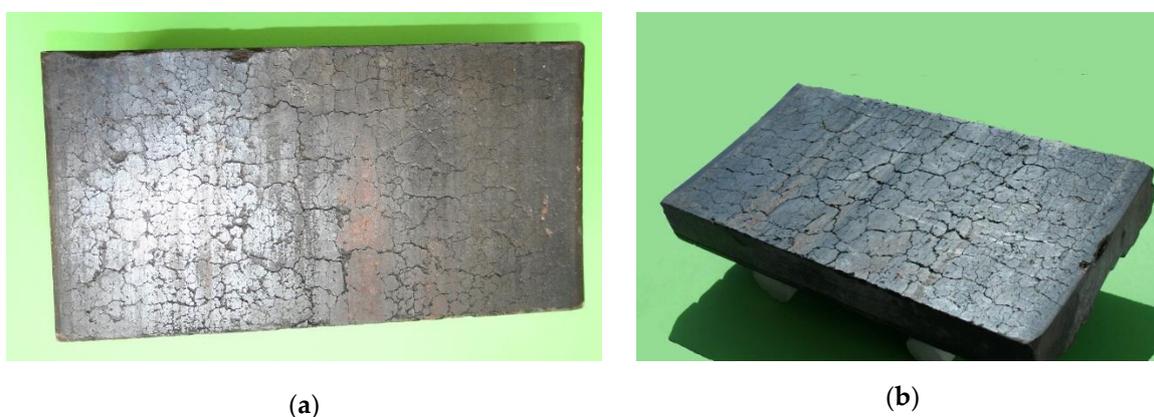
**Figure 4.** Images of brake pad surface: (a) taken perpendicular to its surface; (b) taken from a particular angle that allows us to avoid glares.

As a result, a suitable picture of the brake pad surface can only be taken from a certain angle. Examples of images of the brake pad surface taken perpendicularly to its surface and taken from an angle that allows us to avoid glares are shown in Figure 4.

As one can see from Figure 4b, the brake pad surface is presented in the image at a certain perspective due to the angle of view. At this point, it is necessary to perform

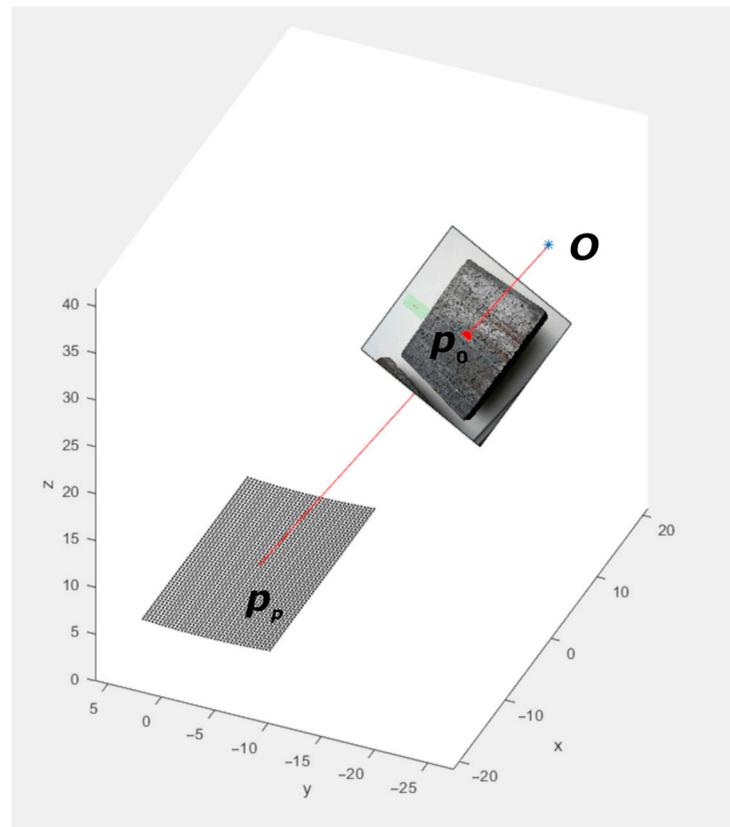
Figure 5. Formation of a brake pad image taken from a particular angle that allows us to avoid glares.

The schematic formation of a brake pad image is shown in Figure 5.

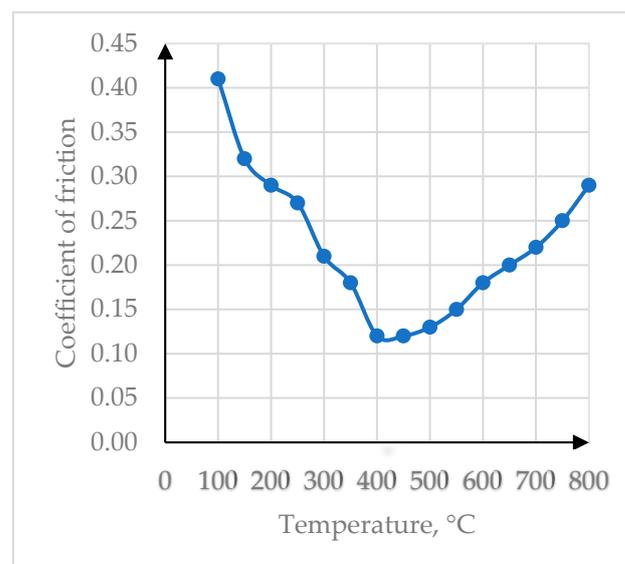
**Figure 6.** Dependence of the friction coefficient on temperature for a friction pad (FK-24A) paired with a steel brake pulley (30ChGSA).

The analysis of the graphical dependence presented in Figure 6 shows that with increasing temperature in the friction zone, the value of the friction coefficient initially decreases and reaches a minimum value of 0.12 at temperatures of 400–470 °C. Under such temperature conditions, the decomposition products of the bond (phenol–formaldehyde resin) act as a solid lubricant. A further increase in the temperature in the friction zone leads to a certain increase in the value of the coefficient of friction, but it no longer reaches a higher value than at the beginning of the test at a temperature of 100 °C. During friction, phenol–formaldehyde resin decomposes under the influence of elevated temperature, providing the necessary positive gradient of mechanical properties in a tribological pair with alloy steel. FK-24A material exhibits high frictional properties during difficult operating conditions of the belt brake of the drilling drawwork. Similar dependences for the change in the friction coefficient on temperature during the operation of retinax in a pair with 40ChN steel were presented in Interstate Standard GOST 10851–94 [105], where the minimum value of the friction coefficient was also observed in the temperature range from 400 to 500 °C.

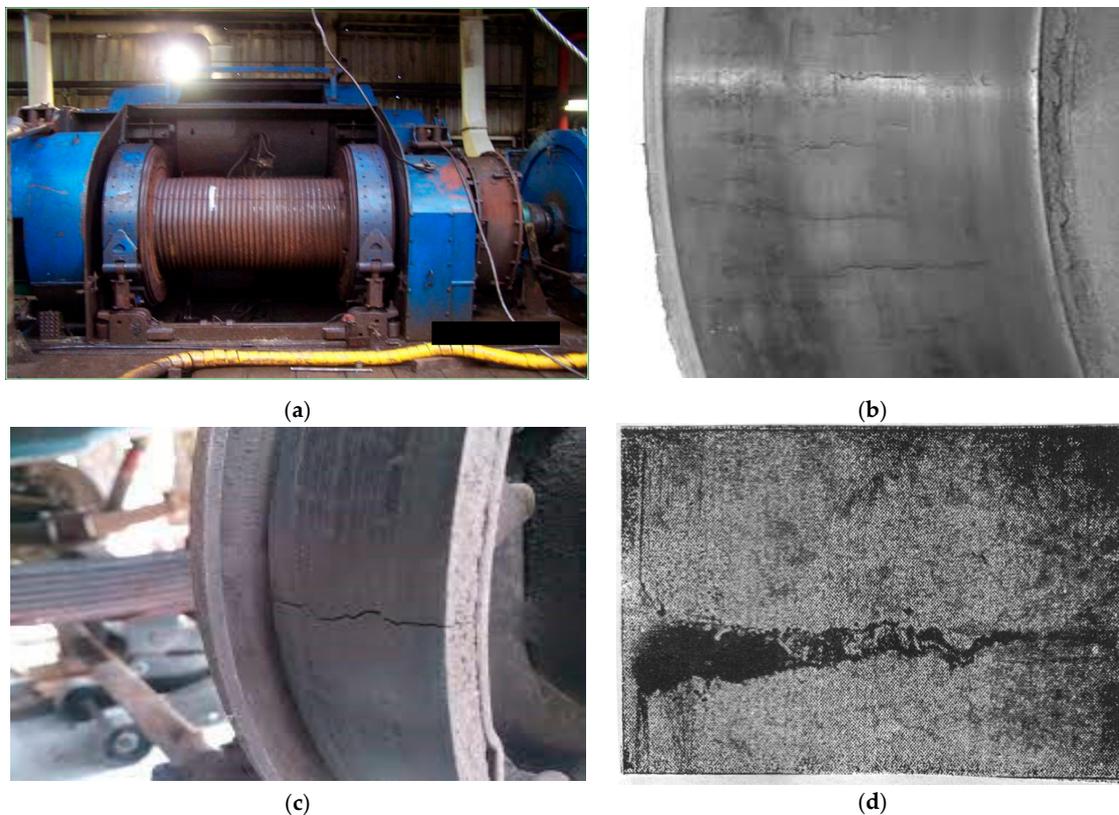
**Figure 7.** General appearance of the drilling drawwork after a long period of operation (a) and different types of cracks on the working cylindrical surface of the brake pulley: (b) an ensemble of surface cracks; (c) one main through crack; (d) one trunk crack (enlarged view).

In the process of long-term operation of drill drawworks (Figure 7a), a large number of braking cycles occur when the drill pipe column is built up during the lowering of the tool into the well or the unscrewing of the drill pipe plugs during the removal of the tool from the well, which leads to cyclic heating/cooling of the brake and the appearance of low-cycle crack fatigue on the working surfaces of brake metal pulleys and friction polymer pads. Cracks are mostly formed on the convex cylindrical friction surface of the metal pulley, which are directed along its longitudinal axis and do not cross each other (Figure 7b). It should be noted that in some cases, a main through crack was formed in the rim of the metal pulley (Figure 7c,d).

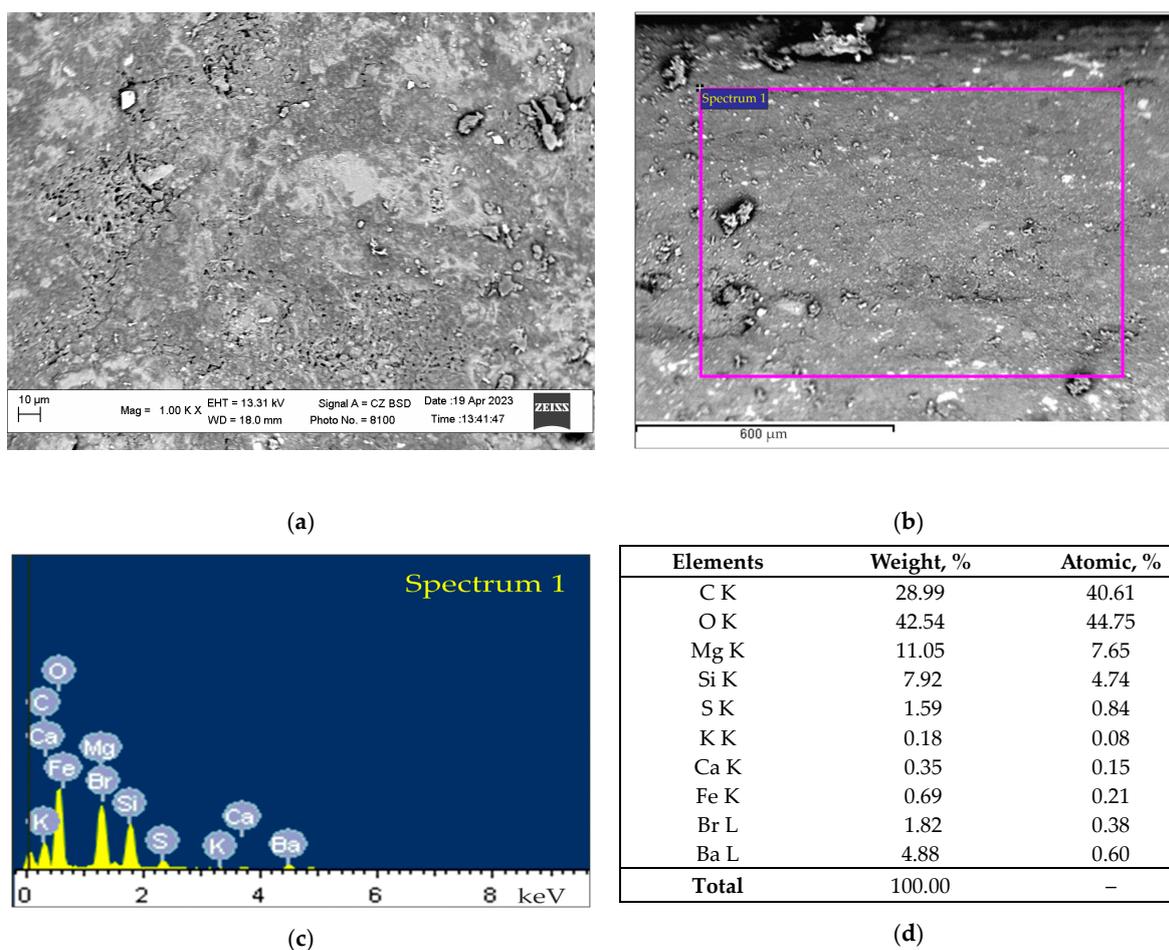
**Figure 8.** SEM image of the friction surface of the brake pad in a worn state without cracks at different magnifications, (a,b), spectrum of 1 (c) and elemental composition of the worn material (d).

We found that at the stage of running-in of the brake pad in the friction zone with the steel pulley, the presence of all the main components of the retinax FK-24A friction material and a small percentage of iron (0.69%) can be observed (Figure 8d).

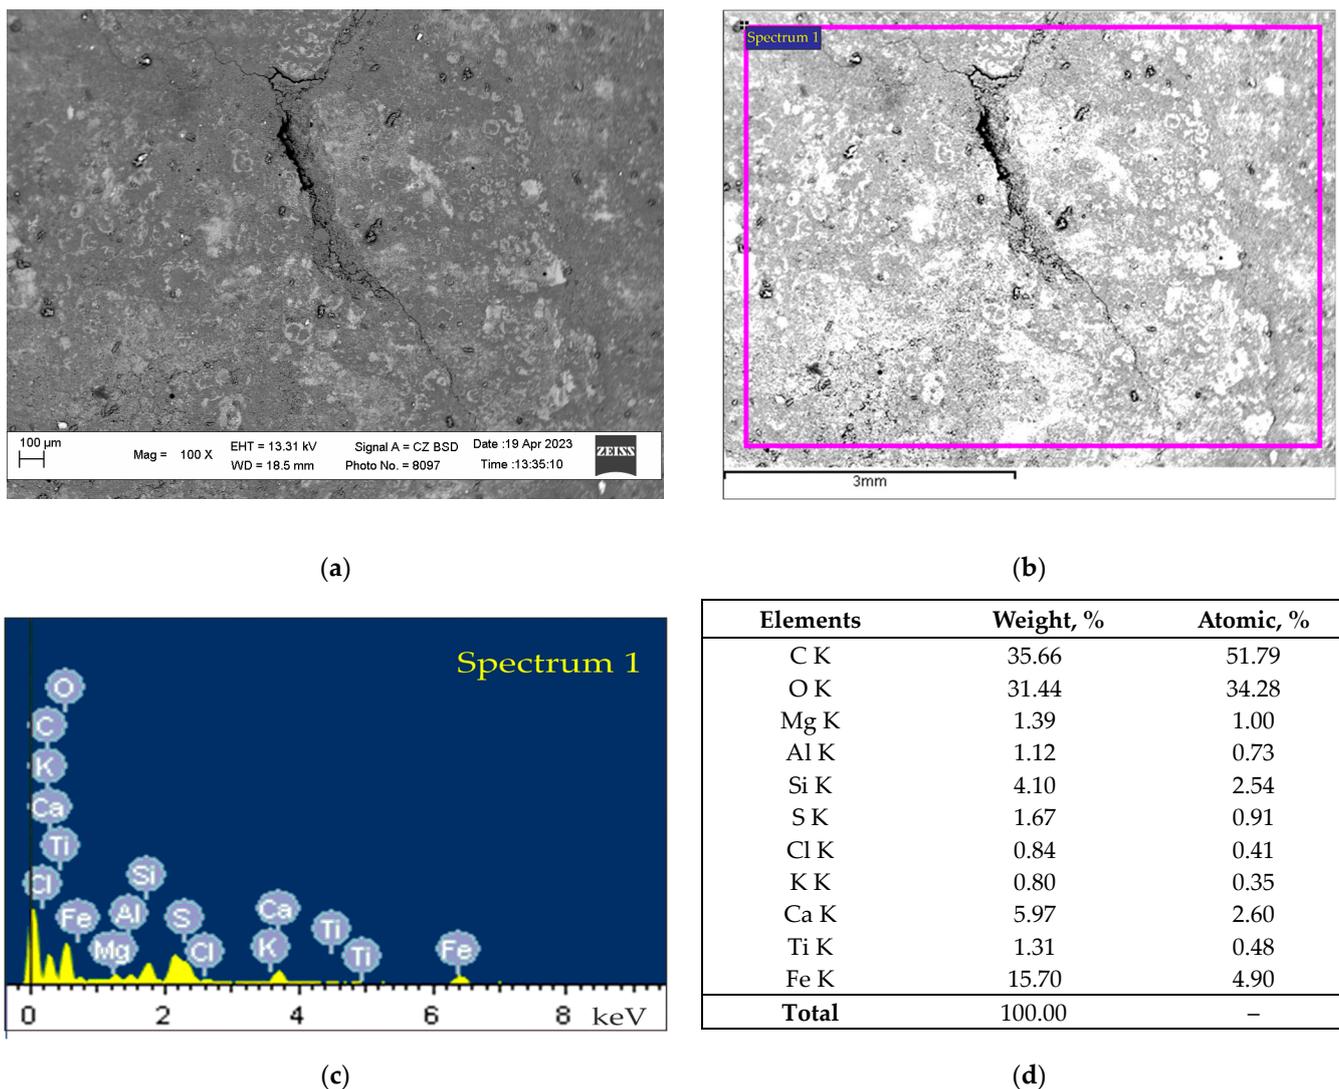
**Figure 9.** SEM image of the friction surface of the brake pad in a worn state with cracks at different magnifications, (a,b), the spectrum of 1 section in the crack zone (c) and the elemental composition of the worn material (d).

It should be noted that at the stage of wear of the brake pad and the formation of cracks on the surface in the friction zone with the steel pulley, the presence of all the main components of the retinax FK-24A friction material, as well as increased iron content of up to 15.70%, is observed (Figure 9d). This phenomenon can be explained by the increased wear of the flooded and brittle metal of the steel pulley and the accumulation of wear products in the cracks and pores of the brake pad.

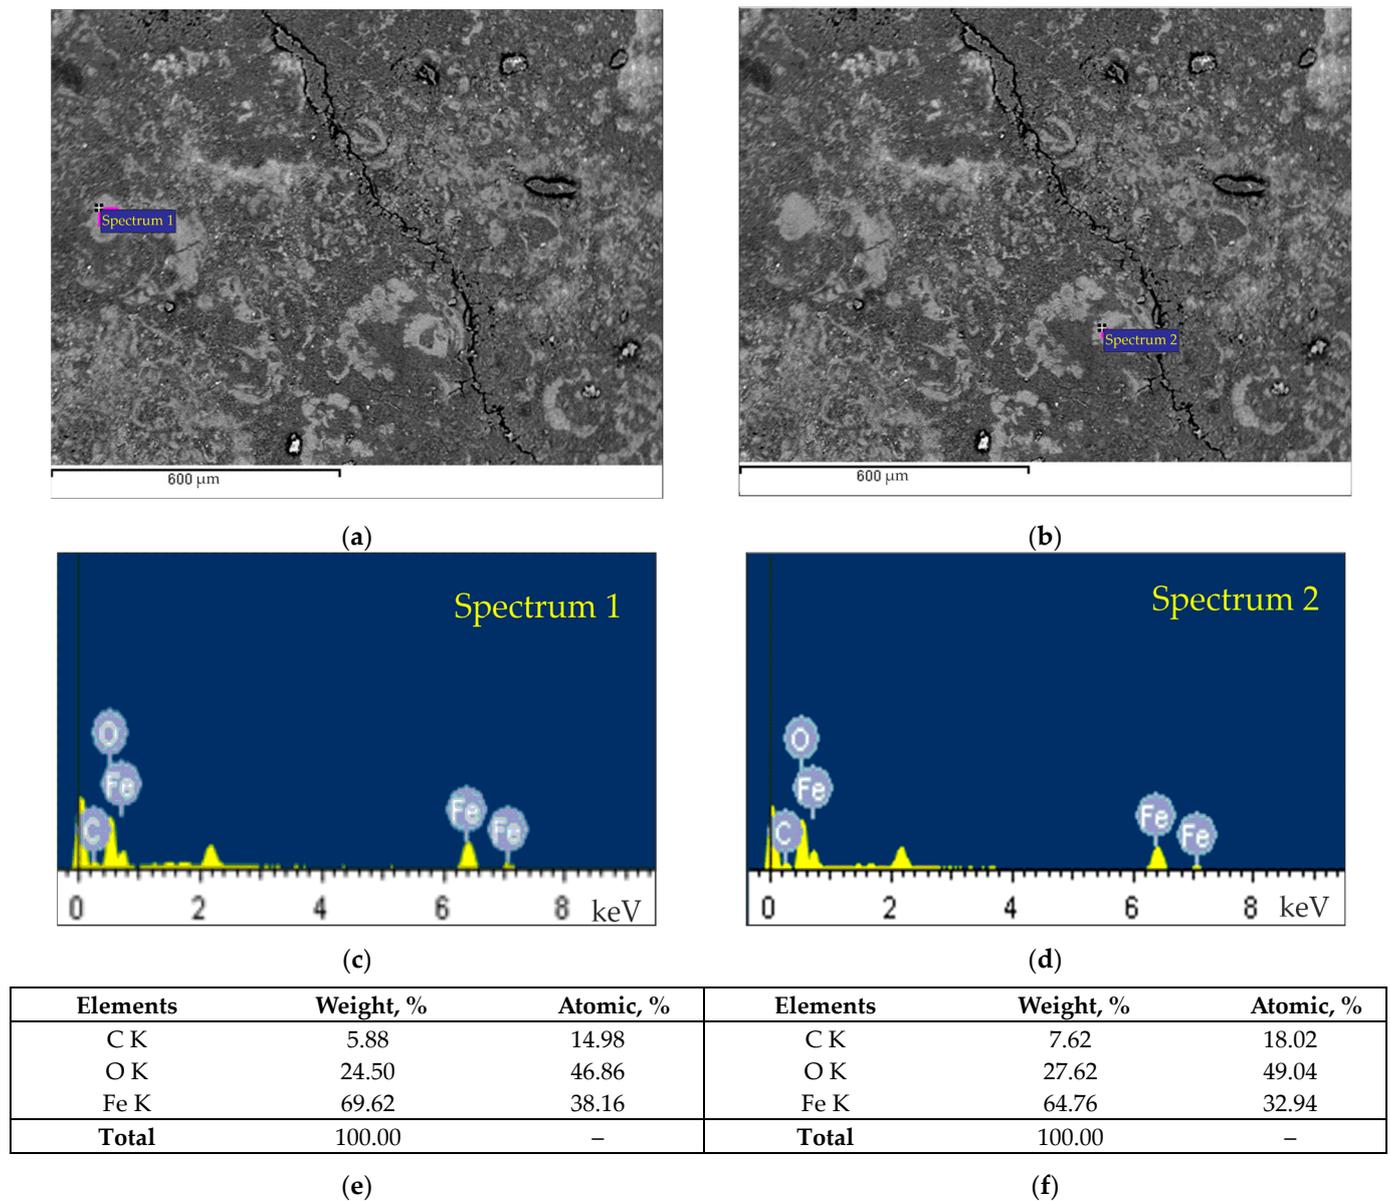
**Figure 10.** SEM image of the friction surface of the brake pad in a worn state with cracks (a,b), spectrum 1 for the area far from the crack (c) and spectrum 2 for the area near the crack (d) and, accordingly, the elemental compositions of the worn material (e,f).

The composition of the polymer friction material FK-24A on the friction surface of the brake pad in a worn state with cracks was also studied in detail (Figure 10).

Experiments were carried out on areas of the surface that were located at different distances from the crack (Figure 10a,b). It was established that the area farther from the crack had increased iron content—69.62% (Figure 10c,e)—and the area near the crack had a lower iron content—64.76% (Figure 10d,f). Such a difference in the amount of wrought iron in the friction surface of the brake pad at different distances from the crack may be due to the fact that part of the wear products accumulates in this crack. This representation of the

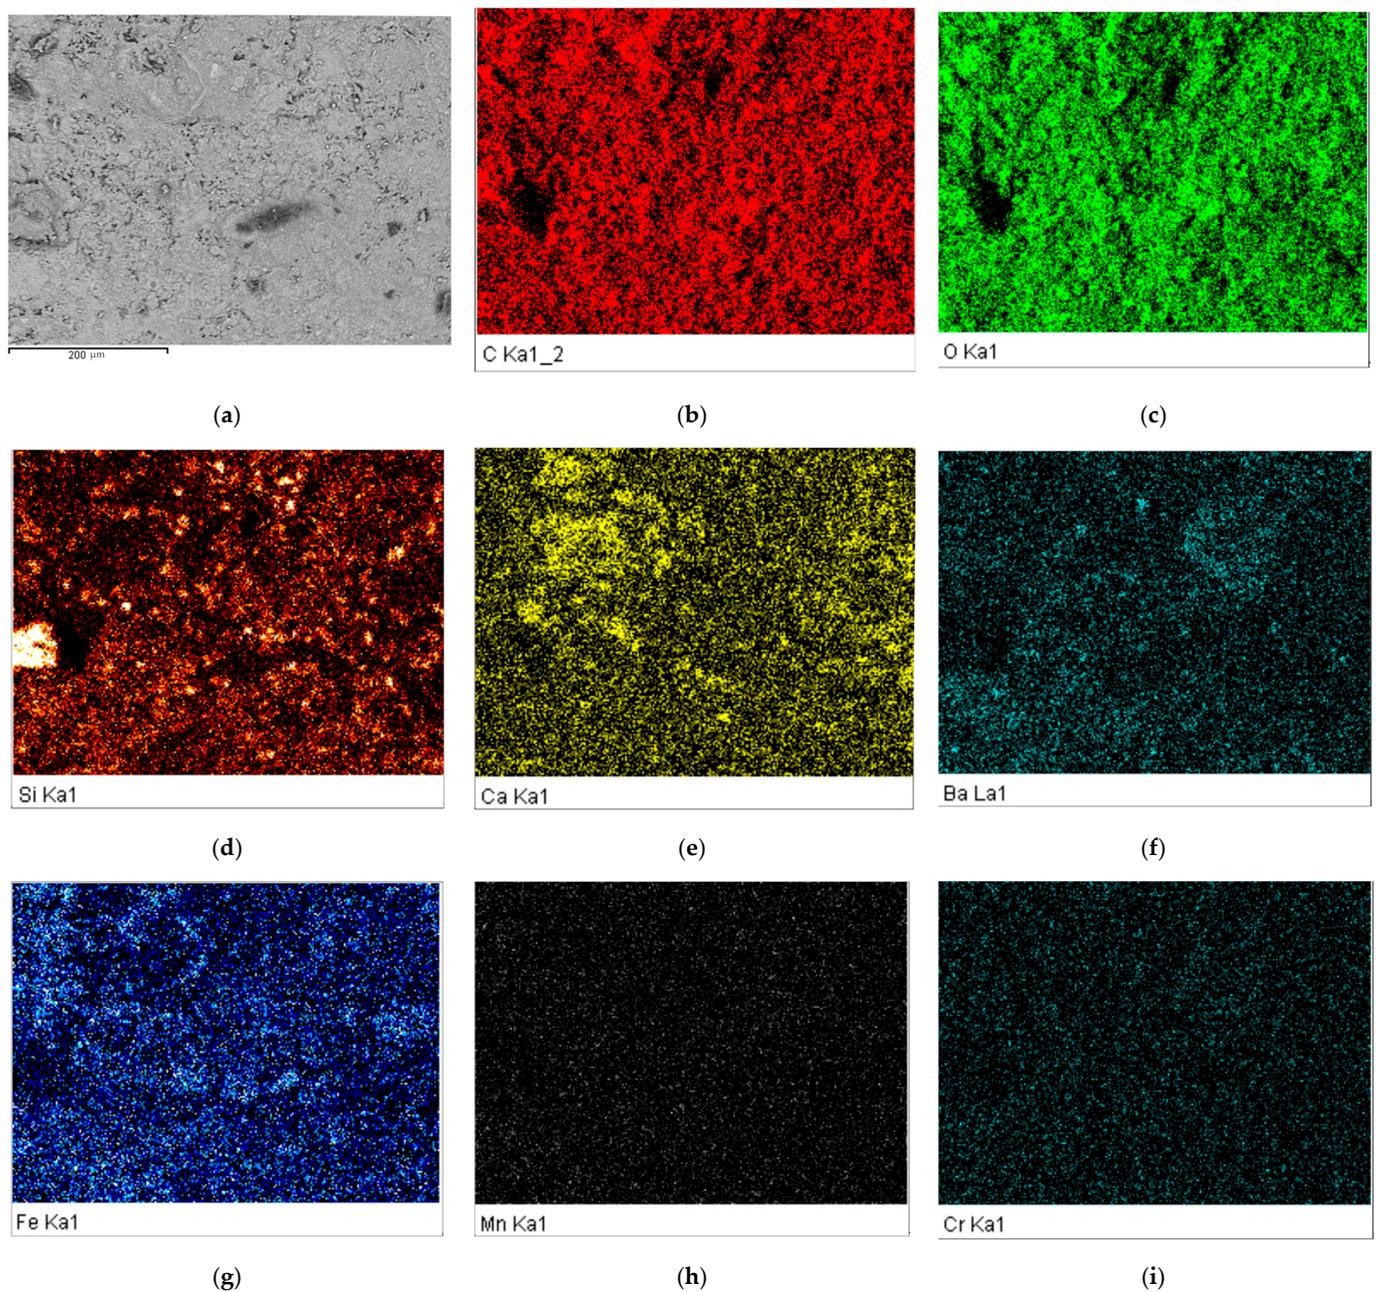
**Figure 11.** SEM image of the worn brake pad surface for the EDXS analysis (a) and the results of the EDS analysis: (b)—C; (c)—O; (d)—Si; (e)—Ca; (f)—Ba; (g)—Fe; (h)—Mn; (i)—Cr.

In Figure 11, the character of the worn surface of the area of interest of the brake pad is shown, along with the mapping of the redistribution of the elements after the friction tests.

The analysis of the EDS maps (Figure 11b–i) shows that C, O, Ca, Ba and Fe are located in the same regions, indicating the existence of complex compounds, while Si is mainly observed in the friction surface defects. The redistribution of Mn and Cr is relatively uniform, showing transfer from the steel counterbody.

understanding of the wear mechanism of brake friction pair elements on a microscale. In particular, this article shows the micro-level distribution of chemical elements of the material of the steel brake pulley relative to thermal cracks formed on the worn friction surface of the polymer brake pad (Figure 10), as well as the distribution of chemical elements on the worn friction surface of the brake pad (Figure 11).

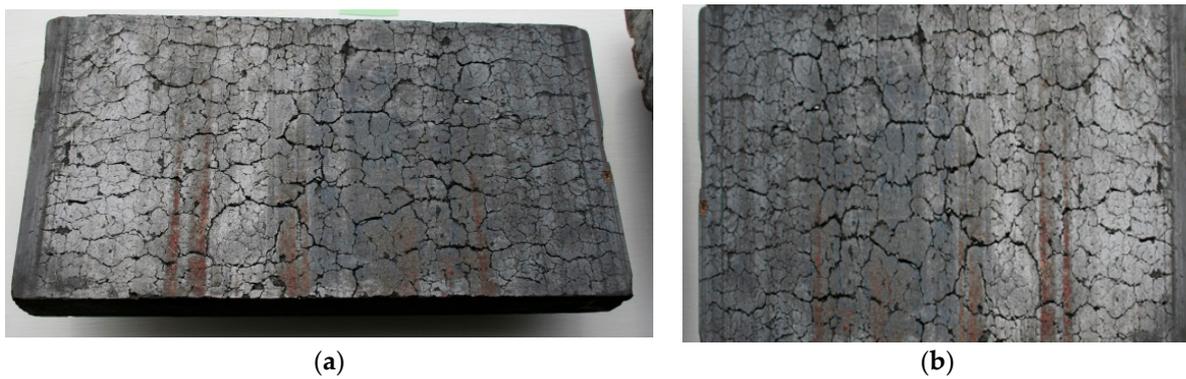
**Figure 12.** Mapping results: (a) obtained image; (b) restored image of the surface of a brake pad.

The first step consists in input image acquisition and its geometric transformation with the purpose of obtaining a transformed image suitable for further processing and is described in Section 2.1. Figure 12 shows the results of mapping of the obtained image of the brake pad friction surface on the surface of a cylinder using image transformation, represented by Equations (1) and (2): Figure 12a is the obtained image and Figure 12b is the restored image of the surface of a brake pad.

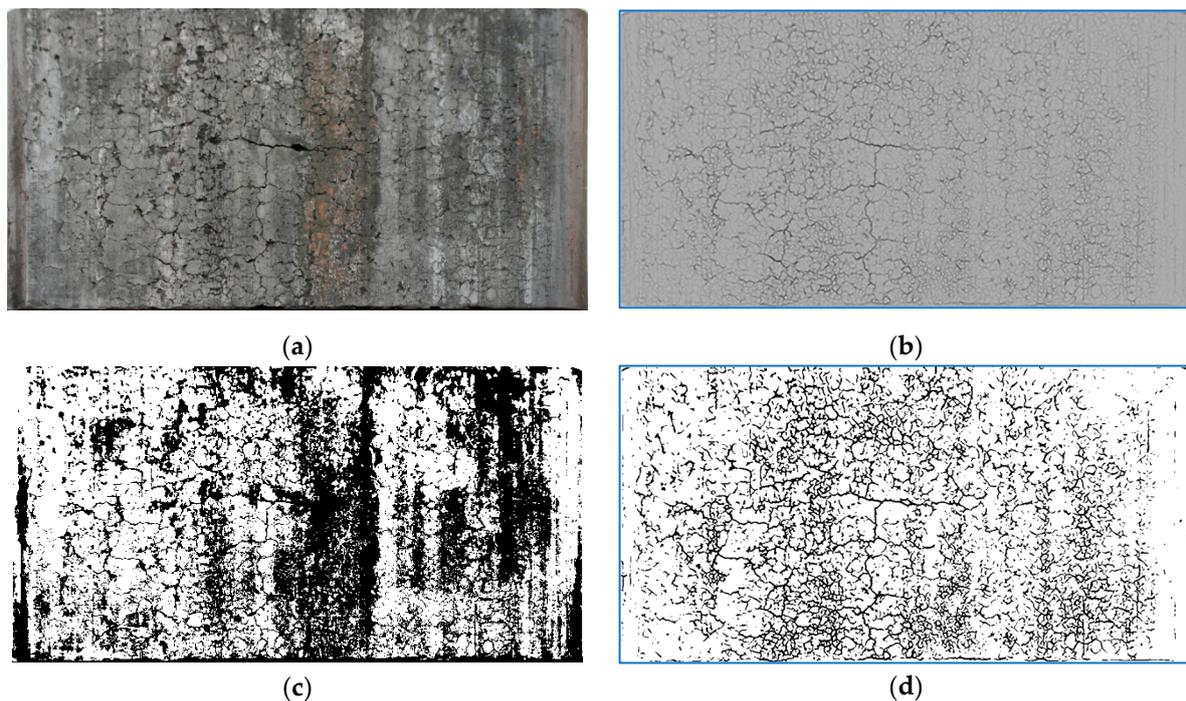
**Figure 13.** Restored input image of brake pad (a), visualization of its measure  $L_c$  (b) and their respective segmentation by Otsu method: (c,d).

After that, the image processing step is applied in order to detect cracks at the friction surface of a brake pad. For this purpose, the restored input image is presented in the scale-space representation (3), and the crack strength measure  $L_c$  (4) is computed. The visualization of measure  $L_c$  (4) calculated for the input image in Figure 13a is shown in Figure 13b. Segmentation of the transformed (Figure 13a) and preprocessed (Figure 13b) images with the Otsu method is presented in Figures 13c and 13d, respectively. As can be concluded from the images in Figure 13c,d, the scale-space-invariant approach is of great importance since direct segmentation without this step gives an unsatisfactory result with a high percentage of oversegmentation.

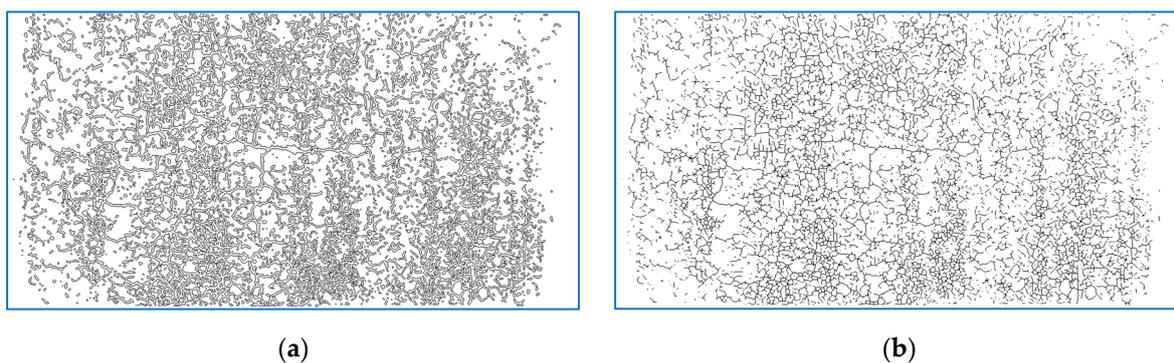
**Figure 14.** Results of contour detection (a) and skeletonization (b) of image in Figure 13d.

The results of the contour detection and skeletonization steps for the image in Figure 13d are presented in Figure 14a,b.
