Bailout procedure after inadvertent false release of a self-expandable TAVI prosthesis

Interventional valve-under-valve implantation

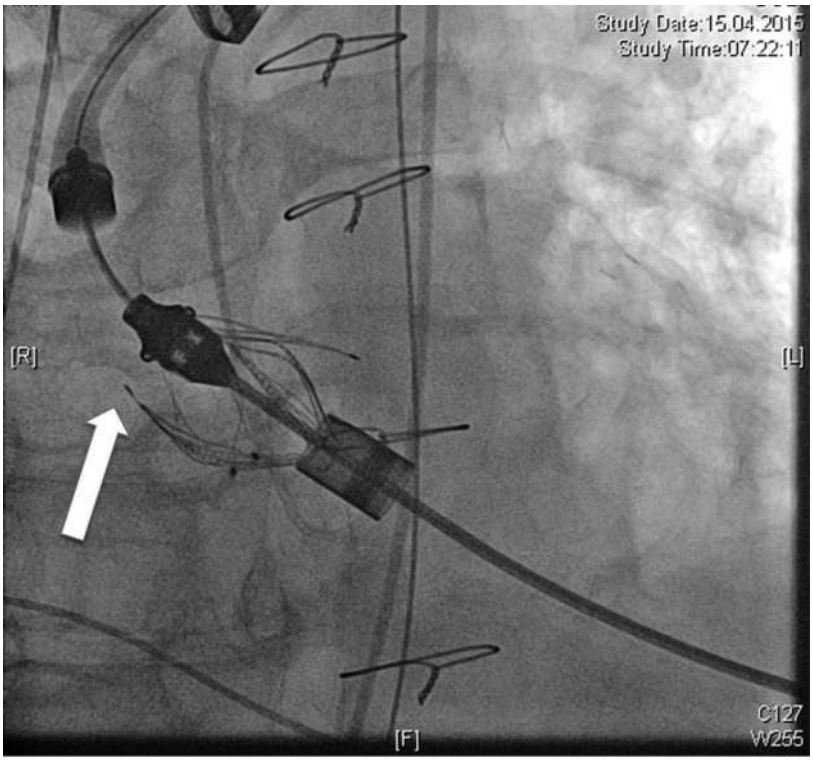
Figure 1: White arrow shows one of the three eyelets of the crown inadvertently and incorrectly popping out of the catheter tip.

In the presented case, involuntary and uncoordinated release of one eyelet of the JenaValve's crown prevented anatomically and functionally correct implantation.

There are three potential explanations: 1) the crimping process was imperfect, 2) the valve was too bulky (full-root-valve) for proper mounting in the delivery system (Cathlete plus), 3) the ascending aorta was too short, resulting in bending-up of the Cathlete plus delivery system with uncontrolled release of the valve. However, the crimping process was supervised by experienced JenaValve™ staff, the implanted valve unfortunately is not amenable for assessment and the length of the ascending aorta was 67 mm, with >65 mm recommended by the instructions for use. Snaring and repositioning of the device was considered inappropriate due to ample radial force of the self-expandable valve as well as the unique feeler design which might have caused dissection or even rupture of the aortic wall.

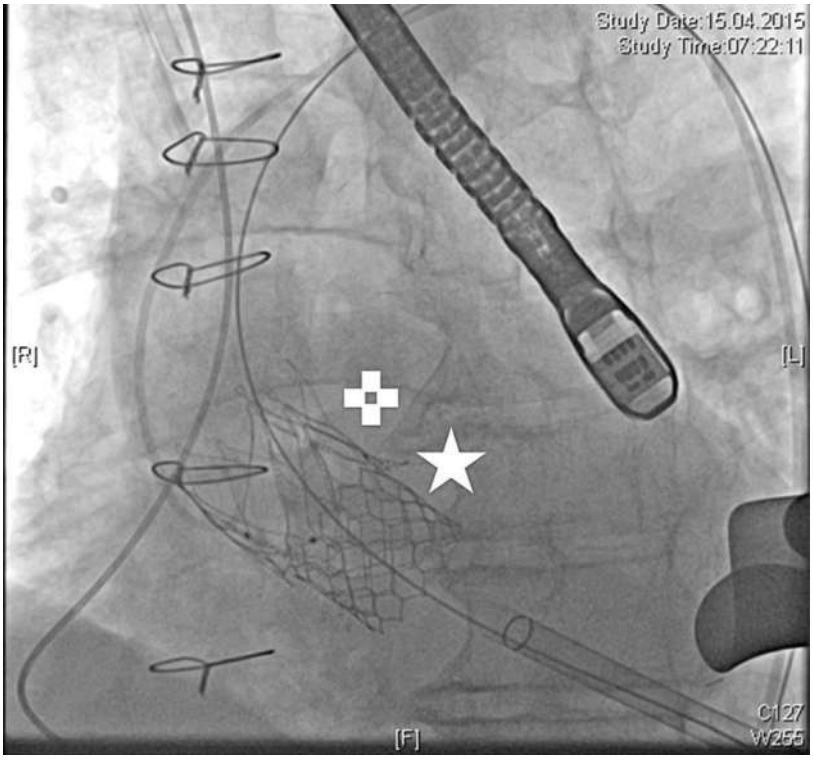
Figure 2: Post-implantation angiography showing both valves on top of each other: JenaValve™ (cross) as well as Edwards Sapien S3 (star).

occluded, and that myocardial perfusion was provided by the left internal mammary artery and two patent vein bypasses, which were grafted to the aorta distal to the upper TAVI. For the second TAVI we decided not to implant another self-expandable valve (JenaValve™) but to use a balloon-expandable valve to avoid manipulation and potential dislocation of the primarily implanted prosthesis.
