Article

uhuMEBr: Energy Refurbishment of Existing Buildings in Subtropical Climates to Become Minimum Energy Buildings

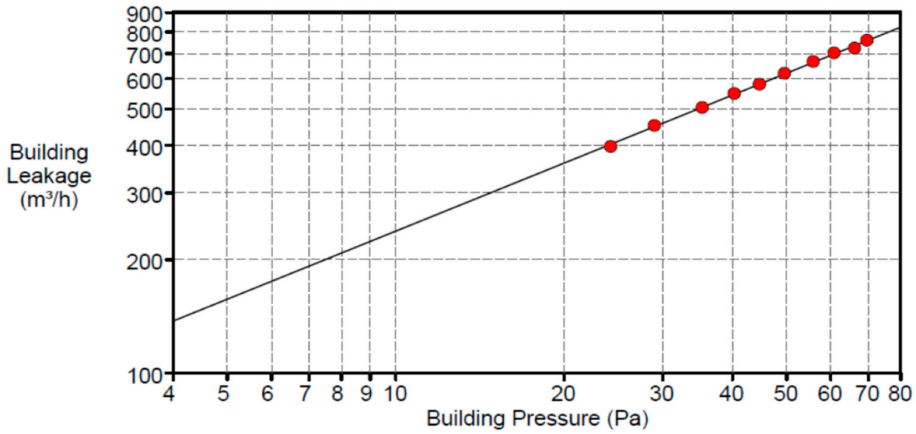
Figure 6. Dwelling envelope airtightness test before refurbishment.

The envelope airtightness test in the dwelling yielded a result of 2.85 h^{-1} for 50 Pa (620 m^3/h for a total inner air volume of 217.70 m^3). Figure 6 shows different dwelling leakage values according to each pressure difference (from 25 to 70 Pa) obtained from the test.

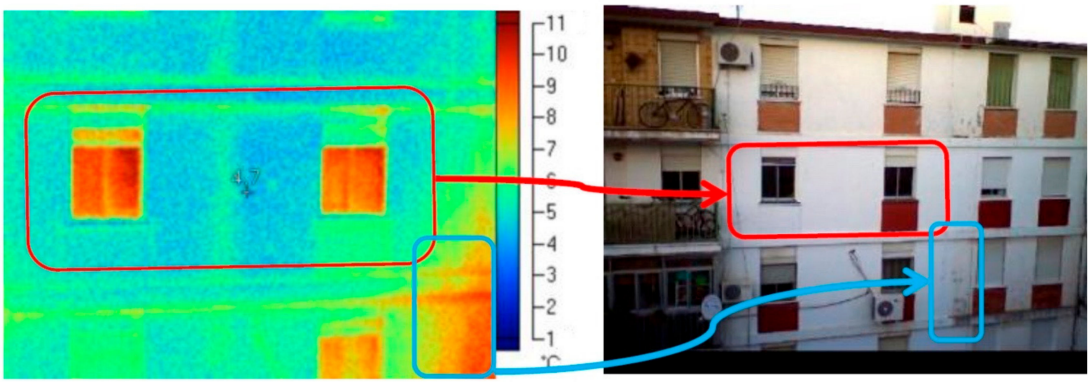
Figure 7. (**a**) Thermal behavior of the dwelling exterior façade; (**b**) Visual aspect.

Figure 7a shows the thermal behavior of the dwelling exterior façade (enclosed in red). Notice the weak points in windows and shutter boxes. Moreover, observe the behavior of a dwelling on the bottom right (enclosed in blue) in the same building. This dwelling (Figure 7b) has a very deteriorated façade (enclosed in blue), unlike the one that is enclosed in red that is freshly painted. Figure 8 shows the thermal behavior of the dwelling façade that overlooks the backyard. Notice, again, the weak points in windows and shutter boxes. Note also that the interior I (Figure 8a) is more deteriorated than the exterior (Figure 8b). Figures 7 and 8 show the poor thermal behavior of the dwelling and its need to improve it.

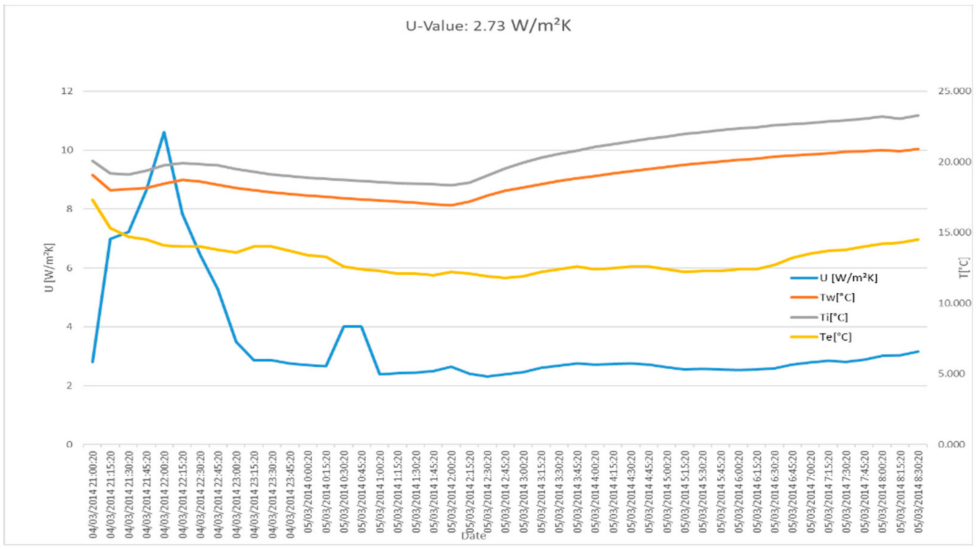
Figure 9. Dwelling envelope thermal transmittance test before refurbishment.

The existing building energy evaluation stage finished with the thermal transmittance test (Figure 9). The measured *u*-value was 2.73 W/m^{2}K; which is well above the 0.3 Wm^2/K required for a MEB. Once the dwelling's weak points were detected, an existing building energy report was drafted (Figure 1). Its study by the technicians led to the decision that it was impossible to solve the multiple dwelling failures (in the field of the energy efficiency only) through corrective maintenance, so the decision to carry out energy refurbishment was made (see Figure 1).

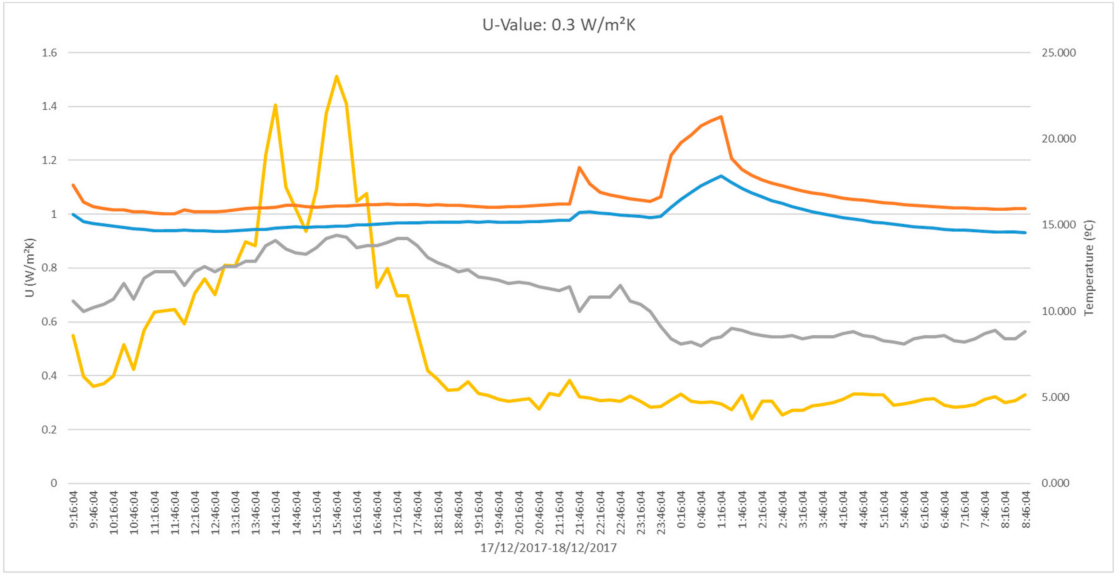
Figure 19. Dwelling envelope thermal transmittance test after refurbishment.

The transmittance test (Figure 19) showed the behavior of the outer envelope with respect to the heat exchange between the interior and exterior of the dwelling. The test implies that the measurement, to be valid, needs to reach steady-state conditions, which means that the average u-value remains substantially constant over time.

Attending Figure 19, it can be observed that practically in the last 13 h the average transmittance value remained constant, which means that the steady-state has been reached and the measured transmittance value was 0.30 W/m^{2}K, which fulfilled the corresponding MEB value (Table 2). A comparison between Figures 9 and 19 shows that the improvement of the envelope transmittance thanks to the ETICS and the carpentry was from 2.73 W/m^{2}K to 0.3 W/m^{2}K, i.e., about nine times smaller.

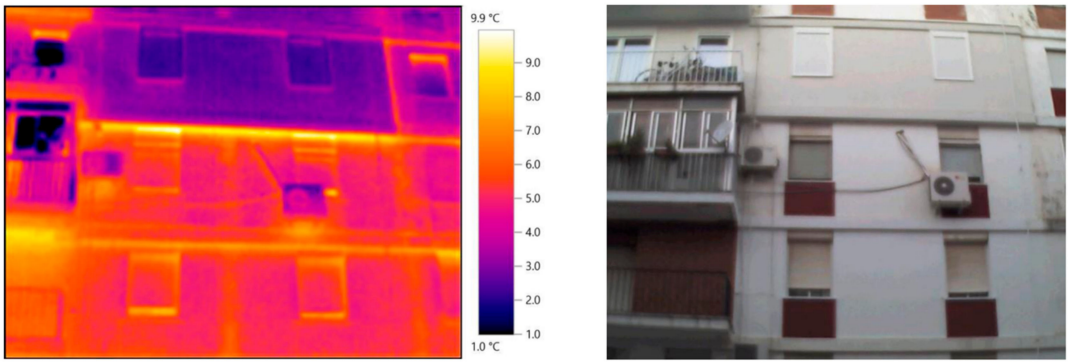
Figure 20. (**a**) Dwelling thermography test after refurbishment; (**b**) Visual aspect.

Regarding thermal envelope behavior, Figure 20a shows the difference between the part of the envelope that has been retrofitted with ETICS and new windows (encircled in white color in Figure 20b) and the original building envelope. Thermal bridges caused by concrete columns and slab borders can be clearly seen in the façade below the refurbished dwelling. This part of the façade is radiating energy out, i.e., losing energy.

Figure 20 complements the results reflected in Figure 19 with respect to thermographies. This Figure shows the dwelling thermography test. It is easy to appreciate the drastic change of the outer envelope thermal behavior after the refurbishment. In fact, if a comparison between Figures 7, 8 and 20 is carried out, immediately it can be observed that, after the refurbishment, the dwelling practically does not lose energy thorough its outer envelope (façades).

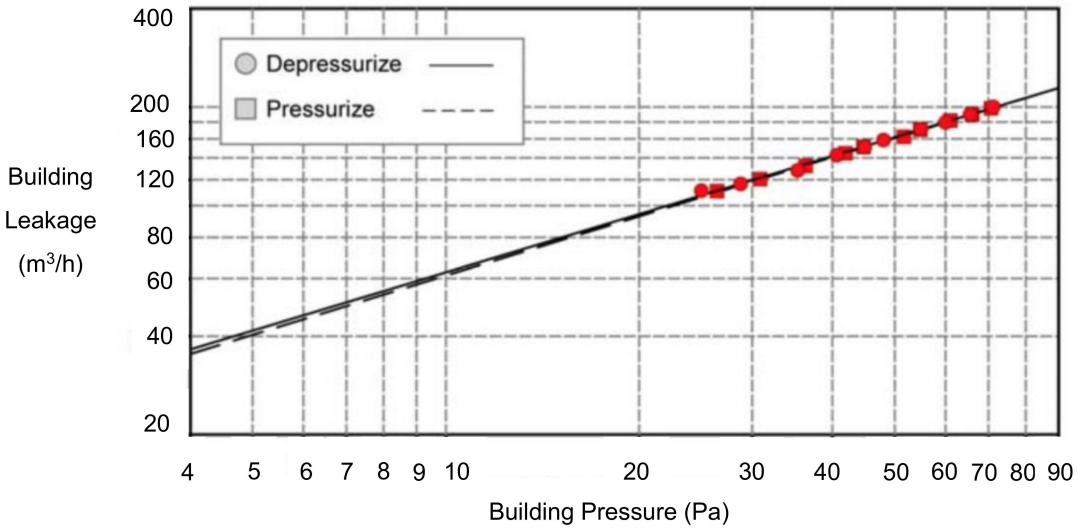
Figure 21. Dwelling envelope airtightness test after refurbishment.

Finally, the standard procedure EN 13829 BDT was followed to check the building envelope airtightness. Figure 21 shows the test results. The average value was 0.59 h^{-1}, which is lesser than 0.60 h^{-1} that is the maximum allowed for an MEB (Table 2).
