Designing for Safe Repairs—Identifying and Mitigating Repair Safety Risks in Washing Machines

Julieta Bolaños Arriola *, Emilia Ingemarsdotter †, Conny Bakker and Ruud Balkenende

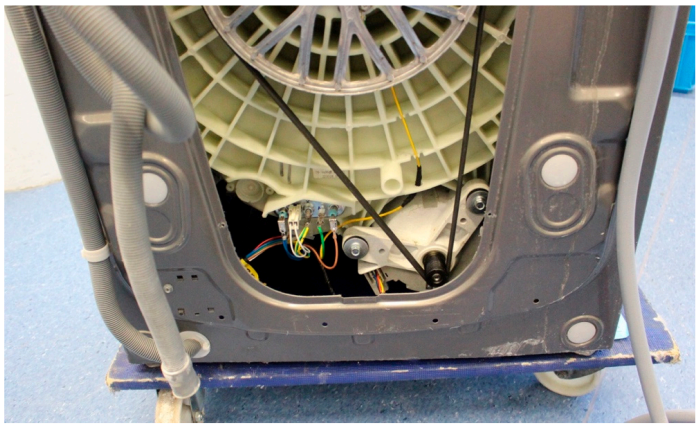
Figure 3. Back opening of the washing machine, showing a number of potential repair-related risks. Immediately after removing the back panel, the repairer is exposed to sharp edges, electrified parts, and moving components. Aggravating factors, such as mobility and visibility issues, to perform repairs that require the disassembly of the motor, are also evident.

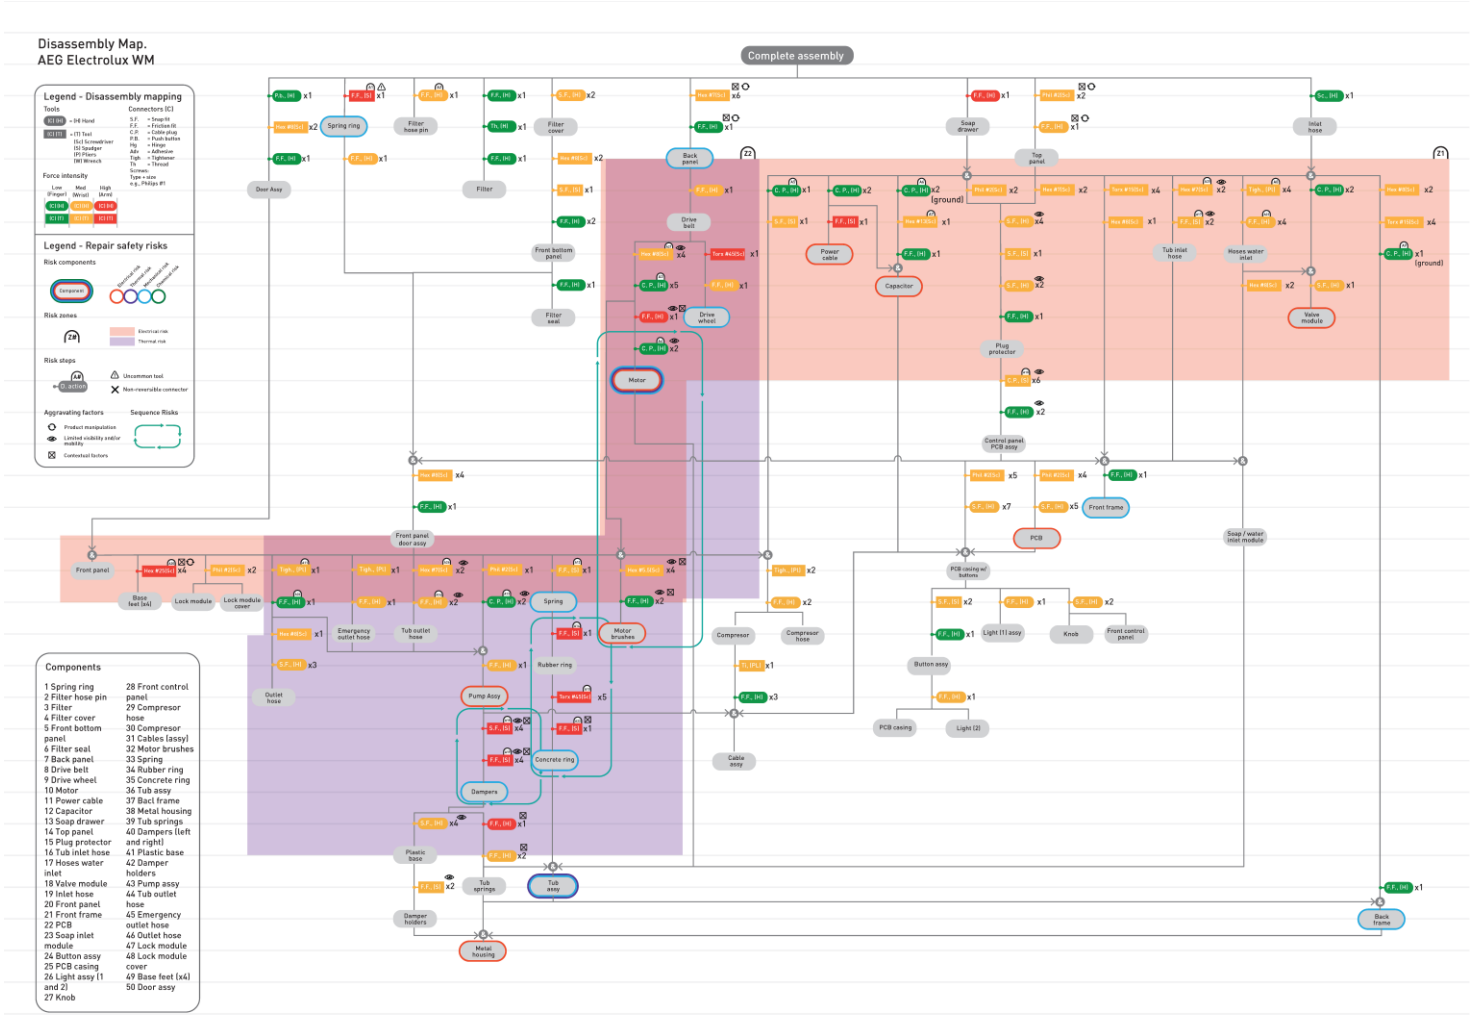
Figure 6. Disassembly map and visualization of risks of the washing machine. The risk mapping elements indicate the presence of thermal and electrical risk zones originating after the removal of panels. Thermal, electrical, and mechanical risks associated with components such as the capacitor, the motor, and the tub are highlighted. The 26 risk steps indicate potential post repair risks due to reassembly issues. Sequence risks highlight differences between the disassembly and reassembly of the rubber ring, and potential shortcuts to reach the motor brushes. A high-fidelity version is available in Supplementary Material S2.

A total of 26 risk steps were identified in the washing machine (Figure 6) and 35 in the washer-dryer combo (Figure 7), suggesting a number of post repair risks. In both machines, most risk steps stem from vulnerable hose connections and the lack of affordances to reconnect cable plugs correctly. A number of disassembly actions require high forces, which could result in injury or reduced mechanical integrity of components. The washer-dryer combo presents additional risks due to the heating element, which lacks reassembly affordances and involves a larger number of hoses and non-reversible connectors. For instance, zip-ties are used in hose connections and cable harnesses. Finally, both machines require an uncommon tool for the correct reassembly of the rubber ring, a component that requires disassembly to access other parts.

Several *risk components* were highlighted in the disassembly maps (Figures 6 and 7). For the washing machine, the capacitor, motor, PCB, and pump all pose electrical hazards due to residual charge. In the washer-dryer combo, however, the main PCB was not marked as risky since it is insulated and does not require direct access for most repairs. Moving components (motor and drive wheel), panels with sharp corners, and heavy components (concrete ring and tub) have been marked as mechanical risks. These are either exposed after removing one or more panels or must be disassembled to reach other parts, increasing risks. It is important to highlight that the disassembly depth of a component shown on the maps should not be confused with the proximity of touching. For example, the motor appears deep in the map sequence since several steps are required for its disassembly; however, in reality, repairers are physically exposed to it immediately after removing the back panel.

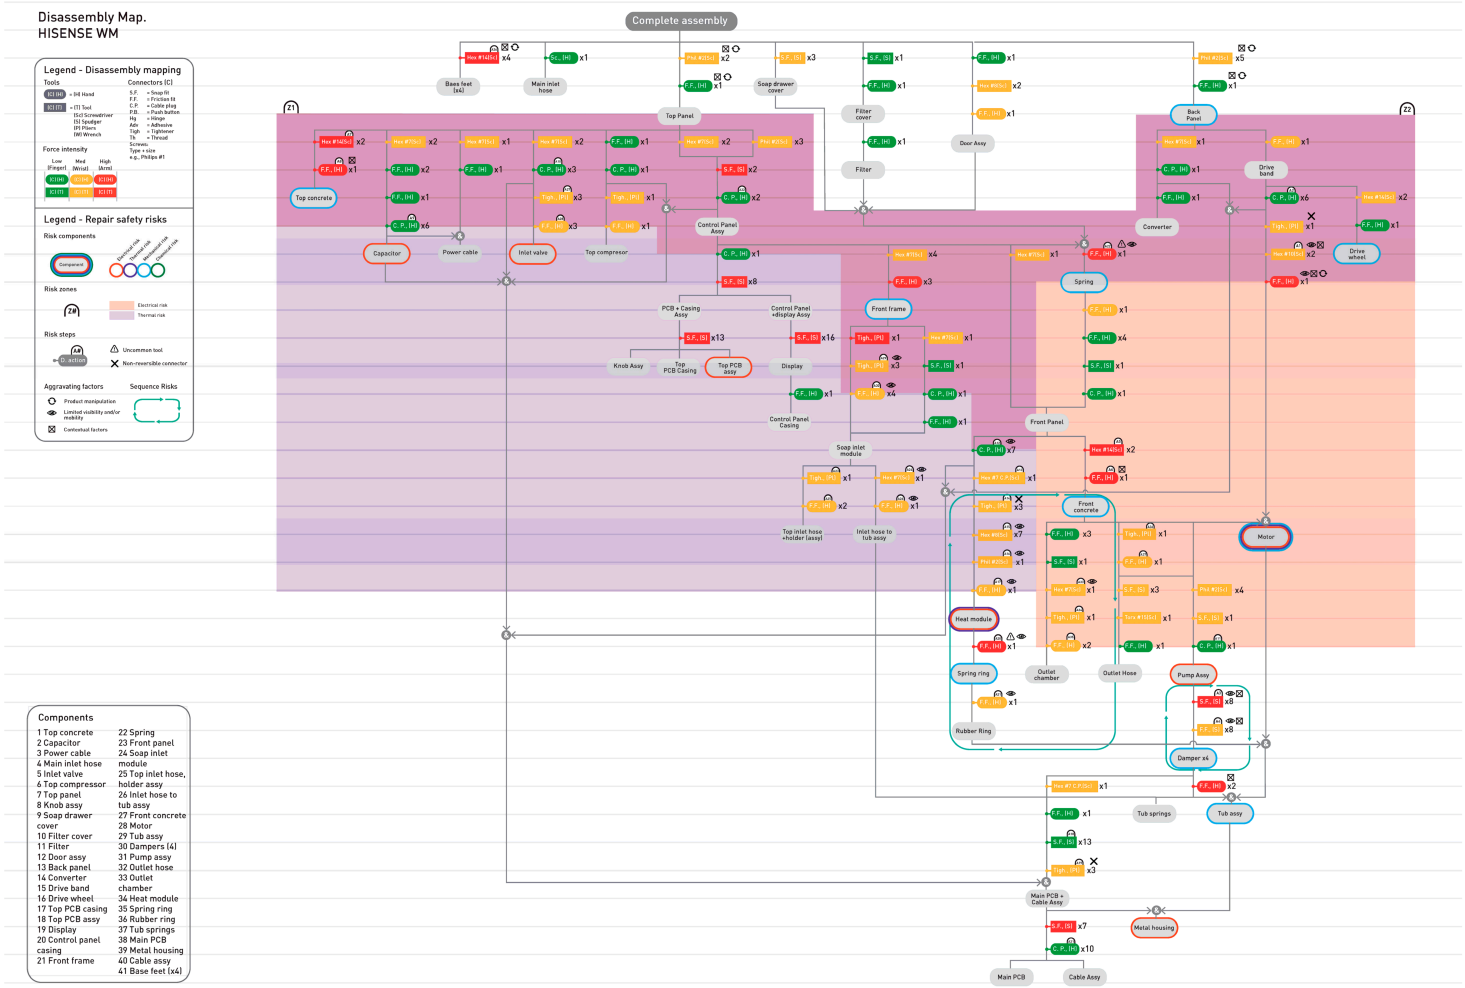
Figure 7. Disassembly map and visualization of risks of the washer-dryer combo. The risk mapping elements indicate the presence of thermal and electrical risk zones originating after the removal of panels. Thermal, electrical, and mechanical risks associated with components such as the capacitor, the motor, and the heating element are highlighted. The 35 risk steps indicate potential post repair risks due to reassembly issues and several non-reusable connectors. Sequence risks highlight differences between the disassembly and reassembly of the rubber ring. A high-fidelity version is available in Supplementary Material S2.
