Identifying Coastal Heritage Vulnerabilities: The Case of Historical Fortified Structures in Northern Portugal

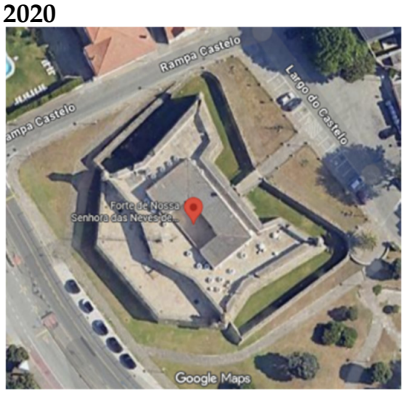
Designation and Location	Anthropogenic Pressures	Natural Hazards	Images—2020 and 2025
Forte de N. S. das Neves, Forte de Leça da Palmeira, Castelo de Matosinhos—Matosinhos, Leça da Palmeira **41.187676, −8.702222**	Urbanization and coastal development; Tourism and social pressure; Population growth in coastal areas; Lack of maintenance or visible neglect.	Coastal erosion; Meteorological and temperature fluctuations; Saltwater intrusion and salt crystallization; Floods and heavy rains.	 **2020**  **2025**
Forte de S. João Baptista—Vila do Conde **41.341731, −8.751788**	Urbanization and coastal development; Tourism and social pressure; Population growth in coastal areas; Lack of maintenance or visible neglect.	Coastal erosion; Meteorological and temperature fluctuations; Saltwater intrusion and salt crystallization; Floods and heavy rains.	 **2020**  **2025**

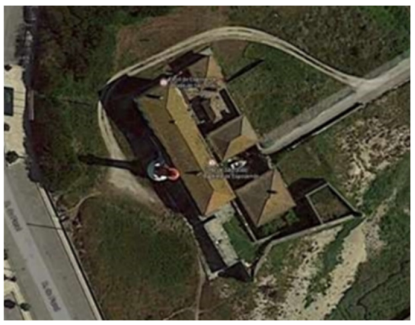
Designation and Location	Anthropogenic Pressures	Natural Hazards	Images—2020 and 2025
Fortaleza de N. S. da Conceição, Castelo da Póvoa—Póvoa de Varzim **41.378177, −8.764017**	Urbanization and coastal development; Tourism and social pressure; Population growth in coastal areas; Poor maintenance.	Meteorological and temperature fluctuations; Saltwater intrusion and salt crystallization; Floods and heavy rains.	 **2020**  **2025**
Forte S. João Batista—Esposende **41.543032, −8.790527**	Urbanization and coastal development; Tourism and social pressure; Population growth in coastal areas; Lack of maintenance or visible neglect.	Meteorological and temperature fluctuations; Saltwater intrusion and salt crystallization; Floods and heavy rains.	 **2020**  **2025**

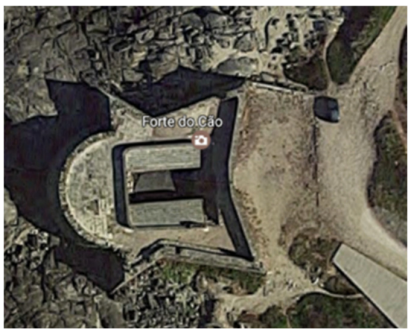
Designation and Location	Anthropogenic Pressures	Natural Hazards	Images—2020 and 2025
Forte or Fortim de Montedor, Forte de Paçô—Carreço, Viana do Castelo **41.758863, −8.876477**	Tourist and social pressure (vandalism); Lack of maintenance or visible neglect (uncontrolled growth of vegetation).	See level rise; Coastal erosion; Meteorological and temperature fluctuations; Saltwater intrusion and salt crystallization; Floods and heavy rains.	 **2020**  **2025**
Forte do Cão, Forte da Gelfa—Vila Praia de Âncora, Caminha **41.797679, −8.873928**	Tourist and social pressure (vandalism); Lack of maintenance or visible neglect (uncontrolled growth of vegetation).	See level rise; Coastal erosion; Meteorological and temperature fluctuations; Saltwater intrusion and salt crystallization; Floods and heavy rains.	 **2020**  **2025**
